Anastelosis of Greco-Roman Temple Remains in Western Anatolia: Principles, Implementations and Assessment

Ozge Deniz Toköz & Başak İpekoğlu

Department of Architectural Restoration, Izmir Institute of Technology, Izmir, Turkey

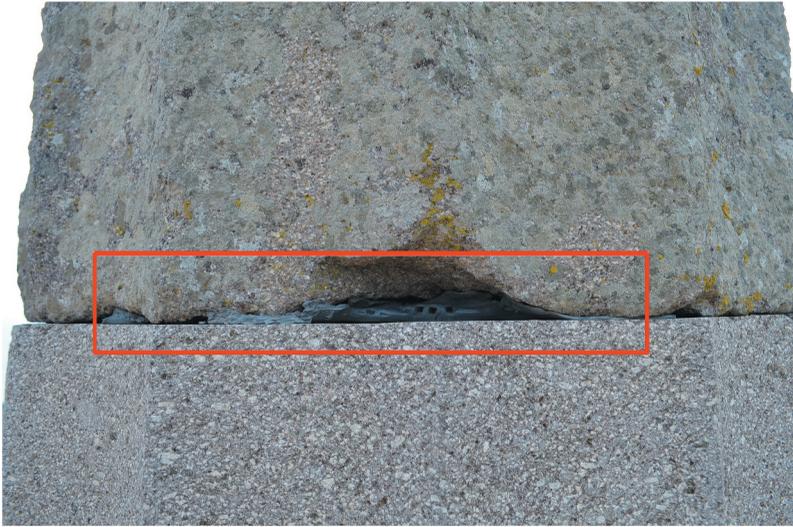
In the first re-erection work at the temple which was conducted by Ege University, three columns in the south and two columns in the north of the temple were re-erected to the top level of capitals by using original and reinforced concrete elements between 1990–2005 (Arslan 2008). Since the reinforced concrete elements used in the re-erection work weathered over time and threatened the durability of original materials, it was decided that parts of the temple would be dismantled and anastelosis work would be performed with new stone material (Arslan 2008). In a recent study, carried out by Çanakkale Onsekiz Mart University, reinforced concrete blocks were removed, new andesite stone blocks were used, which are the same as the original, and joining material was not placed between the capital and the drums, but lead plates were placed between the old eroded drums when necessary (Arslan et al. 2011) (Figure 2). New stylobate blocks

Figure 2. Lead plates between column drums, Assos.

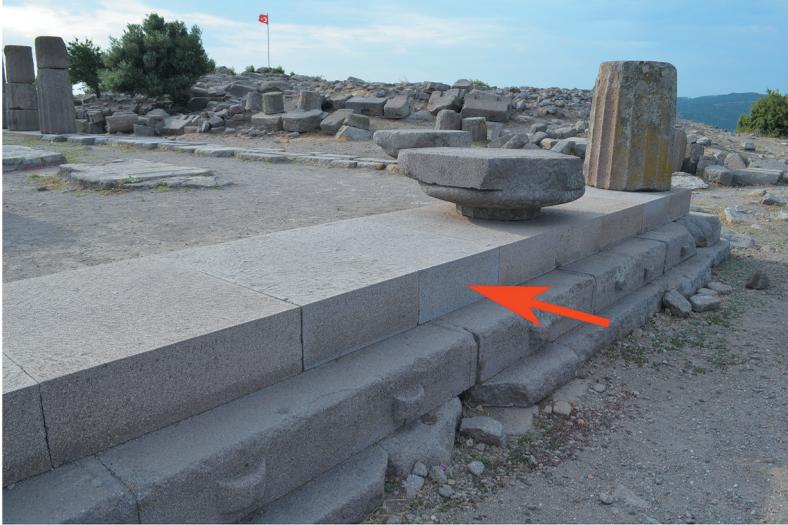
were produced smaller than the original size so that they could be distinguished from the original ones (Arslan 2012). In the on-site examination in October 2016 and June 2017, it was determined that the north-western pediment of the cella was joined to the floor of the temple (Figure 3).

Figure 3. Reduced sized stylobates on east side, Assos.

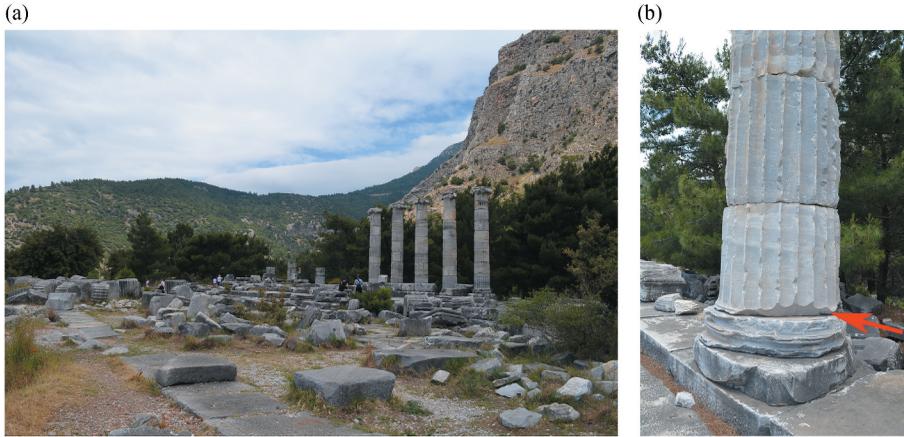
Figure 5. Re-erected columns of the Temple of Athena with reduced height in the sanctuary and missing torus, Priene.

The re-erection work carried out by Turkish authorities in 1965/66, no scientific preliminary work was undertaken, the torus parts of the column bases were not used and the columns were re-erected to a height of 8 m, short by 3.5 m from the original height considering possible earthquakes (Bauer 1969; Rumscheid 2000; Koenigs 2015). In this study, no material was placed between the drums for joining. After this re-erection, documentation studies were started in 1977; to ensure the preservation of existing parts and to avoid loss of ornamentation (Koenigs and Raeck 2001; Koenigs 2015) (Figure 5).

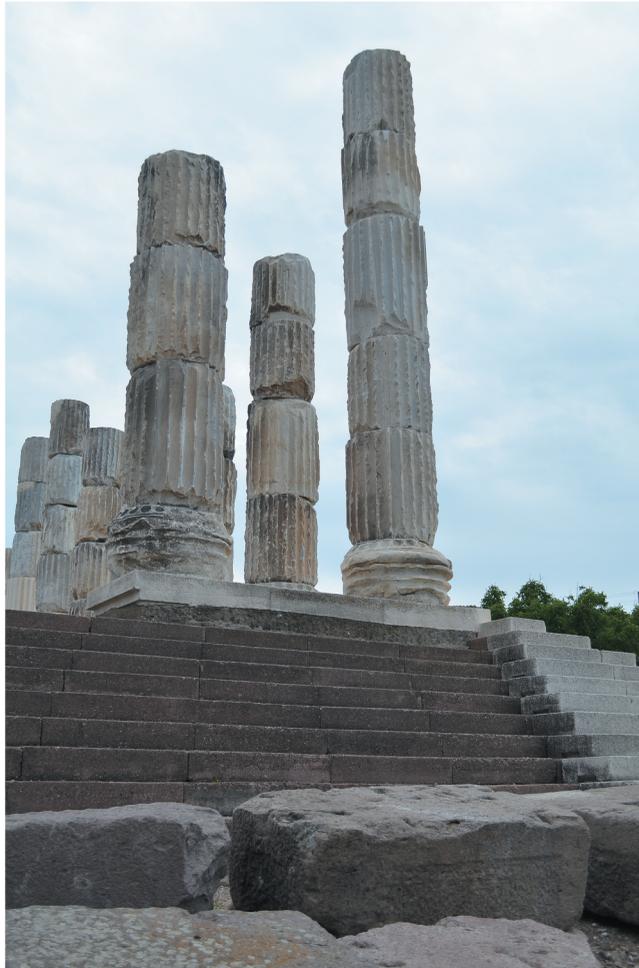
Figure 10. First erected three columns on re-built foundation and crepis on south-east side, Smintheion.

pieces originally from the stylobate level to the frieze level and to give the temple a three-dimensional appearance. Although this project was intended to be applied in the south-west corner, which had been re-erected in previous work, it could not be done due to lack of original parts and structural problems in existing parts. For this reason, it was decided to re-erect the already eroded south-east short side. The reinforced foundation was built on the original eroded foundation by preparing a solid foundation for re-erection. The 18 drums that matched through diameter were brought together, but it was determined from the dowels that they did not

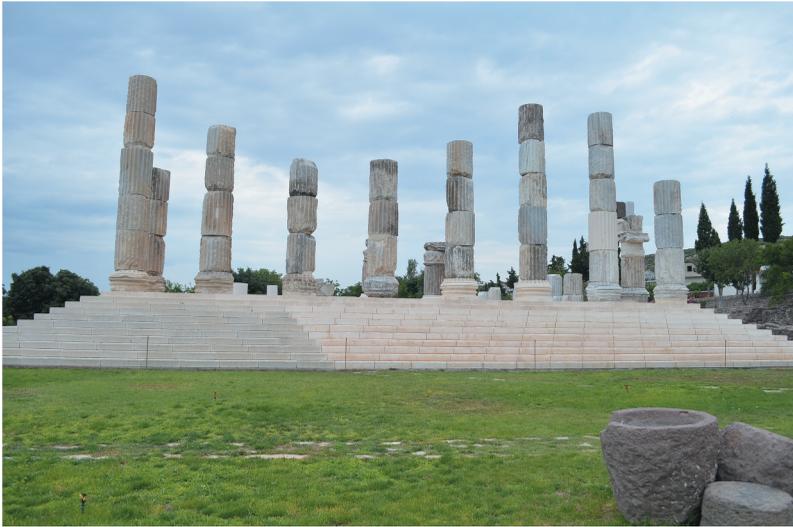
Figure 11. Re-erected original columns on new crepis on south-west side, Smintheion.

match each other (Özgünel 2005) (Figure 10). At the end of the studies completed in 2014, the crepis of the south-western short side was rebuilt with reinforced concrete blocks in terms of harmony with the previous application. The columns on this side were re-erected to different heights and the broken column bases were completed with reinforced concrete. A display was made by putting two rows of columns on the south-eastern long side with their bases, one drum, *columna caelata*, capital each, one architrave and one frieze block over these columns (Özgünel et al. 2018) (Figures 11 and 12).

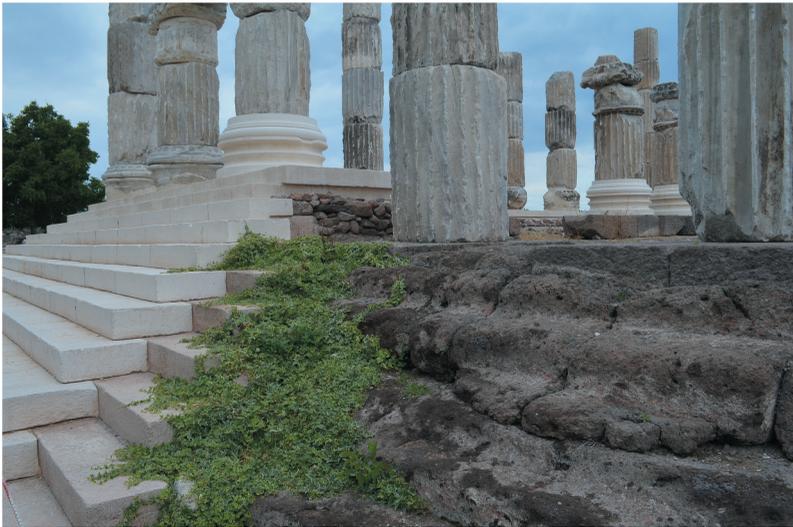
Figure 12. New and original foundation at Smintheion.

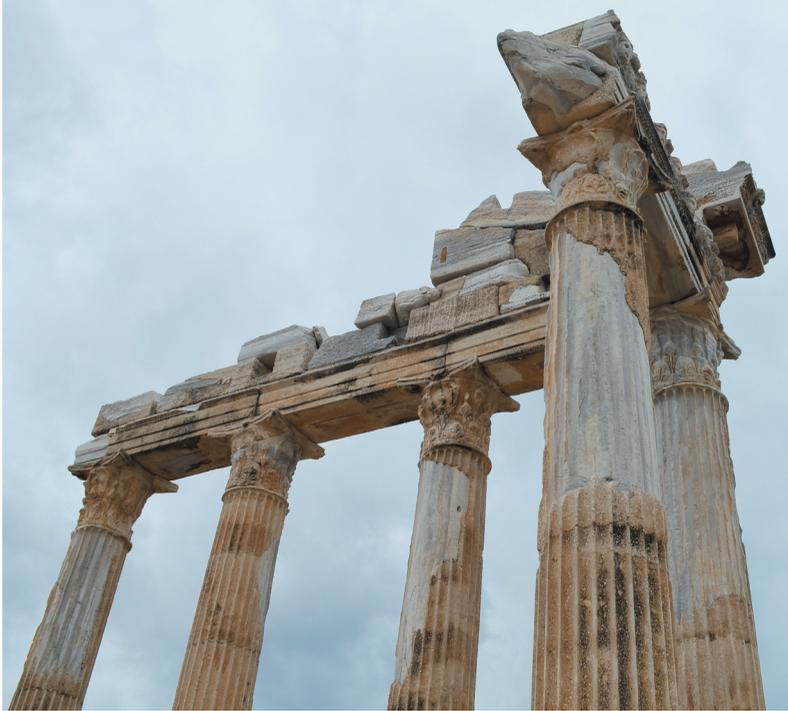
(İnan 1985). In order to re-erect columns safely, a reinforced concrete foundation was built by pouring lean concrete below the stylobate. A mixture of marble dust, marble chips, sand and white cement was poured in order to complete the missing parts of the columns, stylobate and base as continuing one piece. Reinforced concrete new pieces were integrated with original pieces with stainless steel bars (İnan 1985) (Figures 14 and 15).

Figure 14. New reinforced concrete parts of columns, Side.

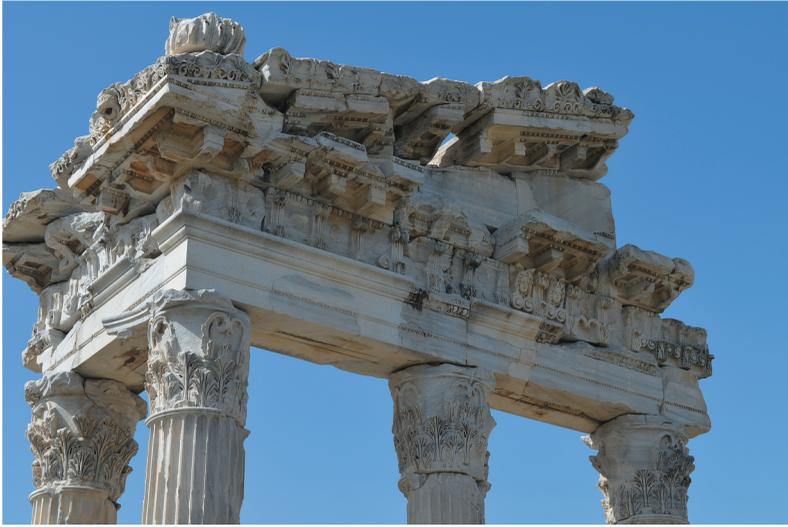
Figure 17. Unornamented completions, Pergamon.

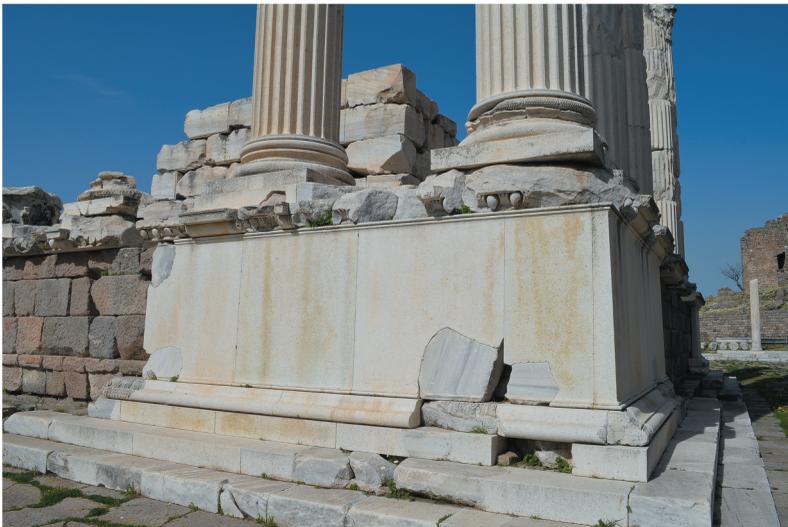
Figure 18. New concrete parts with original pieces, Pergamon.

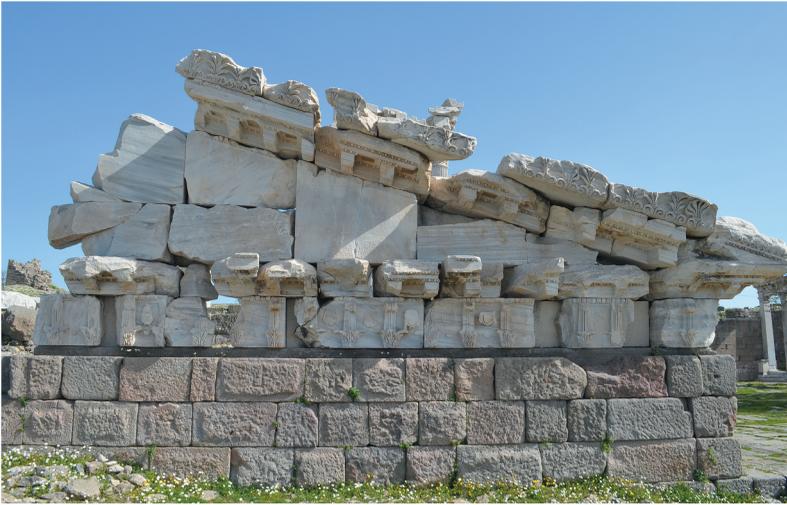
keeping them at constant temperature and humidity. Fibreglass rods were used instead of steel to reduce the risk of lightning when joining elements with high position in the construction. The newly produced parts were left unornamented, only the contour of the ornamentations was processed; the only exception of this decision is new frieze blocks with Medusa heads (Radt 1987, 1988; Nohlen 1999) (Figures 17 and 18). A large part of the original pieces of the southern pediment were placed on the surviving stones of the podium on the south-eastern corner of the temple. It was suggested that this work was carried out in order that the size of the temple could be perceived, the parts of the pediment were protected by raising them from the ground (Radt 1993) (Figure 19).

Figure 19. Southern pediment joined without columns, Pergamon.

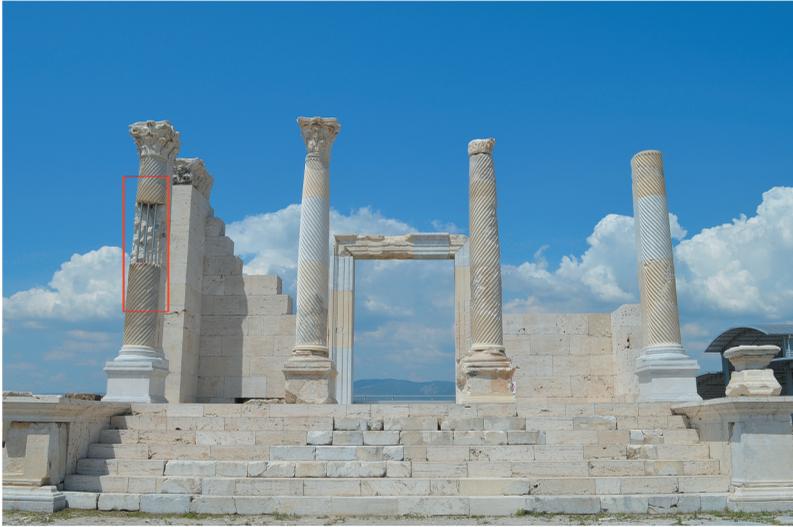
Figure 21. Presentation of damaged left edge column caused by a sledgehammer, Laodikeia.

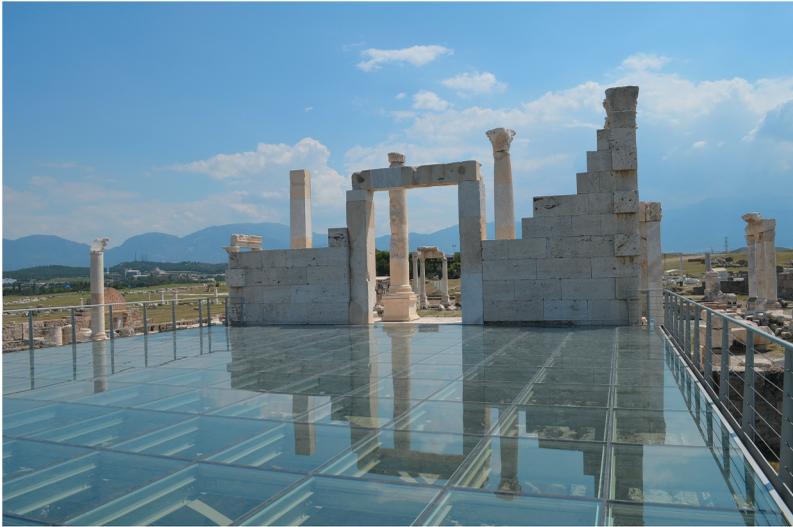
Figure 22. Glass floor of the cella of Temple A, Laodikeia.

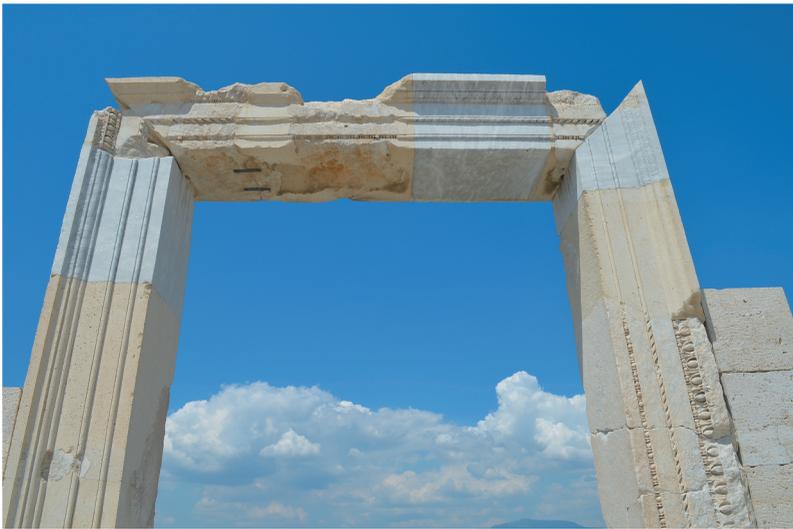
Figure 23. Completions of the door with different materials as marble and reinforced concrete at Laodikeia.

new parts, these elements were produced without ornamentation. Different approaches were followed in Temple A at Laodikeia for the use of new materials on the same element, are visually incompatible. It is impossible to say that the concrete parts are compatible with the original material. In the Temple of Athena at Assos and the Temple of Leto at Letoon, it was aimed to distinguish the new parts, which were produced from the same material as the original, by their uneroded details. However, there is a possibility that when new parts wear out over time they become indistinguishable. Also, the newly produced stylobates of the Temple of Athena at Assos were produced in different dimensions from the original with the aim of distinguishability. In both applications, compatibility issues are not expected to arise because the new elements are the same as the original ones. The implementation of the Temple of Athena at Priene does not have a situation where compatibility and distinguishability problems can arise because no new material was used in the re-erection. New pieces produced in the Temple of Apollo at Smintheion and the Temple of Trajan at Pergamon without ornamentation are easily distinguished.
