**RESTORATION AND PRESENTATION OF  
BYZANTINE DEFENSE STRUCTURES IN CILICIA**

**A Thesis Submitted to  
the Graduate School of Engineering and Sciences of  
İzmir Institute of Technology  
in Partial Fulfillment of the Requirements for the Degree of**

**in Architectural Restoration**

The aim of this study is to evaluate current restorations and presentations of Byzantine defense structures in terms of sustaining and enhancement of the cultural heritage values and their success in solving conservation problems. So, better management of future interventions may be possible. Case study approach was undertaken: Three castle ruins in Cilicia, Turkey were focused on: Yılan and Feke castles and *Kızkalesi* in Korykos. The cases are located in the present-day rural areas. They are restored recently. The study consists of literature review, site survey, documentation and analysis of geographic characteristics, historic background, morphologic characteristics, construction technique and material usage and conservation activities of the case studies, identification of the cultural heritage values and conservation problems before and after interventions at the landscape, site and building s

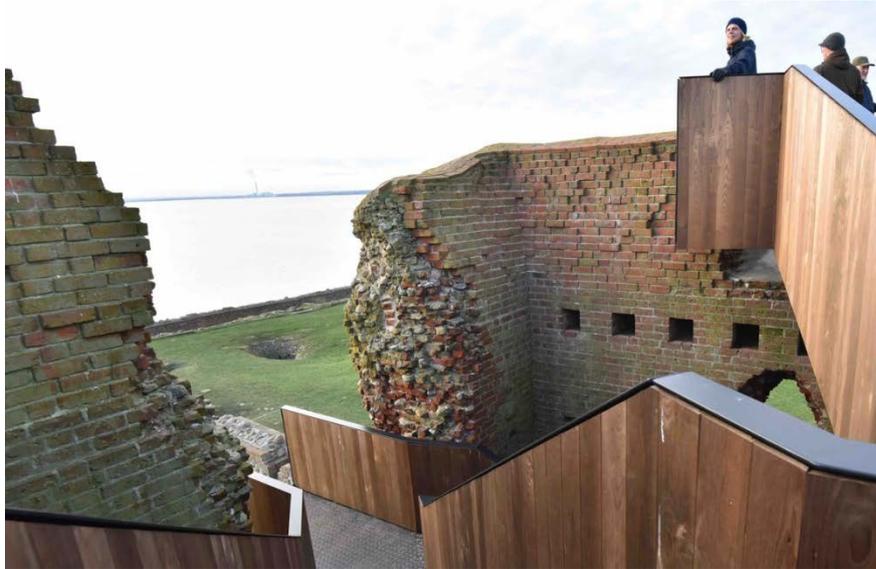
Figure 2.5. Unstable wall parts caused by previous restorations  
(Source: Castro, 2019)

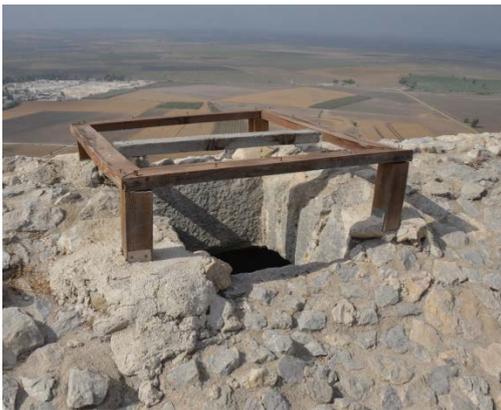
Figure 3.27. A cover above the opening on the vault of the cistern F2 (2020, October 20<sup>th</sup>)

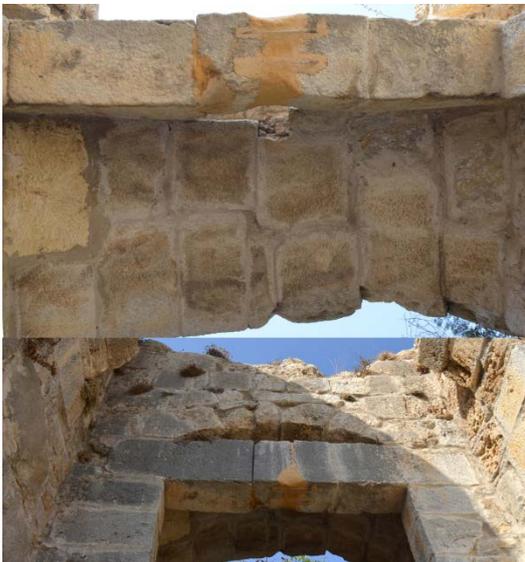
**Consolidation:** Cracks in the walls were filled with hydraulic lime mortar reinforced with araldite (Regional Council for Conservation, 2020). Chrome steel cramps were applied with araldite to the center block of the segmented lintel of the gate C and they were covered with beige colored mortar (Figure 3.29). Joints on the walls were cleaned and hydraulic lime mortar was used for grouting of joint discharge (Regional Council for Conservation, 2020). A temporary timber post was used to support the vault of the cistern I4 (Figure 3.12). For the consolidation of the chapel, a scaffolding that intended to be temporary was implemented (Figure B.5) (Regional Council for Conservation, 2020). The outer walls of the chapel were covered with steel mesh and steel cables, and the load was transmitted to the ground by two posts and steel cables (Figure 3.30). There are no intervention on the chapel walls. Hard capping that consisted of small irregular stones and mortar were applied on the top of the walls.

Figure 3.29. Usage of steel cramps on the stones of the gate C (2020, October 20<sup>th</sup>)

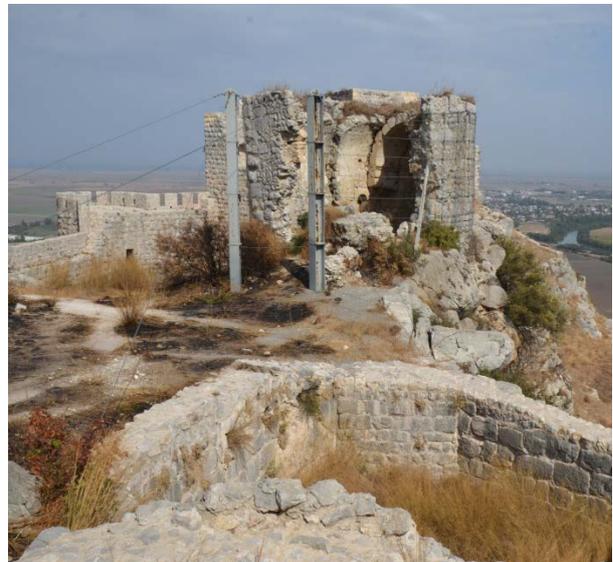
Figure 3.30. Consolidation of the chapel (2020, October 20<sup>th</sup>)

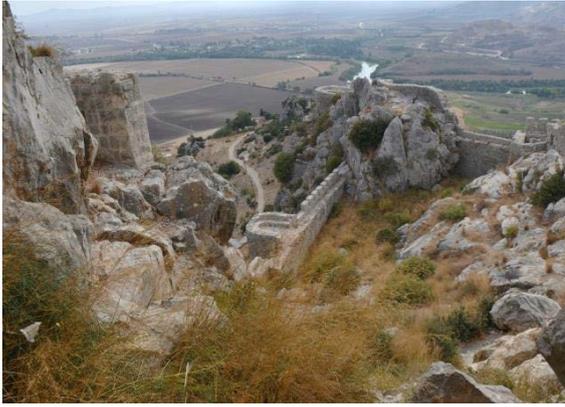
Figure 3.36. View of the middle courtyard (2020, October 20<sup>th</sup>)

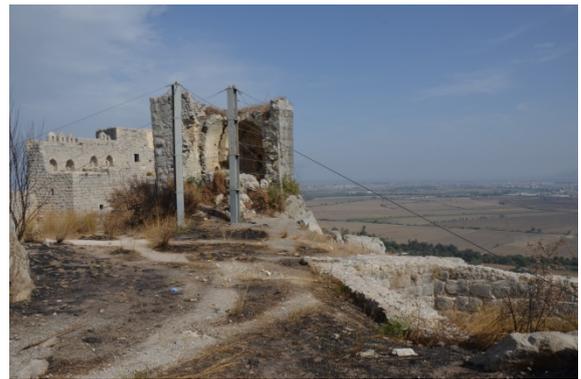
Dense vegetation in the courtyards were cleaned, but they are still obstacle for walking around and entering some structures in the courtyards because of the lack of regular maintenance (Figure 3.36 & Figure 3.37). Rocks and demolished stone blocks are the other obstacles for accessibility. The unstable massive rocks still threaten both life safety of visitors and the structures of the castle. Conservation activities in the castle were carried out unsystematically. For example, consolidation and reinforcement was carried out mostly in the upper courtyard, but especially the D and E walls still have important structural problems. Some structures and damaged wall portions were consolidated, but new injection materials and steel cramps may damage the authentic stones. The precautions against rising damp are useless: e.g., covers above the openings. Also, there are no conservation activities for the authentic plasters. Hard capping was applied on the top of the walls unsystematically: there is no capping on some wall portions of D and E walls. Reintegration of the walls gave way to aesthetic problems stemming from the color differences between the new mortar and stones, and the authentic ones (Figure 3.38). Cleaning activities for plant colonization, black crust, graffiti and carbon deposit were carried out, but the usage of the micro blasting technique may damage the authentic stones (Westminster City Council, 1995, pp. 17-18; Alves & Sanjurjo-Sánchez, 2015, pp. 417-418). As a result of insufficient monitoring, people continue to write on the walls, make fire in the courtyards and throw trash around (Figure 3.39). The castle is not presented.

Figure 3.39. Burning of vegetation in the upper courtyard (2020, October 20<sup>th</sup>)

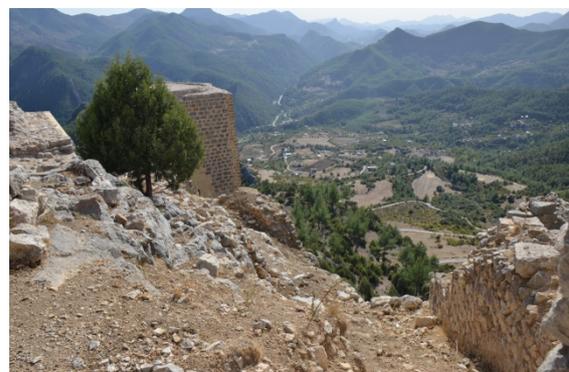
Figure 3.94. Missing wall portions of the west fortification wall (2020, October 21<sup>st</sup>)

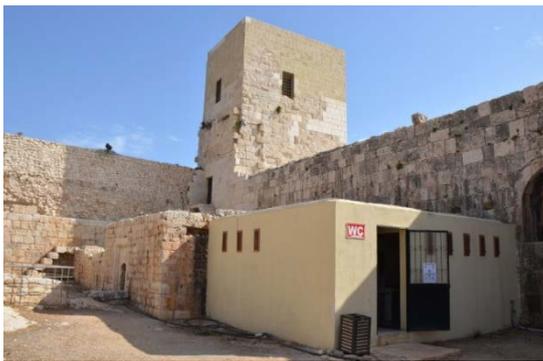
Figure 3.134. The new building (WC) attached to the room E (2020, October 23<sup>rd</sup>)

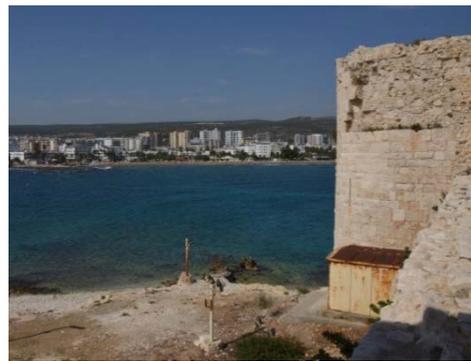
Figure 3.135. Transformer substation attached to tower J (2020, October 23<sup>rd</sup>)

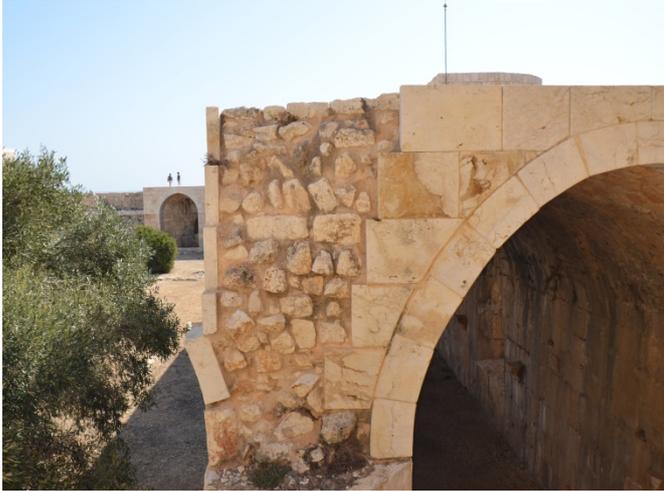
Figure 3.140. Wall detail after the restoration of the portico (2020, October 23<sup>rd</sup>)

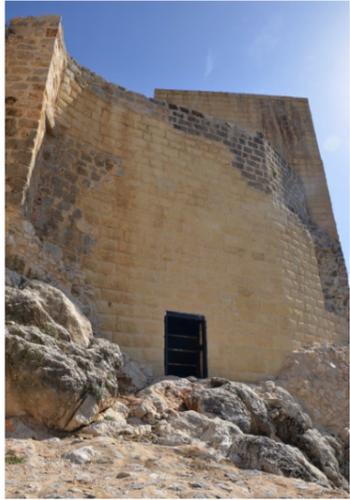
<p>Reintegration at the west facade of the cistern C (2020, October 21<sup>st</sup>)</p>	<p><b>1. RESEARCH</b></p> <ul style="list-style-type: none"> <li>- 1988, May 6<sup>th</sup>: listed as 1<sup>st</sup> degree archaeological site by Adana Regional Council for Conservation with the decision numbered 31</li> <li>- Revision of the conservation site borders: on 1998, September 24<sup>th</sup> with the decision numbered 3164, and on 2009, June 30<sup>th</sup> with the decision numbered 5136</li> <li>- Archaeological excavation within the scope of the restoration project by Adana Archaeology Museum under the control of KVMGM and Adana Directorate of Surveying and Monuments</li> <li>- Some implementations by the Ministry and the residents of Feke at the beginning of the 21<sup>st</sup> century: covering of the portion of the visitor path in front of the entrance platform with slate stones, addition of an iron leaf to the main gate, repair of some wall portions of the outer gatehouse and the entrance platform, construction of parapet walls with the authentic stone blocks in the castle and cement between the cistern C and the entrance passage, at the eastern part of the transition spaces E and F, blocking of the gate of the inner gatehouse with construction of a wall in its opening by using authentic stone blocks and cement, and construction of stone stairs in the southeast corner of the inner gatehouse</li> <li>- Adana-Feke Castle Surveying, Restitution and Restoration Project: architect restorer Bora Işık (project manager), archaeologist Adem Yıldız (site manager), architects Burhan Çiçek, Sezer Kaya, Tuğba Yazıcıoğlu, Dilge Aka and Çiğdem Yan, technician Hüseyin Kavak, and the photogrammetry specialist Kemal Gülçen</li> </ul>
