Quantitative evaluation of the damage to RC buildings caused by the 2023 southeast Turkey earthquake sequence

Earthquake Spectra

2024, Vol. 40(1) 505–530

DOI: 10.1177/87552930231211208

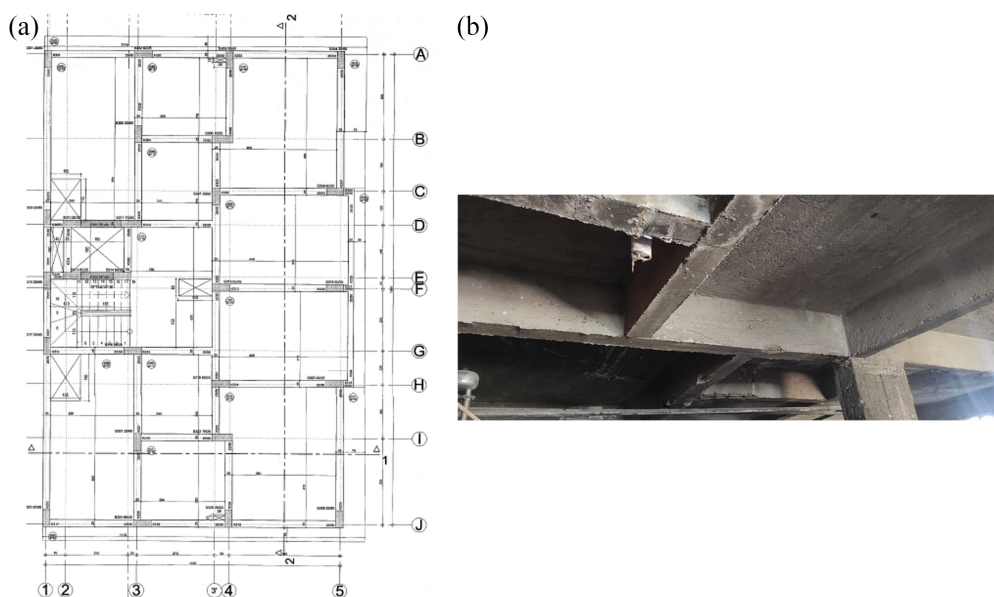
RC frames with beams deeper than slabs. Most surveyed structures had RC frames with RC or masonry infill walls located around an elevator shaft. Where beams deeper than the slabs were observed, they were typically framed into columns. But frames tended to have highly irregular column lines across floor plans (Figure 2) with columns not always aligned along straight gridlines and, in some instances, with beams framing into other beams instead of columns. Some buildings also had upper columns or walls which did not reach the foundation but were supported instead by transfer beams. The longitudinal axes of beams were often offset from the longitudinal axes of supporting columns. Along perimeters, these offsets were introduced to align exterior beam and column faces. Gemici (2019) showed that the described irregularities can cause increases in the initial period of up to 50%.

Figure 2. Irregular framing examples: (a) floor plan and (b) floor soffit.

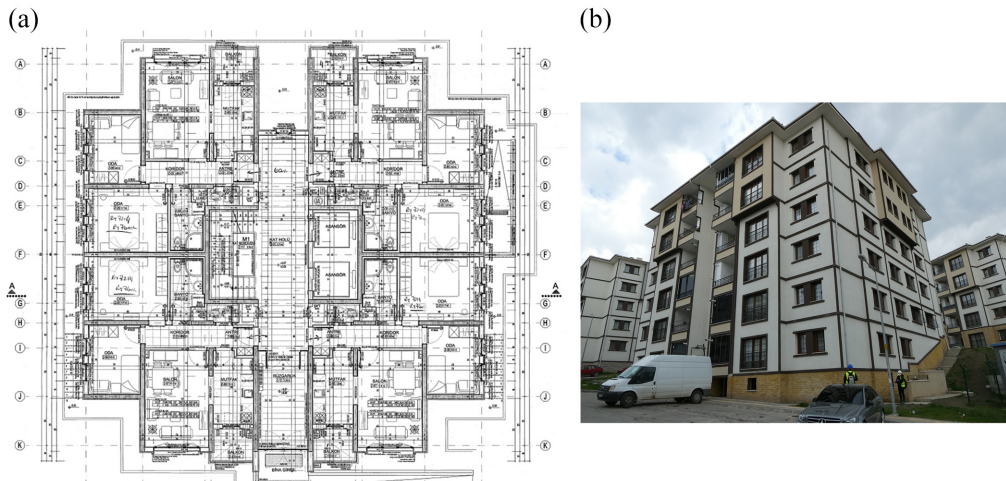
Wall construction. A limited number of buildings were observed to have been built with a method known as “tunnel-form construction” (illustrated here: https://youtu.be/_j-FRe8Ay9s). These structures tend to have abundant structural RC walls (occupying 2% to 6% of a typical floor plan). They were observed to be configured in one of two ways: (1) including similar amounts of wall in each principal floor plan direction, or (2) with most walls oriented in a single floor plan direction. The latter cases were observed to have more signs of structural distress, whereas buildings with well-distributed walls in both orthogonal plan directions commonly performed well, exhibiting only light damage (Figure 5).

Figure 5. Wall structures with similar amounts of wall in each principal floor plan direction: (a) typical floor plan and (b) example of wall building built by Housing Development Administration of Turkey (TOKI-Toplu Konut Idaresi Başkanlığı) at Dulkadiroglu, Kahramanmaraş.

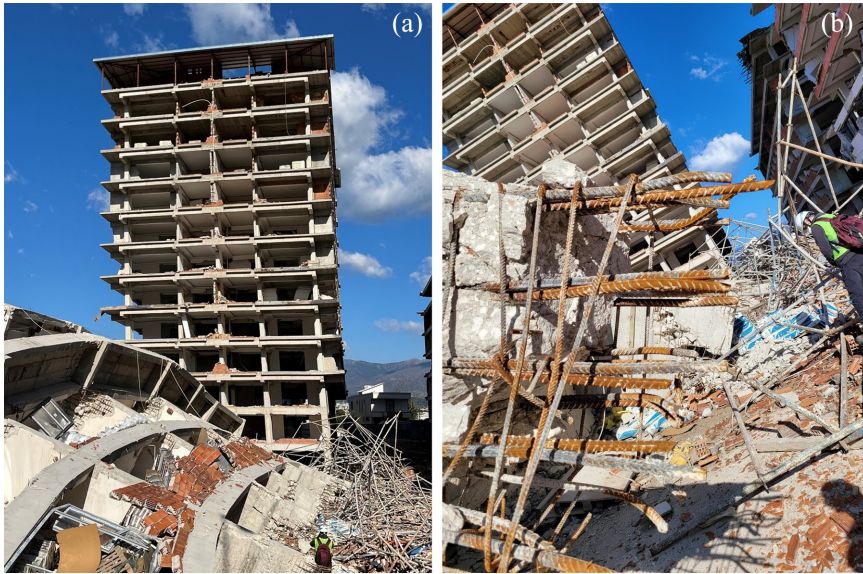
The two 13-story buildings in Figure 15 were in Antakya. They were reported to have been built by the same contractor following the same set of drawings. The detailing observed was one of the best in that (1) crossies were present, (2) tie spacing seemed uniform and acceptable, and (3) splices had enough confinement and cover to develop the strength of and reach fracture in longitudinal bars (Figure 15b). A permanent drift ratio of 6% was measured in the first story of the standing building. For an assumed value of $PGV = 1.3m/s$ (consistent with the most demanding spectrum in Figure 1), and $T = 1.3$ s, the roof drift can be estimated to have been $PGV \times T = 1.3 \times 1.3 = 1.7m$ (Puranam et al., 2019). For an approximate height of 39 m, roof drift ratio would be $1.7/39 = 4.3\%$, consistent with the observed permanent drift considering that the story drift ratio can be as high as 1.3 to 1.5 times the roof drift ratio.

These drift estimates are large enough to suspect overturning caused by second-order (p-delta) effects. The example illustrates the need to control drift to avoid collapse even if detailing is sufficient to produce a ductile response. The standing structure in Figure 15

had $WI=0.04\%$ and $PI=0.11\%$. The wall and column densities were 0.5% and 0.8% , respectively.

Figure 15. Building complex in Antakya: (a) building complex still standing with an approximate residual drift of 6% in the first story, and (b) identical structure that had collapsed (seen in the foreground of Figure 15a)

This example and the previous section suggest strongly that to control damage, in Turkey and elsewhere, it is necessary to decrease drift demand through design limits leading to more robust structures. Detailing is necessary (to ensure stable hysteretic response) but not sufficient (to control damage).
