**INVESTIGATION OF THE PRESERVATION
PROBLEMS OF THE MESCİD AND TÜRBE OF
AKŞEBE SULTAN IN ALANYA**

**MASTER OF SCIENCE
in Architectural Restoration**

**by
Fatma Selin ŞAHİN**

**June 2010
İZMİR**

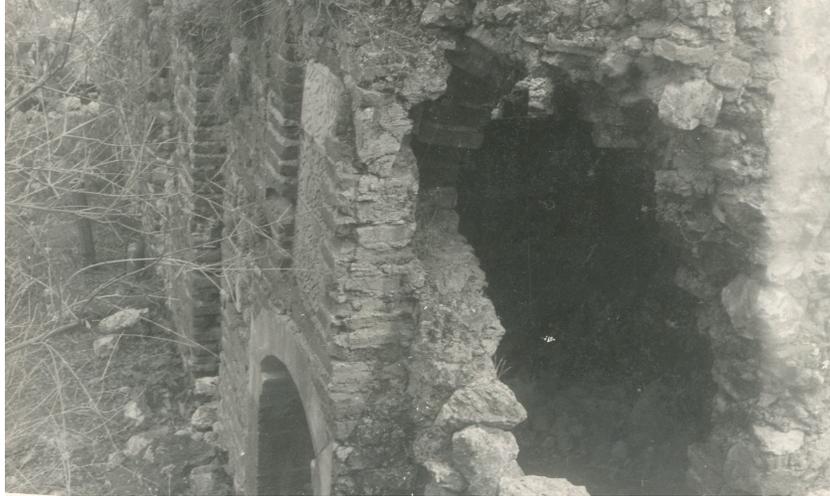
The use of material for the walls does not differentiate in the interior and exterior parts. In general, brick was used in all frames of the openings. Rubble stone and partially brick (mostly repaired parts) were used at the other parts of the walls. As seen in an old photograph, the walls are of double leaves likely without a cavity in between (Figure 3.10.).

Figure 3.10. North wall section

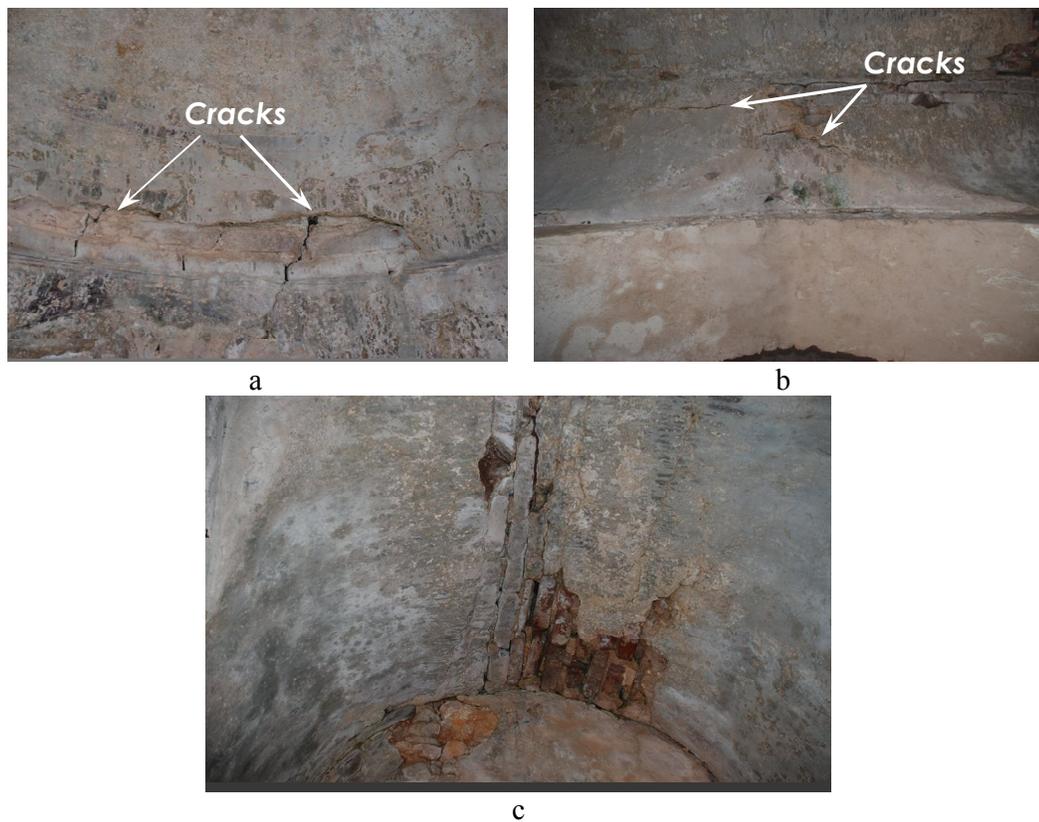
The cracks observed at the haunch zone of the dome which covers the space Z03. They are not wide and no level differences occurred at horizontal ring at the spring line of the dome and the abutment of the vault covering the space Z02. They occurred

likely to be due to the rainwater leaks from the roof heavily damaged long years ago and remained so until the recent interventions (Figure 3.27.a, b, Figure B.3.2.).

Loss of material is observed in through the missing parts of plaster on the vault. Similar to the previous one it was due to the leaks from the roof which caused weakening of mortar in the joints. At present it does not look serious but may lead to more serious problems in the future (Figure 3.27.c).

Figure 3.27. a) Cracks on the haunch zone of the dome of space Z03 b) Cracks near by the vault
c) Loosened joints of the brick bonds of the vault of space Z02

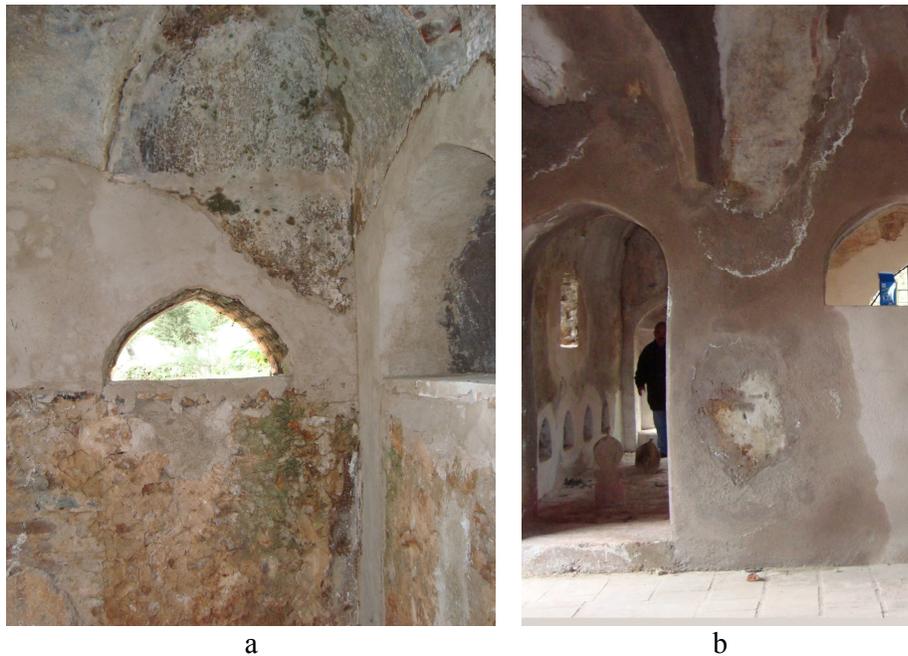
The other group contains biological formations on the upper parts where water leaks observed such as the vault of Z02 (Figure B.3.2.), white colored stains on the cement plastered surfaces such as the eastern wall and the northeast and southeast tromps of the space Z01 (Figure B.3.5.), and plant growth on the exterior faces of the walls (Figure B.3. 8-10). The problems of biological formation and white stains such as those observed on the southeastern tromp of the space Z03 (Figure 3.28.a, Figure B.3.4.) are due to the dampness obviously seen alone on the east wall of the space Z01 (Figure 3.28.b, Figure B.3.5.).

Figure 3.28. a) Biological formations on the tromp of Z03, b) dampness on the eastern wall of the space Z01

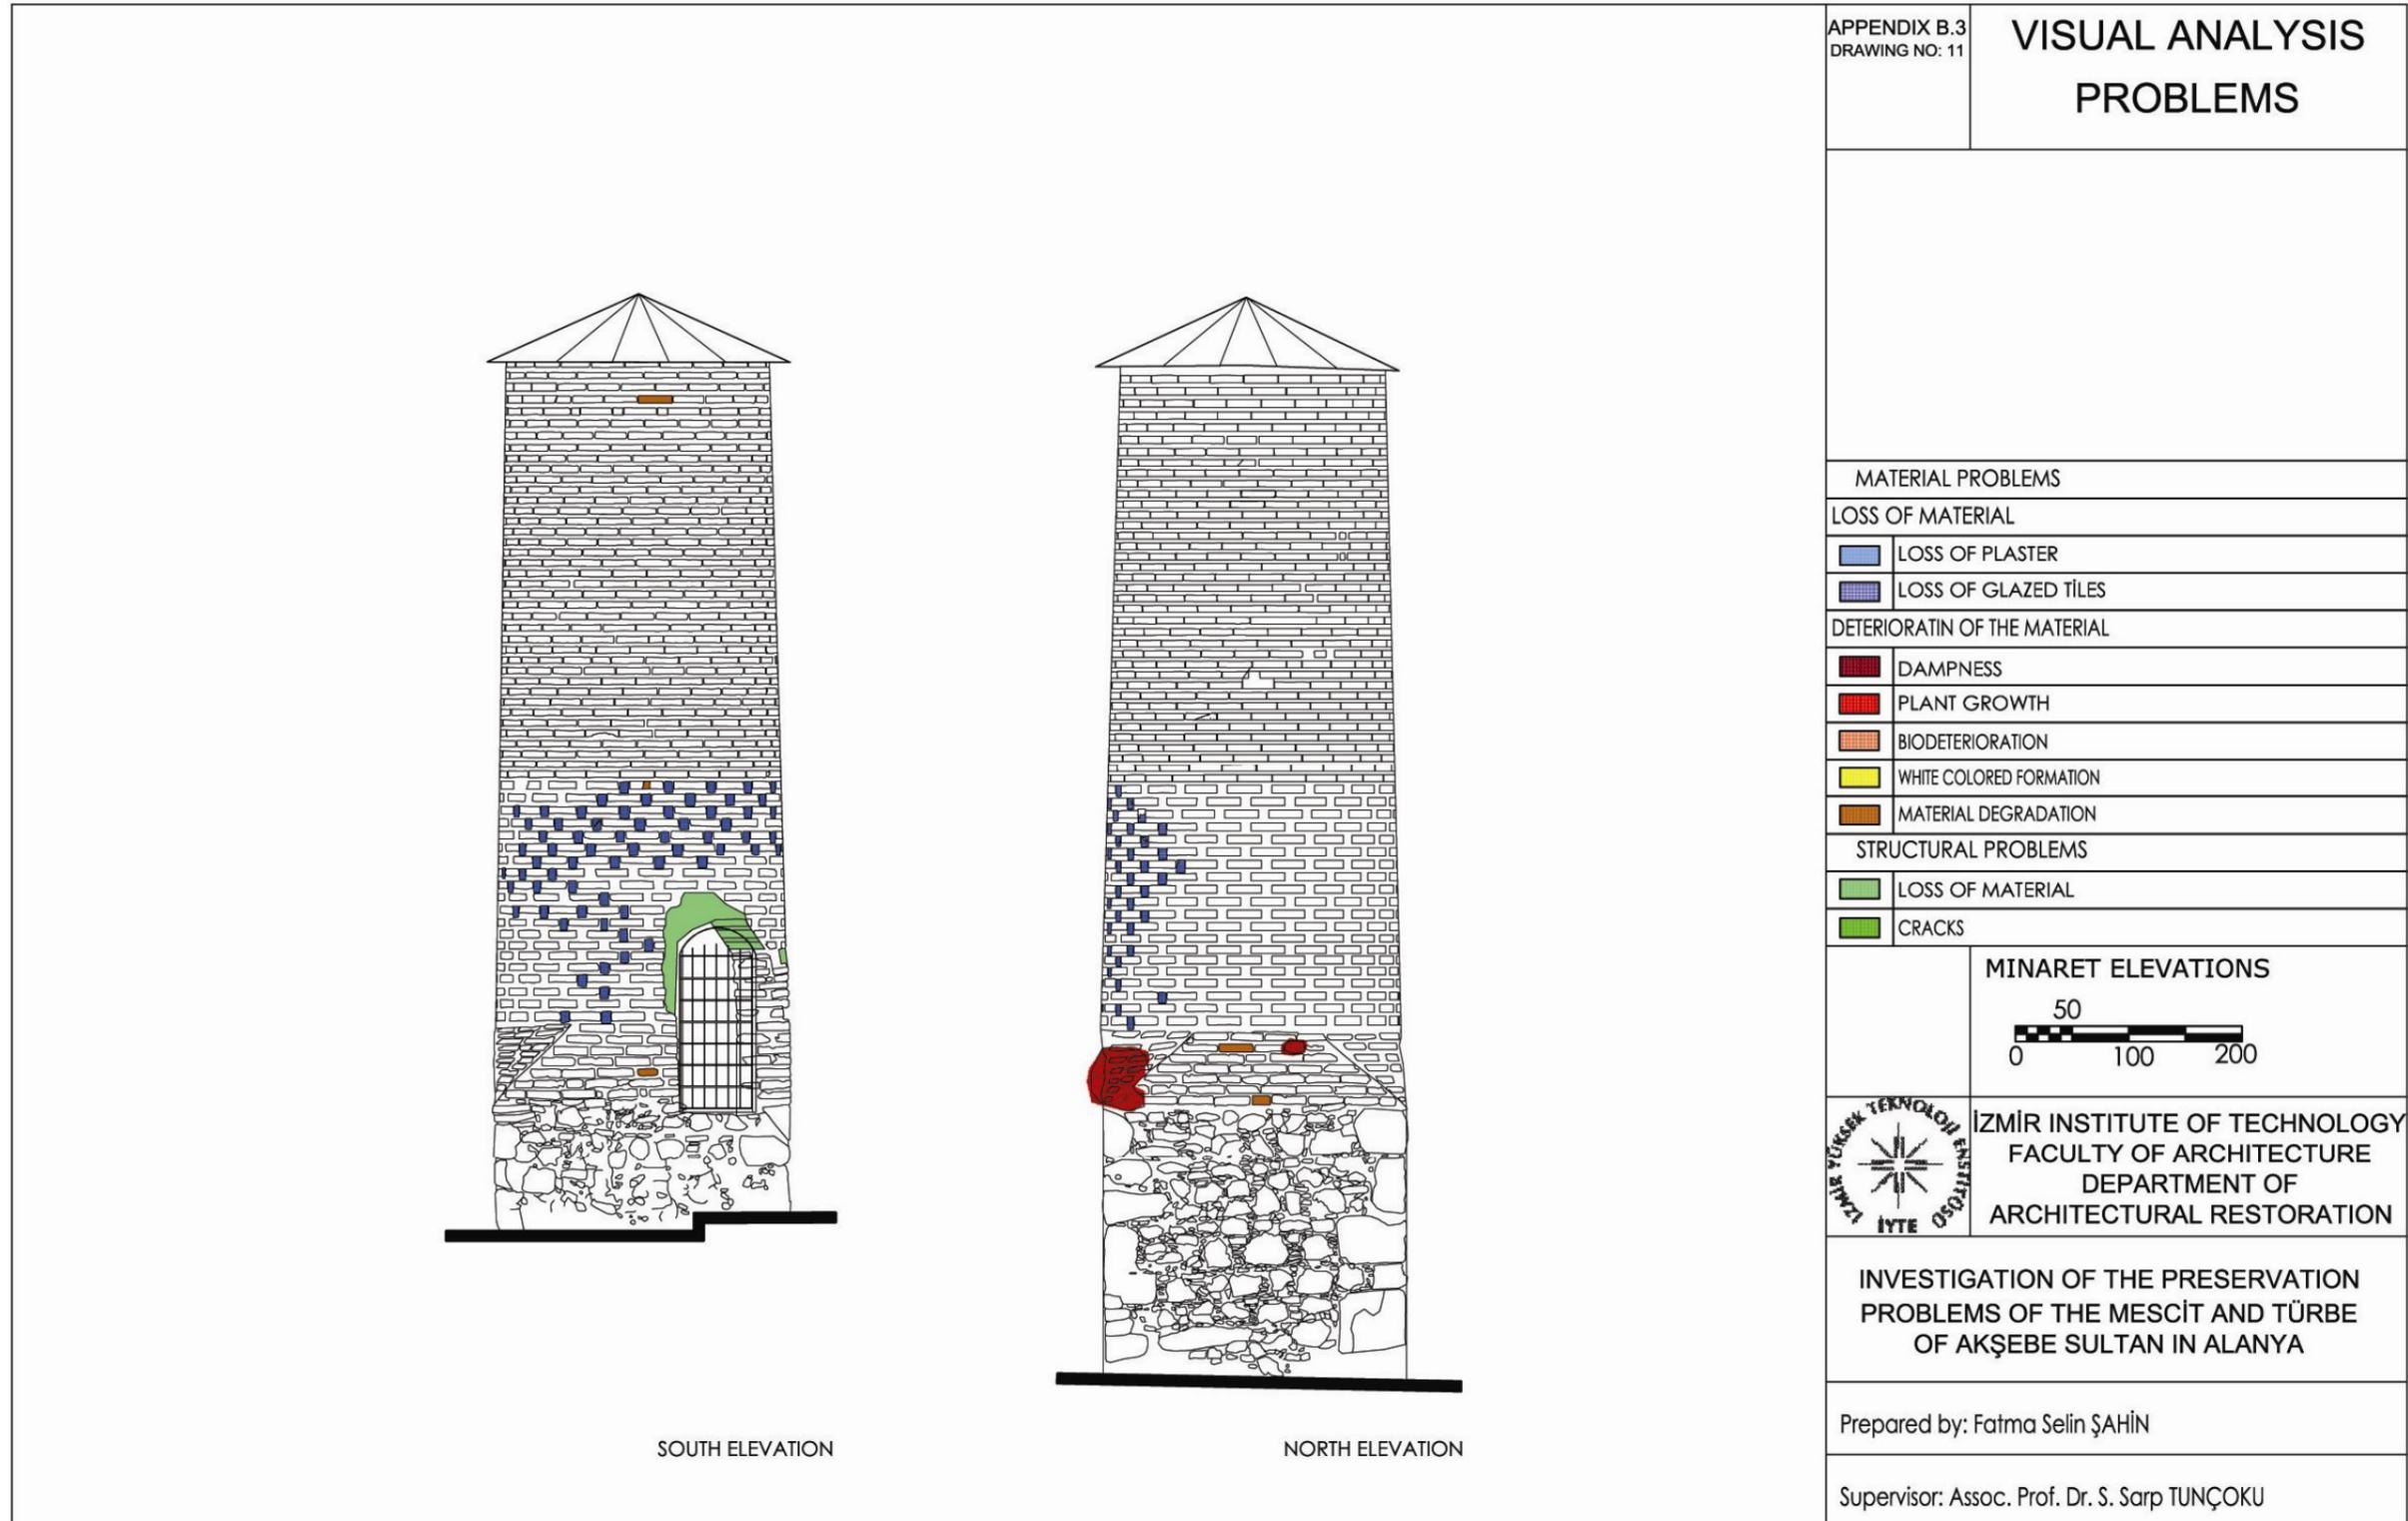
Figure B.3.11. Minaret Elevations

Although the reason is unknown, including the balcony (*şerefe*) and the spire the upper parts of the minaret is missing. In addition to the losses of the upper parts, a considerable part of the minaret entrance is collapsed. Only a small portion of the arch is visible at present (Figure 3.24.b, Figure B.3.11, 12.).

Material degradation is observed on the bricks of the minaret pedestal (Figure B.3.11, 12).
