**EVALUATION OF ALTERATIONS IN OTTOMAN
HANS IN TIRE FOR THEIR RESTITUTION**

**A Thesis Submitted to
the Graduate School of Engineering and Sciences of
İzmir Institute of Technology
in Partial Fulfillment of the Requirements for the Degree**

in Architectural Restoration

**by
Sevinç ÇULCU**

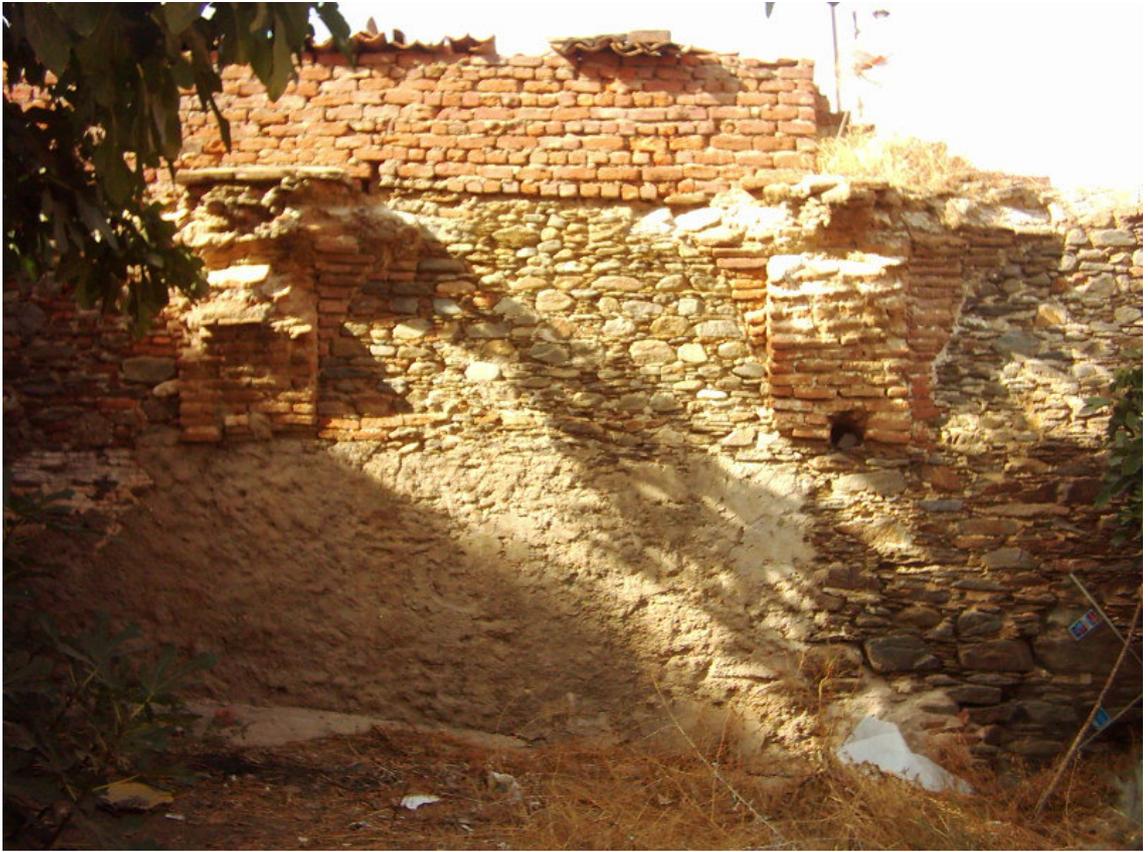
Figure 4.10. Çöplüce Han, Traces of Vaults on the North Wall.
