**STRUCTURAL CONSERVATION OF CEVHER
PAŐA BATH IN KALE, DENİZLİ**

**A Thesis Submitted to
the Graduate School of Engineering and Sciences of
İzmir Institute of Technology
in Partial Fulfilment of the Requirements for the Degree of**

**by
Feyza DURMUŐLAR**

**December 2018
İZMİR**

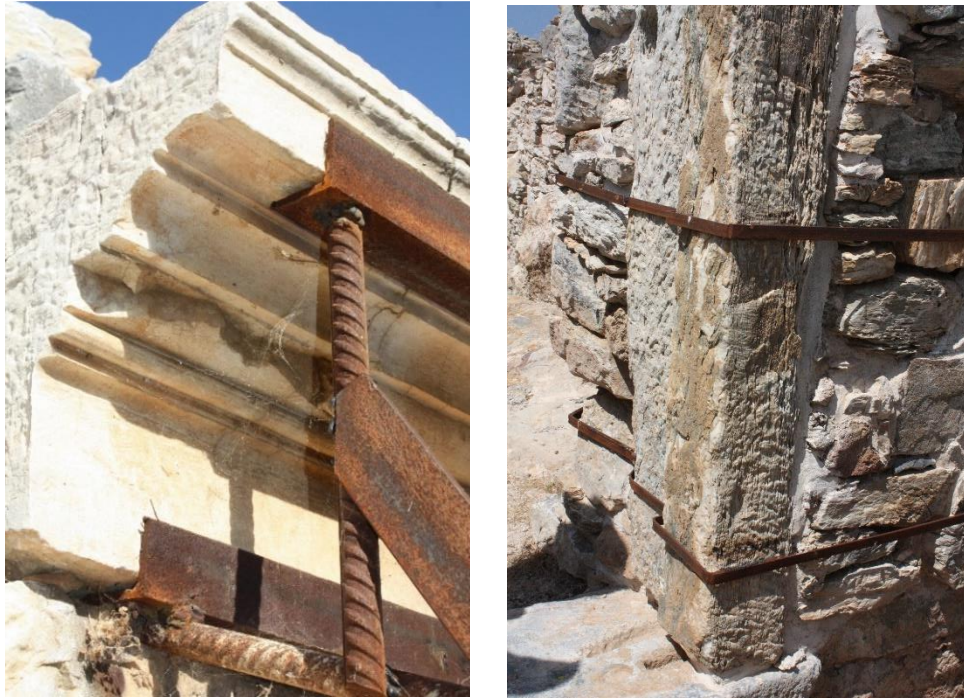
The emergency consolidation of archaeological ruins in Gazipaşa (Fig 2.23 and Fig 2.24) were carried out with iron elements. However, rusting has taken place in time. Therefore, iron elements are not suitable in archaeological sites. The permanent consolidation of the rubble stone masonry and timber frame walls in Mithat Paşa Vocational High School for industry (Fig 2.24) were carried out with steel connection elements. To reduce damage of steel to structure, fire brick was used. Similarly, the permanent consolidation of the similar walls in Agios Voukolos Church (Fig 2.25) was carried out stainless steel bolted galvanized chrome nickel. The ancient bath in Hierapolis is about to collapse (Fig 2.26). Due to its collapse risk, emergency consolidation with steel frame was applied. The emergency consolidation of Bouleuterion in Metropolis (Fig.27 and Fig.28) was implemented with timber elements. Historic walls and vaults dating to Emirate Period in Beçin Castle were consolidated with steel structure as a permanent structure. Material choice is important. Timber was used in temporary and emergency interventions. Stainless steel was preferred in permanent interventions.

Figure 2.23. Rusting problem in a Roman (left) and Byzantine (right) ruin
(Source: Turan, 2018)

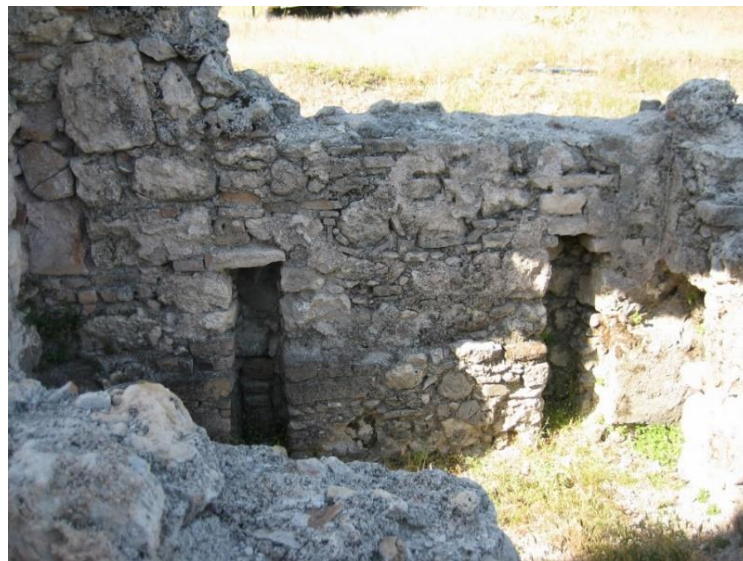
Space 3 (2.58 m x 1.50 m) is located at the southern part of space 2. The walls of the space are in ruin with different heights. The h of the northern wall which has opening to space 2 changes between 0.65 to 0.98 m. The southern walls height also changes between 3.45 to 1.54 m. There are some architectural elements such as niches, vertical and horizontal pipes. There are three niches, 2 horizontal and 1 vertical pipes. Floor covering is missing (Fig 3.12). There is level difference between space 2 and space 3. There is no superstructure.

Figure 3.12. Space 3, southern wall

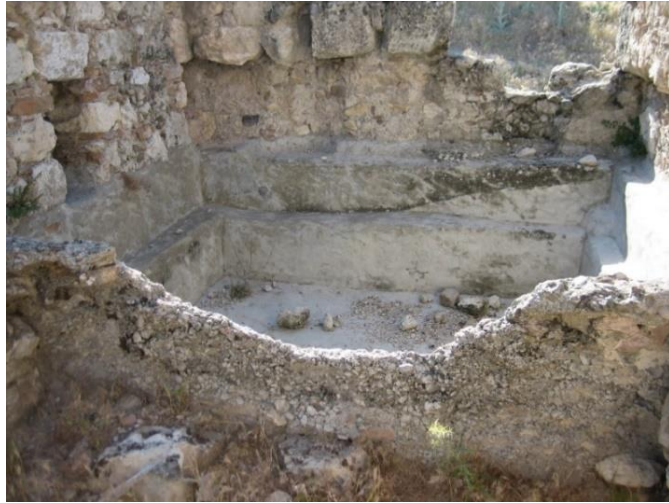
Space 5 (3.17 m x 3.17 m) is converted into a concrete pool. The walls are covered with screed until 0.95 m from ground level. At the back of the cement plaster, there are stone masonry walls at northern, southern and eastern sides, which are part of southeastern façade. The southern wall is the highest wall: 3.36 m. Cement plaster is seen until 0.92 m. The h of eastern wall is 1.37 m. Cement plaster is observed up till 0.94 m level from ground level. The lowest wall, which is the western part of space 5, is 0.8 m in height and it is part of the pool. The depth of this pool is 1.37 m. The ground covering is concrete (Fig 3.14). There is no superstructure.

Figure 3.14. View of space 5 from the entrance

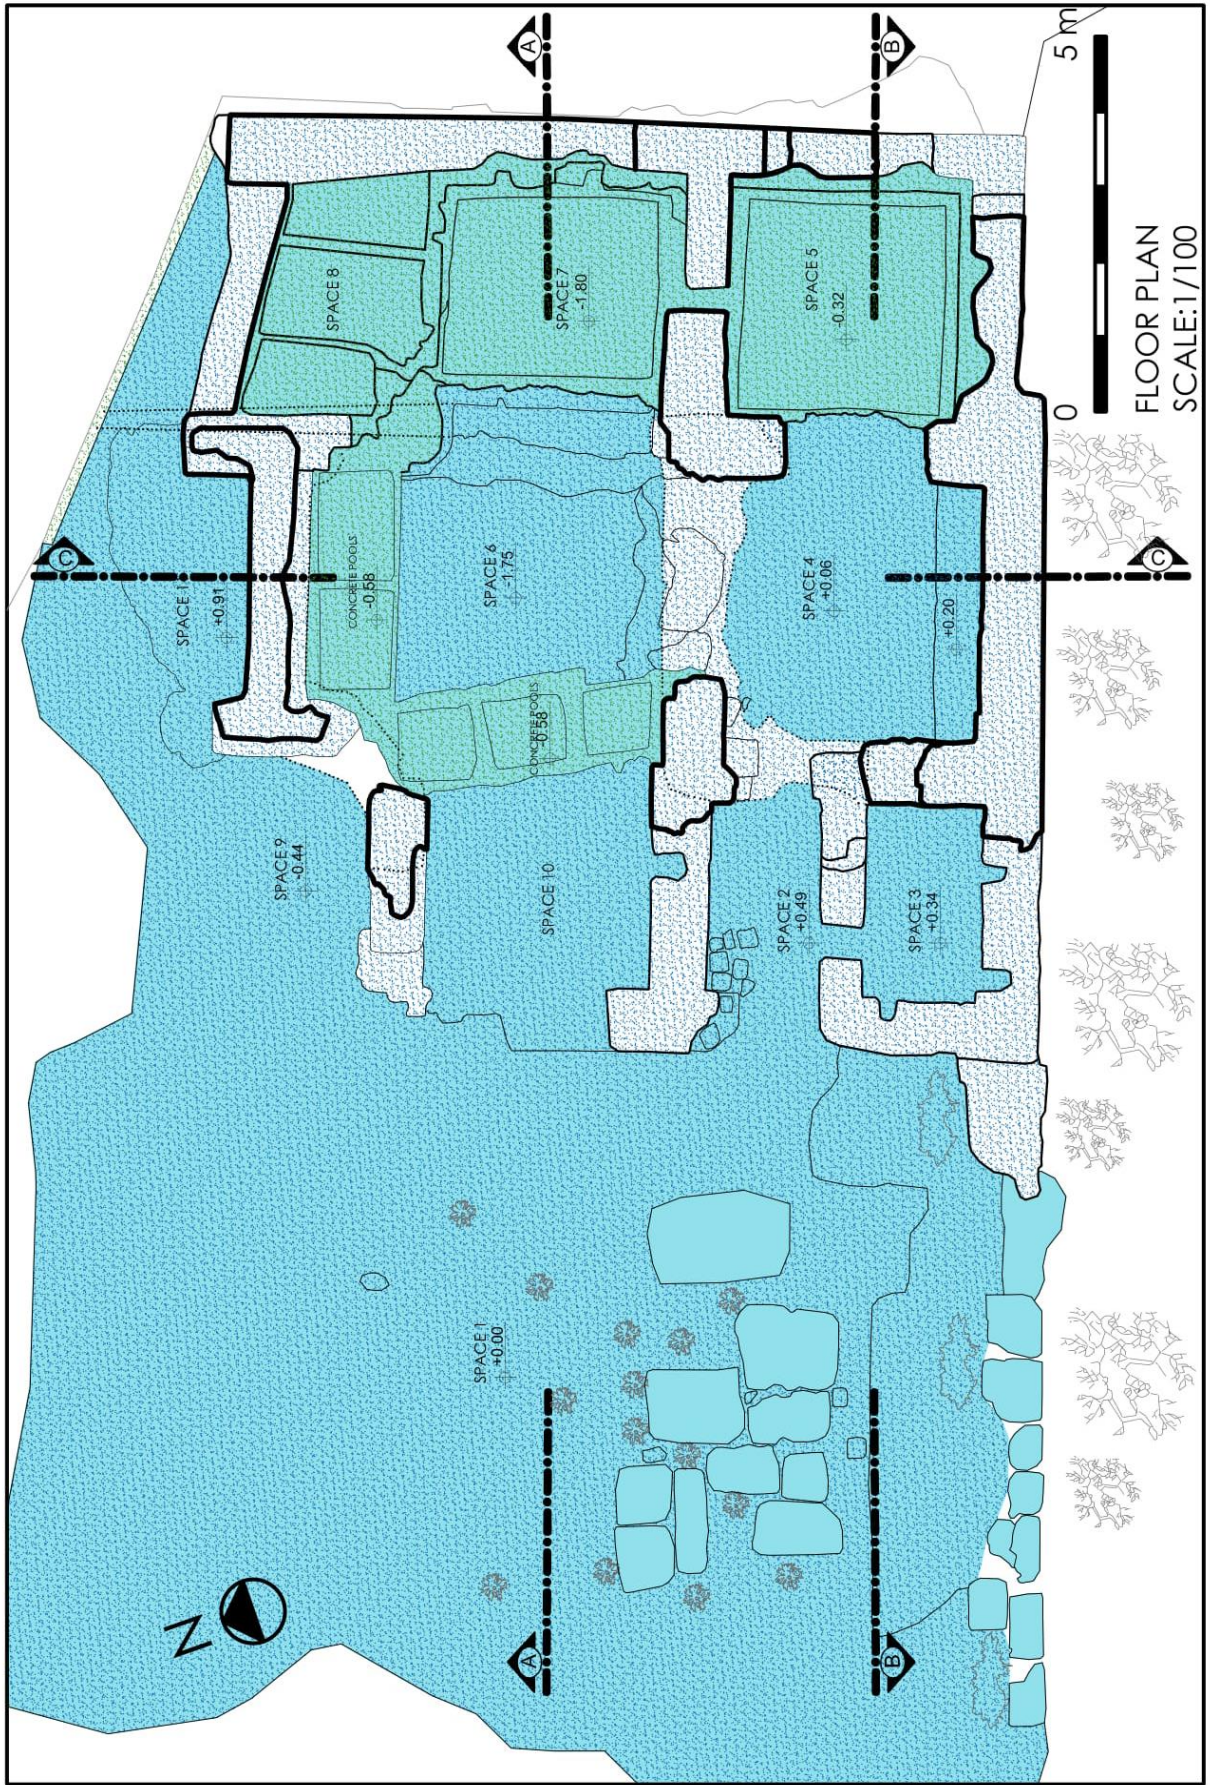
Figure D.1. Alteration Analysis of the Bath

There are two types of alterations at the bath: missing parts and the additional parts (Appendix C).

Since the borders of spaces 1, 9 and 11 are not totally observed, these spaces are evaluated as partially missing. Building elements such as arches, domes and squinches, walls and floor covering are also partially missing.

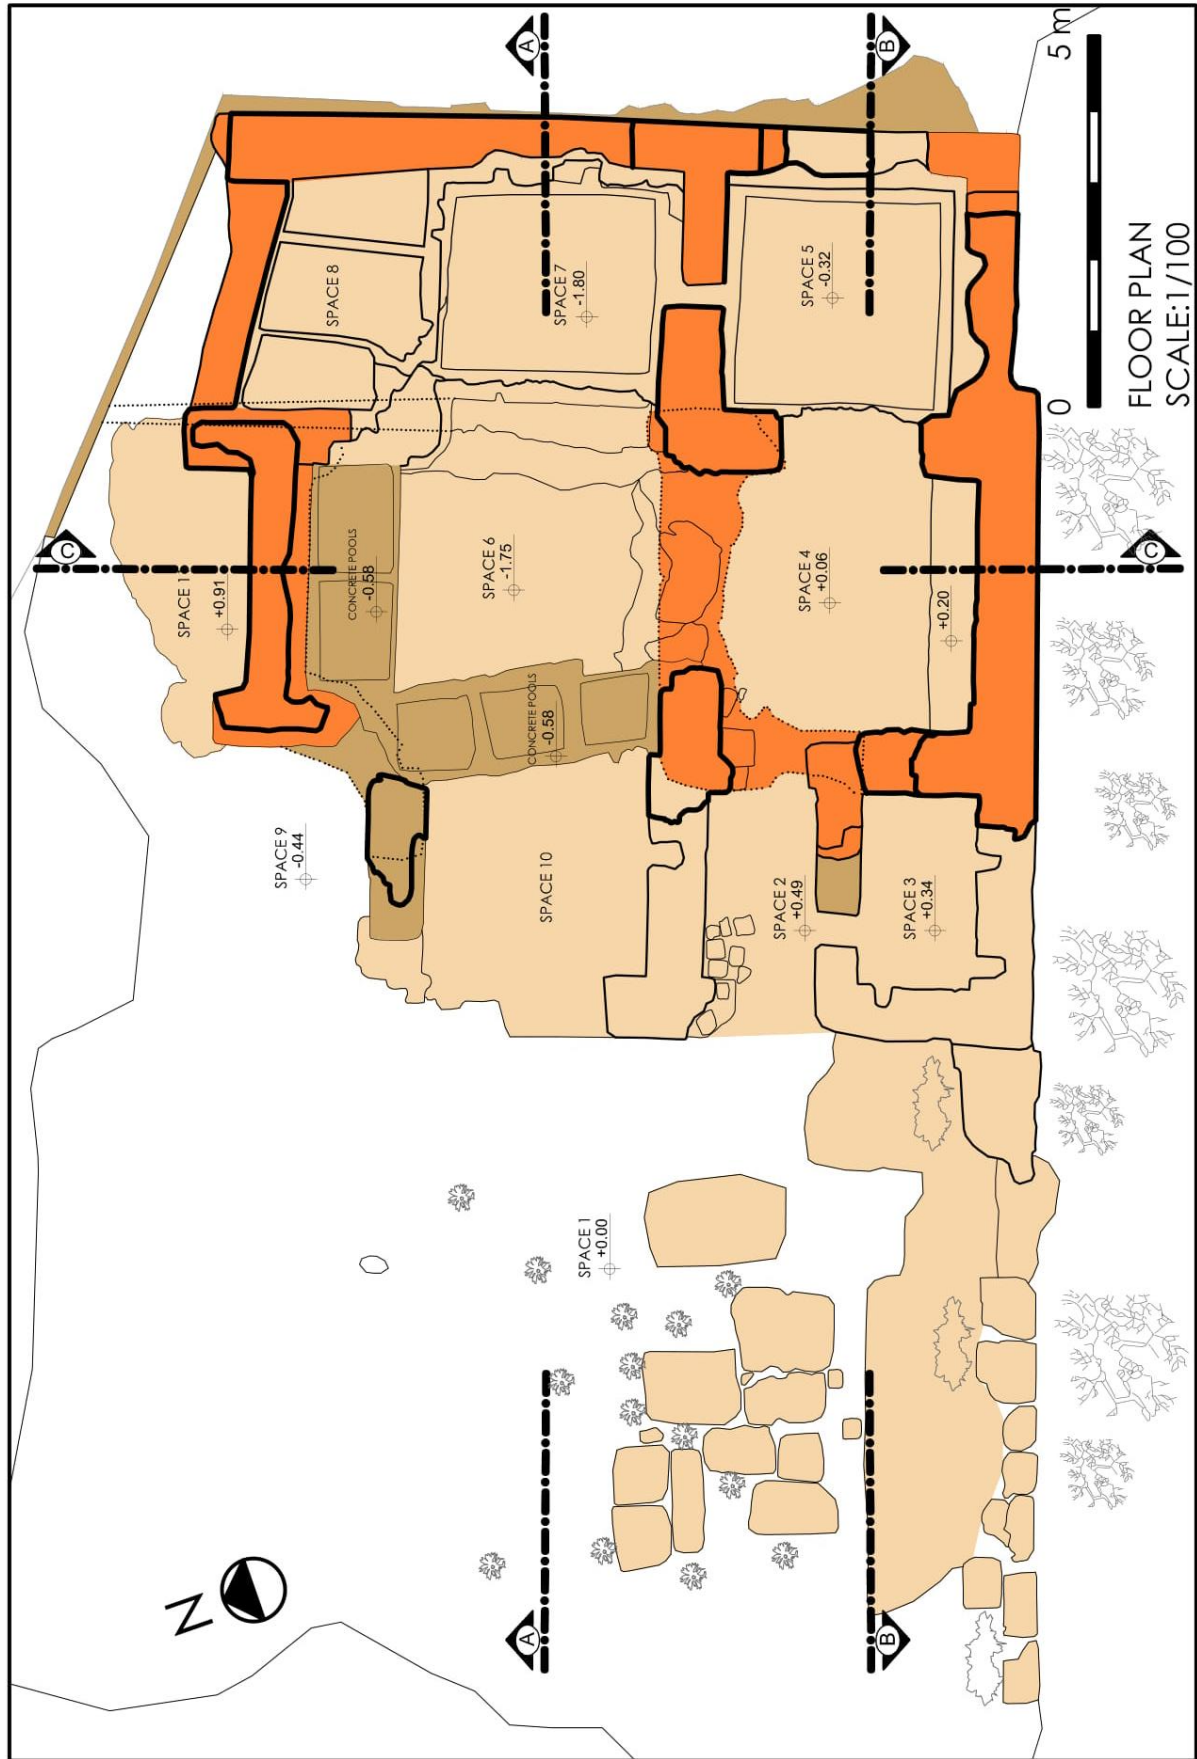
Figure E.1. Present Condition of the Bath: Symptoms

Symptoms of structural failure and material deterioration are diagnosed in three groups: CC1, CC2 and CC3 (Table B1). CC1 refers to local structural failure with local material deterioration. This condition class contains partial collapses as structural failure, biological growth and cement interventions as a material deterioration. CC2 refers to local structural failure with widespread material deterioration. Cracks as structural failure and crumbling, discoloration, biological growth and cement interventions as material problems are observed. CC3 refers to major structural failure such as total and almost collapses with widespread material deterioration. Joint discharge, discoloration and biological growth are material deteriorations of CC3. These classes are also related with excavation levels. The parts of the building which were discovered with excavation have not been damaged much due to protection of earth. Upper parts of the bath which have been exposed to climatic conditions are damaged more. Therefore, the parts which are under excavation level are generally in CC1. The top portion that has been affected by direct rain penetration is in CC3. The middle portion is in CC2.

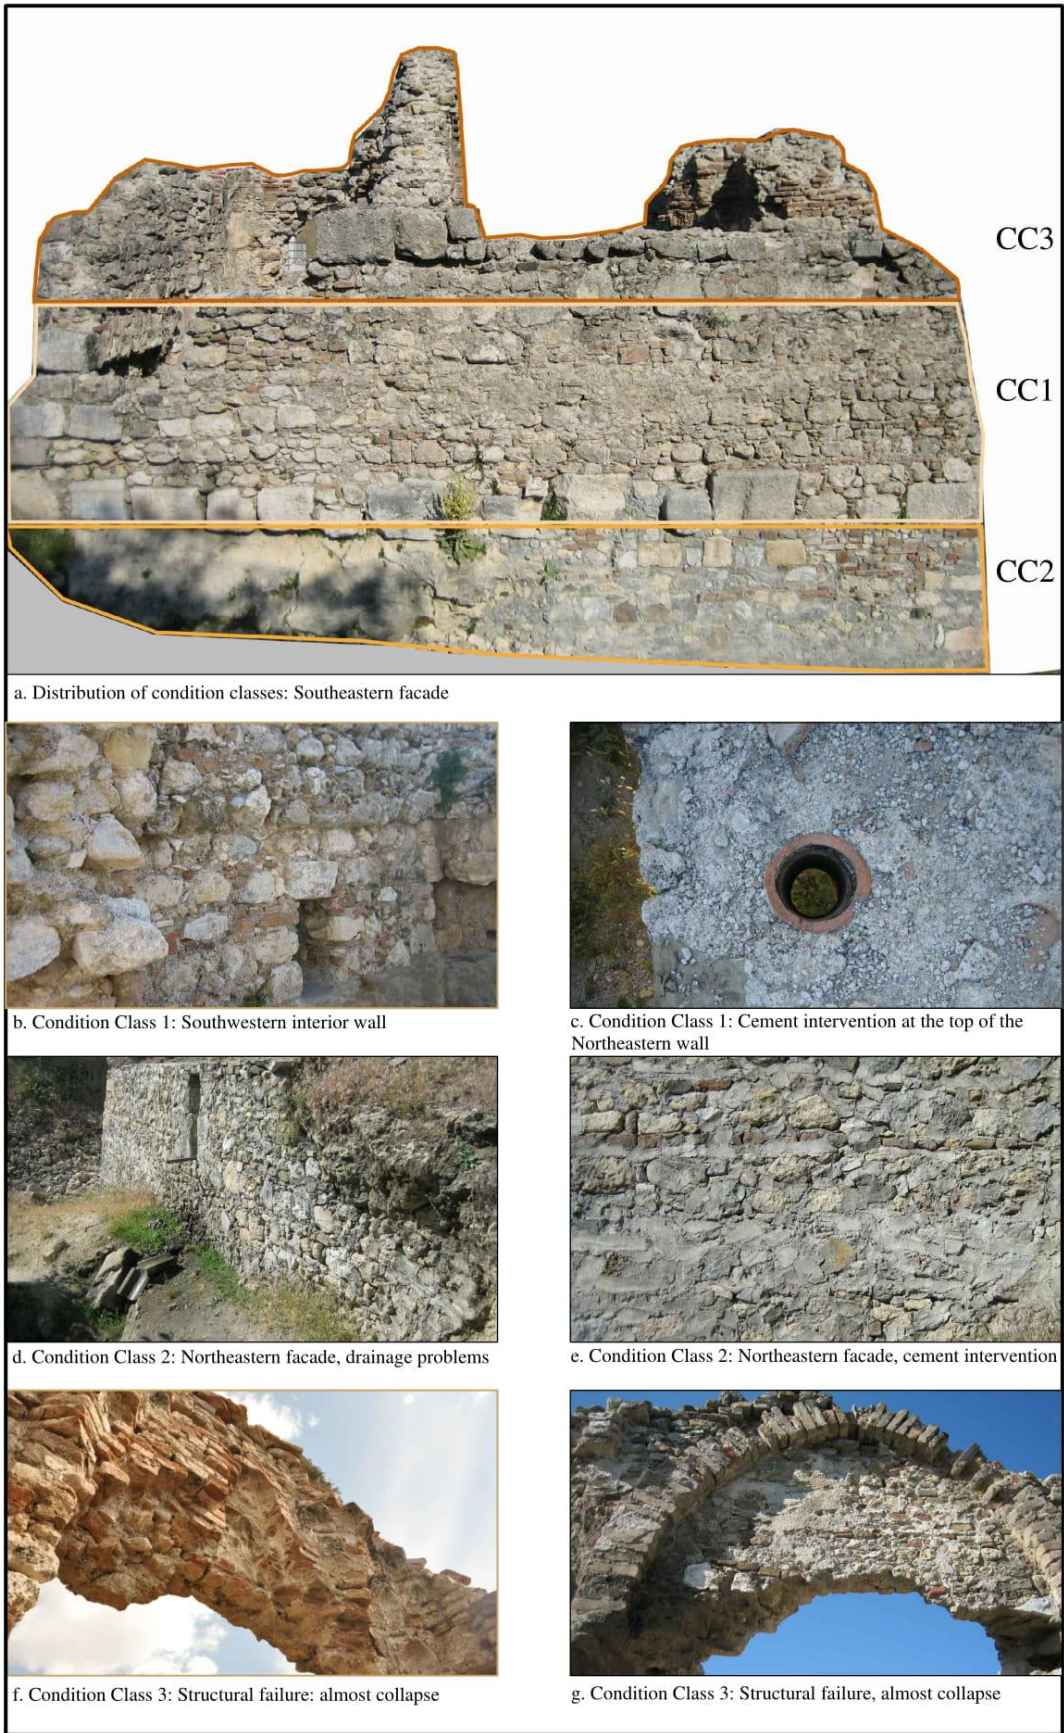
Figure E.3.a Distribution of condition classes, E. 3.b. CC1, E. 3.c. CC1,
 E. 3.d. CC2, E. 3.e. CC2, E.3.f. CC3, E.3.g. CC3

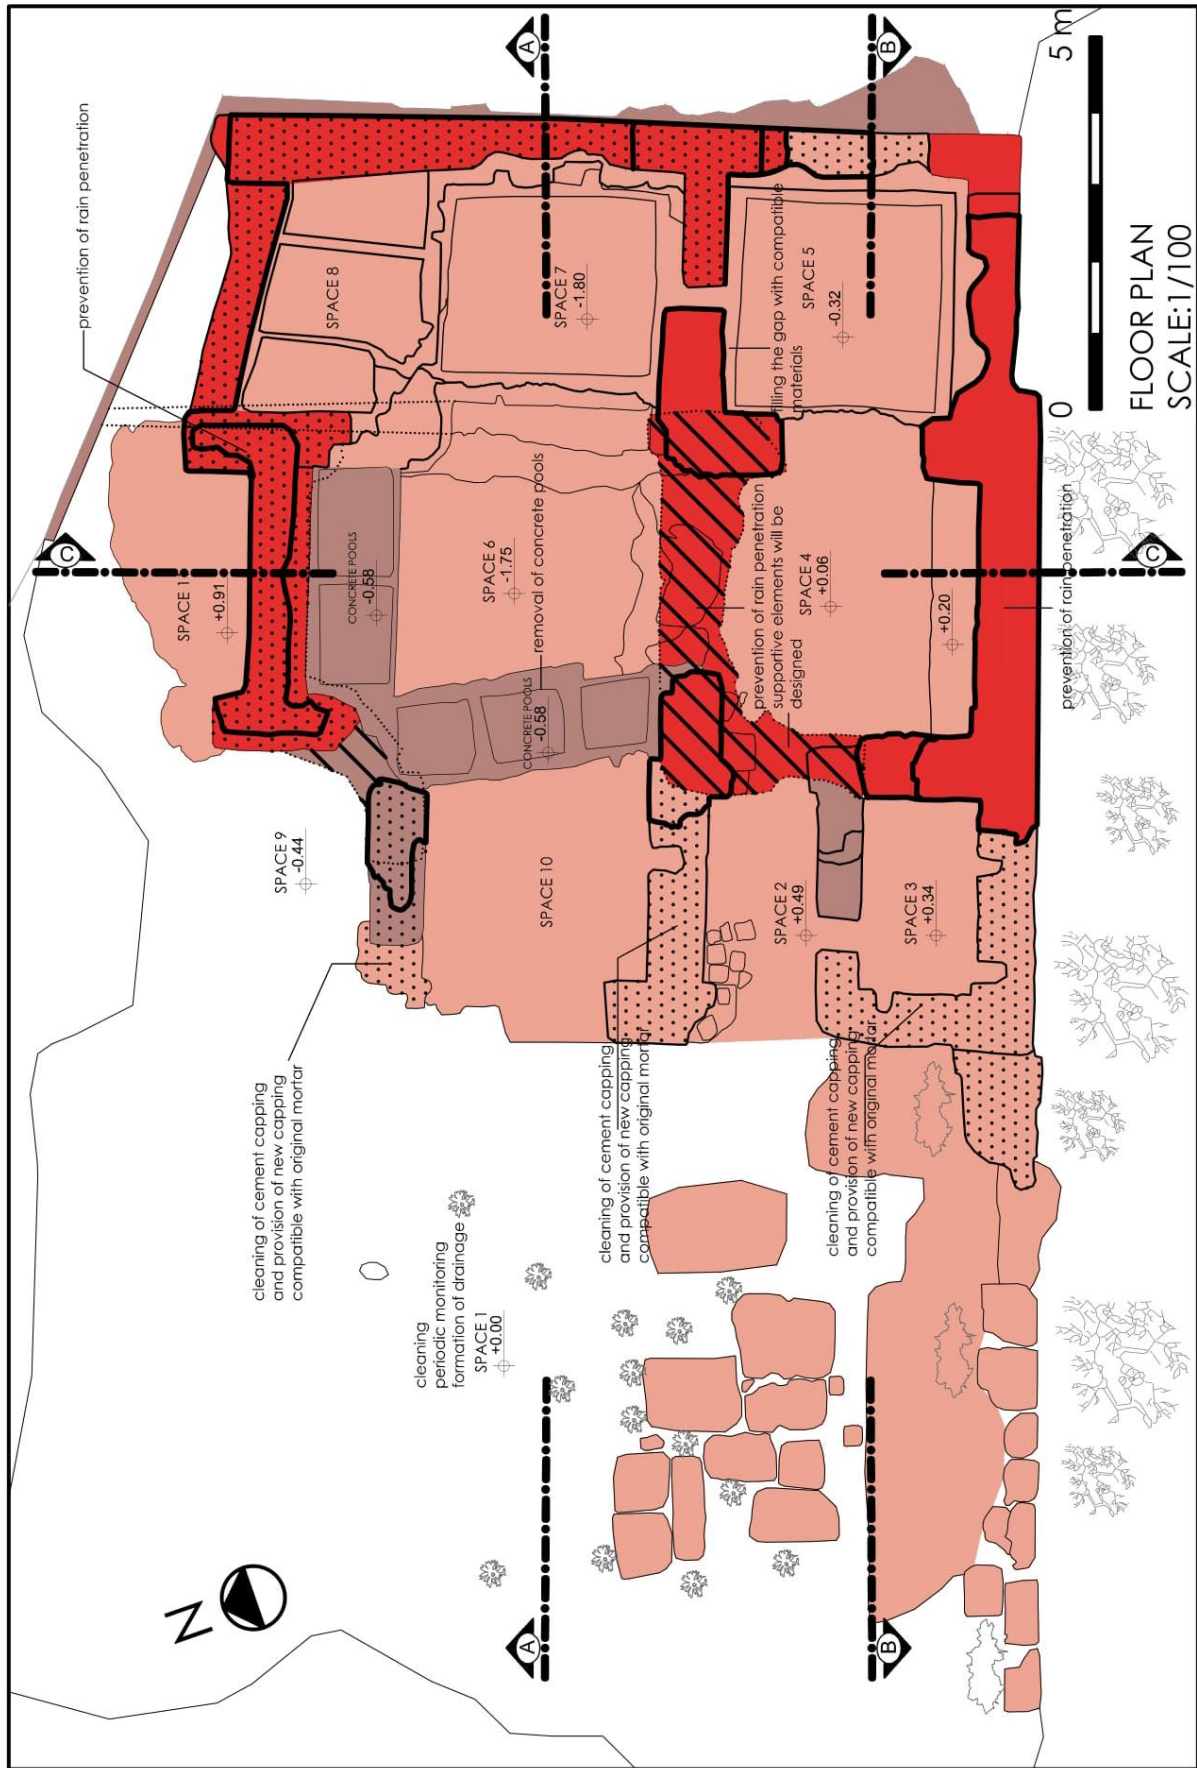
Figure E.4. Present Condition of the Bath: Risk Assessment and Possible Measures of the Bath

There are three different urgency classes in correspondence to each condition class. UC1 refers to intermediate actions. This class is equal to CC1. There is a risk of

potential loss of historical material due to climatic and seismic effects. UC2 corresponds to CC2. The conservation actions should be done in short term. There is a risk of potential deterioration of original material due to cement interventions. In addition, there is a risk of potential salt crystallization due to cement mortar and plaster. The UC3 is equal to CC3. The actions of this class should be done immediately. There is a potential of seismic vulnerability, which has impact on safety. Salt crystallization under capping may take place.

The actions in RC1 corresponds to conditions class 1, RC2 refers to CC 2 and RC3 refers to CC3. RC1 contains actions such as maintenance and simple repair. RC2 and RC3 involves maintenance, simple repair and restoration.

For partial collapse and biological growth problems in CC1, maintenance is recommended. In the context of partial collapse, periodic monitoring is proposed. For biological growth in CC1, cleaning and periodic monitoring is proposed. There are two types of cement interventions in this class. One of them is cement interventions for capping purposes. Cleaning of cement capping and provision of new capping compatible with original mortar is suggested in the context of simple repair. Other cement interventions are the concrete pools. Their removal should be planned in content of simple repair.

For cracks in CC2, filling the gap with compatible material is recommended in the context of simple repair. For both discoloration and biological growth, cleaning and periodic monitoring is recommended in the context of simple repair. For crumbling, both simple repair and maintenance is proposed. Replacement of deteriorated stones with similar new material is in the context of simple repair. Prevention of rising damp and formation of drainage are in the context of maintenance. There are cement interventions on the walls in this class. Consolidation, which consists of different stages, is suggested for these cement portions in the context of restoration. These stages are shoring, cleaning of cement intervention on the walls and partial reconstruction with original stone and compatible mortar.
