Structural vulnerability of ancient dry masonry towers under lateral loading

Ancient towers
Failure mechanism
Resistance
Dry masonry
Conservation

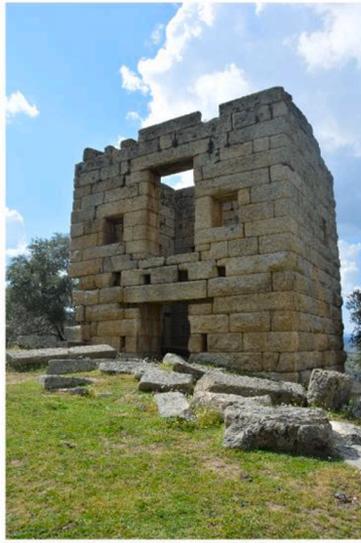
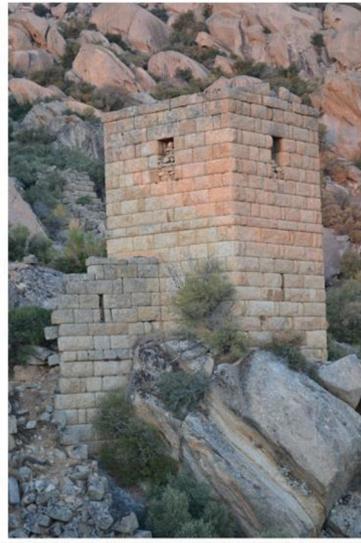
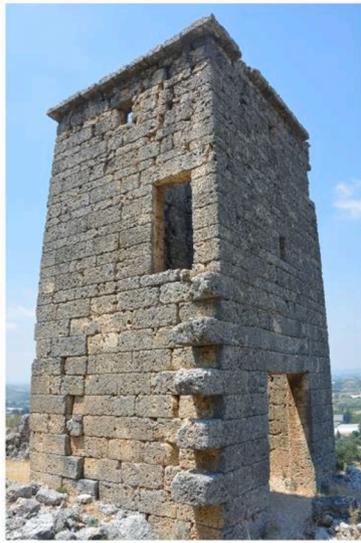
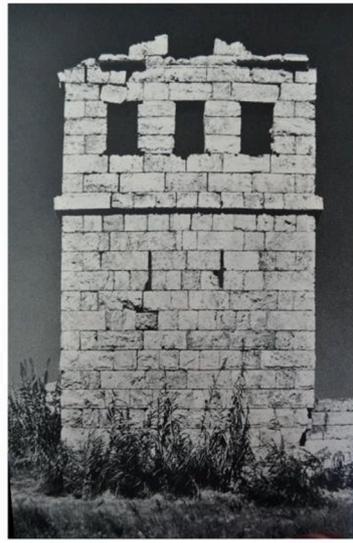
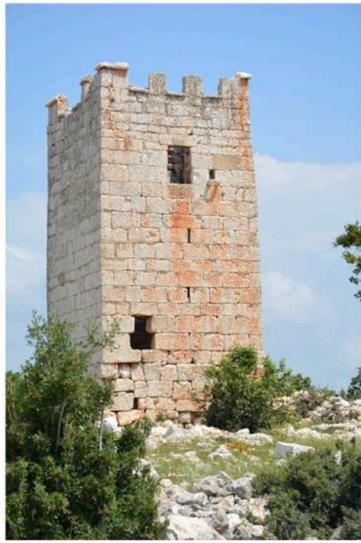
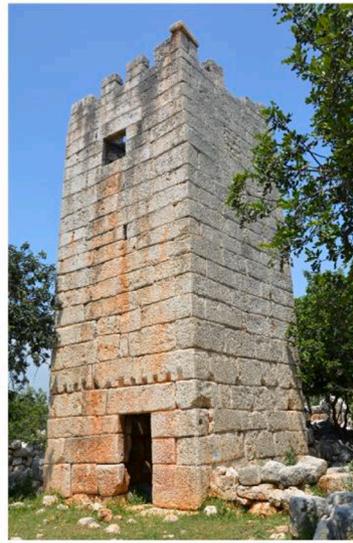
Fig. 1. Towers in Caria, Pamphylia and Cilicia.

The towers were selected in three different earthquake regions: Caria, Pamphylia, and Cilicia Regions. The towers have different properties in different regions, so parameters were determined depending on the regions. Blocks were laid using the header and stretcher technique, with two outer leaves and a gap, in the towers of Caria Region, alternating header and stretcher rows were used in the Pamphylia Regions, and the classical isodomic masonry-style was observed in the Cilicia Region. These wall profiles show differences in terms of the arrangement and size of blocks, the wall thicknesses and the number of leaves, either single or double-leaf, depending on region. Six wall profile types were determined (Fig. 4).

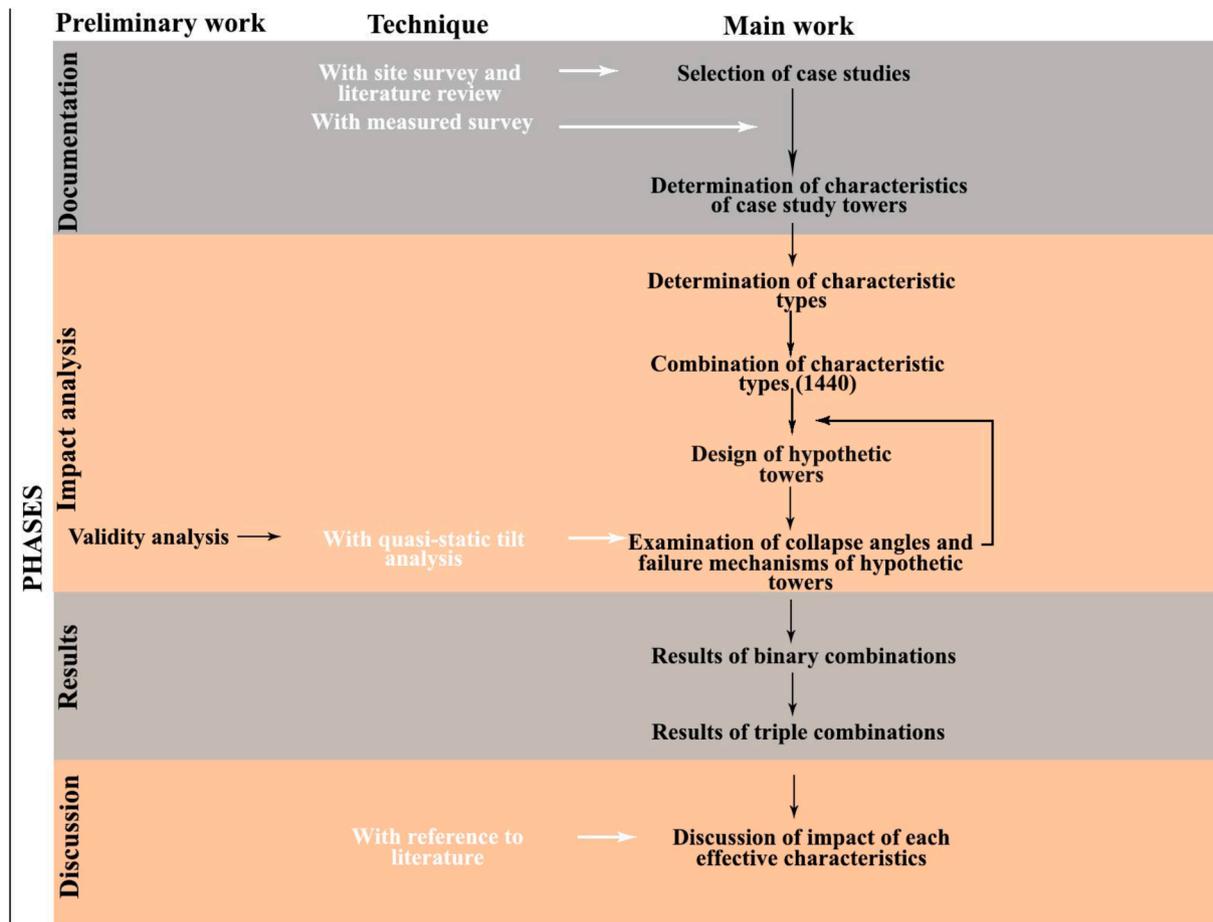
Fig. 2. The methodology of the study.

The following approach uses a combination of quasi-static analysis together with conventional methods of architectural conservation. The work is undertaken in three phases: documentation of the characteristics of the case study towers; impact analysis of hypothetical towers designed by a combination of the characteristic types, and an examination of the analysis results (Fig. 2).

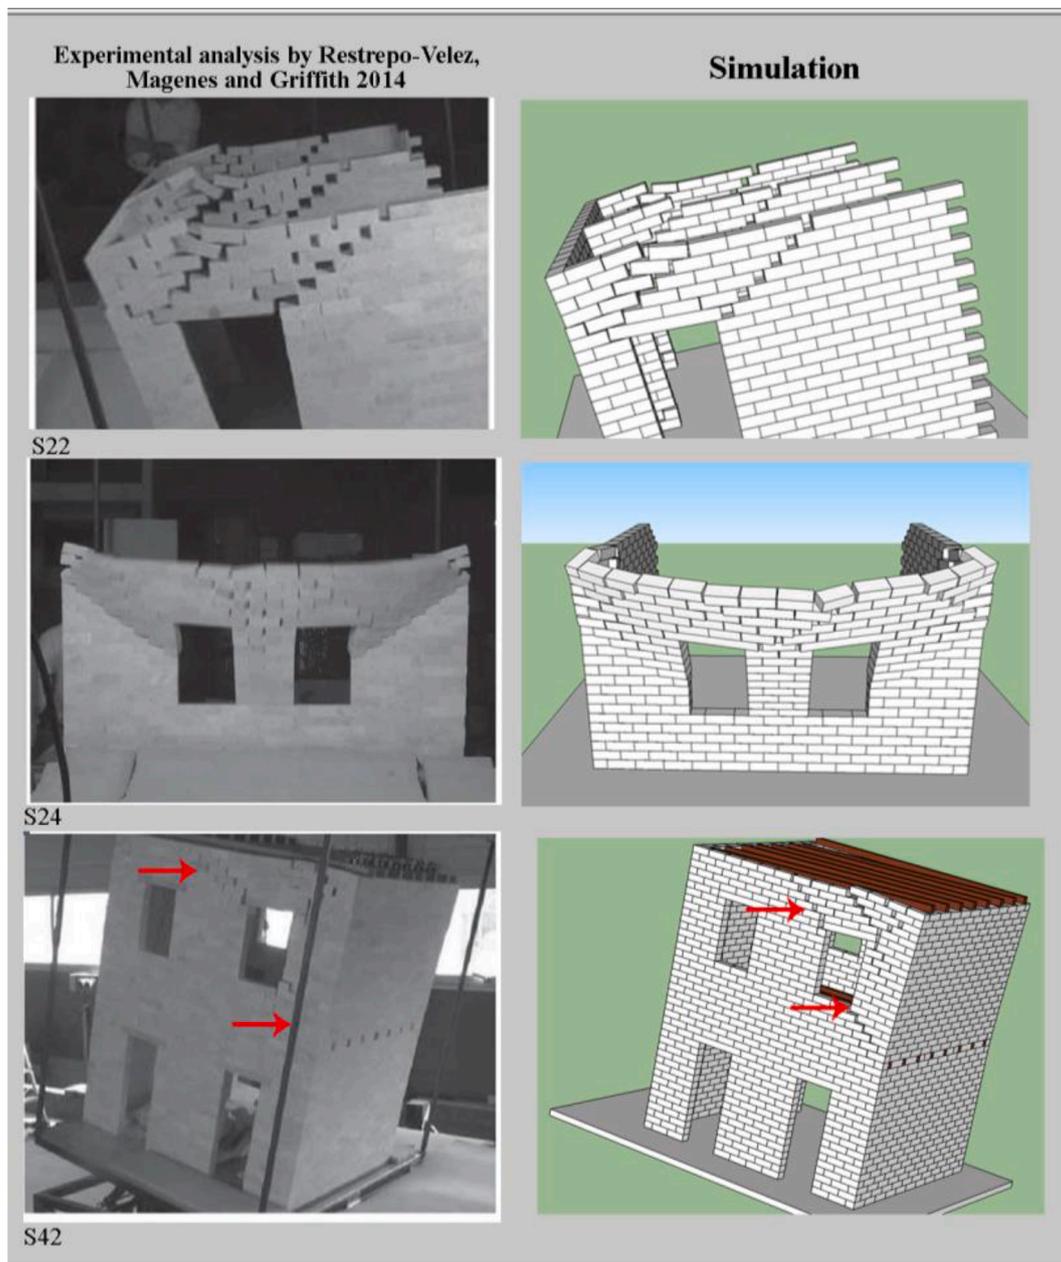
Fig. 3. Validation of the method (Restrepo Vélez et al., 2014).

To ensure accuracy in the 3D model computer simulations, an update time step of 1/120 was taken and the iterative value of 16 was chosen. The damage mechanisms and collapse angles of the real versus the virtual models were found to be almost identical (Table 1, Fig. 3).

Based on the wall sizes and properties of materials, produced by Restrepo-Vélez, Magenes, and Griffith (2014), 3D models were created using SketchUp software, and the failure mechanisms were investigated by tilting these models using a virtual table in MsPhysics. Restrepo Vélez et al. (2014) performed a comprehensive quasi-static testing programme, considering 1:5 scale models of dry-joint stone masonry walls and buildings, using marble units. The dimensions of their marble blocks were 80 mm × 40 mm × 30 mm. The friction of blocks was taken as 0.77 and their unit weight was 2680 kg/m³ (Bui et al., 2017). (Kinetic friction was calibrated at 0.67). A typical specimen in this quasi-static testing programme had a height of 0.6 m, equivalent to 21 courses. The specimens were one, two- or three-sided walls, with or without openings, with different staggering ratios, and also included a two-story building with openings similar to the tower walls.

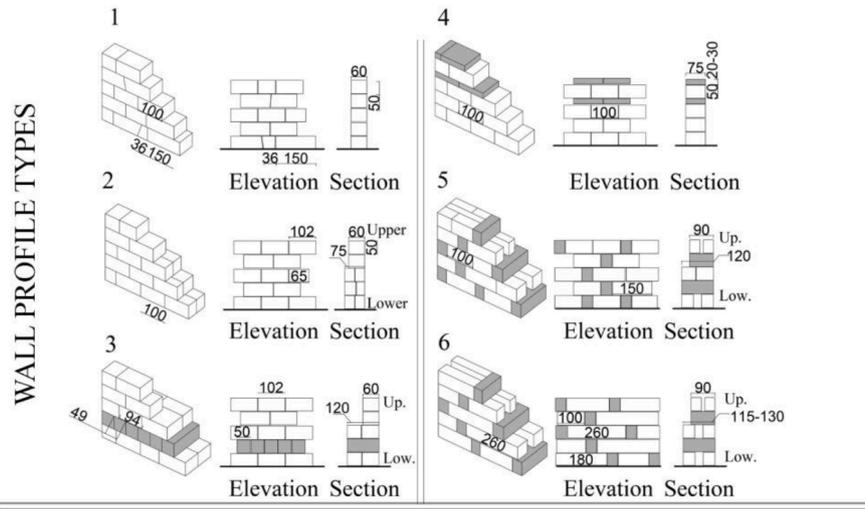
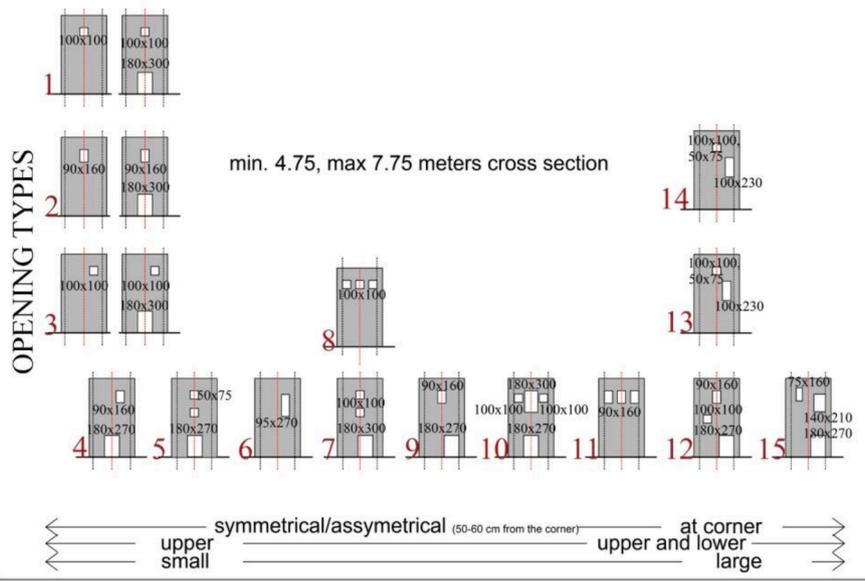
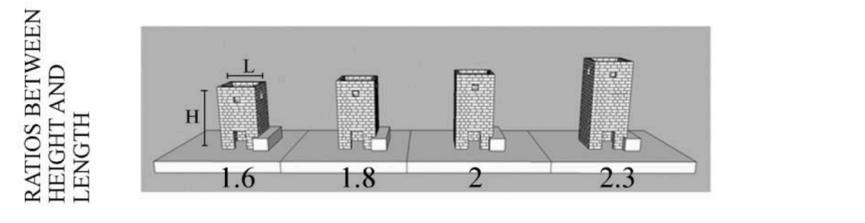
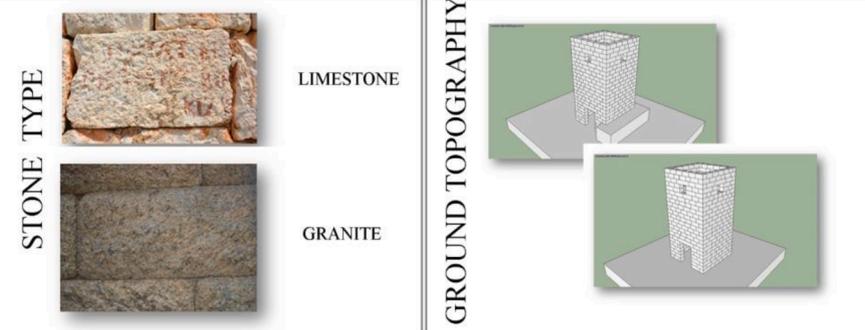
Fig. 4. Characteristic types.

facade looking toward the mountain ($h/l = 1.6$). The h/l values of other towers vary between 1.8 and 2. Four different height to length ratios were therefore chosen (1.6, 1.8, 2, and 2.3) (Fig. 4).

Tower openings vary in their positions, size, and number. When all possibilities were combined, 15 opening types were determined. Whether an opening is positioned in the out-of-plane or the in-plane wall relative to the direction of the lateral loading, is important in determining the structural behaviour of the tower (Fig. 4).

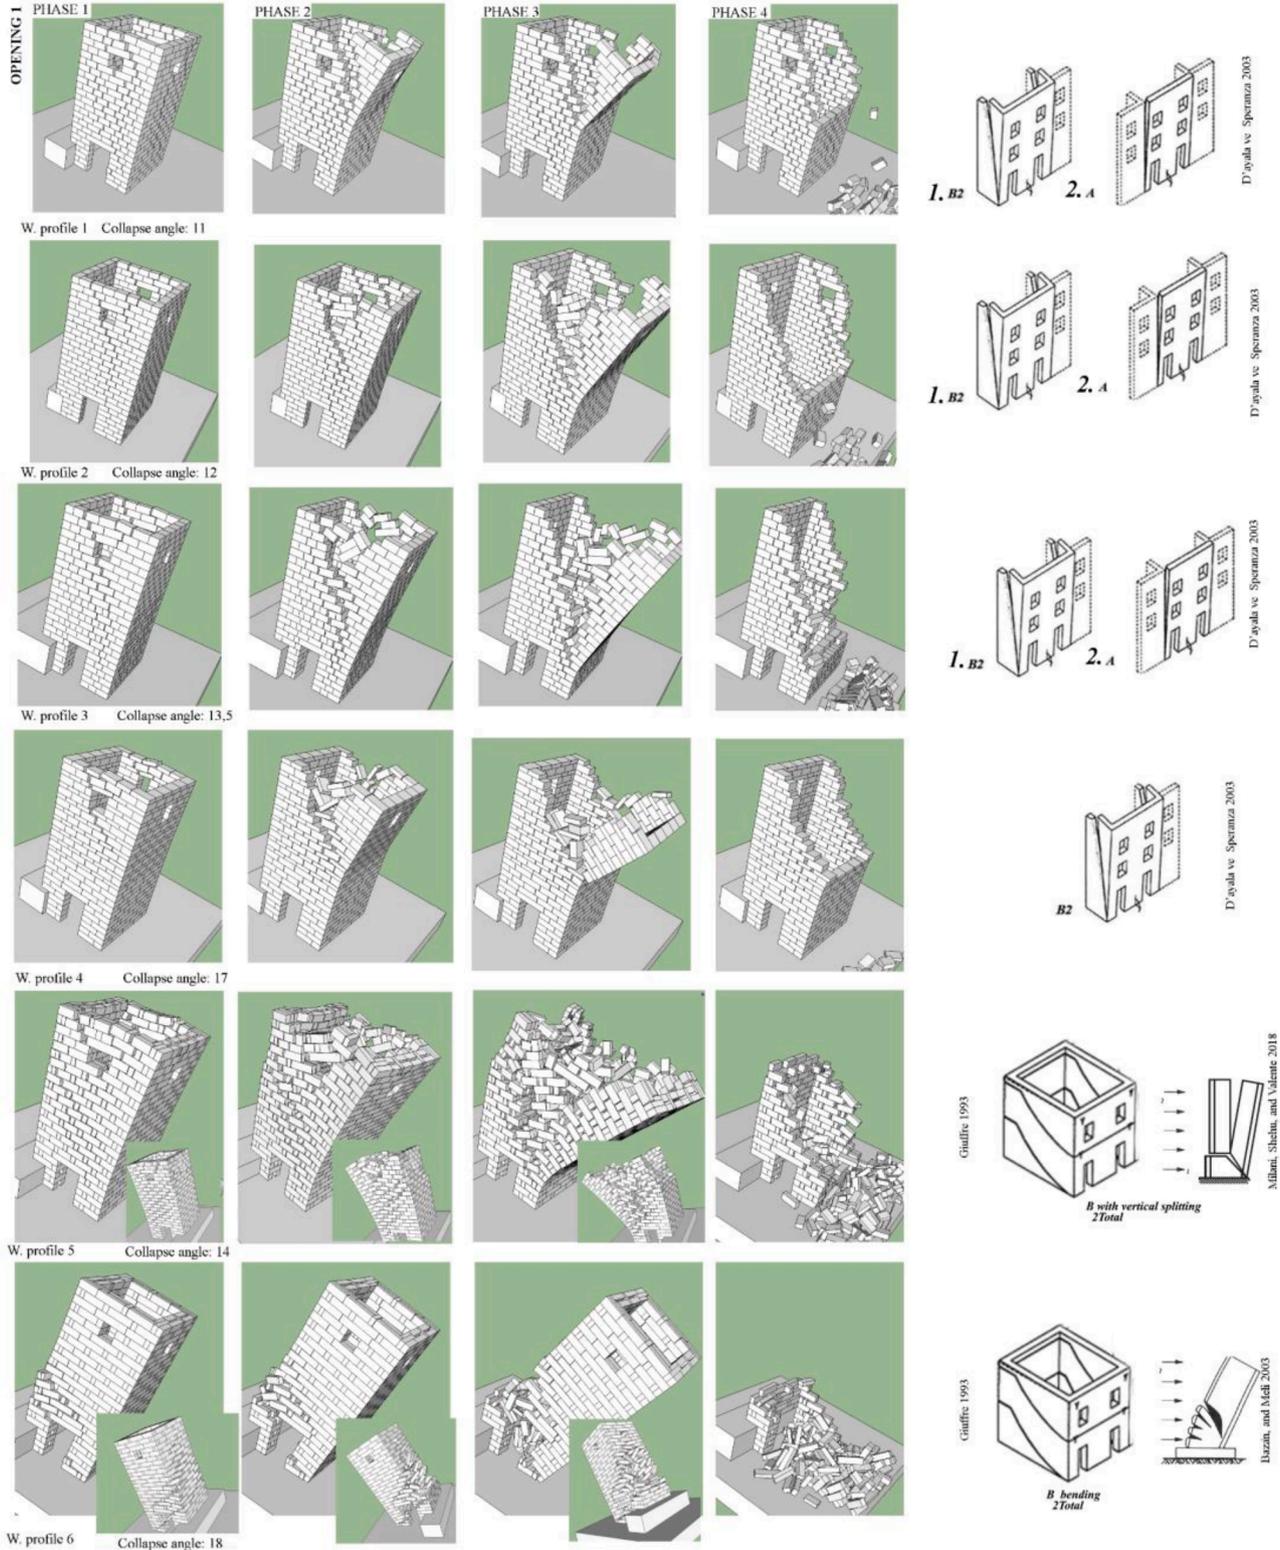
Fig. 5. Typical failure mechanisms and collapse angles of wall profile types (Giuffrè, 1993; D' Ayala and Speranza, 2003; Bazan and Meli, 2003; Milani et al., 2018).

FAILURE MECHANISMS RELATED TO WALL PROFILE TYPES (phases, respectively)

In single-leaf wall profiles, longer stone depths (75 cm) directly result in higher out-of-plane resistance, similar to the studies of Shi et al. (2008). Wall profile 4 has a longer stone depth (75 cm) when compared to wall profiles 1, 2, and 3 (60 cm). Wall profiles 1, 2, and 3 demonstrate an out-of-plane failure (G or DT). However wall profile 4 results in typical in-plane failure when openings are located in out-of-plane position (Fig. 5; Table 5).

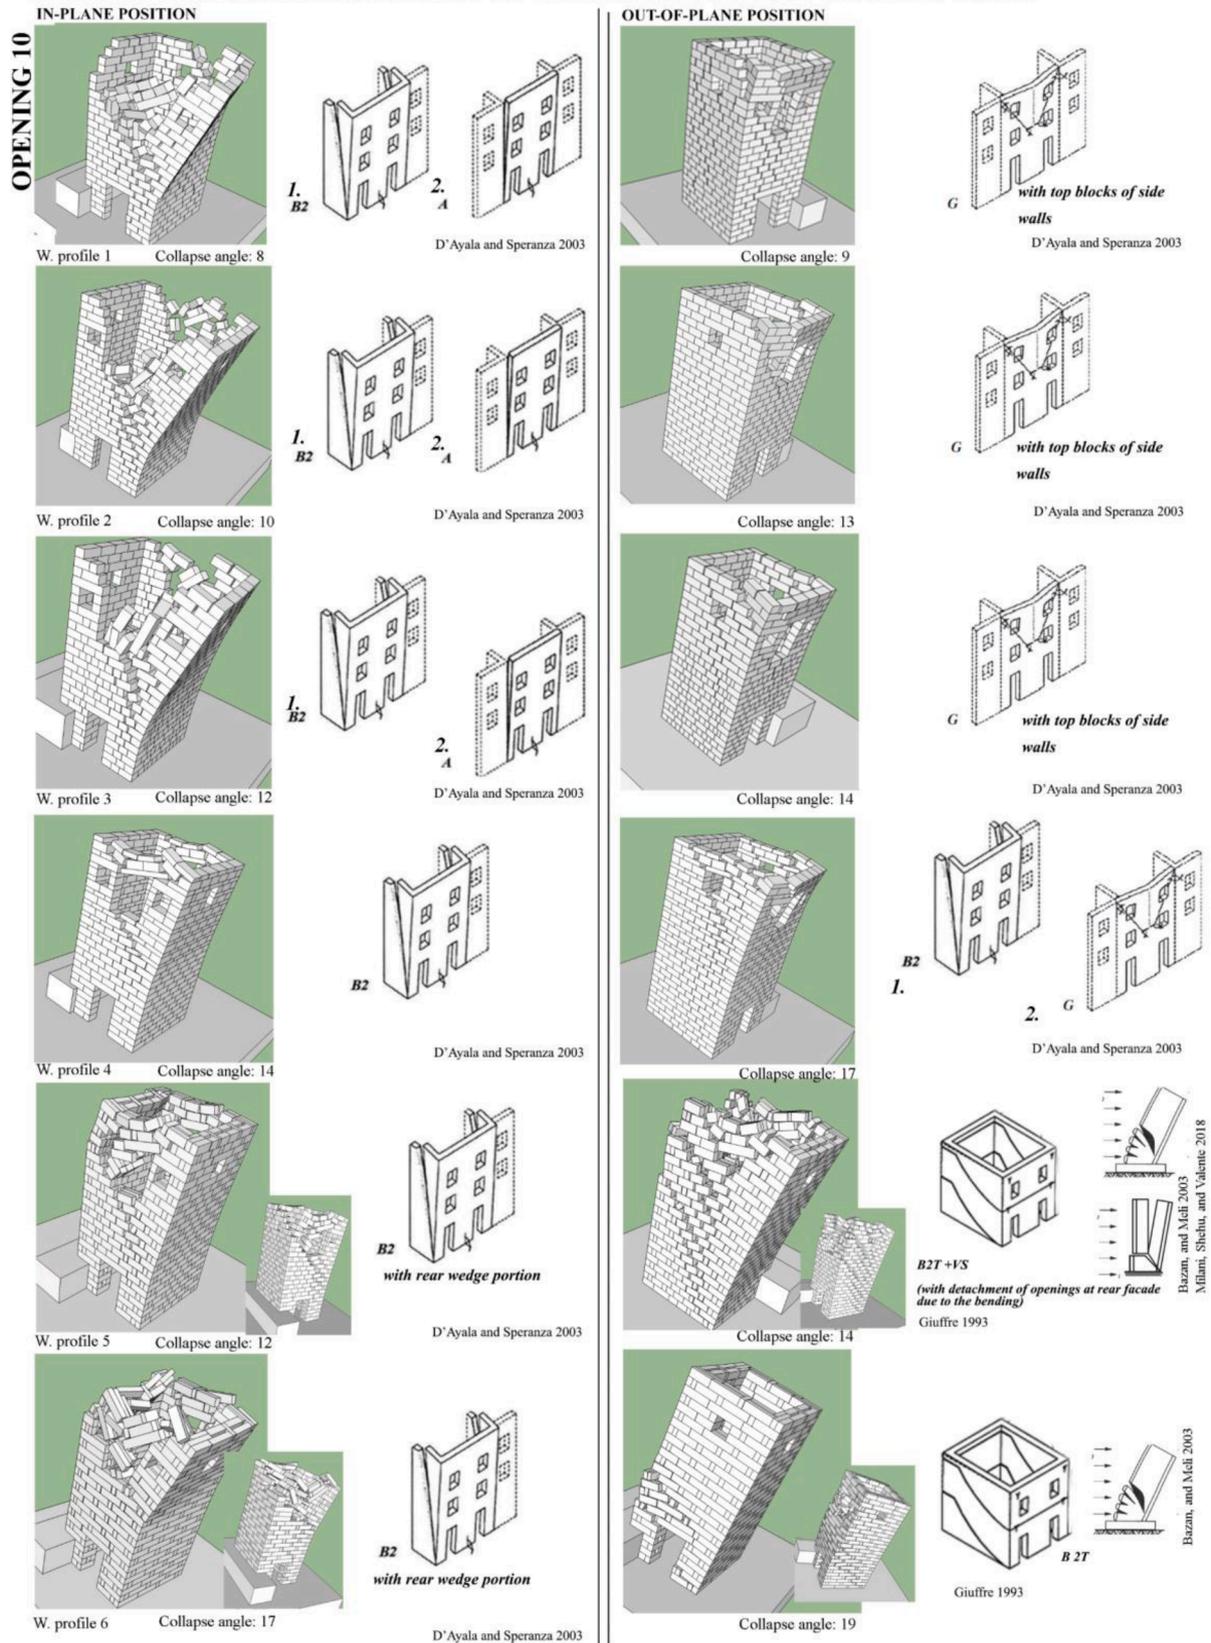
Fig. 6. Failure mechanisms and collapse angles of wall profile types with opening 10 (Giuffrè, 1993; D'Ayala and Speranza, 2003; Bazan and Meli, 2003; Milani et al., 2018).

FAILURE MECHANISMS RELATED TO WALL PROFILES AND OPENING TYPES

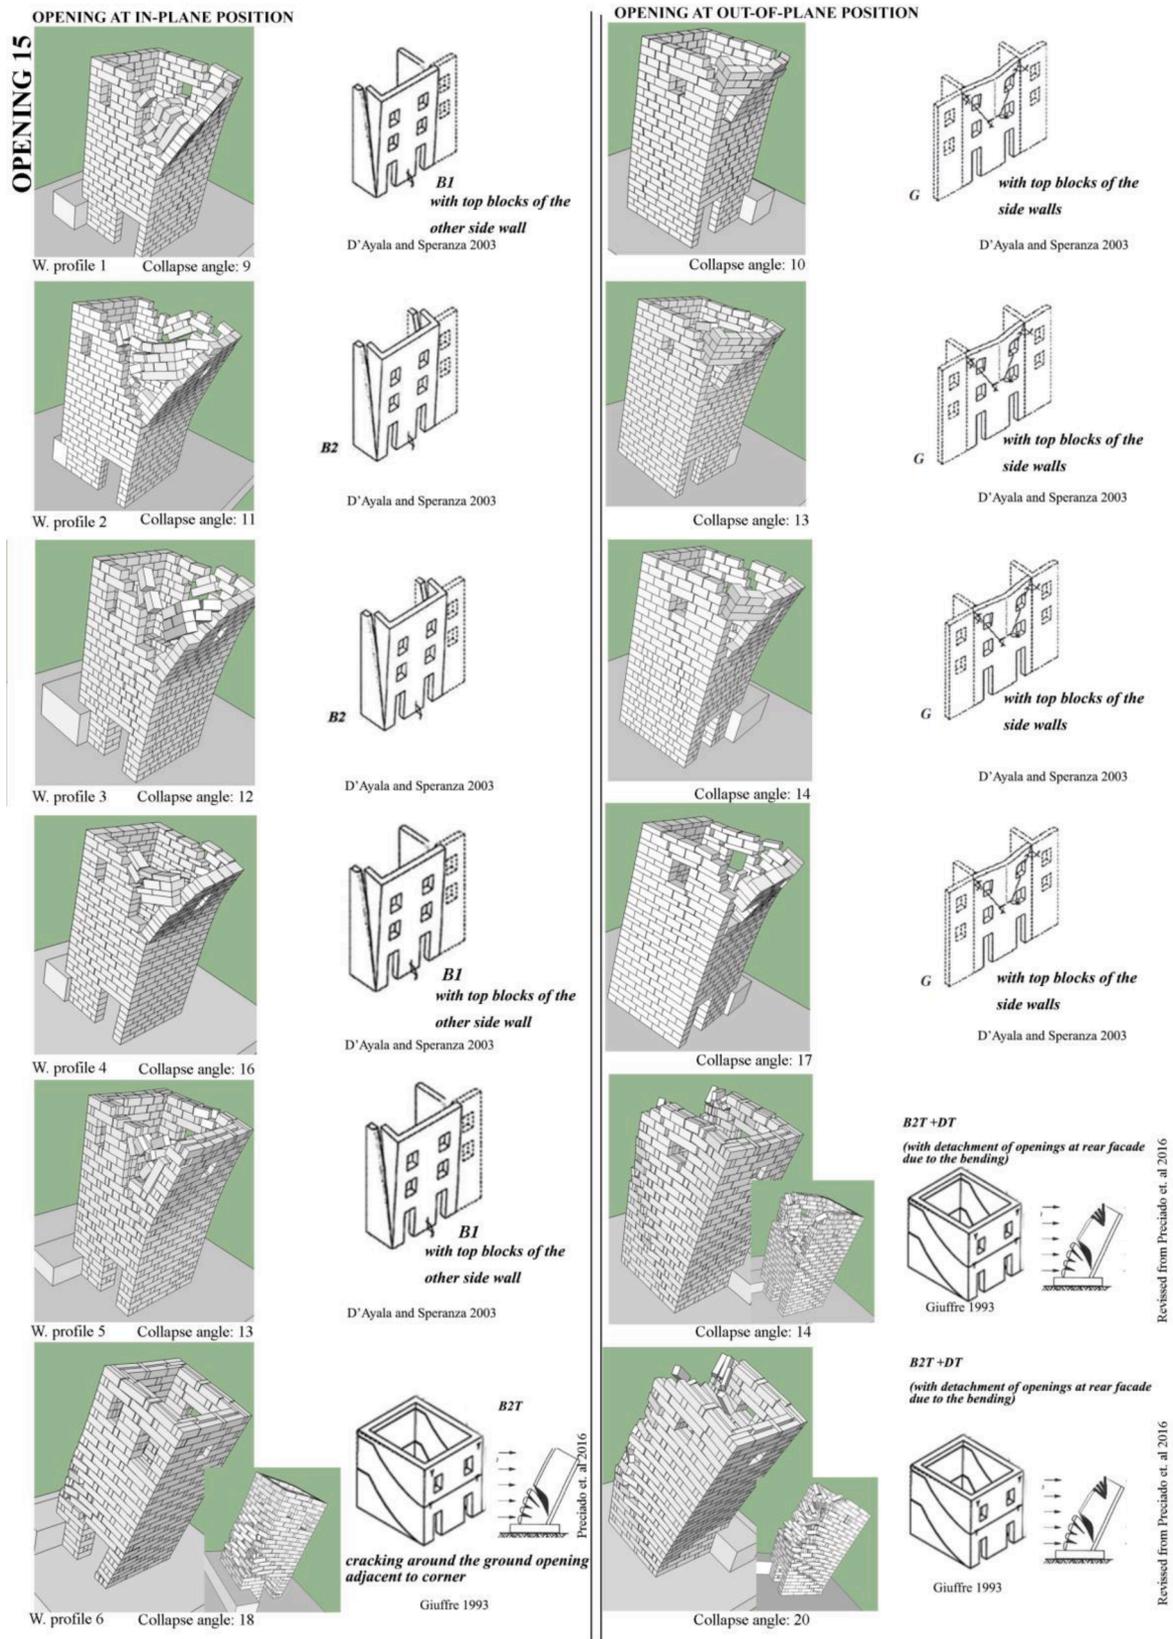
Fig. 7. Failure mechanisms and collapse angles of wall profile types with opening 15 (Giuffrè, 1993; D'Ayala and Speranza, 2003).

FAILURE MECHANISMS RELATED TO WALL PROFILES AND OPENING TYPES

failure observed in the smallest collapse angles of all of the wall profiles. Opening 10 causes mechanism B_2 , the collapse of two side walls with in-plane diagonal cracks. The effect of opening 10 is seen most distinctly on wall profiles 5 and 6 (Fig. 6), since opening 10 causes mechanism B_2 in place of total overturning. Failure mechanism B_1 followed by B_2 is directly related to the opening being located in the in-plane position: it is mostly seen in openings 8, 11, 14, and 15 (Fig. 7; Table 4; bold letters).

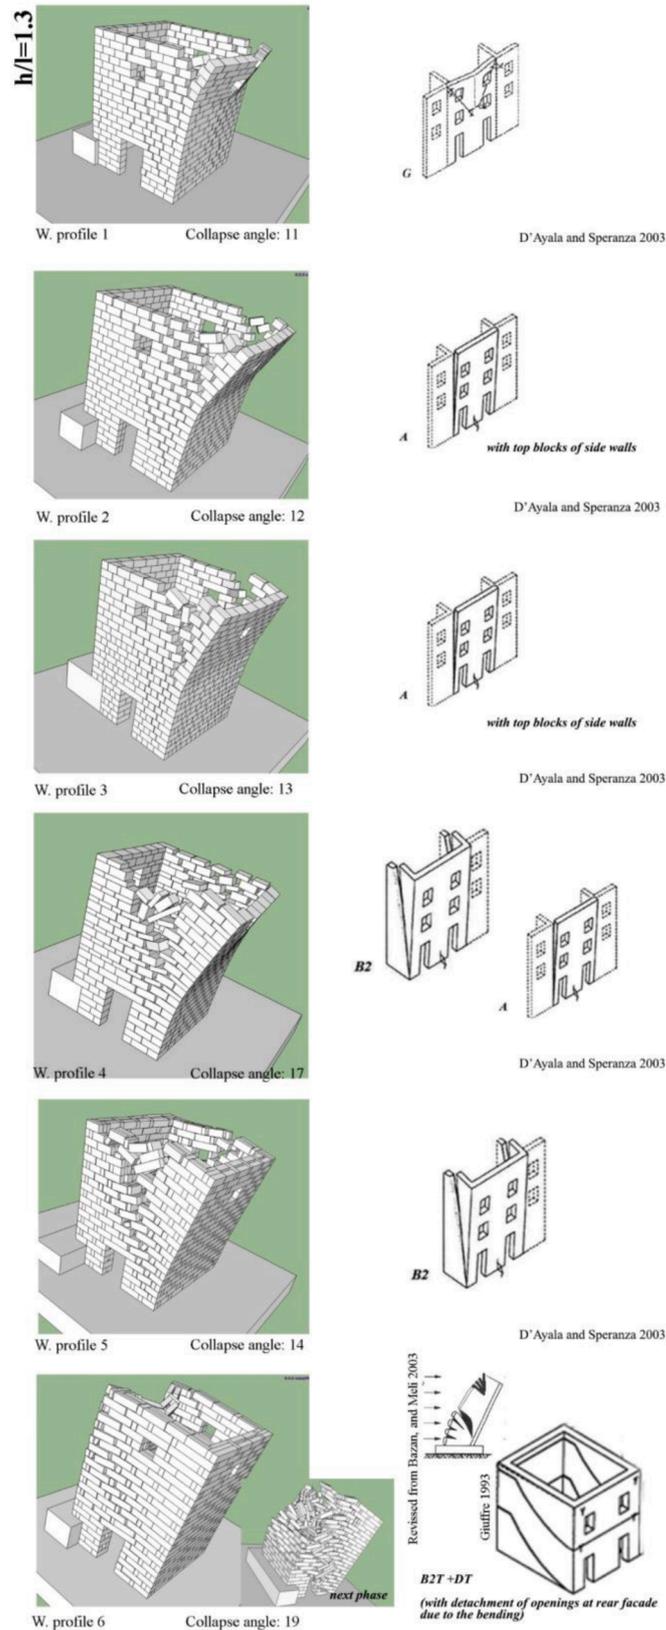
Fig. 8. Failure mechanisms and collapse angles of different wall profiles in different ratios (Giuffrè, 1993; D'Ayala and Speranza, 2003; Bazan and Meli, 2003).

FAILURE MECHANISMS RELATED TO WALL PROFILE AND H/L RATIO

Out-of-plane failures (mechanism A, G or DT) occur at ratios smaller than 1.3 when a 'negligible impact opening' is present. Mechanism G occurs at wall profile 1, mechanism A occurs at wall profiles 2 and 3. Mechanism A is combined with the typical failure mechanism for wall profile 4 ($B_2 + A$). Wall profile 5 demonstrates in-plane behaviour (B_2) in place of total body behaviour. In addition, even if the strongest wall profile, profile 6, sustains its total body behaviour, detachment of the rear facade is combined with mechanism $B_{2T} + DT$, at h/l ratios smaller than 1.3 (Fig. 8; Table 4; blue letters).

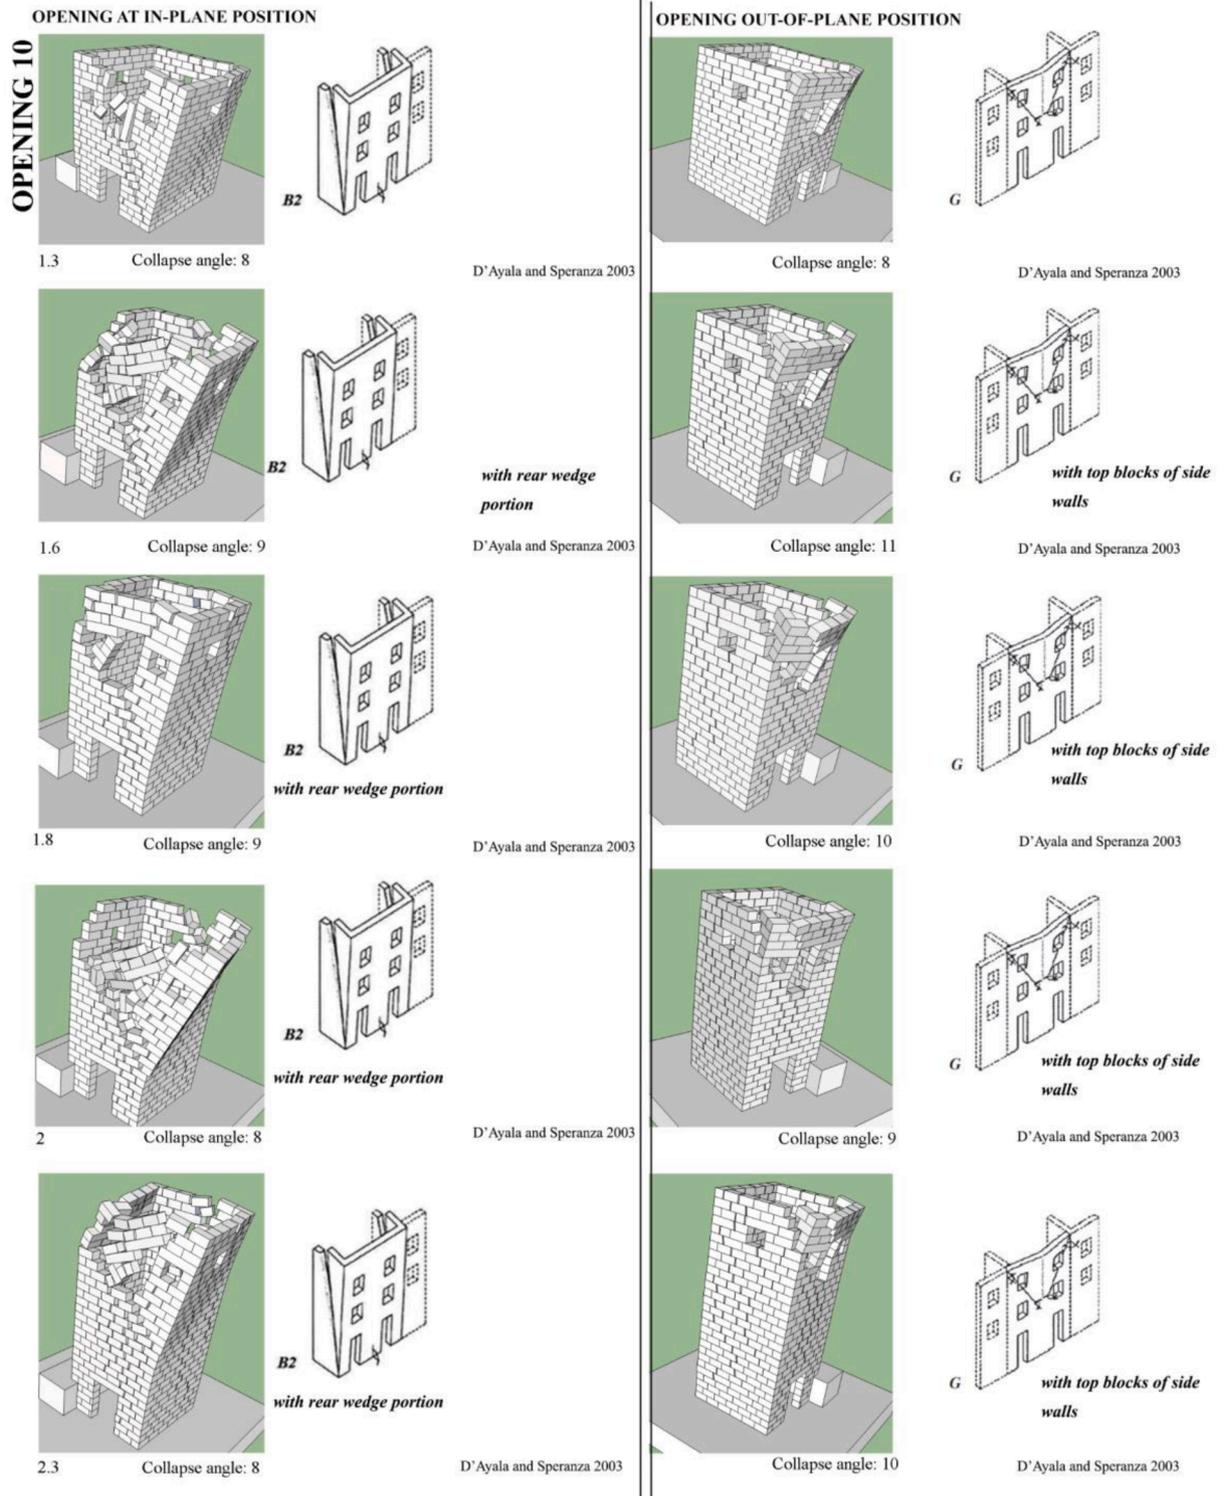
Fig. 9. The failure mechanism of wall profile 1 with opening 10 in different ratios (D'Ayala and Speranza, 2003).

FAILURE MECHANISMS RELATED TO OPENING TYPES AND H/L RATIO

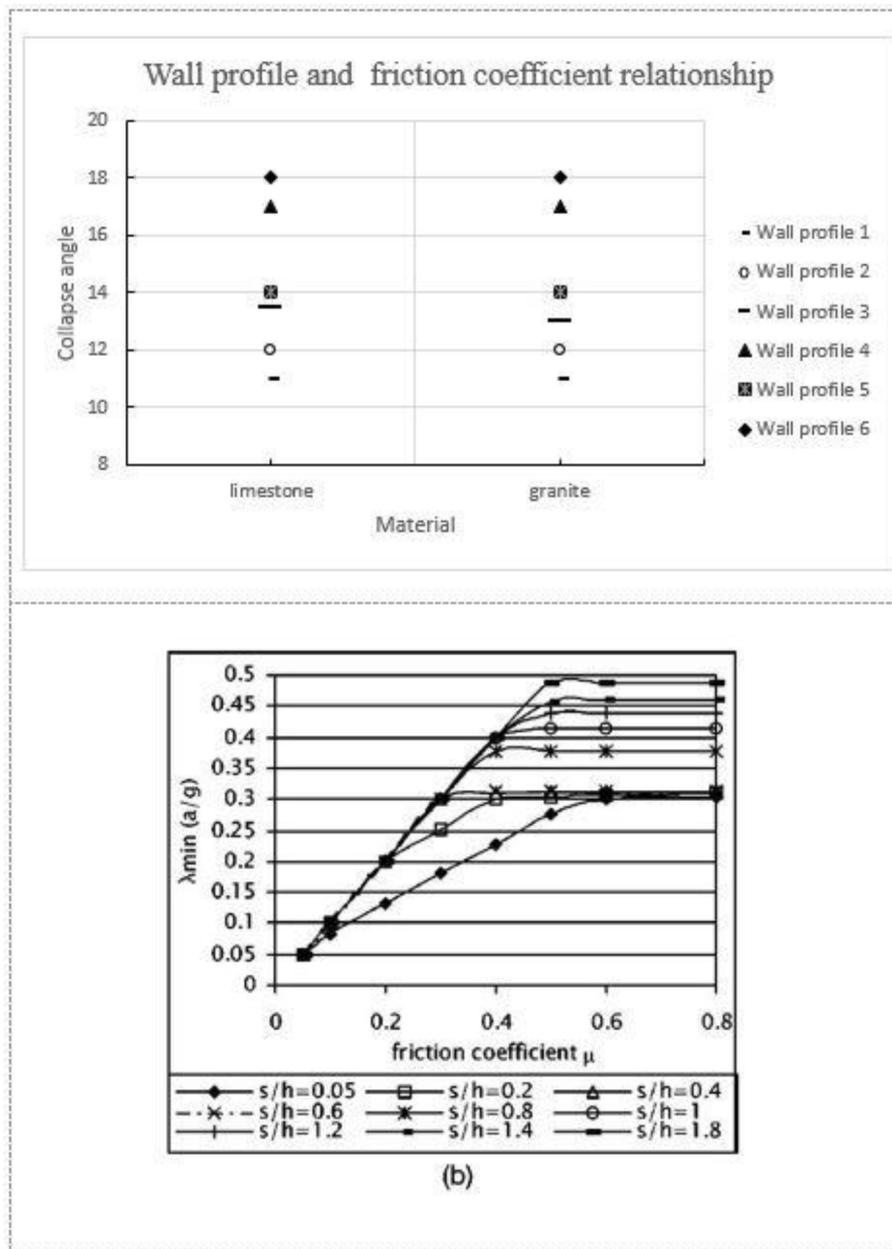
Fig. 11. Impact of friction coefficient on structural resistance (graph (b) from D’Ayala and Speranza, 2003).

- Increasing staggering ratios ($s/h \geq 1.7$) resulted in an improvement of seismic performance, only for those structures where the h/l ratio was higher than 1.
- It appears that there was a standardization in ancient construction techniques for dry masonry towers. This was observed in the proportional relationships between wall height and length, as well as material usage. Although wall thicknesses altered, the height/length ratio remained between 1.6 and 2. These values provided minimum structural vulnerability for these towers.
- In terms of material usage, it has been observed that the blocks used in the construction of these towers; namely, granite and limestone; had similar coefficients of friction (0.6 and 0.72 respectively) and
