**EVALUATION OF WINDOW DESIGN AND
DAYLIGHT PERFORMANCE OF MAIN ROOM IN
KULA HOUSES**

**A Thesis Submitted to
the Graduate School of Engineering and Sciences of
İzmir Institute of Technology
in Partial Fulfillment of the Requirements for the Degree of**

in Architectural Restoration

**by
Cansu BATTAL**

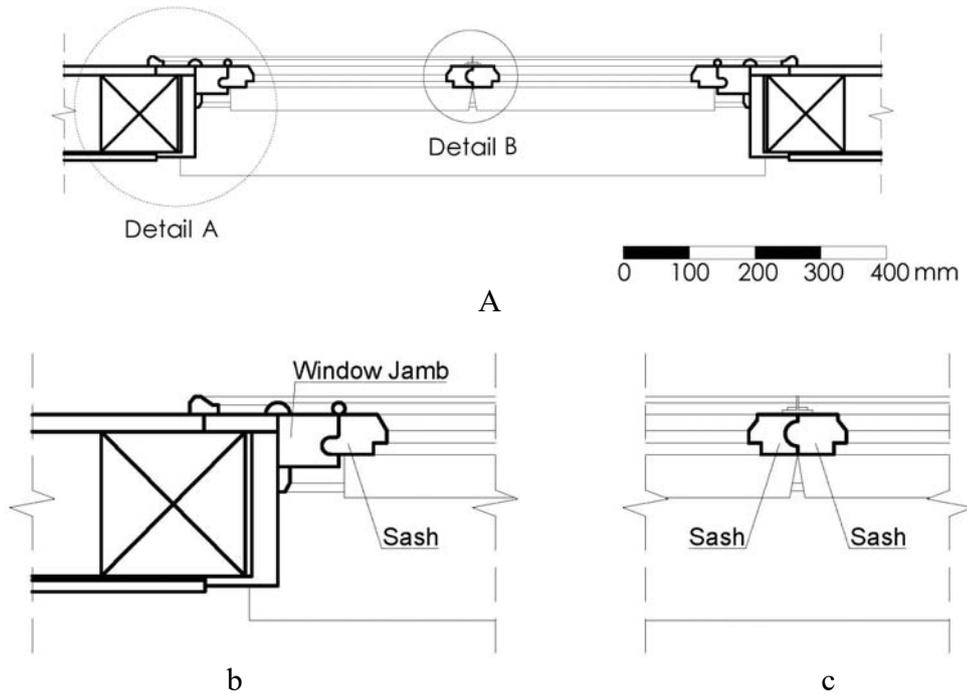
Figure 2.16. Window plan (a), tongued-grooved joint detail A (b), detail B (c)
(Source: Yüksek, 2005, 22)

the vertical hinged sashes with the wooden joinery of window is tongue¹²-groove¹³ (*lamba-zivana*) joint. In groove joint, there is a slot (the groove) cut all along the length in wooden joinery of window. In the window sash, a ridge (the tongue), which is suitable for groove, enters into the groove and closes. Grooved joint provides protection against weather conditions (Figure 2.16). The joining of the window sashes can also be tongue-groove; however, perpendicular sliding sash (*giyotin*) is combined in the form of finger joint (*kurtağzi*) (Yüksek, 2005, 17-26).

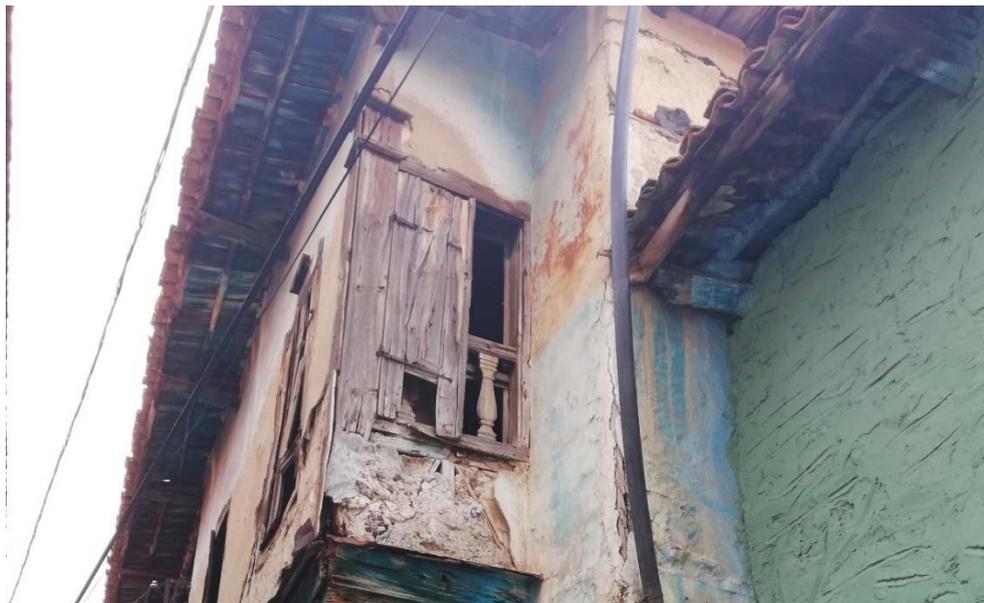
Figure 4.10. Under the eaves uncoated and exposed beams in Uurlar House, Kula, Manisa (Prepared by Author, 26.07.2018)

Three types of eaves are observed in traditional houses, these are under the eaves uncoated and exposed beams (Figure 4.10); under the eave flat and inward sloping wood veneer (Figure 4.11); the wood-lath concave eave (Figure 4.12). The width of the eaves is between 50 and 150 cm. There are two types of roofs as gable roof and hipped roof. Roofs are covered with pantile (*alaturka kiremit*).

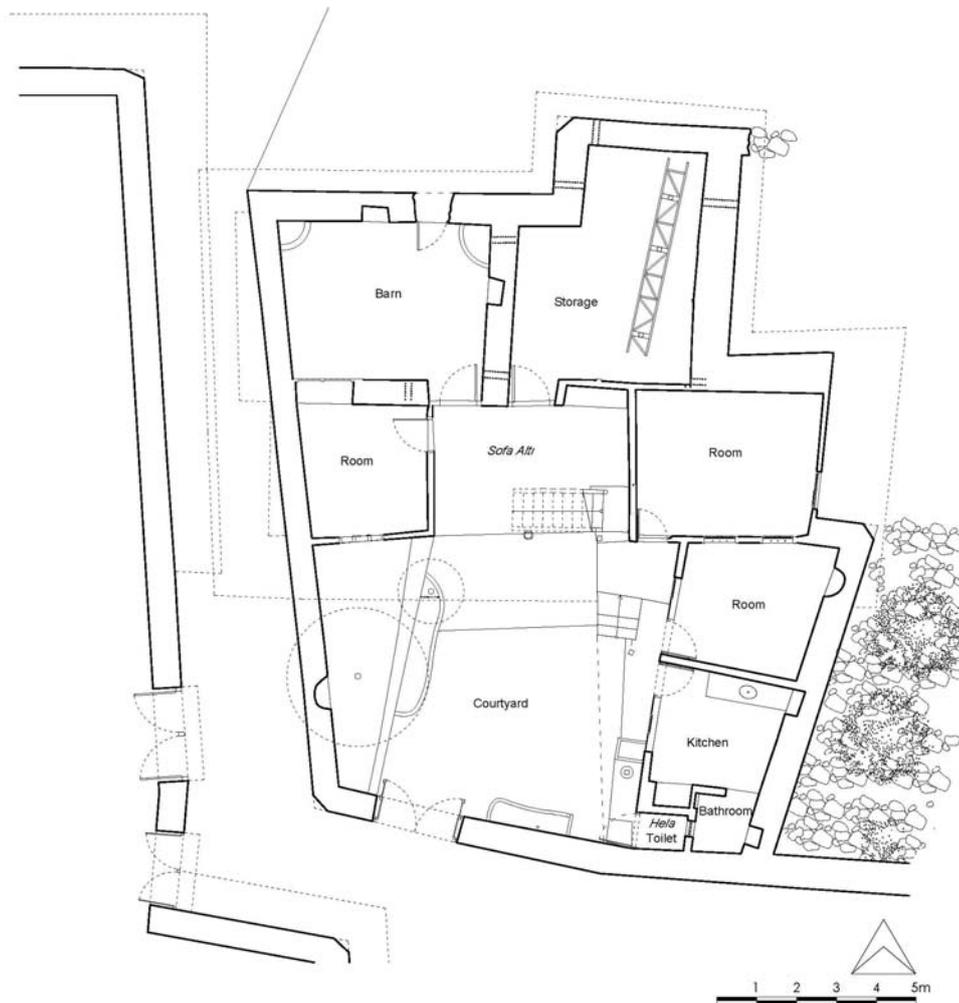
Figure 5.3. The plan of the ground floor of Kaçıklar House.
(Source: Kenar et al. 2019)

The two-storey building is located to the north of the lot, and the single-storey outbuilding to the east. Today, outbuilding spaces consist of a toilet, a bathroom, a kitchen and a daily room (Figure 5.3).

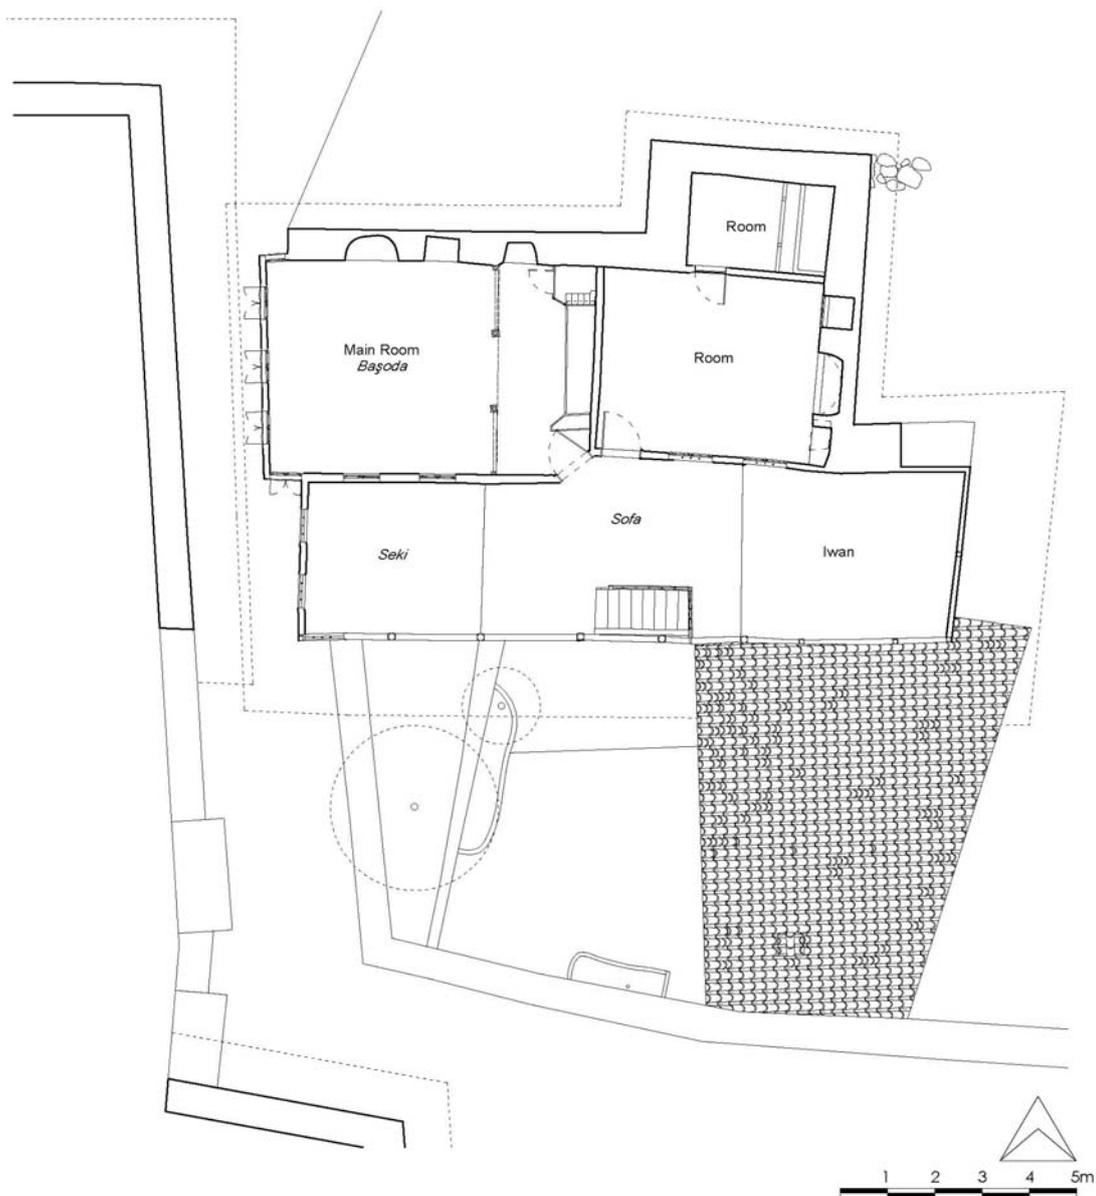
Figure 5.4. The plan of the first floor of Kaçıklar House.
(Source: Kenar et al. 2019)

There is one room in the east and west on the ground floor of the building; in addition, a barn in the west and a storage in the east are arranged to position further north between these rooms. There is a cellar underneath the room in the east and this room is entered through a platform accessed by a four-step staircase. For this reason, the ground level of the room is 1.03 m higher than the ground level of the courtyard (Figure 5.3). It is reached from the platform in front of the room, the staircase with two steps and then to the outer *sofa* (*hayat*) upstairs with a 10-step wooden stairs (Figure 5.4).

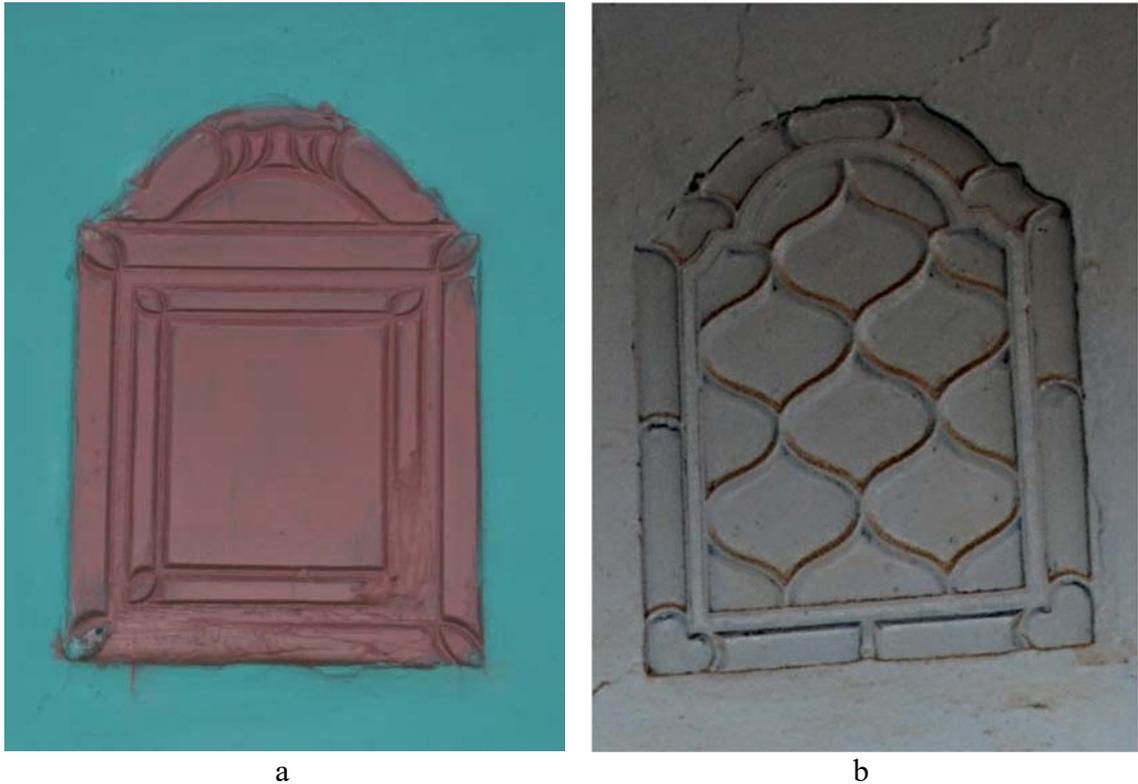
Figure 5.15. The internal part (*içlik*) of the top window (Prepared by Author, 15.10.2018) (a), the external part (*dışlık*) of the top window (Prepared by Author, 15.10.2018) (b)

b) Technical Features: The top windows consist of internal (*içlik*) and external (*dışlık*) parts. In upper windows the frames are timber; the sash bar and sections are plastered (Figure 5.16 a).

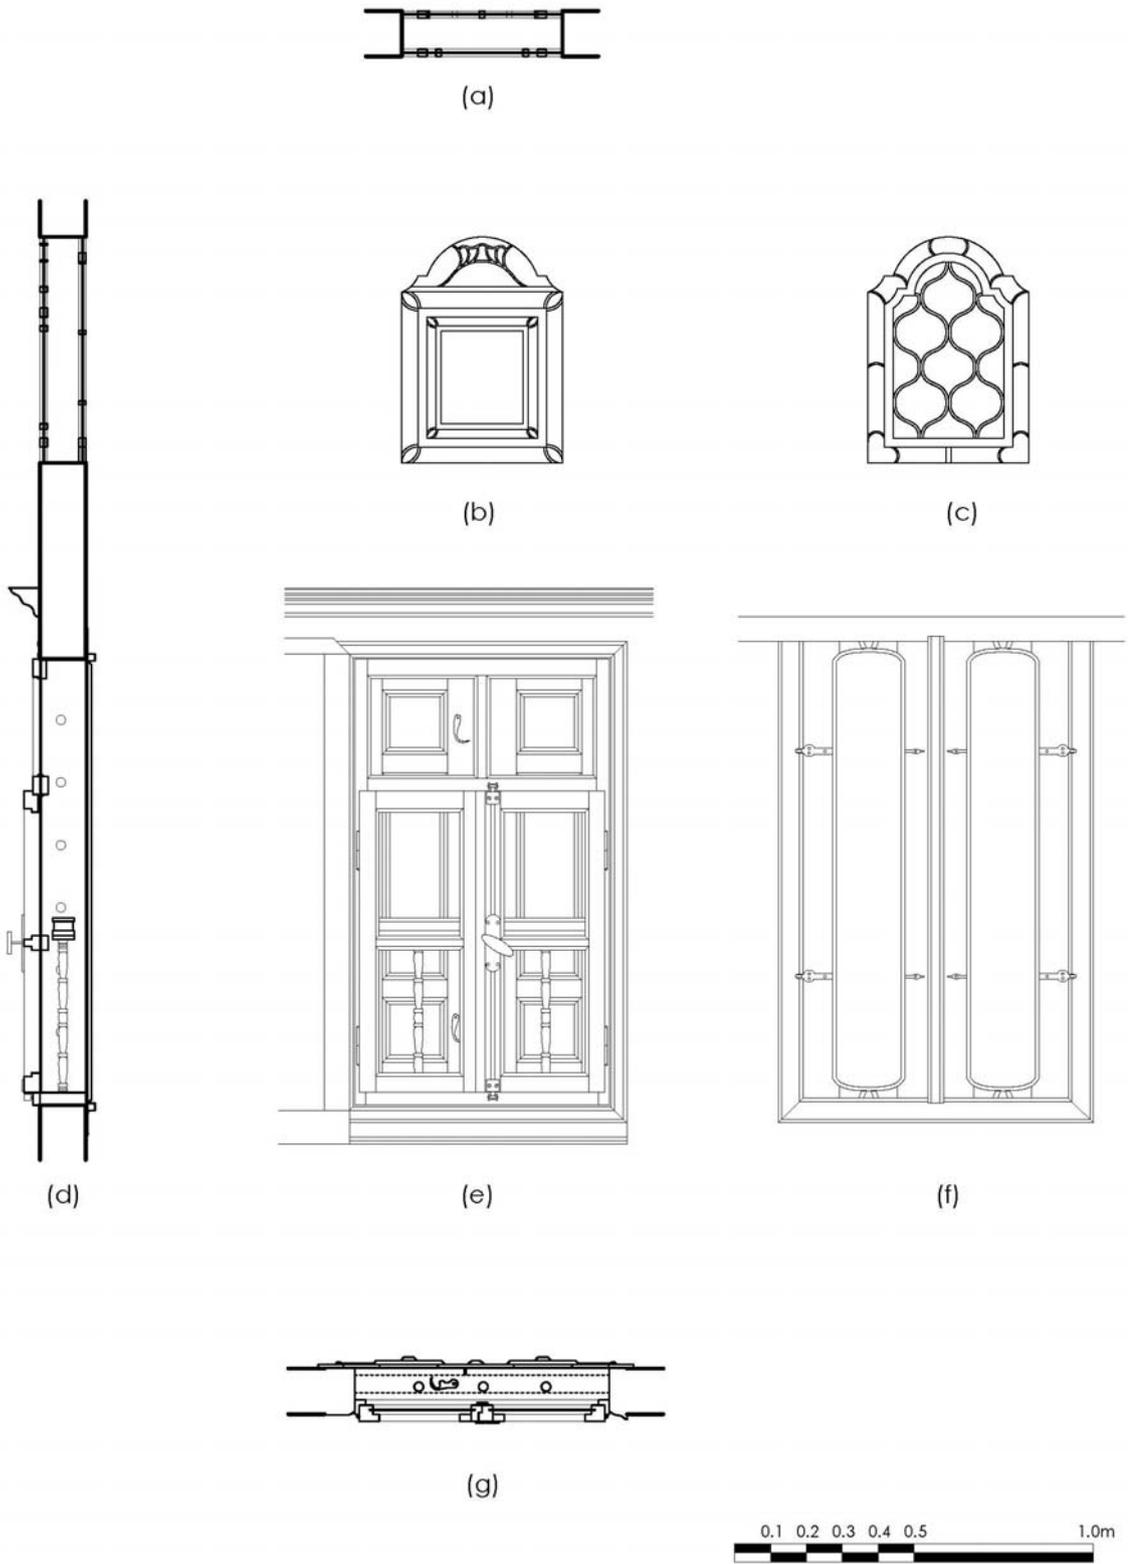
Figure 5.16. Top window plan (a), Top window internal part (içlik) view (b), Top window external part (dışlık) view (c), Rectangular and top window section (d), Rectangular window view (e), Rectangular window shutter view (f), Rectangular window plan (g).

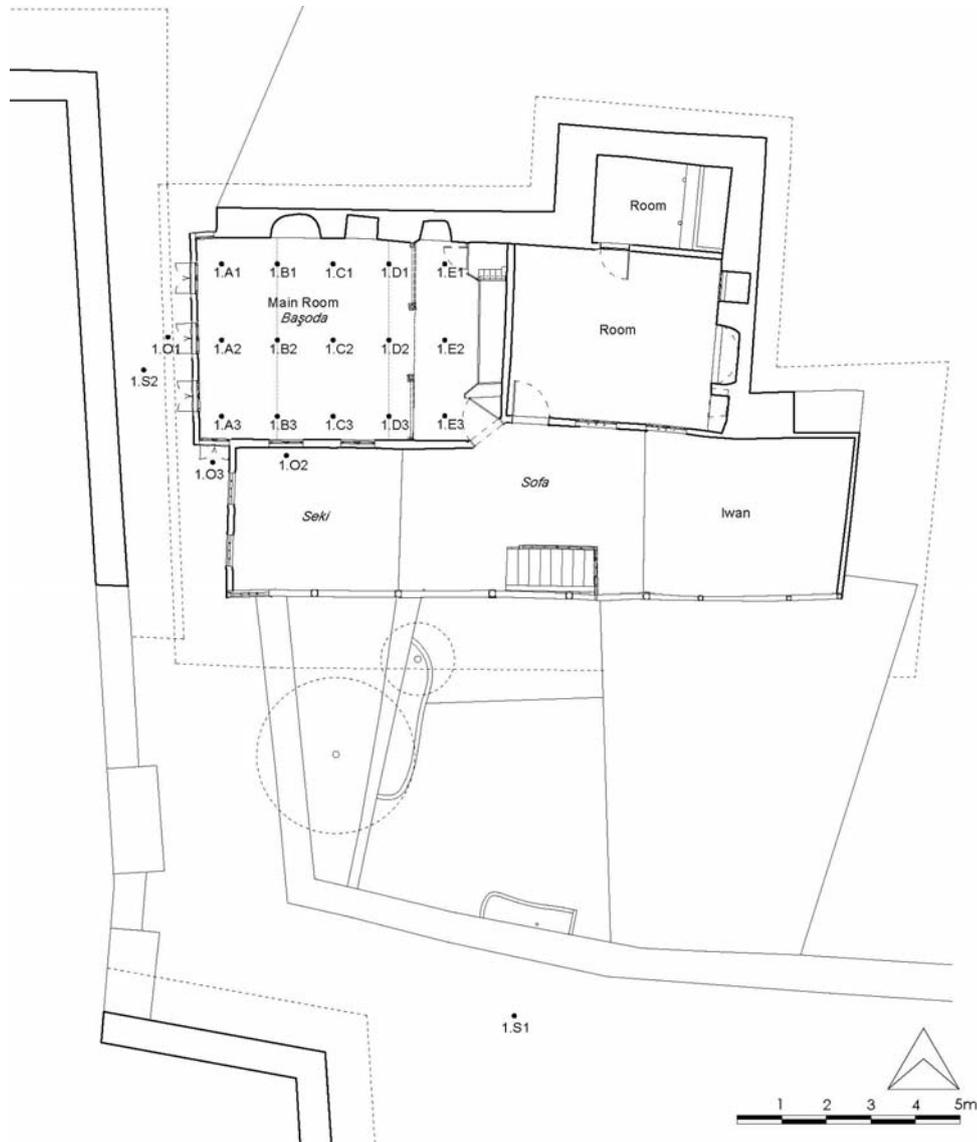
Figure 5.17. Measurement points for illuminance in the main room of Kaçıklar House.

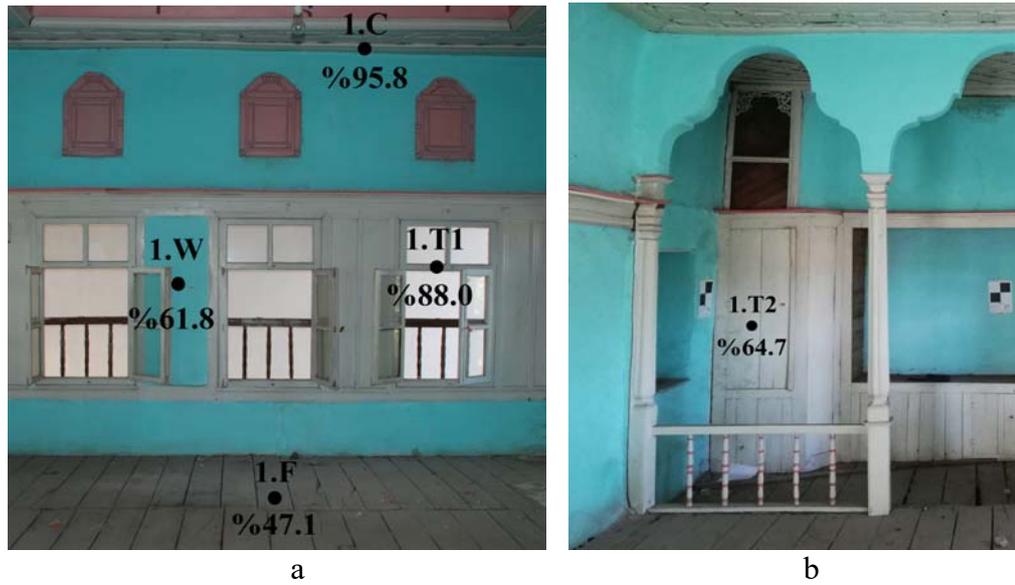
Figure 5.18. The surface reflectance at the measurement points in the main room of Kaçıklar House on the west wall (15.10.2018) (a), on the east wall (15.10.2018) (b).

To identify the materials forming the surfaces in the main room, luminance measurements were taken from the determined points (Table 3.1) by the luminance meter and on the determined dates (Table 3.2). The average of the reflectance was calculated using the formula (7) and are specified in Table 5.1. The percentages of surface material reflectance (p value) change between 47.1% and 95.8%. The light color of the ceiling causes p value to be higher (95.1%), the dark color of the floor covering provides reflectance to be lower (47.1%) (Figure 5.18 a, Figure 5.18 b).

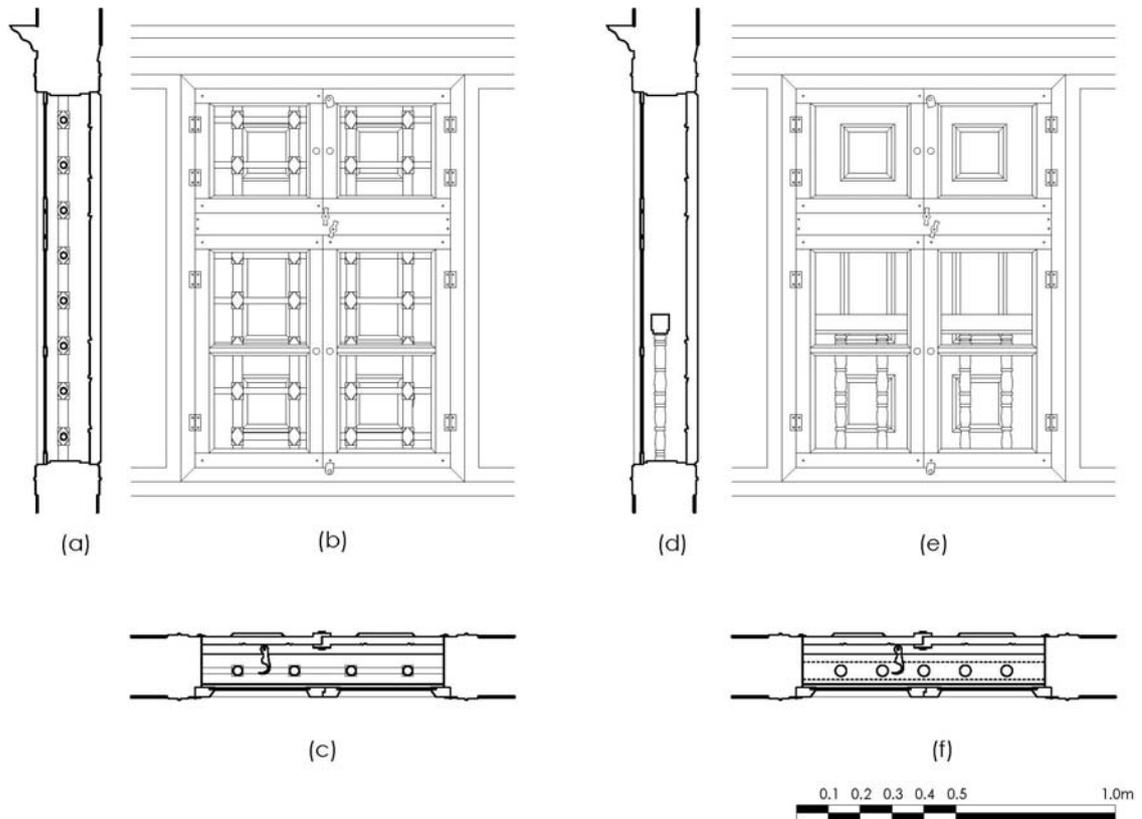
Figure 5.35. Rectangular window section with full rain (a), view (b), plan (c), Rectangular window section of half-rain (d), View (e), Plan (f)

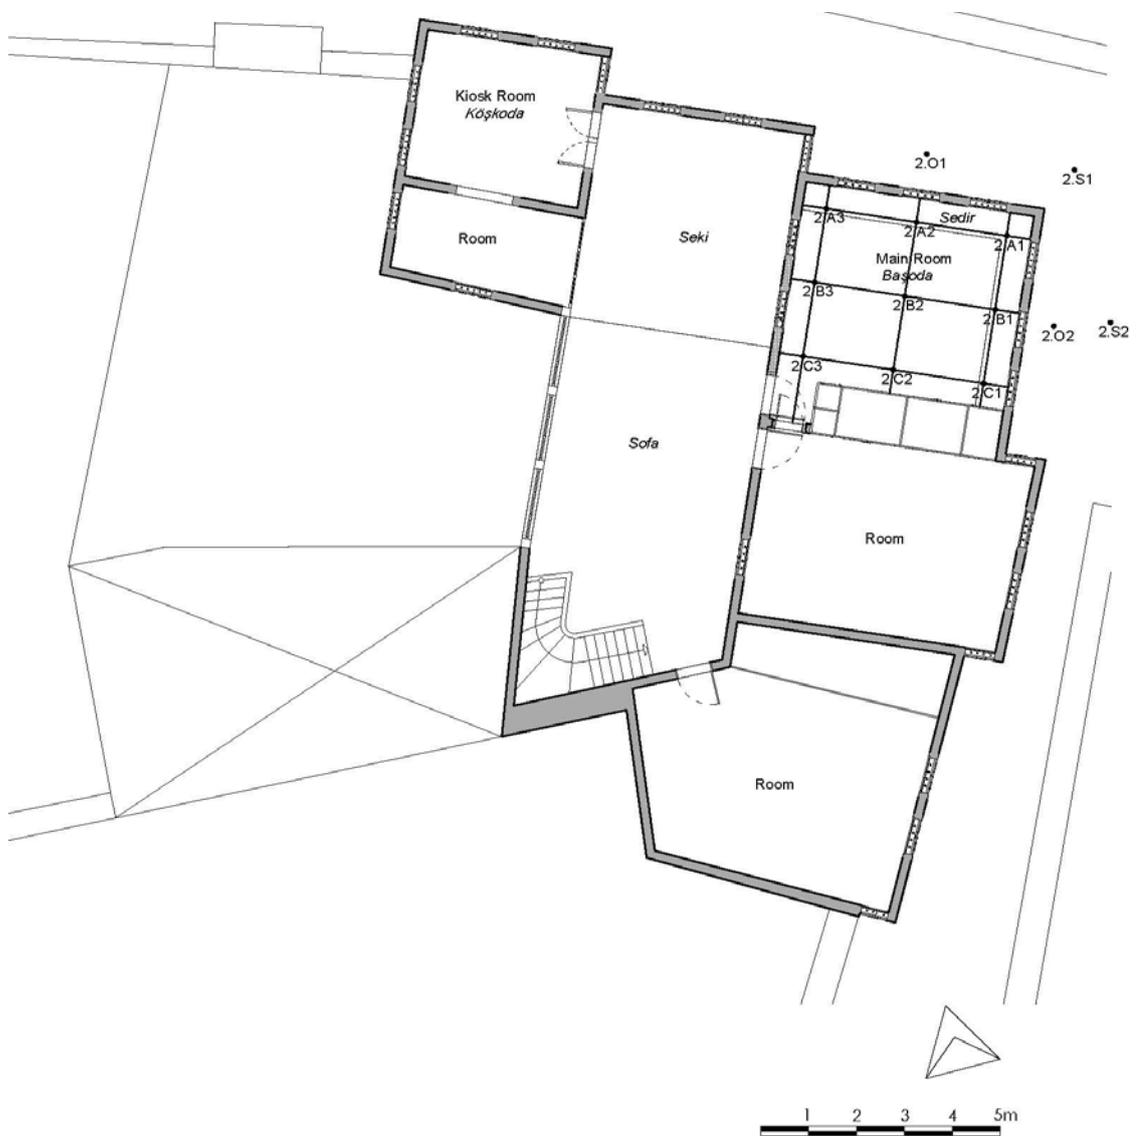
Figure 5.36. Measurement points for illuminance in the main room of Zabunlar House

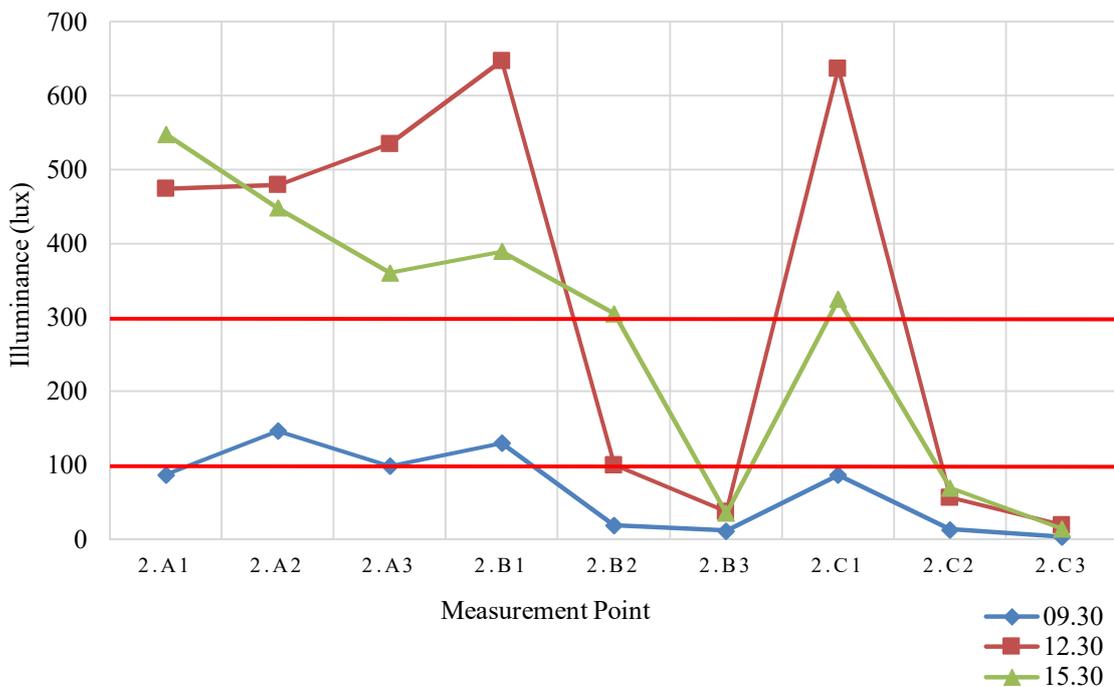
Figure 5.38. Measured interior illuminance (lux)
(December 16, 2018).

Point \ Time	9.30	12.30	15.30
2.O1	3763	4517	3389
2.O2	5672	5650	4851
2.S1	1227	1283	5982
2.S2	6271	7231	5425

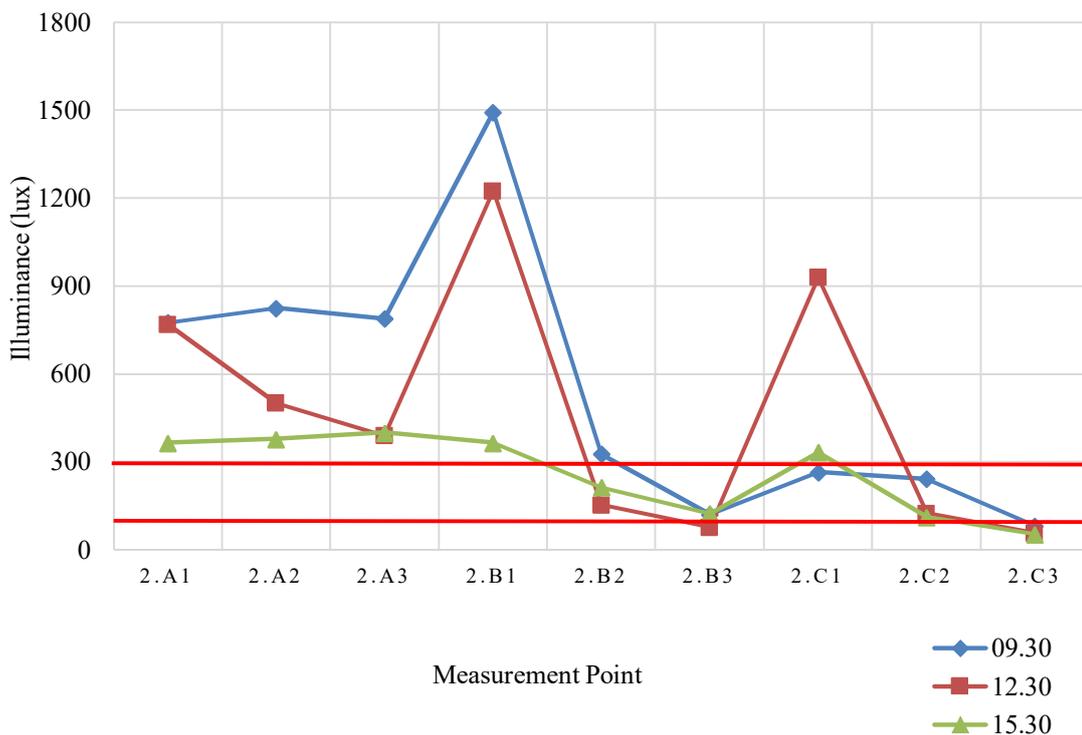
Figure 5.39. Measured interior illuminance (lux)
(April 3, 2019)

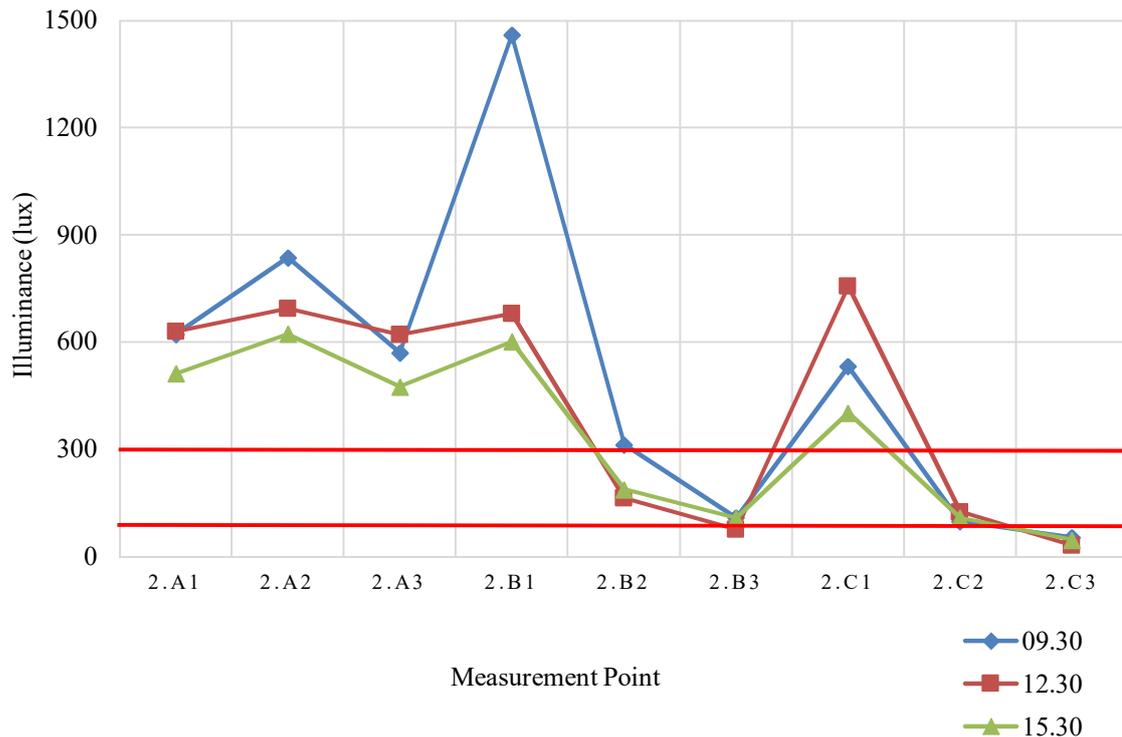
Figure 5.40. Measured interior illuminance (lux)
(June 27, 2019).

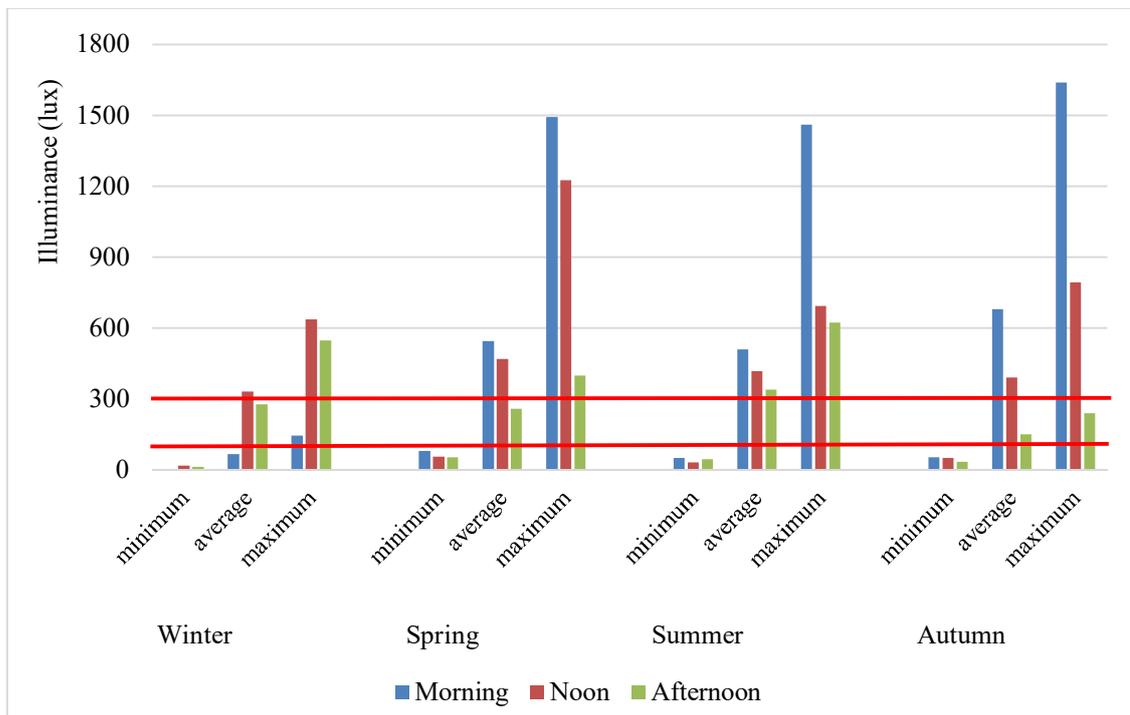
Figure 5.42. Illuminance (lux) of the main room in Zabunlar House.

Considering the measurements taken under the eaves (2.O1-2.O2), the width of the streets in the north and east, the distance between the mutual houses and the lathing concave covering of the eaves, and the ratio of the window glass area to the floor area (WGFR: $5\% < 6.08\% < 30\%$) between the standard values ensure the level of illumination in the main room. The inadequacy of the measurements taken from the west of the room (2.B3 ve 2.C3) in terms of illumination level results from the fact that the *sofa* is closed. Also, the dark color of the wall finishing material of the room causes the reflection factor to be low, thus affecting the daylight performance negatively.

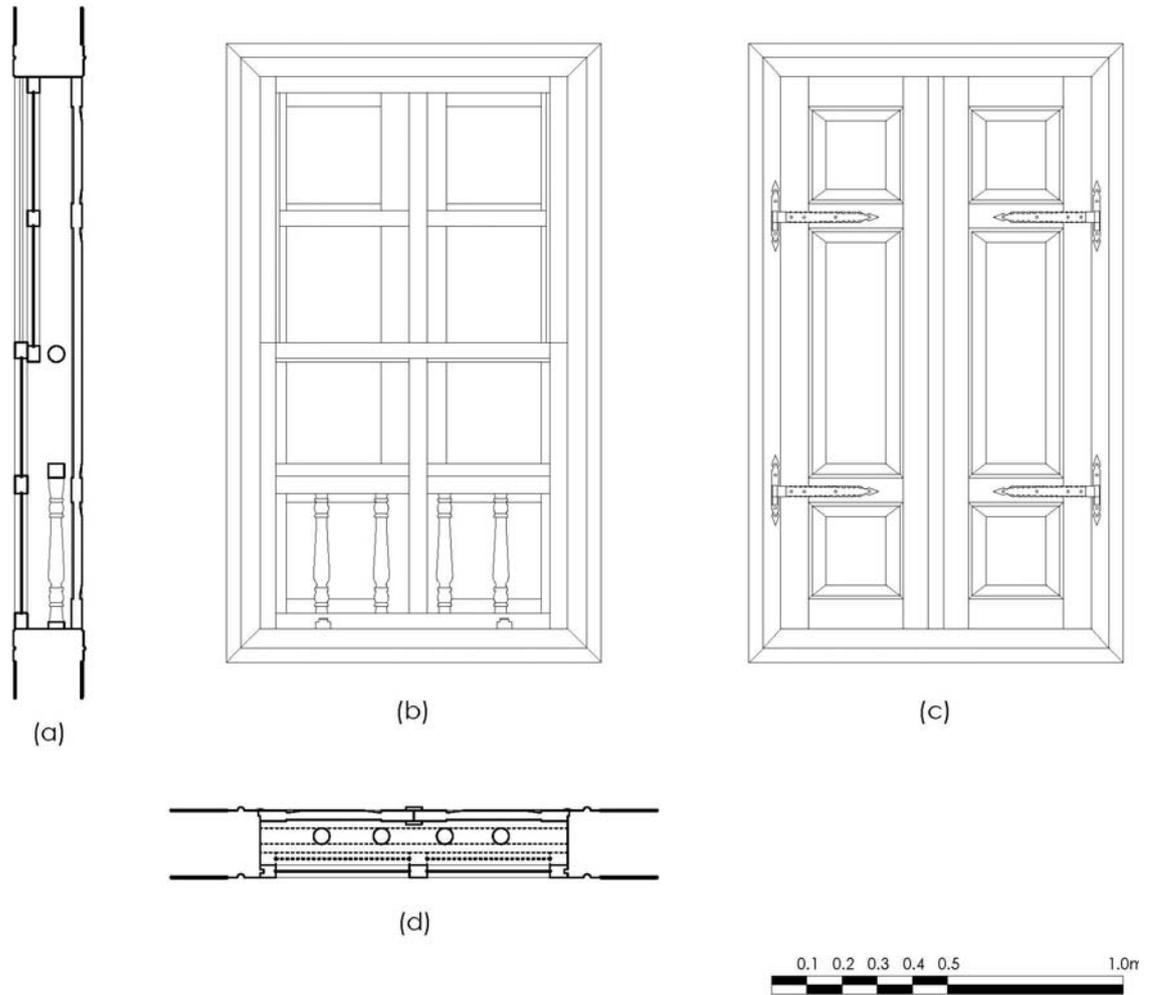
Figure 5.56. The rectangular window section (a), elevation (b), shutter elevation (c), plan (d)

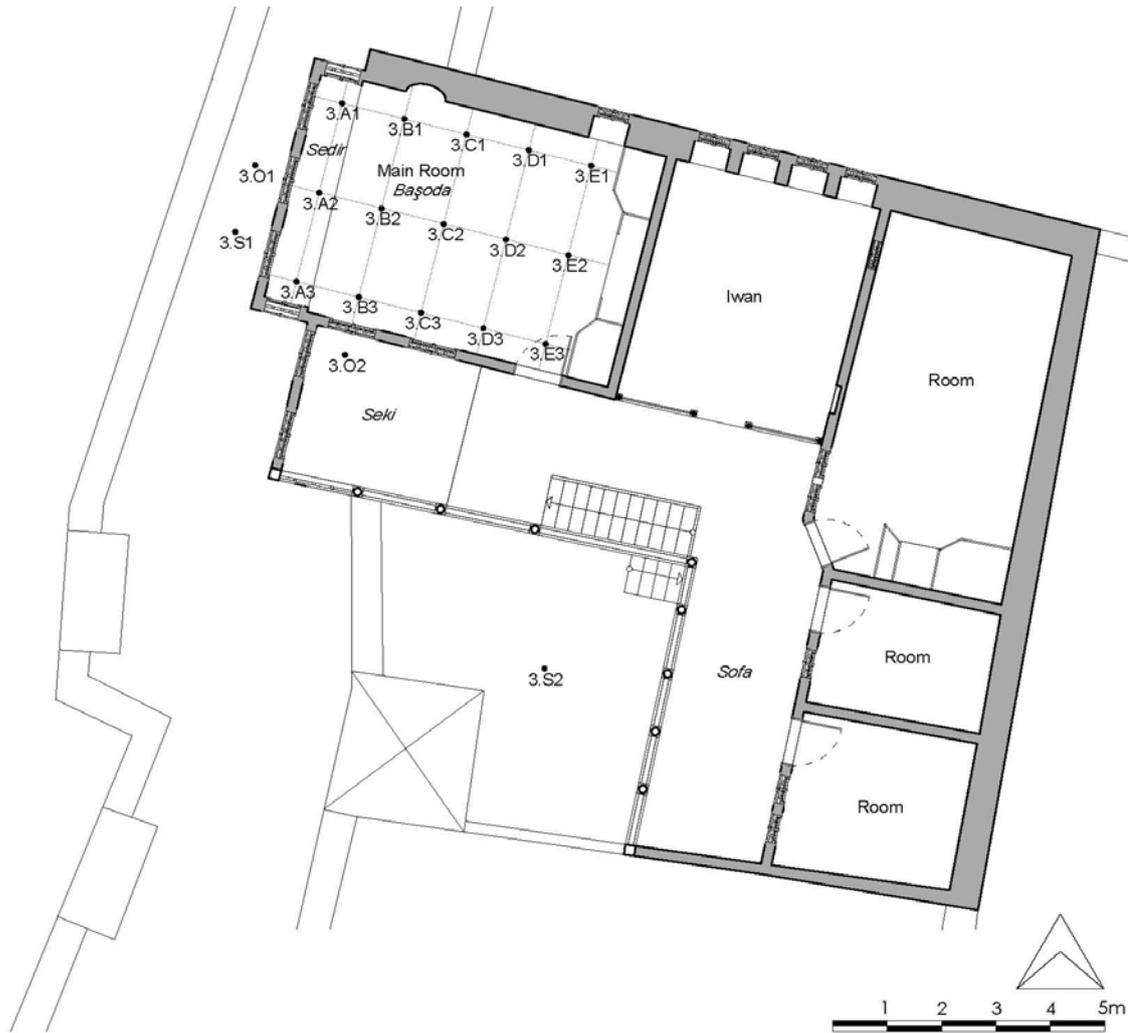
Figure 5.57. Measurement points for illuminance in the main room of Kestaneciler House

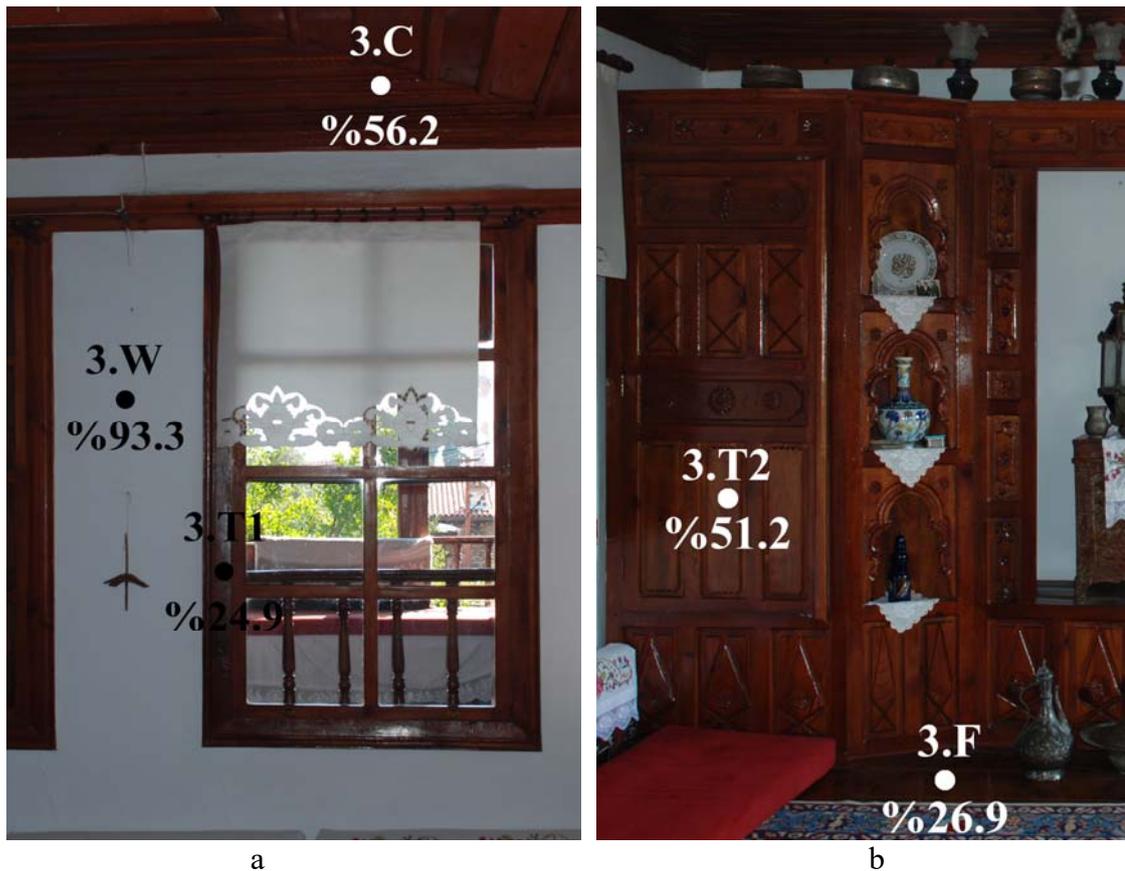
Figure 5.58. The surface reflectance at the measurement points in the main room of Kestaneciler House on the south wall (Prepared by Author, 15.10.2018) (a), on the west wall (Prepared by Author, 15.10.2018) (b)

To identify the materials forming the surfaces in the main room, luminance measurements were taken from the determined points (Table 3.1) by the luminance meter and on the determined dates (Table 3.2). The average of the reflectance was calculated using the formula (7) and is specified in Table 5.13. The percentages of surface material reflectance (p value) change between 24.9% and 93.3%. The white color of the wall causes p value to be higher (93.3%), the dark color of the wooden mullion of the window provides reflectance to be lower (30.1%) (Figure 5.58).

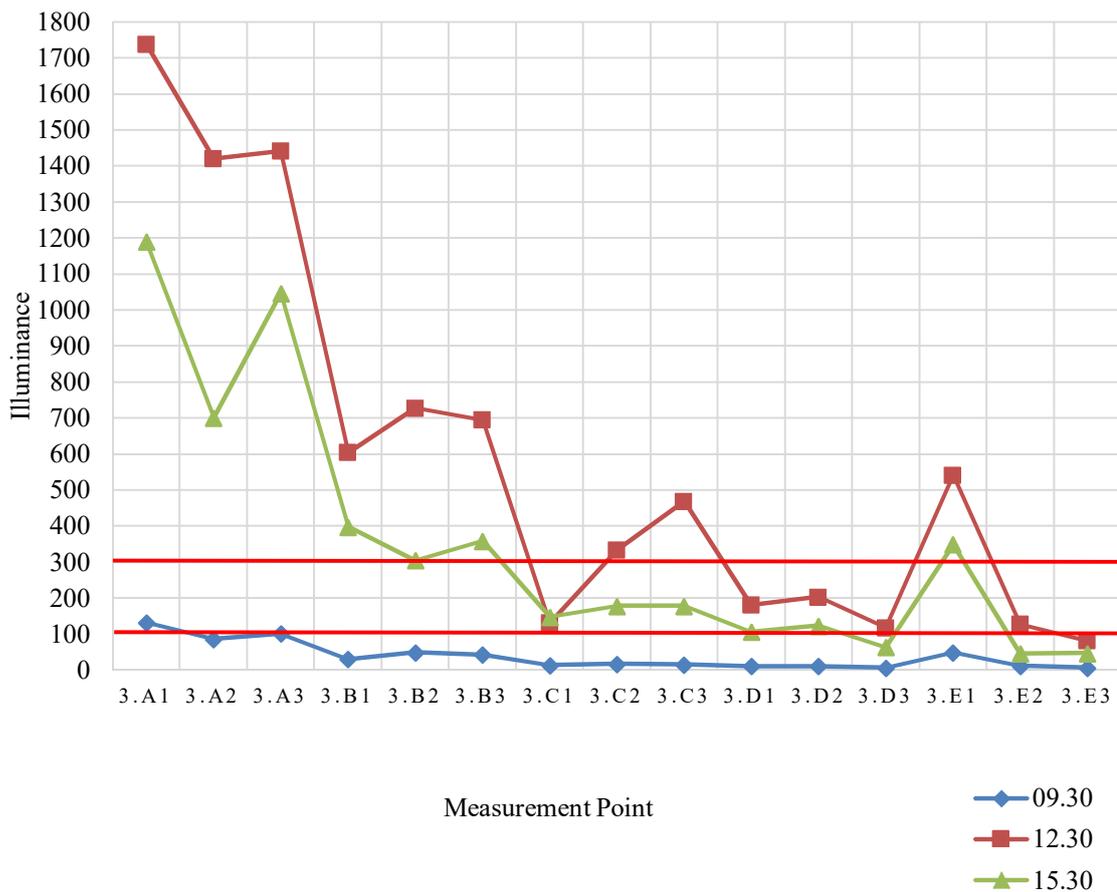
Figure 5.59. Measured interior illuminance (lux) (December 16, 2018)

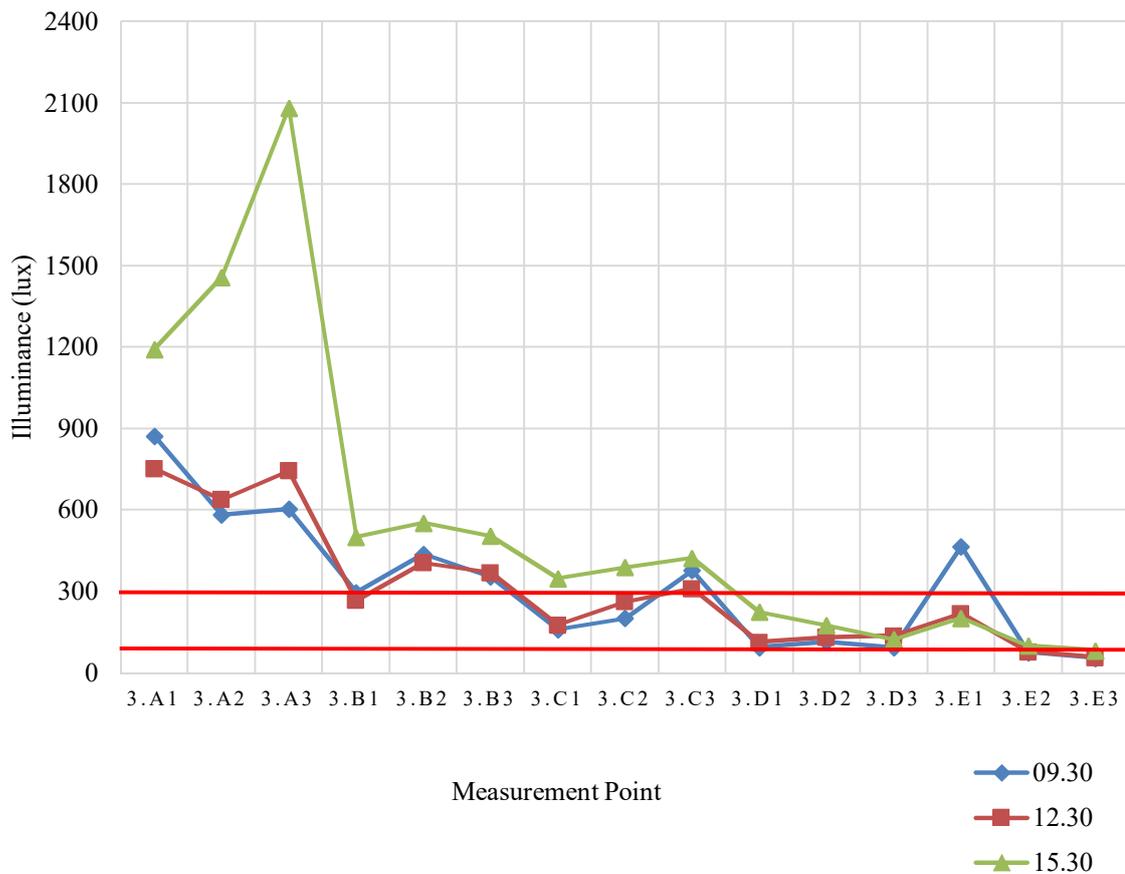
Figure 5.60. Measured interior illuminance (lux) (April 3, 2019)

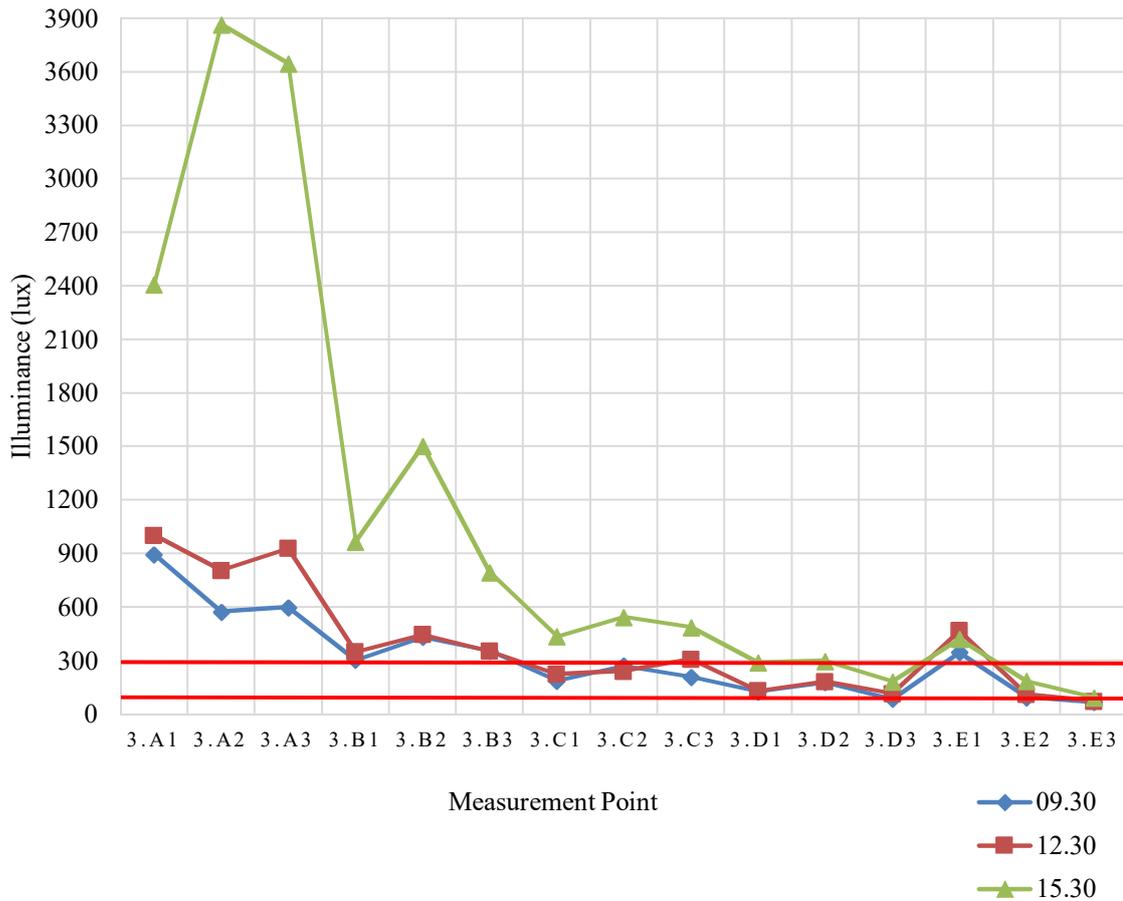
Figure 5.61. Measured interior illuminance (lux) (June 27, 2019)

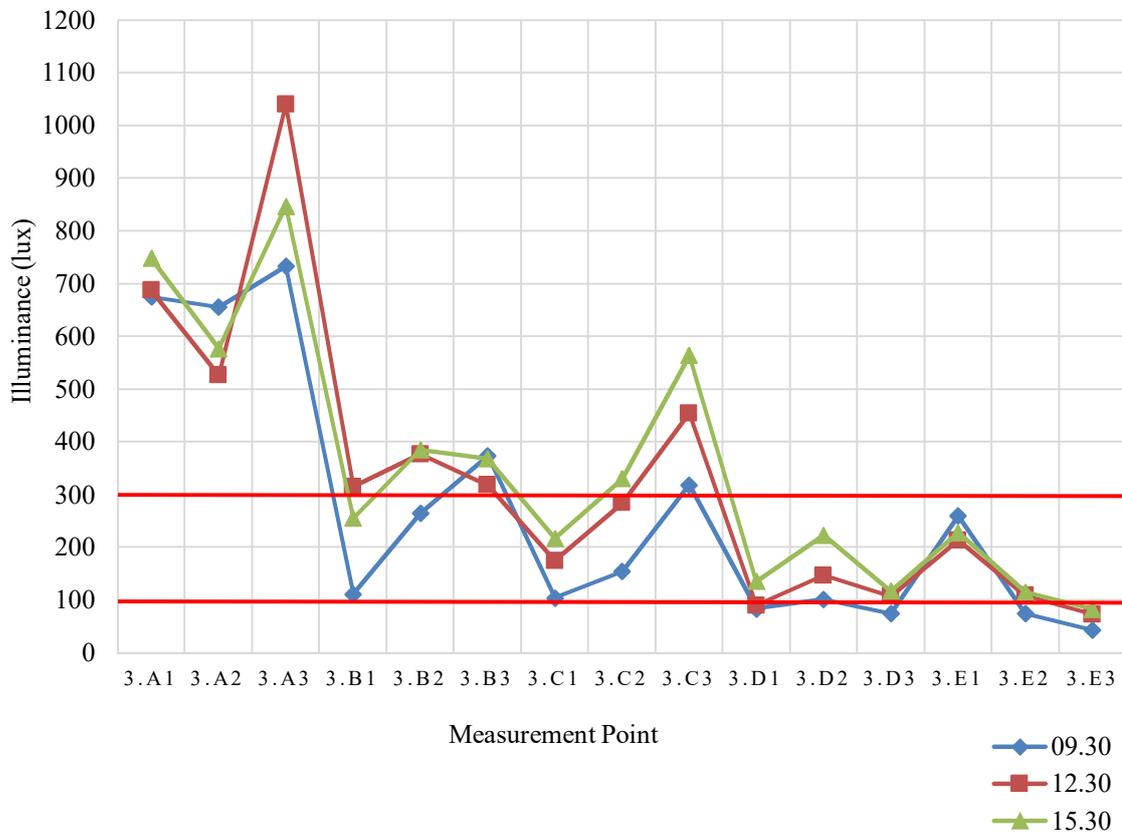
Figure 5.62. Measured interior illuminance (lux) (October 3, 2019).
