**EVALUATION OF WINDOW DESIGN AND
DAYLIGHT PERFORMANCE OF MAIN ROOM IN
KULA HOUSES**

**A Thesis Submitted to
the Graduate School of Engineering and Sciences of
İzmir Institute of Technology
in Partial Fulfillment of the Requirements for the Degree of**

in Architectural Restoration

**by
Cansu BATTAL**

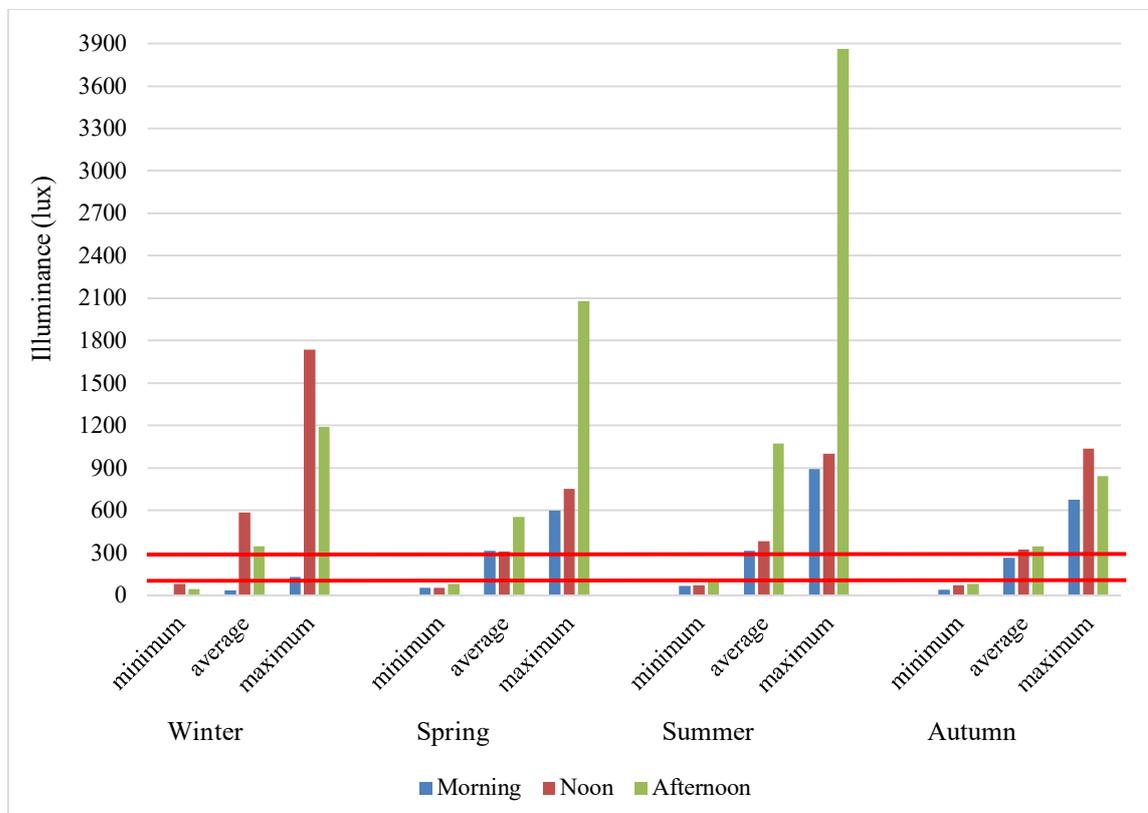
Figure 5.63. Illuminance (lux) of main room in Kestaneciler House.

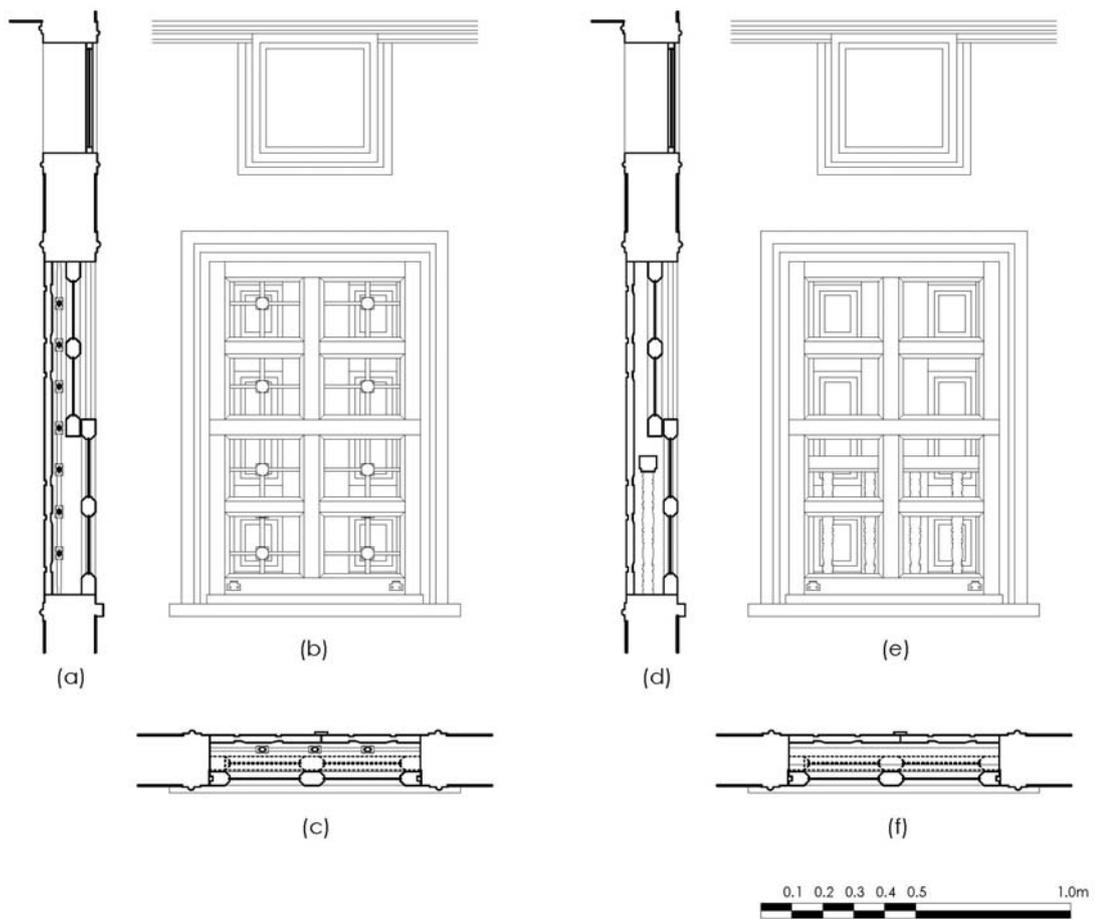
Figure 5.78. The rectangular window section with full rain (a), view (b), plan (c); the rectangular window section of half-rain (d), view (e), plan (f).

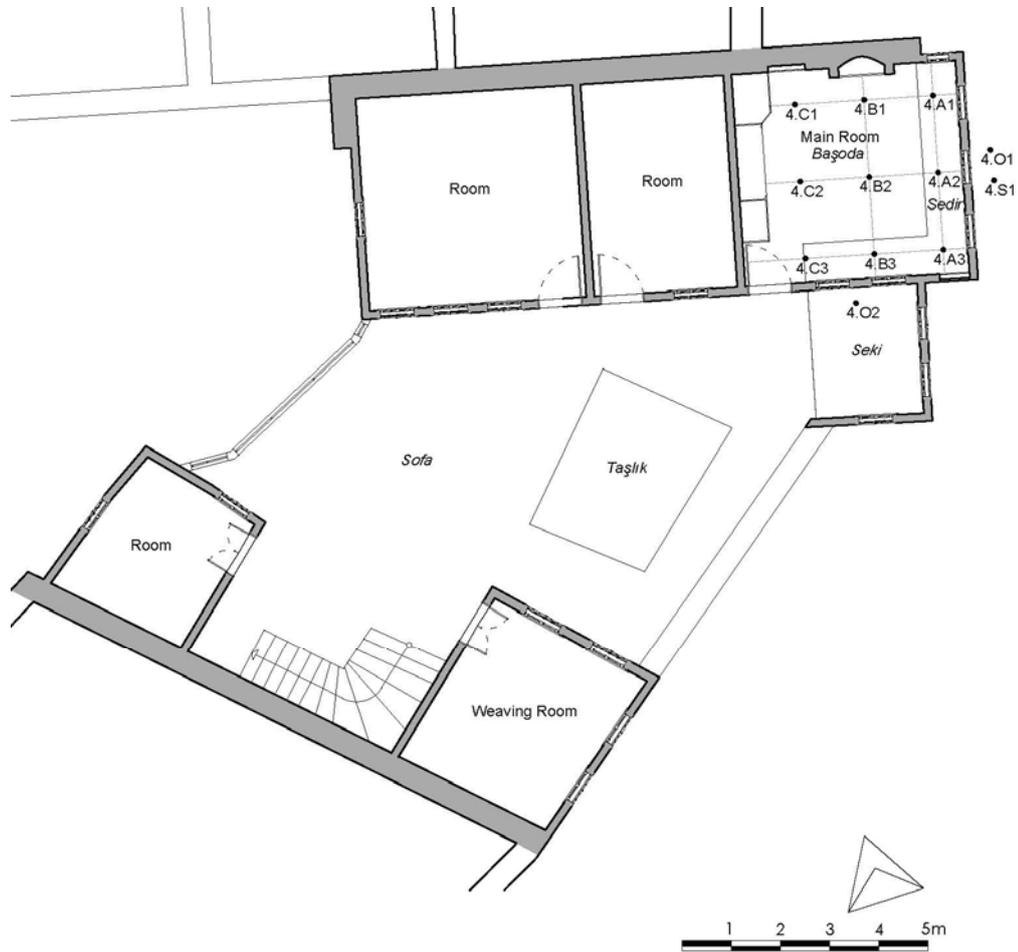
Figure 5.79. Measurement points for illuminance in the main room of Zühtü Bey House

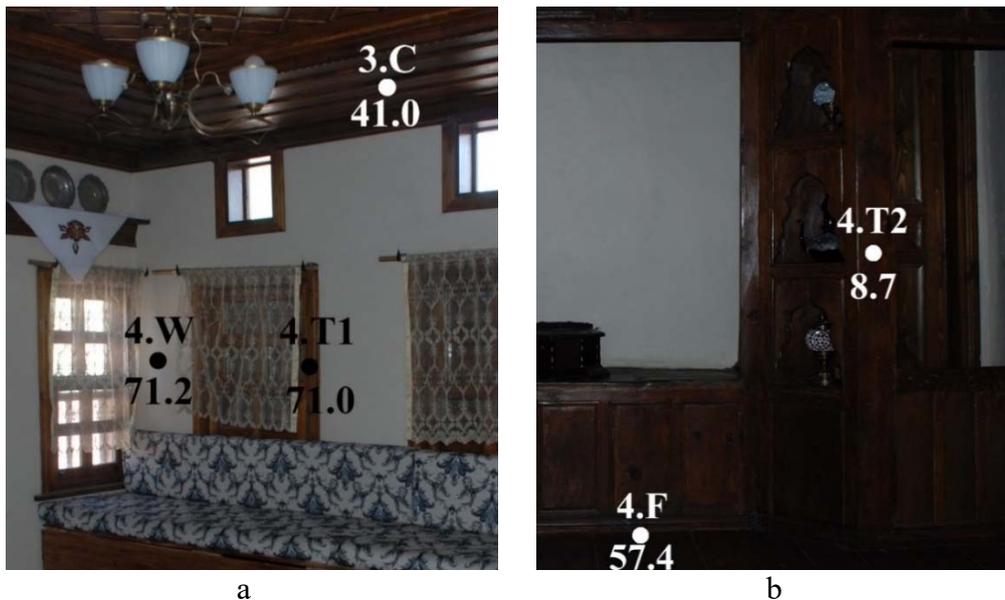
Figure 5.80. The surface reflectance at the measurement points in the main room of Zühtü Bey on the south wall (Prepared by Author, 15.10.2018) (a), on the west wall (Prepared by Author, 15.10.2018) (b)

To identify the materials forming the surfaces in the main room, luminance measurements were taken from the determined points (Table 3.1) by the luminance meter and on the determined dates (Table 3.2). The average of the reflectance was calculated using the formula (7) and is specified in Table 5.19. The percentages of surface material reflectance (p value) change between 8.7% and 71.2%. The white color of the wall causes p value to be higher (71.2%), the dark color of the wooden large cupboard for bedding provides reflectance to be lower (8.7%) (Figure 5.80).

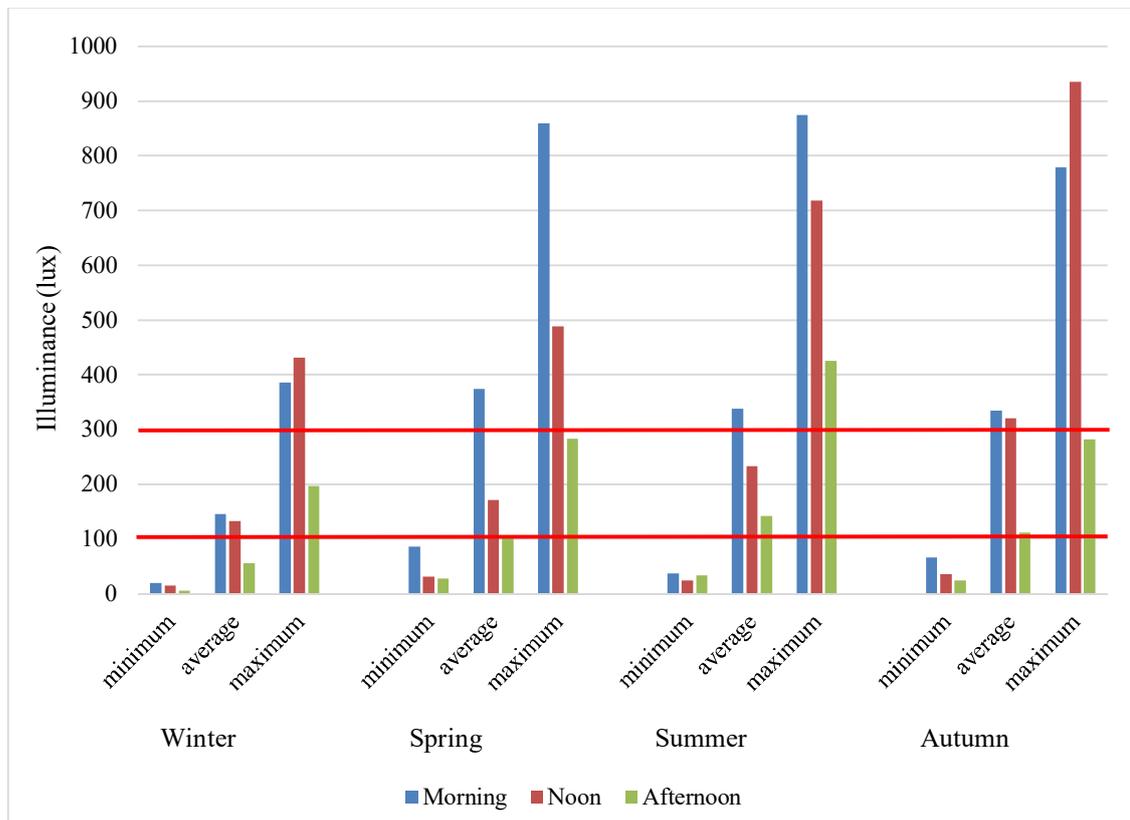
Figure 5.85. Illuminance of main room in Zühtü Bey House.

finishing material (4.W) is in cream tone and its reflection factor is high (p: 71.2). All of these are the main reasons that the daylight level is close to the standard value (300 lux). In the measurements taken from the *seki* (4.O2), it is observed that insufficient light is received from the semi-open space (from the south). In addition, the built-in cupboard located to the west of the south wall is thought to be in its original state, and its window to the south of the east wall has a top window like the others, but was later closed, which adversely affects daylight performance.

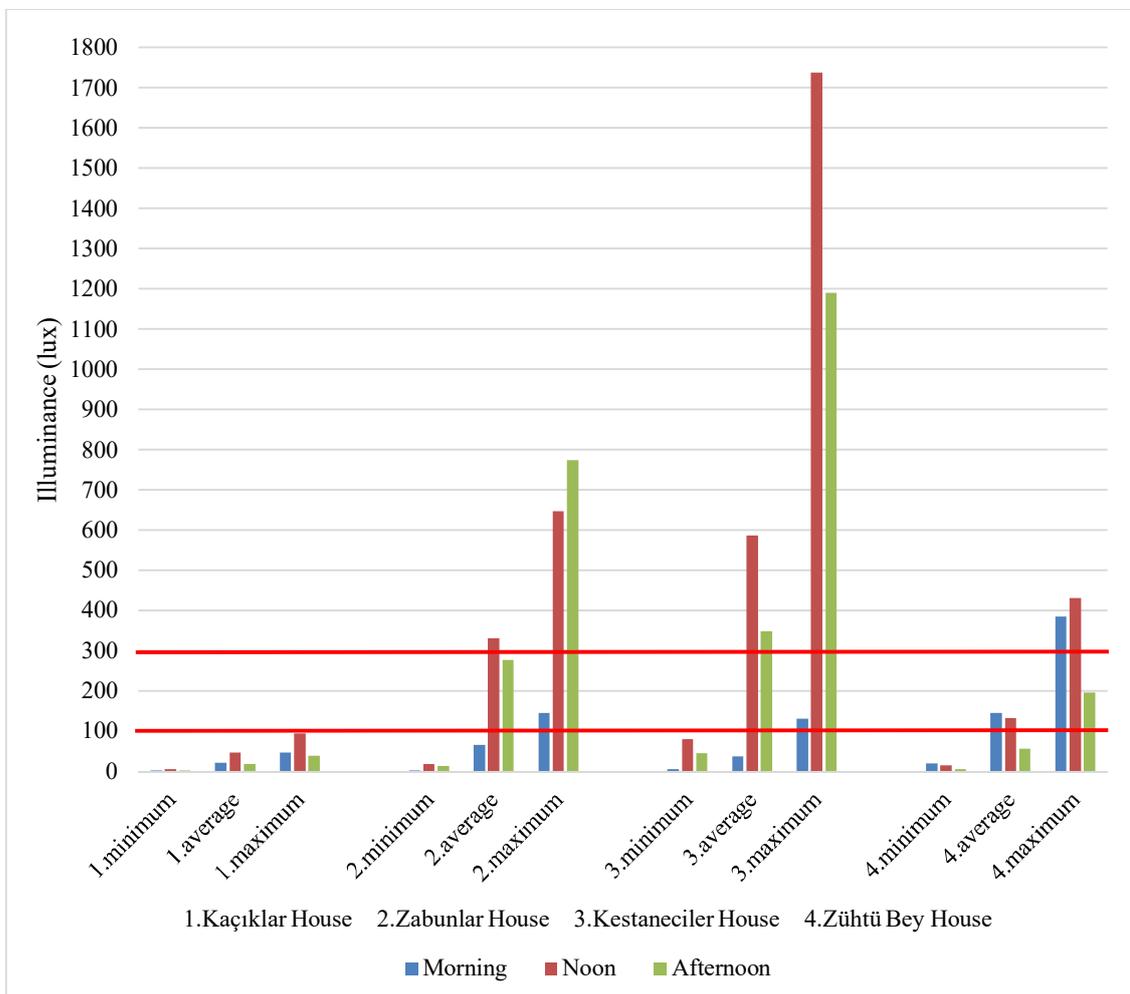
Figure 6.1. Minimum, average and maximum values of the measured houses according to the hours in the winter season

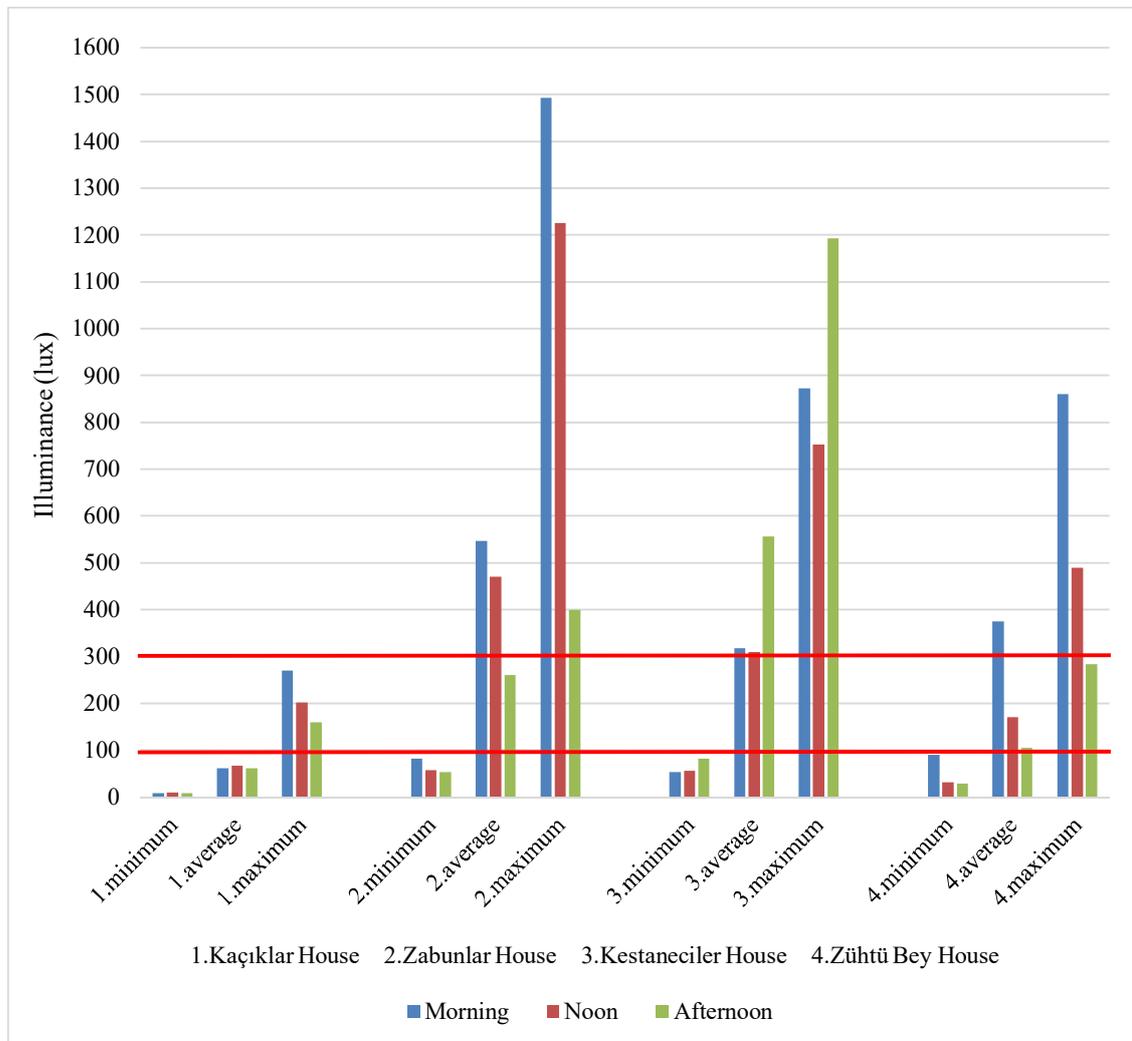
Figure 6.2. Minimum, average and maximum values of the measured houses according to the hours in the spring season

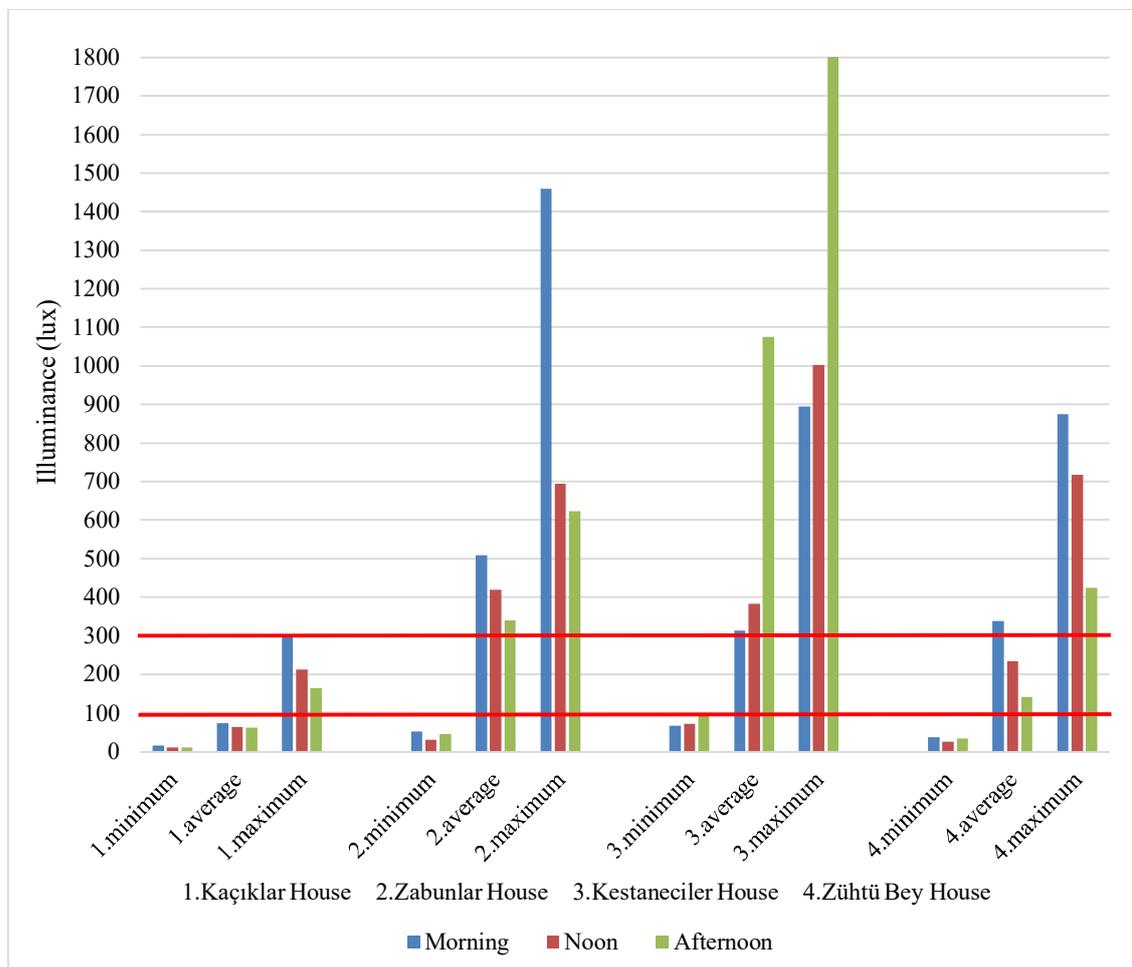
Figure 6.3. Minimum, average and maximum values of the measured houses according to the hours in the summer season

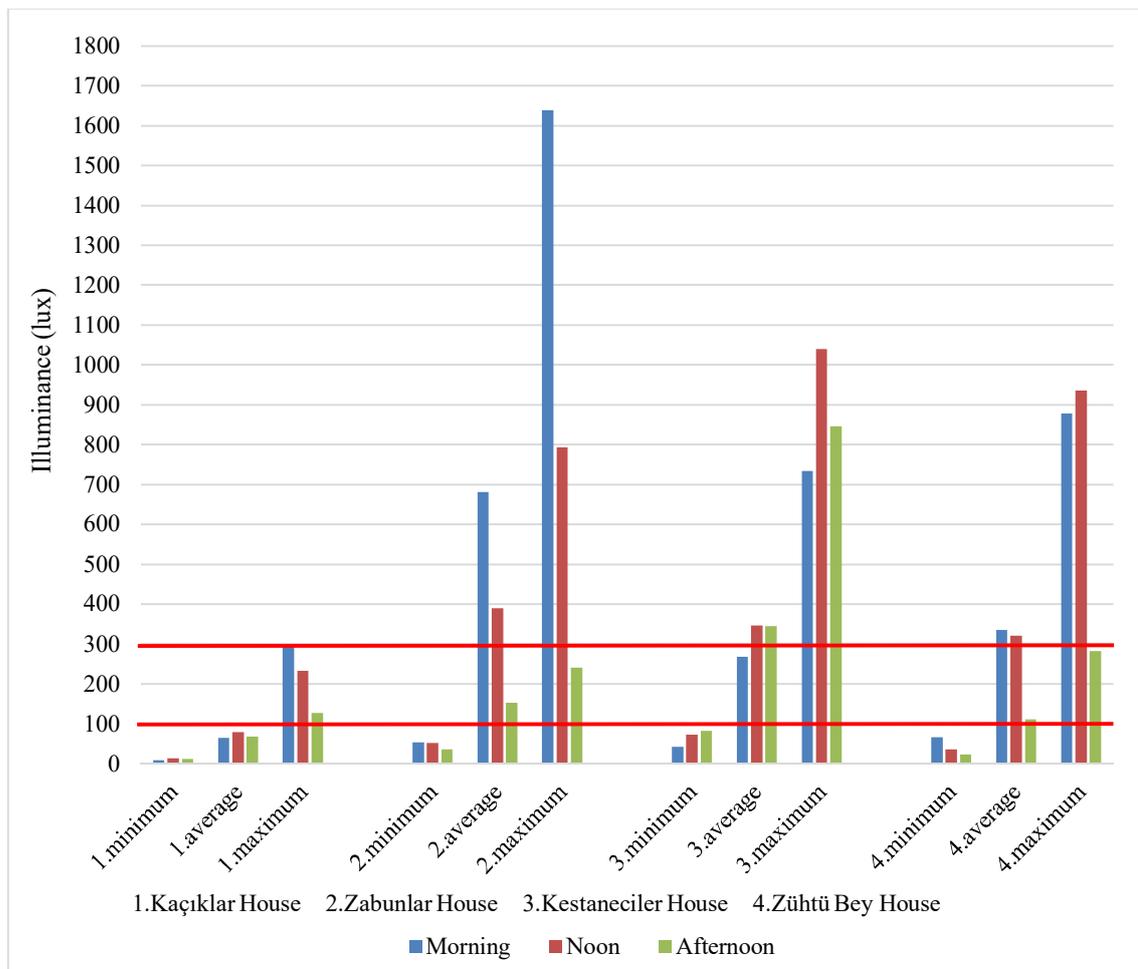
Figure 6.4. Minimum, average and maximum values of the measured houses according to the hours in the autumn season
