**EXPERIMENTAL AND NUMERICAL  
INVESTIGATION OF PIPING IN UNIFORM  
EMBANKMENT DAM WITH WEAK LAYER AT  
THE UPPER REGION**

**A Thesis Submitted to  
the Graduate School of Engineering and Sciences of  
İzmir Institute of Technology  
in Partial Fulfillment of the Requirements for the Degree of**

**MASTER OF SCIENCE**

**in Civil Engineering**

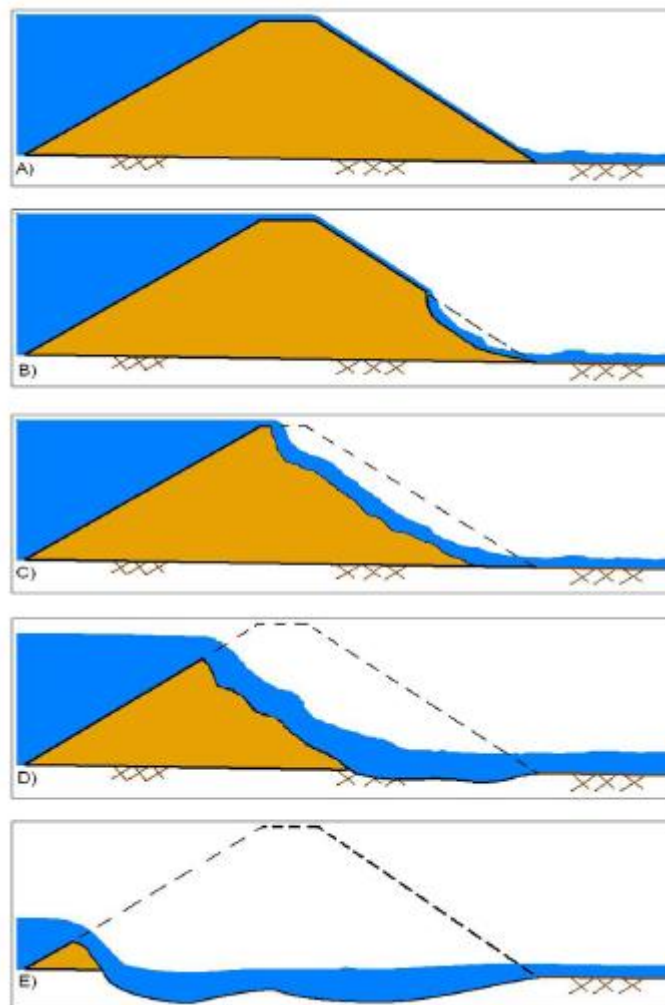
According to the TD-39 report of the U.S. Army Corps of Engineers (Brunner 2014), Figure 3.2 represents the overtopping process; the downstream side will be exposed to headcut erosion during overtopping failure as shown in Figure 3.2 (A). A broad-crested weir behaviour is observed during the water flowing over the crest level and the headcut will expand by eroding backward and to the dam center where displayed in Figure 3.2 (B), Figure 3.2 (C) shows when the headcut arrives crest level, Figure 3.2 (D) demonstrates loss of upstream crest where a sharp-crested weir behaviour can be observed, then, erosion will proceed throughout the dam (Figure 3.2 (E)).

Figure 3.2. Breach process of overtopping failure (Source: Training Document No.39 report of U.S. Army Corps of Engineers (Brunner 2014))

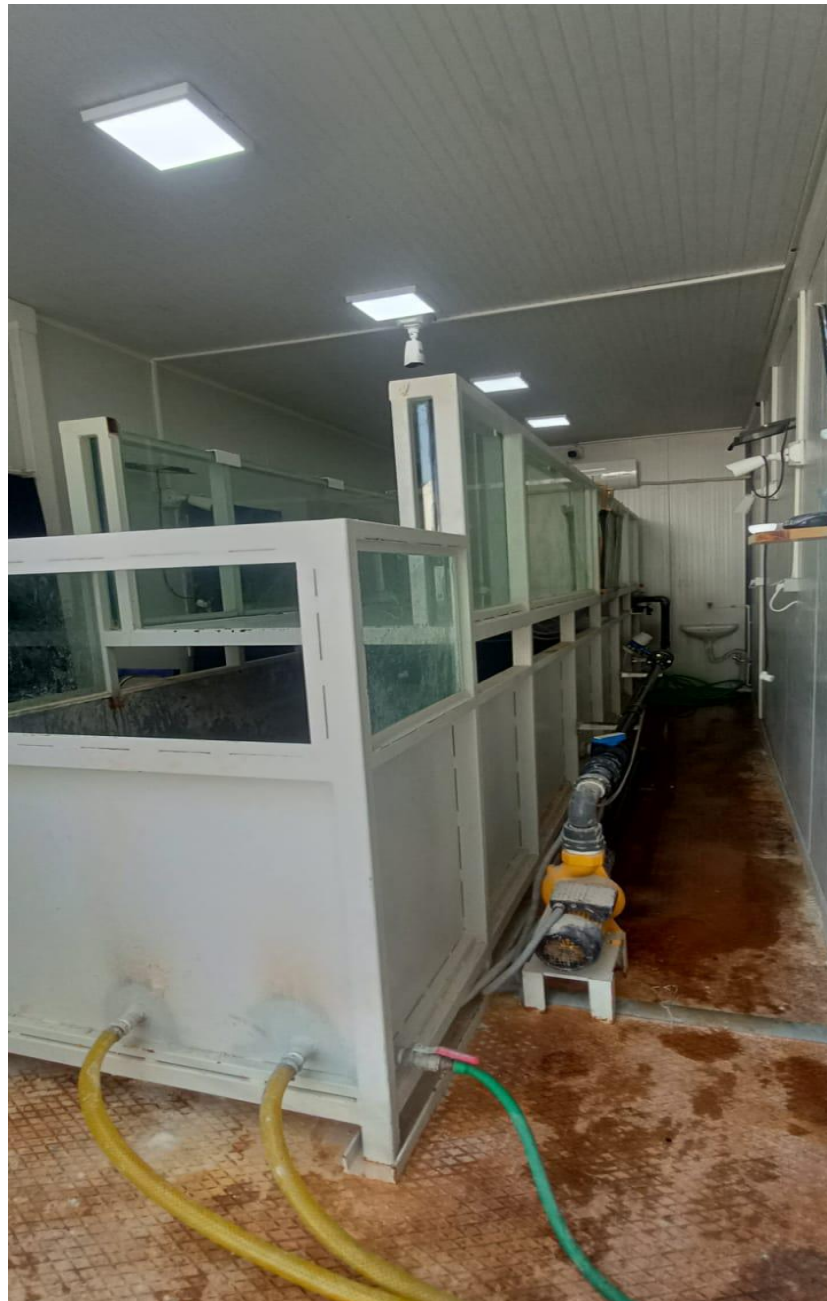
To adjust the flow from the pump to the flume, a control valve is used. A flow straightener was assembled during the production of the flume on the upstream side to make a smooth flow and decrease turbulence. The flowrate was measured by a magnetic flowmeter. To adjust the water level, an electromagnetic sensor was attached which starts and stops the pump when water depths in the channel were 0.540 m and 0.555 m, respectively. Grid lines were arranged on the side glasses with 1-cm grid interval.

Figure 4.2. Experimental Flume

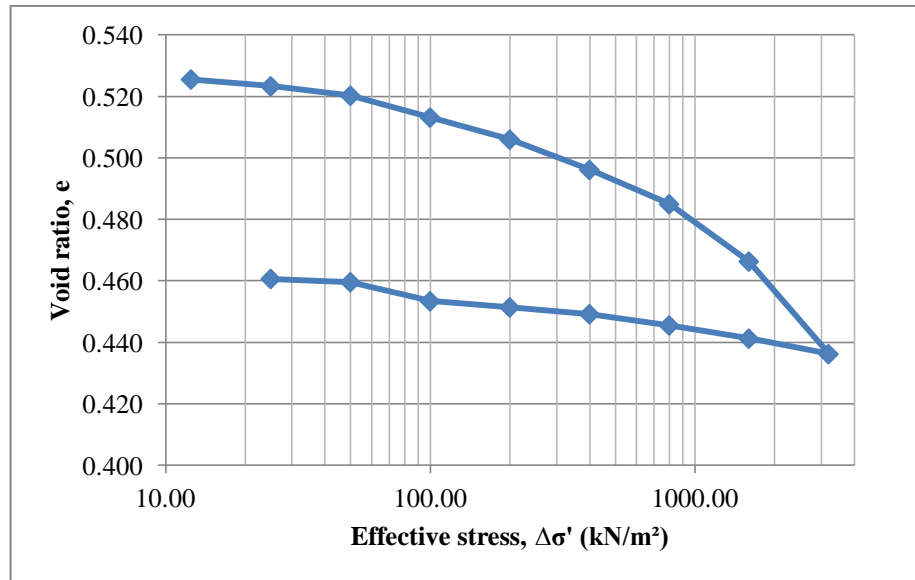
According to the consolidation test results (Figure 4.8), the compression index ( $C_c$ ), recompression index ( $C_r$ ) and, swelling index ( $C_s$ ) were found to be 0.100, 0.009, and 0.007, respectively. The oedometric modulus of deformation ( $E_{\text{oed}}$ ) was obtained as 35714 kN/m<sup>2</sup> (Figure 4.9).

Figure 4.8. Compressibility curve

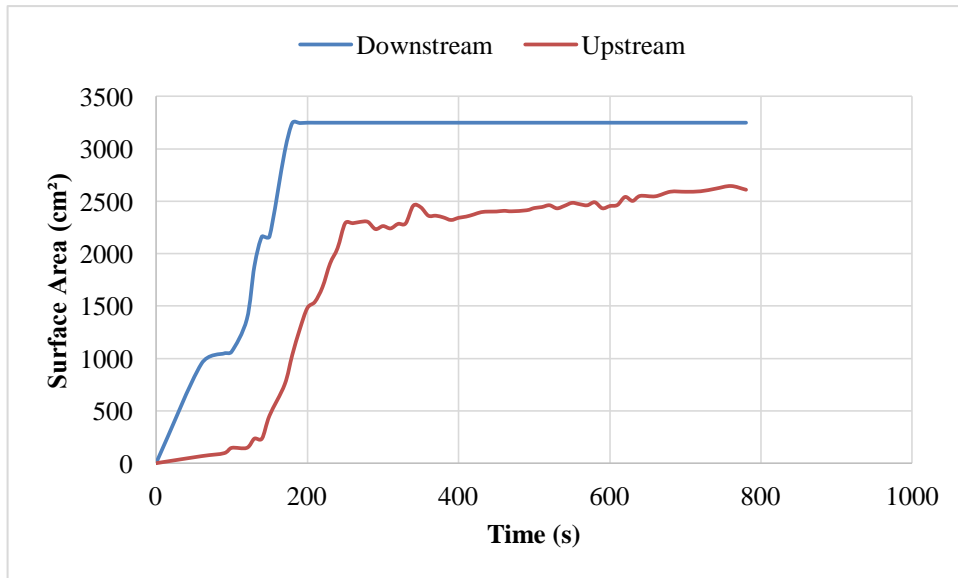
The temporal variations of the breach area at downstream and upstream are shown in the Figure 7.13.

Figure 7.13. Temporal variations of the breach area at downstream and upstream
