**INVESTIGATION OF THE INDOOR  
MICROCLIMATE OF HISTORIC AGIOS  
VOUKOLOS (*AZİZ VUKOLOS*) CHURCH IN İZMİR  
TO DETERMINE AND IMPROVE THERMAL  
COMFORT CONDITIONS**

**A Thesis Submitted to  
the Graduate School of Engineering and Sciences of  
İzmir Institute of Technology  
in Partial Fulfillment of the Requirements for the Degree of**

**in Architectural Restoration**

**by  
Damla AKIN YALÇIN**

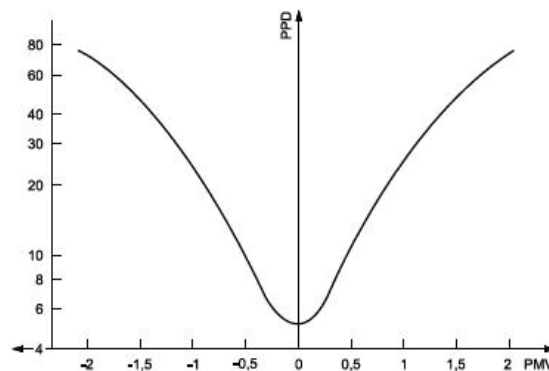
Figure 2.1. Relation between PMV and PPD (Source: ISO, 2005)

The Predicted Percentage Dissatisfied (PPD) is an index that estimates the percentage of thermally dissatisfied occupants who feel extremely hot or extremely cold. Thermally dissatisfied people are those who voted hot, warm, cool or cold on the 7-point thermal sensation scale given in Table 2.1 (ISO, 2005). The relation between PMV and PPD is shown in Figure 2.1.

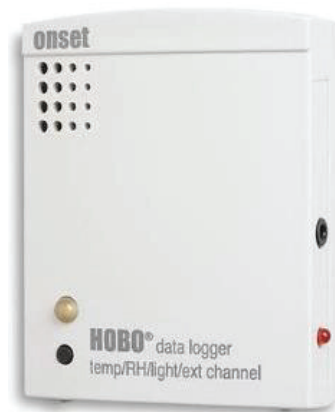
Figure 3.1. HOBO U12-012 data logger device (Source: Onset, 2019)

The measurements were carried out with data logger devices that measure air temperature and relative humidity, which are shown in Figure 3.1 and whose properties are given in Table 3.1.

<b>Measuring Range</b>	
Air Temperature:	-20 °C – 70 °C
Relative Humidity:	5% - 95%
<b>Accuracy</b>	
Air Temperature:	Between 0°C – 50°C, ± 0.35°C
Relative Humidity:	Between 10% - 90%, ± %2.5

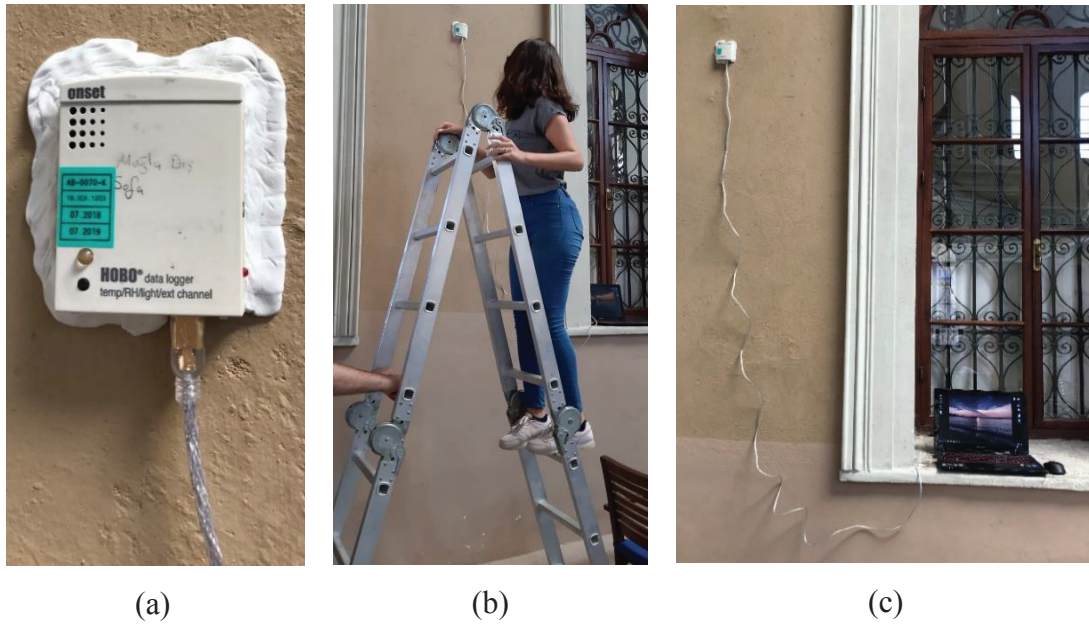
Figure 3.4. Data transfer from data logger No. 2 to digital environment (07.08.2019), a) Data logger No. 2, b) Attaching a connecting cable to the device, c) Data transfer

Measurements were made between 9 July 2019 – 22 May 2020, covering all seasons, and the measurement values were recorded with a 10-minute cycle. The data were transferred from the devices to the electronic environment with the HOBOWare software using the connection cable.

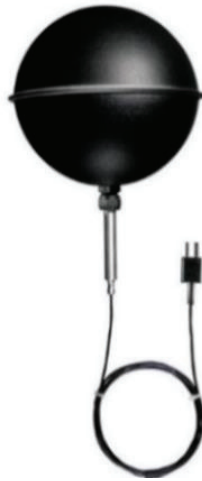
Figure 3.5. Globe thermometer probe measuring mean radiant temperature (Source: Testo, 2004)

The globe thermometer probe was placed in the middle of the cross plan, taking into account the positions of the seating units, and at a height of 90 cm relative to the seated individual, as seen in Figure 3.7. Also care was taken not to be exposed to direct sunlight. Measurements were conducted every fifteen days and at event times, covering all seasons, and the measurement values were recorded with a 2-minute cycle. During the events, continuous measurements could not be conducted in terms of the safety of the devices.

<b>Mean Radiant Temperature</b>	
Measuring Range	0 °C – 120 °C
Accuracy	Between 0 °C – 49.9 °C, ± 0.5°C Between 50°C – 120°C, ± 1°C

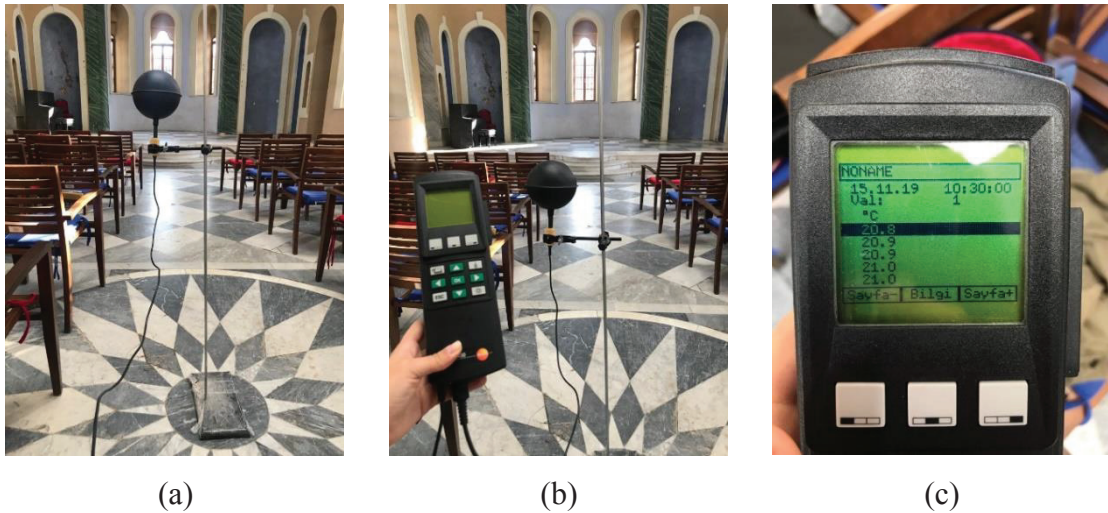
Figure 3.7. Mean radiant temperature measurement with a globe thermometer (15.11.2019), a) Placement of the globe thermometer in the space, b) Mean radiant temperature measurement setting, c) Testo 400, which records and displays the values

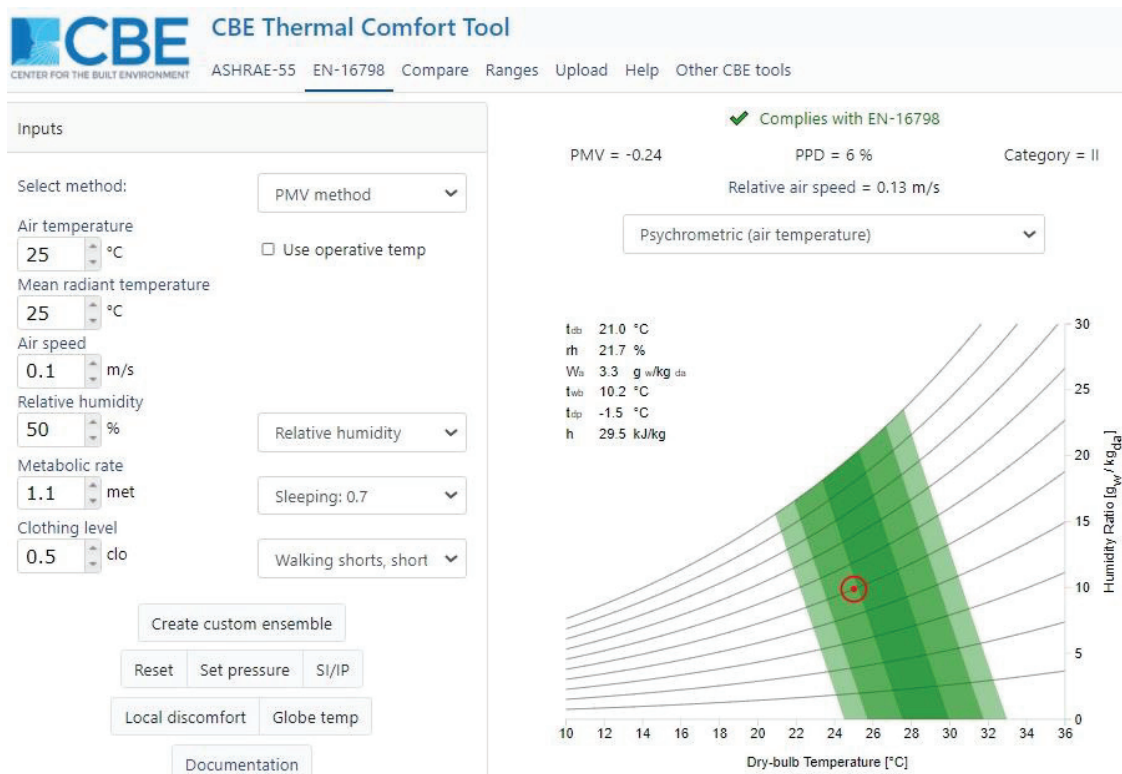
Figure 3.10. Model making PMV-PPD calculations based on EN 16798-1 (Source: Tartarini et al., 2020)

Predicted Mean Vote (PMV) – Predicted Percentage Dissatisfied (PPD) calculations for thermal comfort analysis were made by using CBE Thermal Comfort Tool according to the EN 16798-1. This tool was created by University of California, Berkeley (Figure 3.10).

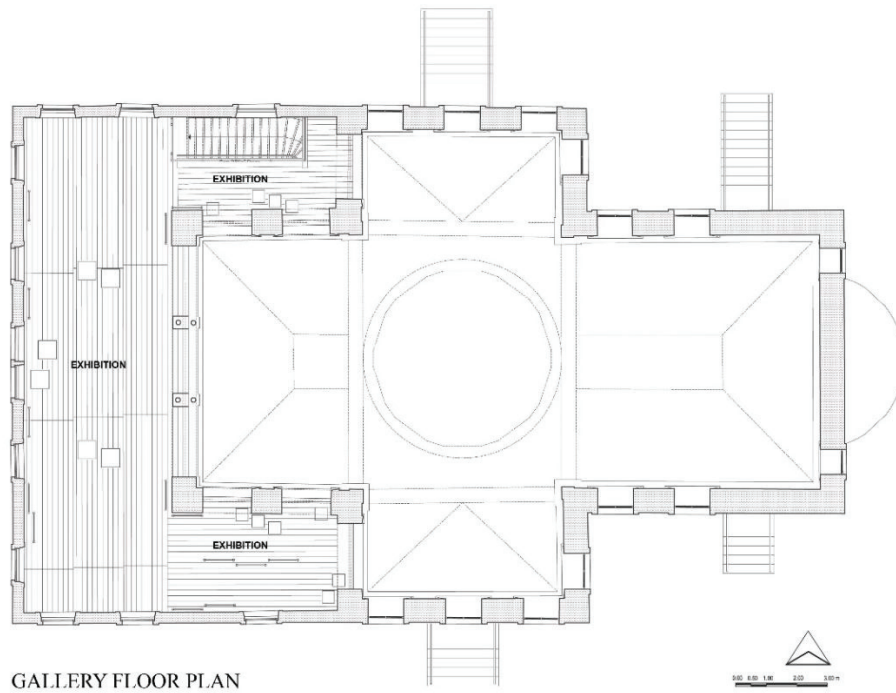
GALLERY FLOOR PLAN

Figure 4.5. Gallery floor plan  
(Source: Yardim et al., 2004-2007)

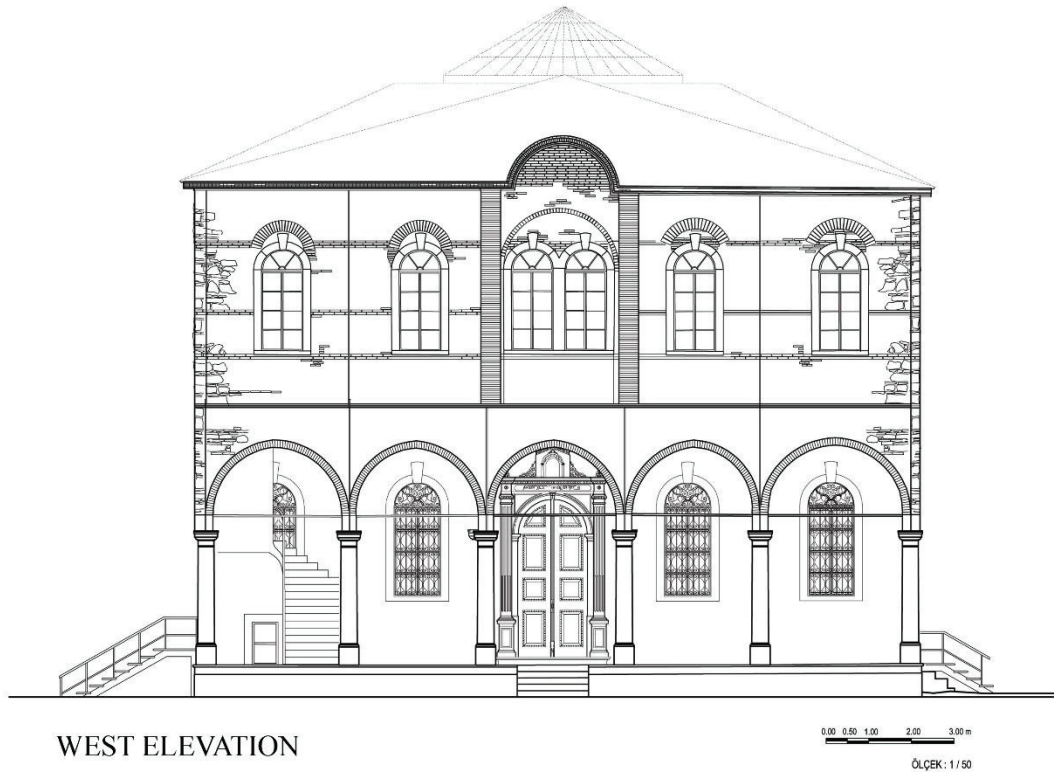
Figure 4.12. West elevation  
(Source: Yardım et al., 2004-2007)

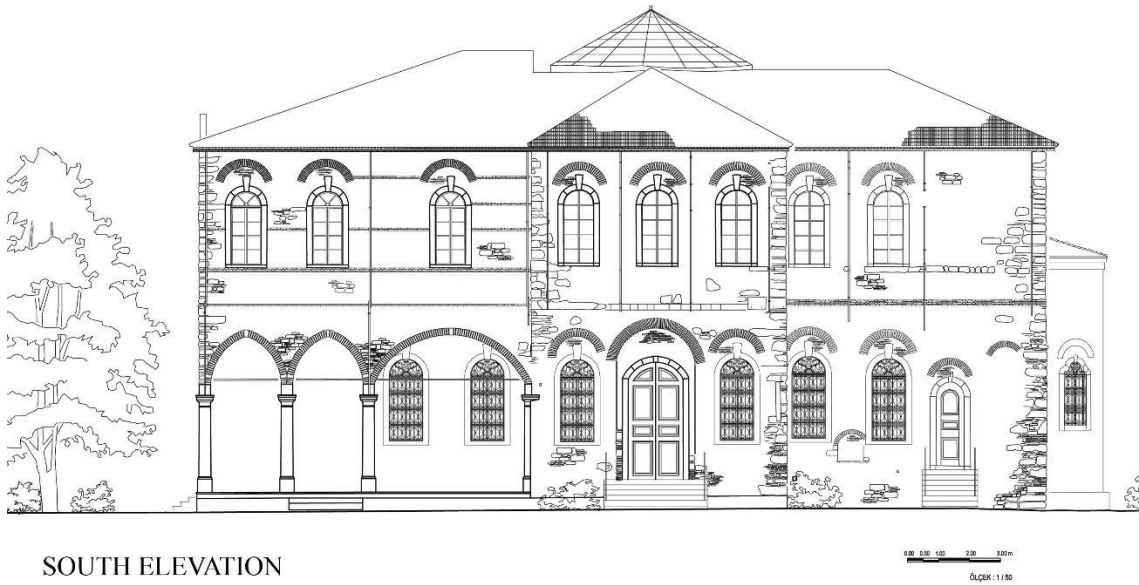
Figure 4.13. South elevation  
(Source: Yardım et al., 2004-2007)

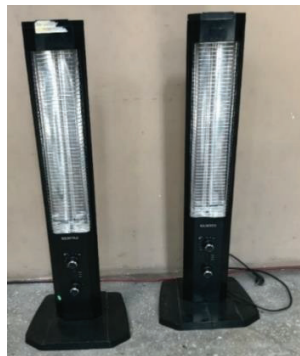
Figure 4.15. Electric radiant heaters used during events in the church (14.01.2020)

Considering that there is no heating-cooling system in the church, a new heating-cooling system was not recommended in the intervention decisions. During events in the church, which is used as a Culture and Art Center, four 900 or 1800 W electric radiant heaters are used in the winter (Figure 4.15), and cooling is provided by keeping the windows open during the summer. Within the scope of the study, this situation was examined with both measurements and surveys studies.

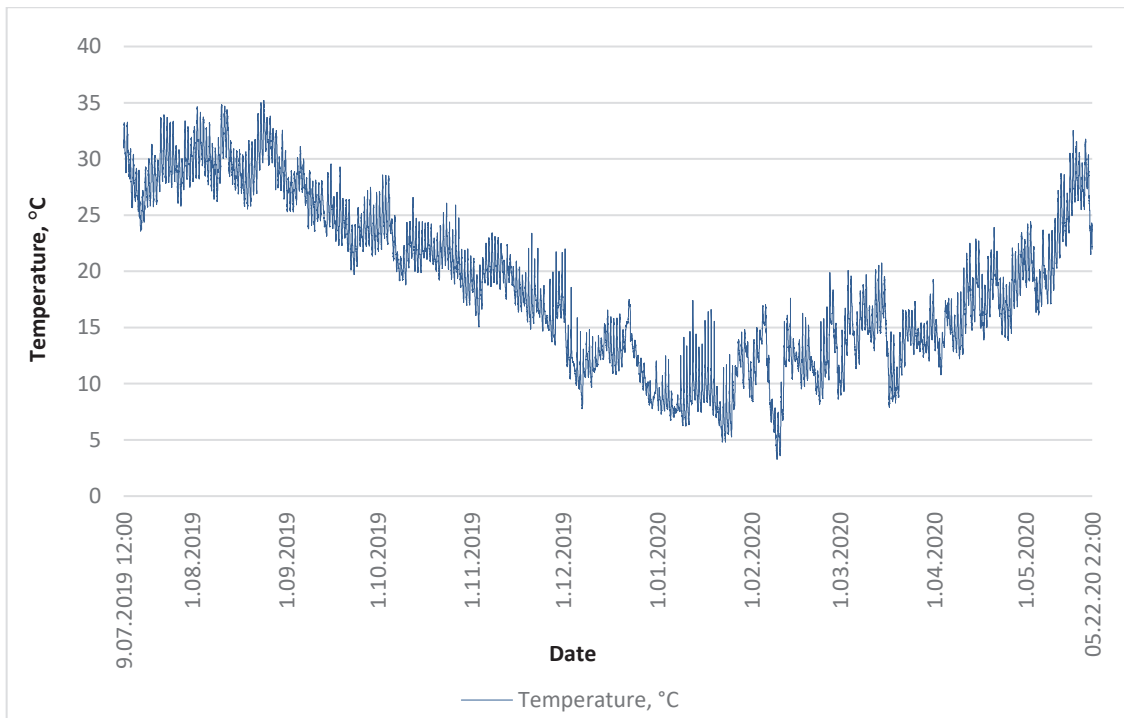
Figure 5.1. Hourly outdoor air temperature values of data logger No. 1 during the year

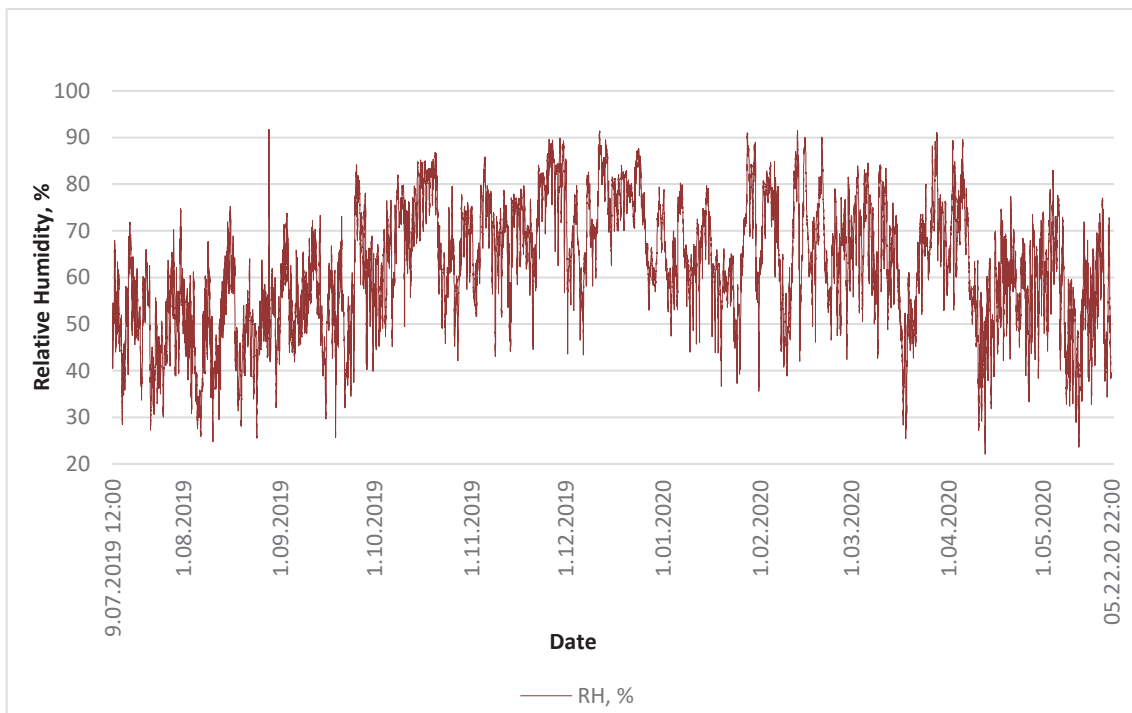
Figure 5.2. Hourly outdoor relative humidity values of data logger No. 1 during the year

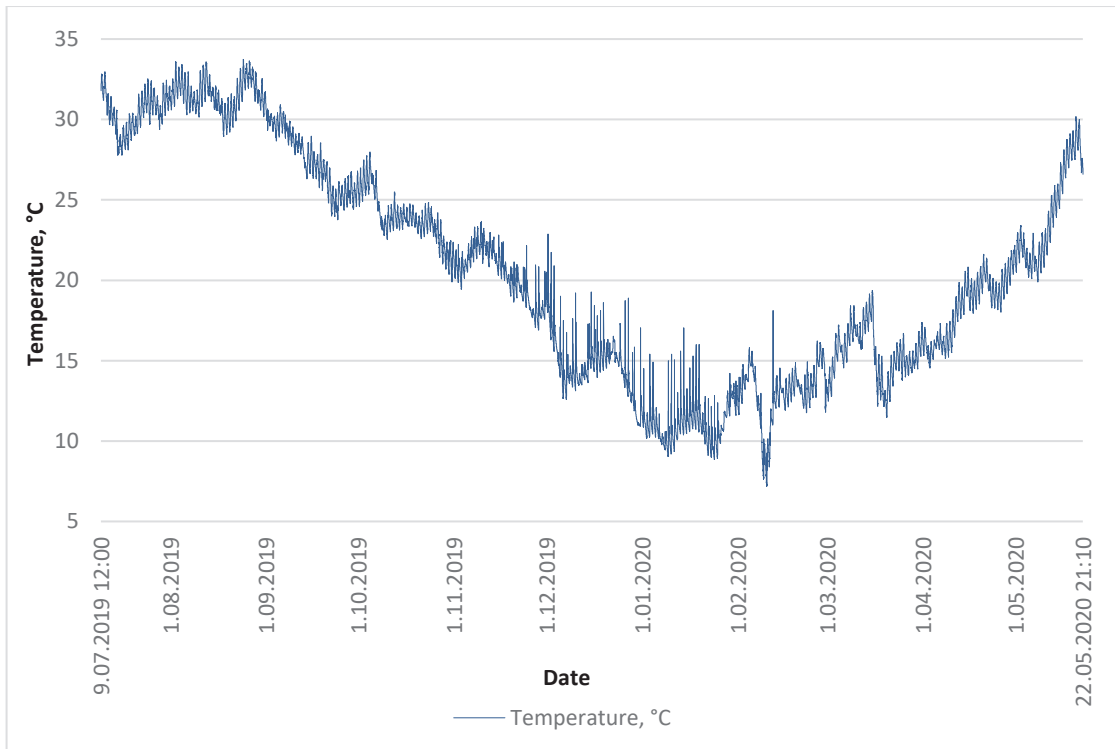
Figure 5.3. Hourly air temperature values of data logger No. 2 during the year

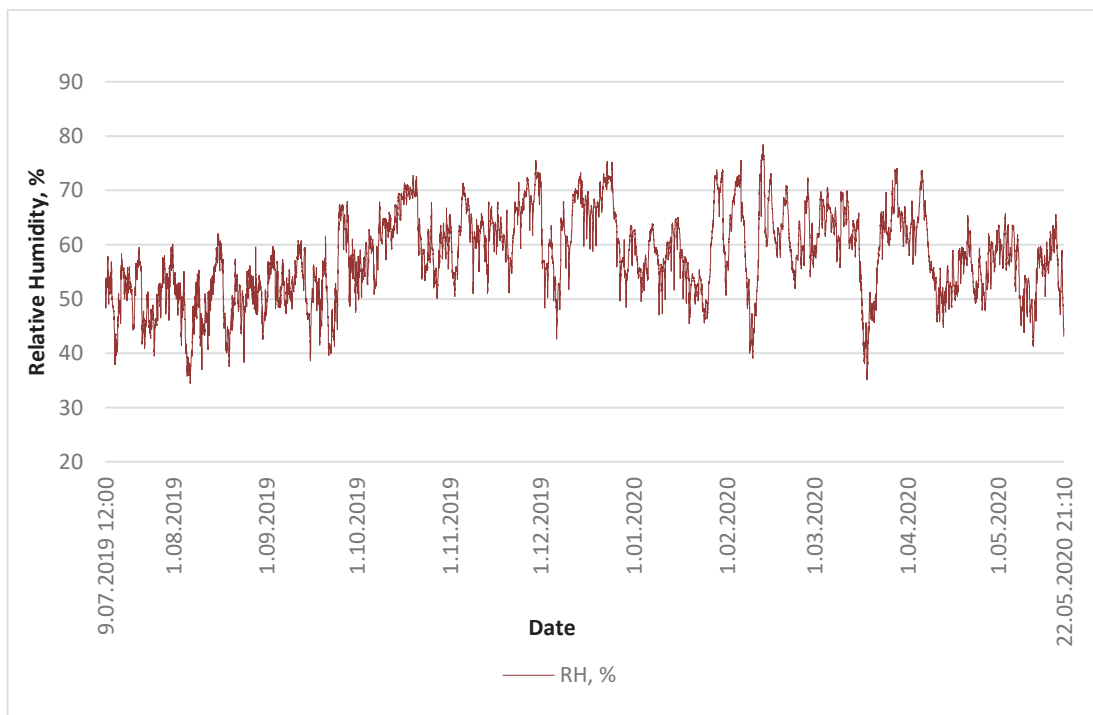
Figure 5.4. Hourly relative humidity values of data logger No. 2 during the year

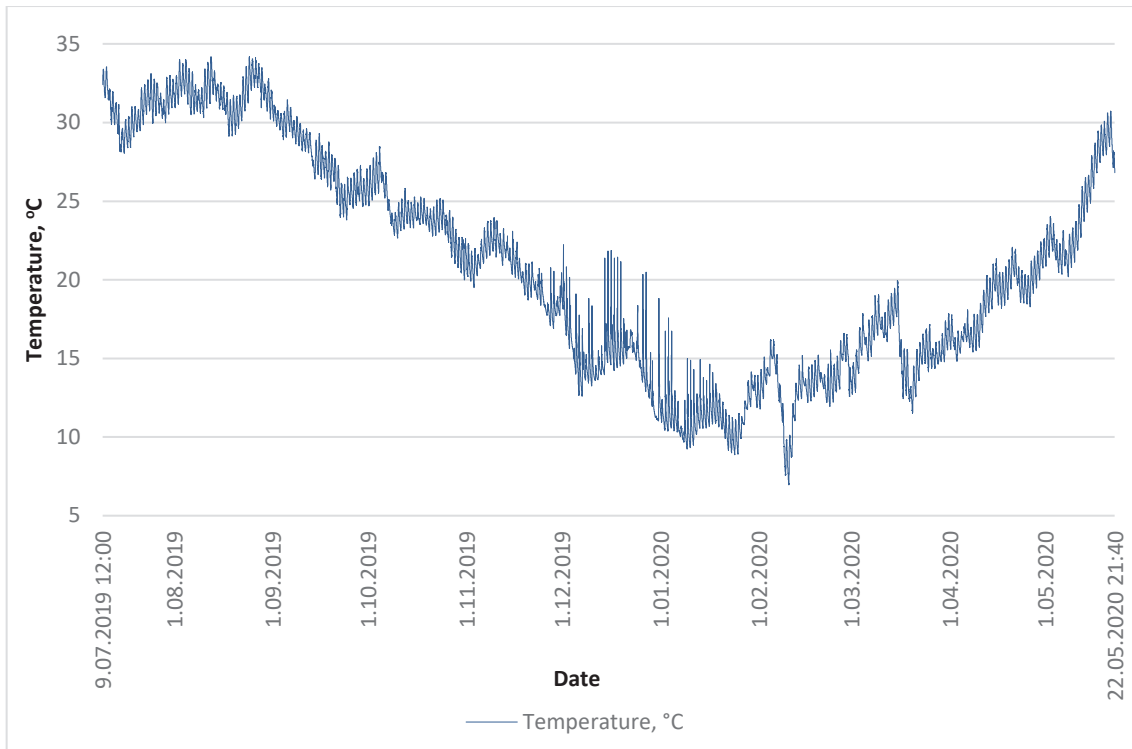
Figure 5.5. Hourly air temperature values of data logger No. 3 during the year

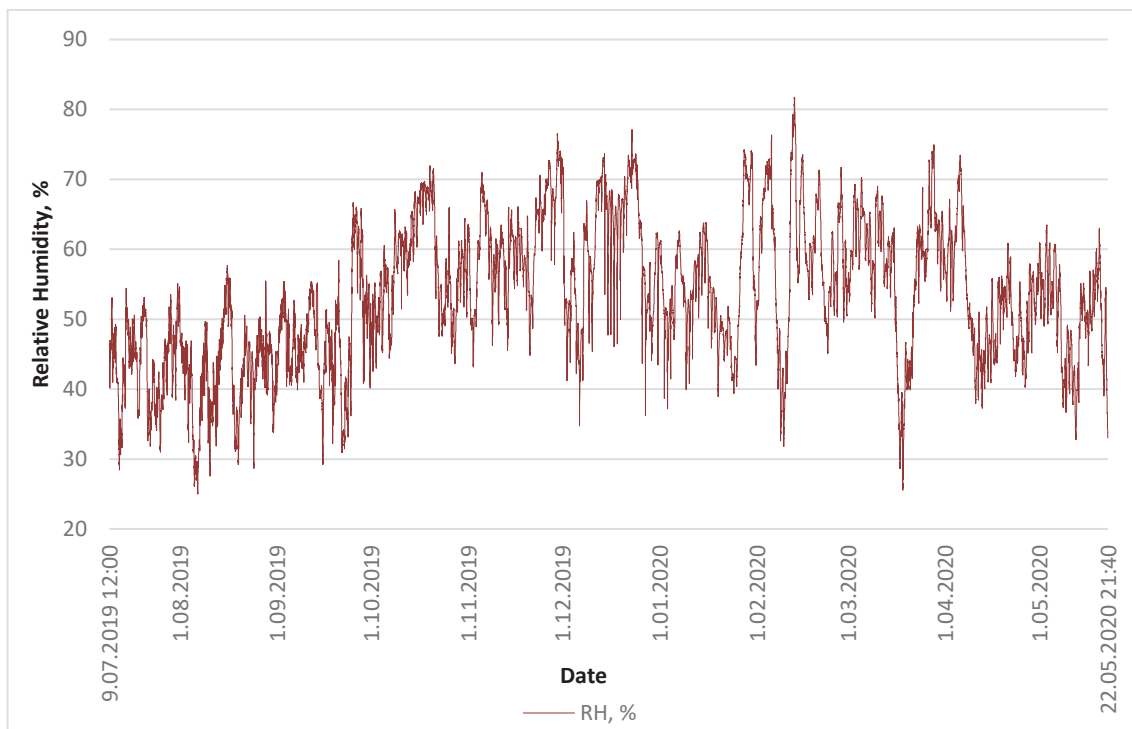
Figure 5.6. Hourly relative humidity values of data logger No. 3 during the year

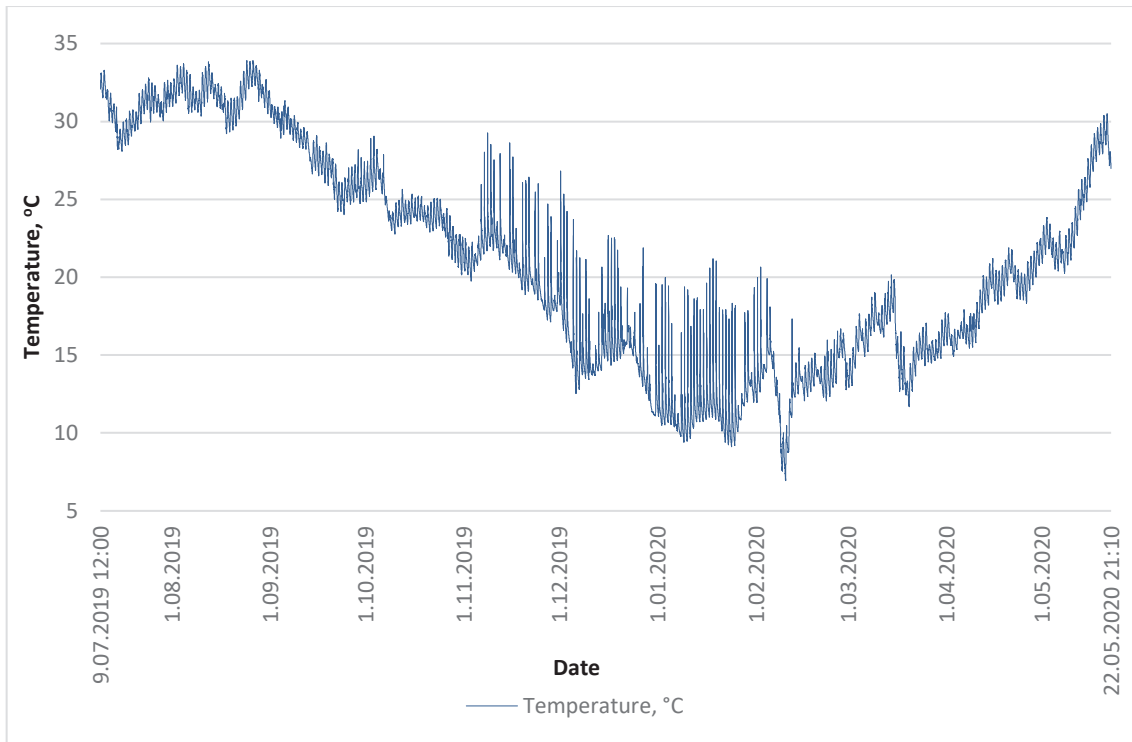
Figure 5.7. Hourly air temperature values of data logger No. 4 during the year

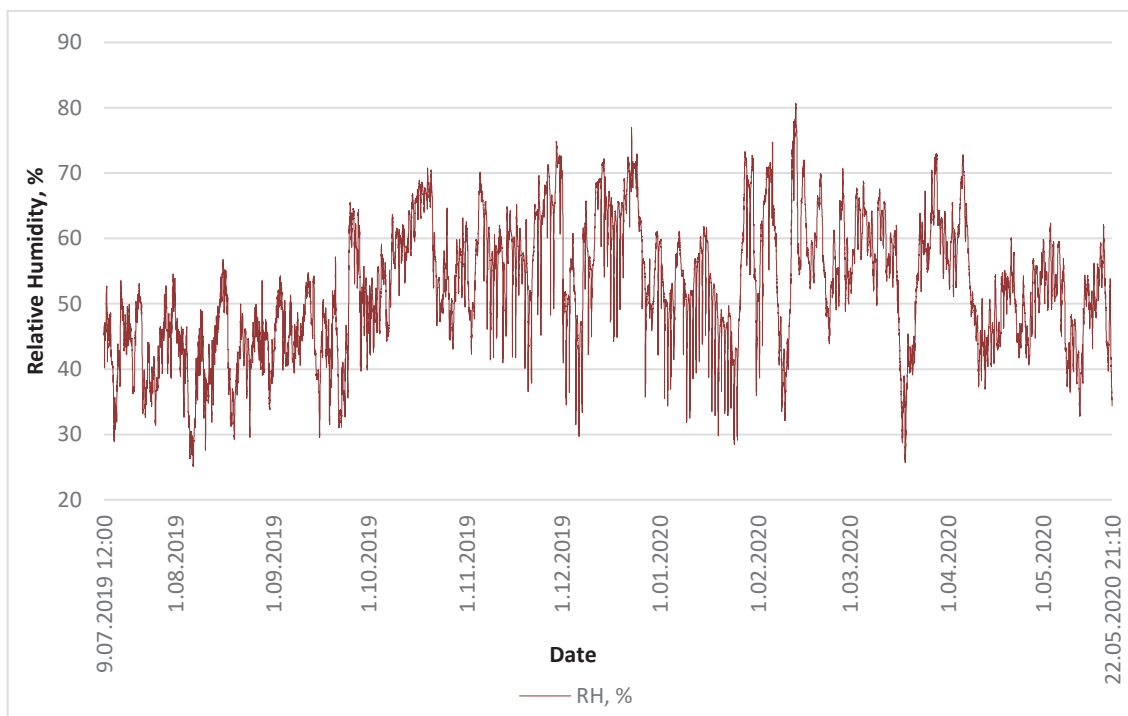
Figure 5.8. Hourly relative humidity values of data logger No. 4 during the year

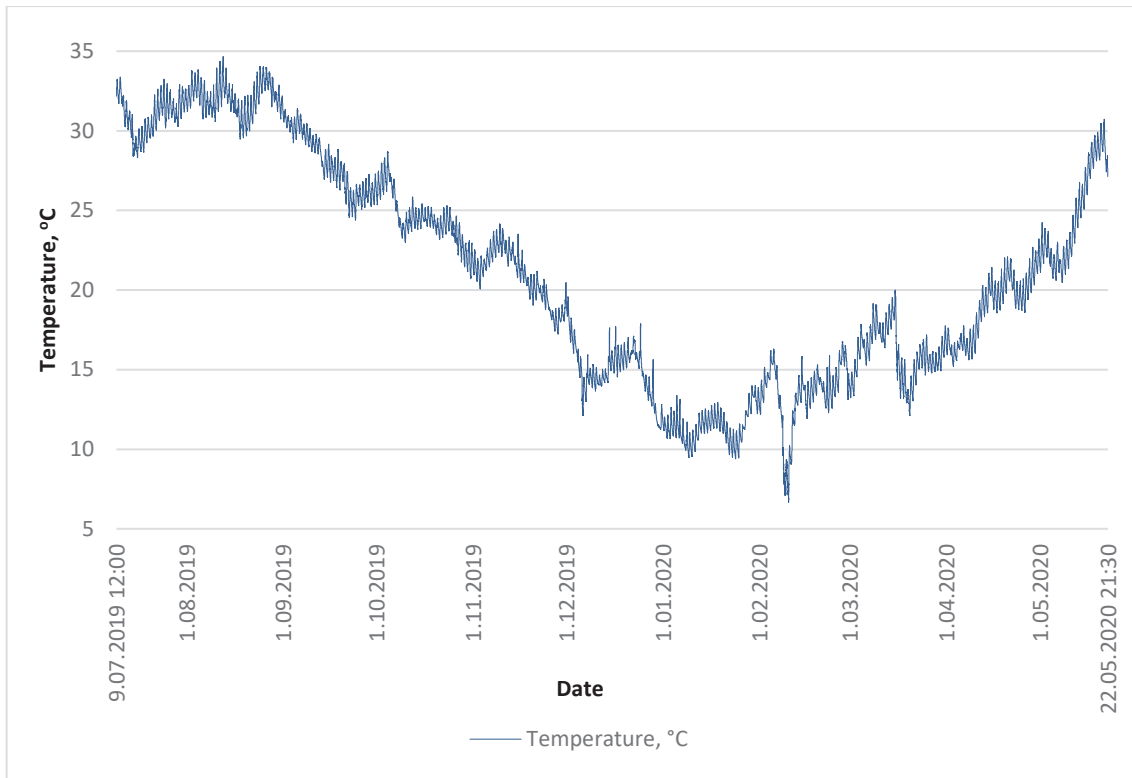
Figure 5.9. Hourly air temperature values of data logger No. 5 during the year

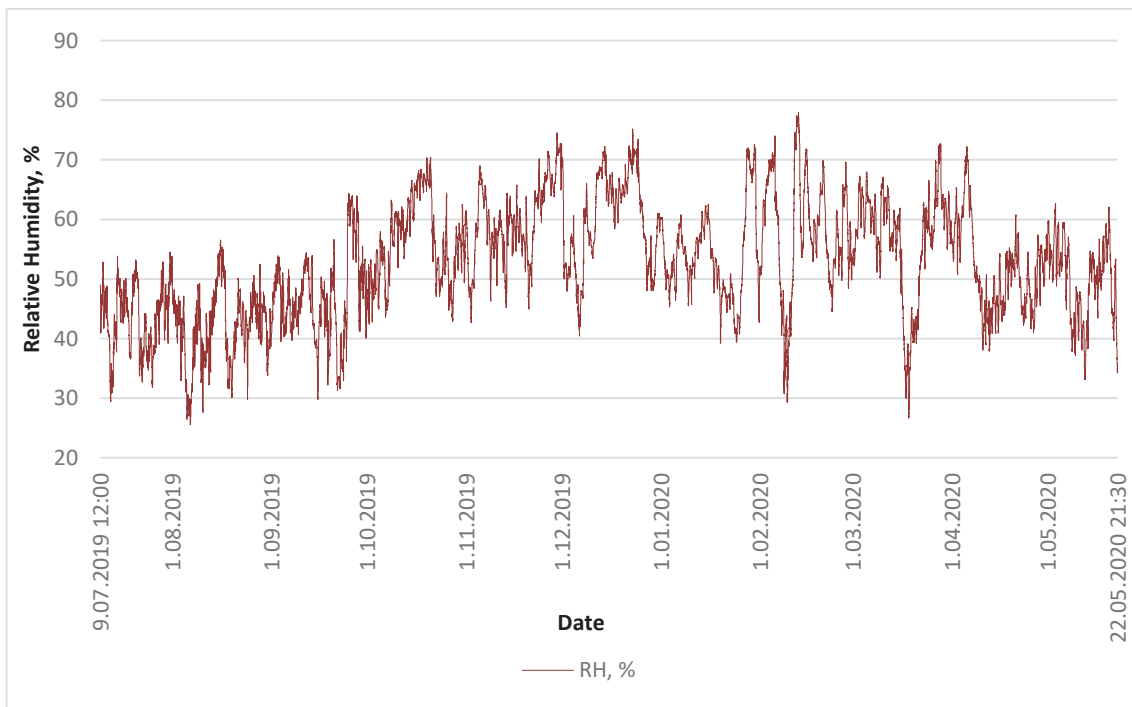
Figure 5.10. Hourly relative humidity values of data logger No. 5 during the year

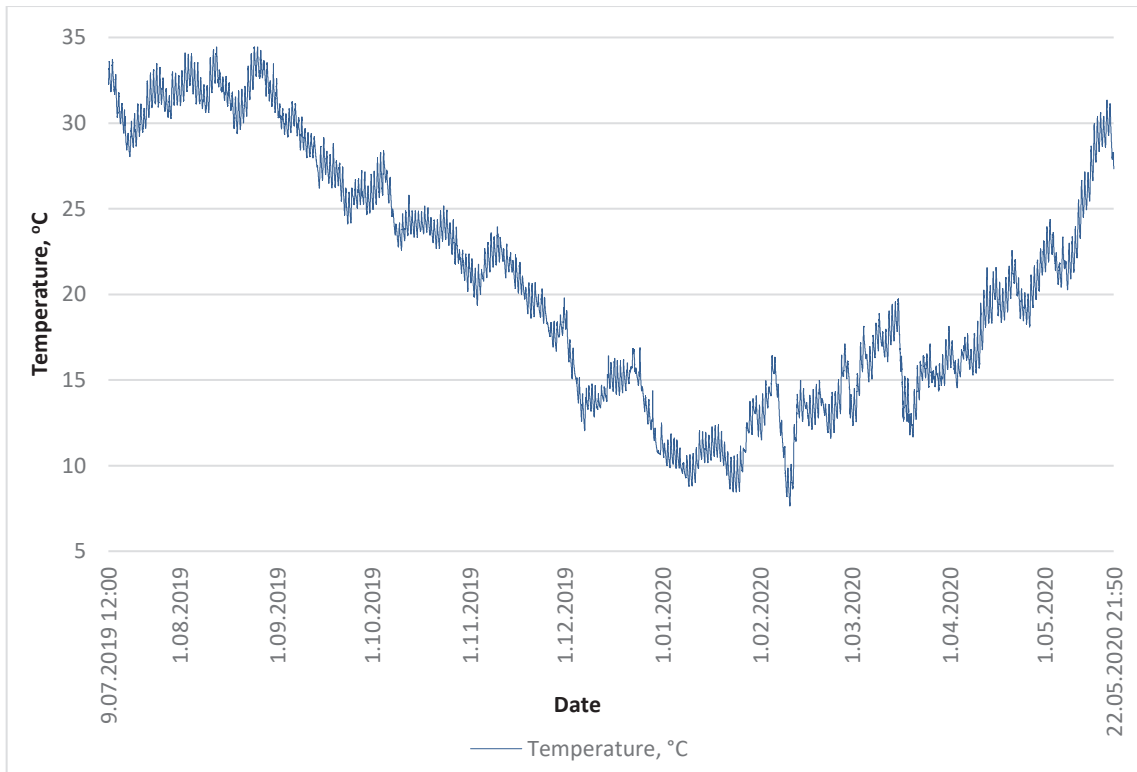
Figure 5.11. Hourly air temperature values of data logger No. 6 during the year

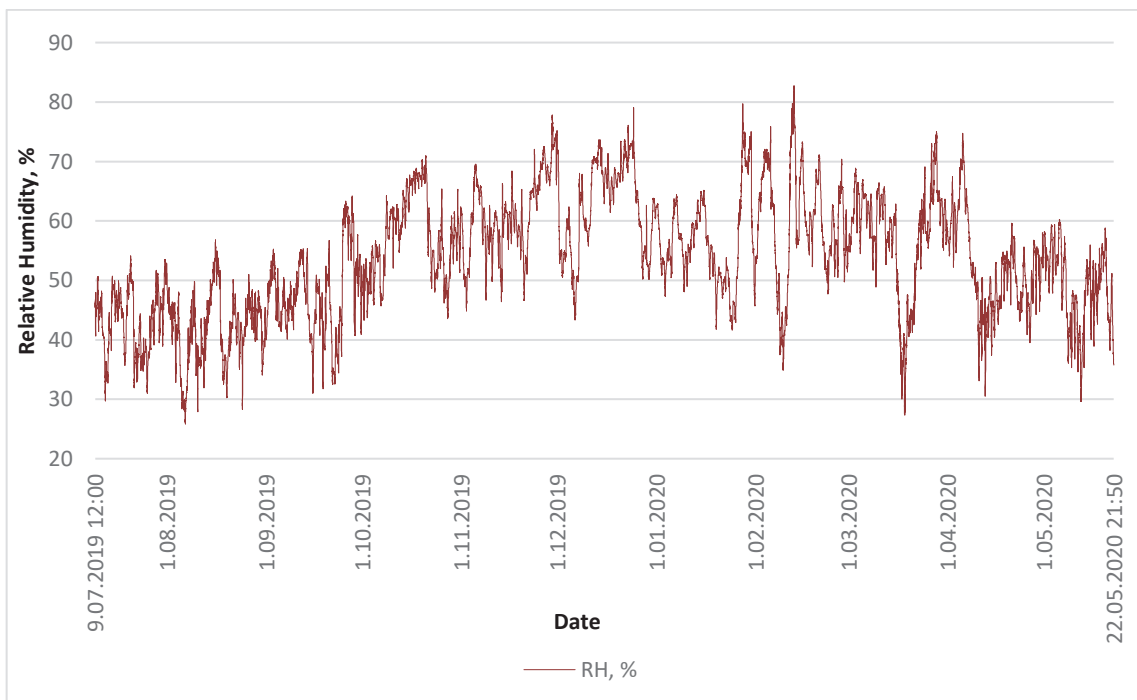
Figure 5.12. Hourly relative humidity values of data logger No. 6 during the year

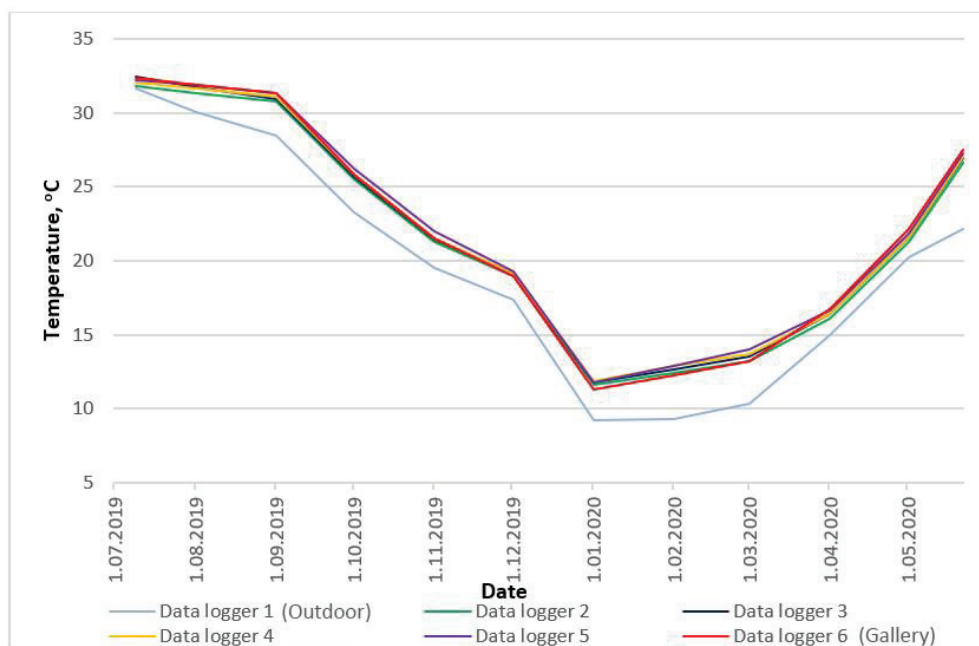
Figure 5.13. Comparison of monthly air temperature values measured by six devices

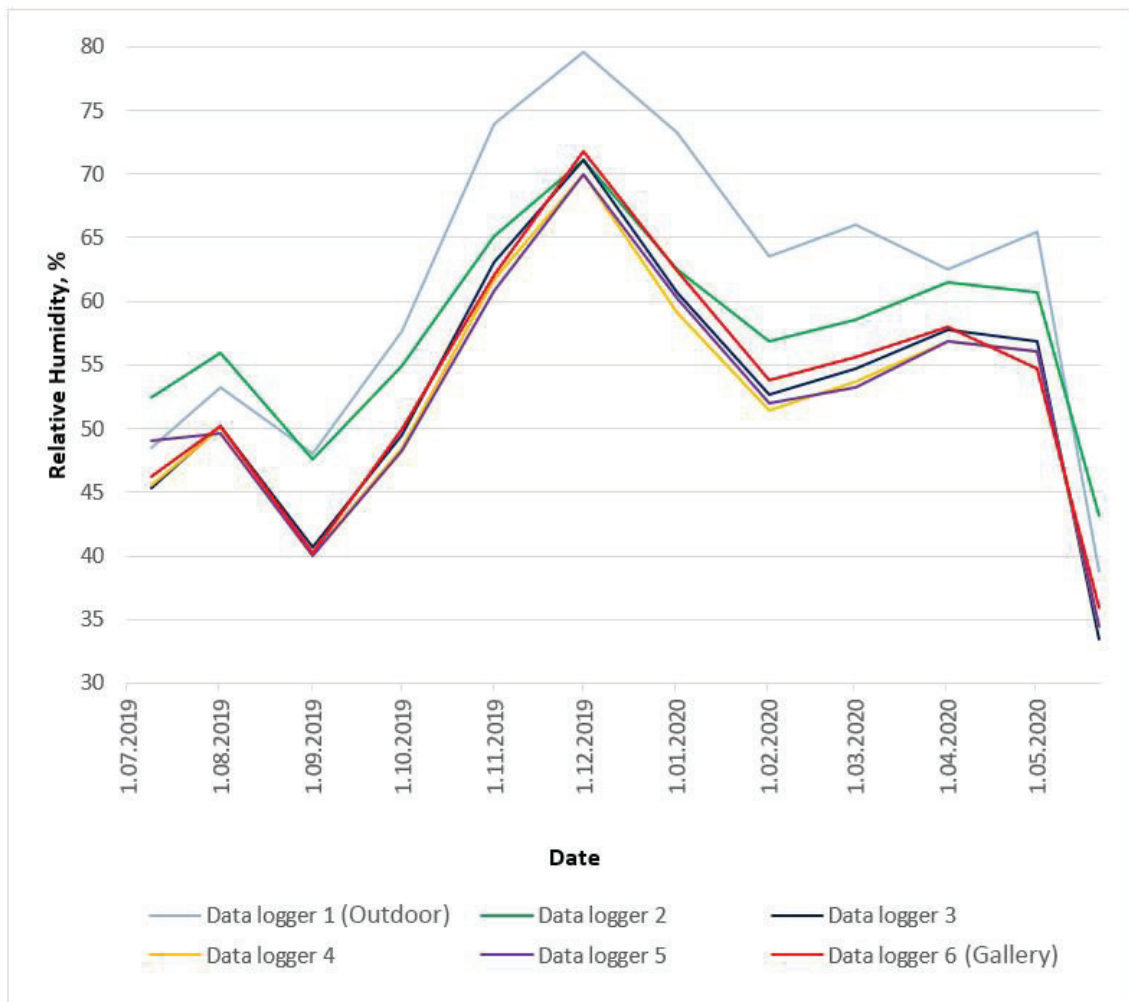
Figure 5.14. Comparison of monthly relative humidity values measured by six devices

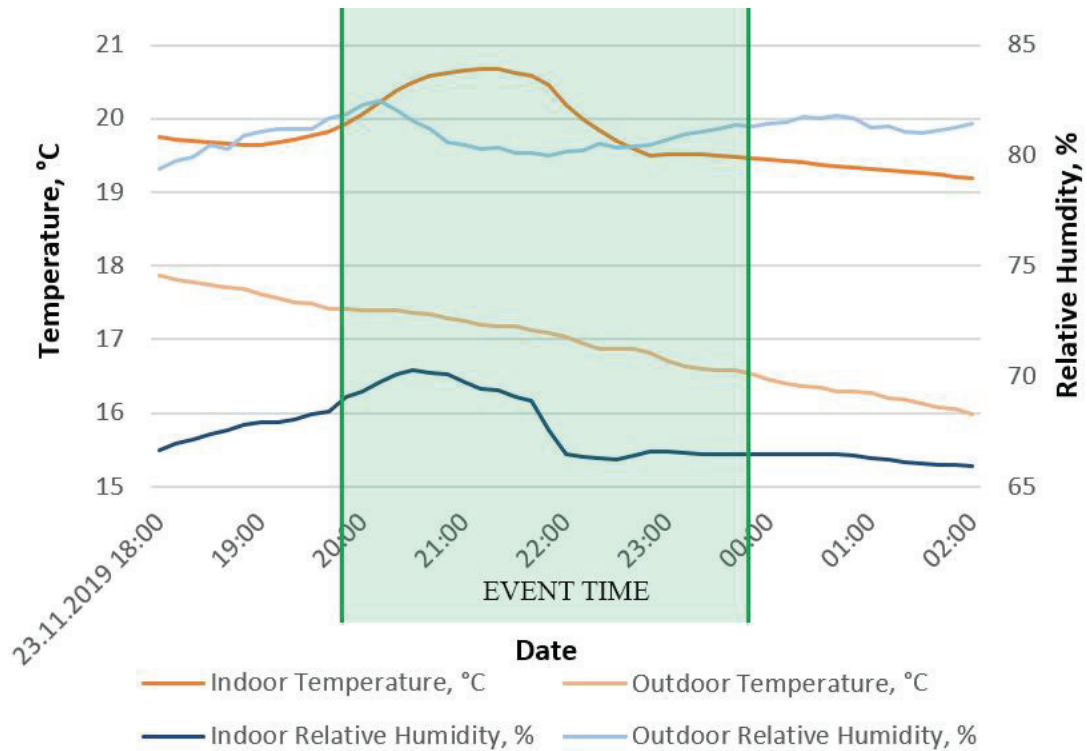
Figure 5.15. Air temperature and relative humidity values recorded in the 10-minute cycle at the event on 23 November 2019

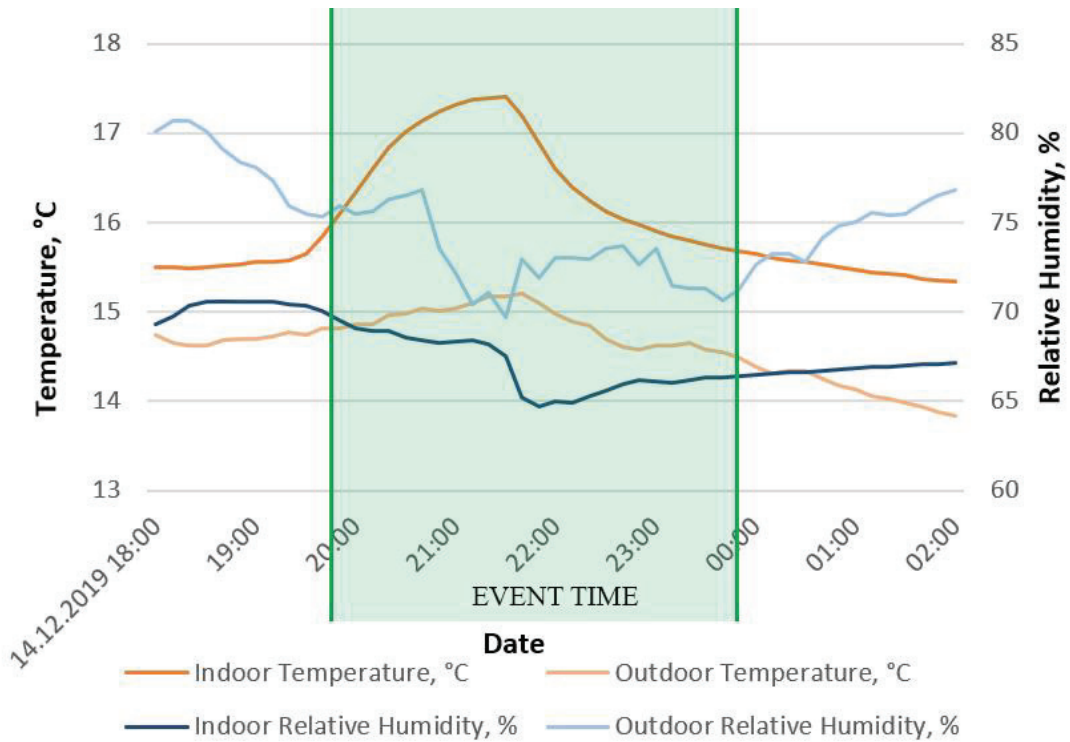
Figure 5.16. Air temperature and relative humidity values recorded in the 10-minute cycle at the event on 14 December 2019

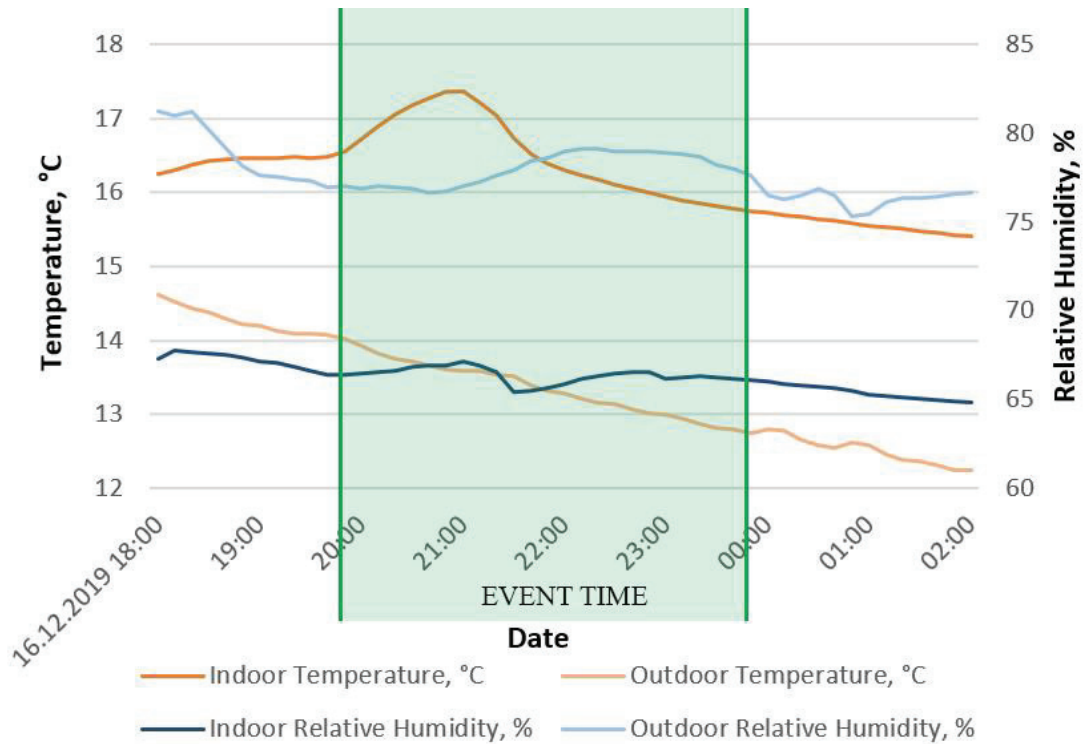
Figure 5.17. Air temperature and relative humidity values recorded in the 10-minute cycle at the event on 16 December 2019

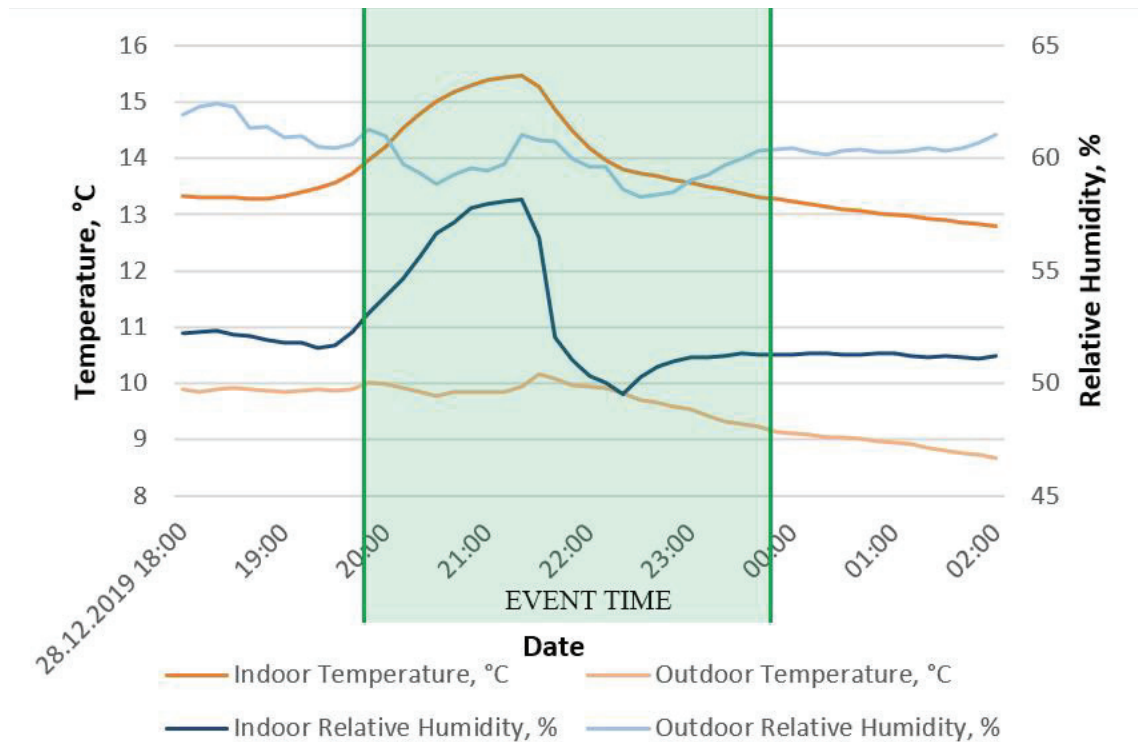
Figure 5.18. Air temperature and relative humidity values recorded in the 10-minute cycle at the event on 28 December 2019

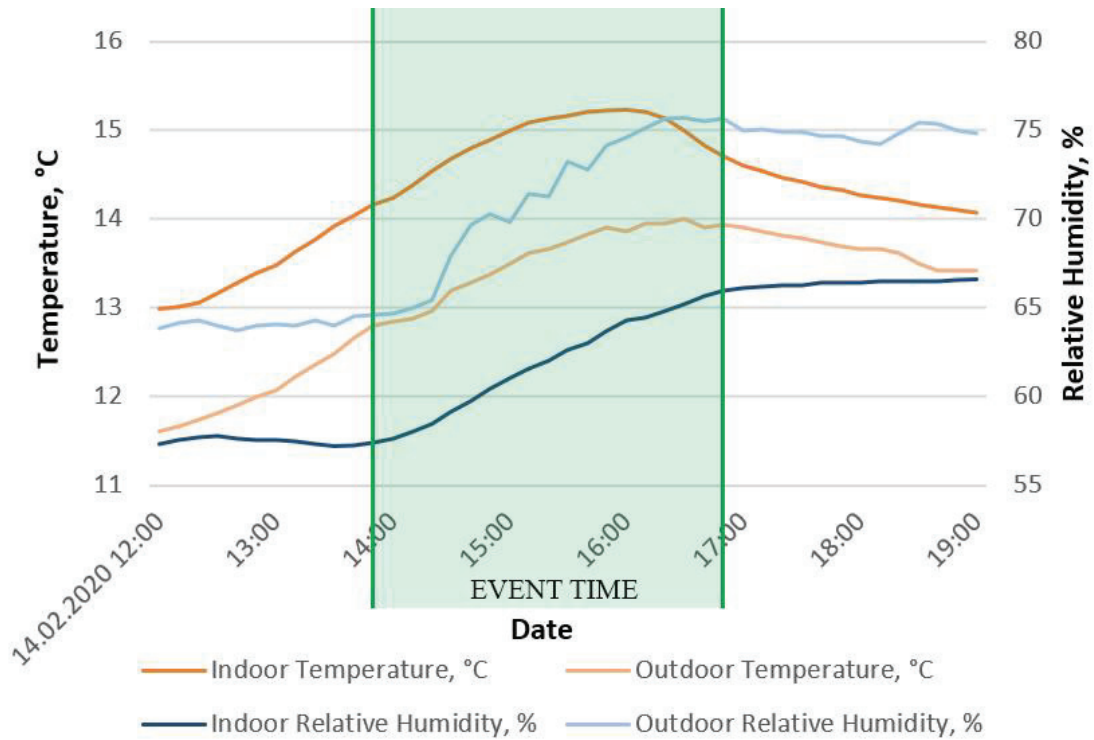
Figure 5.19. Air temperature and relative humidity values recorded in the 10-minute cycle at the event on 14 February 2020

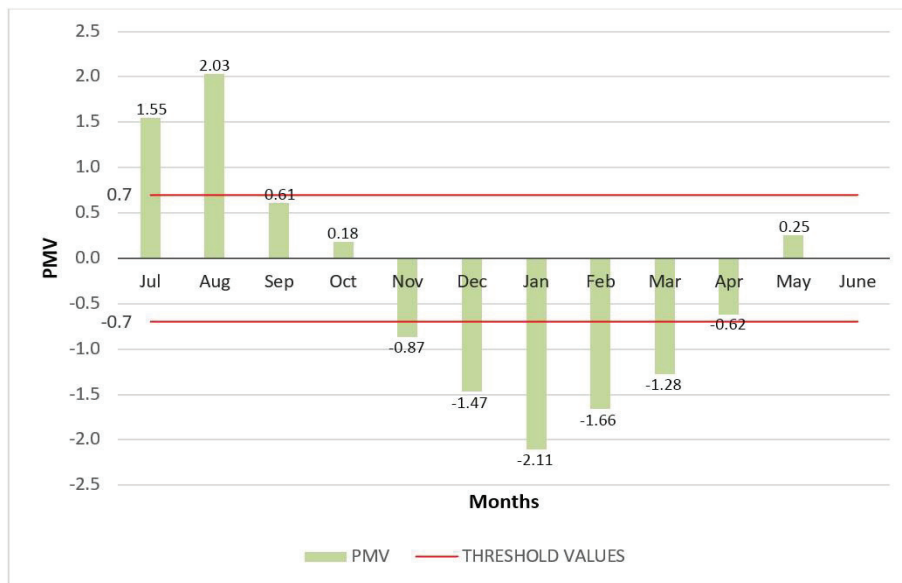
Figure 5.20. Threshold values and PMV values according to monthly calculations

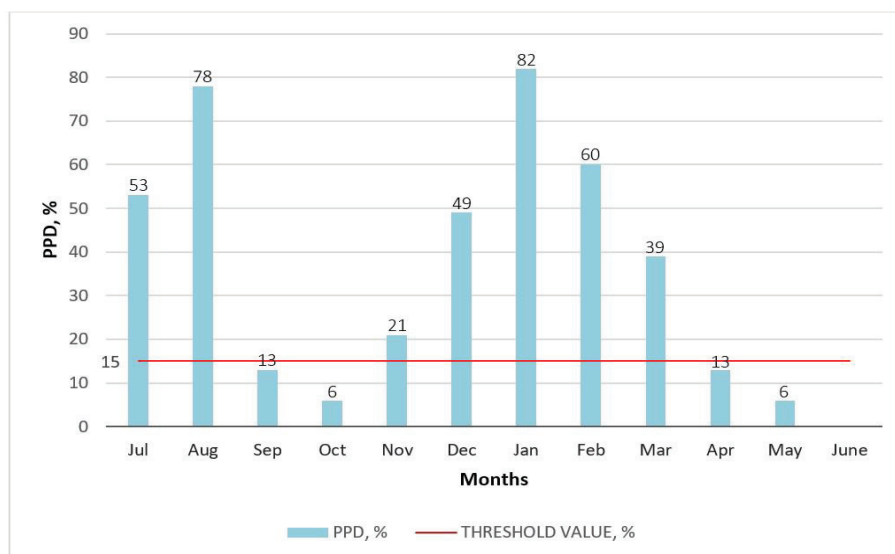
Figure 5.21. Threshold values and PPD values according to monthly calculations
