**INVESTIGATION OF THE INDOOR  
MICROCLIMATE OF HISTORIC AGIOS  
VOUKOLOS (*AZİZ VUKOLOS*) CHURCH IN İZMİR  
TO DETERMINE AND IMPROVE THERMAL  
COMFORT CONDITIONS**

**A Thesis Submitted to  
the Graduate School of Engineering and Sciences of  
İzmir Institute of Technology  
in Partial Fulfillment of the Requirements for the Degree of**

**in Architectural Restoration**

**by  
Damla AKIN YALÇIN**

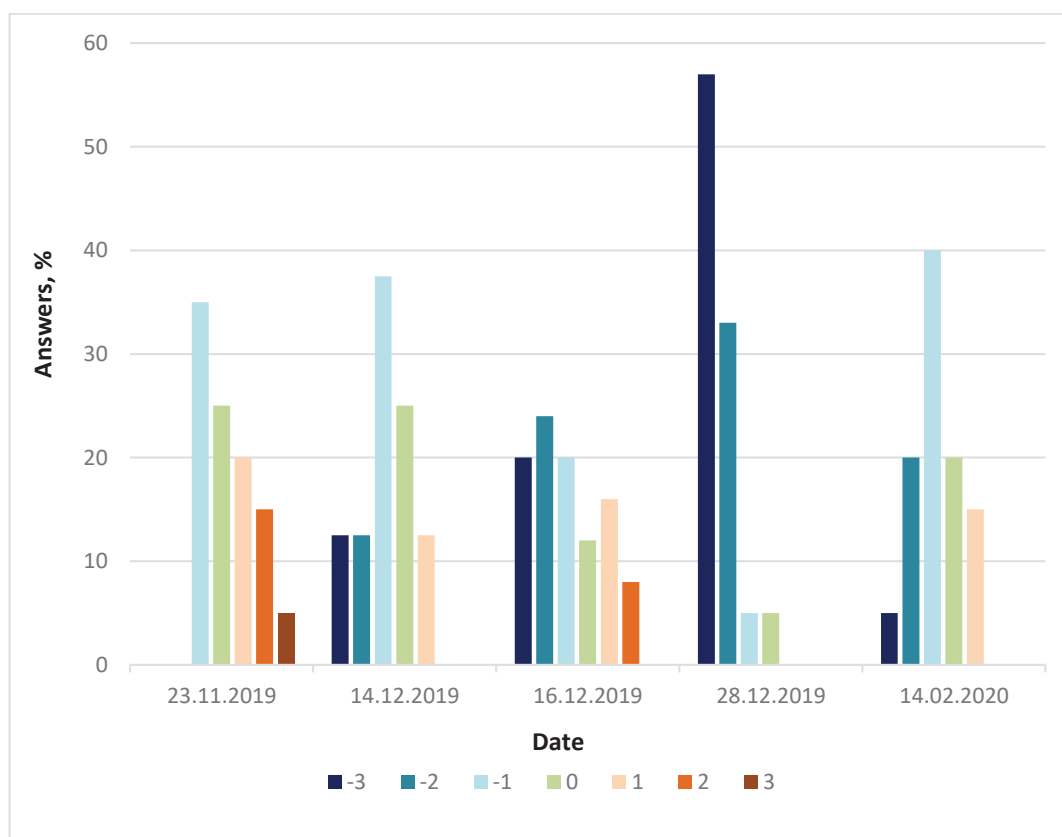
Figure 5.22. Answer percentages in survey studies

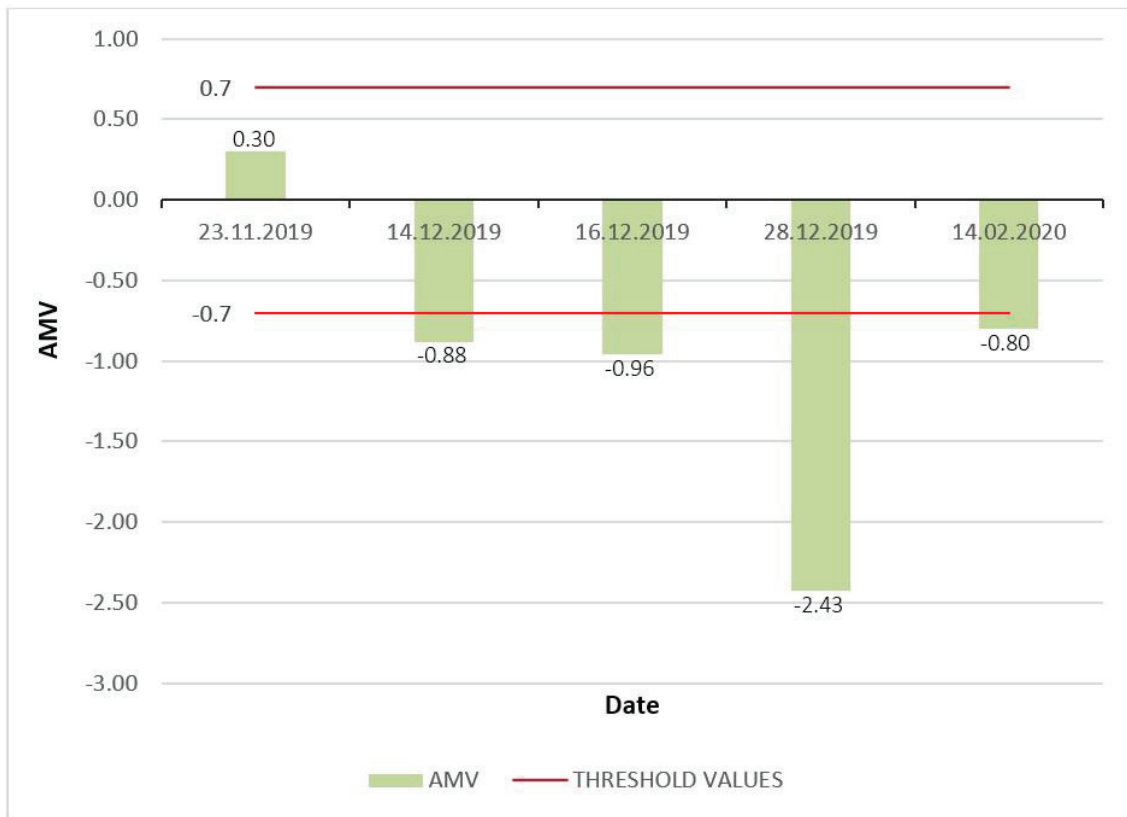
Figure 5.23. Threshold values and AMV values

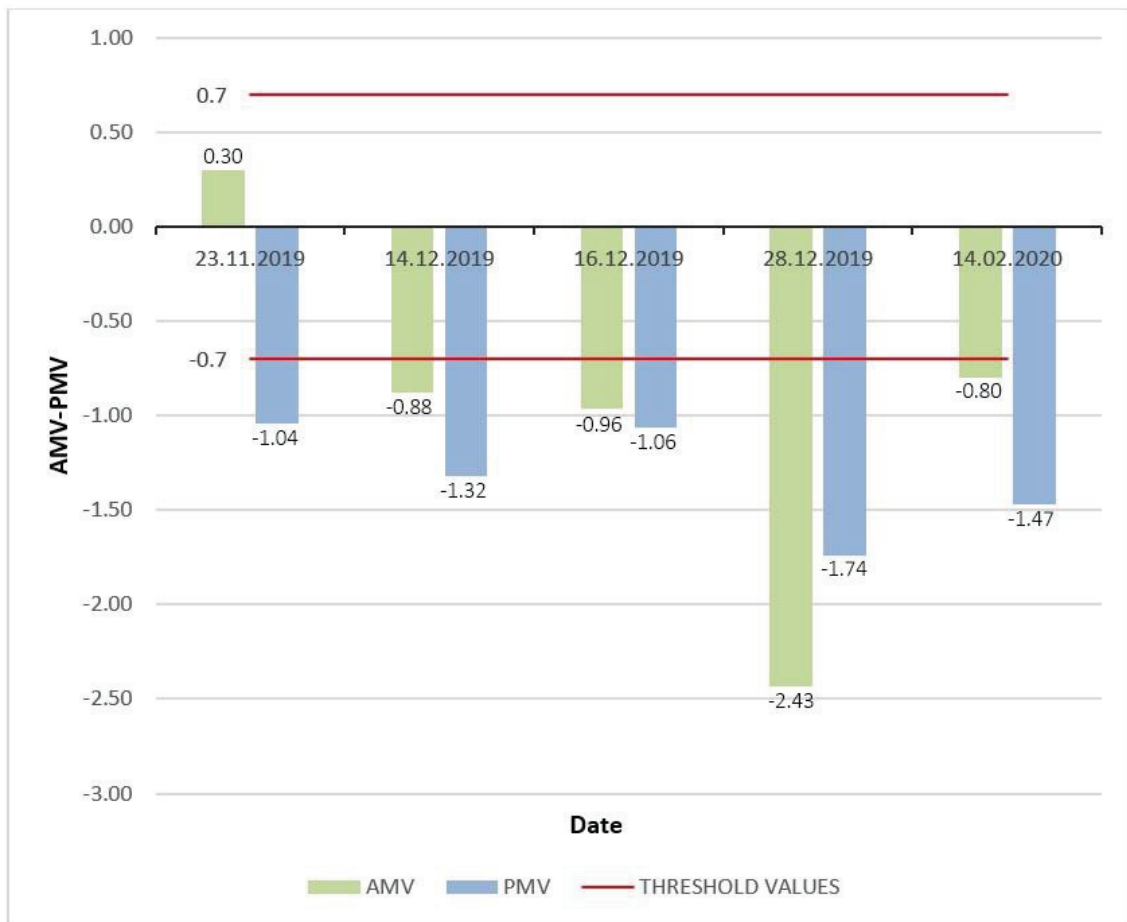
Figure 5.24. Comparison of AMV-PMV values and threshold values

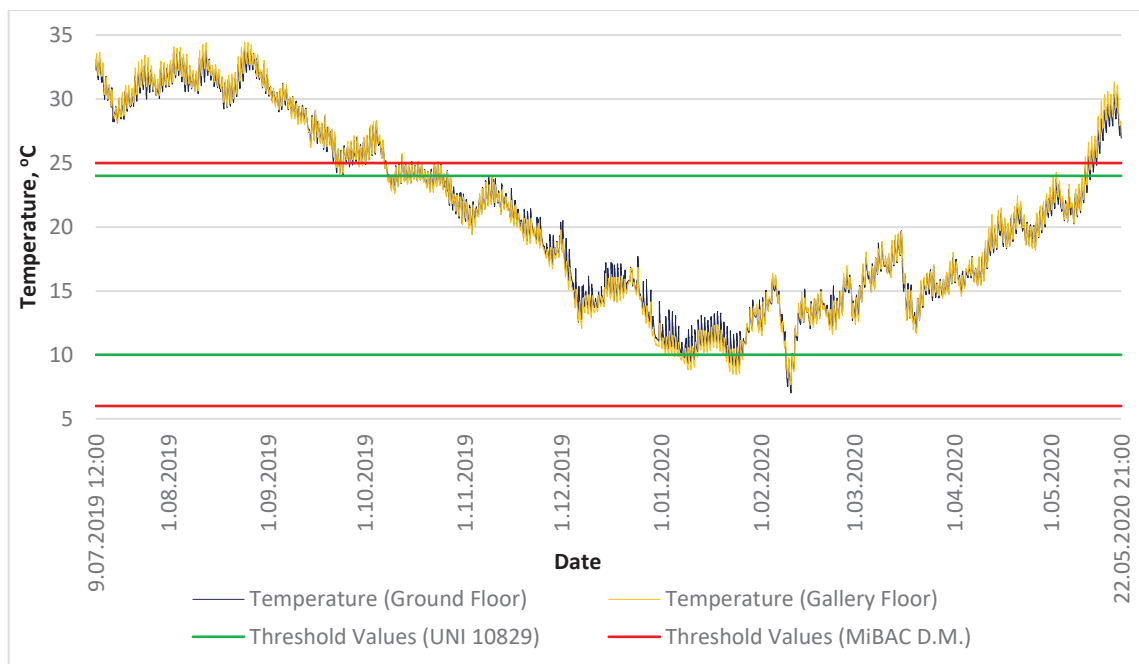
Figure 5.26. Diagram showing hourly indoor air temperature values and the appropriate air temperature range to preserve wall paintings

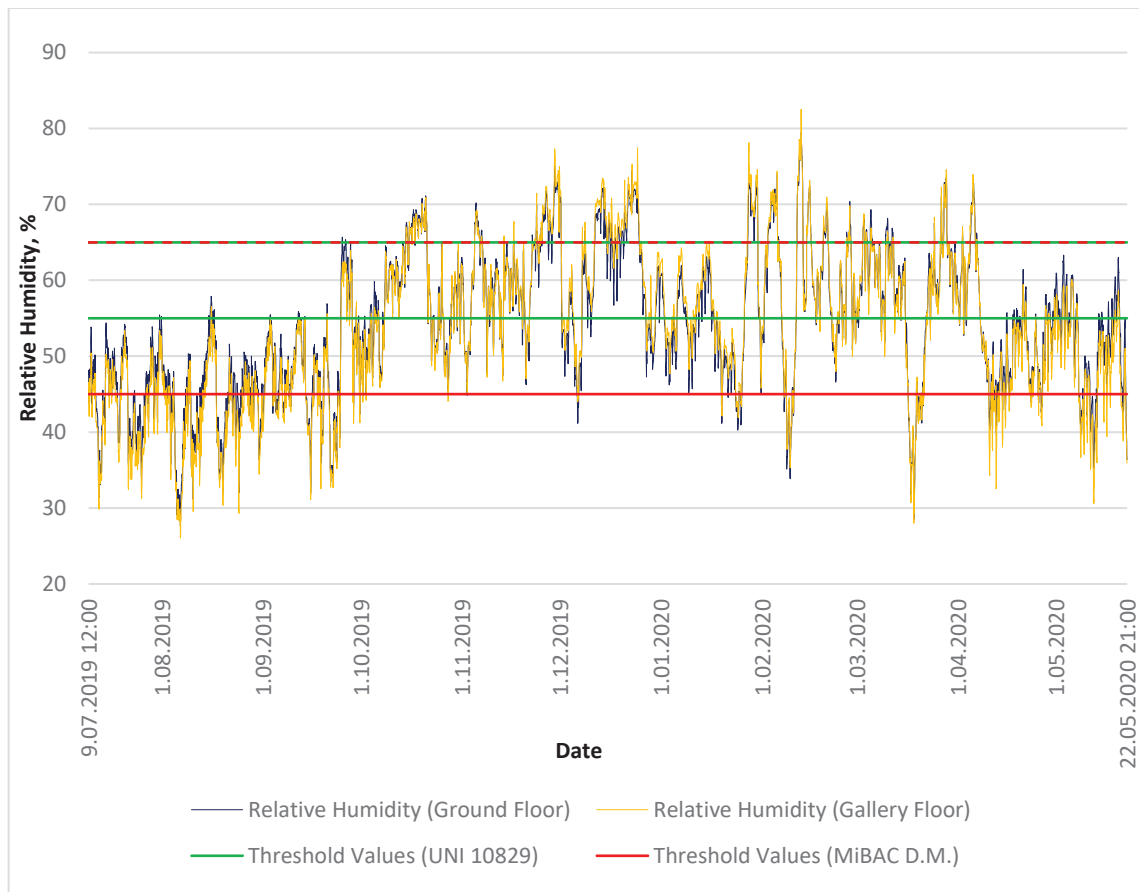
Figure 5.27. Diagram showing hourly indoor relative humidity values and the appropriate relative humidity range to preserve wall paintings

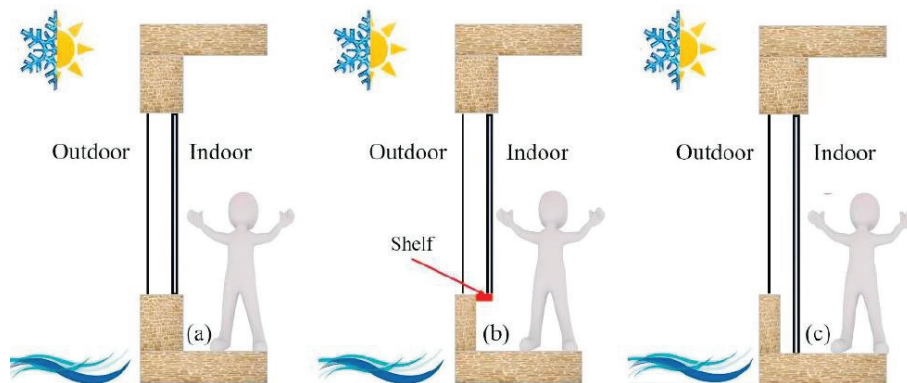
Figure 5.28. Secondary glazing installation types  
(Source: Coillot et al., 2017)

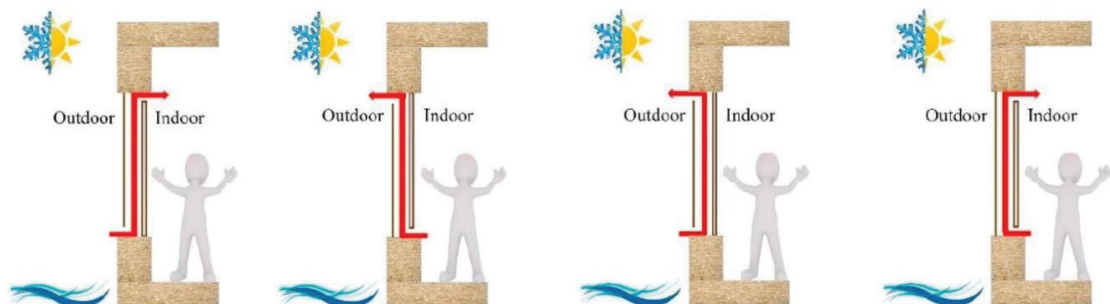
Figure 5.29. Air flow through double windows  
(Source: Coillot et al., 2017)

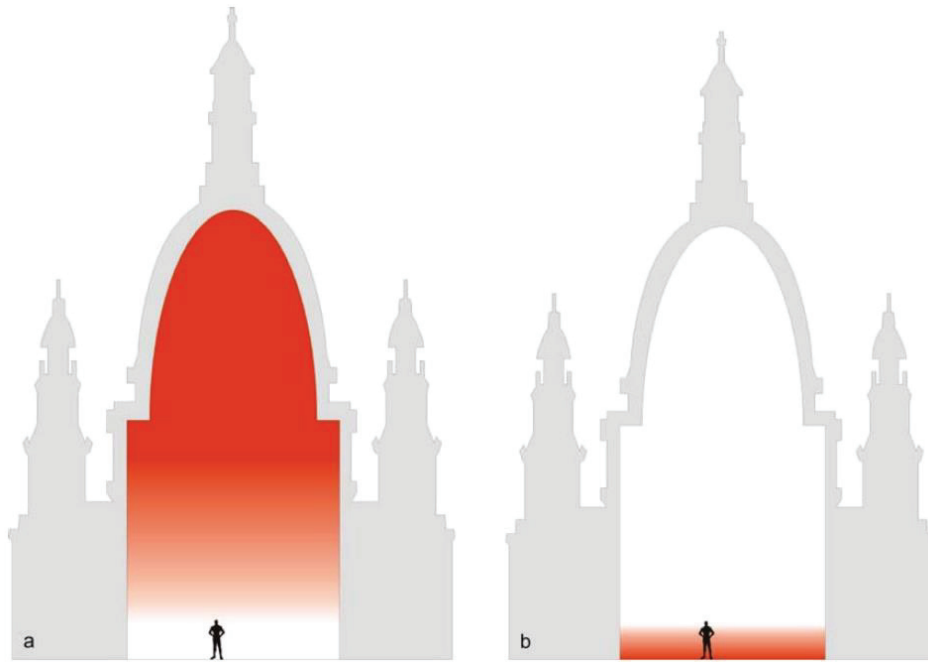
Figure 5.30. a) Central heating, b) Local heating  
(Source: Camuffo ve Della Valle, 2007)

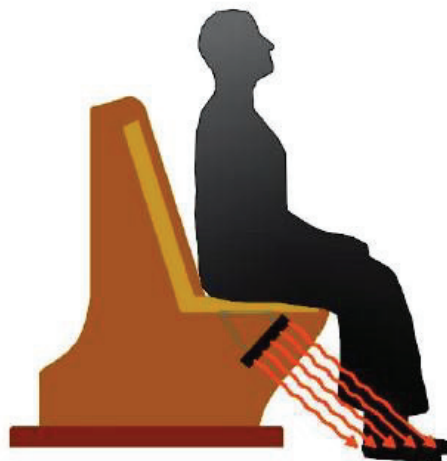
Figure 5.32. Pew heating by using low temperature radiant heaters (Source: Pałupska and Kanaś, 2018)

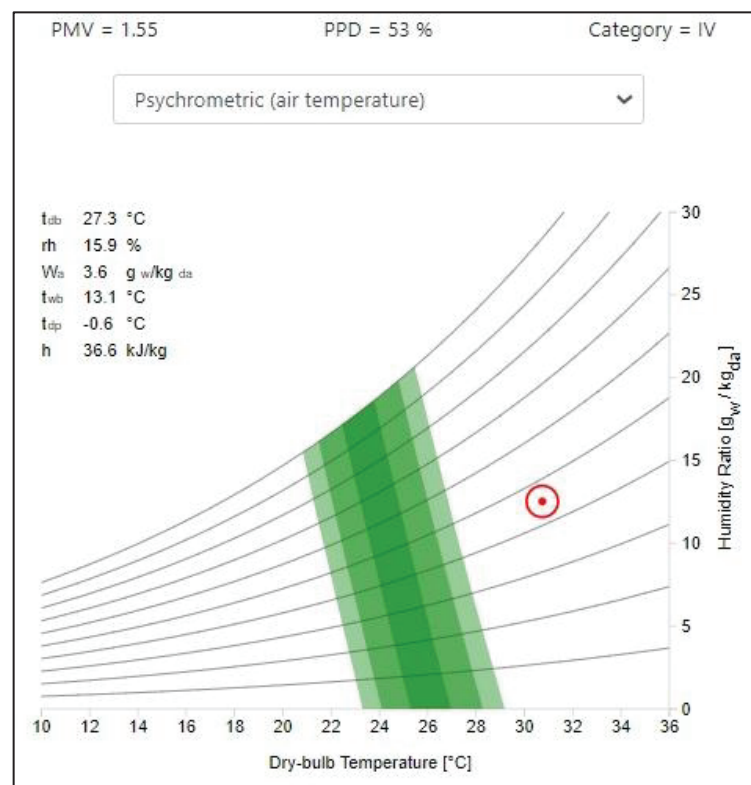
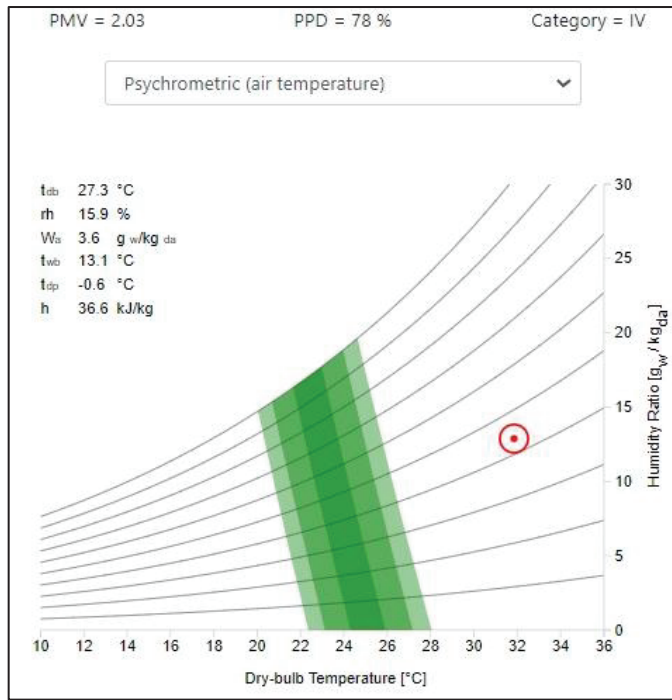
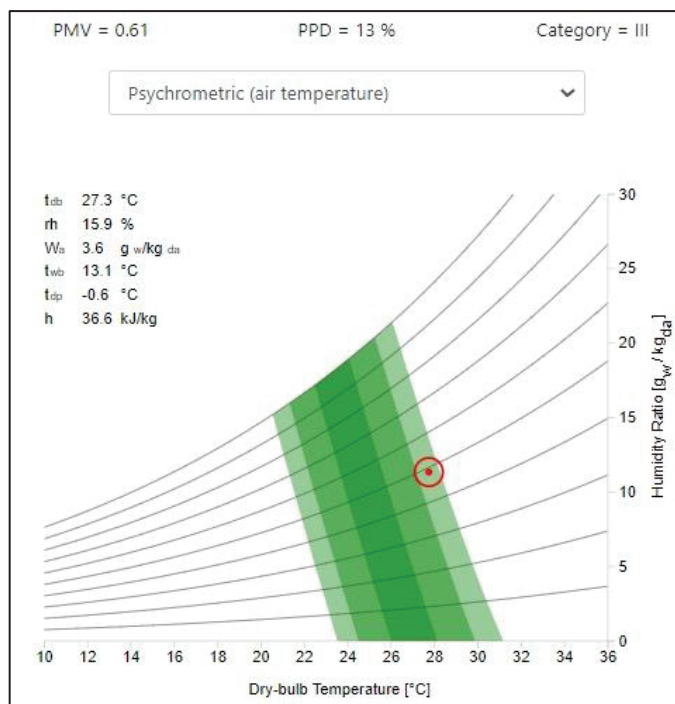
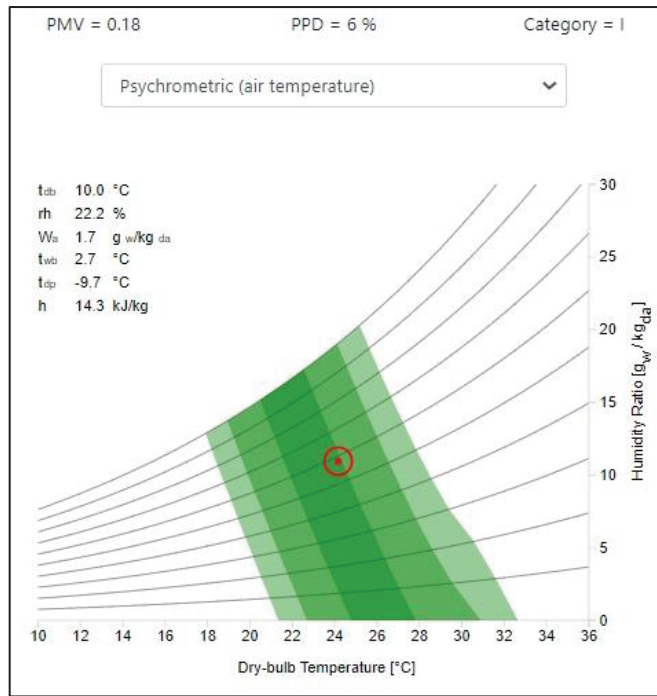
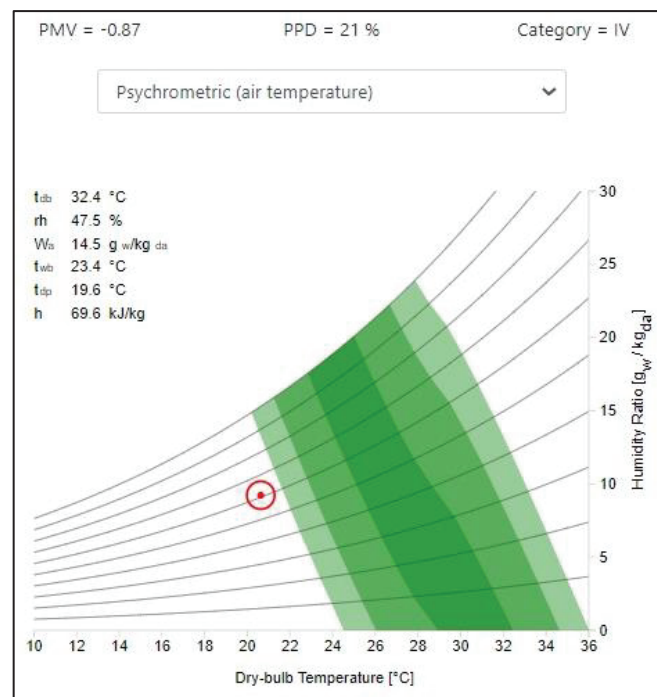
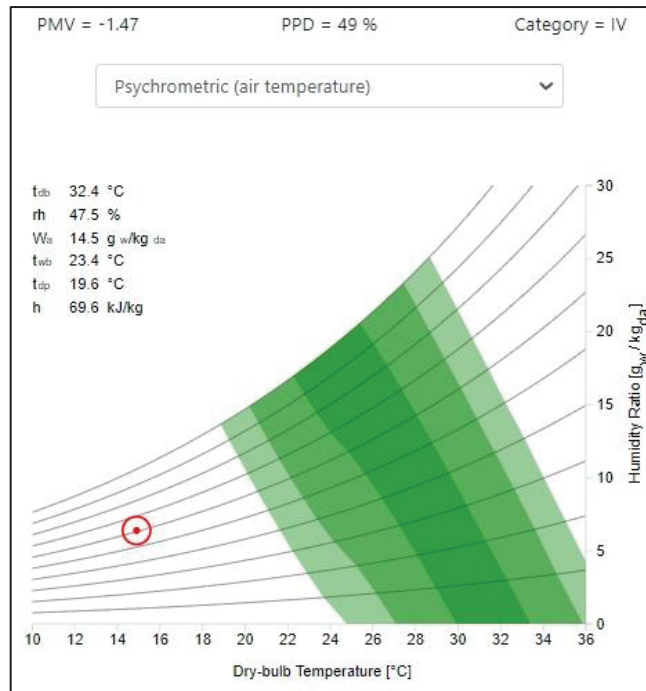
Figure B.1. Psychrometric diagram for July 2019 determining the thermal comfort category (Tartarini et al., 2020)

Figure B.2. Psychrometric diagram for August 2019 determining the thermal comfort category (Tartarini et al., 2020)

Figure B.3. Psychrometric diagram for September 2019 determining the thermal comfort category (Tartarini et al., 2020)

Figure B.4. Psychrometric diagram for October 2019 determining the thermal comfort category (Tartarini et al., 2020)

Figure B.5. Psychrometric diagram for November 2019 determining the thermal comfort category (Tartarini et al., 2020)

Figure B.6. Psychrometric diagram for December 2019 determining the thermal comfort category (Tartarini et al., 2020)

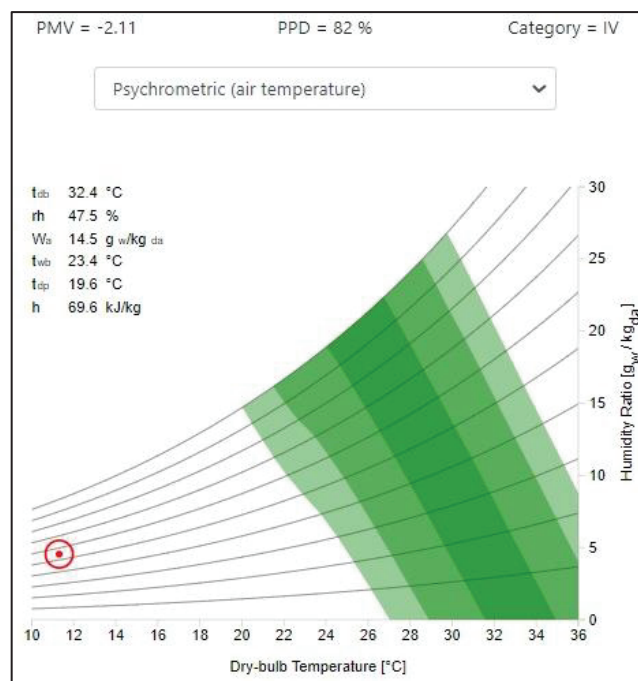
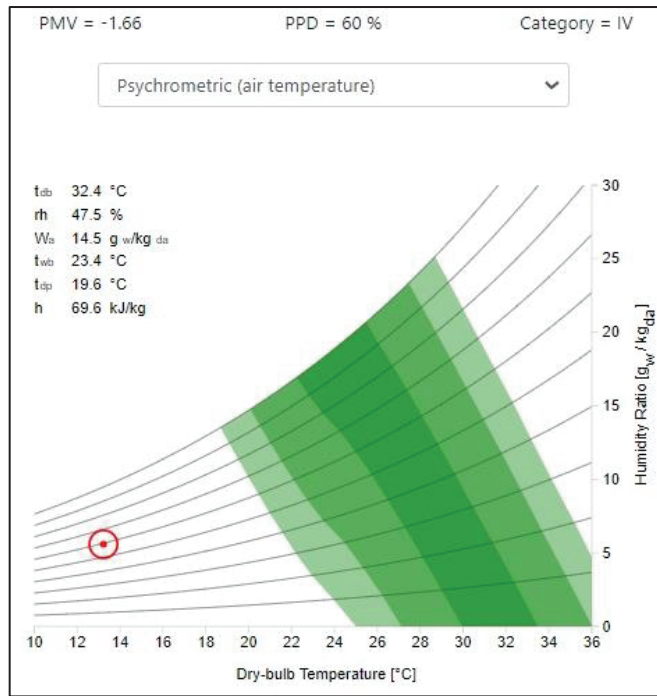
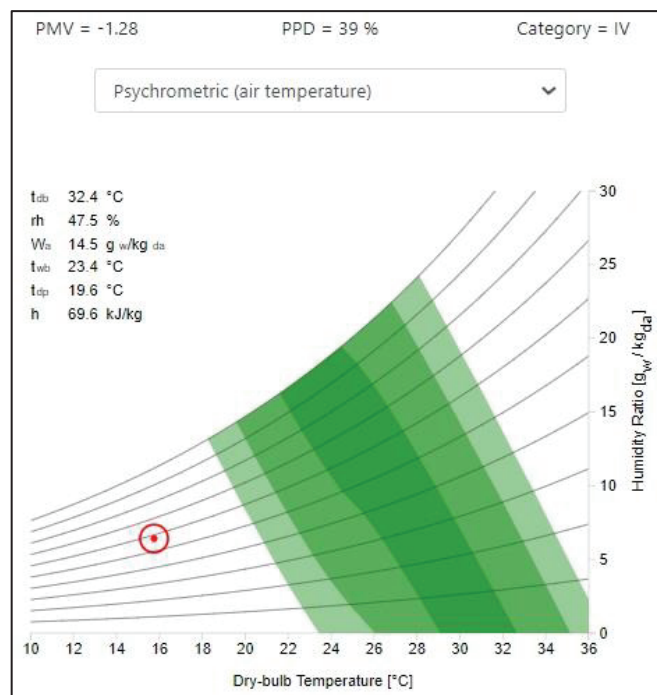
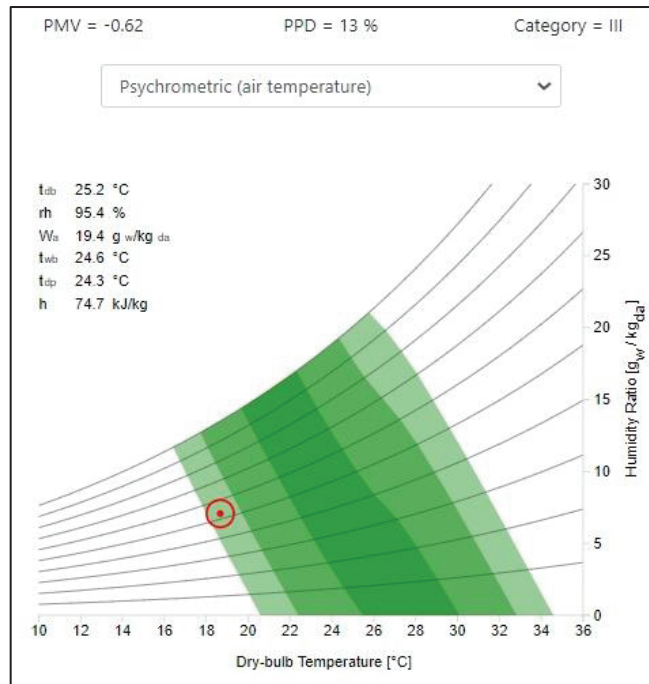
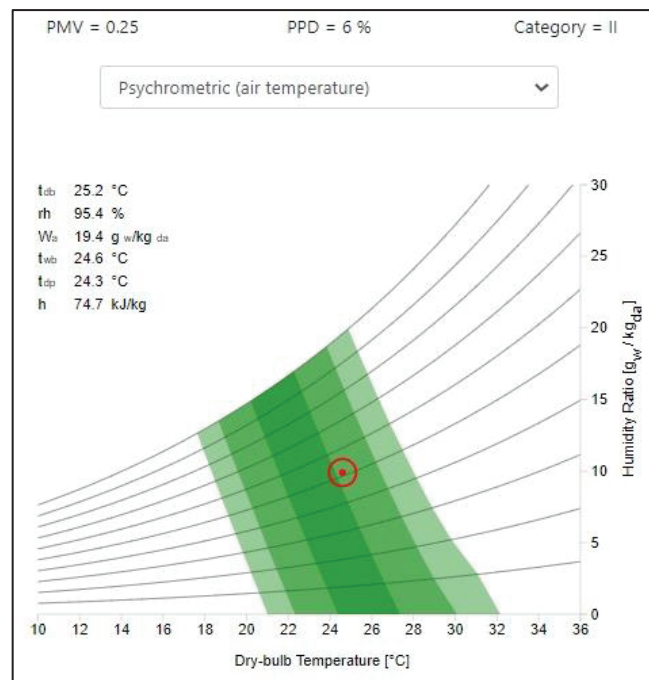
Figure B.7. Psychrometric diagram for January 2020 determining the thermal comfort category (Tartarini et al., 2020)

Figure B.8. Psychrometric diagram for February 2020 determining the thermal comfort category (Tartarini et al., 2020)

Figure B.9. Psychrometric diagram for March 2020 determining the thermal comfort category (Tartarini et al., 2020)

Figure B.10. Psychrometric diagram for April 2020 determining the thermal comfort category (Tartarini et al., 2020)

Figure B.11. Psychrometric diagram for May 2020 determining the thermal comfort category (Tartarini et al., 2020)
