**Construction Techniques and Materials  
of the Ottoman Period Baths  
in Seferihisar–Urla Region**

**Department: Architectural Restoration  
Major: Architectural Restoration**

**İzmir Institute of Technology  
İzmir, Turkey**

**July 2004**

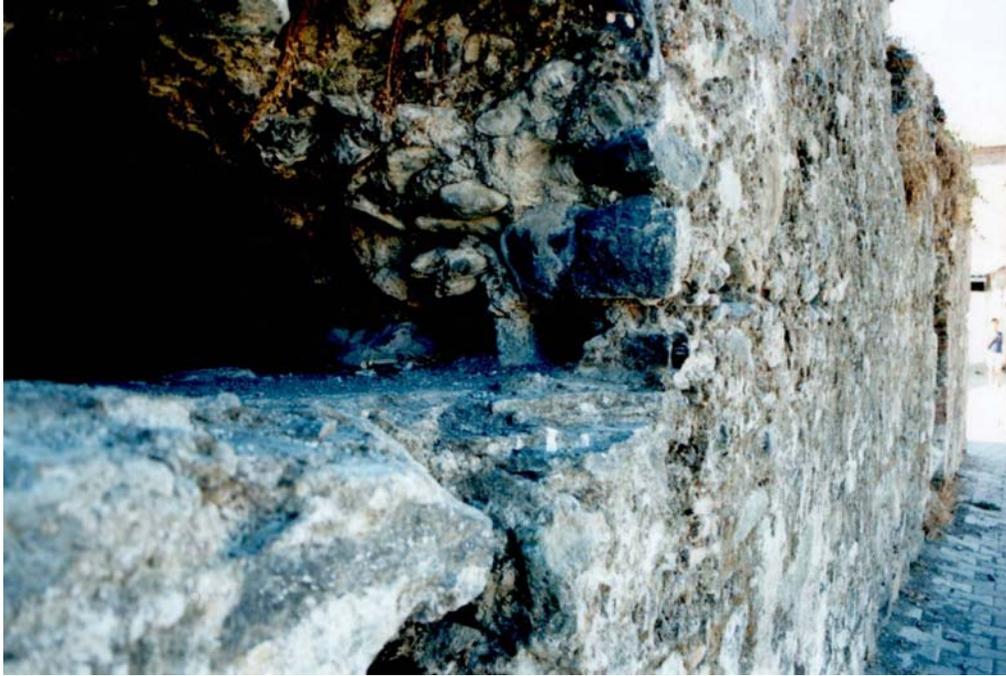
Figure 3.6. Ulaış Hamamı, The Timber Beams in the Walls

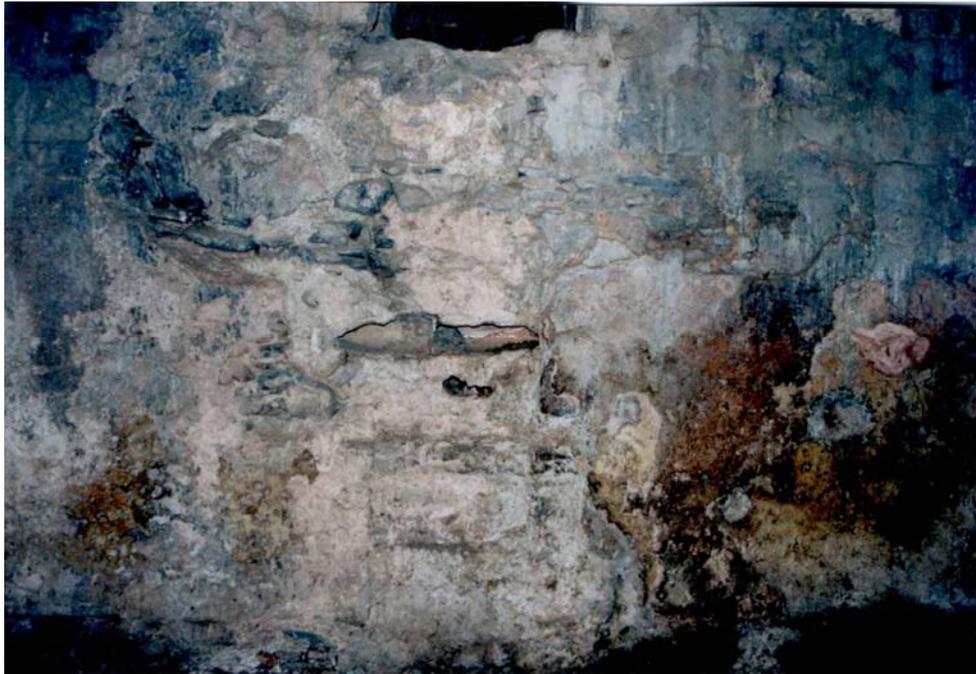
Figure 3.7. Ulaış Hamamı, Terracotta Pipes in the West *Halvet*

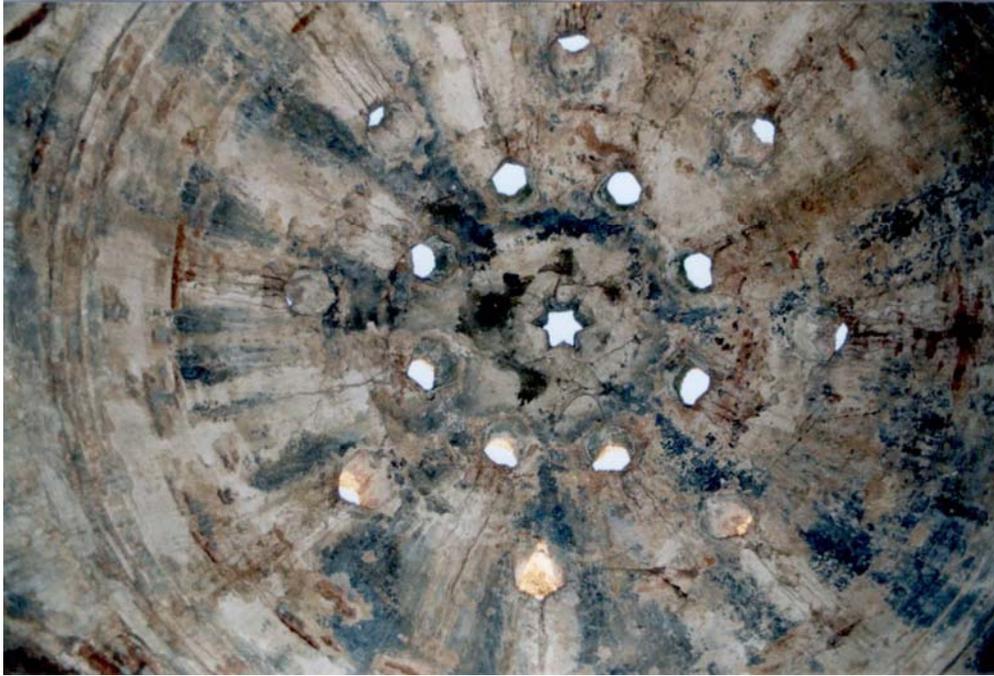
Figure 3.8. Ulamiş Hamamı, The Use of Oculi on the Dome of the West *Halvet*

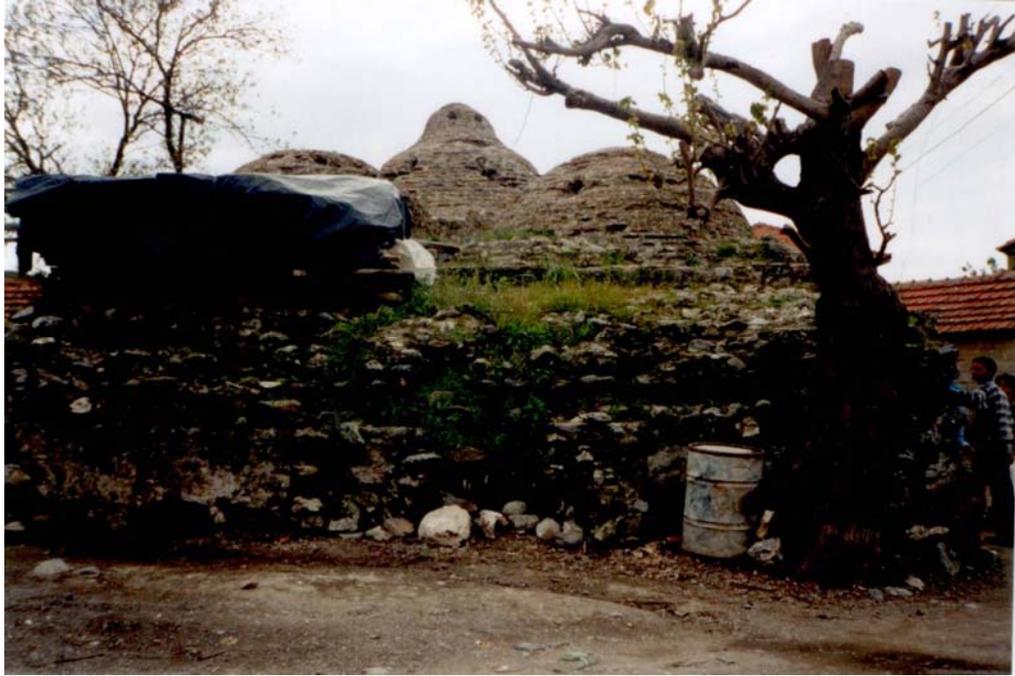
Figure 3. 10. Ulamiş Hamamı, The Water Reservoir

The furnace under the water reservoir and *cehennemlik* could not be observed since the ground was filled with debris (Figure 3.10). On the other hand, the locations of the flue chimneys could not be determined since the superstructure was covered with plant and earth.

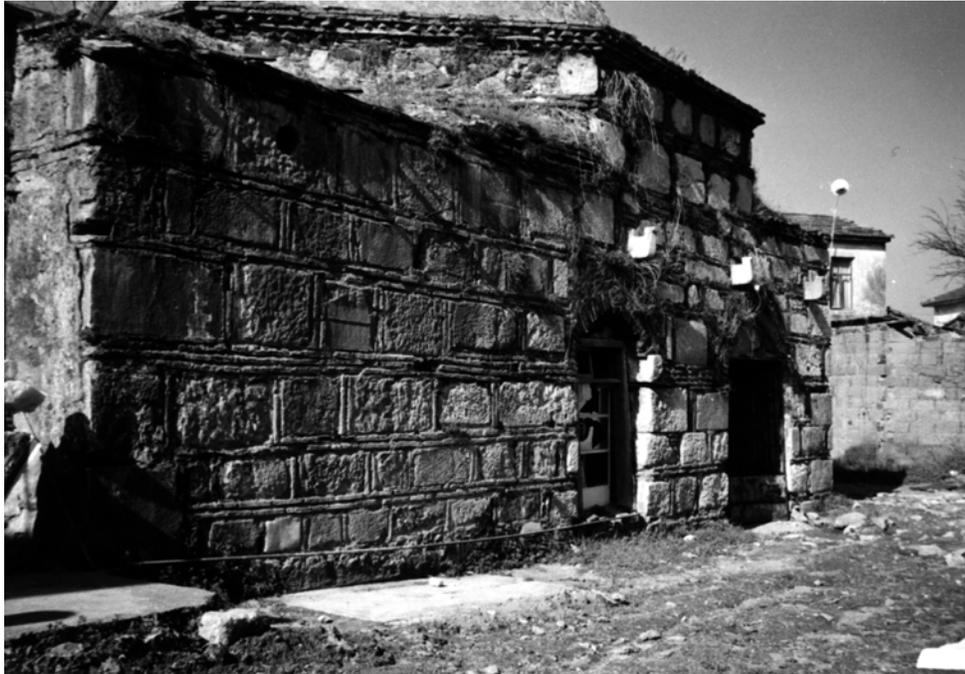
Figure 3.22. Seferihisar Büyük Hamam, Reused Cut Stone / Brick Alternating Bond of the Entrance Facade.

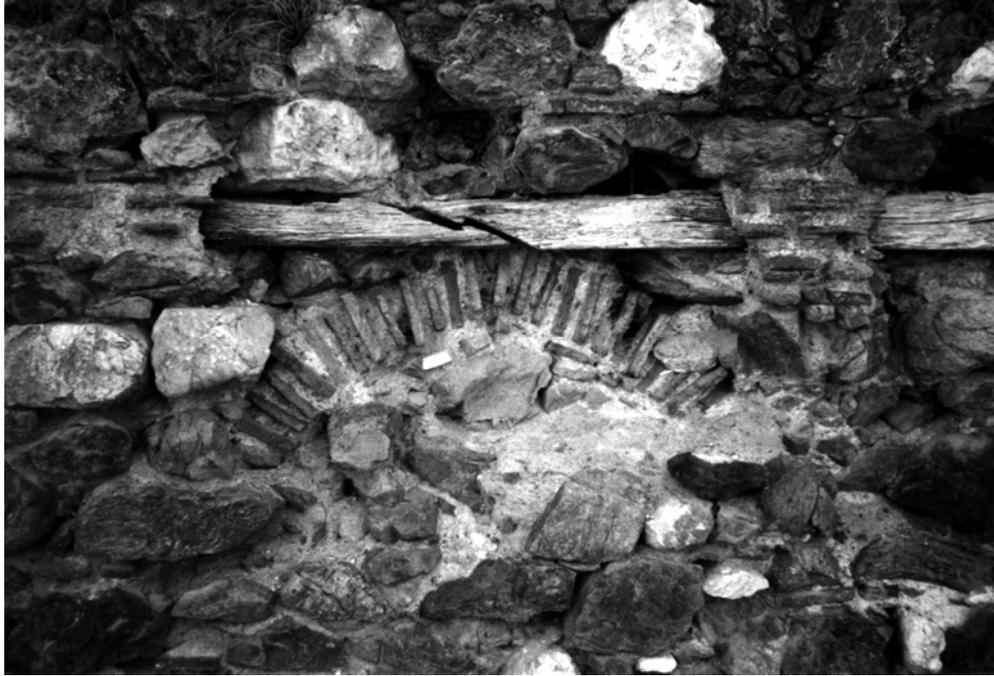
Figure 3.23. Seferihisar Büyük Hamam, The Use of Timber Beam in the Exterior North Wall.

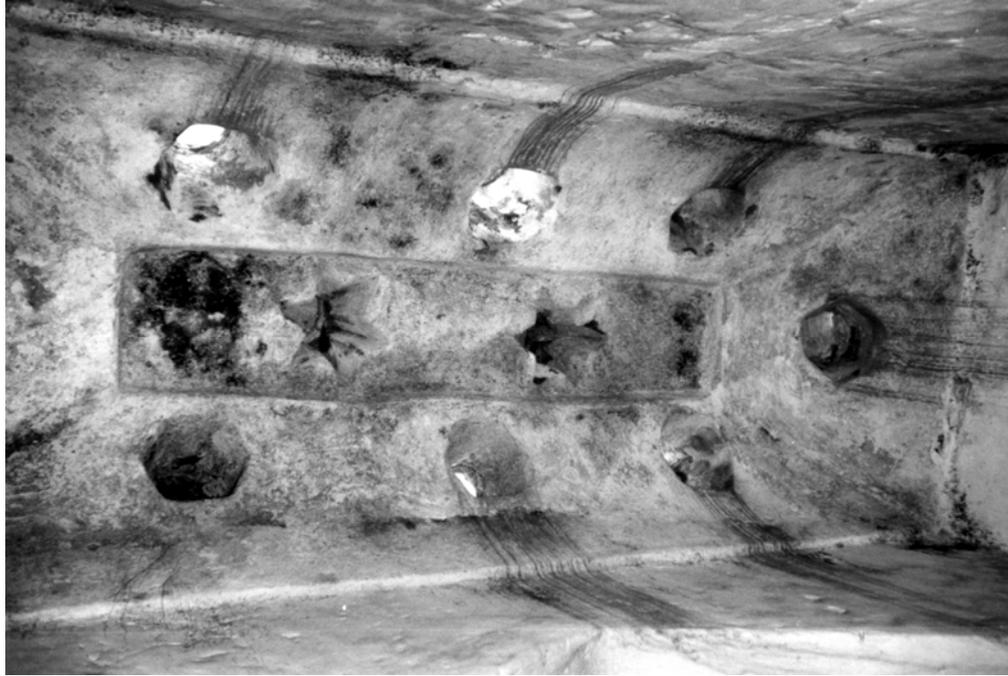
Figure 3.25. Seferihisar Büyük Hamam, The Panelled Vault in the Side Sections of the Main Sıcaklık Space

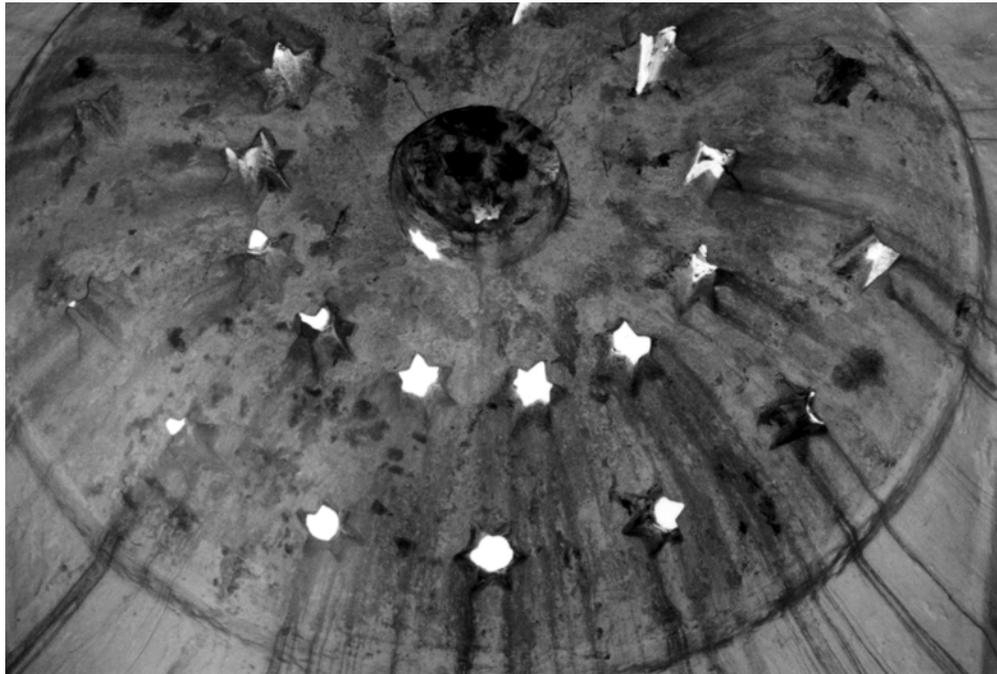
Figure 3.26. Seferihisar Büyük Hamam, The Use of Oculi and Hemispherical Cupola on the Dome of Main Sıcaklık Space

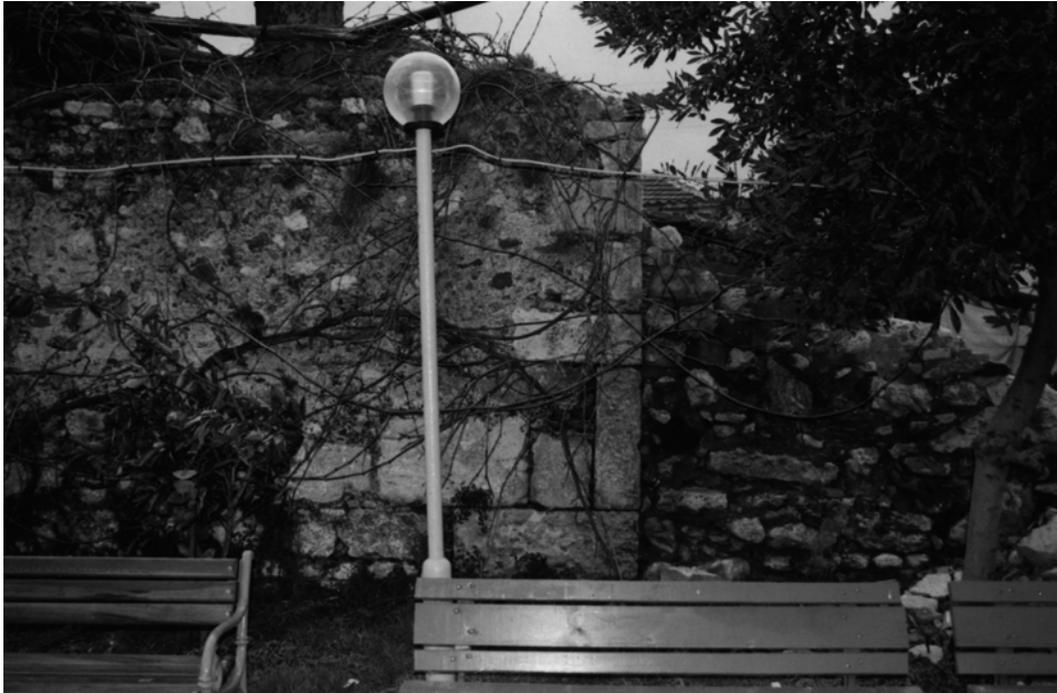
Figure 3.36. Sığacık Kaleiçi Hamamı, The Northeast Facade, The Use of Reused Cut Stone in Vertical Line

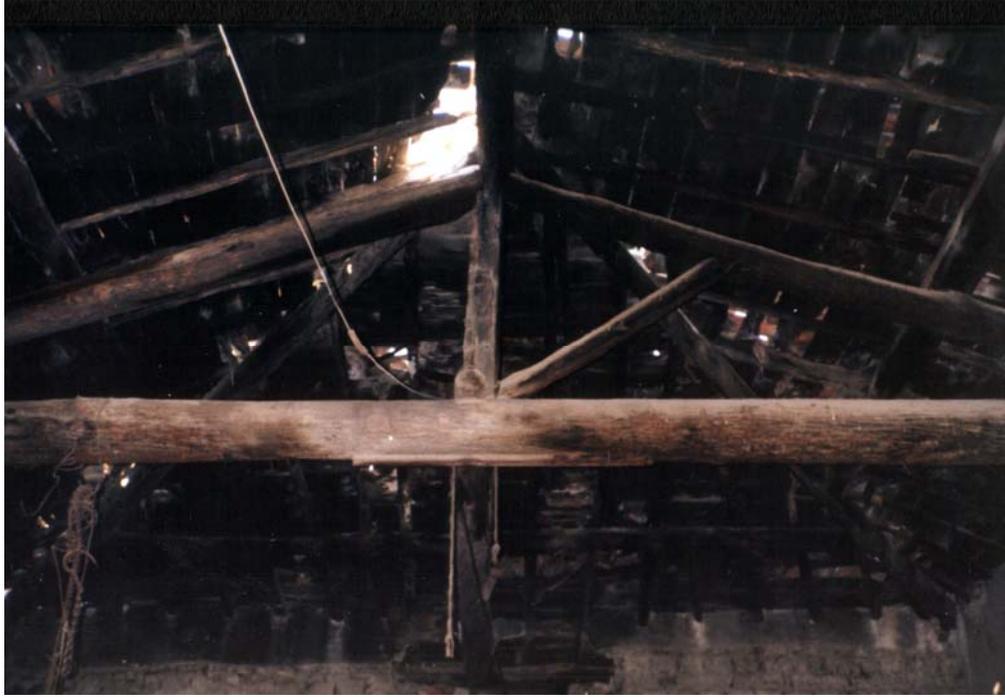
Figure 3.39. Sığacık Kaleiçi Hamamı, Timber Roof of the *Soyunmalık* Space

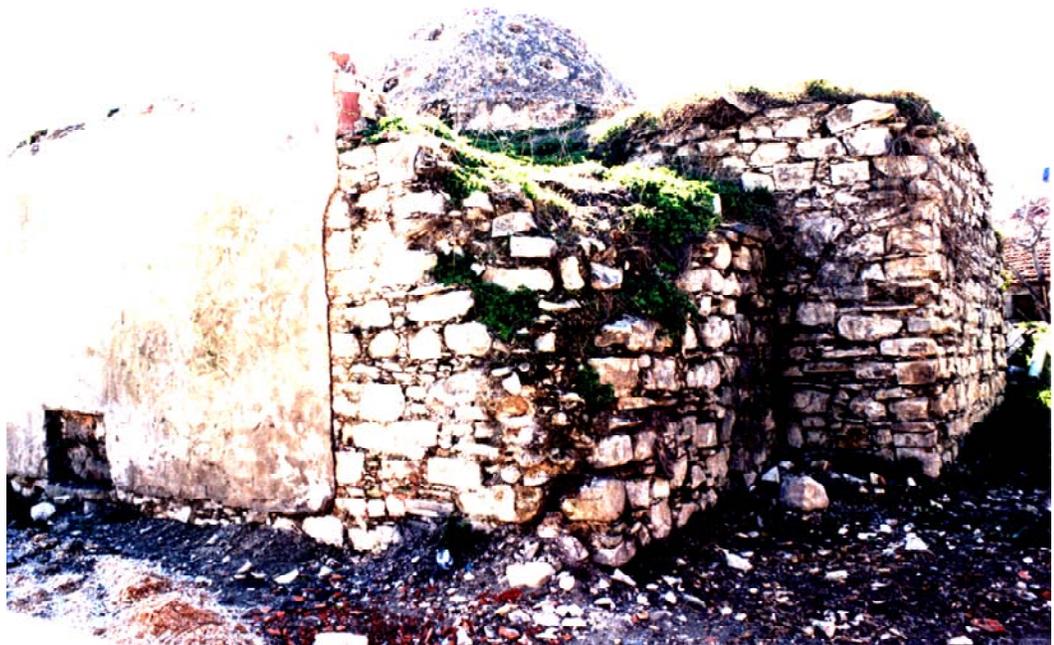
Figure 3.43. Urla Çifte Hamam, The Northwest Facade, Rubble Stone Bond of the Exterior Walls

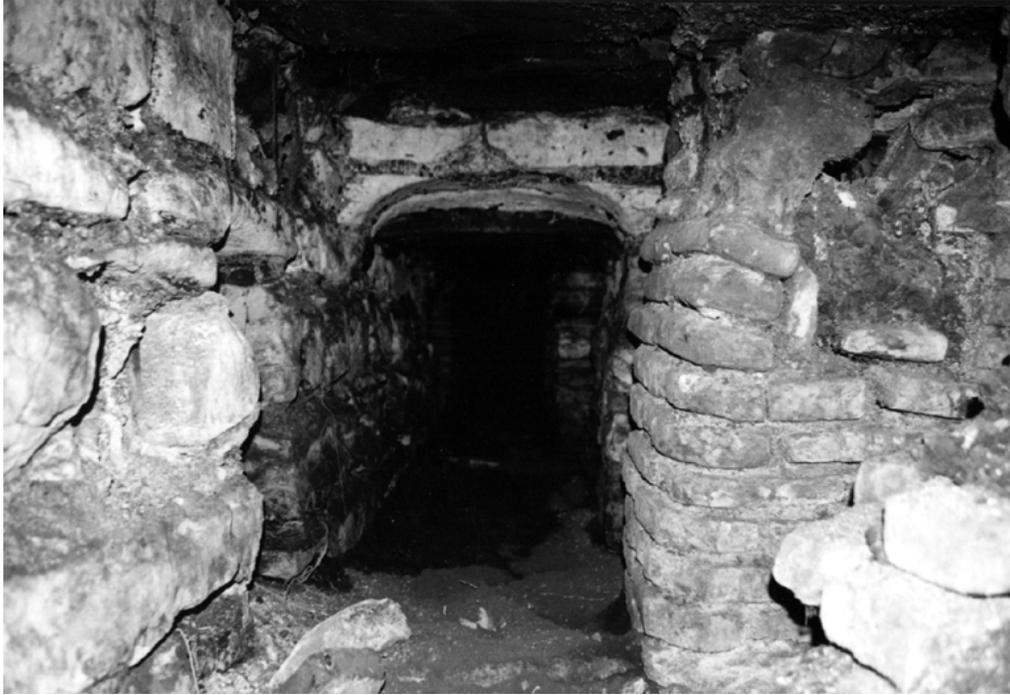
Figure 3.46. Urla Çifte Hamam, The Use of Stone Lintel above the opening of the Masonry Walls in the *Cehennemlik* Section

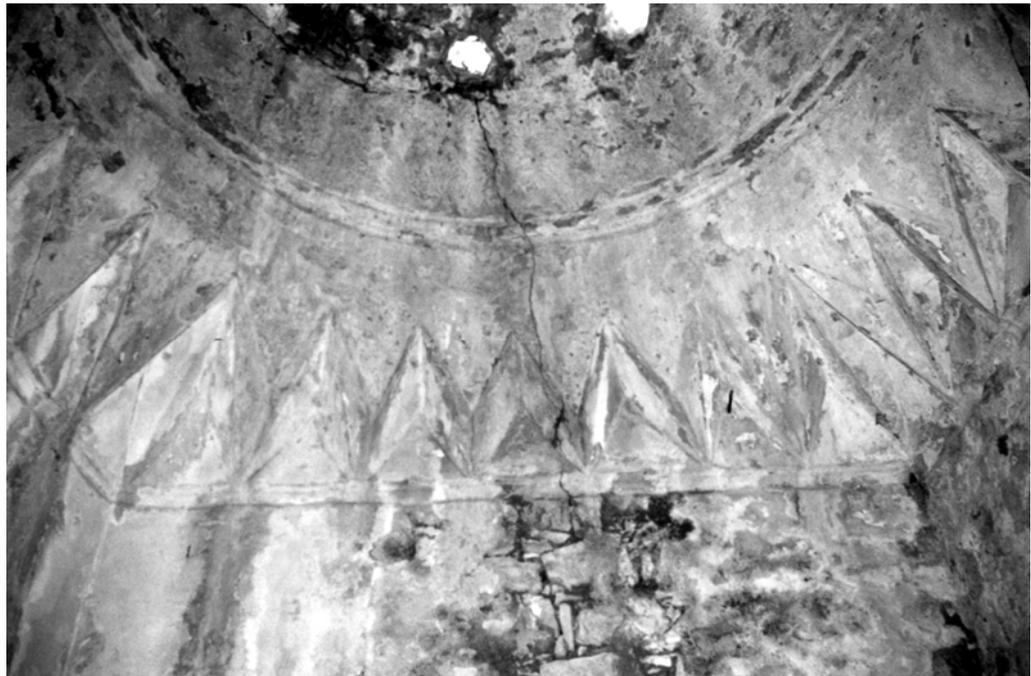
Figure 3.55. Urla Kamanlı Hamamı, The Belt of Turkish Triangles in the West *Halvet*

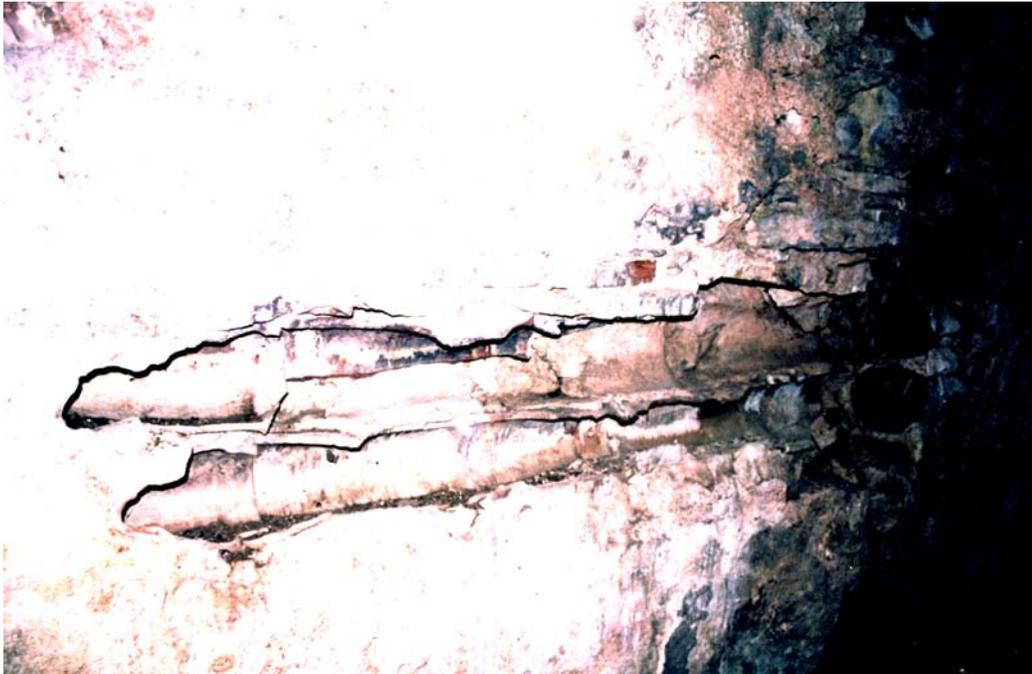
Figure 3.57. Urla Kamanlı Hamamı, Terracotta Pipes in the Main *Sıcaklık* Space

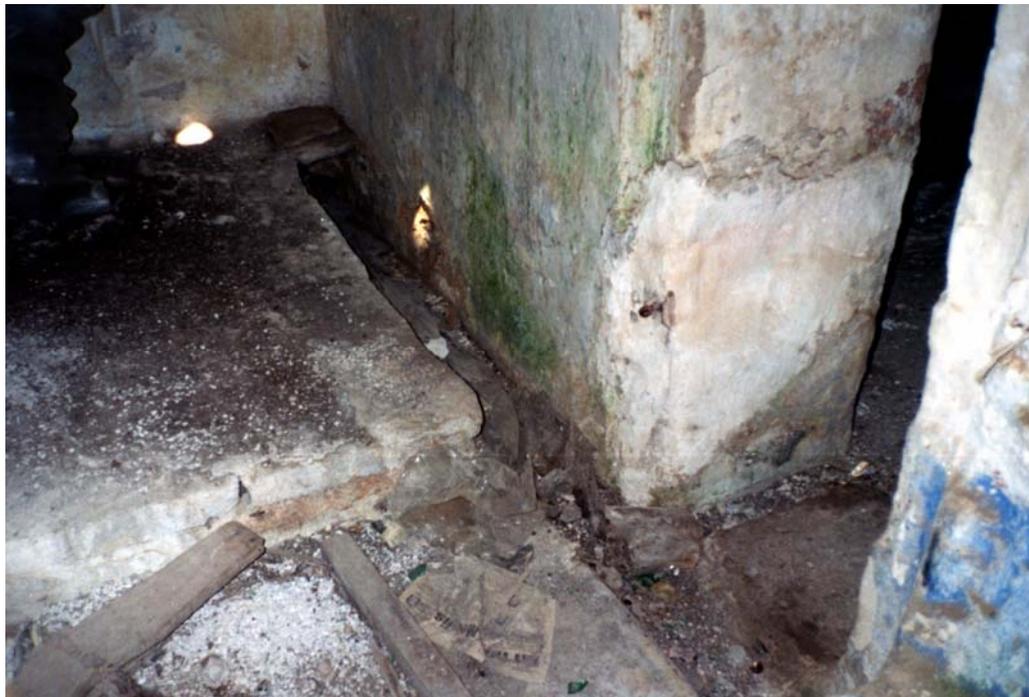
Figure 3.69. Urla Özbek Hamamı, The Waste Water Channels in the *Ilıklık* Space

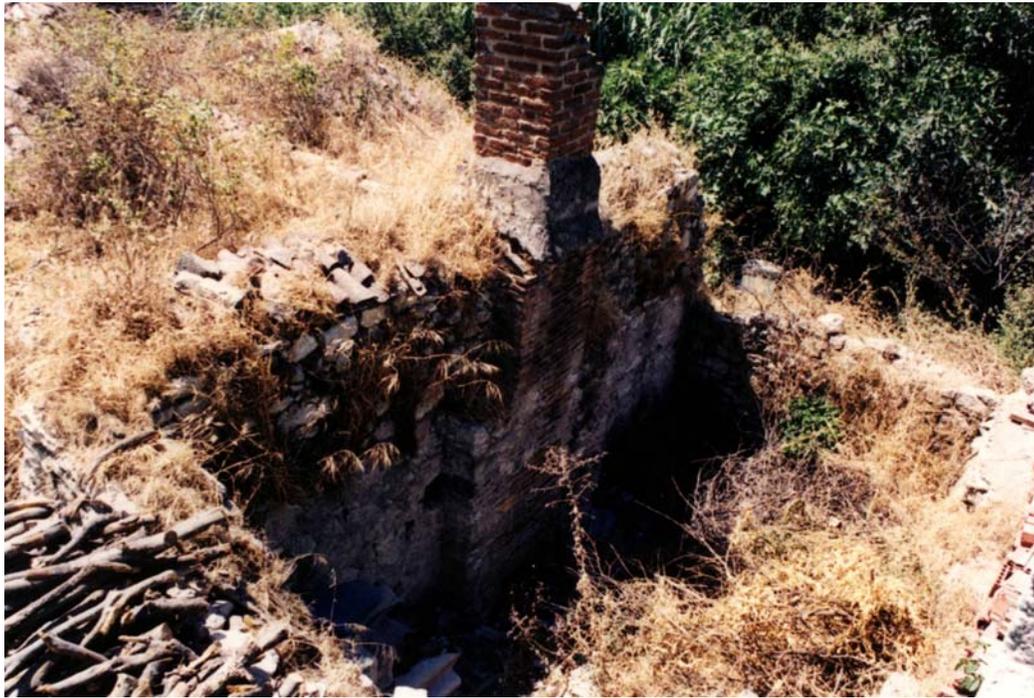
Figure 3.71. Urla Özbek Hamam, The Furnace

The heating system consists of the *külhan* under the water reservoir, the *cehennemlik* under the floor of *sıcaklık* spaces and the *tüteklik*s in the walls of *ıhlık* and *halvets* (Figure 3.70). The furnace and chimney on the northeast of the building still exist today. The *tüteklik* chimneys over the walls are ruined today (Figure 3.71).

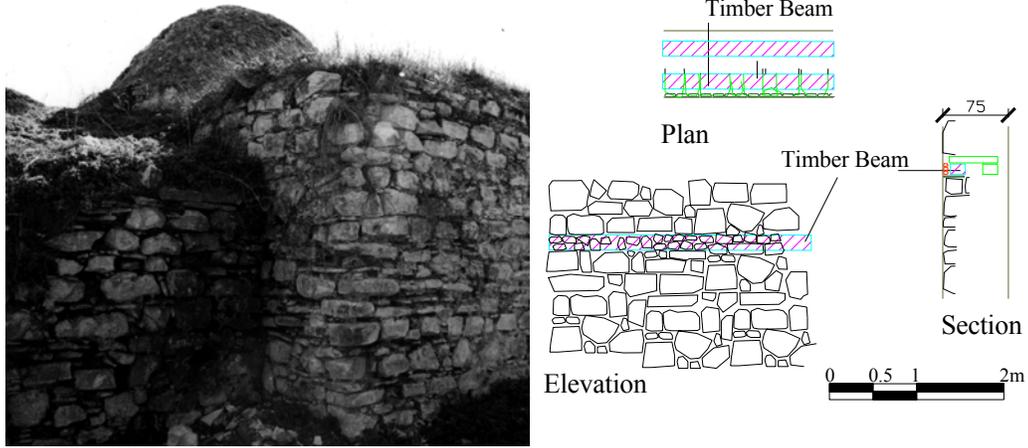
Figure 4.1. Urla Çifte Hamamı, Northwest elevation, Rubble stone bond

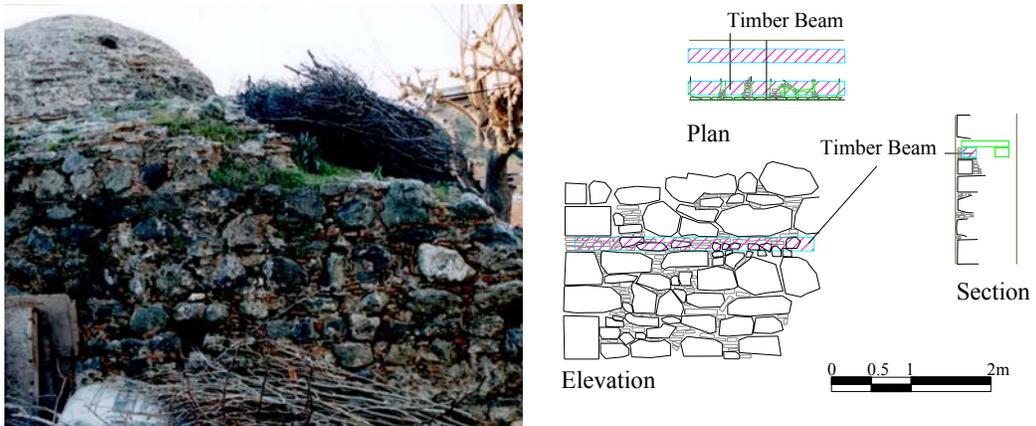
Figure 4.2. Ulamış Hamamı, East elevation, Rubble stone-large pieces of bricks in joints

**Use of rubble stones and large pieces of bricks in joints:** Brick pieces in the rubble stone bond were placed into the lime mortar filling the emptiness among rubble stones parallel to the horizontal joints on the surface and in the thickness of the wall. In Ulamış Hamamı, Seferihisar Küçük Hamam and Sığacık Kaleiçi Hamamı, north, south walls, and except the projecting part of the east wall of Düzce Hamamı, the east walls of *sıcaklık* spaces of Seferihisar Büyük (Great) Hamam and the northern wall belonging to the water reservoir of Özbek Hamamı, this bonding technique was used for the walls of the *sıcaklık* spaces. The corners of the exterior walls of Seferihisar Büyük Hamam and Sığacık Kaleiçi Hamamı were strengthened with a vertical line of reused cut stone (Figure 4.2).

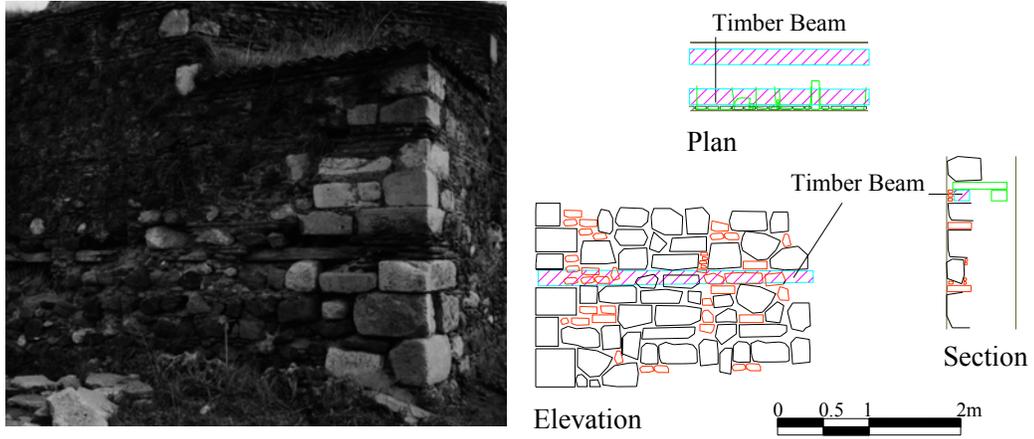
Figure 4.3. Seferihisar Büyük Hamam, North elevation, Rubble stone-bricks in some places and large pieces of bricks in joints

**Use of rubble stones, bricks in some places and large pieces of bricks in joints:** In rubble stone bond, bricks were placed parallel to joints among rubble stones in some places and large pieces of bricks were used in the horizontal and vertical joints on the surfaces of the walls. This bonding technique is seen at the interior walls, north and west exterior walls of Seferihisar Büyük Hamam and all interior walls of Düzce (Hereke) Hamamı (Figure 4.3).

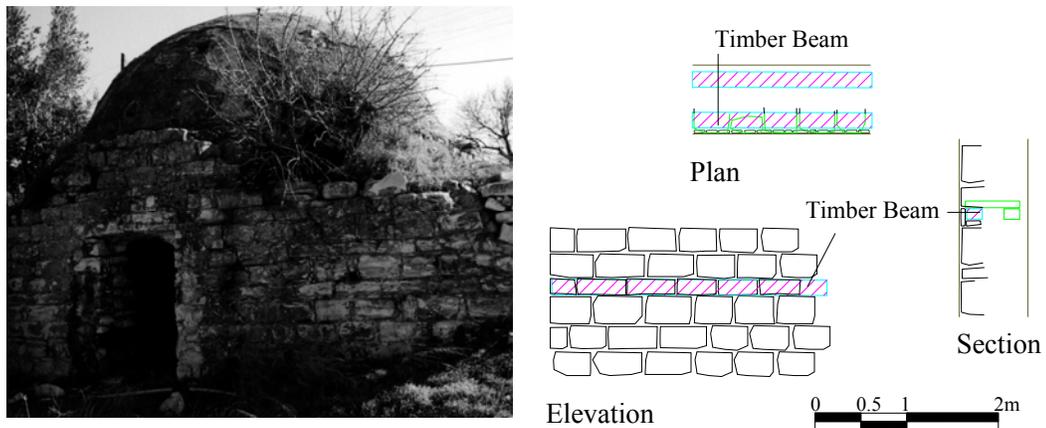
On the external part; among rough cut stone, well-arranged bonds were formed with 1-1.5 cm. joints with lime mortar as binding material. The thickness of the walls was filled with rubble stones and mortar in random. The northeast and northwest exterior walls of Rüstem Paşa Hamamı and projecting part on the northwest wall of Urla Çifte Hamam have this type of bond. Both rough cut stone and rubble stones were used in the interior walls of Kamanlı Hamamı, at the corners of interior walls, smooth surfaces were achieved by using rough cut stone (Figure 4.4).

Figure 4.4. Rüstem Paşa Hamamı, North-west elevation, Rough cut stone bond

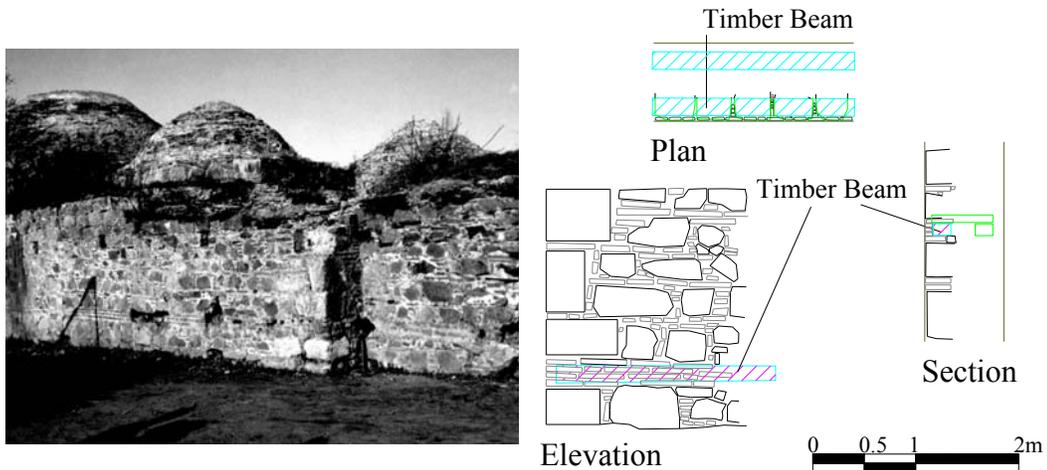
Figure 4.5. Düzce(Hereke) Hamamı, West elevation, Rubble stone-brick alternating bond

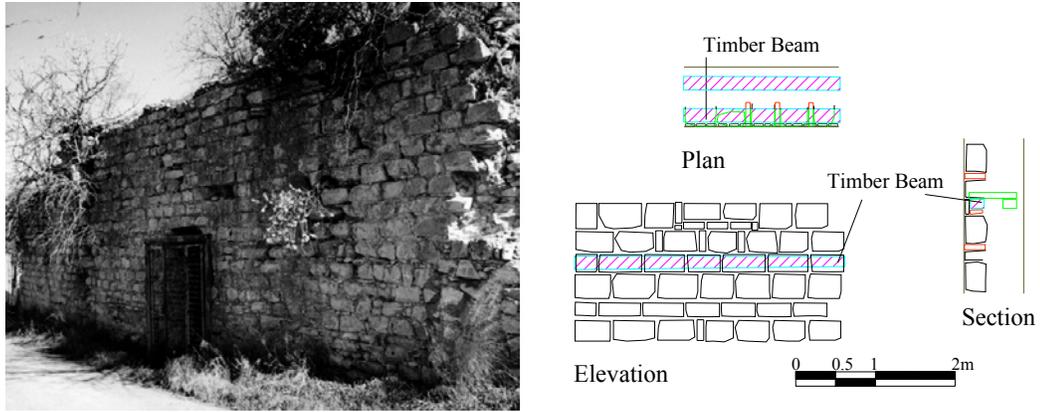
Figure 4.6. Kamanlı Hamamı, West elevation, Rough cut stone-brick alternating bond

**Rough cut stone / brick alternating bond:** This bonding technique is a course of rough cut stone encircled by bricks in some places and a course of brick. Exterior surfaces were built with joints 1-1.5 cm. in width, rubble stones and lime mortar were filled into the thickness of the walls. This bond type was only applied to the exterior walls of the *ıhlık* and *sıcaklık* spaces in Kamanlı Hamamı (Figure 4.6).

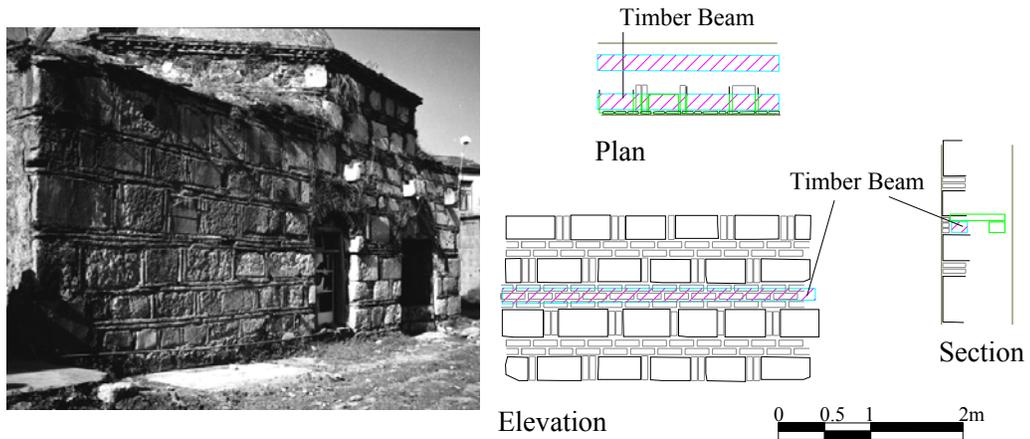
**Cut stone / brick alternating bond:** This is a bonding technique that was formed by a row of reused cut stone encircled by bricks, two rows of brick with horizontal and vertical thin joints. It can be seen in Seferihisar Büyük Hamam, on the parts belonging to the dressing hall (*soyunmalık*) and warm area (*ılıkık*) of the east wall where the entrance was placed. In the alternating bond seen at the corners of the exterior walls and the sides of doors and windows in Düzce Hamamı, one row of reused cut stone and one row of brick were used (Figure 4.7).

Figure 4.7. Seferihisar Büyük Hamam, East elevation, Cut stone-brick alternating bond

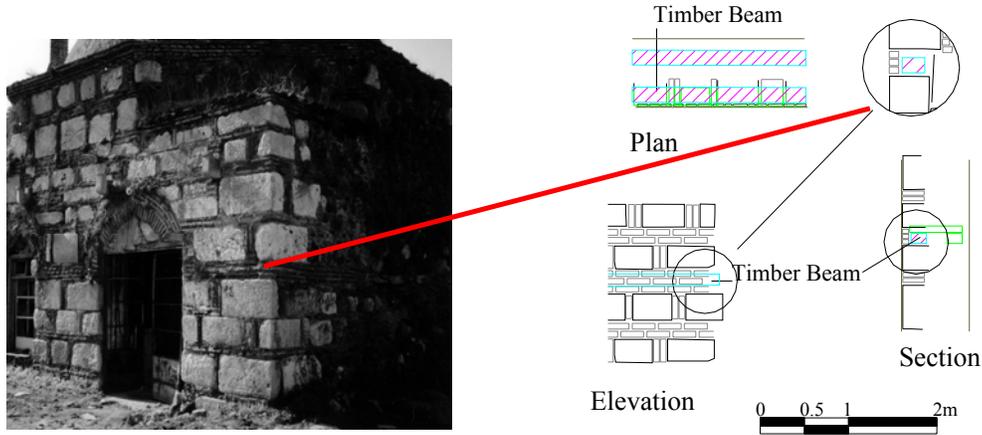
window openings. Timber beams were generally placed in two rows in the thickness of the wall. The first is behind brick bond which consists of three courses and close to the surface, the other was placed in the thickness of the wall. The beams which are approximately 15 x15 cm. connected to each other by the timber elements placed vertical to the beams in the wall through the use of metal clamps (Figure 4.8).

Figure 4.8. Seferihisar Büyük Hamam, North and east elevation, The use of timber beam

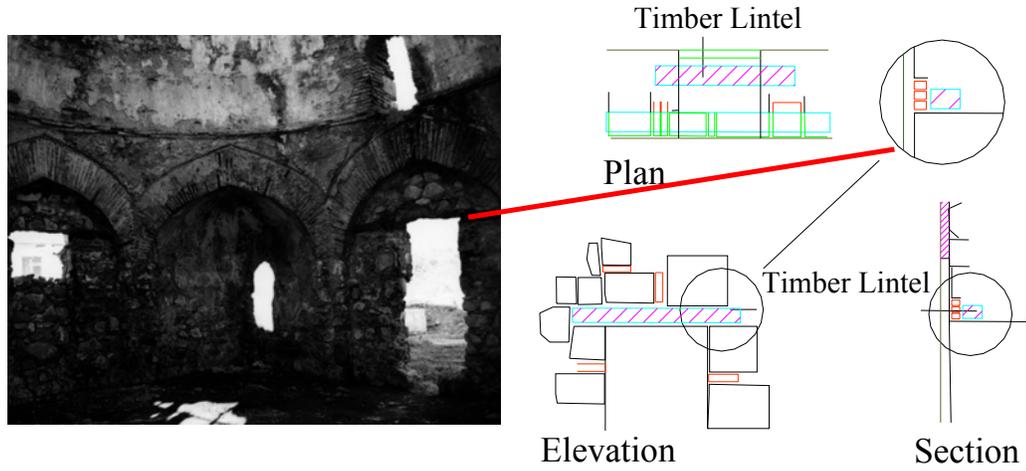
Figure 4.9. Düzce(Hereke) Hamamı, *Soyunmalık* space, The use of timber lintel

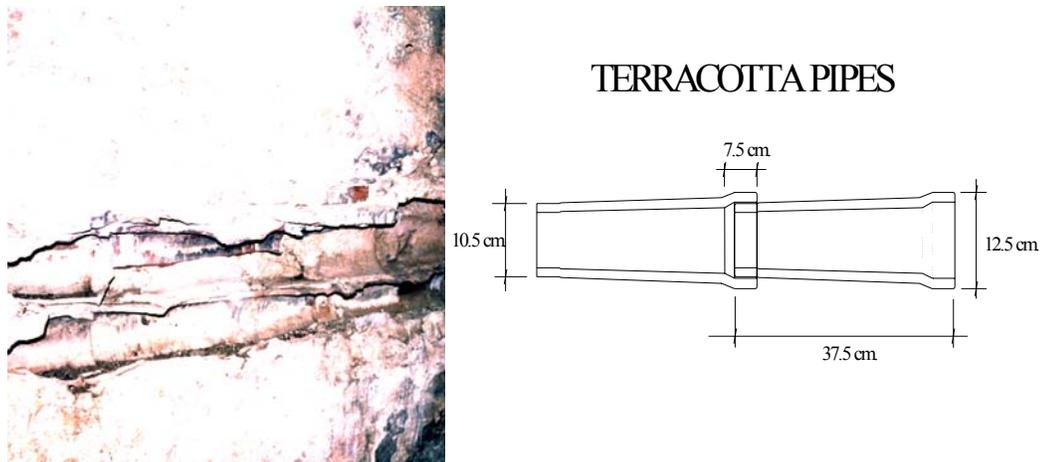
Terracotta pipes, which were also called “*merbah*” or “*pöhrenk*” (Önge 1995), were made of baked clay and were placed along the walls to provide distribution of cold and hot water from the reservoir to the *sıcaklık* spaces (Figure 4.29). They are in the cylindrical form and one end is larger than the other to be connected to each other. One end is approximately 10.5 cm. the other is 12.5 cm. in diameter, 1.5 cm. in thickness and 37.5 cm. in length. They were embedded with a waterproof mortar called “*lökün*” along the walls (Önge 1995). These pipes in the walls are arranged in one or two lines for cold and hot water according to the necessity or the size of the bath. They were divided into two lines from the wall of the reservoir and placed along the internal surfaces of the walls.

Figure 4.29. Urla Kamanlı Hamamı, Two Row Terracotta Pipes in the Northwest *Halvet*

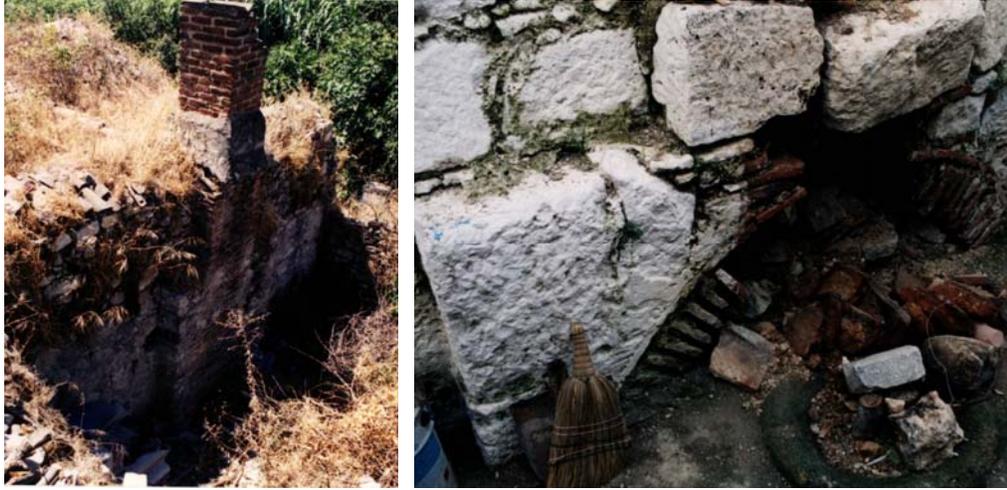
The heating system consists of a furnace located underneath the water reservoir, *cehennemlik* arranged underneath floors of *ılıklık* and *sıcaklık* spaces, flue chimneys built with terracotta pipes vertically in the walls (Figure 4.40 and 4.41). *Cehennemlik* was built by covering cut stone on masonry walls which were nearly 90-120 cm. high, formed using brick or cut stone materials adhered with lime mortar. *Cehennemlik* section was arranged underneath the floors of *ılıklık* and *sıcaklık* spaces in all baths however, not under the *ılıklık* space of Urla Çifte Hamam and Kamanlı Hamamı. While the fire, which was set in the furnace section, provided heat for the water in the water reservoir through the help of a water boiler, the smoke circulated through *cehennemlik* space provided heat to the floors. On the other hand, the heating of spaces were supplied by circulating steam of water heated in the water reservoir. This steam passed from the controlling window to the bath spaces. The circulating steam in *cehennemlik* space was sent off outside through flues located in the walls. In addition, the floors were heated by the steam, circulating underneath the floors. In Turkish baths, the furnace openings were generally located in a pointed deep arched niche in front part of furnace and a large furnace chimney, rising from the upper part of that niche, was built so as not to be consumed by fire, blown back when the furnace wing was opened. In the studied baths, a section, perpendicular to the long side of the water reservoir, projecting out in the center, was arranged and brick bond arched furnace opening was placed. That furnace chimney rising on the top of this part has been observed. This order has been understood through the traces in the examples of Özbek Hamamı, Seferihisar Küçük Hamam, and Sığacık Kaleiçi Hamamı. But, since the floor level was filled with debris in most of the studied baths the furnace section could not be observed. Furnace chimneys were built with bricks of 16 x 21 x 6-7 cm. dimensions.

Figure 4.40. A Urla Özbek Hamamı, The Furnace (*Külhan*) Section  
B Sığacık Kaleiçi Hamam, The Furnace (*Ocak*)
