**CONSERVATION AIMED EVALUATION OF
DARKALE RURAL SETTLEMENT IN
SOMA, MANİSA**

**A Thesis Submitted to
the Graduate School of Engineering and Sciences of
İzmir Institute of Technology
In Partial Fulfillment of the Requirements for the Degree of**

in Architectural Restoration

**by
Ayşen ETLACAKUŞ**

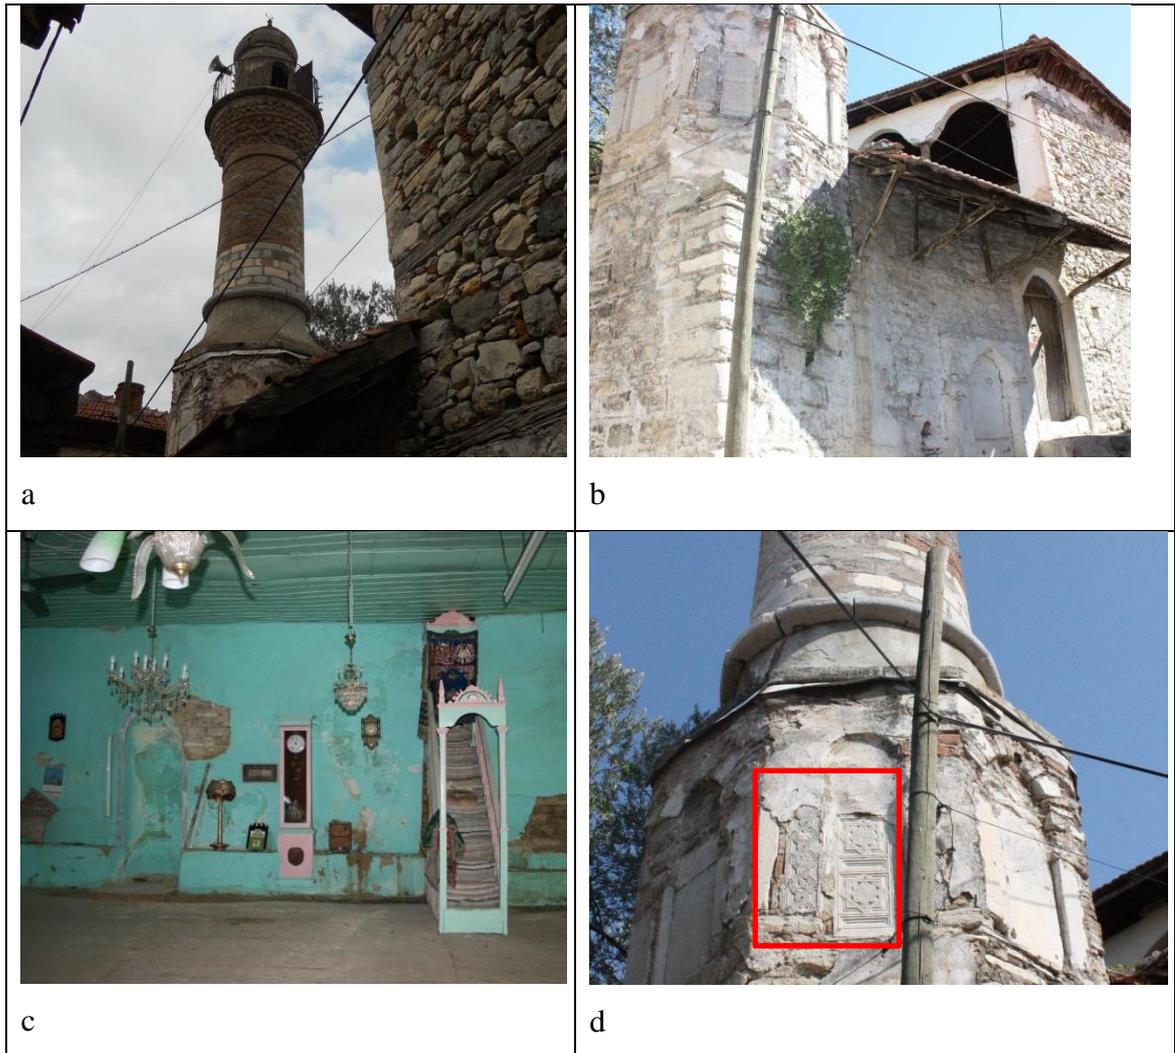
There is a fountain adjacent the west wall of the mosque and it is located near the entrance (Figure 31b). The mosque has a square plan type. It was constructed with stone masonry wall and timber posts. The last comers praying hall is designed as a semi-open space which is constructed with timber frame system. There is a ladies praying hall which is elevated from the ground level. A *mihrap* niche and *minber* are observed in the mosque. All of the walls are plastered and painted. While the floor is covered with slate, the ceiling is covered with timber (Figure 31c).

Reused materials which are thought to be from Seljuk Period were used in the construction of the minaret (Figure 31d). Moreover, antique building materials are observed in the courtyard.

Figure 31. a) The short minaret of the mosque, b) Entrance of the mosque and its fountain, c) the view of the interior of the mosque, d) Reused materials at the minaret.

Minareli Mosque is abandoned at present because of its structural failures and serious material deteriorations stemming from lack of maintenance and aging.

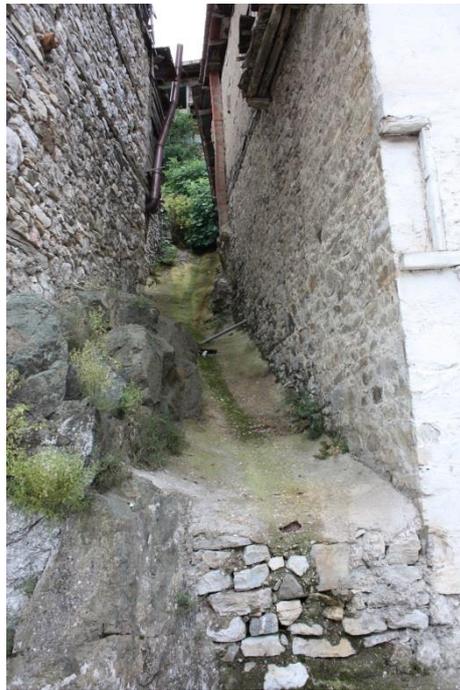
Additionally, narrow sloppy ramp are observed between the two housing units which is not used by human (Figure 44). These street elements provide to carry of rainwater from the higher street to lower one. The flooding is prevented thanks to these ramps.

Figure 44. The view of ramp between two housing units, 2013.

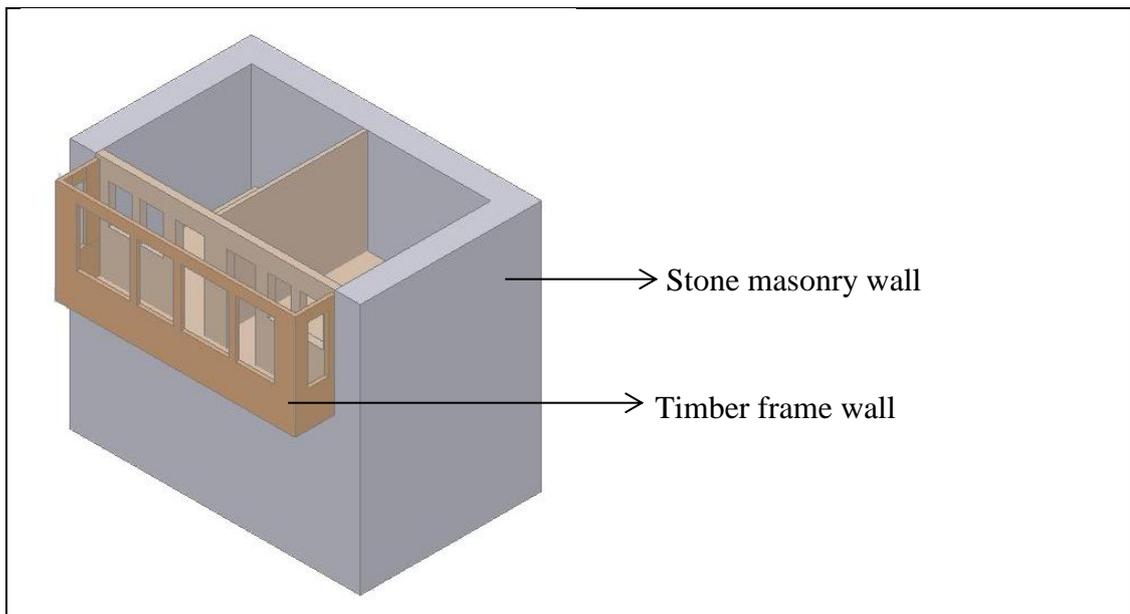
Figure 51. Schematic 3D drawing of construction technique of Darkale housing unit

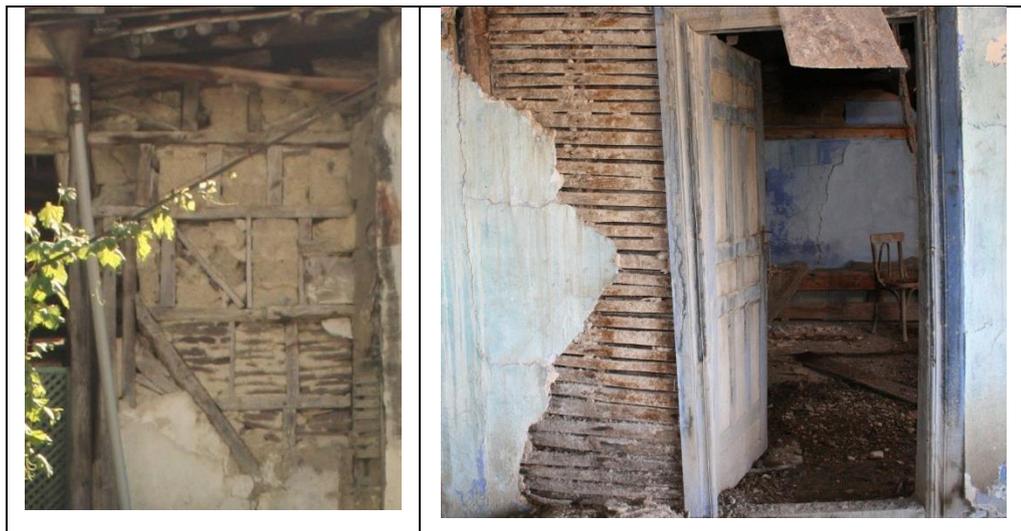
Figure 55. Timber frame and timber lath construction system, 2013

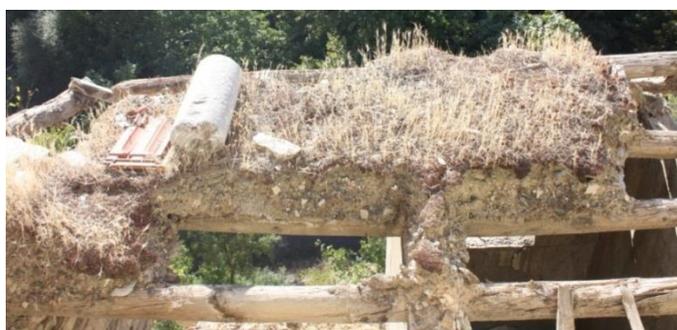
Figure 59. The view of the *loĝ* stone on the roof with earth covering, 2013

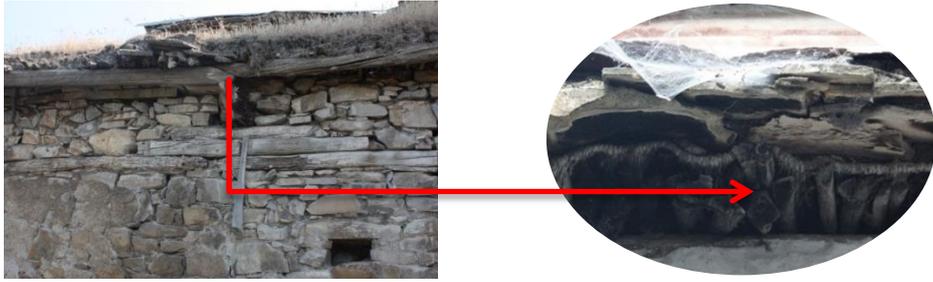
Figure 60. The view of detail of the earth covering, 2013

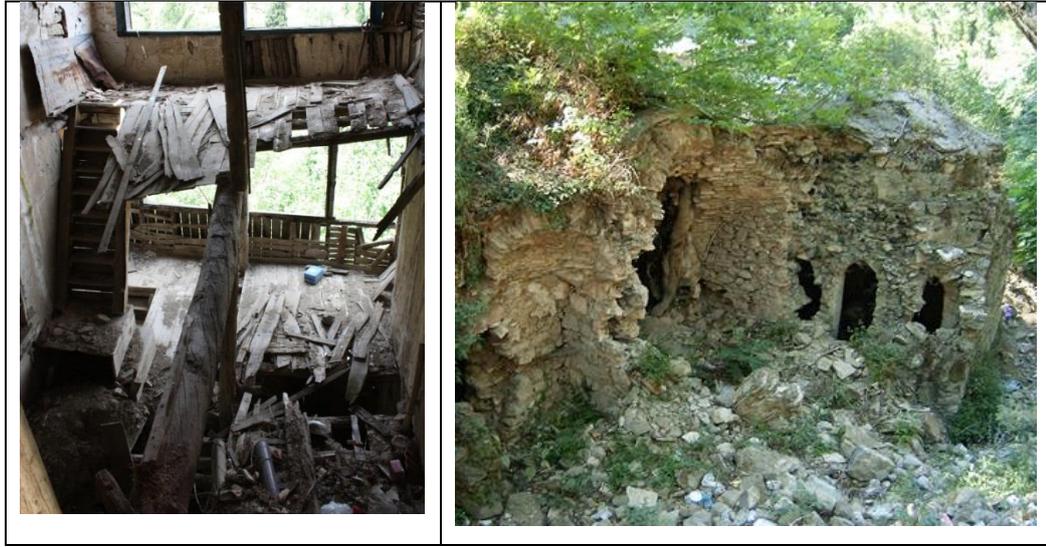
Figure 64. The view of the housing unit and a bath in bad condition, 2014

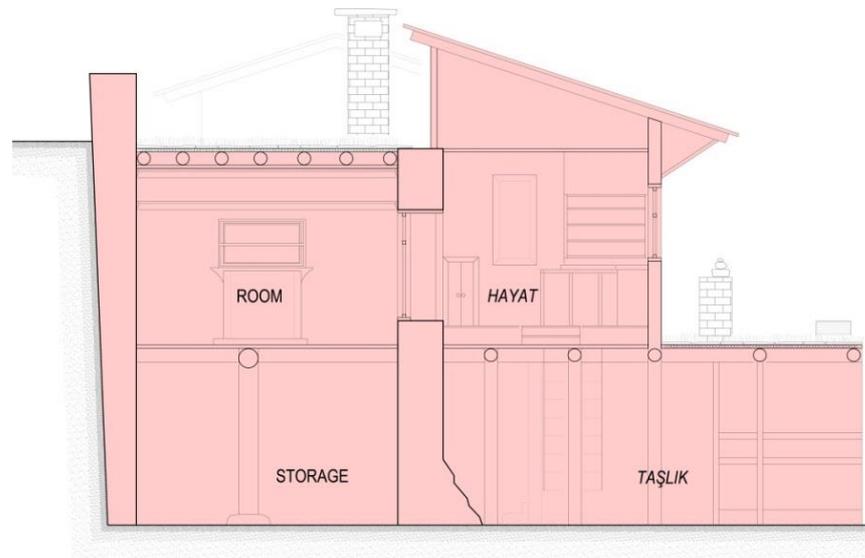
Figure 68. The section of house numbered 43 composed of only main mass.

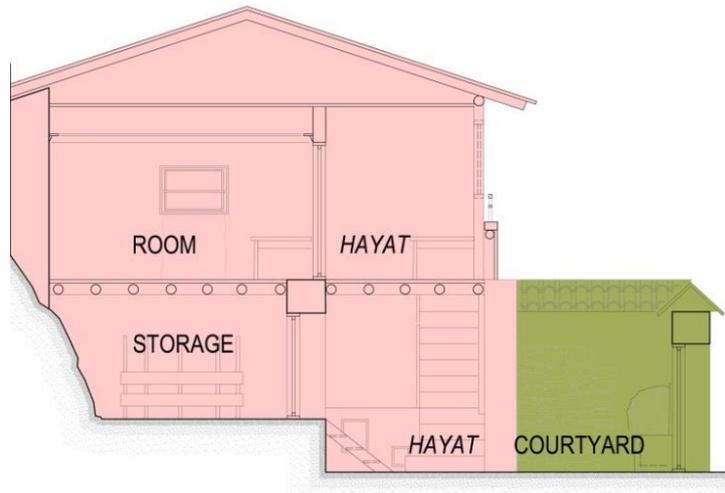
Figure 69. The section of house numbered 45 composed of main mass and courtyard.

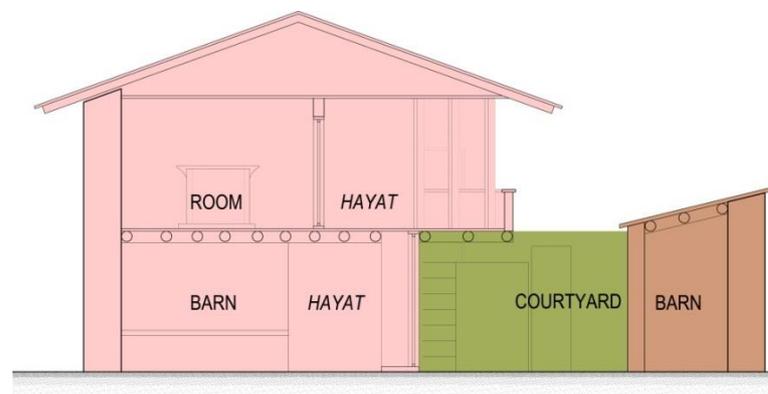
Figure 70. The section of house numbered 115 composed of main mass with courtyard and annex.

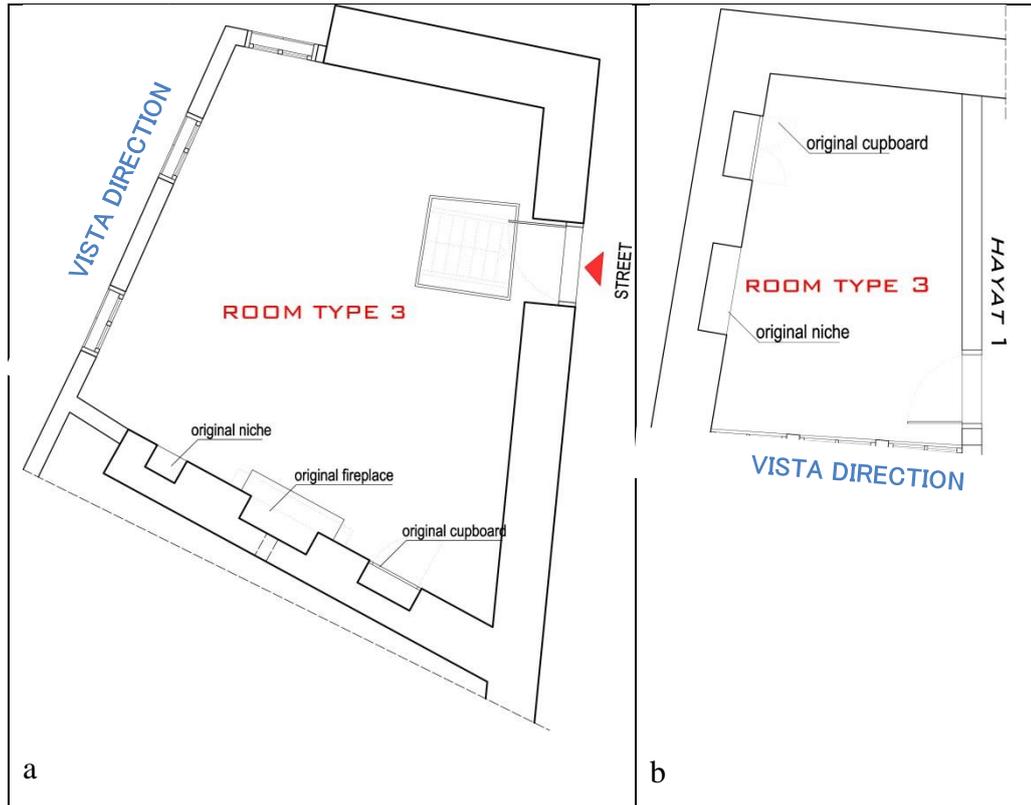
Figure 78. a) The plan of the Room Type 3, house numbered 13, b) The plan of the Room Type 3, house numbered 45.

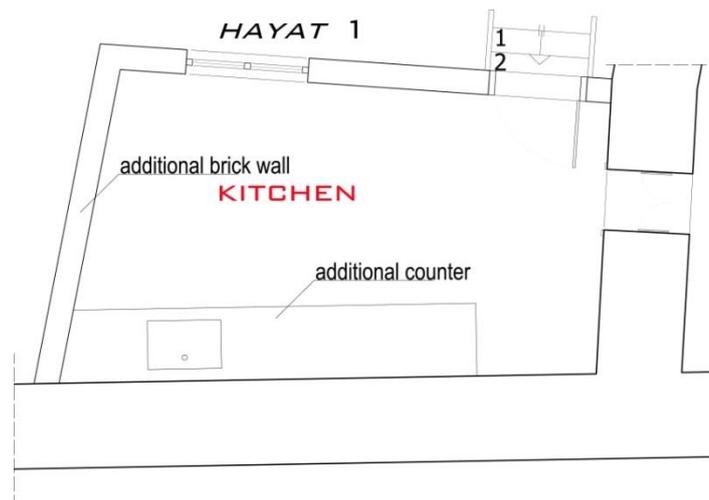
Figure 83. The plan of the kitchen, house numbered 151.

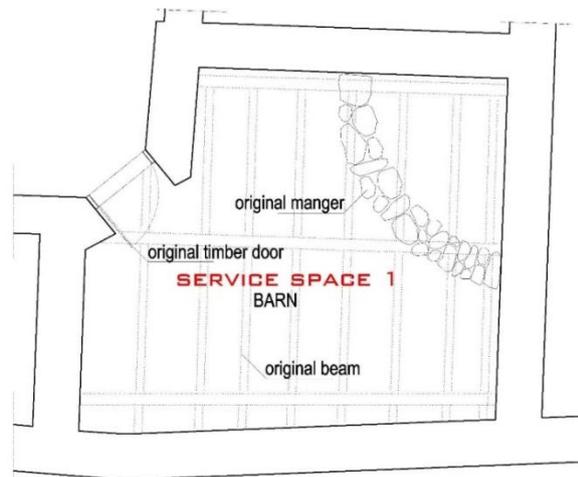
Figure 88. The plan of the Service Space1, house numbered 8.

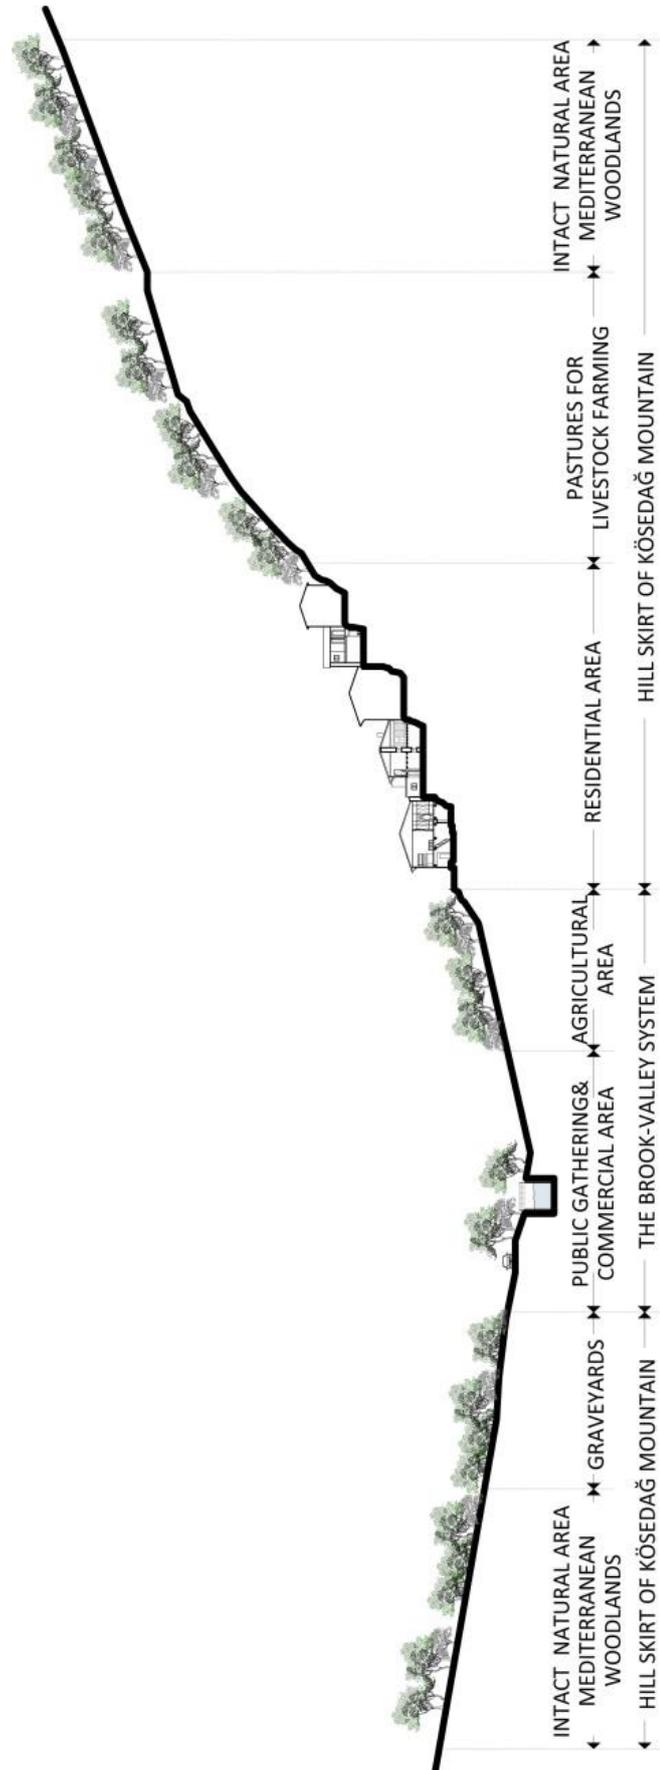
Figure 100. The site section of Darkale cultural landscape.

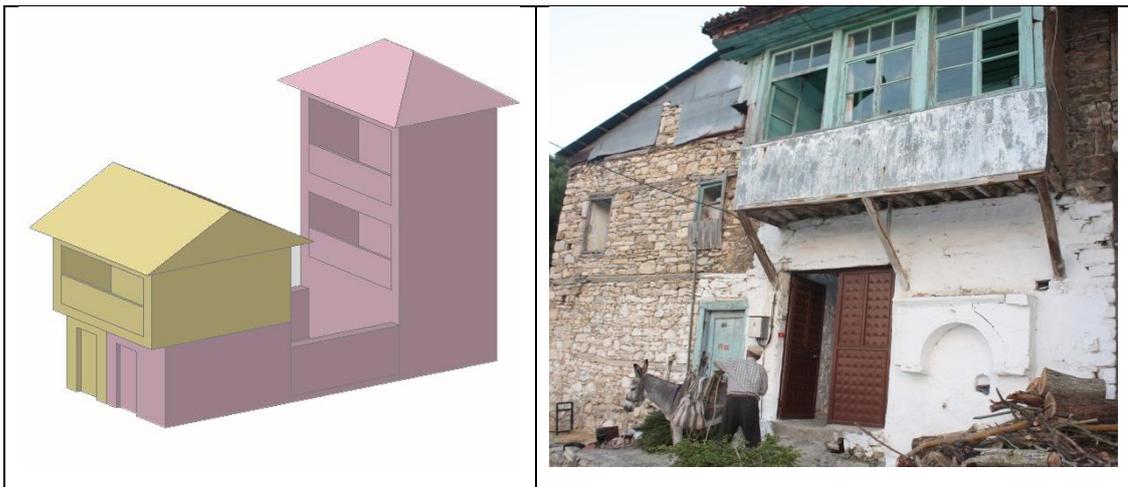
Figure 113. Schematic 3D drawing and photo of the houses numbered 53-A and 53-B

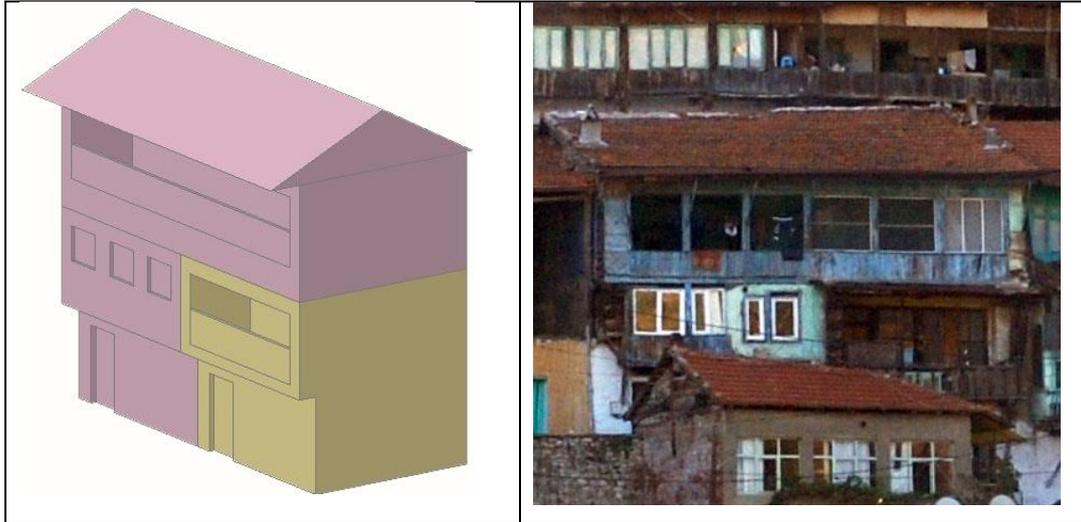
Figure 114. Schematic 3D drawing and photo of the houses numbered 97 and 98

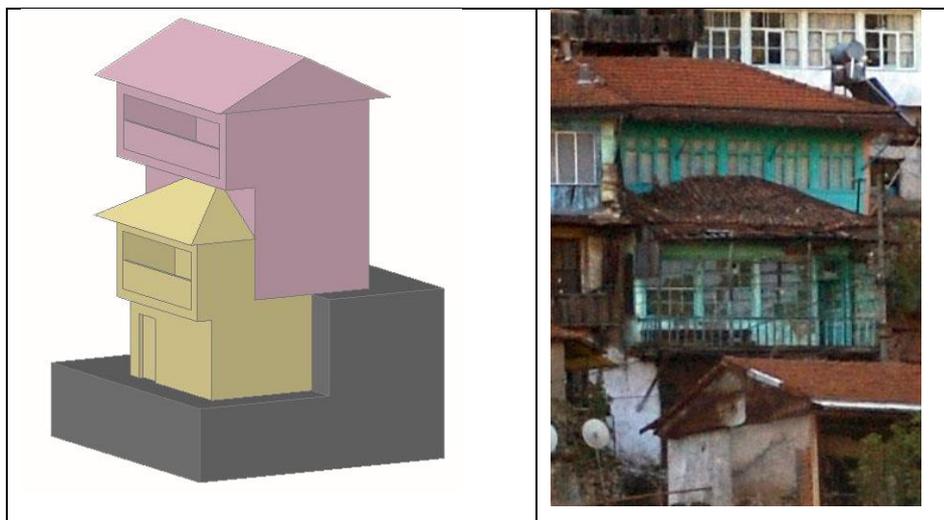
Figure 115. Schematic 3D drawing and photo of the houses numbered 23 and 98-B.

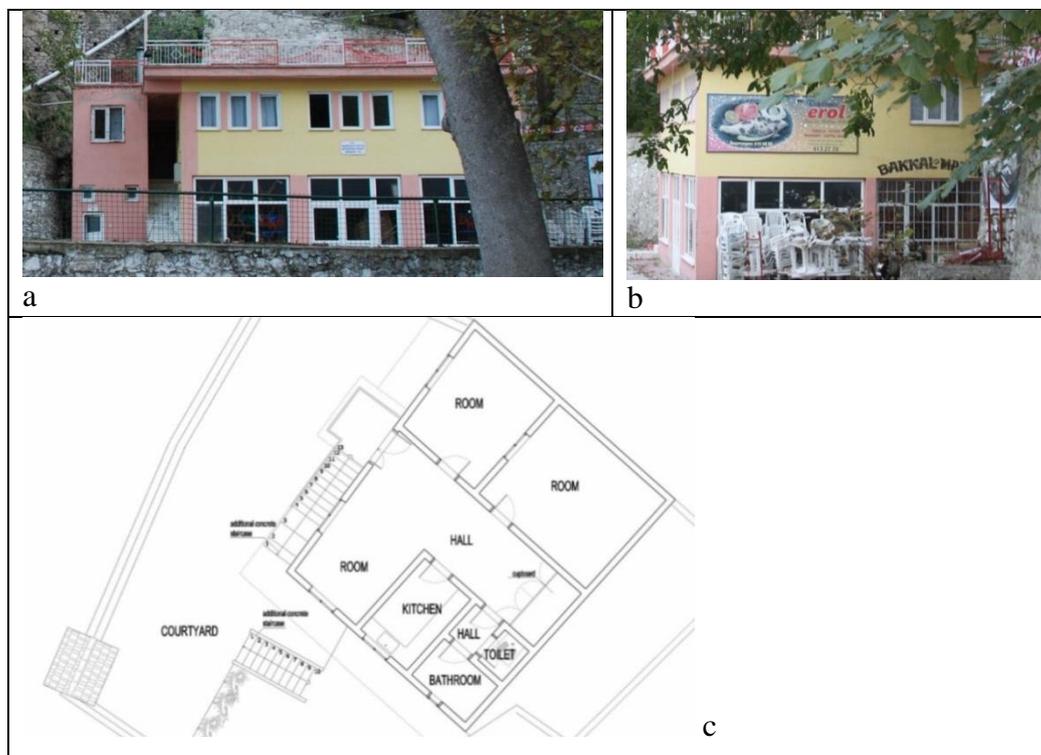
Figure 116. a-b) The view of the unqualified mass addition, 2013, c) The example of the mass addition, house numbered 55.

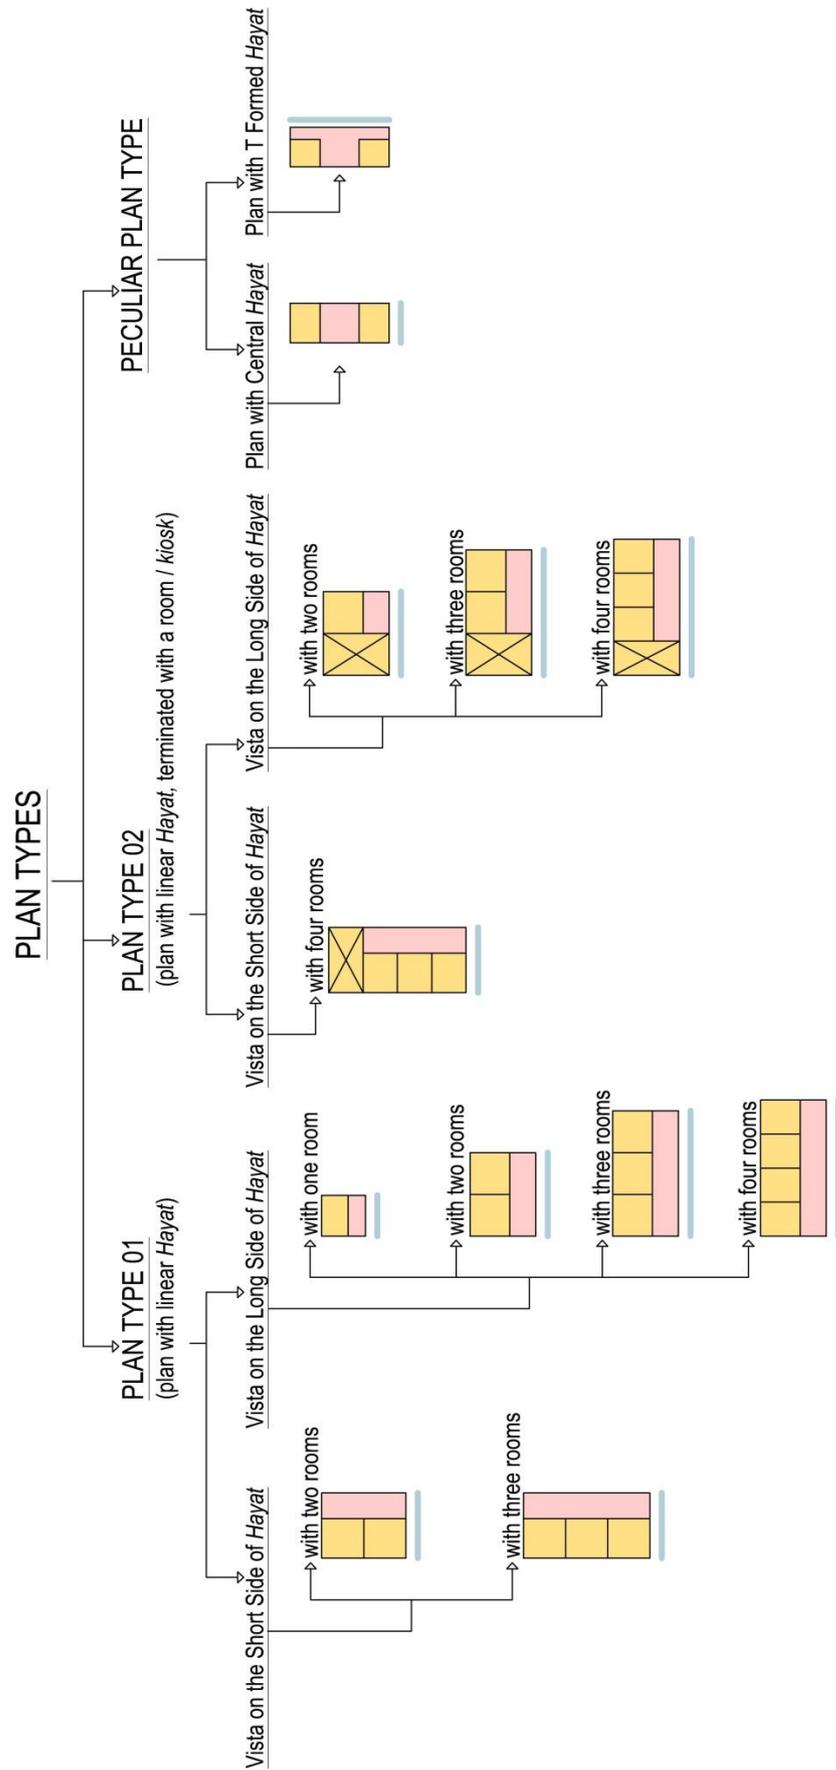
Figure 121. The diagram of the housing typology.

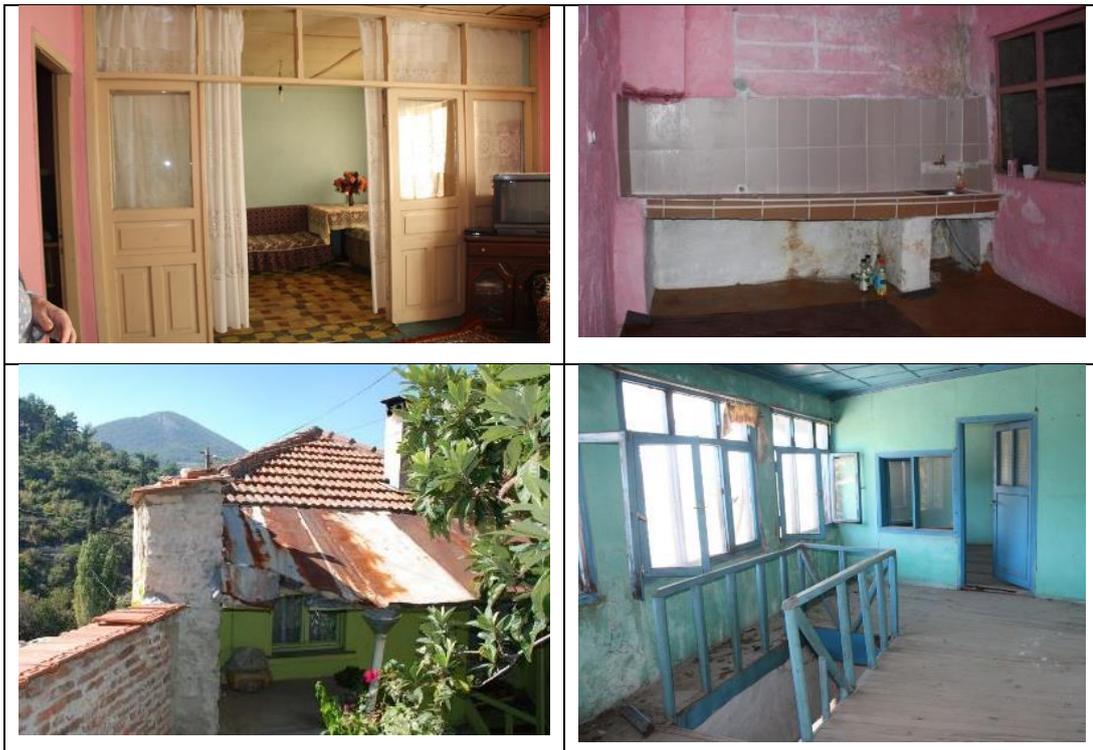
Figure 122. The functional transformations of spaces.
