**PLASTER CHARACTERISTICS OF
ÇİNİLİ HAMAM
BUILT BY MİMAR SİNAN IN İSTANBUL**

**A Thesis Submitted to
the Graduate School of Engineering and Sciences of
İzmir Institute of Technology
in Partial Fulfillment of the Requirements for the Degree of
MASTER OF SCIENCE
in Architectural Restoration**

**by
Emre İPEKÇİ**

**July 2016
İZMİR**

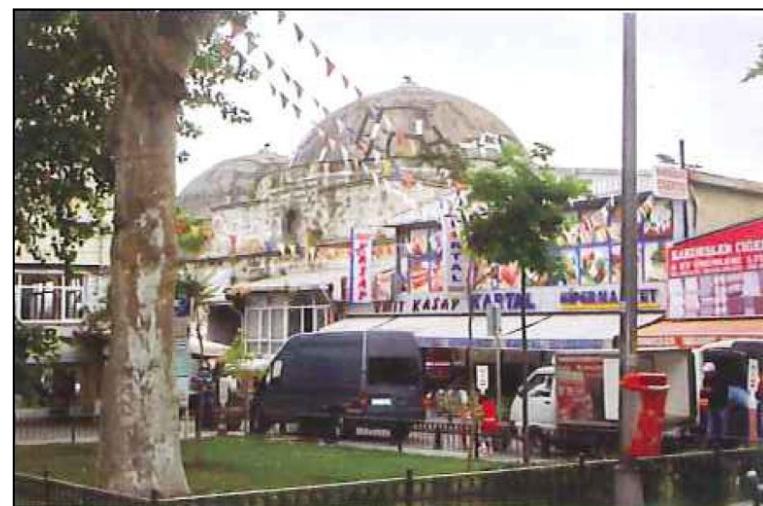
Figure 2.4. Zeyrek Çinili Bath, northwest elevation
(Source: KA.BA 2012)

As a result of these fires, the bath lost its waqf property and was transferred to personal ownership. The bath was repaired by Ali Bey between 1833 and 1850 and started to use as public bath again (Koçu 1944) (Figure 2.3, 2.4).

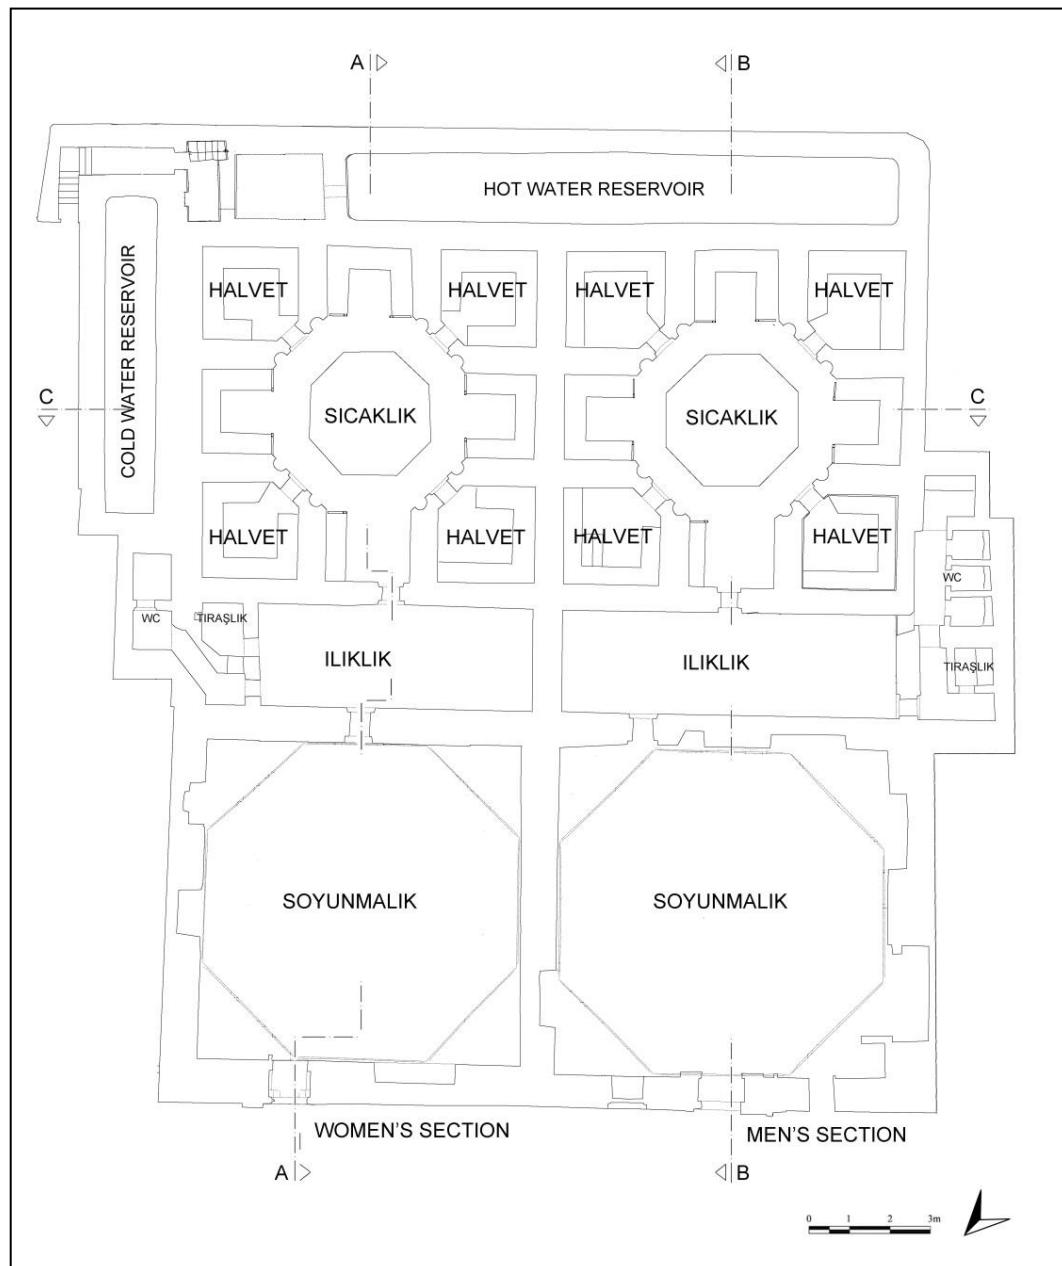
Figure 2.7. Plan of Zeyrek Çinili Bath
(Source: KA.BA)

Zeyrek Çinili bath was built as a typical double bath consisting of men's and women's sections. These sections were built symmetrically with the same plan organization. Each of the sections has a "soyunmalık" (changing area), a "ılıklik" (warm area) and a "sıcaklık" (hot area). Hot and cold water reservoirs and külhan are situated on the behind of the sıcaklık spaces. The entrances of the bath are provided from the northwest separately to the men's and women's sections (Figure 2.7).

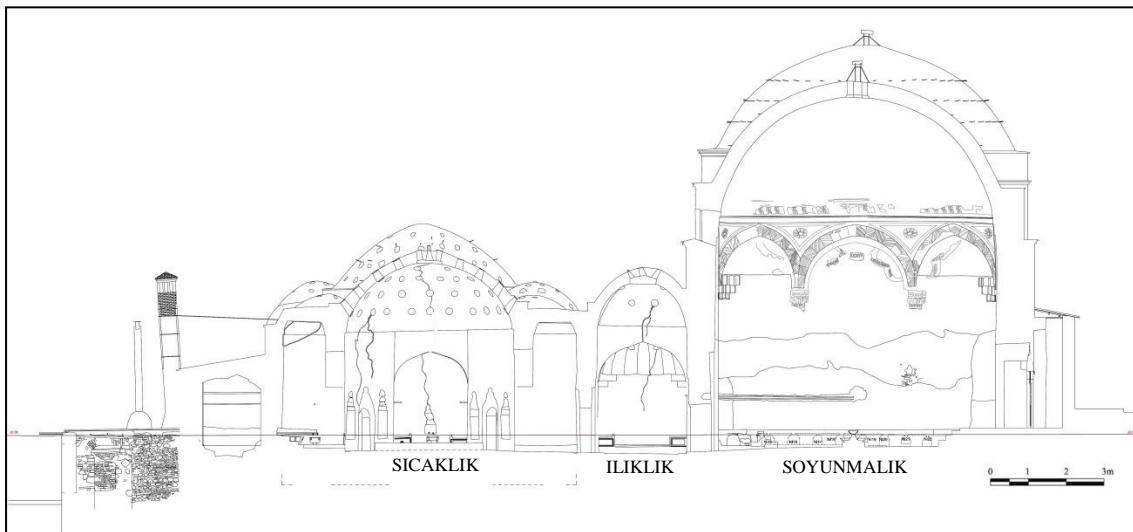
Figure 2.8. Section A-A of Zeyrek Çinili Bath
(Source: KA.BA)

The soyunmalık which is entered from the outside as the first space is square planned, covered with a large dome (Figure 2.8). Wooden two-storey galleries consisting of changing rooms were added to soyunmalık and also a marble fountain was placed at the middle of the soyunmalık of Men's section in the 19th century (Koçu 1944).

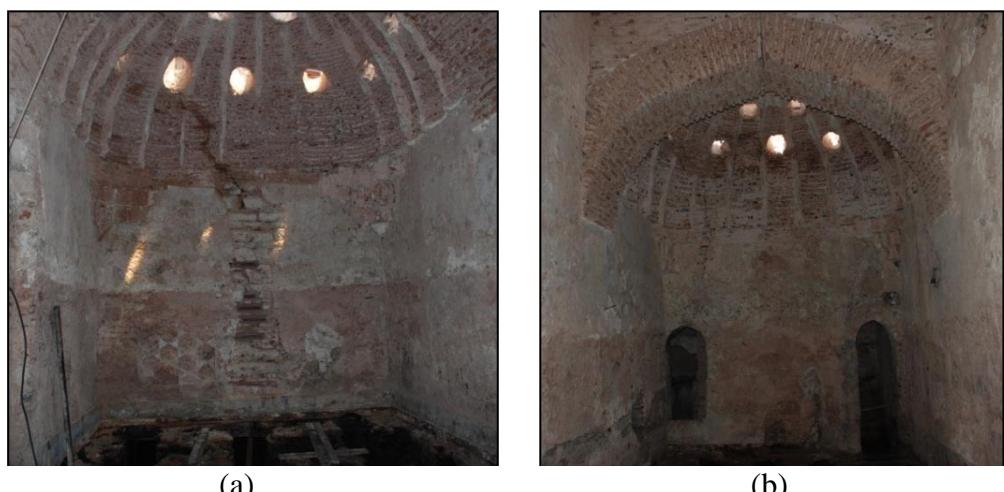
Figure 2.9. Northeast elevation (a) and southwest elevation (b) of ılklik of Zeyrek Çinili Bath

The ılklik is located on the between of soyunmalık and sıcaklık as a transition space. It has smaller area than soyunmalık and sıcaklık. This space is rectangular planned and connected to service rooms like toilets and shaving rooms (Figure 2.9).

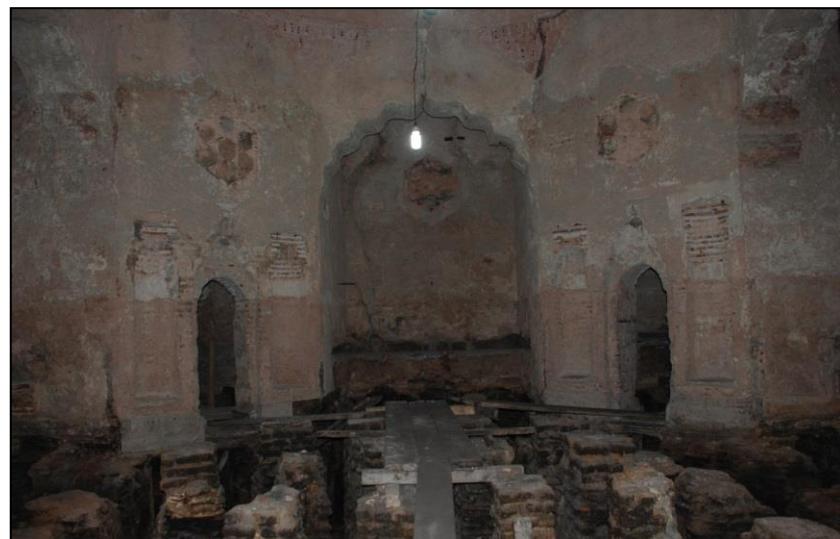
Figure 2.10. Sıcaklık of Zeyrek Çinili Bath

The sıcaklık space which is square planned has four halvet rooms on the corners and four iwans on between of them. Two niches with muqarnas are situated on sides of halvet entrances. An octagonal marble slab is placed on the centre of the sıcaklık (Figure 2.10).

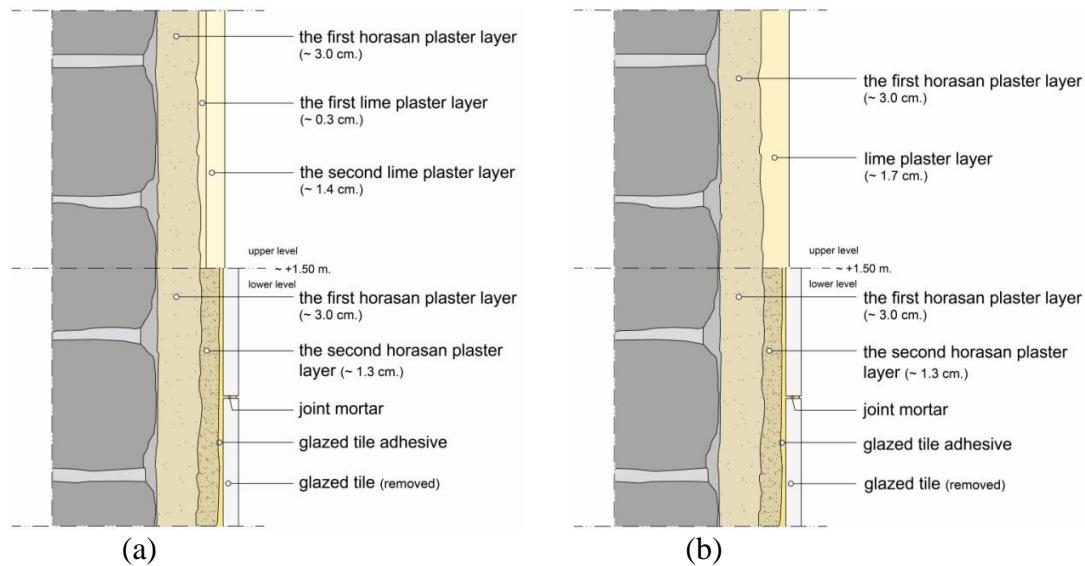
Figure 2.11. Plaster layers of ılklik (a) and sıcaklık (b) of Zeyrek Çinili Bath

The upper level plasters were consisted of a rough horasan plaster layer with one or two fine lime plaster layers. The plasters of the domes of men's and women's soyunmalık spaces were consisted of a rough horasan plaster layer and a lime plaster layer (Figure 2.11, 2.12)

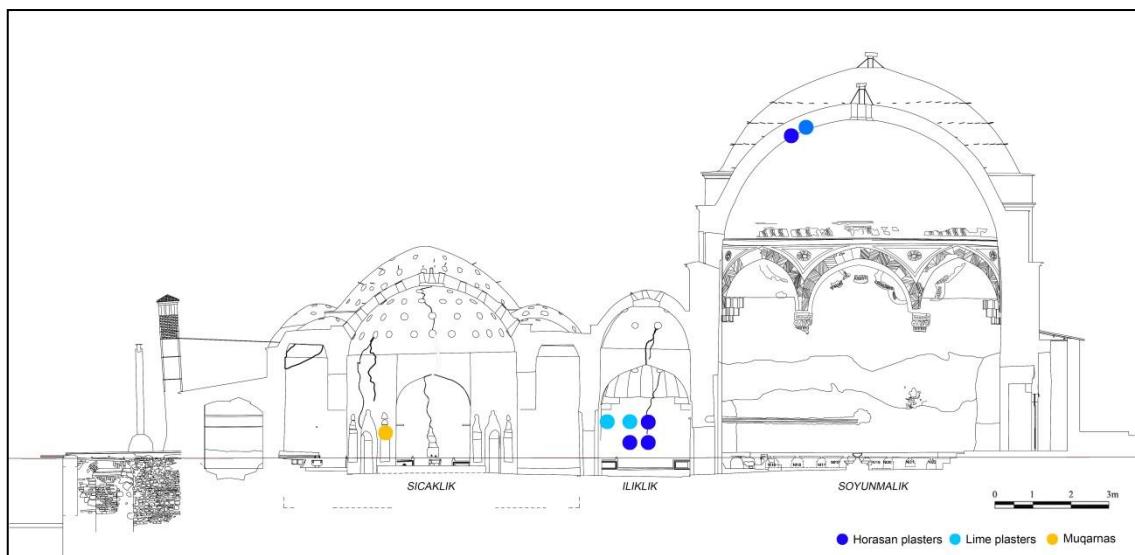
Figure 3.1. Section A-A of Zeyrek Çinili Bath showing where the samples were collected
(Source: KA.BA 2015)

Horasan and lime plaster samples were collected from the interior wall surfaces of ılklık, sıcaklık and halvet spaces and from the domes of soyunmalık of the men's and women's sections of the bath (Figure 3.1-3.8).

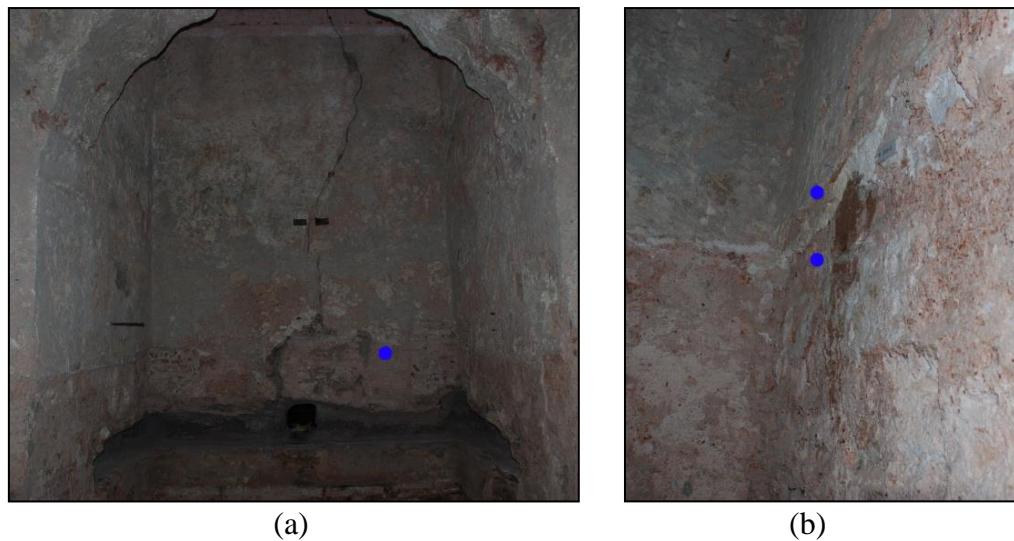
Figure 3.3. Sıçaklık space of the men's section (a) and women's section (b) showing where the samples were collected

16 samples were collected from the men's section of the bath. 6 samples were from lower level and 6 samples were from upper level. 2 samples were taken from niche mortar and glazed tile adhesive. 2 samples were taken from the dome of men's soyunmalık space. 16 samples were collected from women's section of the bath. 6 samples were from lower level and 6 samples were from upper level. 2 samples were taken from a muqarnas and joint mortar of the glazed tiles. 2 samples from the dome of women's soyunmalık space were taken (Figure 3.3-3.8).

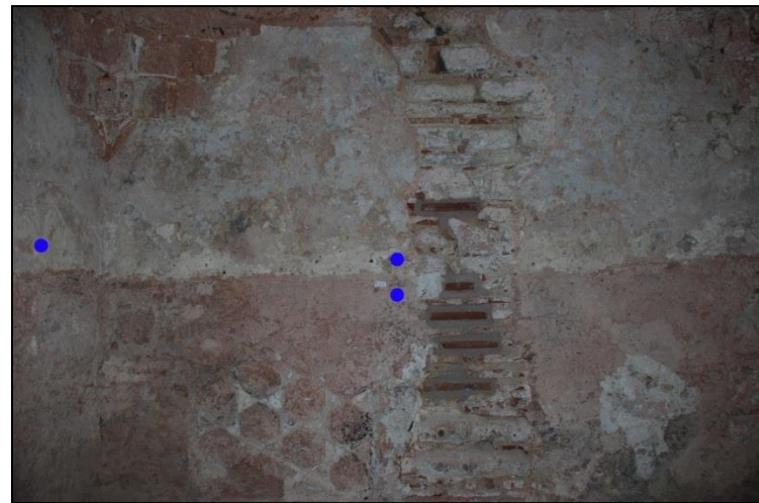
Figure 3.5. Iliklik space showing horasan plasters attached glazed tiles

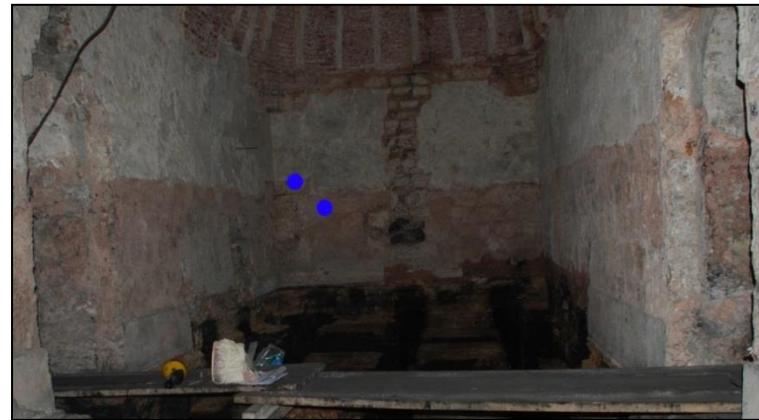
Figure 3.6. Iliklik space showing where the samples were collected

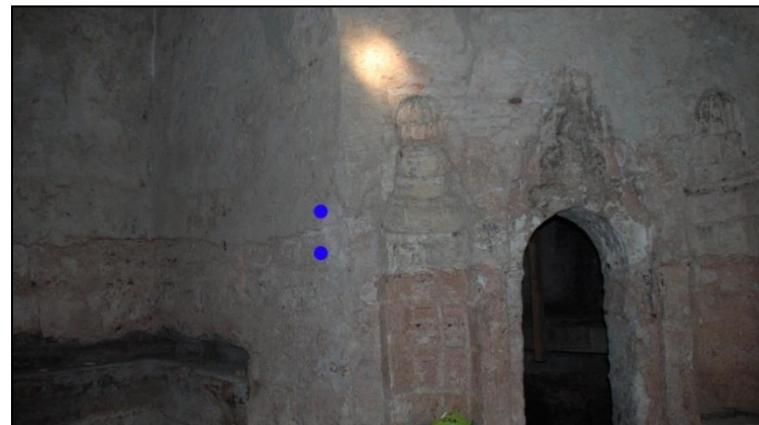
Figure 3.7. Sıcaklık space showing where the samples were collected

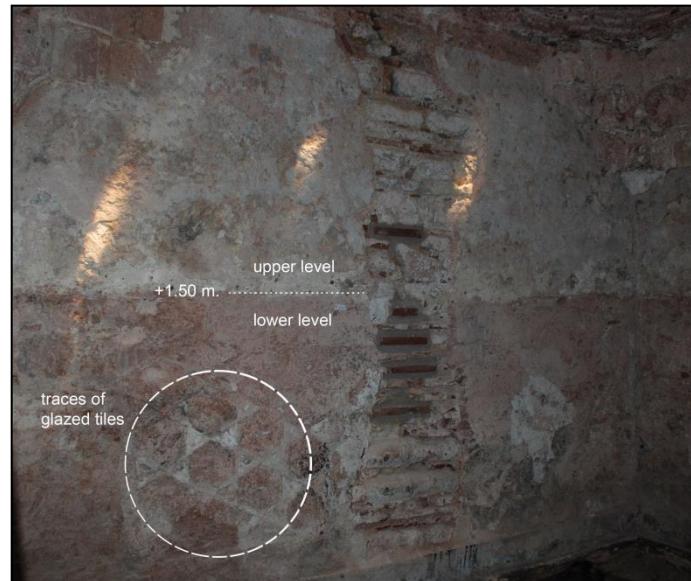
Plasters applied on the wall surfaces of the inner spaces of the bath can be classified as lower level and upper level plasters. The lower level plastering on the wall surfaces were extended to 1.5 m height from the floor surfaces and the upper level plastering were extended along the wall surfaces from 1.5 m height. These levels are distinguished clearly due to their colors, layers and traces of glazed tiles (Figure 4.1).

Figure 4.1. The image from ılkılık space of the bath showing levels and traces of the glazed tiles on the wall surface

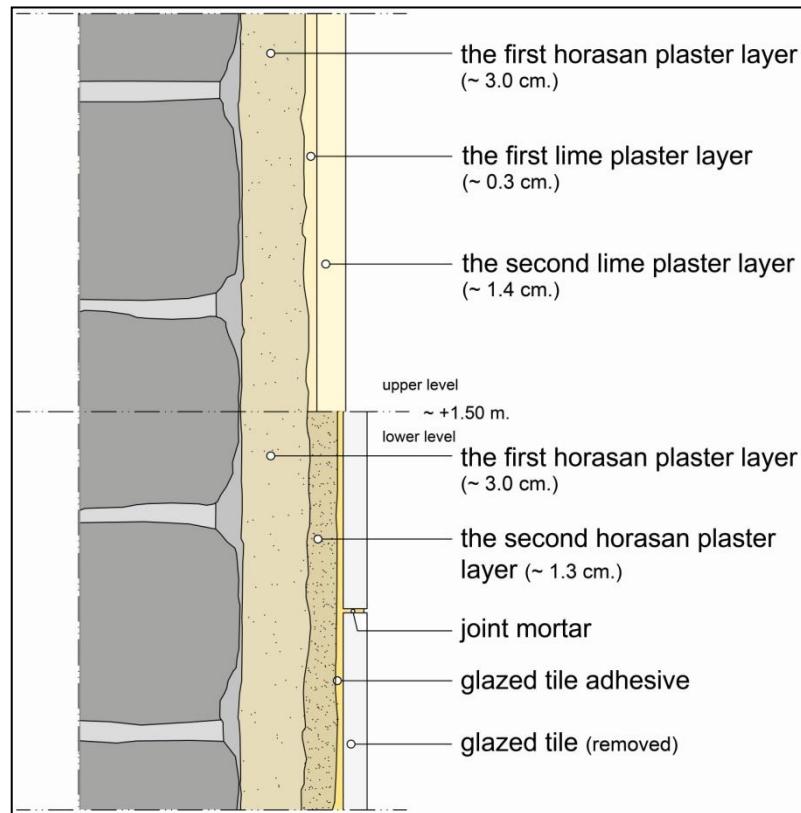
Figure 4.2. Plaster layers of ılklik spaces

The lower level plasters were consisted of two horasan plaster layers. The first layer of the lower level horasan plasters was rough while the second layer was fine. The thickness of the first layer was about 3.0 cm and the second layer was nearly 1.3 cm. Glazed tiles were adhered on the second layer of the horasan plasters by glazed tile adhesive (Figure 4.2, 4.3 and 4.4).

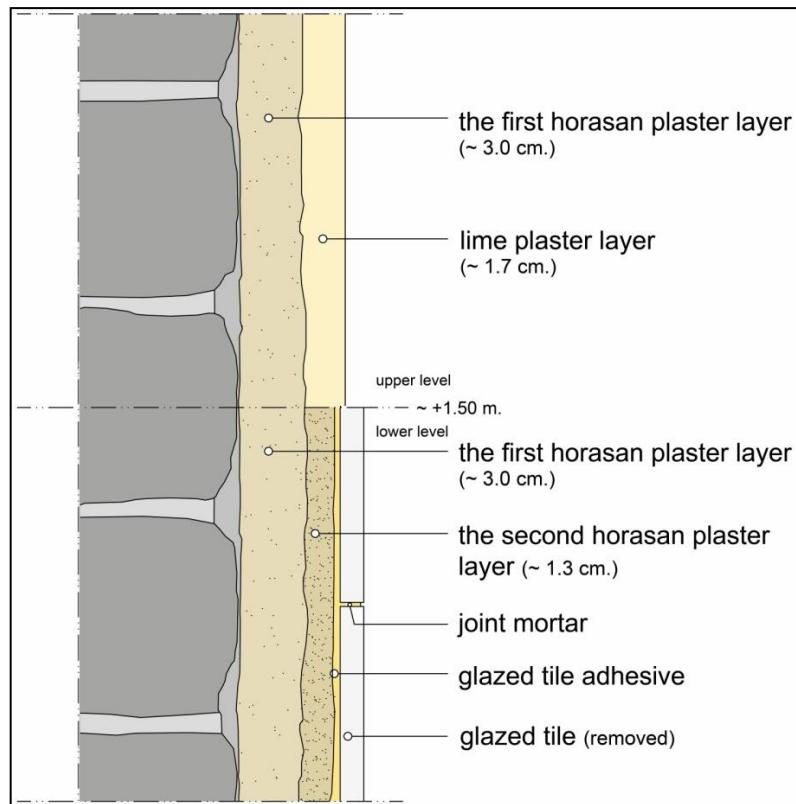
Figure 4.3. Plaster layers of siccaklık spaces

The upper level plasters were consisted of a rough horasan plaster layer with one or two fine lime plaster layers. The thickness of the upper level horasan plaster was about 3.0 cm. The thickness of the first and the second layer of the lime plasters were nearly 0.3 and 1.4 cm on the wall surfaces of the ılklik space and were about 0.5 and 1.2 cm on the wall surfaces of the halvet space (Figure 4.2 and 4.4). The upper level plasters of the sıcaklık spaces had one lime plaster layer on the horasan plaster and thickness of this lime plaster layer was about 1.7 cm (Figure 4.3).

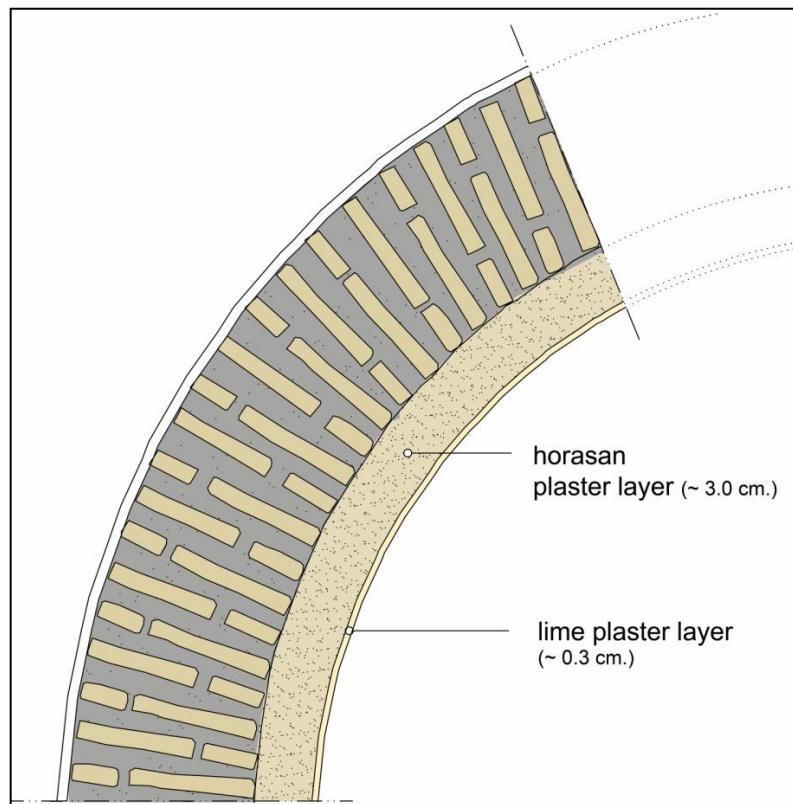
Figure 4.5. Plaster layers of domes of soyunmalık

The plasters collected from the domes of men's and women's soyunmalık spaces were consisted of a rough horasan plaster layer with one fine lime plaster layer. The thickness of the horasan plaster was about 3.0 cm and the lime plaster was about 0.3 cm (Figure 4.5).

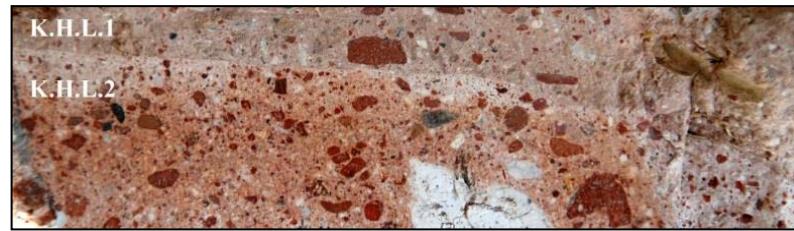
Figure 4.6. Interfaces between horasan plaster layers from the lower level

Layers of horasan and lime plasters and interfaces between the layers were determined by using binocular microscope (Figure 4.6, 4.8, 4.9) and SEM-EDS (Figure 4.7).

SEM and binocular analysis indicated that layers of horasan plasters of lower levels were well adhered to each other and distinguishable due to their appearances and a distinct line between each of plaster layers (Figure 4.6, 4.7). This distinct line was observed clearly due to the fact that second layers of plasters were applied after the first layers were dried on the wall surfaces. This multilayered plaster technique could be executed for protecting the wall from water effects.

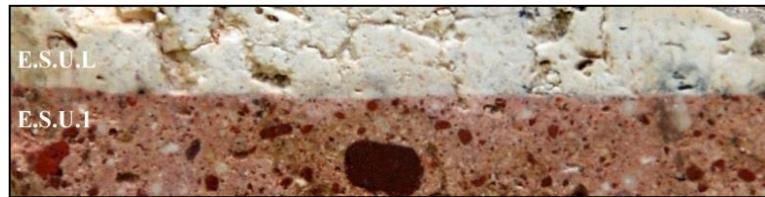
Figure 4.8. Interfaces between horasan and lime plaster layer from the upper level

Binocular analysis showed that horasan plaster and lime plaster layers of the upper level had a strong adhesion between each of plaster layers (Figure 4.8).

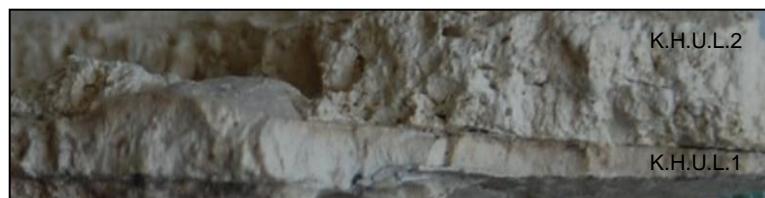
Figure 4.9. Lime plaster layers from the upper level

On the other hand, binocular analysis indicated that lime plaster layers of the upper level had a weak adhesion. Also, a clear difference between their textures was observed (Figure 4.9). The bottom lime plaster layer was fine and the upper was rough. It showed that these lime layers can be originated from the repair of the bath.

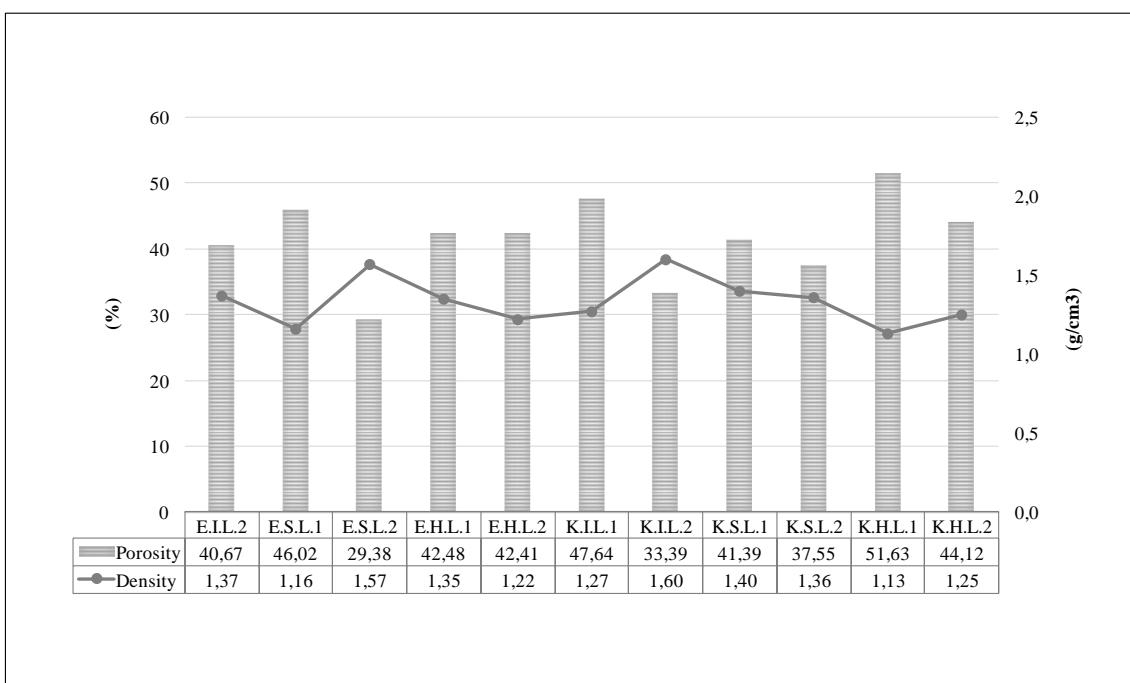
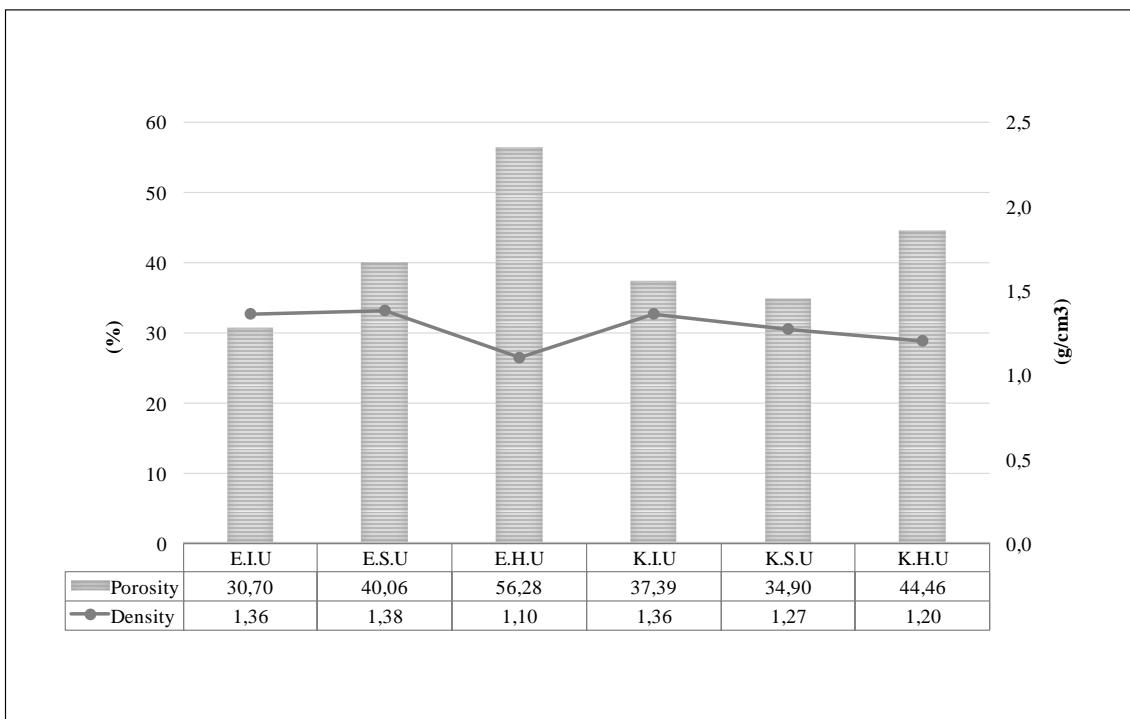
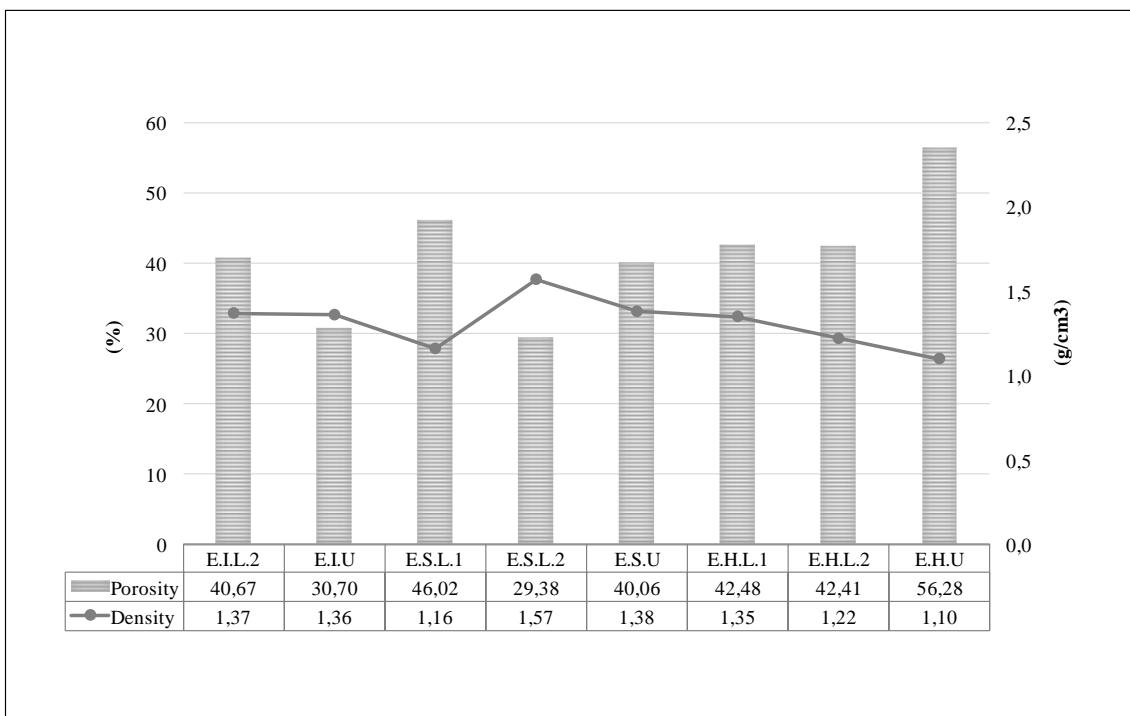
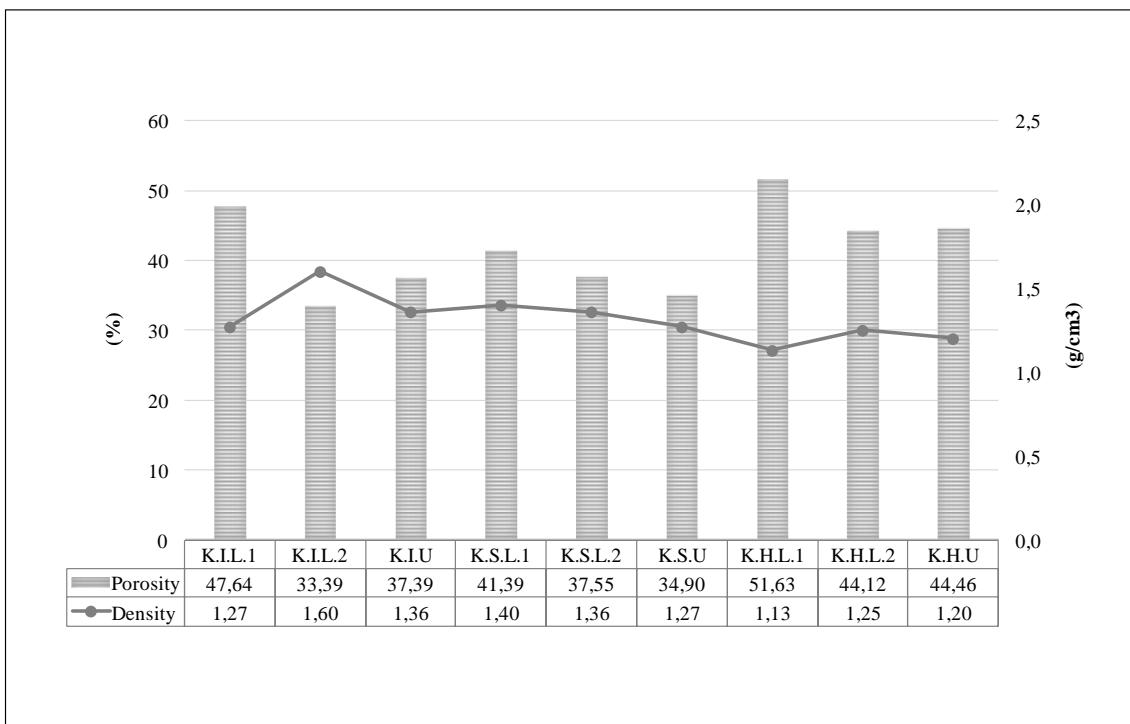
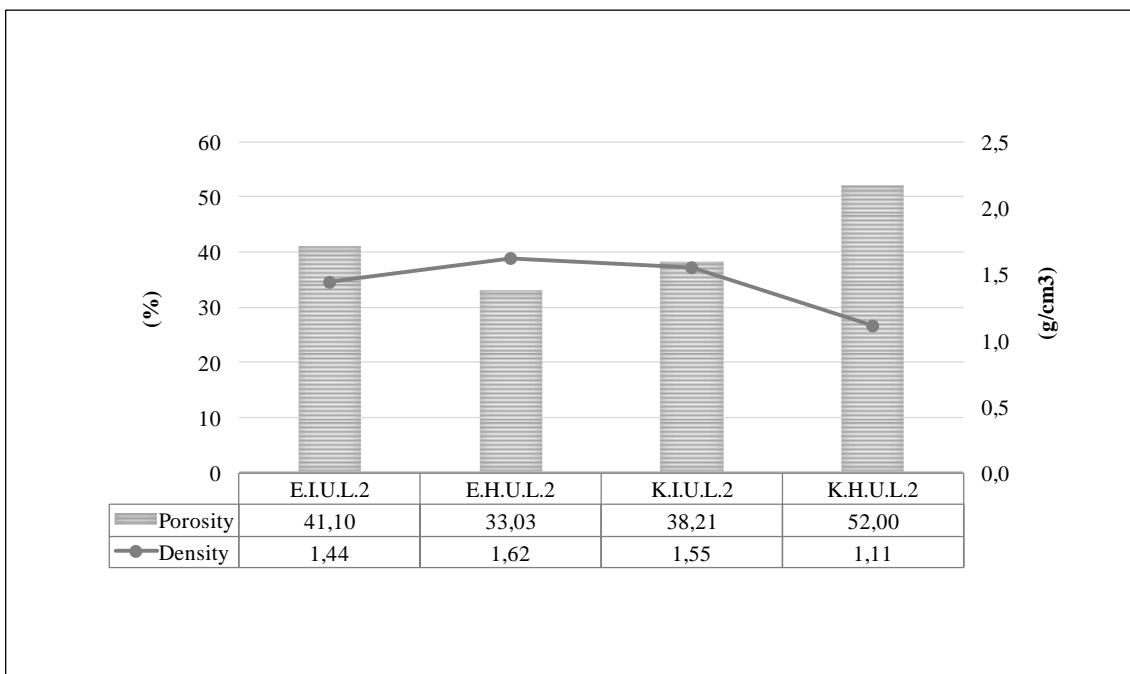
Based on these results, the density and porosity values of horasan plasters collected from lower and upper levels of all spaces were nearly in the same ranges. Accordingly, the density and porosity values of horasan plasters used in the men's and women's sections were almost similar to each other. In addition, the density and porosity values of lime plasters of the bath were in the similar ranges. These density and porosity values indicated that horasan plasters and lime plasters used in the bath are low dense and high porous materials.

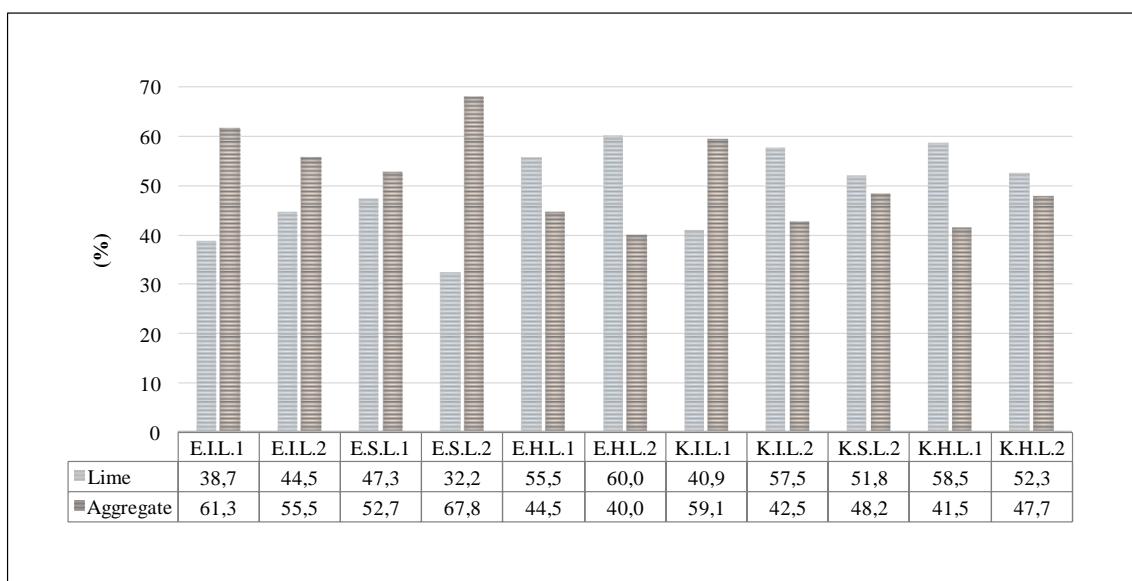
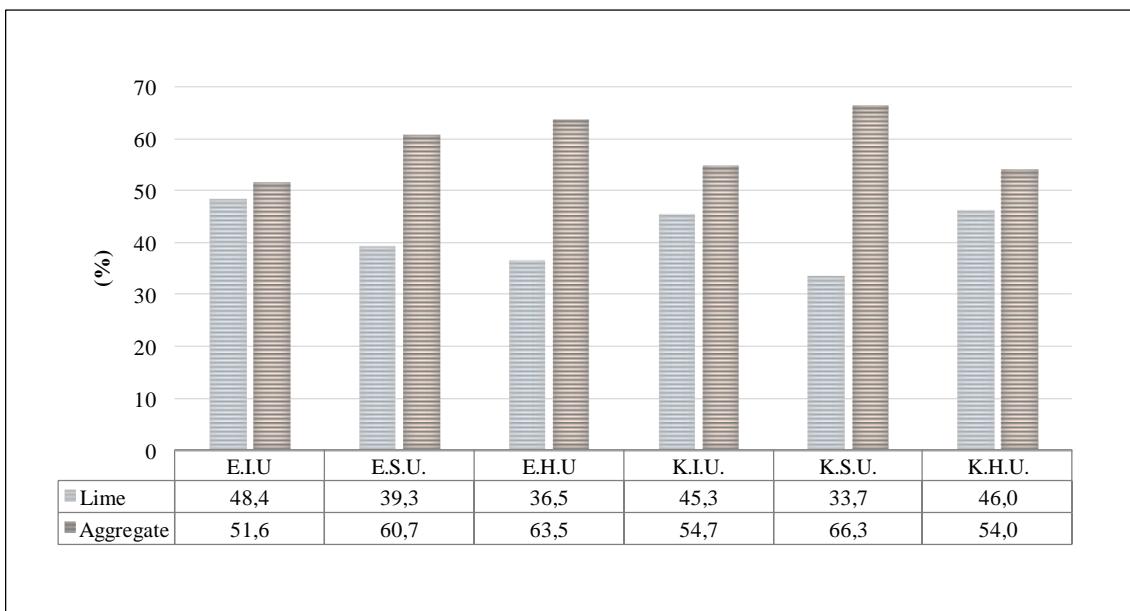
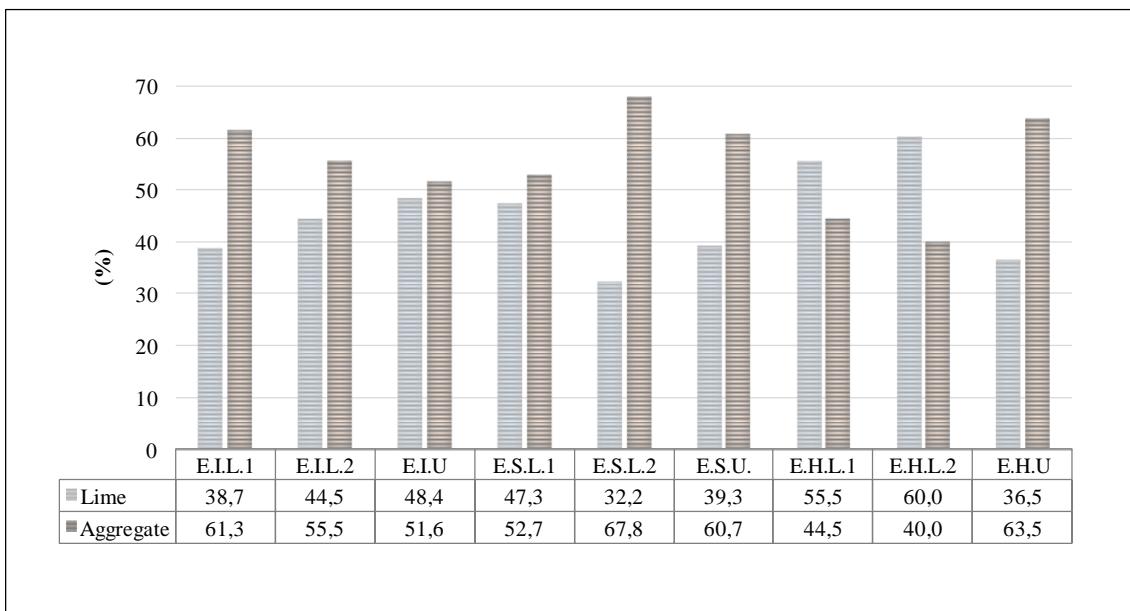
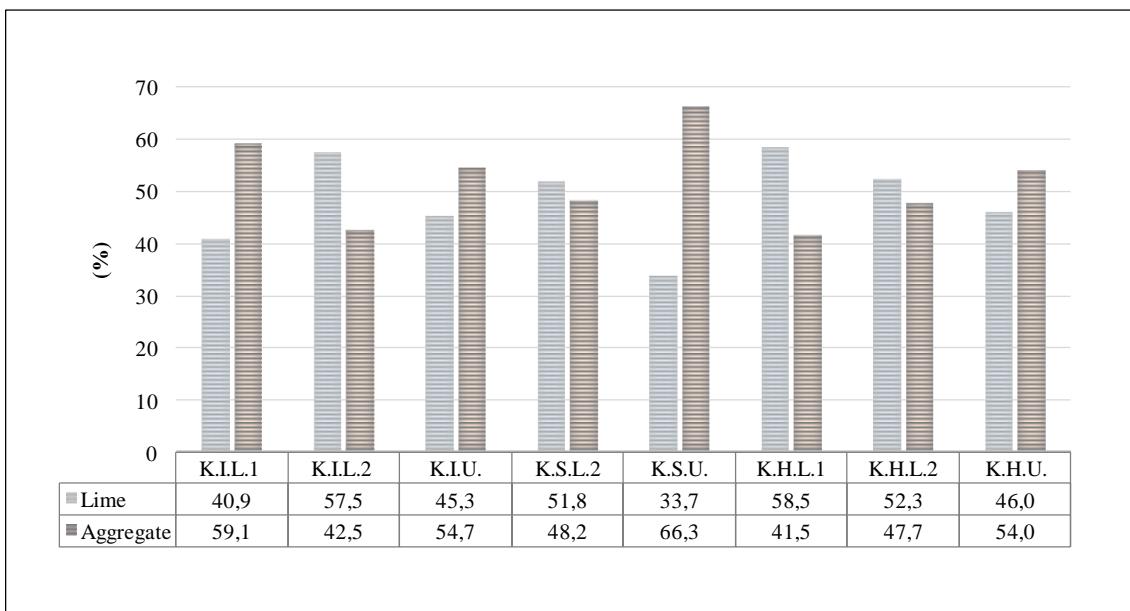
These values showed that percent of lime and aggregate values of lower and upper level horasan plasters were in the similar ranges. Also, horasan plasters of men's and women's sections had similar percent of lime and aggregate values.

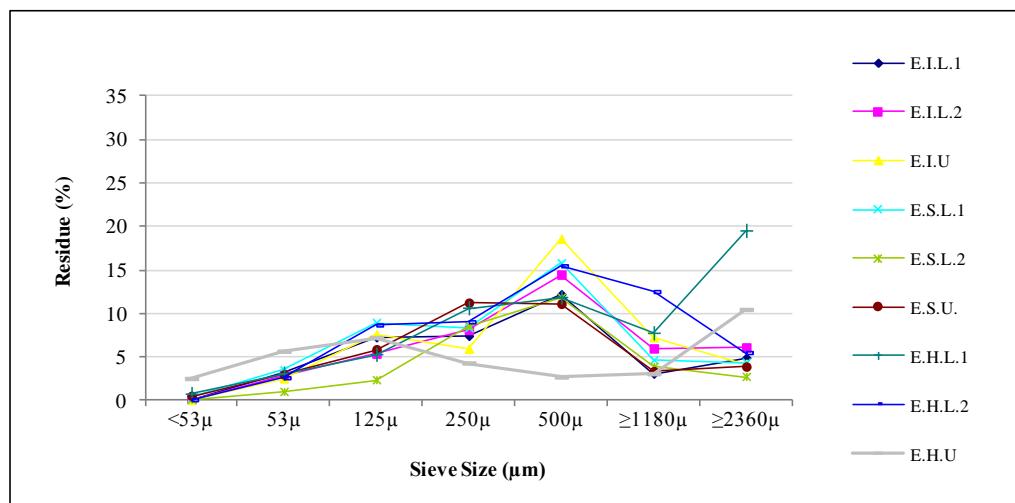
Figure 4.19. Particle size distributions of horasan plasters of men's section

The particle size distribution of the horasan plaster samples showed that aggregates which had particle sizes 500 μm . were the main fraction of the total aggregates. This main fraction used in horasan plasters of the men's section and women's section was in the range of 16-40 % and 8-32 % (Figure 4.19).

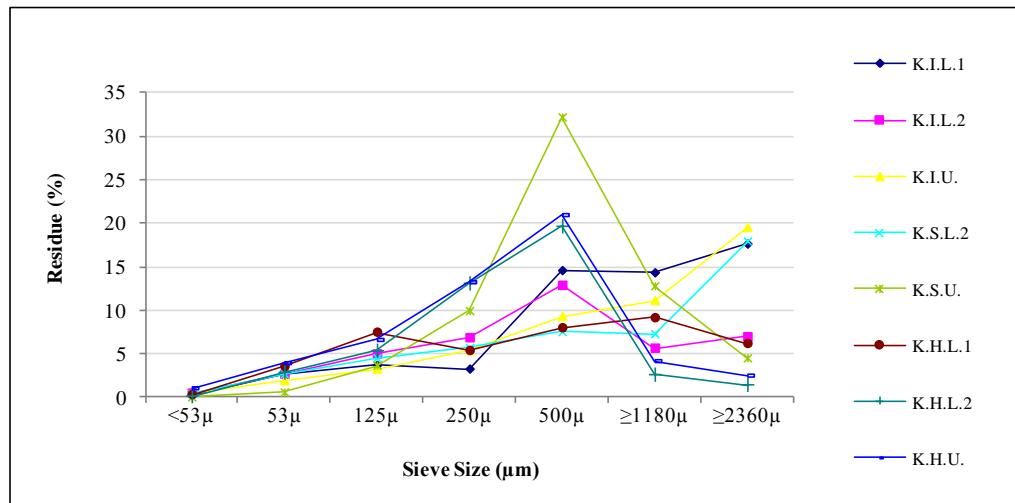
Figure 4.20. Particle size distributions of horasan plasters of women's section

Aggregates used in horasan plasters of the men's section composed of particle sizes 500 μm ranged between 16-40% and particle sizes between 500-1180 μm ranged between 17-26%. Aggregates used in horasan plasters of the women's section which had particle sizes 500 μm . were in the range of 8-32% and particle sizes between 500-1180 μm were in the range of 14-24% (Figure 4.20).

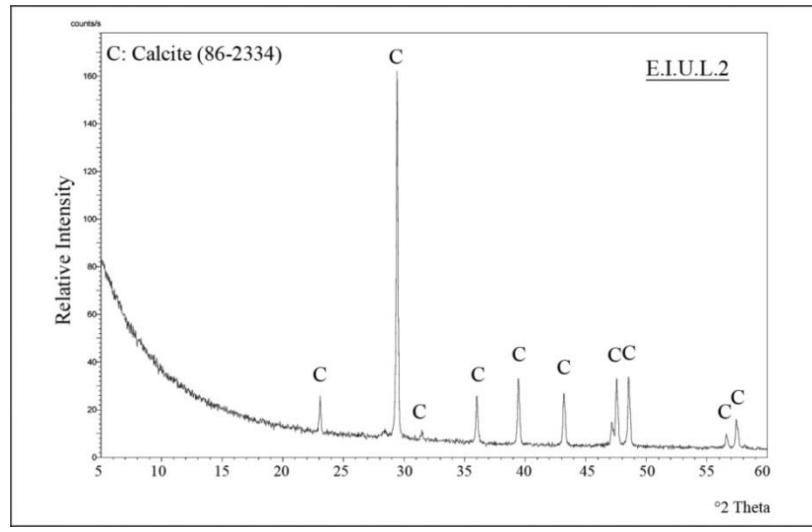
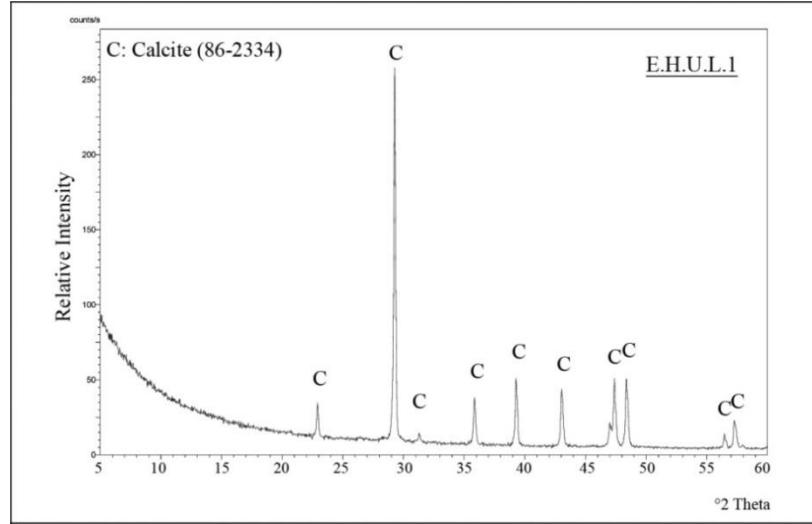
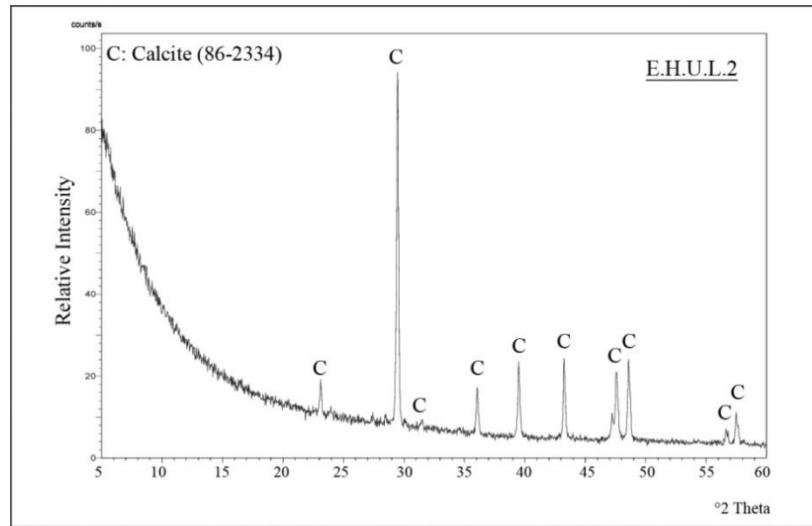
Figure 4.28. XRD patterns of lime plasters from ılıklik (a) and halvet (b), (c) of the men's section

Sample code	Minerals determined on XRD patterns
E.I.U.L.2	C
E.H.U.L.1	C
E.H.U.L.2	C
K.I.U.L.2	C
K.H.U.L.2	C, M
C: Calcite, M: Magnesite

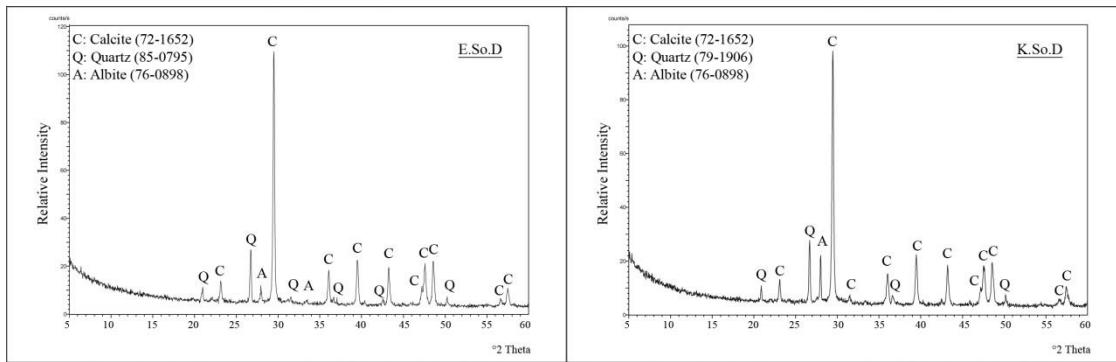
Figure 4.30. XRD patterns of horasan plasters from domes of the men's and women's soyunmalik

Sample code	Minerals determined on XRD patterns
E.So.D	C, Q, A
K.So.D	C, Q, A
E.So.D.L	C, G
K.So.D.L	C, G
C: Calcite, Q: Quartz, A: Albite, G: Gypsum

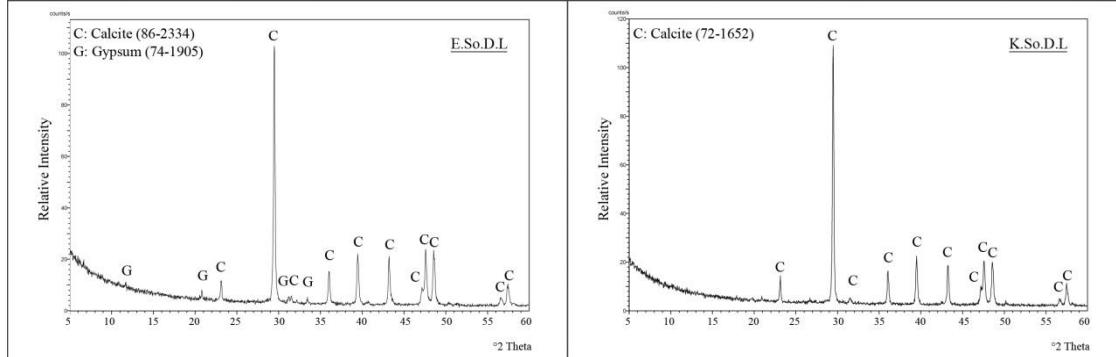
Figure 4.31. XRD patterns of the lime plasters from domes of the men's and women's soyunmalik

On the other hand, mainly calcite peaks were observed on the XRD patterns of lime plasters from domes of the men's and women's soyunmalik (Table 4.8, Figure 4.31). Although calcite (C: CaCO_3) peaks were clearly determined, minor gypsum peaks were also determined by the XRD analysis of the lime plaster from men's soyunmalik dome (E.So.D.L.). This can be explained that the domes of men's and women's soyunmalik had different lime plaster contents from each other.
