Impact of transparency in the design of protective structures for conservation of archaeological remains

Funda Yaka Çetin^{a,*}, Başak İpekoğlu^b

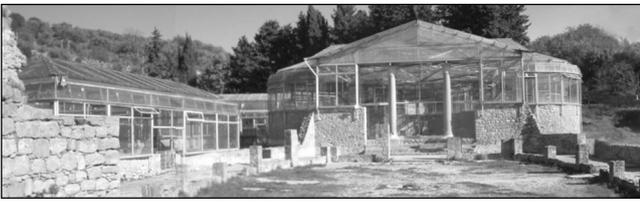
Fig. 1. Protective enclosure over the Roman Villa at Piazza Armerina at Sicily, Italy [17].

number of sites such as Neolithic Houses at Çatalhöyük, Turkey; Terrace Houses 2 at Ephesus, Turkey; Danae and Dionysos Houses at Zeugma, Turkey and Roman Villa at Piazza Armerina in Sicily, Italy.

These advantages give rise to transparency in the design of protective structures. Nevertheless some problems can be observed in terms of conservation and display in practice. When direct sunlight is not prevented transparent material allows short-waves to pass through into the protective structure. Once radiation hits the remains, it changes into long-waves, which are not able to pass through the glass and get trapped inside. Short-waves emitted by the remains cause sharp rise of temperature and damage to the remains [14]. The protective structure at Piazza Armerina can be a significant reference to conservation problems due to greenhouse effect. The light steel protective structure resting on the original walls was built in 1950 to protect and display the mosaic pavements (Fig. 1). Transparent and translucent plastic panels were used to cover the facades and roof structure. Level ceilings were installed under the translucent roof cover, to protect from heat and prevent shadows of the metal framework from falling on the mosaic [15]. The walls were constructed partly of corrugated sheeting and partly of slats of the Venetian-blind type; in some cases the wall panels, can be opened for ventilation in hot weather. However, level ceilings and plastic panels failed to control solar radiation and heat. The translucent enclosure created a kind of showcase that resulted in high temperature and relative humidity, frequent condensation [16,17]. Due to the adverse climate inside the protective enclosure it had to be removed and a new structure with opaque material is being constructed.

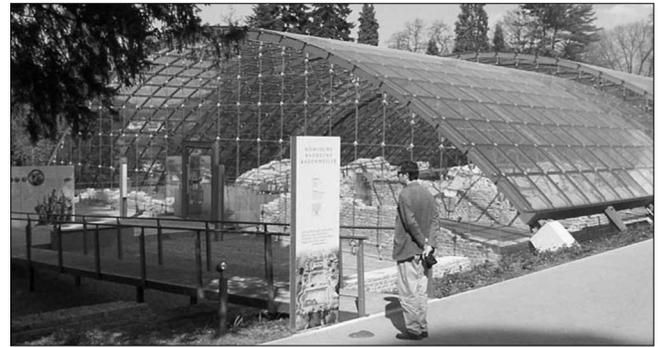
Fig. 3. Protective enclosure over the Roman Bath at Badenweiler, Germany [Courtesy of D. Laroche].

intercept thermal insulation [14]. The protective structure over the Roman Bath at Badenweiler, Germany in the appearance of a transparent vault is an example (Fig. 3). The glazed shell structure, which was built in 2001, designed to provide an optimum in transparency. The glass surfaces were mounted above the ground to form inlets for ventilation [19]. In addition, separations between the vaults contribute to air circulation through outlets. A solar shading system was installed on the south to avoid overheating on hot days. However, condensation on the glazed surfaces can be observed in winter when the interior surface temperature of the glass falls below dew point of the air (Fig. 4).

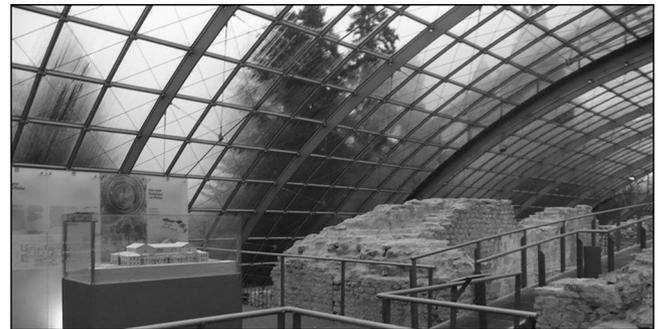
Fig. 4. Condensation on the glass, Badenweiler, Germany [23].

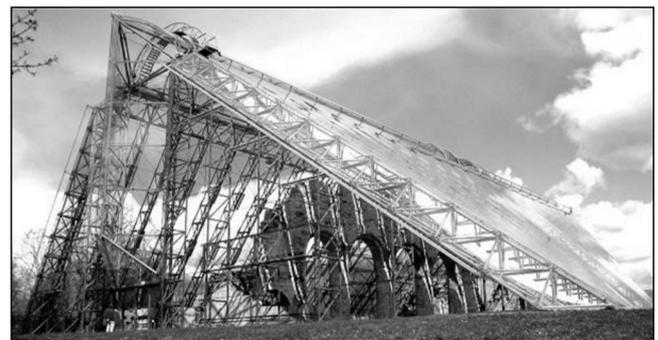
Fig. 5. Protective enclosure over the Hamar Cathedral, Norway [24].

In the colder climate of Norway, to prevent the Hamar Cathedral from frost damage, a glass and steel structure in the form of a cathedral roof was constructed in 1998 (Fig. 5). A heat management and ventilation system was developed to protect the remains and to eradicate potential condensation problems [20]. Heaters provide direct heating of the ruins and fans supply warm air along the glass to reduce condensation risk as well. For sunny days solar protection elements were mounted under the sloping surface.
