**CONSERVATION APPROACHES OF PATINA  
FORMATION ON MARBLE AND TRAVERTINE  
SURFACES IN THE ARCHAEOLOGICAL SITES**

**A Thesis Submitted to  
the Graduate School of Engineering and Sciences of  
İzmir Institute of Technology  
in Partial Fulfillment of the Requirements for the Degree of**

**DOCTOR OF PHILOSOPHY**

**in Architecture**

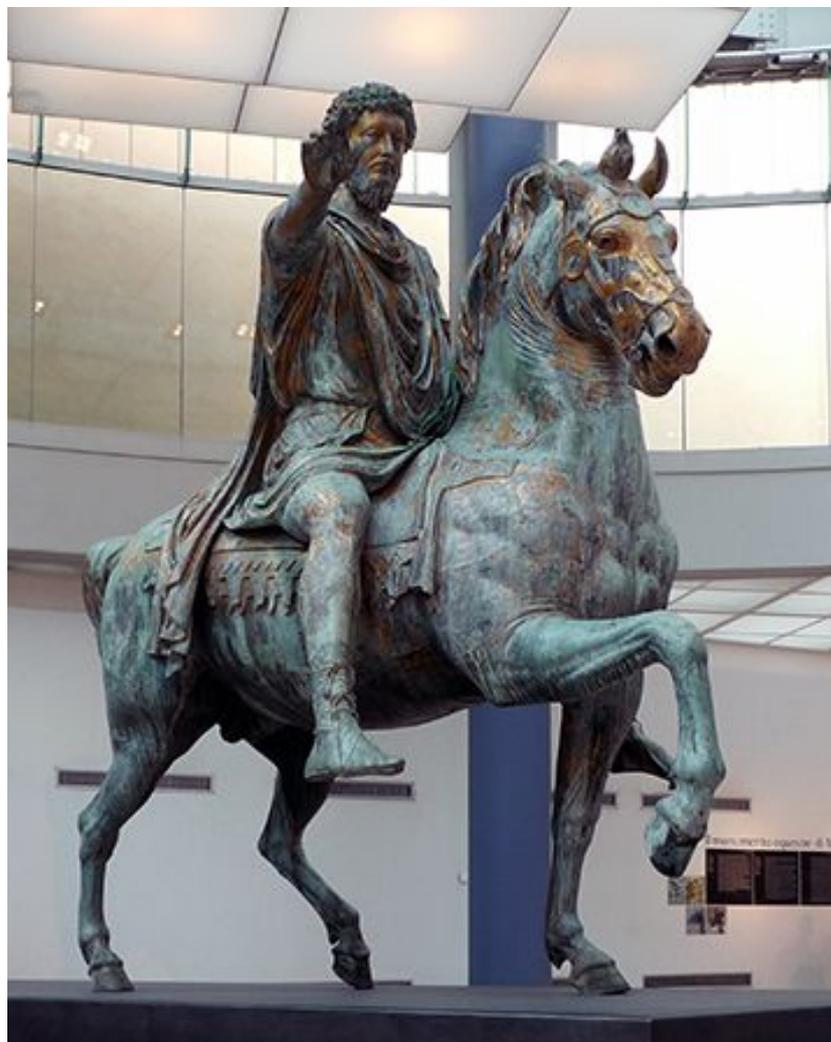
Figure 1.10. Patina on bronze Equestrian Sculpture of Marcus Aurelius, Capitoline Museums, Rome (Source: <https://www.khanacademy.org/>)

*time causes to appear on paintings”* (Weil 1977). It was latterly related with material weathering in French Encyclopedie in 1751. According to it, the origin of the “*patina*” term came from the Italian word “*patena*”, which means a shiny dark varnish applied to shoe; and latterly was used for the green formations on bronze surfaces that form by the time (Figure 1.10). Patina formation was redefined in Webster’s New World Dictionary published in 1970 under two items: a fine crust or film layer on bronze materials formed as a result of oxidation processes; and a thin coating or color change occurred as a result of aging (effect of the time passing by) (Weil 1977).

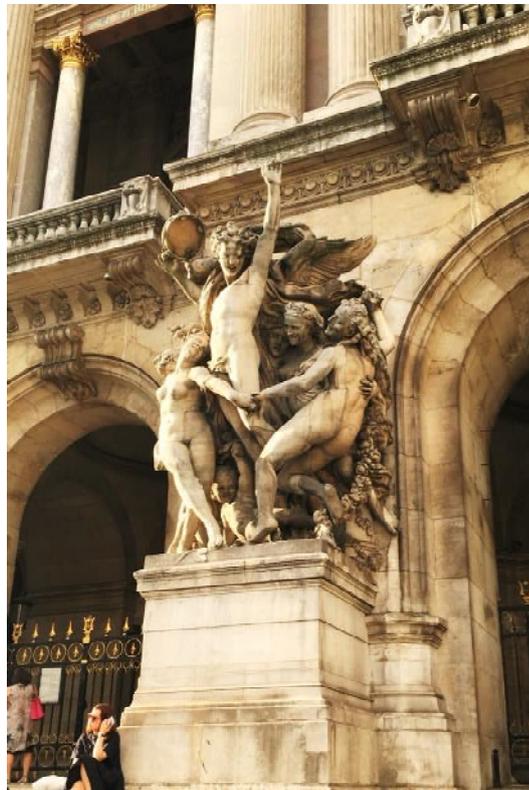
Figure 1.12. Patina formations on the facade of Academie Nationale De Musique, Paris and the surfaces of marble statue standing in front of it

These discolorations may also change according to the characteristics of patina. There may be changes in the hue of the patina formation on different surfaces of the same monument (Figure 1.11, Figure 1.12). The material characteristics such as crystal size,

texture, mineralogy and color of different patina layers are related with rock substrate, climate and other environmental factors (Vendrell-Saz et al. 1996). The different hues and colors of patina layers on 5 different case study buildings were compared in a research study (Vendrell-Saz et al. 1996). The results show that the darkness of the patina is mostly related to the surface condition if it is located in an open or sheltered area, the reaction of surface against UV light, the solubility of patina layer in water. Different hues of same color are mostly related to the same patina type in the same monument surface in common (Vendrell-Saz et al. 1996).

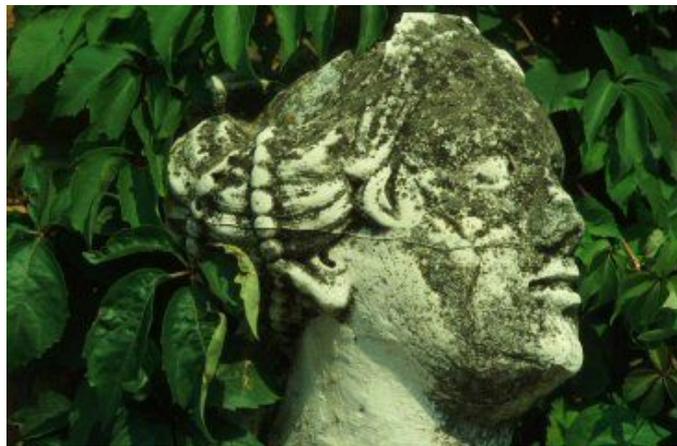
Figure 1.13. Green patina formation on sculpture, Italy  
(Source: Fitzner and Heinrichs 2002)

The green patina is also formed as a results of green biofilm formation by settling of biological forms as lichens, mosses and algae in the pores and on the surface of the stone (Figure 1.13). Staining due to pigments present in algal cells is the most common cause of greening especially in cool and humid climates (Cutler et al. 2013). The algal biofilms have destructive effects and negative impacts on the long term stability of the stone materials which is explained in a research study by Cutler et al. discussing it on a monument surface with all its aesthetic and structural damages (Cutler et al. 2013).

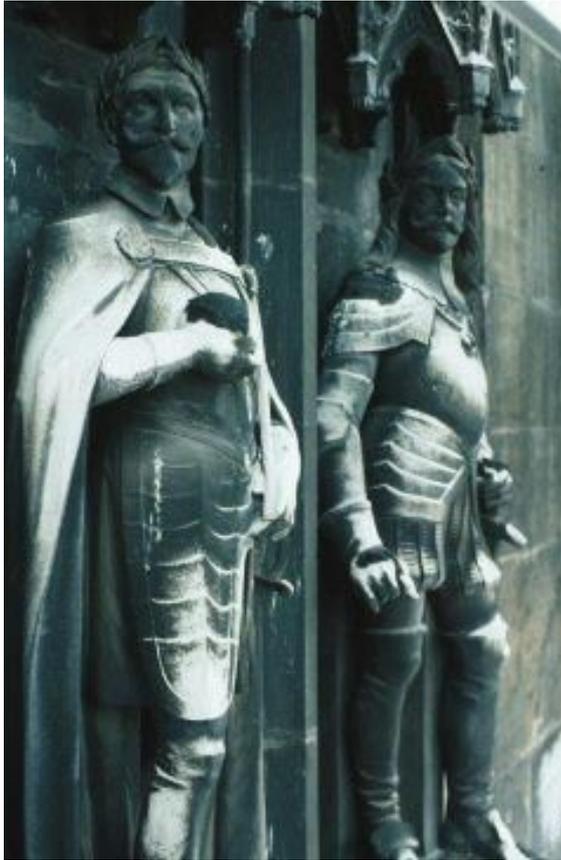
Figure 1.14. Black patina formation related with air pollution on the statue at Town Hall, Germany (Source: Fitzner and Heinrichs 2002)

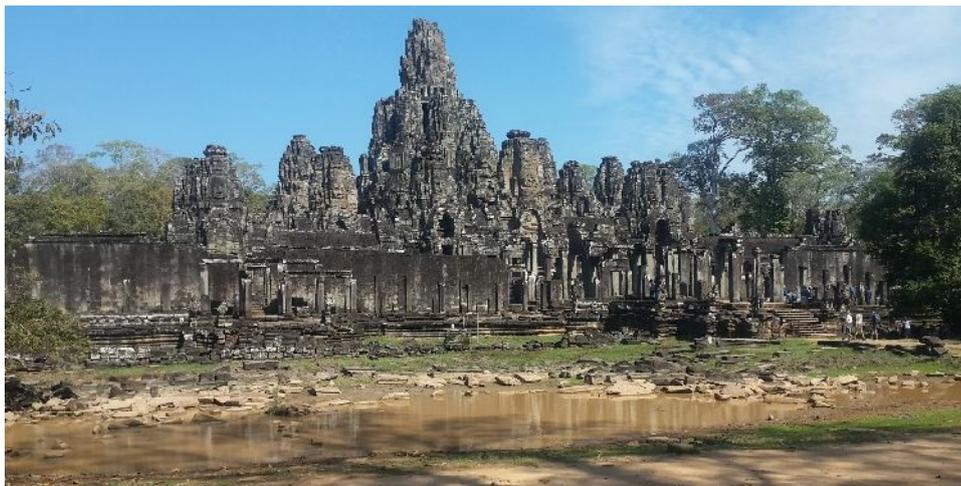
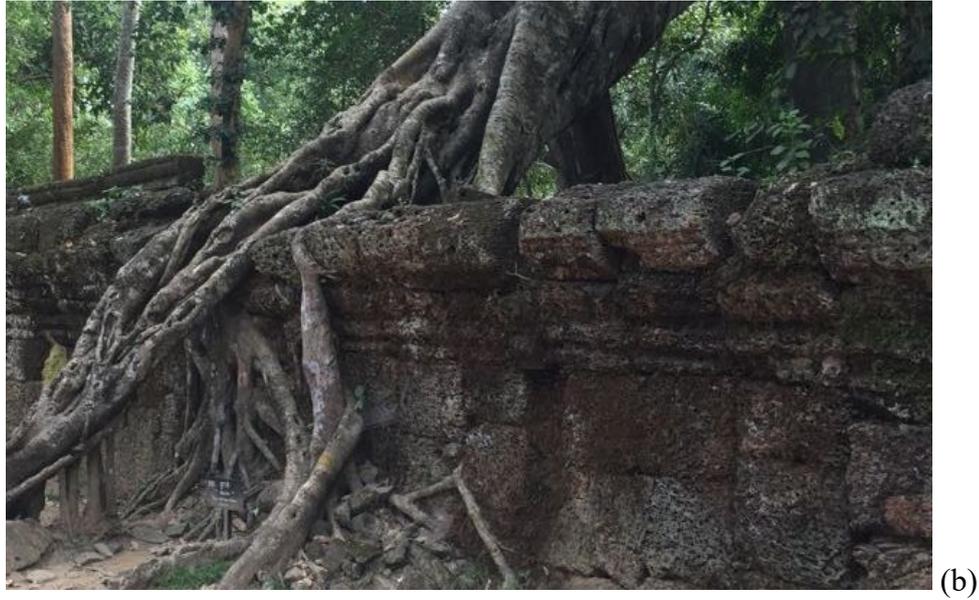
Figure 1.15. Black patina formation related with microorganisms on towers (a) and walls (b) of Angkor Wat, Cambodia (Source: Personal archive of N. Murtezaoglu)

Figure 1.15. (cont.)

The origin of grey to black patina may also be the pigmentation of black fungi microorganisms as fungi, cyanobacteria, green algae which contain dark pigments are also other agents of black patina (Macedo et al. 2009) (Figure 1.15). Among them, black fungi have the capacity to settle down on the stone surface and penetrate into the stone structure. They cause physical and chemical damages during their growth (Diakumaku et al. 1995). Diakumaku et al. mentioned that black fungi cause aesthetic damage when they spread over the stone surfaces including various melanin pigments that may also be observed as black in color (Diakumaku et al. 1995). The presence of black fungi formation was documented on almost all the stone monuments located in the Mediterranean Basin in a research study about the effects, isolation and identification of it on marble surfaces (Krumbein et al. 1995).

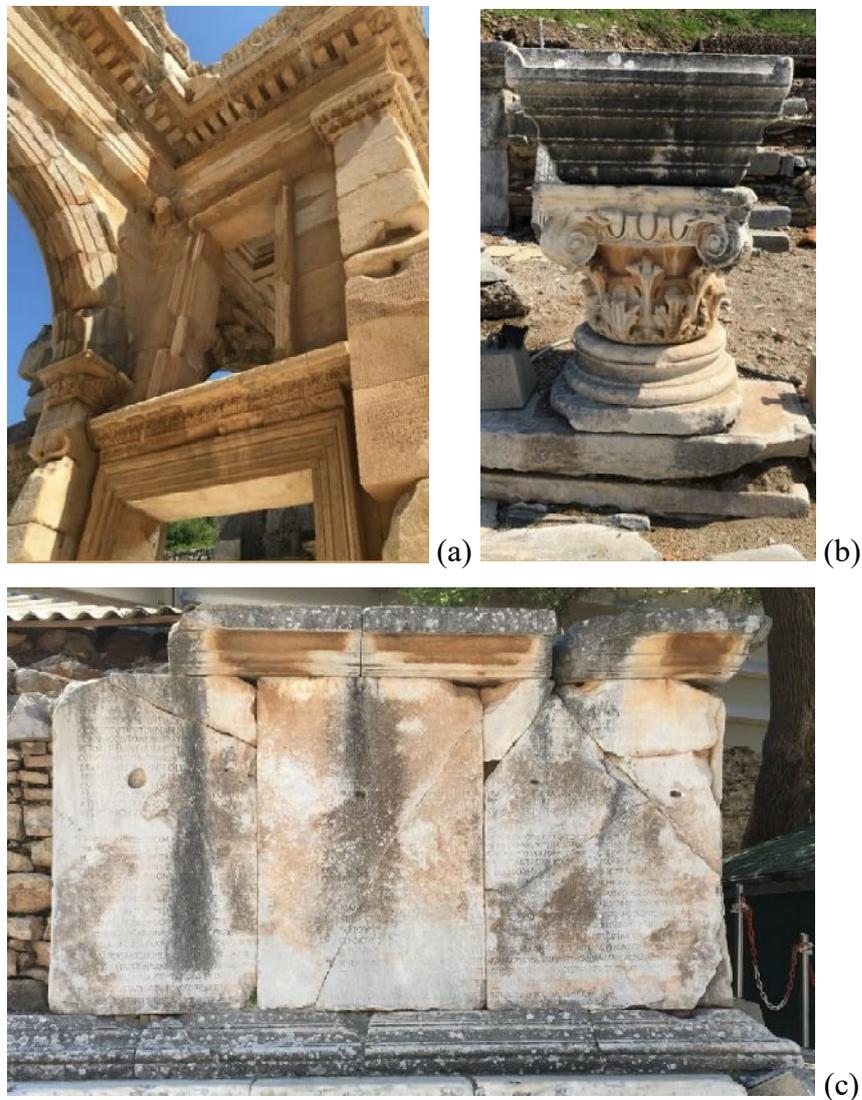
Figure 1.16. Yellow patina formation on the marble ruins as building stones (a), columns capital (b) and historical writings (c) in Ephesus, Turkey

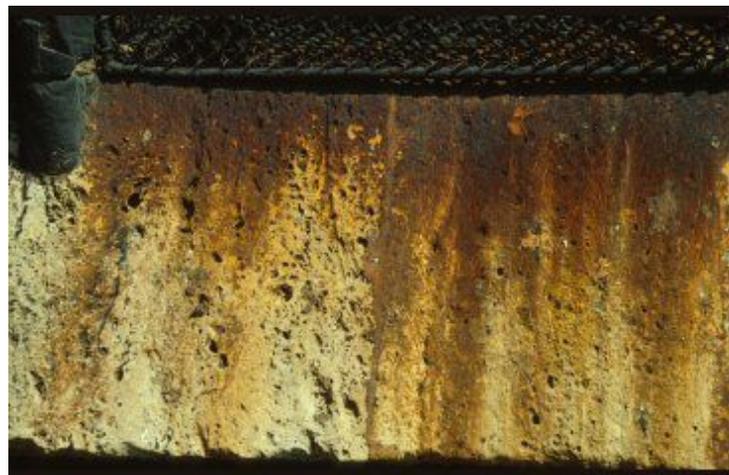
Figure 1.17. Brown patina formation on the stones of Cathedral, Halberstadt, Germany (Source: Fitzner and Heinrichs 2002)

The presence of metal compound adjacent to stone materials is another reason of yellowing of stone materials (Figure 1.17). If the stone material has metal components as bars, rods or pins, the oxidation and mobilization may occur on them. The reddish-brown patina may be formed because of the metal ions released and transferred from them (Macchia et al. 2011).

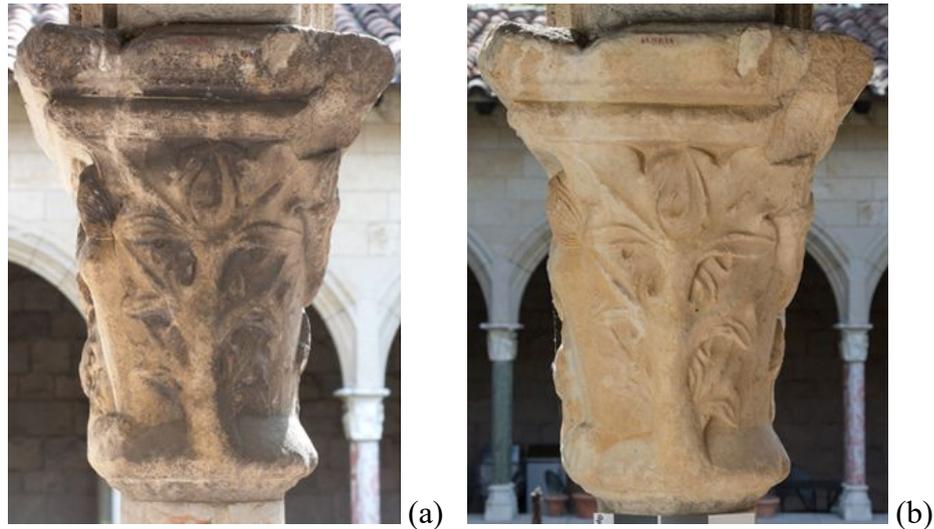
Figure 1.18. Patina on marble surface of capital before (a) and after (b) laser cleaning (Source: <http://www.metmuseum.org/blogs/in-season/2014/laser-cleaning-for-stone-conservation>)

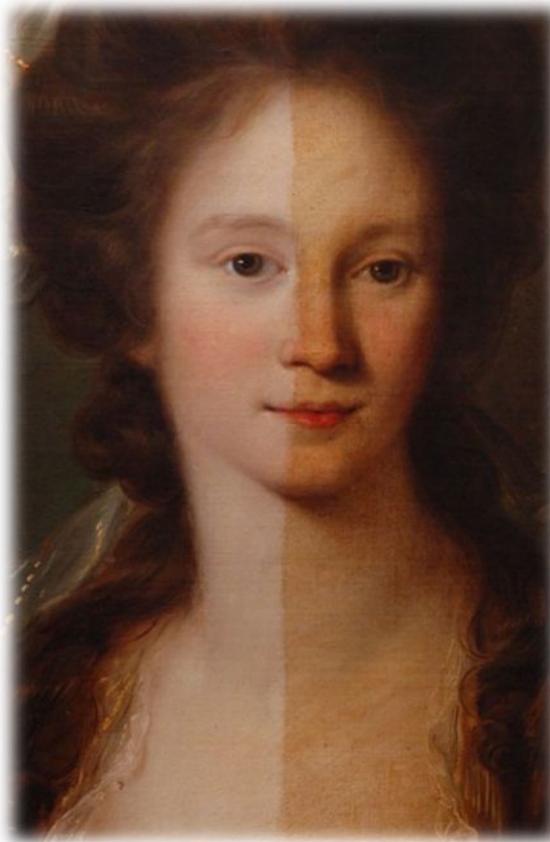
Figure 1.19. Patina formation on oil painting before (right) and after (left) cleaning  
(Source: <http://www.simongillespie.com/wp-content/uploads/2013/05/Varnish-Removal-2-400x603.jpg>)

The cleaning of patina was a contentious subject for oil paintings and bronze artifacts in the same time period (Figure 1.19). The patina formation on oil paintings is considered as a special addition to the materials according to Brandi, an art historian

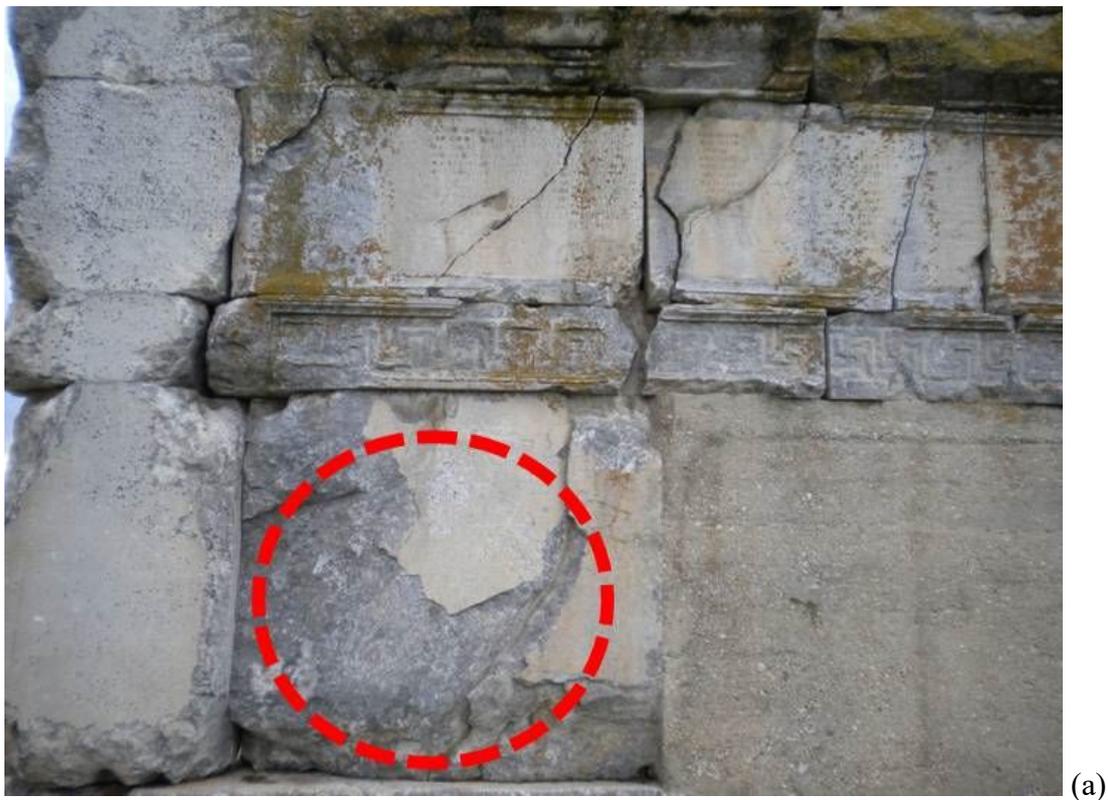
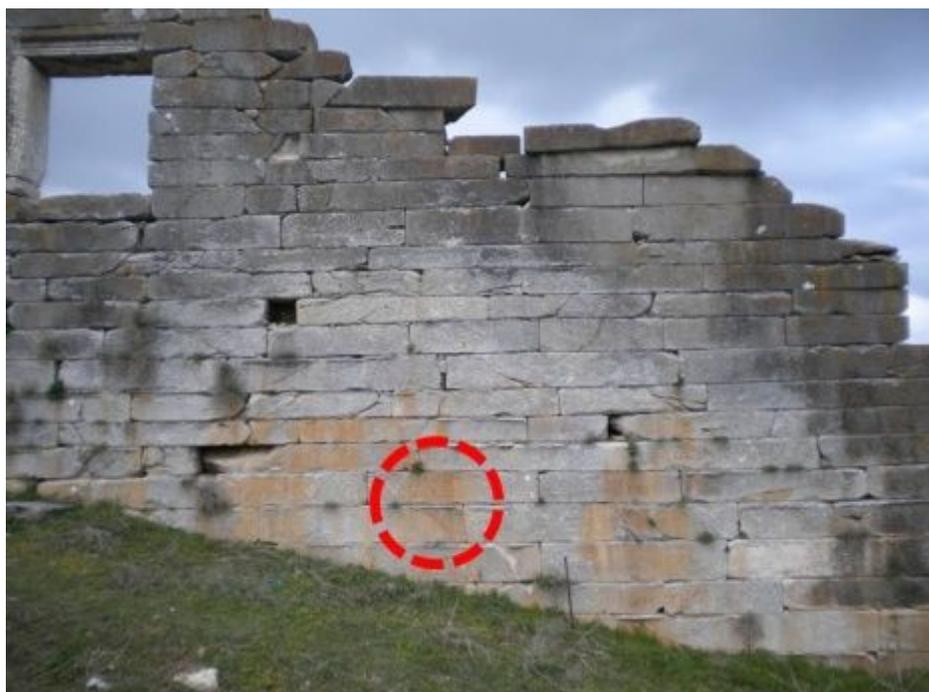
Figure 2.1. The locations of yellow patina and marble samples taken from the wall of Zeus Temple (a) and Theatre (b) in Aizanoi

Figure 2.1. (cont.)

were taken from the areas where yellow patina was observed on marble surfaces. Six yellow travertine samples were collected from necropolis (300 BC), agora (60 AD), bath (300 AD) and fountain (300 AD) in Hierapolis (Denizli) (Figure 2.4, Figure 2.5, Figure 2.6). However, the yellow patina formation on yellow travertine surfaces was not as appreciable as on marble surfaces. The locations where the samples were collected were documented with photographs. The collected samples were put in pockets separately and named considering an order in nomenclature (Table 2.1, Table 2.2).

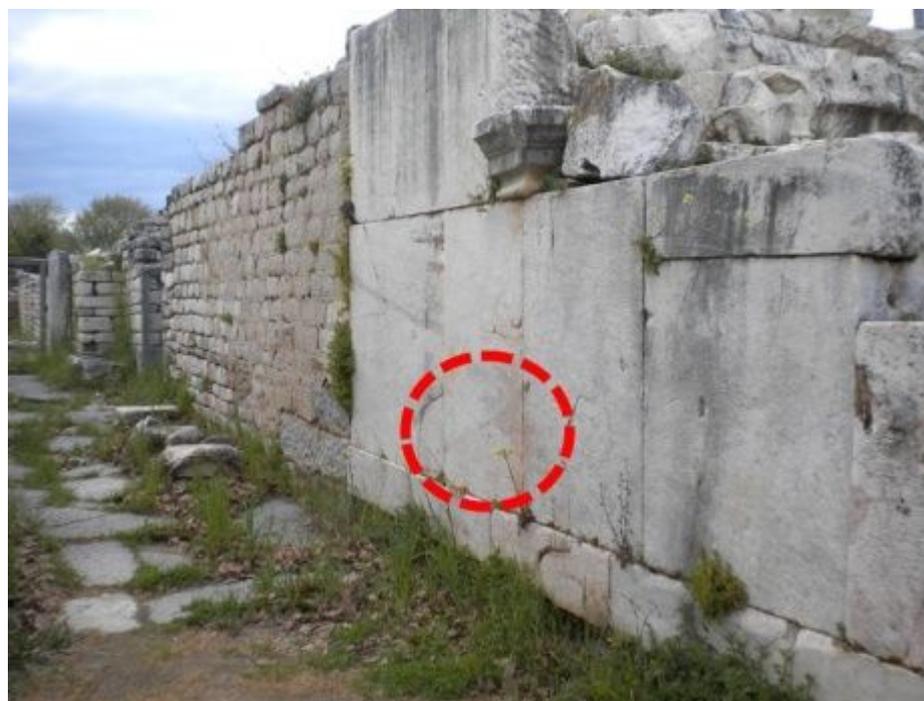
Figure 2.2. The location of yellow patina and marble samples taken from the wall of Bouleuterion in Aphrodisias

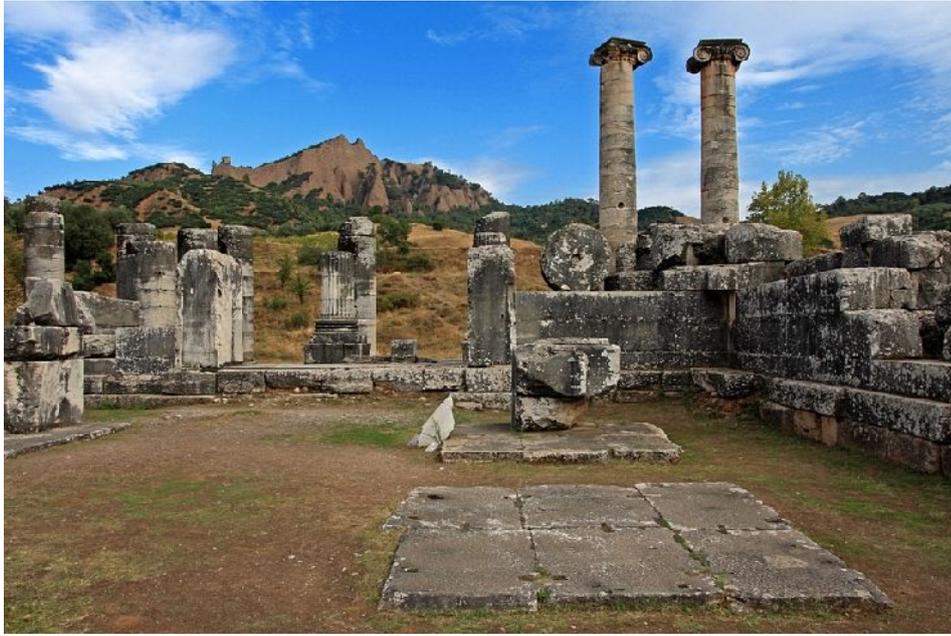
Figure 2.3. The representative yellow patina covered marble samples taken from the ground in the Temple of Sardes

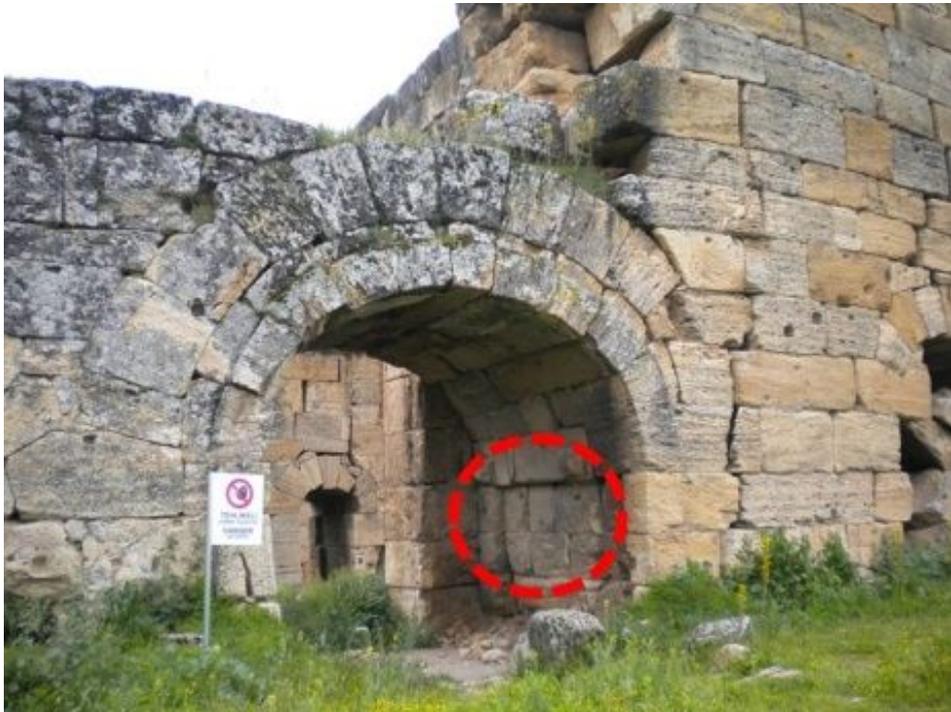
Figure 2.4. The location of yellow patina and yellow travertine samples taken from the Bath in Hierapolis

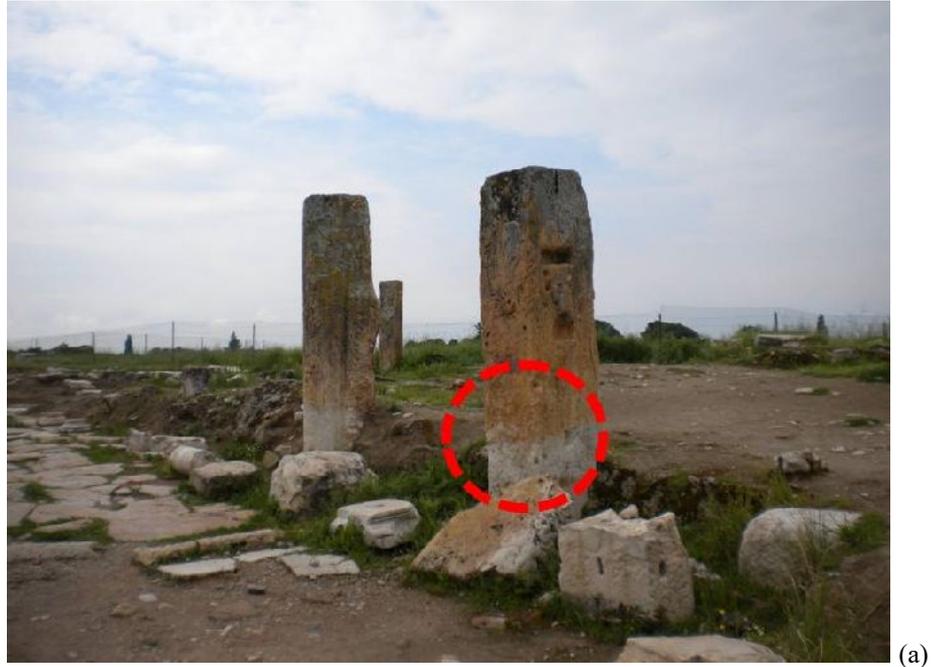
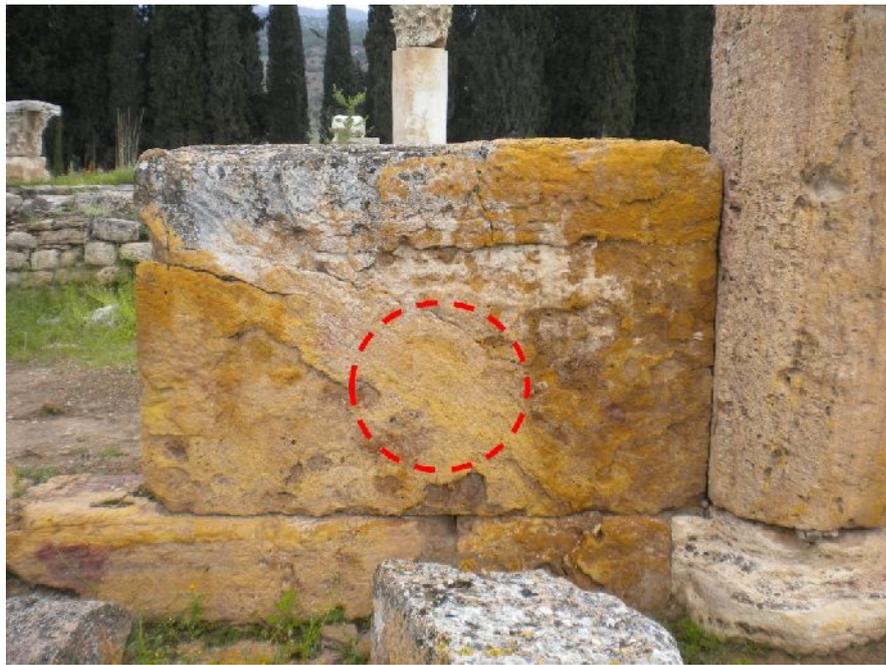
Figure 2.5. The locations of yellow patina and yellow travertine samples taken from the column (a) and wall (b) of Agora in Hierapolis

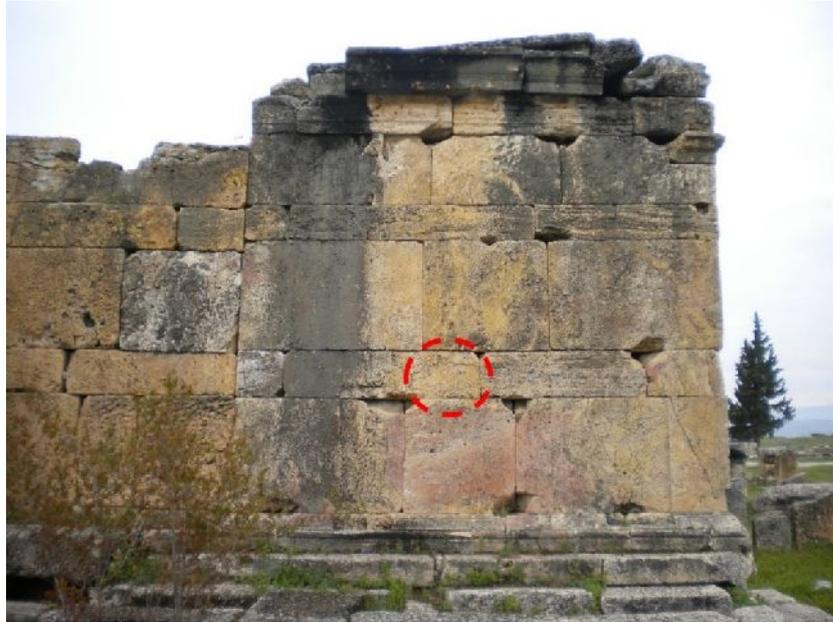
Figure 2.6. The location of yellow patina and yellow travertine samples taken from Necropolis in Hierapolis

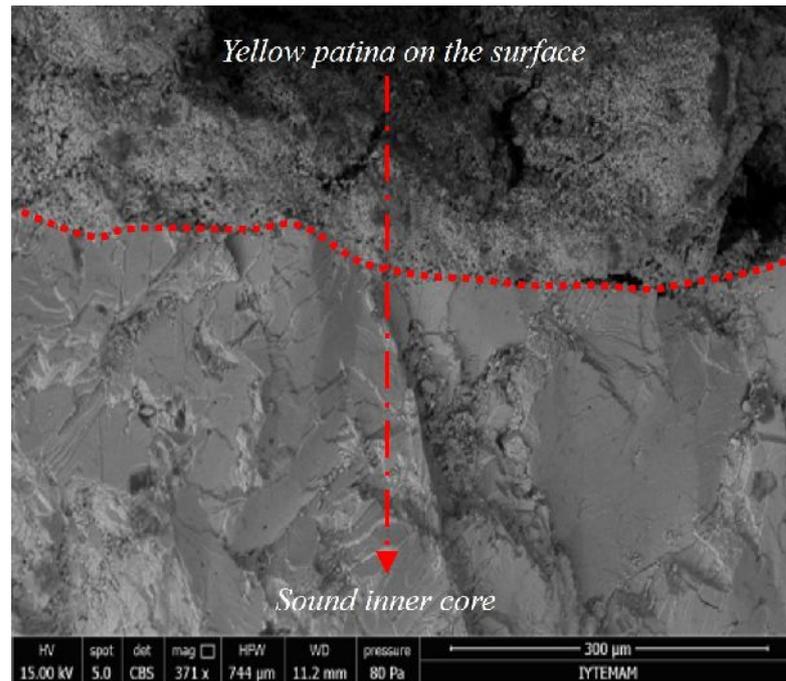
Figure 2.7. A representative marble sample showing its use for SEM-EDX mapping

SEM-EDX analyses were also performed on the prepared cross-sections of stones showing the presence of patina layer and intersection of yellow patina and limestone surfaces by using 250x and 500x magnified images. Mapping was also held on the same cross sections to observe the elemental distribution from surface to the inner core of the stones (Figure 2.7).

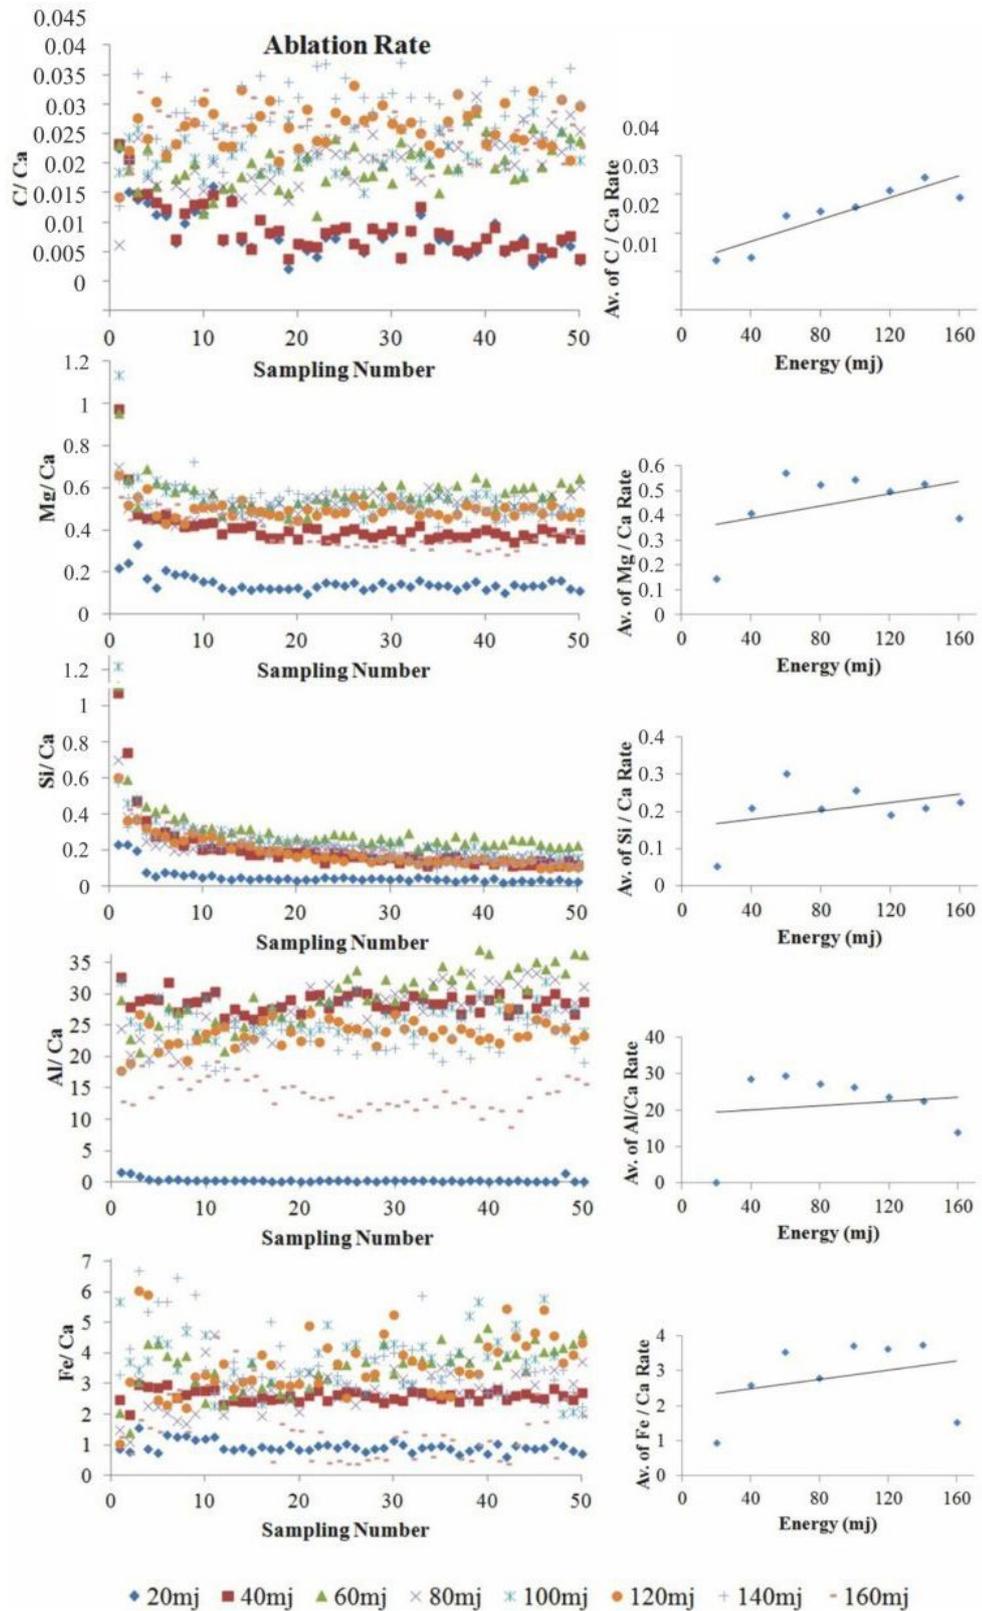
Figure 2.8. Graphs showing the ablation rates of elements in LIBS analyses of marble applied in different energy levels between 20 and 160 mj

The in-depth profiling was performed on a specific point for each sample to determine the elemental variation from yellow patina to the inner cores of all the marble and travertine samples (Figure 2.9). It was tested by applying the LIBS placing the samples on the stage of the device in two different ways in order to decide the proper experimental method for LIBS accurately. In the first method the LIBS analyses were held on three specimens as yellow patina formed surface, sound inner parts and a section. The chemical compositions of surface and inner parts were calculated for marble and travertine separately. In-depth LIBS analyses were made on the section of one marble sample. Each sample were cut approximately 0.5x0.5x1.0cm cubes and used in the analyses. The results were evaluated from the sections of the surfaces laterally and the results were compared (Figure 2.9(a)). The samples were exposed to 100 laser shots on the cross sections laterally and analyzed by measuring the spectral line intensities of the calcium, silicon, carbon, iron, magnesium and aluminum on marble and travertine samples. The patina layer was tent to broken easily during sample preparation and the patina surface was lost on the samples.

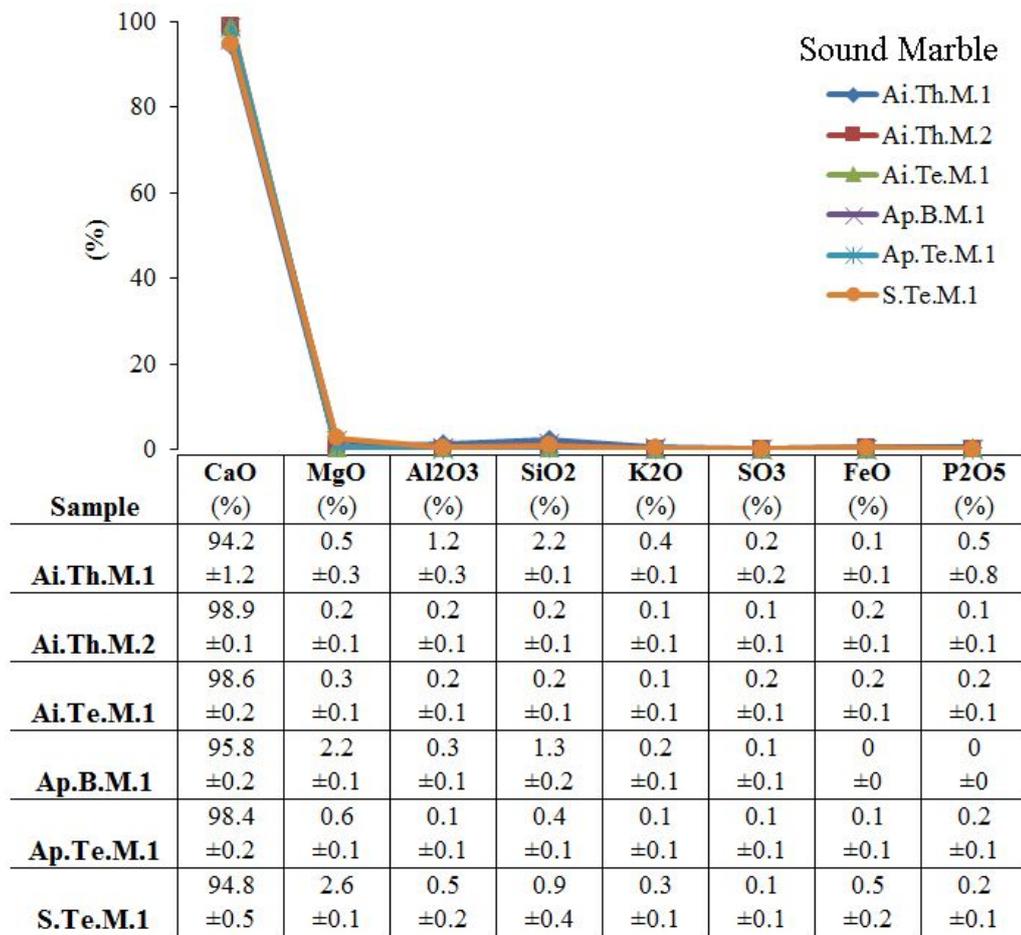
Figure 3.2. The amounts of major and minor elements in sound inner cores of marble

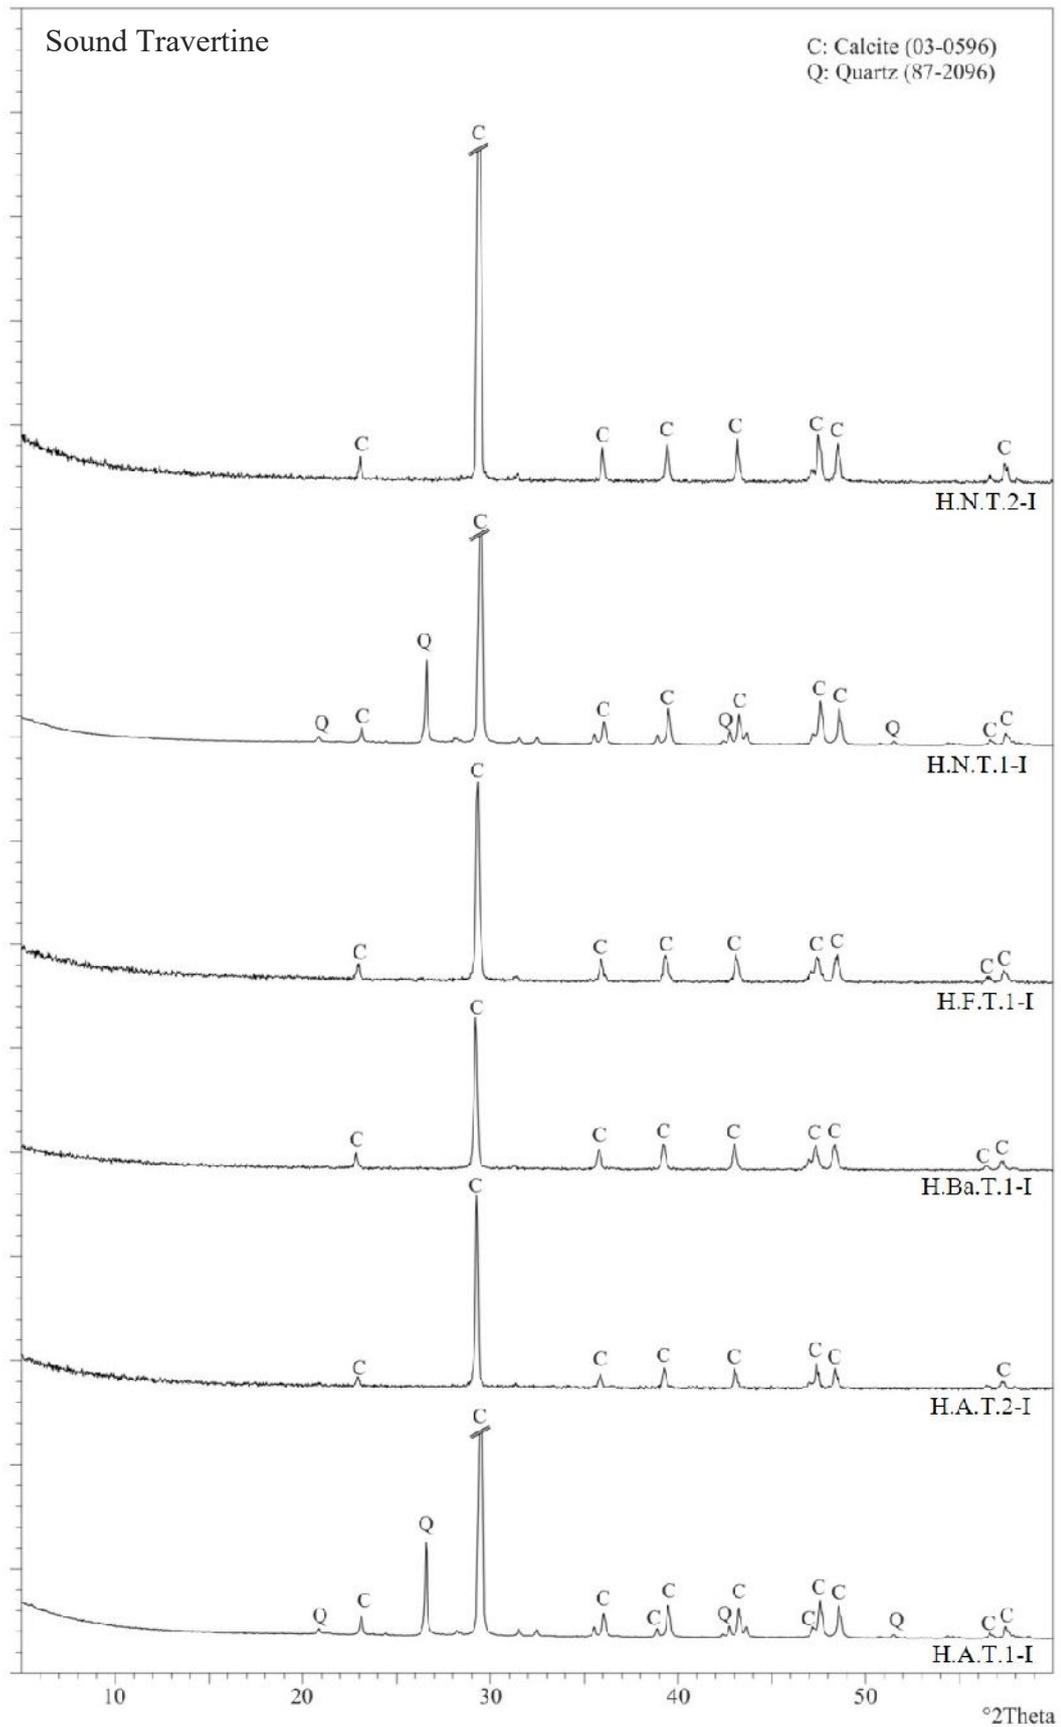
Figure 3.3. XRD patterns of sound inner cores of travertine samples collected from various buildings in Hierapolis archaeological site

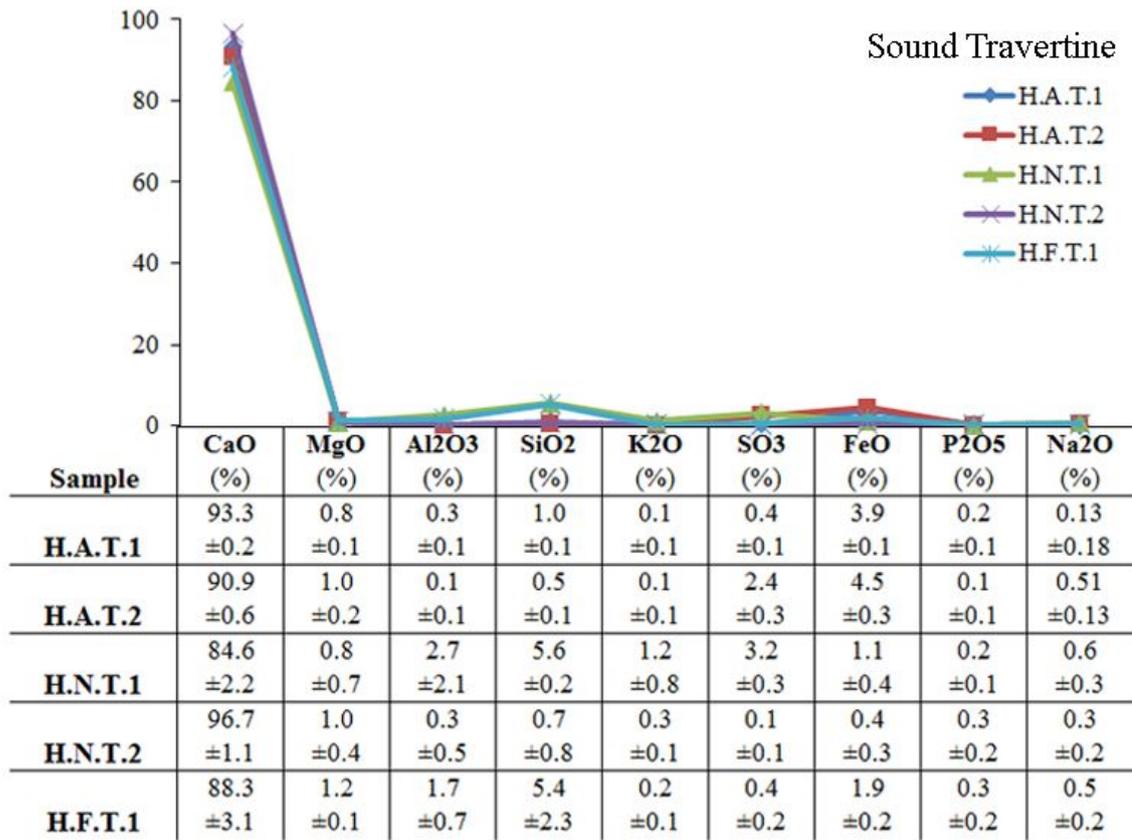
Figure 3.4. The amounts of major and minor elements in sound inner cores of travertine

Similarly with marble, travertine is mainly composed of calcite minerals as a calcareous stone. In addition to this, quartz is also present in the XRD spectrums of travertine samples (Figure 3.3). CaO is the major element with 89% approximately. MgO, Al<sub>2</sub>O<sub>3</sub>, SiO<sub>2</sub>, K<sub>2</sub>O, SO<sub>3</sub>, FeO and P<sub>2</sub>O<sub>5</sub> are the minor elements determined in the SEM-EDX analyses of sound travertine samples with the varying percentages between 0.05 and 4.5 (Figure 3.4).

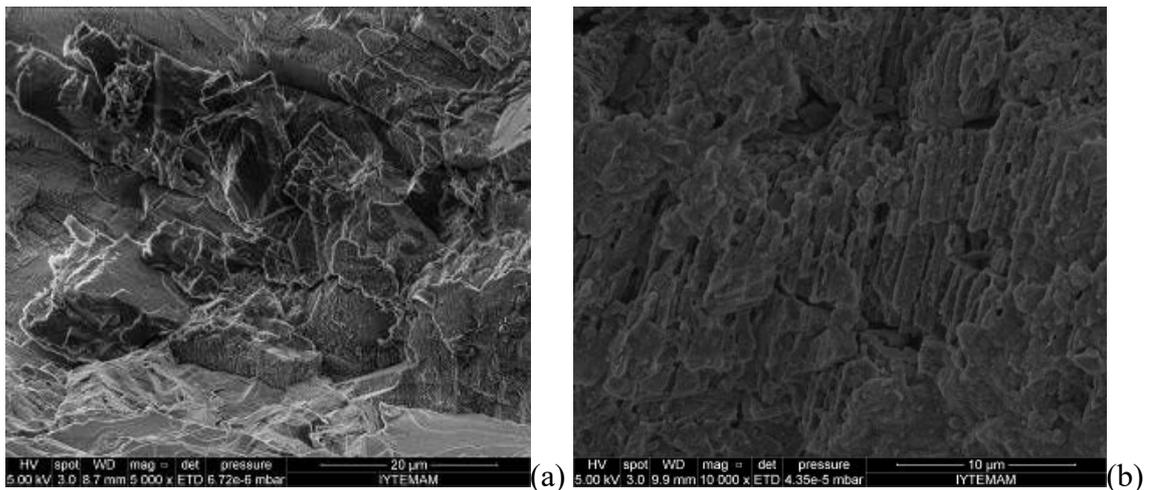
Figure 3.5. Calcite crystals of sound inner cores of marble (Ai.Te.M.1) (a) and travertine (H.N.T.1) (b)

The chemical composition of marble and travertine samples are in accordance with the mineralogical compositions representing calcite minerals as the main material of studied calcareous stones. When the mineralogical composition of marble and yellow travertine are considered, calcite crystals compose more than 90% of calcareous stone materials which is the main source of CaO (Press and Siever 2002). As a proof of this, the coarse grained calcite crystals were clearly observed in the magnified SEM images of sound inner cores of studied marble and travertine samples. The calcite crystals are well interlocked with each other in marble samples (Figure 3.5(a)). However, travertine is more porous than marble as observed from the bounding and microstructure of calcite crystals of both stone types (Figure 3.5).

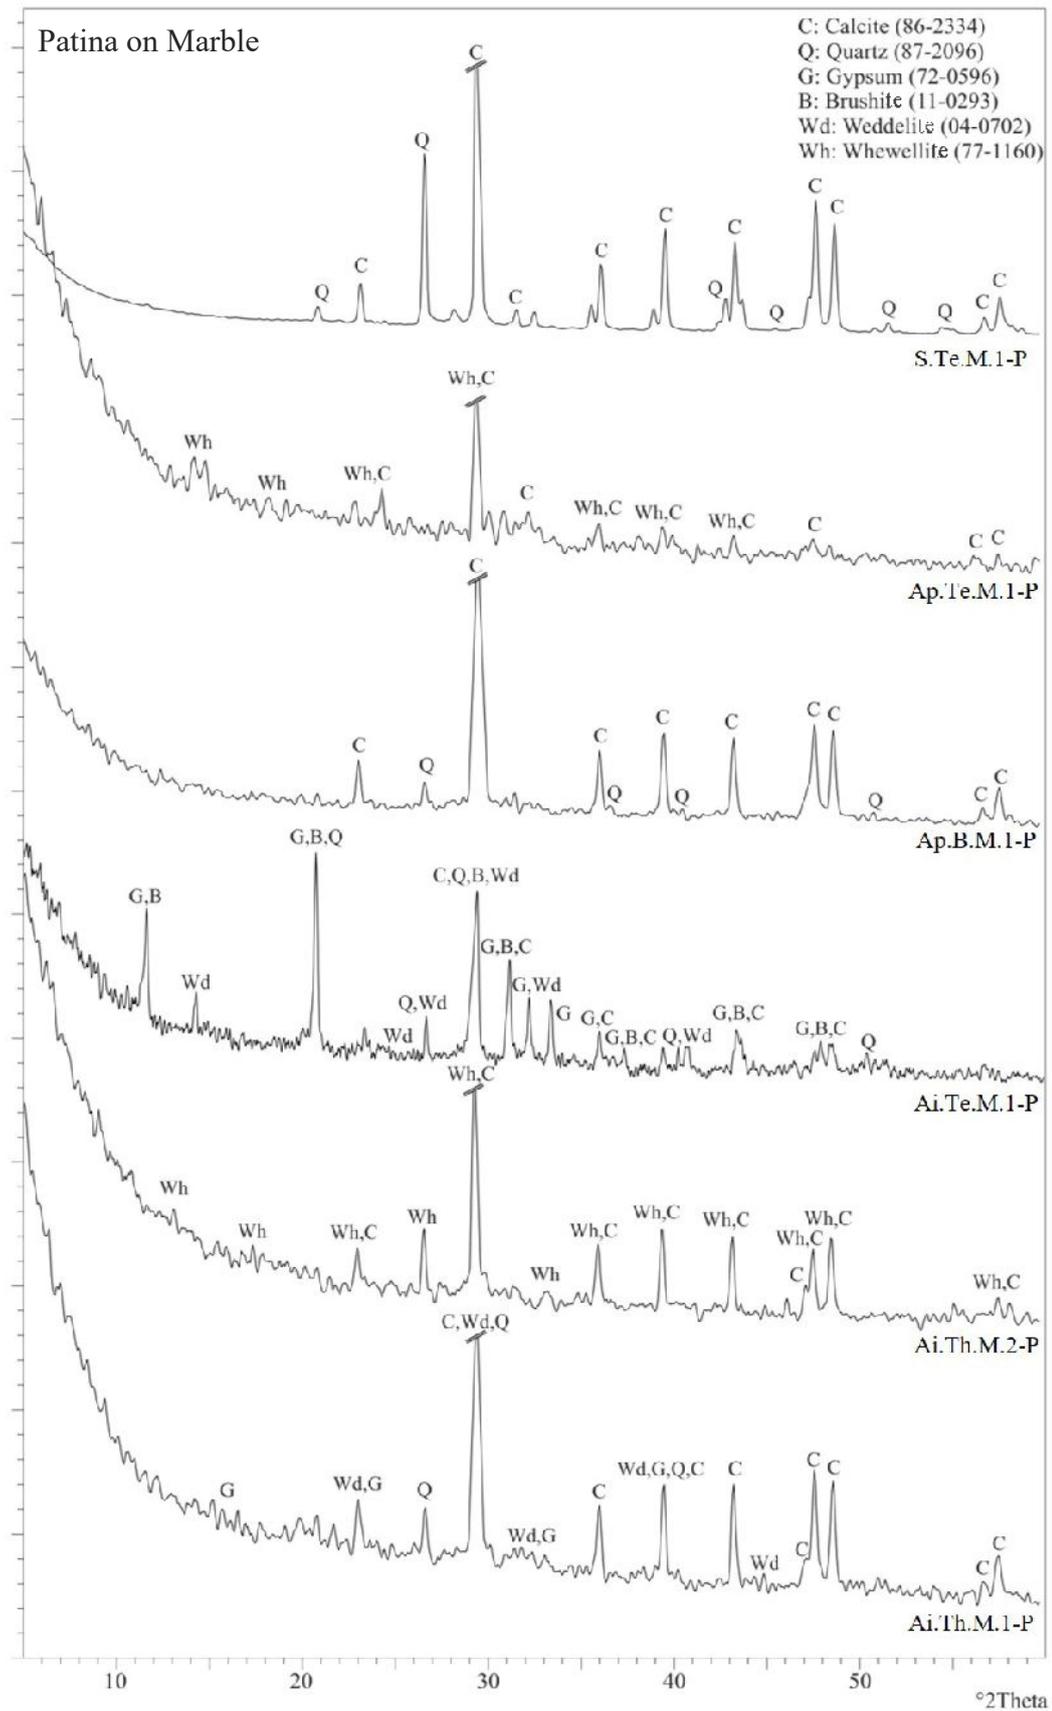
Figure 3.6. XRD patterns of patina samples formed on marble surfaces of various buildings in Aizanoi, Aphrodisias and Sardes archaeological sites

The XRD patterns indicated that the yellow patina formed on marble surfaces collected from Aizanoi and Aphrodisias are mainly composed of calcium oxalate in the form of weddellite ( $\text{CaC}_2\text{O}_4 \cdot 2\text{H}_2\text{O}$ ) or whewellite ( $\text{CaC}_2\text{O}_4 \cdot \text{H}_2\text{O}$ ), gypsum ( $\text{CaSO}_4 \cdot 2\text{H}_2\text{O}$ ), quartz ( $\text{SiO}_2$ ), and calcite ( $\text{CaCO}_3$ ) minerals in general (Figure 3.6). Brushite ( $\text{CaHPO}_4 \cdot 2\text{H}_2\text{O}$ ) was also determined in one of the yellow patina samples collected from the marble wall of Zeus Temple in Aizanoi (Figure 3.6). Similarly, whewellite, gypsum, quartz and calcite minerals were observed on the XRD patterns of yellow patina on travertine samples collected from Hierapolis archaeological site (Figure 3.7). Calcite and quartz were the only minerals present in the XRD patterns of patina samples on marble collected from temple in Sardis and on travertine collected from fountain in Hierapolis (Figure 3.6, Figure 3.7).
