**CONSERVATION APPROACHES OF PATINA  
FORMATION ON MARBLE AND TRAVERTINE  
SURFACES IN THE ARCHAEOLOGICAL SITES**

**A Thesis Submitted to  
the Graduate School of Engineering and Sciences of  
İzmir Institute of Technology  
in Partial Fulfillment of the Requirements for the Degree of**

**DOCTOR OF PHILOSOPHY**

**in Architecture**

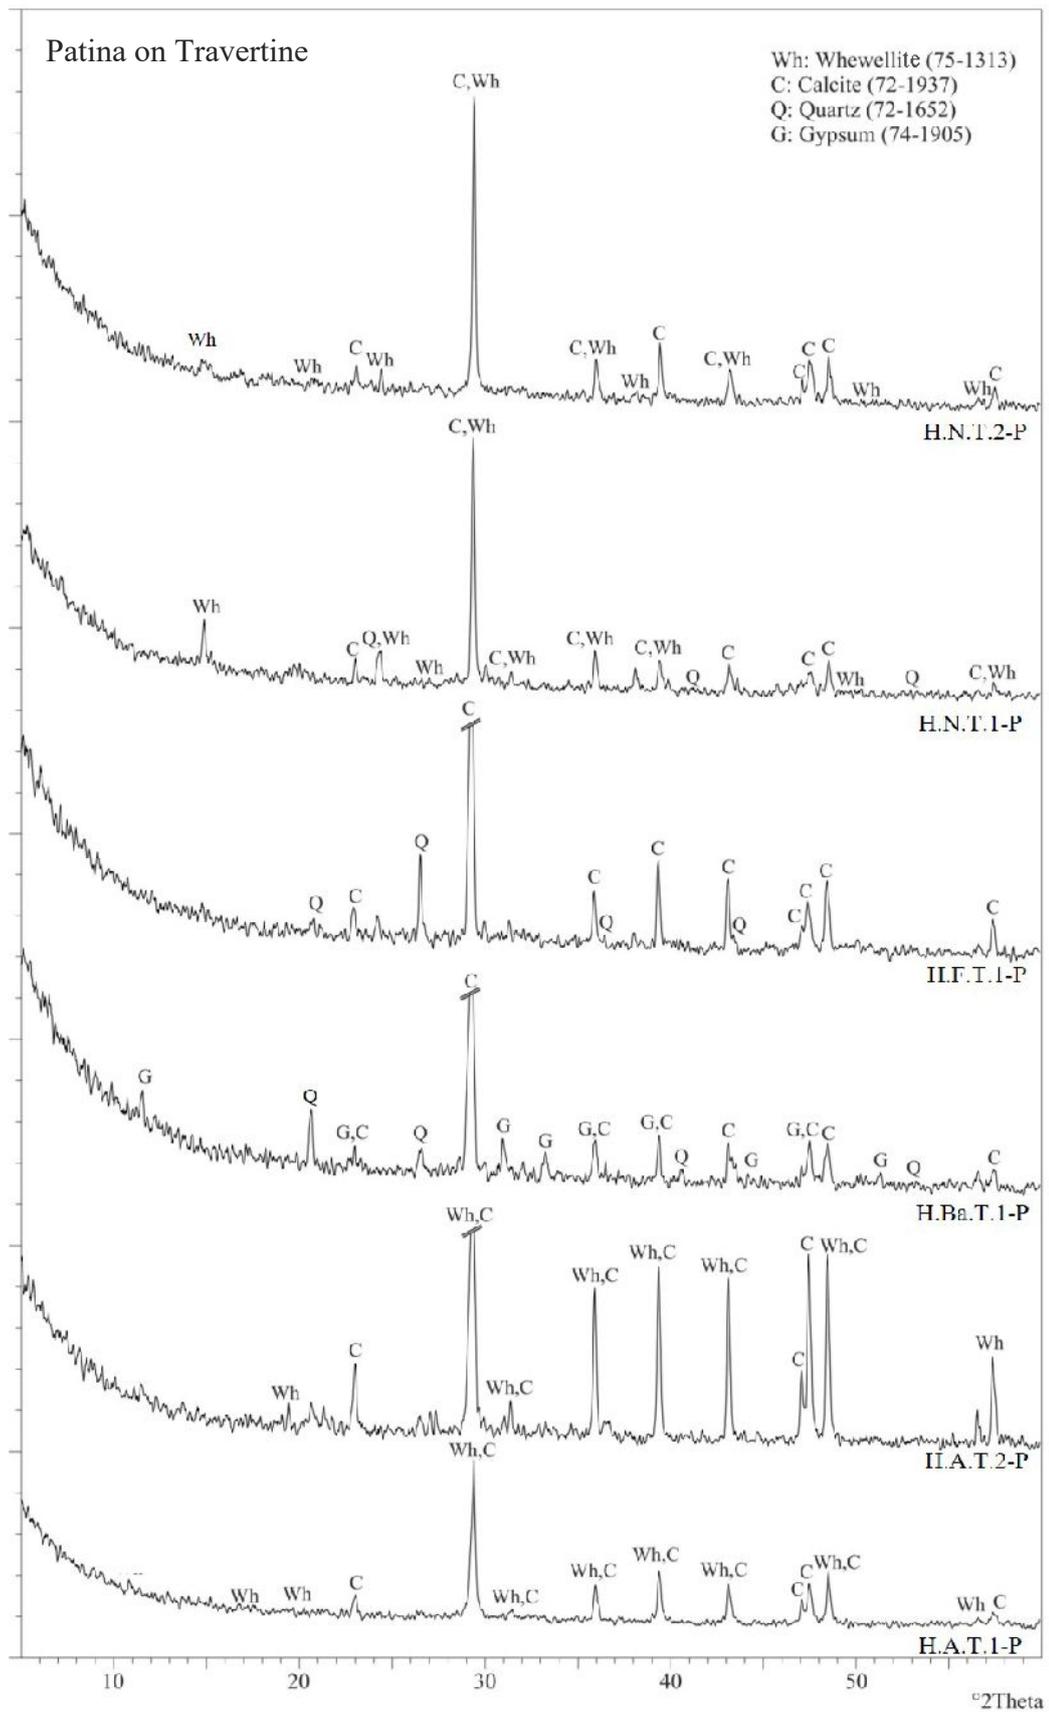
Figure 3.7. XRD patterns of patina samples formed on travertine surfaces of various buildings in Hierapolis archaeological site

The XRD patterns indicated that the yellow patina formed on marble surfaces collected from Aizanoi and Aphrodisias are mainly composed of calcium oxalate in the form of weddellite ( $\text{CaC}_2\text{O}_4 \cdot 2\text{H}_2\text{O}$ ) or whewellite ( $\text{CaC}_2\text{O}_4 \cdot \text{H}_2\text{O}$ ), gypsum ( $\text{CaSO}_4 \cdot 2\text{H}_2\text{O}$ ), quartz ( $\text{SiO}_2$ ), and calcite ( $\text{CaCO}_3$ ) minerals in general (Figure 3.6). Brushite ( $\text{CaHPO}_4 \cdot 2\text{H}_2\text{O}$ ) was also determined in one of the yellow patina samples collected from the marble wall of Zeus Temple in Aizanoi (Figure 3.6). Similarly, whewellite, gypsum, quartz and calcite minerals were observed on the XRD patterns of yellow patina on travertine samples collected from Hierapolis archaeological site (Figure 3.7). Calcite and quartz were the only minerals present in the XRD patterns of patina samples on marble collected from temple in Sardis and on travertine collected from fountain in Hierapolis (Figure 3.6, Figure 3.7).

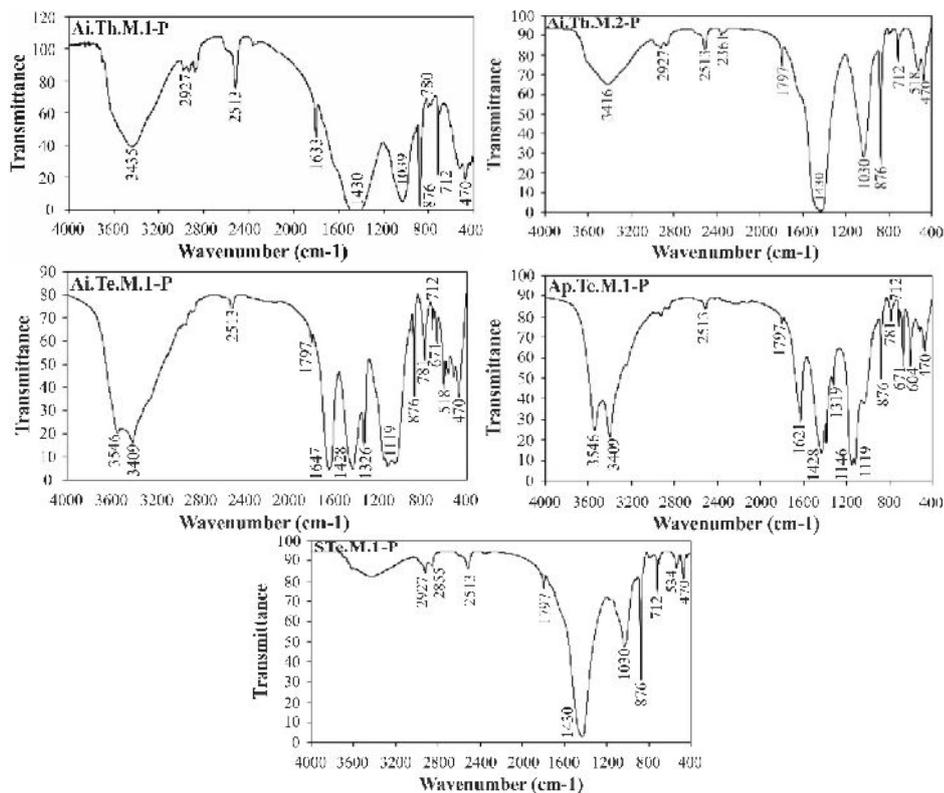
Figure 3.8. FT-IR graphs of patina samples on marble in Aizanoi, Aphrodisias and Sardes archaeological sites

The mineralogical composition of yellow patina was also determined by FT-IR (Figure 3.8, Figure 3.9). FT-IR results of the same marble and travertine samples presented one form of hydrated oxalate as whewellite characterized by the bands at around 1635, 1323 and 783  $\text{cm}^{-1}$  (Figure 3.8, Figure 3.9). Two of the prominent bands at 1635 and 1323  $\text{cm}^{-1}$  are related with  $\text{OH}^-$  vibrations and  $\text{C}=\text{O}$  stretching presenting in whewellite (Rodriguez et.al. 2011). The absorbance bands at around 2925, 2927 and 2850  $\text{cm}^{-1}$  are assigned to C-H stretching showing the presence of organic compounds in the patina which may be the sign of biologic tissues in the stones. The stretching and bending vibrations of calcite ( $\text{CaCO}_3$ ) with the bands at  $\sim 2513$ , 1797, 1430, 876, 712  $\text{cm}^{-1}$  and quartz ( $\text{SiO}_2$ ) at  $\sim 1031$   $\text{cm}^{-1}$  were also observed. Hence, these bands are ascribed to carbonates at around 1430  $\text{cm}^{-1}$ , and to silicates at around  $\sim 1030$   $\text{cm}^{-1}$  in the previous studies (Rodriguez et.al. 2011). Gypsum was determined at 3546, 3409, 1146, 1119, 671, 470  $\text{cm}^{-1}$ . In addition, brushite is determined with the bands at 1054, 566  $\text{cm}^{-1}$  in the same yellow patina sample (Ai.Te.M.1) promoting its XRD results (Figure 3.8).

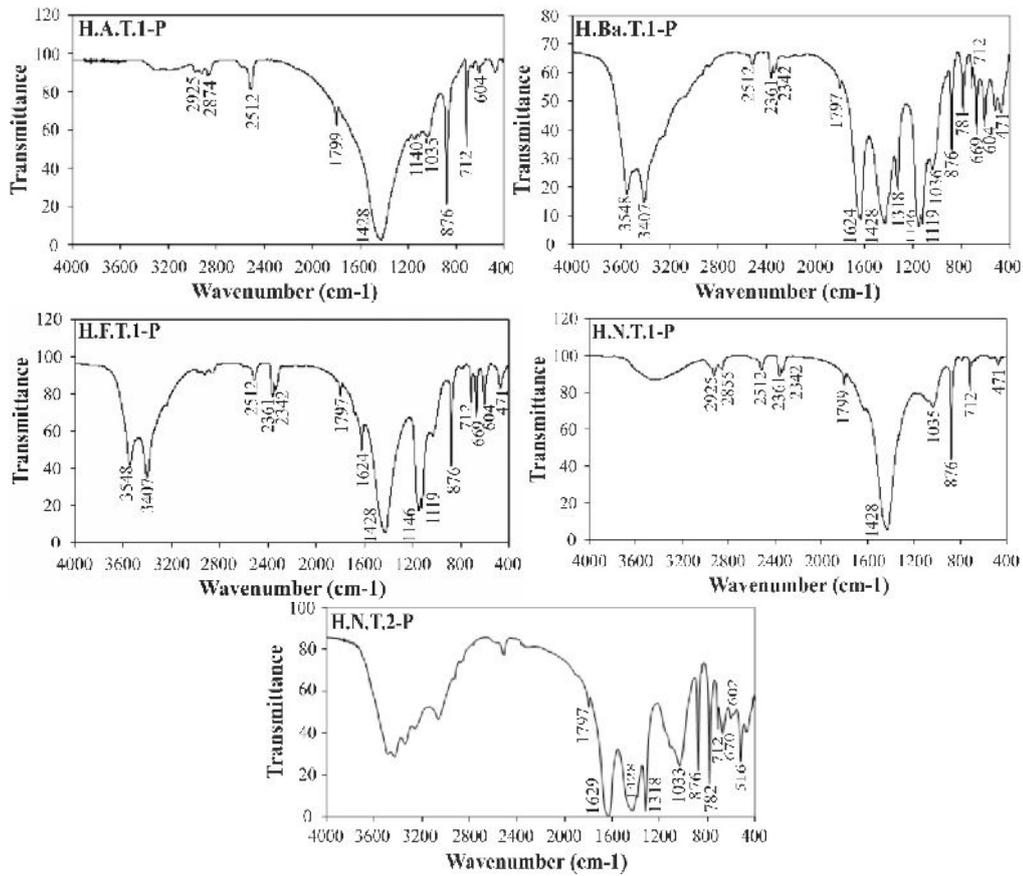
Figure 3.9. FT-IR graphs of patina samples on travertine in Hierapolis archaeological site

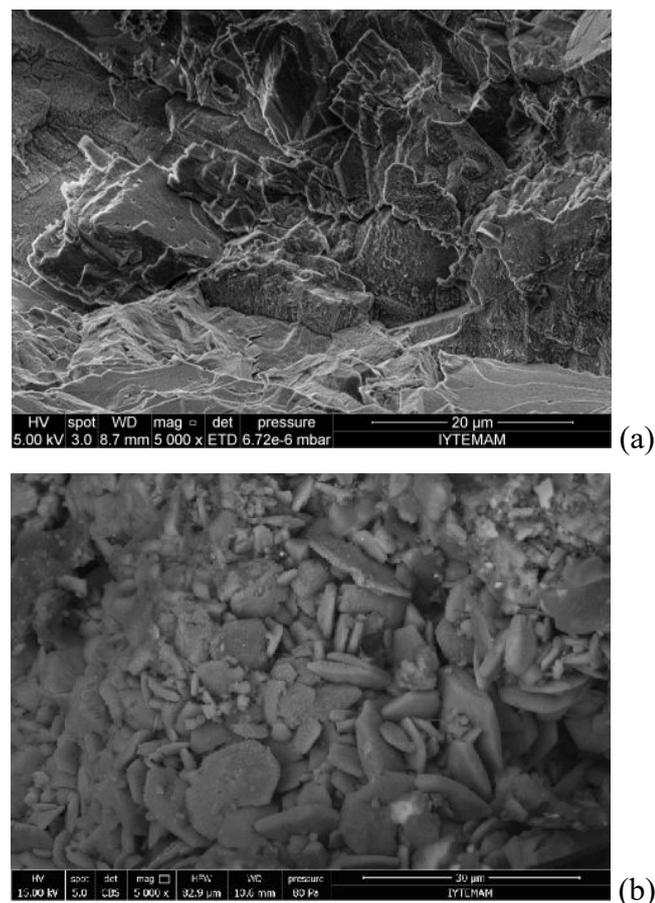
Figure 3.10. SEM images of one representative marble sample (Ai.Te.M.1) showing calcite (a) and calcium oxalate crystals formed on it (b)

The coarse grained calcite crystals were observed in the magnified SEM images of sound inner cores of both of the stone types (Figure 3.10 (a)). The well interlocked coarse grained calcite crystals of marble are covered with leaf shaped euhedral calcium oxalate crystals forming a homogeneous nodular surface on the original stone substrata (Figure 3.10 (a, b), Figure 3.11(a)). It is clearly observed as a film layer on magnified SEM images of marble (Figure 3.11(a)).

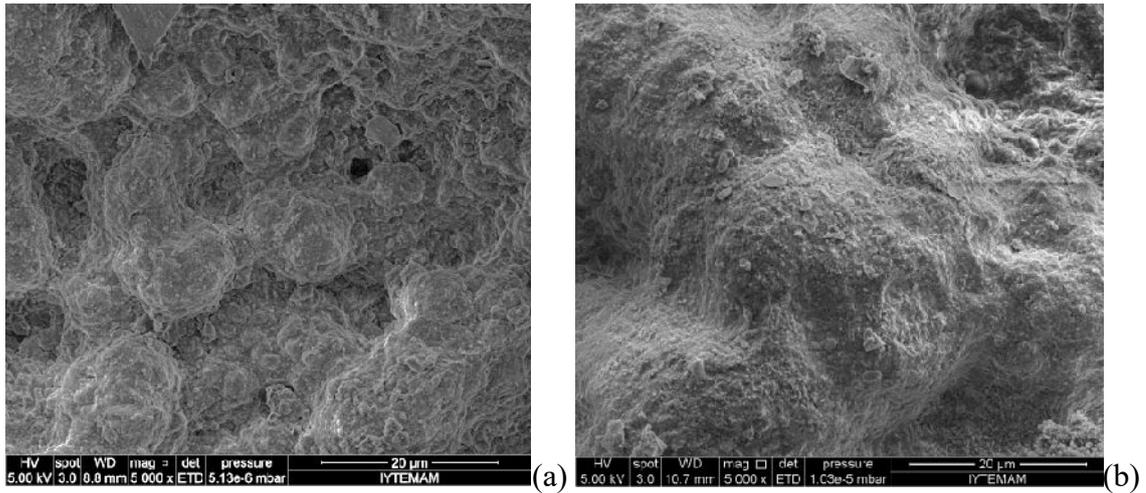
Figure 3.11. Magnified SEM images showing the outer nodular appearance of calcium oxalate layer on marble (Ai.Th.M.1 (a)) and travertine (H.N.T.1 (b))

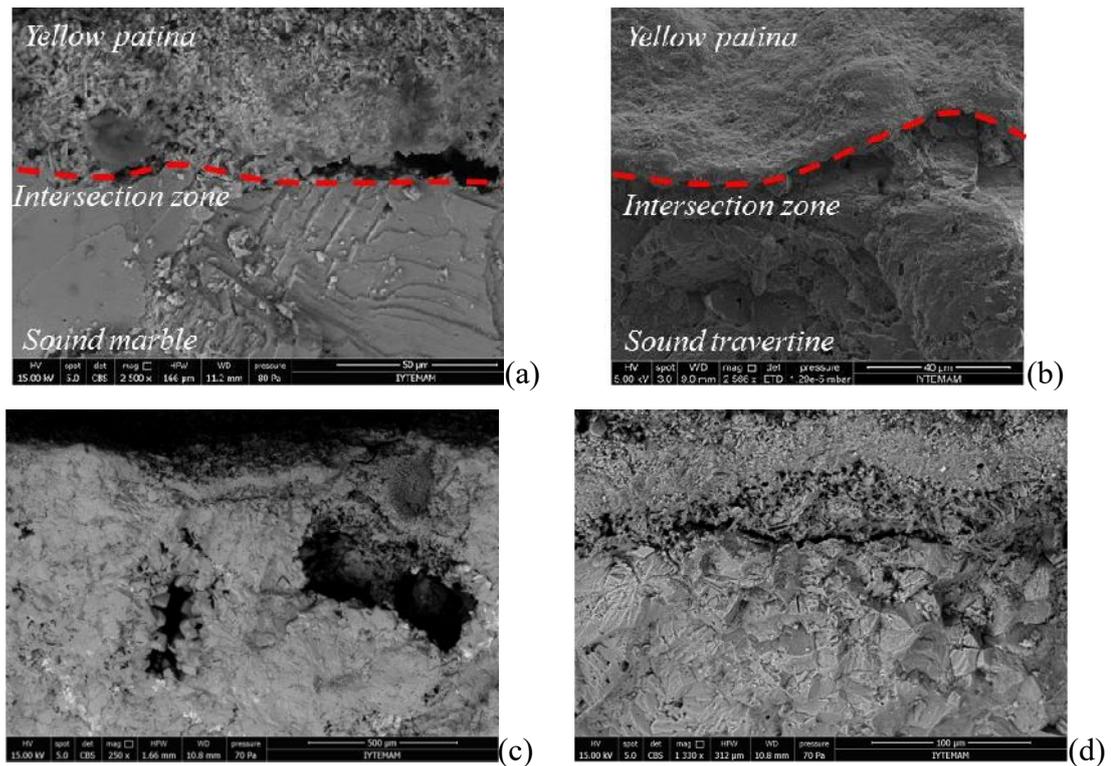
Figure 3.12. SEM images of yellow patina on marble (Ai.Th.M.1 (a)) and travertine surfaces (H.N.T.1 (b)), sections representing the yellow patina, inner core and intersection of both (H.Ba.T.1 (c, d))

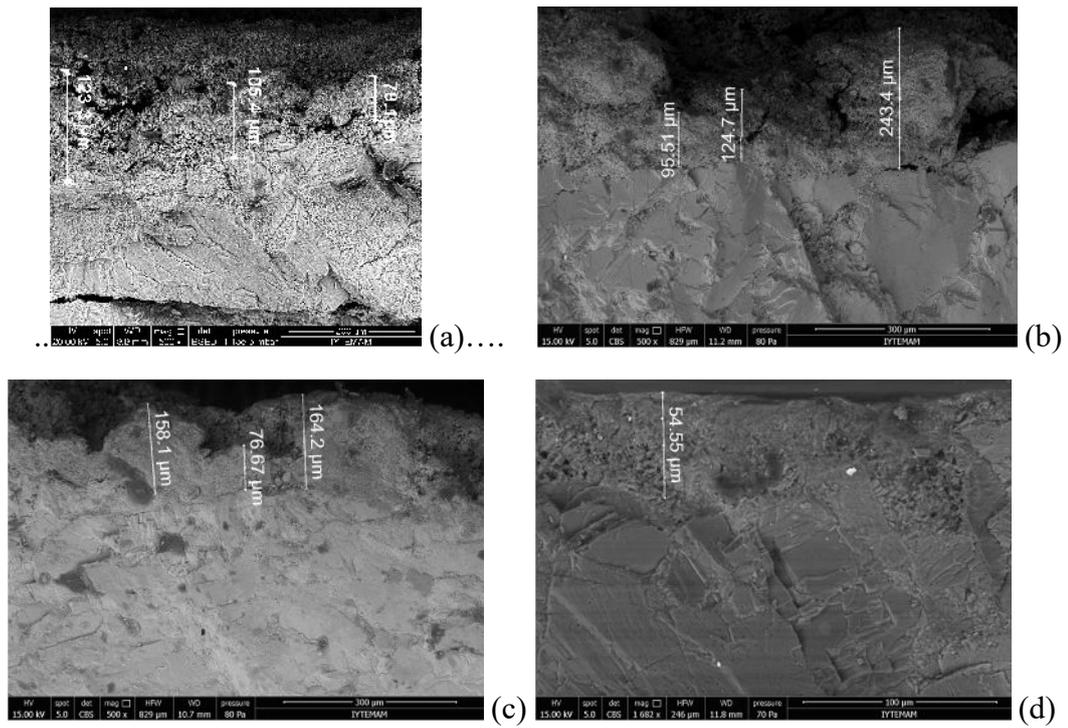
Figure 3.13. SEM images of the intersection of marble and patina with its thickness (Ai.Th.M.1 (a), Ai.Th.M.2 (b), Ai.Te.M.1 (c), Ap.Te.M.1 (d))

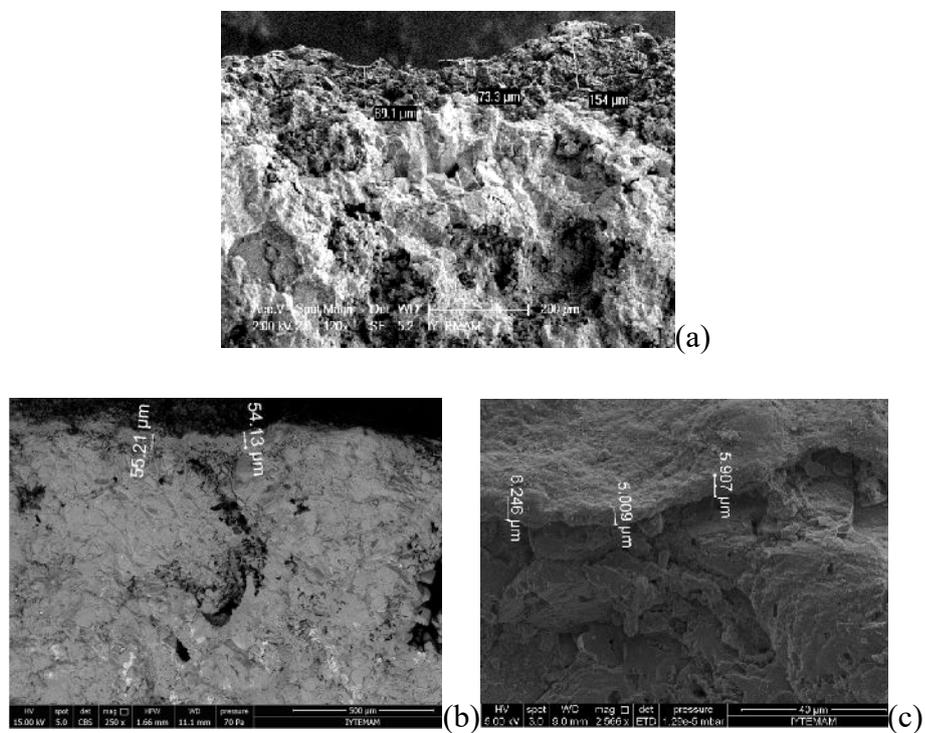
Figure 3.14. SEM images of the intersection of travertine and patina with its thickness (H.A.T.1 (a), H.Ba.T.1 (b), H.N.T.1 (c))

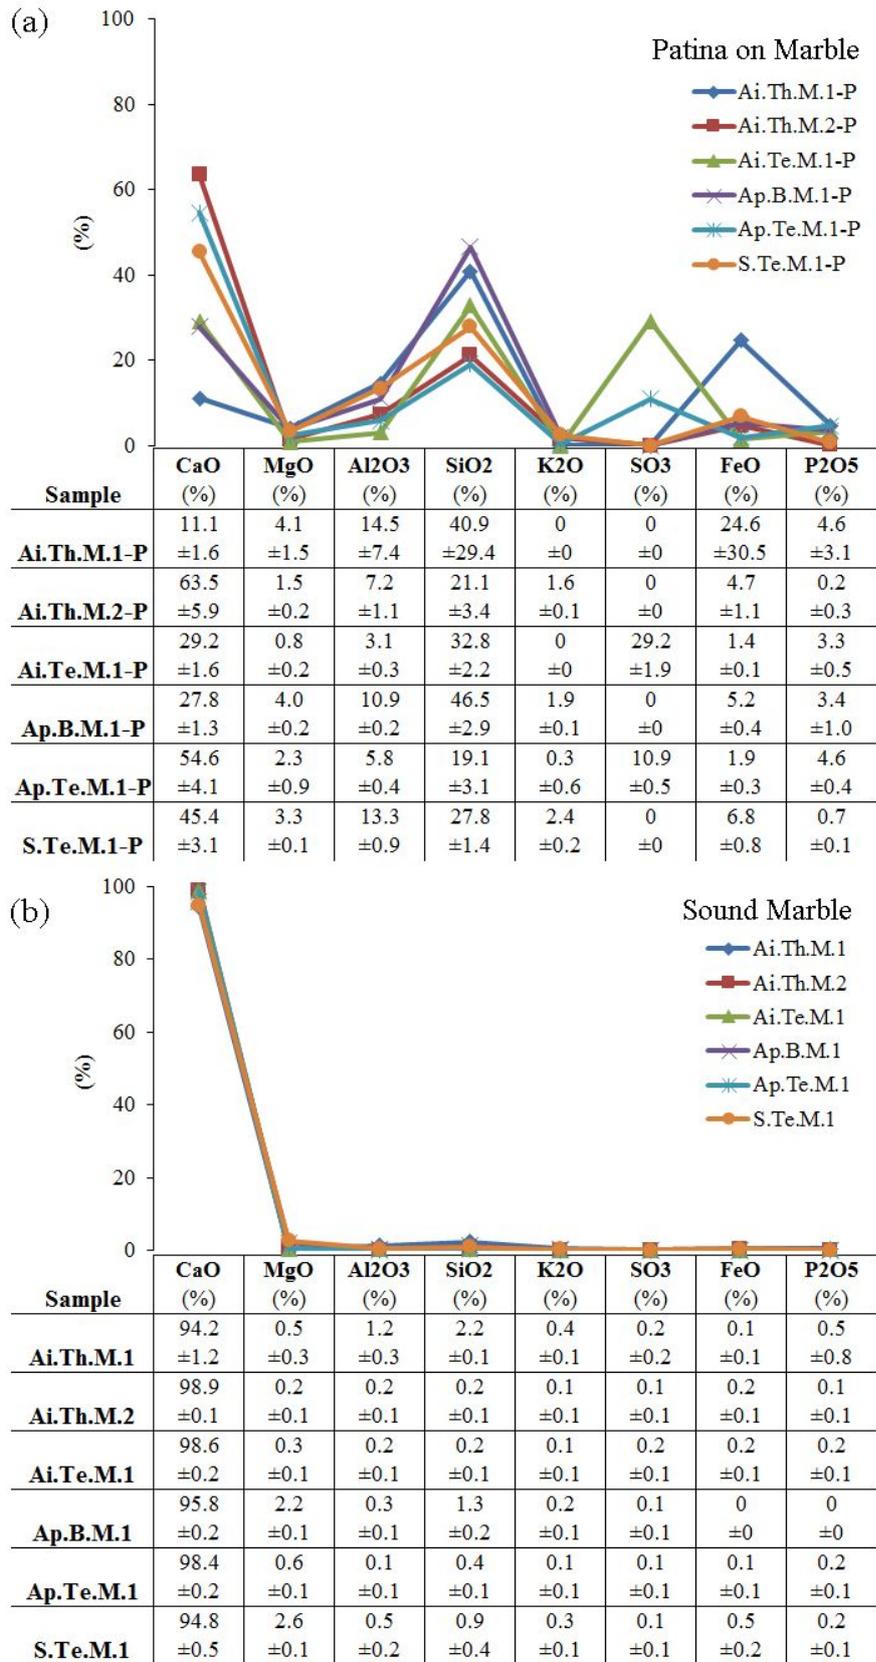
Figure 3.15. The amounts of major and minor elements in yellow patina formation (a) and sound inner cores (b) of marble samples

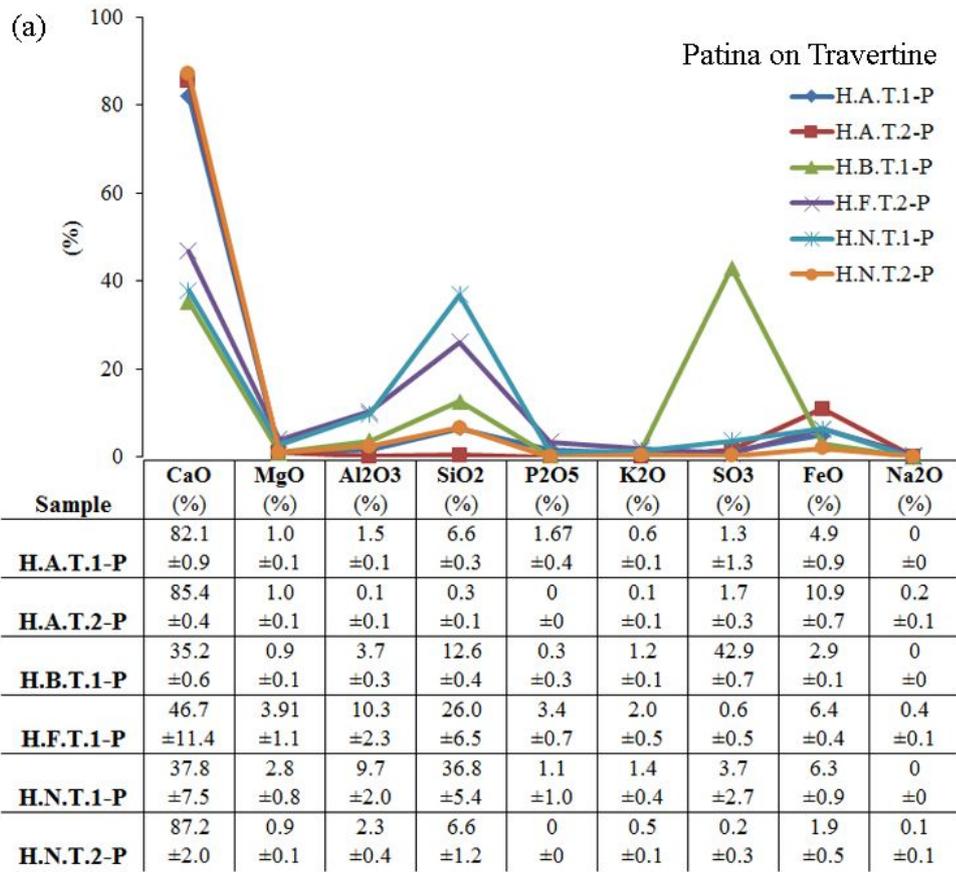
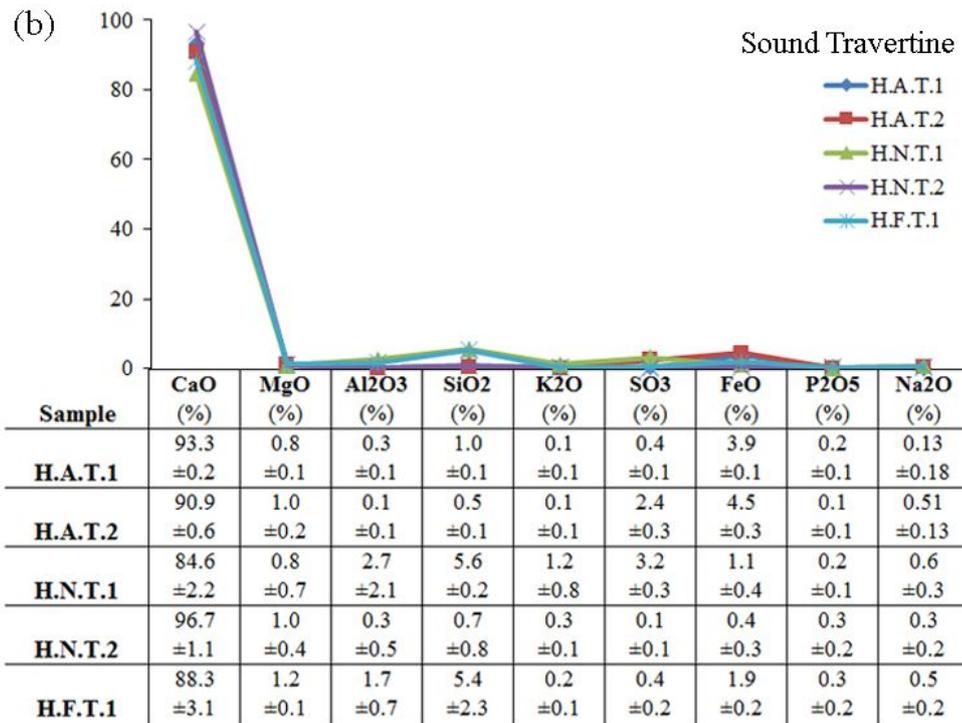
Figure 3.16. The amounts of major and minor elements in yellow patina formation (a) and sound inner cores (b) of travertine samples

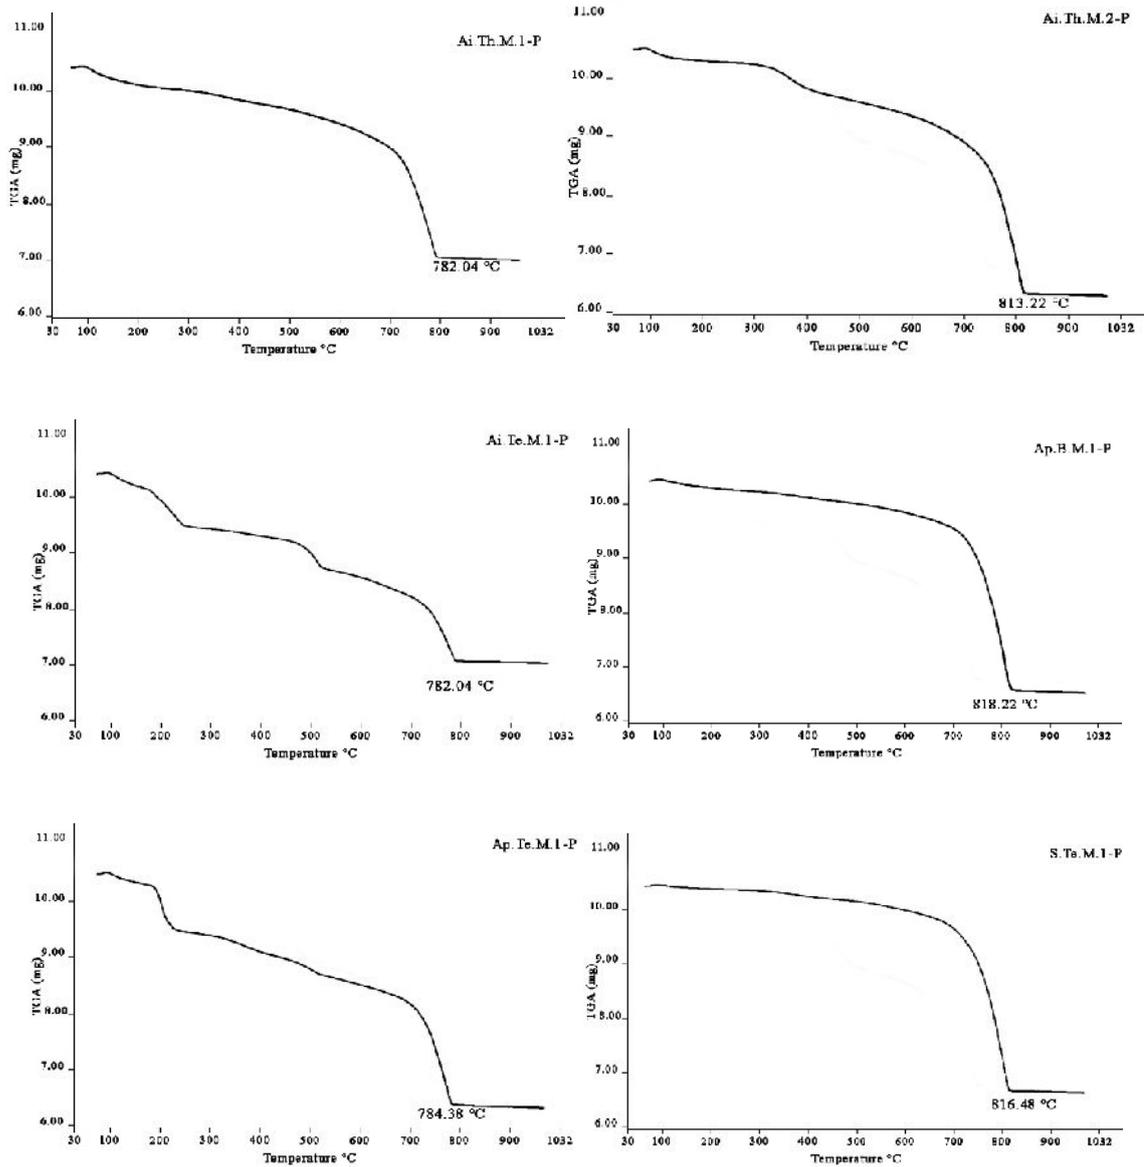
Figure 3.17. TGA graphs of patina samples taken from marble surfaces

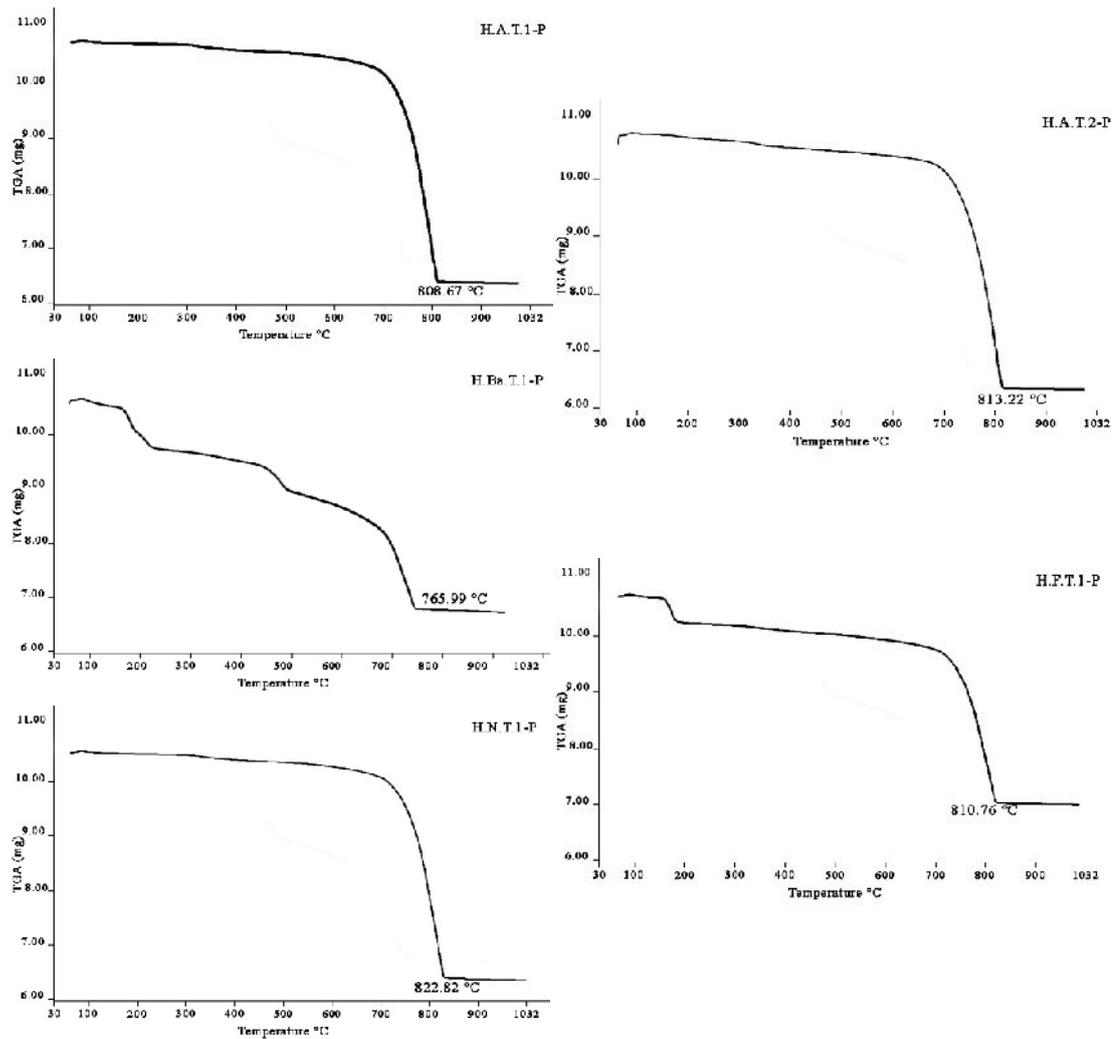
Figure 3.18. TGA graphs of patina samples taken from travertine surfaces

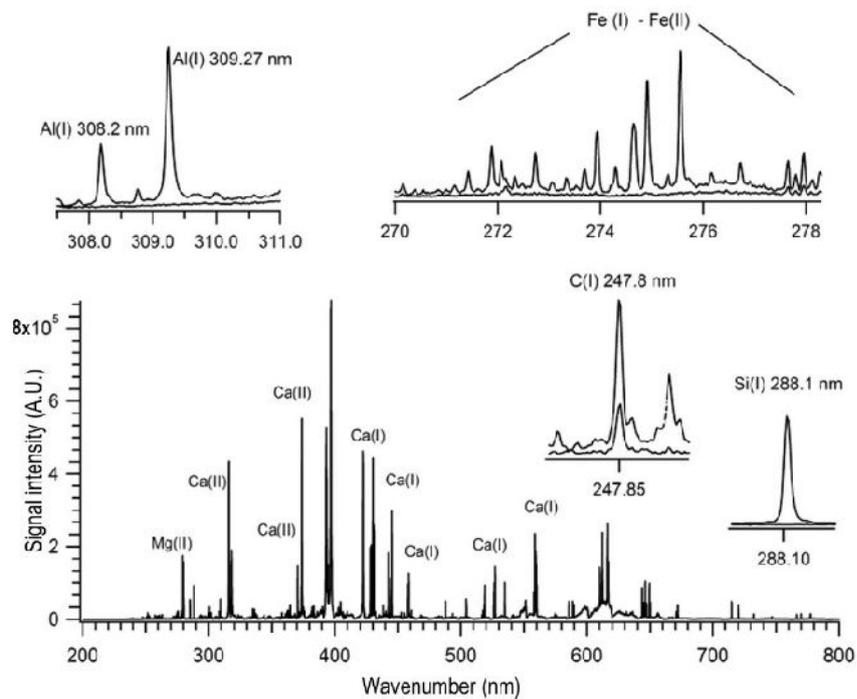
Figure 3.19. Atomic emission lines of C, Si, Al and Fe of sound inner core (spectrum below) and yellow patina (spectrum above) by LIBS spectrum of marble (Ai.Th.M.1)

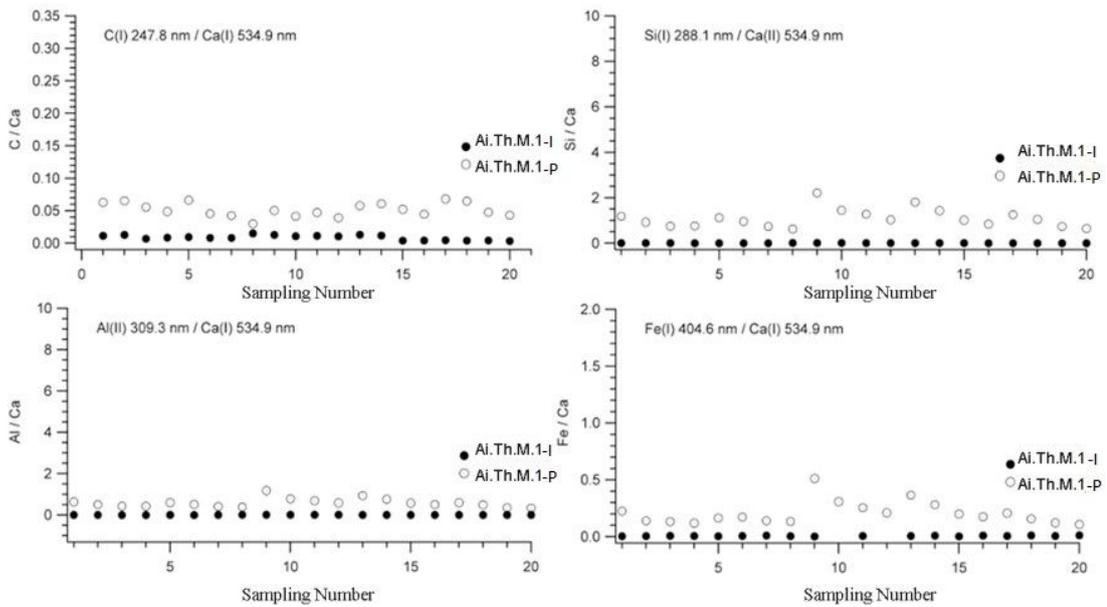
Figure 3.20. The graphs showing the ratios of C, Si, Al and Fe signals to Ca signal in the yellow patina (Ai.Th.M.1-P) and sound inner cores of marble sample (Ai.Th.M.1-I)

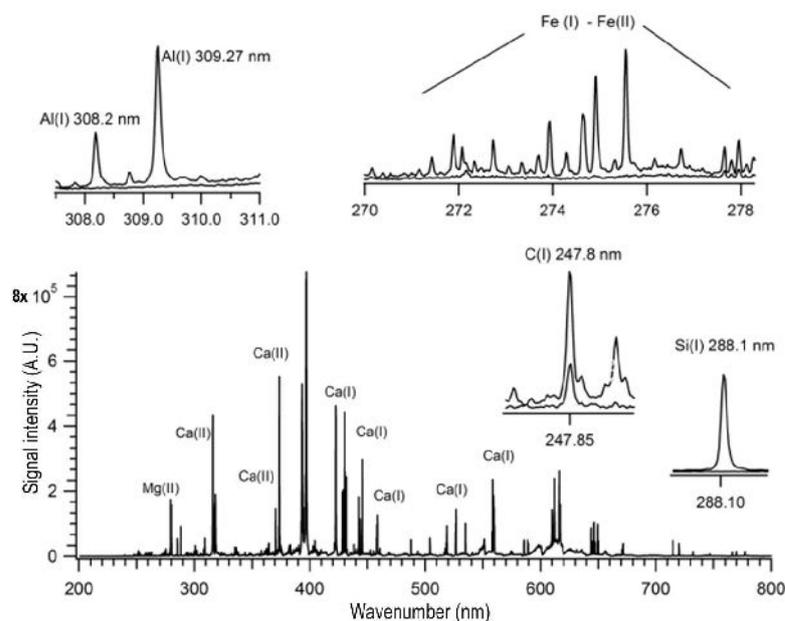
Figure 3.21. Atomic emission lines of C, Si, Al and Fe of sound inner core (spectrum below) and yellow patina (spectrum above) by LIBS spectrum of travertine (H.N.T.1)

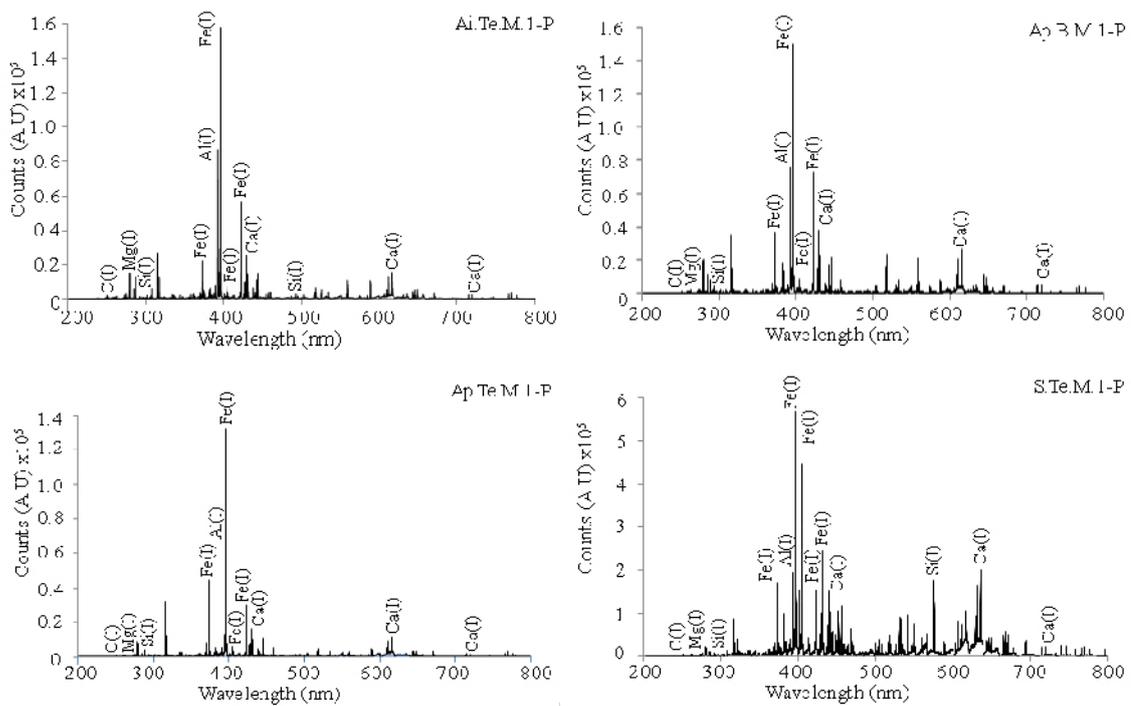
Figure 3.22. Atomic emission lines of C, Ca, Mg, Si, Al and Fe of yellow patina on marble samples by LIBS spectrum

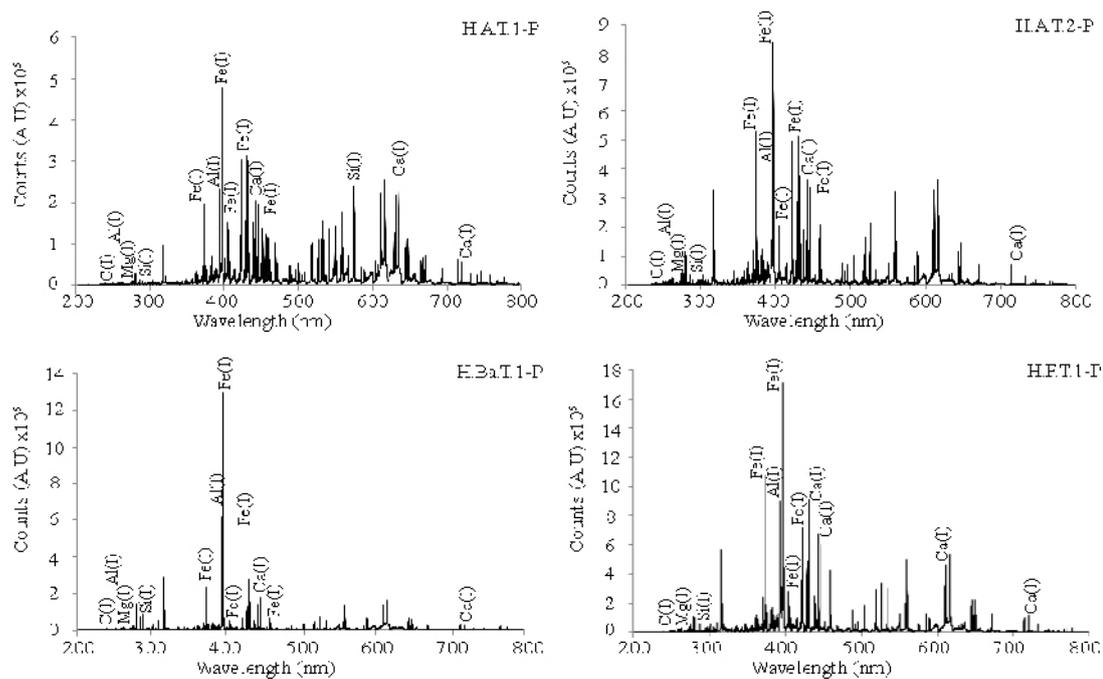
Figure 3.23. Atomic emission lines of C, Ca, Mg, Si, Al and Fe of yellow patina on yellow travertine samples by LIBS spectrum

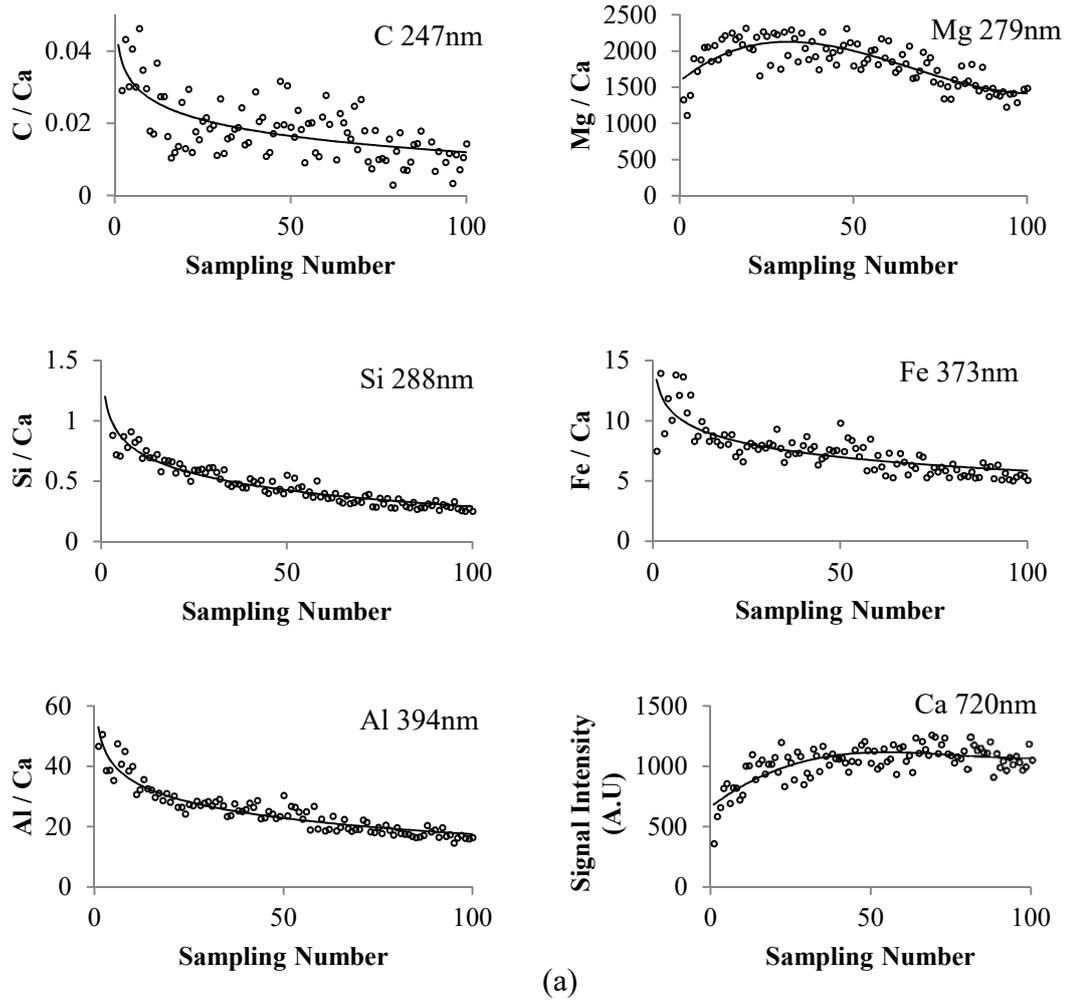
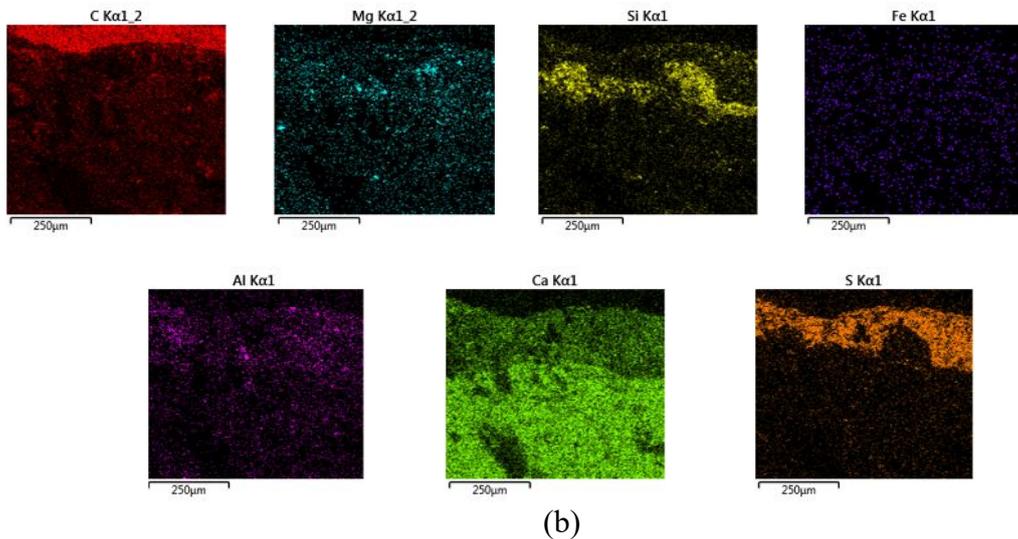
Figure 3.25. Variation of C, Mg, Si, Al and Fe signal intensities normalized to Ca signal with respect to depth in LIBS (a) and SEM-EDX mapping of Ai.Te.M.1 (b)

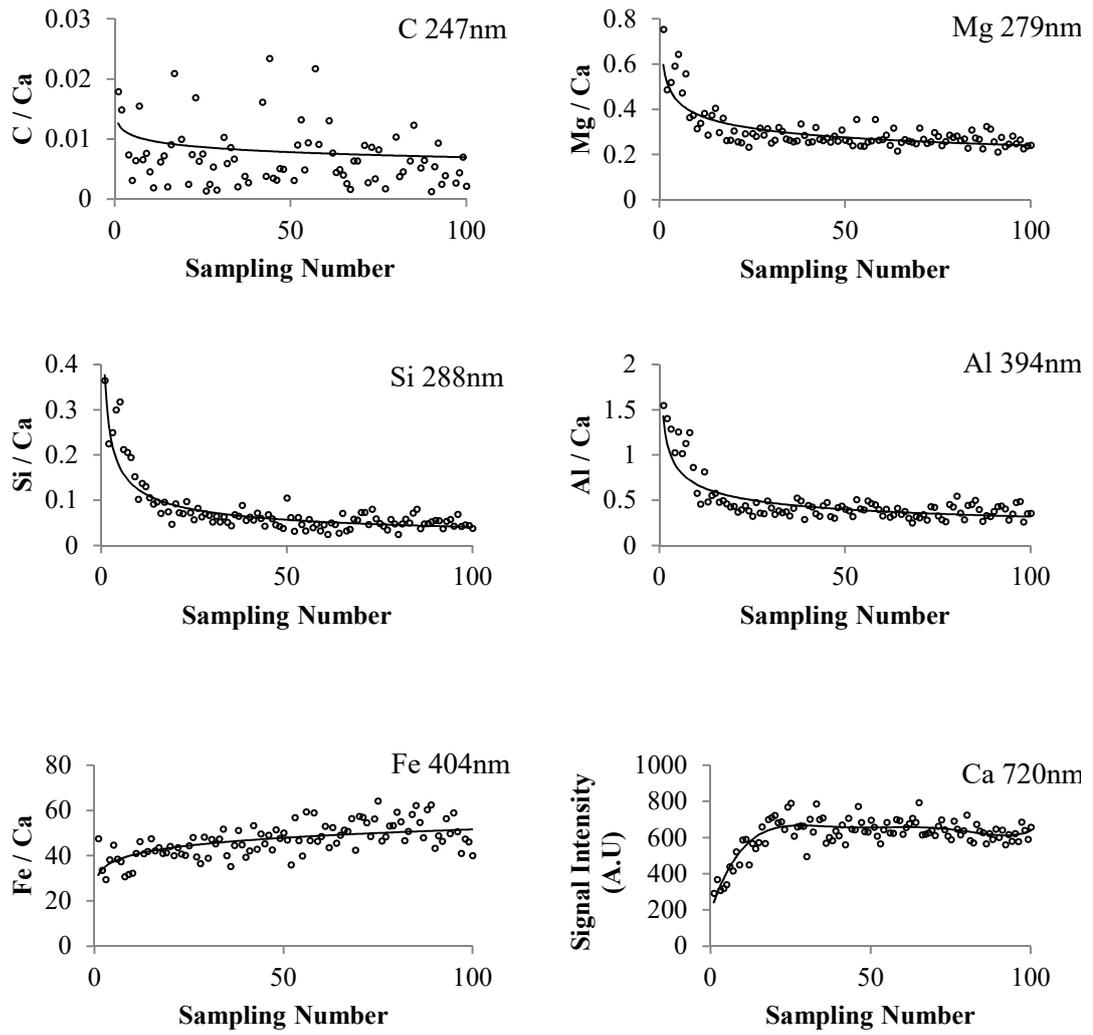
Figure 3.28. Variation of C, Mg, Si, Al and Fe signal intensities normalized to Ca signal with respect to depth for S.Te.M.1 in LIBS

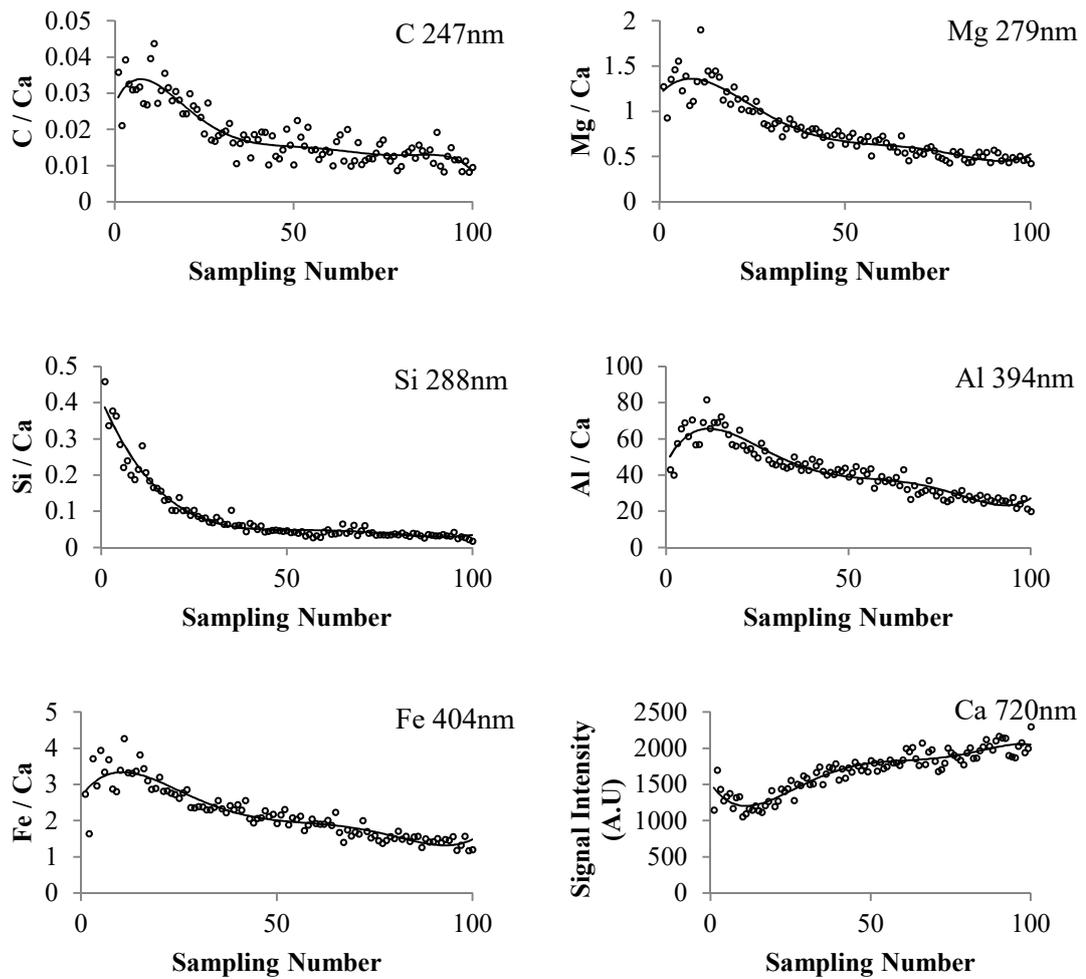
Figure 3.29. Variation of C, Mg, Si, Al and Fe signal intensities normalized to Ca signal with respect to depth for H.N.T.1 in LIBS

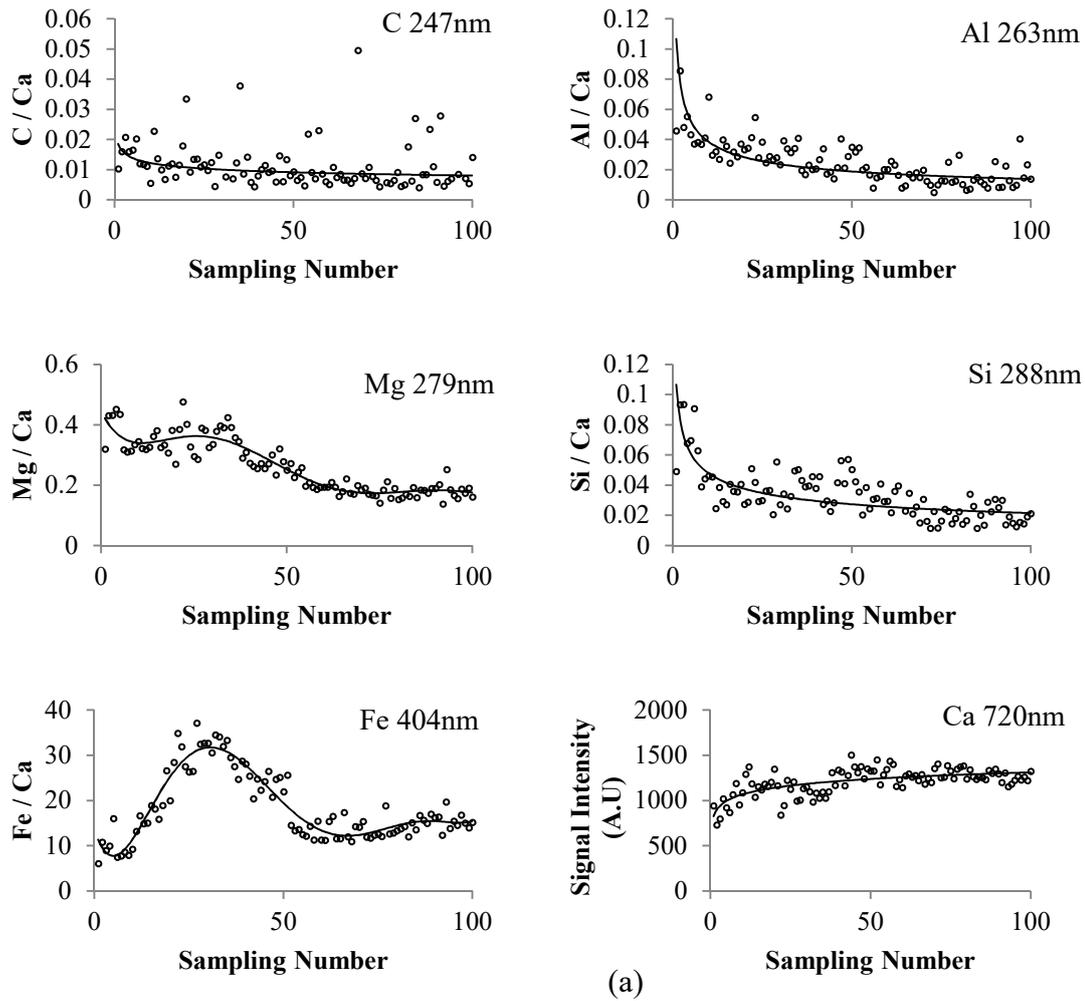
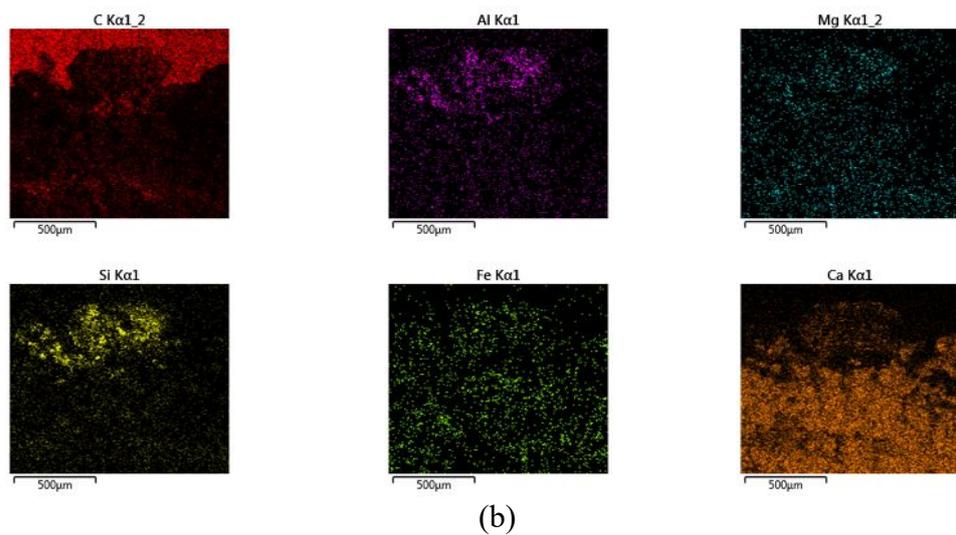
Figure 3.30. Variation of C, Mg, Si, Al and Fe signal intensities normalized to Ca signal with respect to depth in LIBS (a) and SEM-EDX mapping of H.A.T.1 (b)
