**CONSERVATION APPROACHES OF PATINA  
FORMATION ON MARBLE AND TRAVERTINE  
SURFACES IN THE ARCHAEOLOGICAL SITES**

**A Thesis Submitted to  
the Graduate School of Engineering and Sciences of  
İzmir Institute of Technology  
in Partial Fulfillment of the Requirements for the Degree of**

**DOCTOR OF PHILOSOPHY**

**in Architecture**

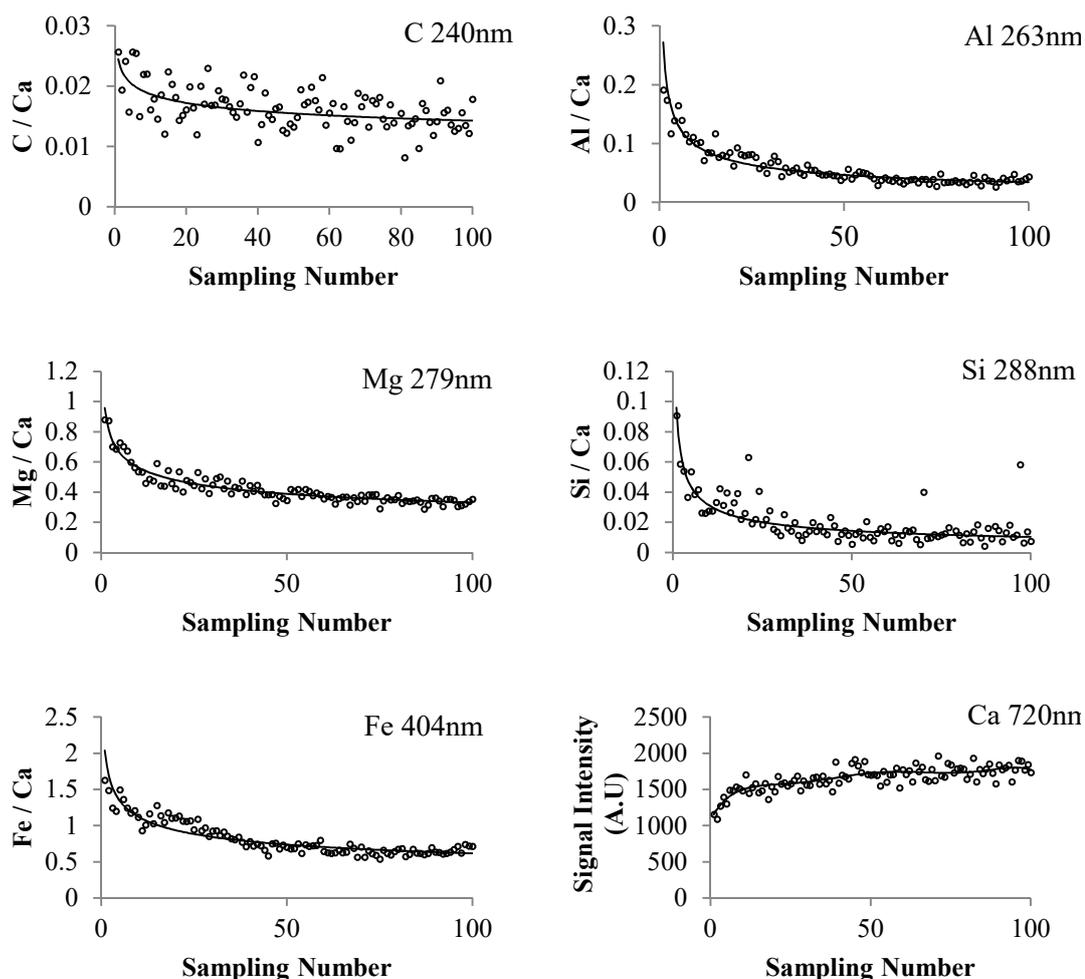
Figure 3.31. Variation of C, Mg, Si, Al and Fe signal intensities normalized to Ca signal with respect to depth for H.A.T.2 in LIBS

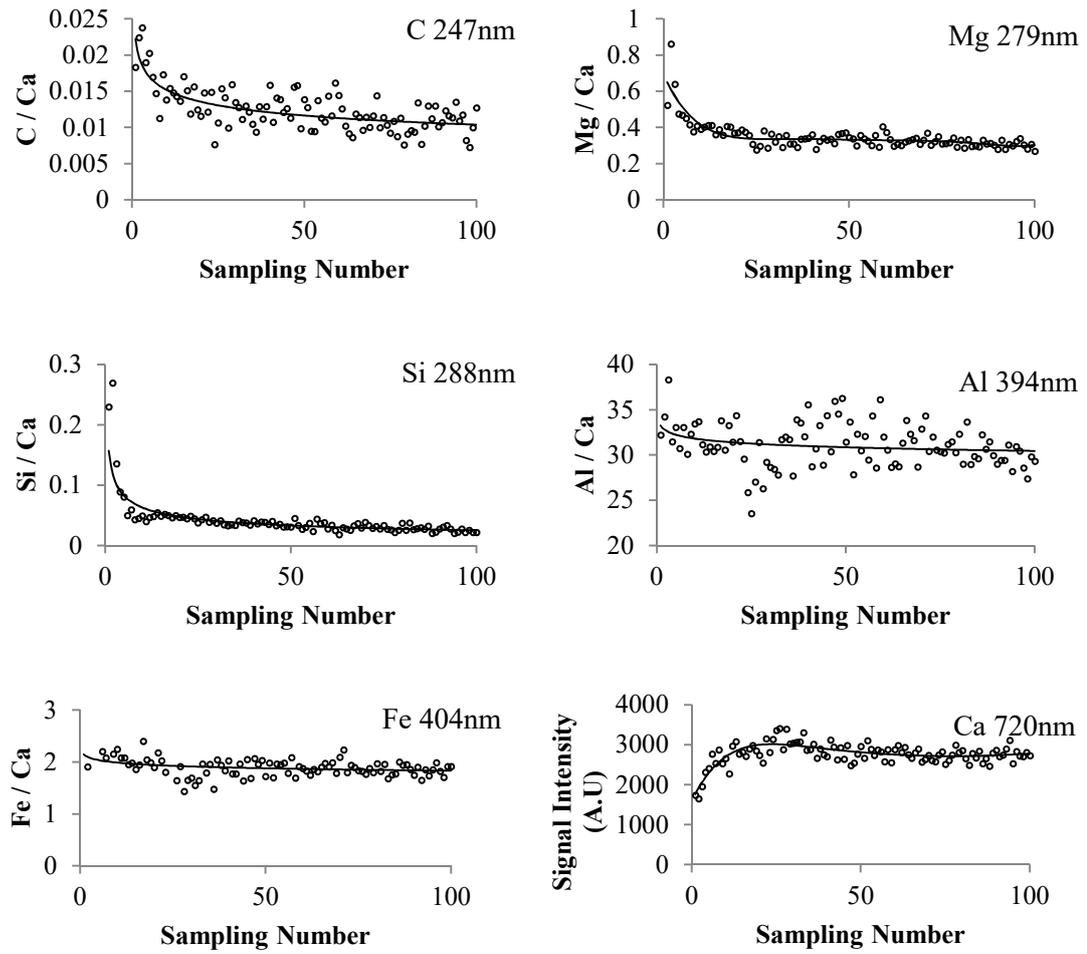
Figure 3.32. Variation of C, Mg, Si, Al and Fe signal intensities normalized to Ca signal with respect to depth for H.F.T.1 in LIBS

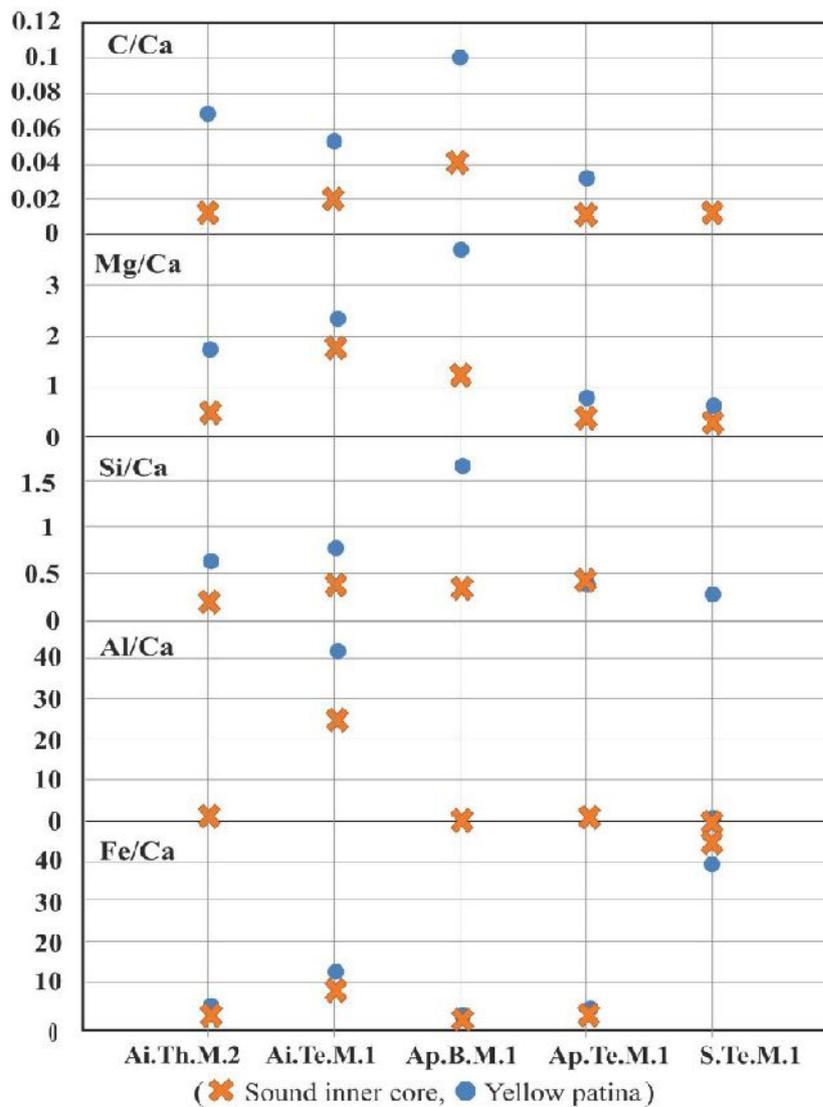
Figure 3.34. Graph showing the average content of C, Mg, Si, Al and Fe in the superficial layer of patina (~first 5  $\mu\text{m}$  depth) and inner core of marble using LIBS

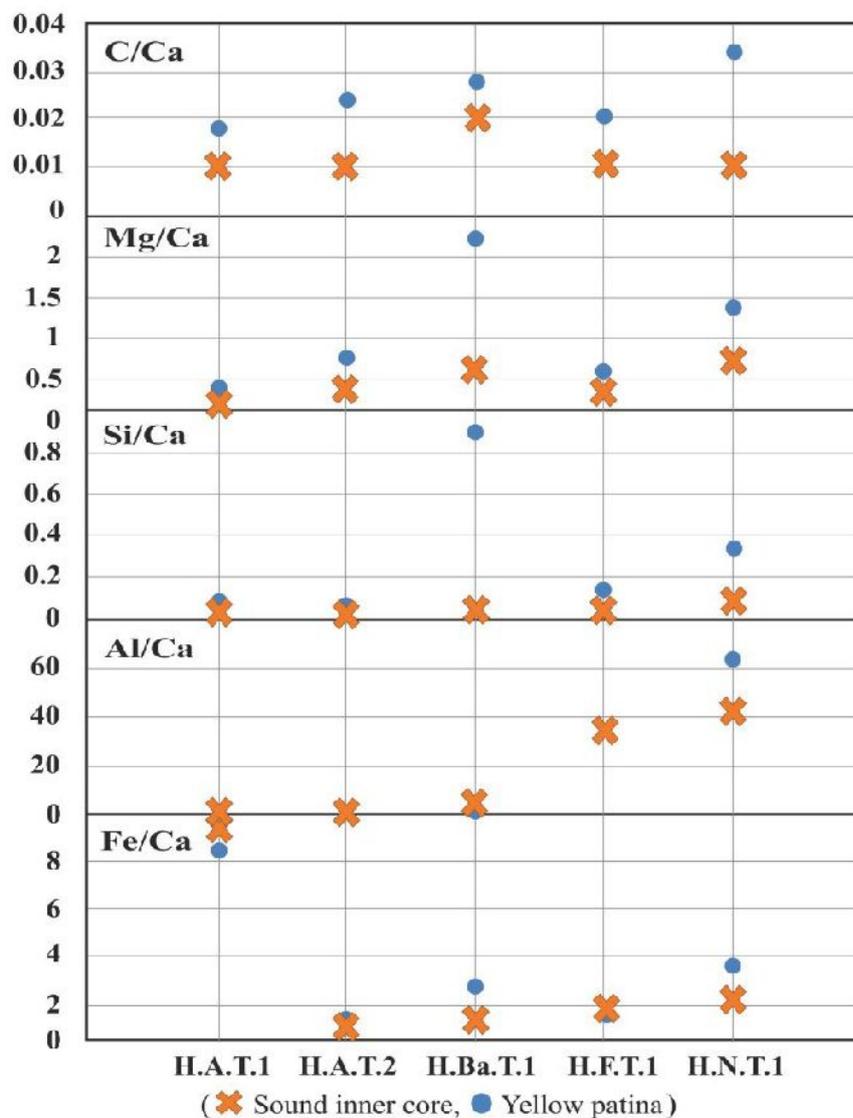
Figure 3.35. Graph showing the average content of C, Mg, Si, Al and Fe in the superficial layer of patina (~first 5  $\mu\text{m}$  depth) and inner core of travertine using LIBS

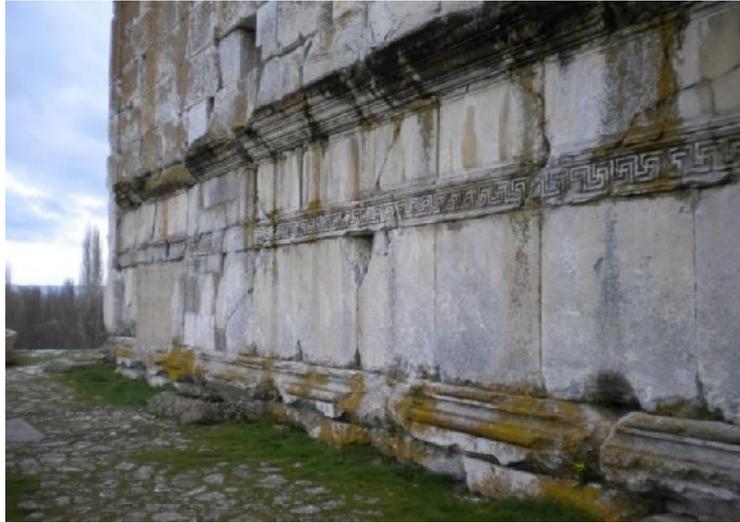
Figure 3.36. Biological formations on the marble walls of Zeus Temple in Aizanoi

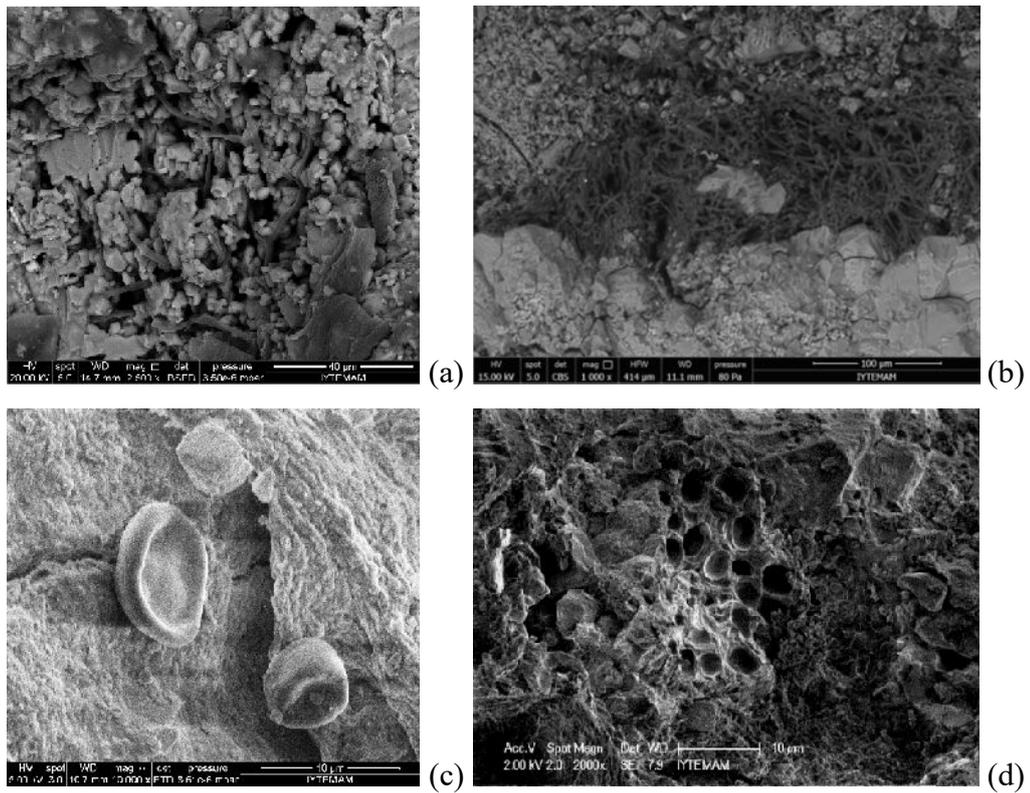
Figure 3.37. SEM images of lichen formations (H.A.T.1 (a, b), H.N.T.1 (c)) and traces of living organisms (H.N.T.1 (d)) in the yellow patina formations of travertine surfaces

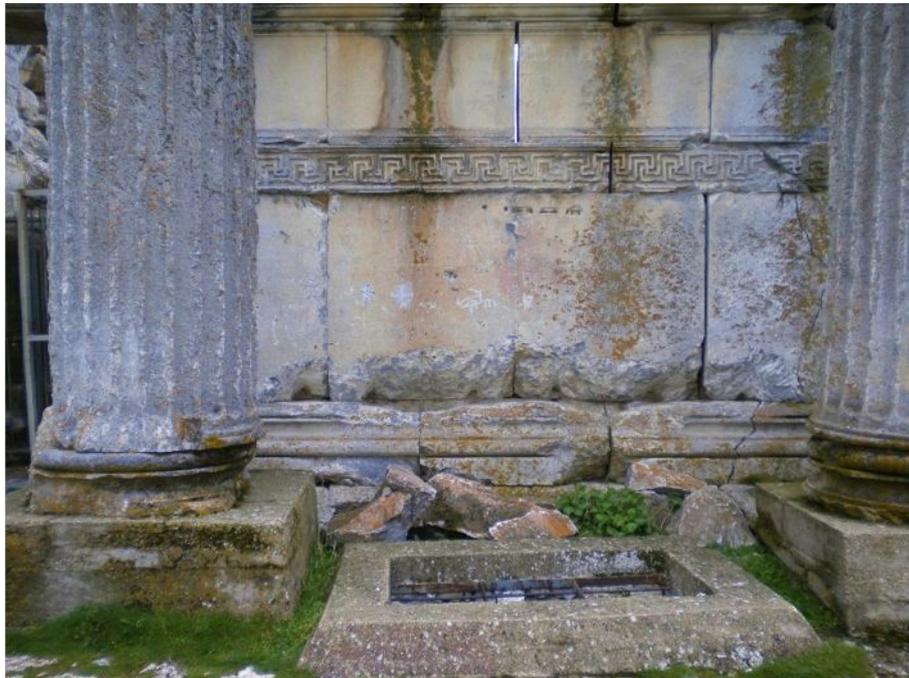
Figure 3.38. Different hues of yellow patina on marble ruins of Zeus Temple in Aizanoi

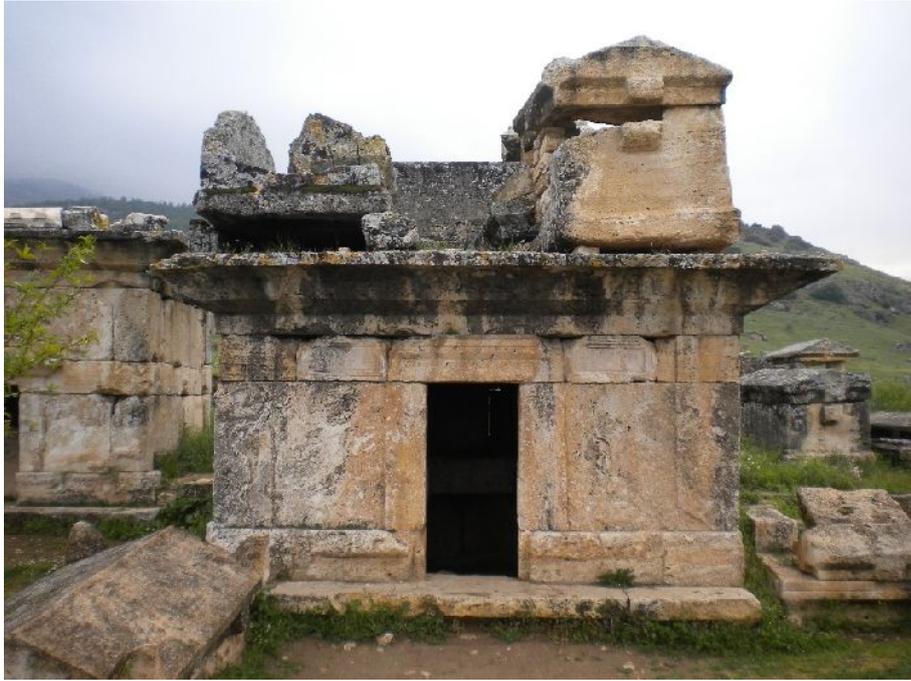
Figure 3.39. Different hues of yellow patina on travertine ruins of Necropolis in Hierapolis
