**CONSERVATION AND PRESENTATION OF
GRECO-ROMAN TEMPLE REMAINS IN
WESTERN ANATOLIA: A CRITICAL
ASSESSMENT ON SELECTED EXAMPLES
THROUGH THE CONCEPT OF ANASTELOSIS**

**A Thesis Submitted to
the Graduate School of Engineering and Sciences of
İzmir Institute of Technology
in Partial Fulfillment of the Requirements for the Degree of**

in Architectural Restoration

**by
Özge Deniz TOKÖZ**

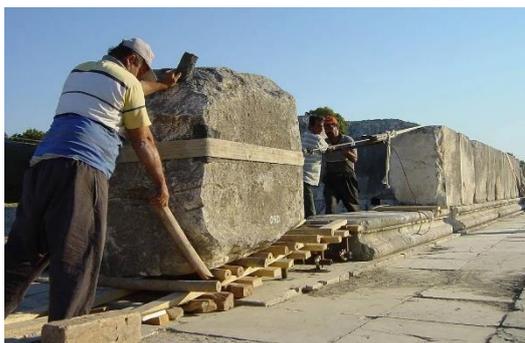
Figure 2.27. Using ancient systems for placing of stones at Letoon, Muğla, Turkey (Source: <https://www.didierlaroche.org> Retrieved at April 17, 2018).

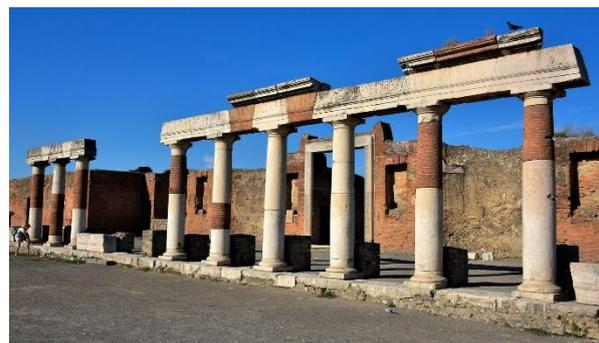
Figure 2.28. Completion of missing parts with brick in Eumachia at Pompeii, Naples, Italy (Source: <https://www.encirclephotos.com> Retrieved at April 17, 2018).

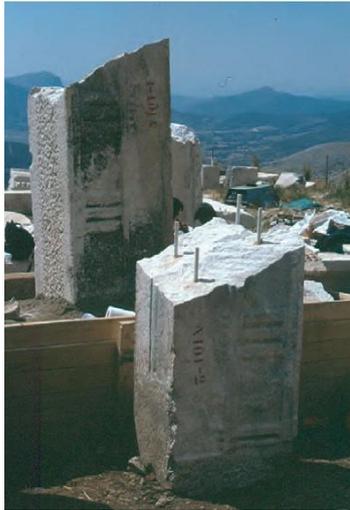
Figure 2.29. Fiberglass rods in restoration of the Sagalassos monuments in Burdur, Turkey (Source: Patricio, 2011).

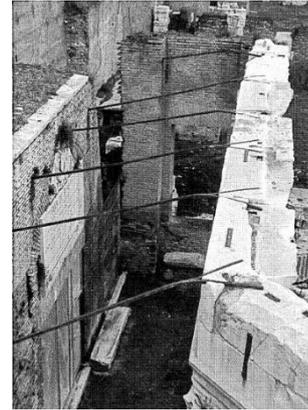
Figure 2.32. Iron tension rods in the Deorum Consentis Portico, Rome, Italy (Source: Starosta, 1999).

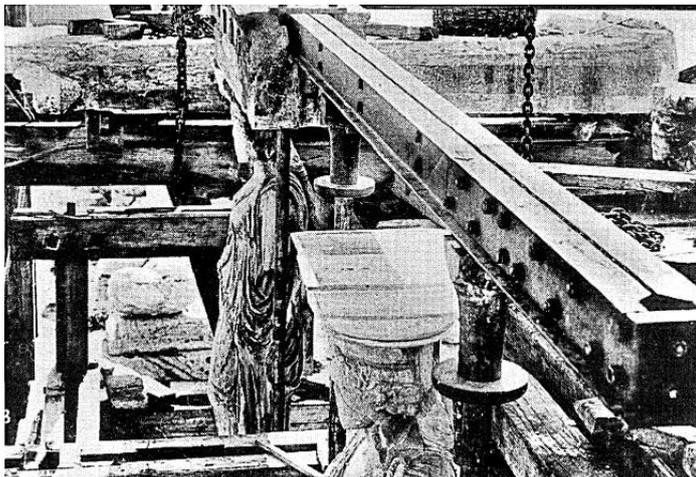
Figure 2.33. Iron I-beams in architrave of the Caryatid's Portico in Erechtheion, the Acropolis of Athens, Greece (Source: Starosta, 1999).

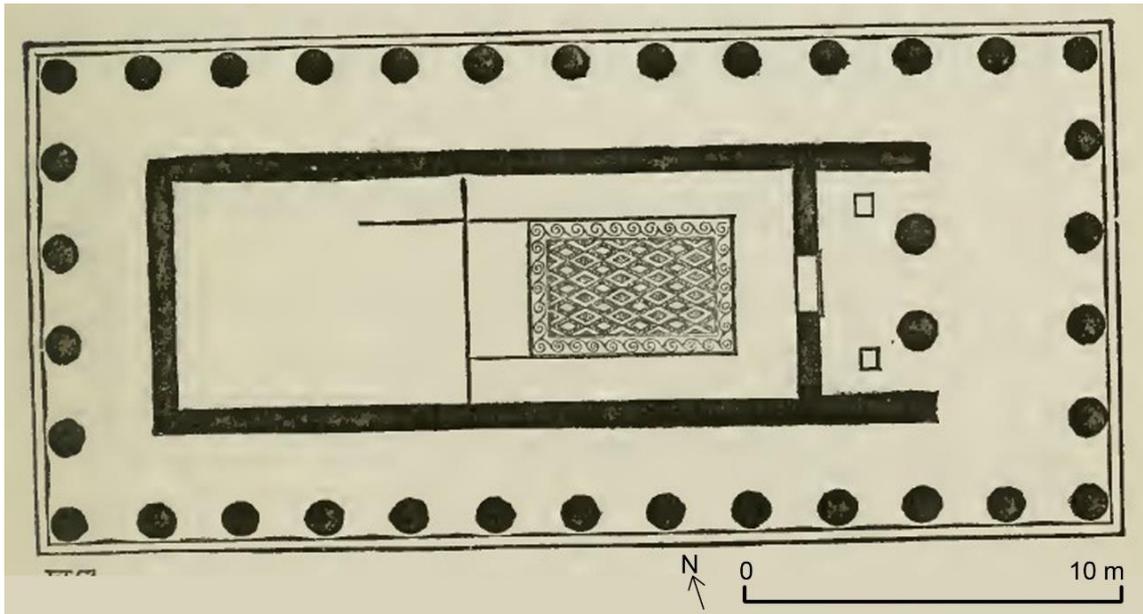
Figure 3.41. Restitution plan of the temple.
(Source: Clarke, 1882)

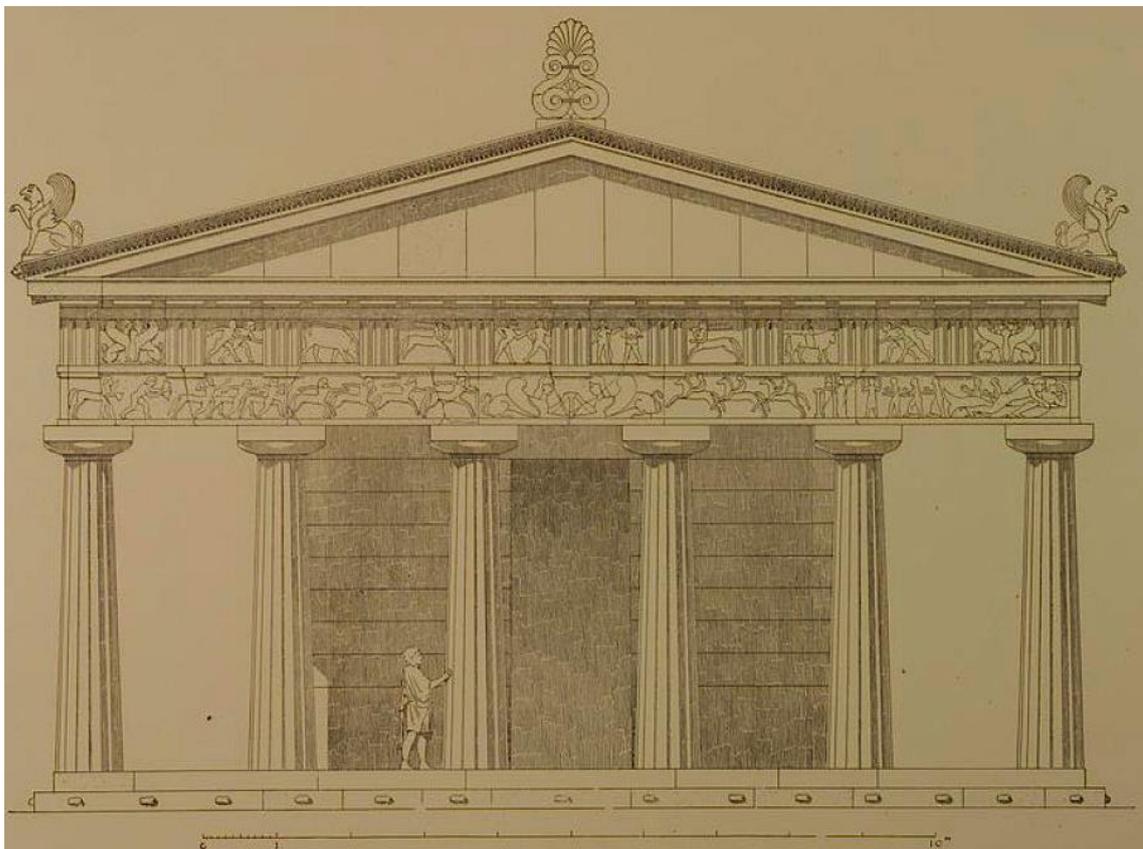
Figure 3.42. Restitution elevation of the Temple of Athena.
(Source: Clarke, Bacon & Koldewey, 1904)

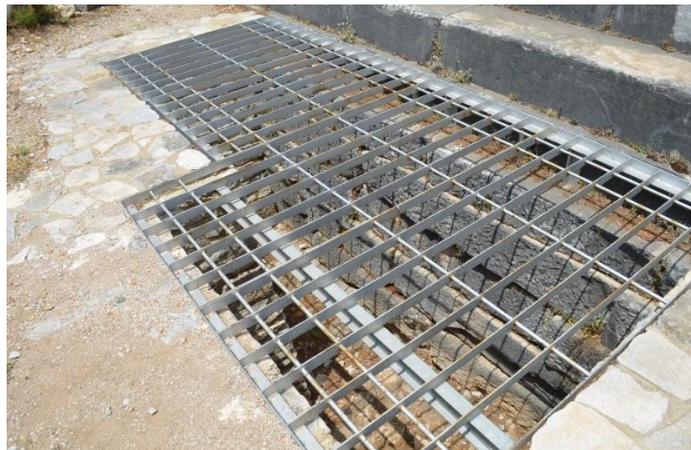
Figure 3.77. The drilling hole next to the foundation wall of the temple (May 19, 2017).

southern side of the temple in 2013. The drilling pit is about 6 m in length, 2 m in width and 3 m in depth. This pit was not closed in order to learn about the foundation wall observed only in the western and southern parts of the temple when the rest of the temple was sitting on the rock. The drilling pit was consolidated by building a new wall with lime mortar and field stone. While the pit was being cleaned, a mortar-free wall remain was found. In order to exhibit this wall, which is thought to have been constructed in the same period as the temple, the new wall extending in the north and south direction was suspended with the steel supports of the upper part wall by leaving some gaps in the wall. The pit was covered with a detachable grate (Raeck, Mert, & Filges, 2015) (Figure 3.77).

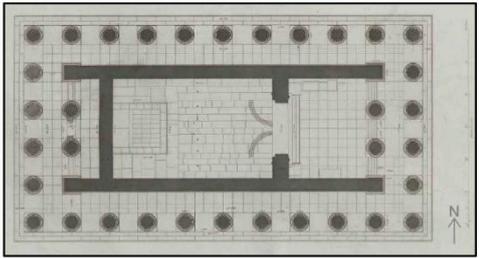
<p style="text-align: center;">Plan of the Temple</p>
	<p>Original material Marble</p> <p>Applied parts Re-erection of 5 columns on north side</p>	<p>New material No new material was obtained during site survey</p> <p>New structural system No new structural system was obtained during site survey</p>

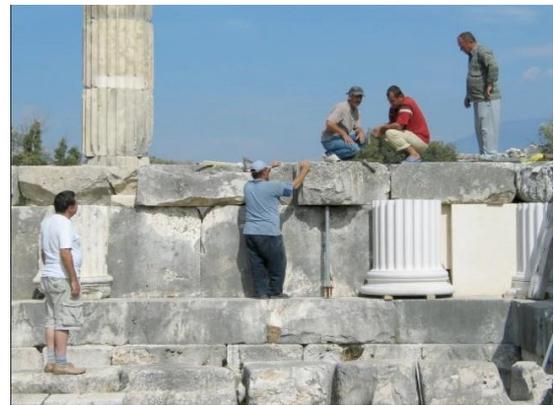
Figure 3.102. Re-placing of missing semi-column of cella (Source: <https://www.didierlaroche.org> Retrieved at April 27, 2018).

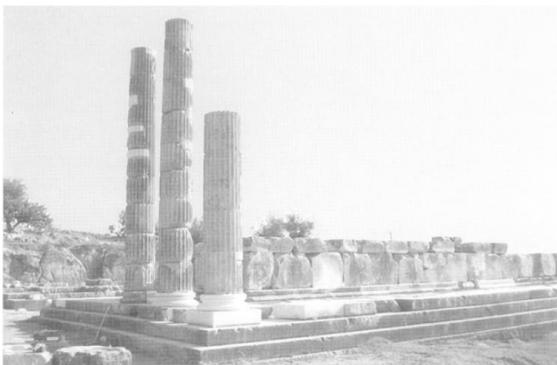
Figure 3.103. Re-erection of northwest column in 2004 (Source: Laroche, 2005).

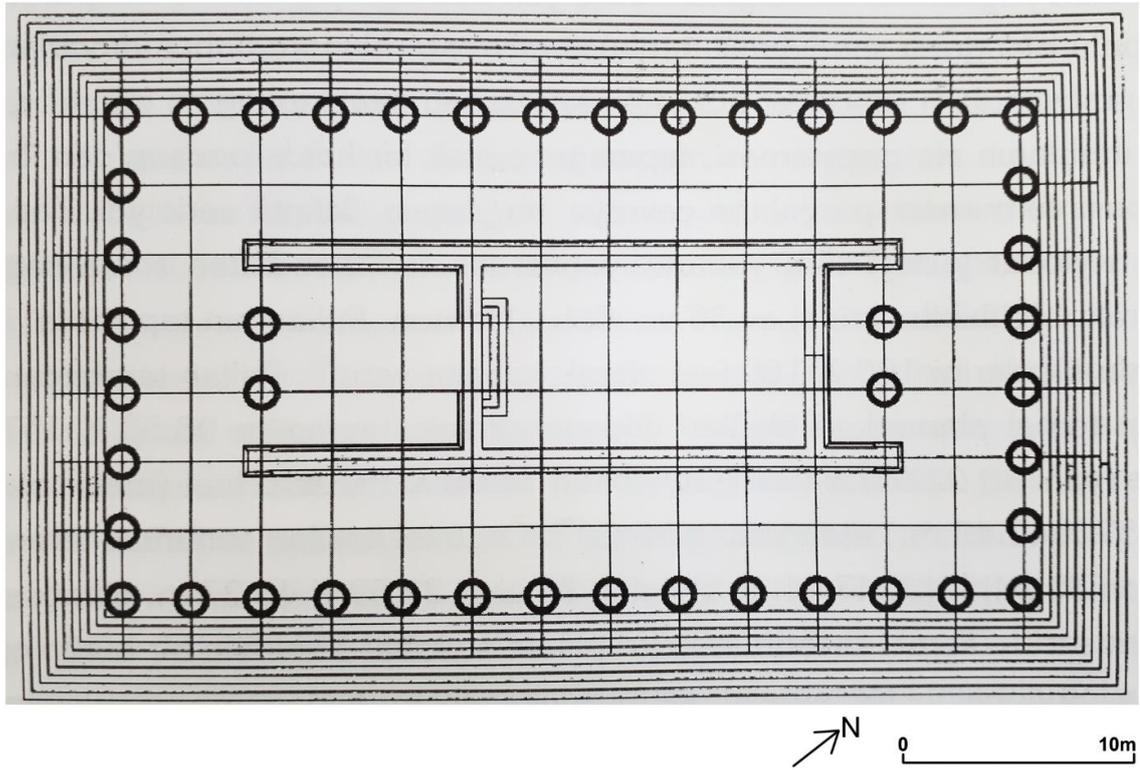
Figure 3.118. Restitution plan of the temple.
 (Source: Gökçe, 2000)

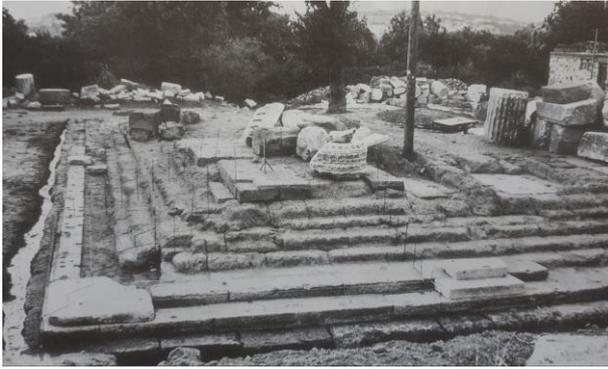
Figure 3.120. Foundation of the temple on southeast corner (Source: Özgünel, 2001).

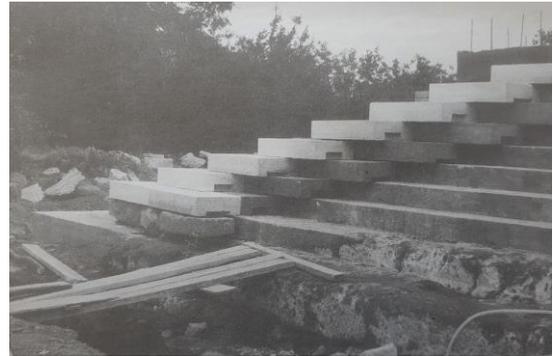
Figure 3.123. Placing artificial andesite and marble step blocks on reconstructed foundation in 1989 (Source: Özgünel, 2001).

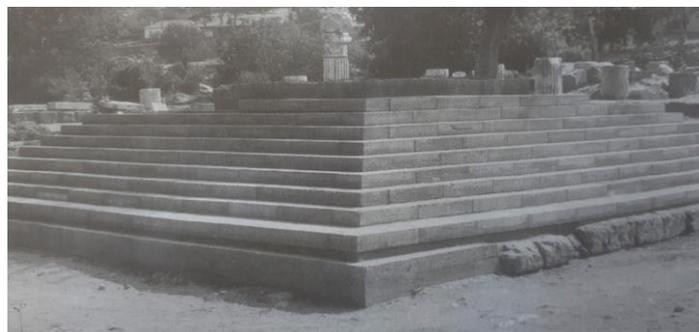
Figure 3.124. Finished state of artificial andesite and marble steps on reconstructed foundation in 1991 (Source: Özgünel, 2001).

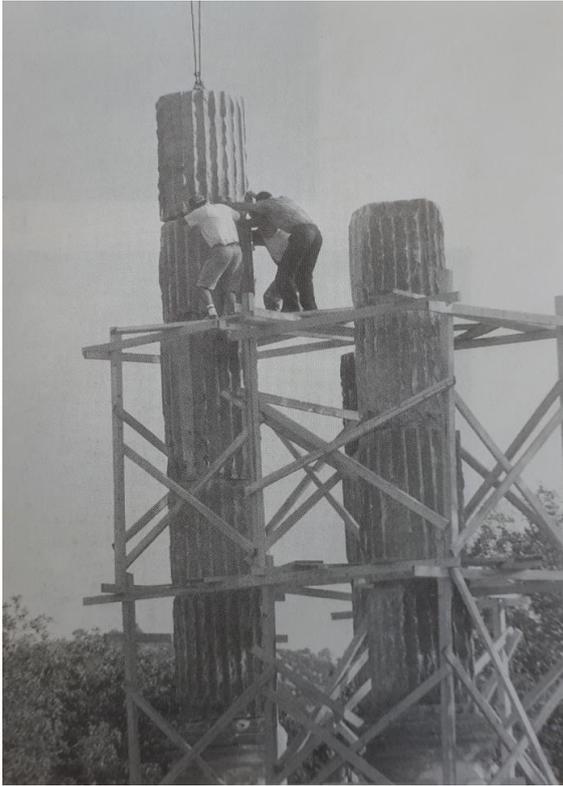
Figure 3.125. Re-erection of columns on southwest corner in 1995 (Source: Özgünel, 2001).

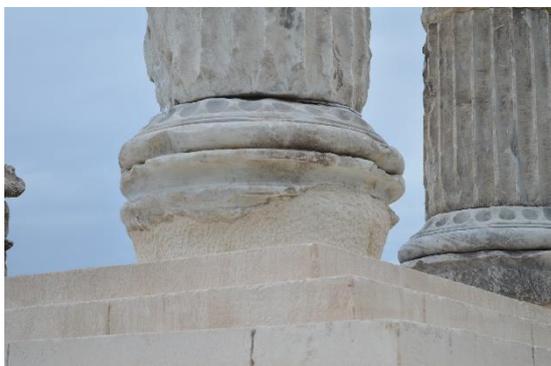
Figure 3.137. Completion of missing parts with new material (June 17, 2017).

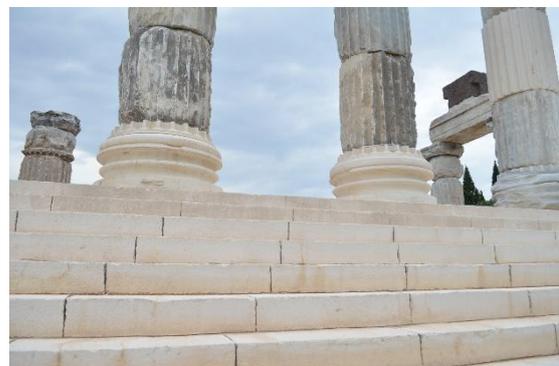
Figure 3.138. New material columns bases and crepis (June 17, 2017).

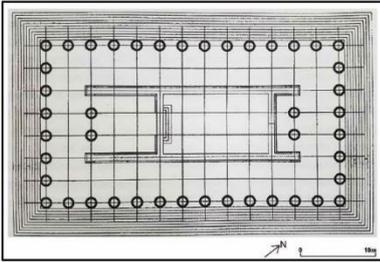
<p style="text-align: center;">Plan of the Temple</p>
	<p>Implementation date 1980-1995 2005-2014</p> <p>Director of excavation Coşkun Özgünel</p> <p>Responsible for the project Fuat Gökçe (METU) / Coşkun Özgünel</p>	
	<p>Original material Tuff and andesite stone in substructure Marble in upper structure and as covering</p> <p>Applied parts New foundation on south side, re-erection of columns of different heights on southwest, organization of the two columns on the southeast side comprises a base, a drum, a columna caelata and an architrave and frieze over these</p>

<p>Result Reconstruction of foundation, re-erected columns, anastelosis of three columns, partial display</p>

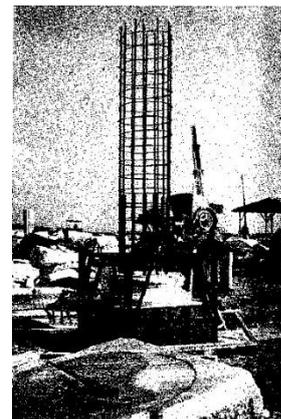
Figure 3.152. Reproduction of missing part of a column with reinforcing iron bars (Source: İnan, 1985).

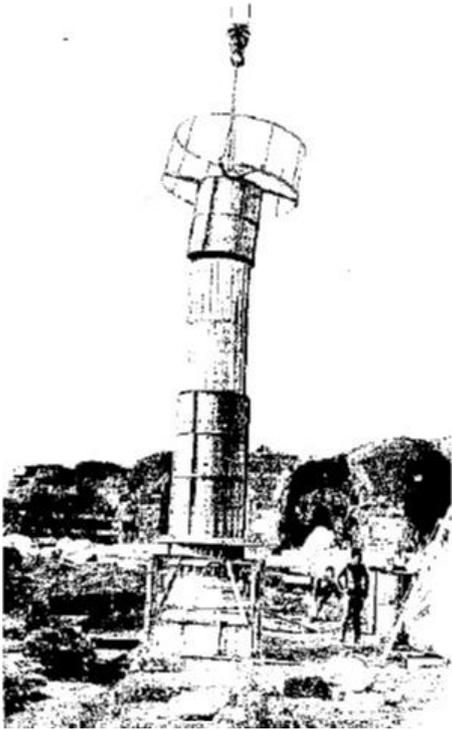
Figure 3.153. Moulding of a column.
(Source: İnan, 1986)

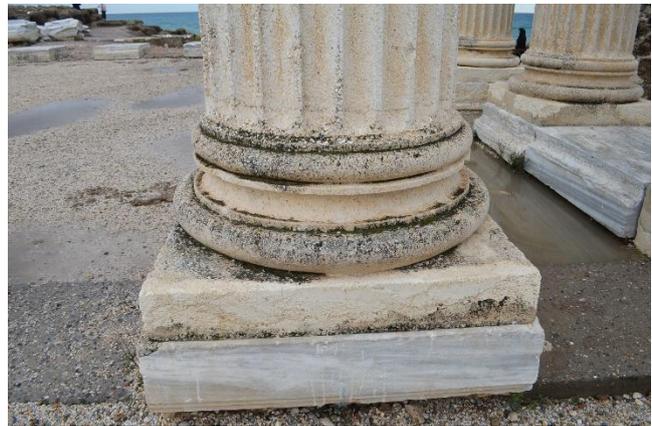
Figure 3.161. Decay of the new material in column base (October 29, 2017).

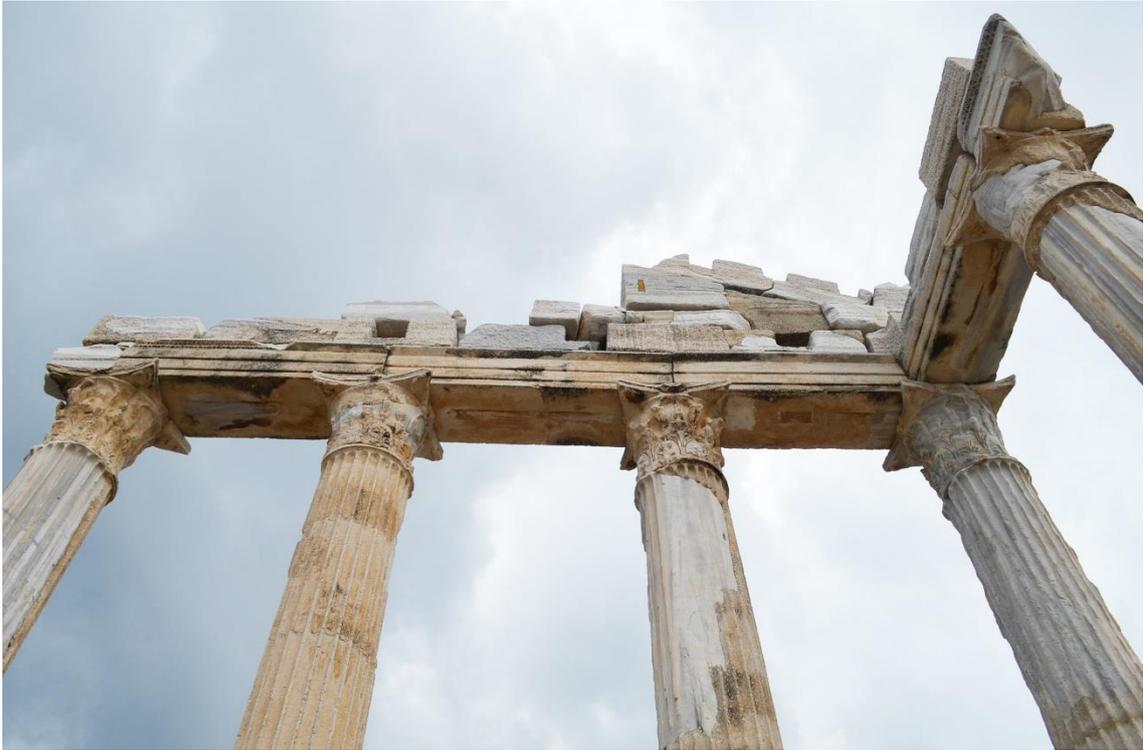
Figure 3.162. Decay of the new material in architraves (October 29, 2017).

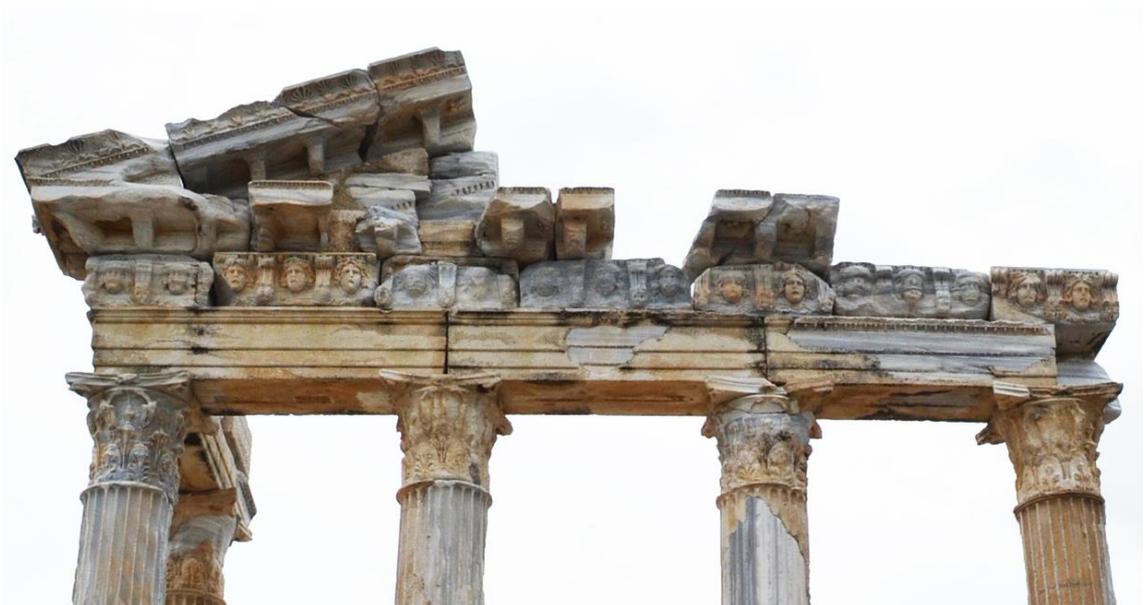
Figure 3.163. Reproduction of architraves and friezes without ornamentation (October 29, 2017).

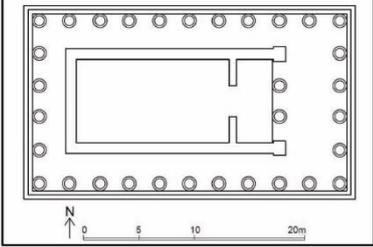
<p style="text-align: center;">Plan of the Temple</p>
	<p>Implementation date 1983-1989</p> <p>Director of excavation Jale İnan</p> <p>Responsible for the project M. Yorulmaz, F. Çili, Z. Ahunbay (İTU)</p>	
	<p>Original material Conglomerate blocks on foundation Marble in upper structure</p> <p>Applied parts Re-erection of 5 columns on northwest corner including partial pediment New foundation</p>	
EVALUATION	<p>Emphasis of the structure within the site scale The more greater and important Temple of Athena near temple cannot be recognizable Focal point in the temple area near the seaside</p>	<p>Reliability Doubt about original height of the columns and placing of survived members Misleading information about colour of the temple</p>

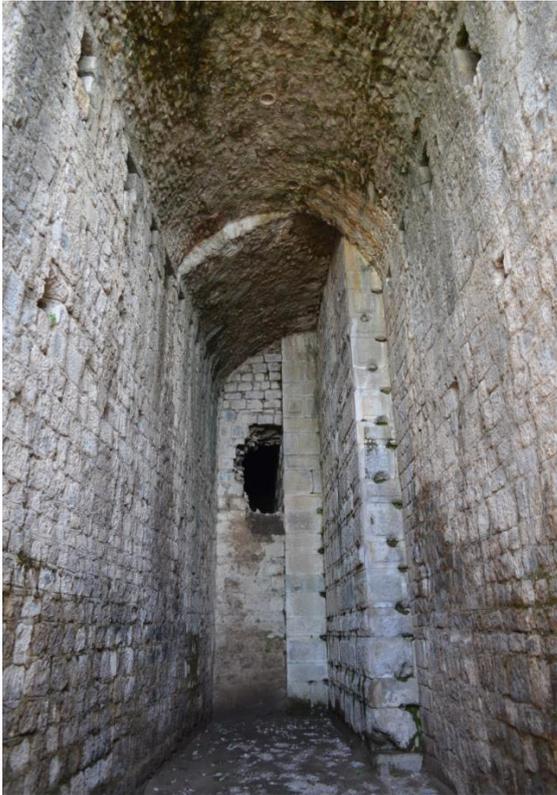
Figure 3.170. Foundation wall of the temple in vaulted room as substructure (April 1, 2018).

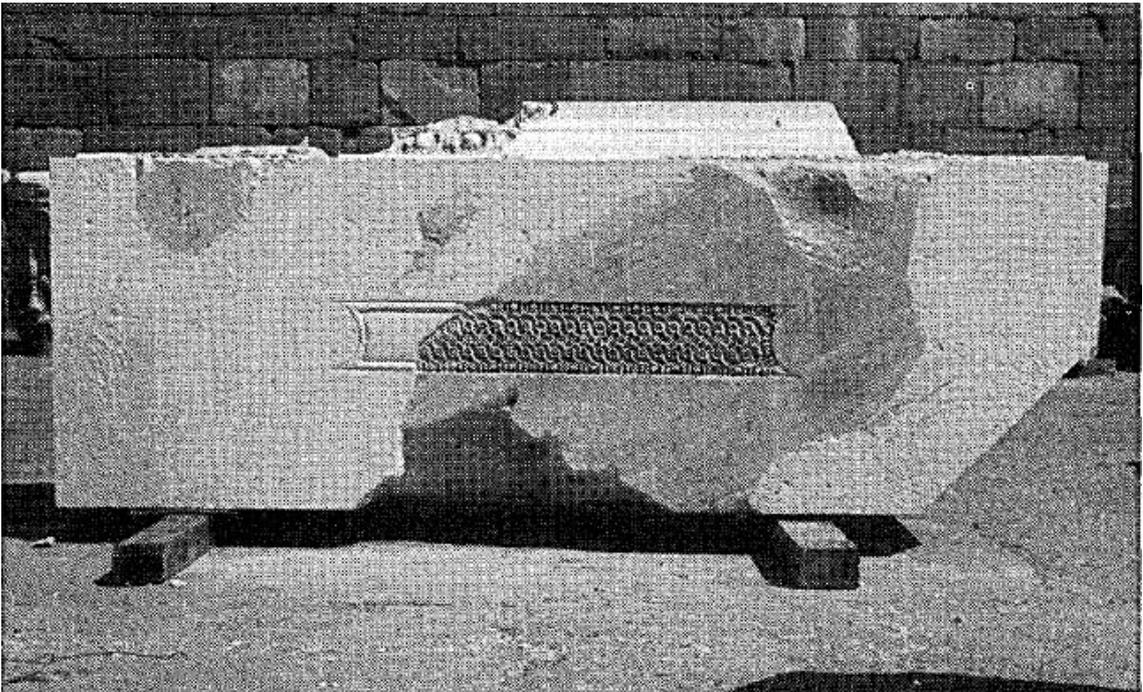
Figure 3.178. Completion of missing parts of an architrave without ornamentation. (Source: Nohlen, 1999)

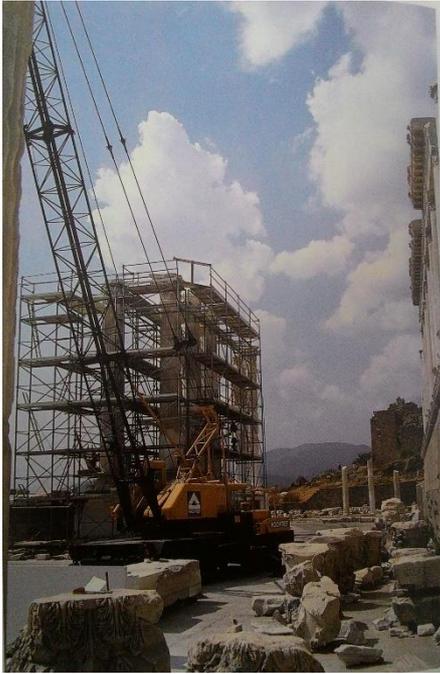
Figure 3.179. Re-erection of temple columns in 1989 (Source: Radt, 2002).

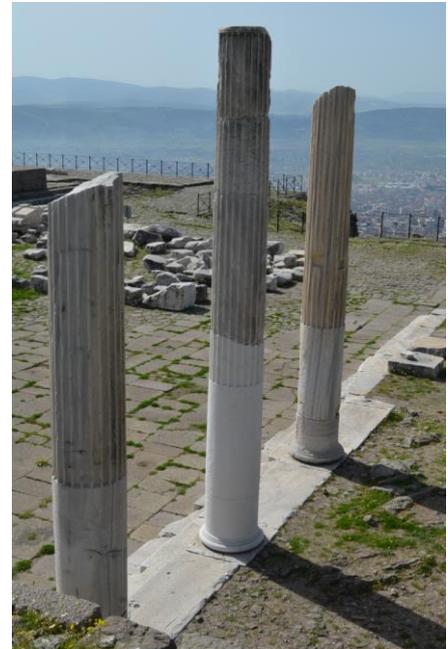
Figure 3.192. Changing damage part of the column with new marble (April 1, 2018).

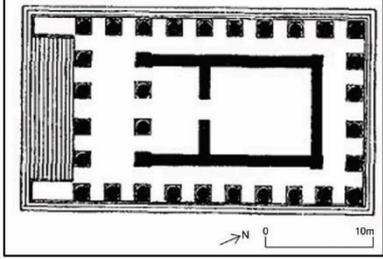
<p>Plan of the Temple</p>
	<p>Original material Local andesite stone in foundation Marble in upper structure and as covering</p>		
<p>Applied parts Consolidation on south substructure, re-erection of columns on north, west and south galleries, 4 columns on northeast corner including pediment, 3 columns on northwest, joining south pediment and cella of the temple</p>	<p>New structural system No new system Titanium reinforced steel bars and fiberglass bars for joining</p>

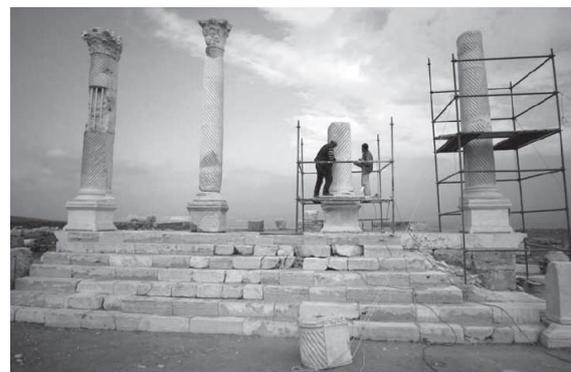
Figure 3.203. Re-erection of columns in prostyle (Source: Şimşek, 2011).

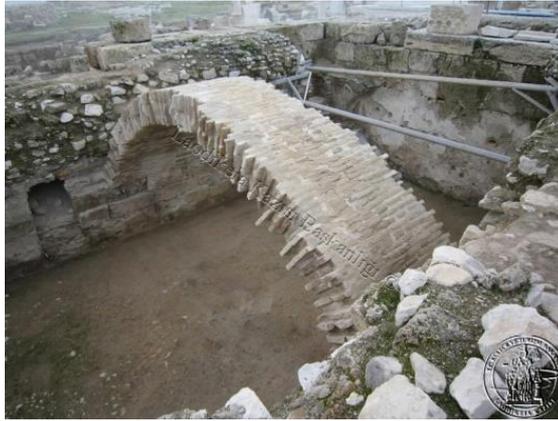
Figure 3.204. Reconstruction of arch in vaulted room.
(Source: <http://laodikeia.pau.edu.tr> Retrieved at March 28, 2018)

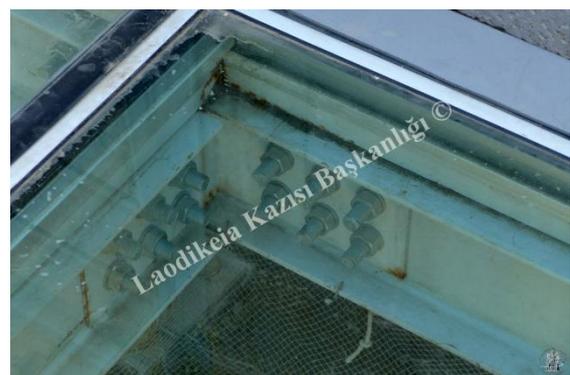
Figure 3.211. Rusting in steel structure.
 (Source: <http://laodikeia.pau.edu.tr>
 Retrieved at March 28, 2018).

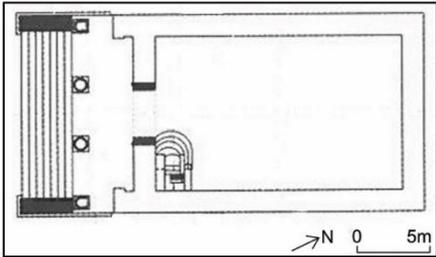
<p style="text-align: center;">Plan of the Temple</p>
	<p>Implementation date 2009-2011</p> <p>Director of excavation Celal Şimşek</p> <p>Responsible for the project -</p>	
	<p>Original material Travertine Marble in upper structure and as covering</p> <p>Applied parts Re-erection of 4 columns on prostylos; 15 columns on porticos Completion of cella façade, podium and vaulted room Glass terrace on cella floor</p>	
EVALUATION	<p>Emphasis of the structure within the site scale Regained its historical importance in the city, also re-erected nearby structures. Re-constructed structure is in harmony with re-constructed site Striking glass terrace in the site</p>	<p>Reliability Suspect about detailed study before implementation Misleading information about destructed column</p>
