**HISTORICAL DEVELOPMENT OF GÖZTEPE
DISTRICT IN İZMİR AND PRESERVATION
PROBLEMS OF ITS MONUMENTS**

**A Thesis Submitted to
the Graduate School of Engineering and Sciences of
İzmir Institute of Technology
in Partial Fulfillment of the Requirements for the Degree of
MASTER OF SCIENCE
in Architectural Restoration**

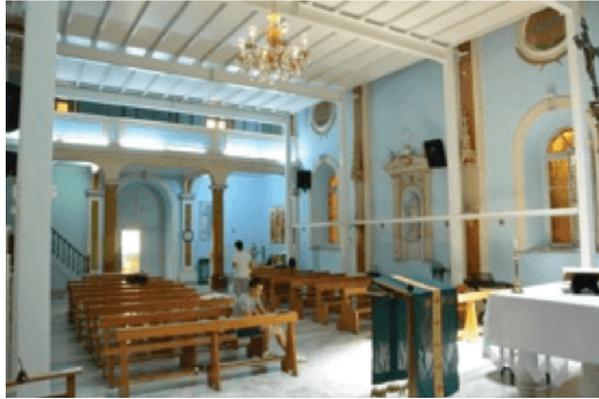
Figure 3.4. Interior of Notre Dame de Lourdes Church with the steel scaffolding,2014
(Source: ANKA Mimarlık Restorasyon Archives 2014)

In time, due to the bowing of the ceiling and deteriorations at the wooden roof elements, a risk of partial collapse occurred at the church. Besides, narrow vertical cracks were observed on the main walls. These urgent conditions had led to the preparation of a conservation project for the site. A steel scaffolding (Figure 3.4) was installed to the interior space of the church for maintaining the integrity of the mass until the official documentation process was completed (Figure 3.5). In 30th December, 2014, measured drawings, restitution and restoration projects of the church were pre-approved by the municipality (AOCC 2014). With the April 28th, 2015 decision of the Conservation Council, the registration of the church continued, while the conservation degree was determined as first group immovable cultural property in need of protection. According to the document, the measured drawings, restitution and restoration projects of the church was examined and found appropriate for application. It was stated that a report, regarding the execution of the project, needs to be send to KUDEB unit of the municipality. In 2015, the building juxtaposing the church was also labeled together with the church for its conservation status as first group immovable cultural property in need of protection (AOCC 2015). Partial application of the restoration project is seen on the site.

The interventions, which were done after the consent processes, were only related with the urgent conditions that caused safety problems and danger to the integrity of the structure. The foundation of the church was consolidated together with the excavation for setting a proper drainage. The small capillary cracks on the masonry walls of the church were recovered with different applications, based on the sizes of the cracks. The wooden roof was consolidated according to the static project and the roof was suspended due to the bowing of the ceiling. The previous concrete consolidation of the priest house was preserved. The authentic load-bearing walls and the concrete additions worked together for a long time so the detachment of the elements would cause more harm than good. The applications related to alterations were not processed completely such as changing the pvc framed elements to the authentic ones. In summary, the maintenance of the church and the house are carried out as before. Notre Dame de Lourdes Church (Figure 3.6) is one of the twelve churches of İzmir today, which continues its authentic function.

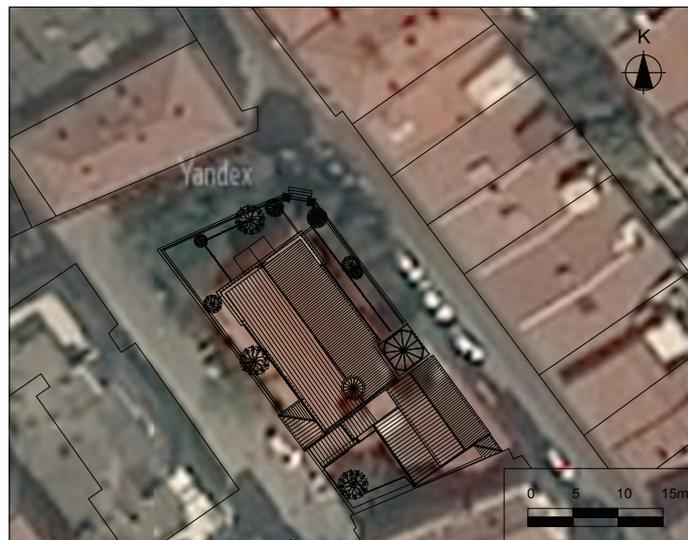
Figure 3.7. Site plan of Notre Dame de Lourdes Church
(Source: Adapted from *ANKA Mimarlık* 2014 and yandex)

Within the church lot, there are two prismatic masses juxtaposing each other and circumscribed by courtyards or gardens at their north, west, south partially on east, and streets at their east. The first mass is the church building itself (~22 x 10.5 m), while the latter is a house (~13 x ~9.75 m). The house has been used for accommodation by the priests of the church. The two masses are spatially connected from inner space. The monumentality of the church mass is emphasized not only with its relatively large size, but also recessed positioning from all sides of the lot and elevation from the street entrance at the northeast of the courtyard. The two side recessments are utilized as narrow gardens with trees. The church is oriented through northeast-southwest directions. The main entrance of the church is at the northern corner of the front courtyard. Courtyards are surrounded by high walls. The priest house, on the other hand, is directly accessed from 81st street and possesses a rear courtyard with a tree at its south corner and additional

storage shed at its west. There is also a secondary entrance providing access to the courtyard of the priest house from the 84th street (Figure 3.7).

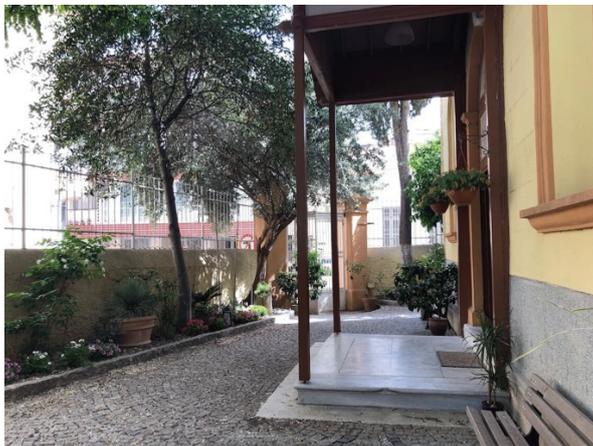
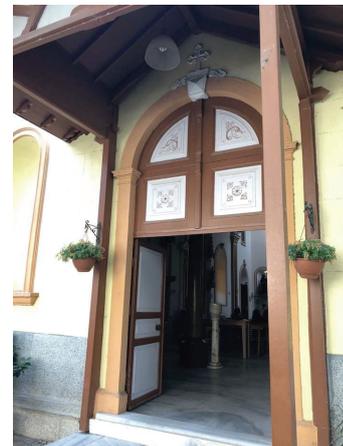
Figure 3.8. Courtyard (a) and the entrance door (b) at the northwest facade of Notre Dame de Lourdes Church, 2019

The courtyard/garden wall surrounds the church from three sides (Figure 3.8). The heights of the garden walls differ relatively according to the slope of the street levels. An iron entrance door is placed on the northern corner of the garden area for providing access. There are two rectangular piers on both sides of the entrance door. Cone headed profiles are seen as their capitals. The church can be perceived behind the garden walls with the iron railings. All facades of the church are covered with plaster as well as the garden walls.

The narthex wall provides the main entrance to the church (Figure 3.8). The facade is symmetrical from the entrance axis. The marble area, which is in front of the entrance, is covered with a wooden pitched roof with a triangular face on the front. On the entrance, an arched form with stone casings are seen around the wooden door with two leaves. On the key stone of the stone casing, 1900 is inscribed with Roman numbers, in addition, a cross and floral pattern is present. The renewed wooden door leaves are plainer than the wooden panels filling the arched form of the entrance. There are two

arched niches with stone casings on the both sides of the entrance door. The niches have circular sections. Another arched niche is seen above the door followed by a circular window opening on the top. The circular window is located at the pediment of the facade. Two arched windows are seen on the first floor on the same alignment with the central niche. Keystones are seen on the arched and stone casings. The two window openings and the top circular window opening are all covered with metalwork. On the northwest and southwest corners of the facade, plasters were shaped to imitate a cut stone bonding. The patterns of the corners are also visible from the northeast and southwest facades. A leveled roof cornice surrounds all the facades. All of the facades of the structure are covered with concrete based mosaic up till approximately 1 meter from the ground level.

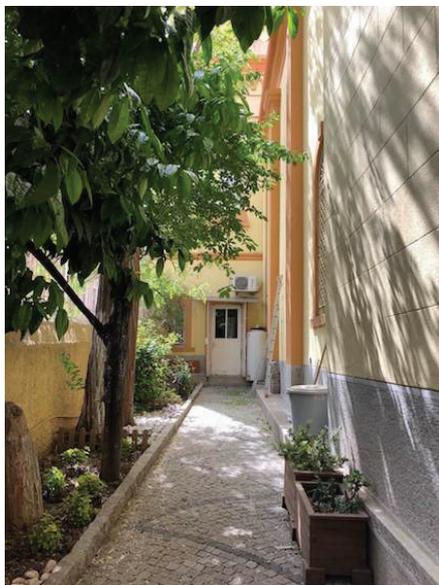
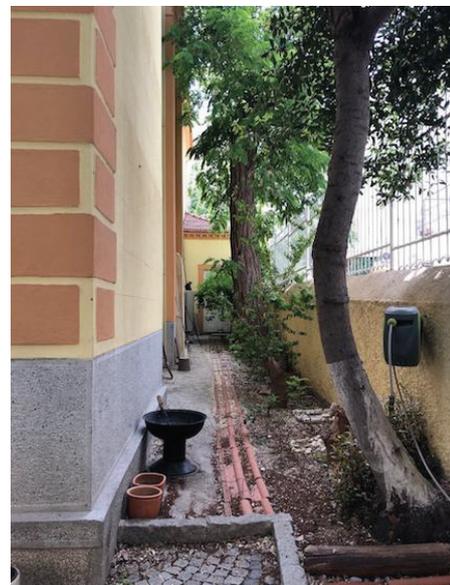
Figure 3.9. Courtyard areas in front of the northeast (a) and southwest (b) facades of Notre Dame de Lourdes Church, 2019

The northeast facade (Figure 3.9) is divided to three sections by two fluted pilasters. The first and the third sections have arched window openings on them. The windows are covered with authentic metalwork and have stone casings with modest key stones. The slope of the pitched roof, which rises above the cornice, is perceived from the street. Bell tower can be observed on the eastern side of the facade. The tower faces directly the 81st street. The ground floor of the tower is blind and the other floors are organized similar to the northeast facade. When considered entirely, the octagonal faces on the second floor have window openings on four sides which are parallel to the church's main body. The northeast and southwest facades of the church are similar in facade

organization. Same facade organization is perceived on the southwest facade (Figure 3.9) such as the division with the pilasters, window openings, roof, and etc. The southwest facade differs from the northeast one with the wall of the diakonikon cell. A small circular window opening is seen on the southwest wall of the diakonikon space, for the purpose of lighting the interior space. The frieze and the pent roof are also visible from the street level.

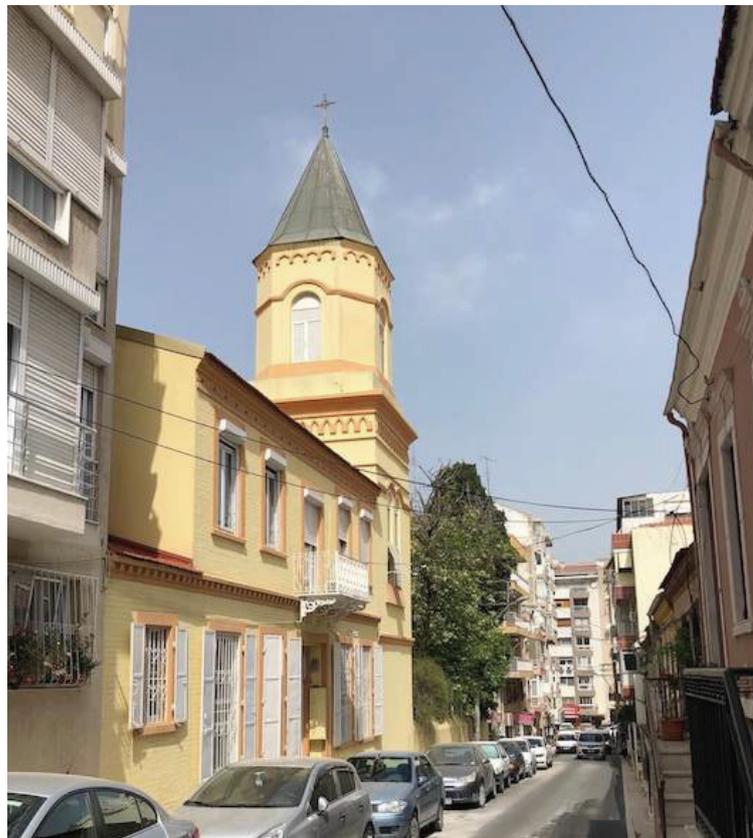
Figure 3.10. Northeast facade of the priest house, 2019

The northeast facade has a symmetrical organization, when the single storied portion on the eastern side is left out (Figure 3.10). A central entrance door with two windows on each side is located on the ground level. The entrance niche has rectangular formed stone casings. Double leafed door with metalwork provides the entrance. At the first-floor level of the facade, a balcony is seen at the center with two windows on each side of the door. The single storied space also has a window opening to the main facade. The window differs from others by being on a higher level. The windows of the main facade are in rectangular shape and have stone casings. The ground floor's windows with timber joinery have iron shutters while the windows are in pvc frame with pvc shutters on the first floor. The iron brackets and balustrades of the balcony are authentic. Between ground and first floors, dentils are seen. Metalwork inside the casings of the ground floor are not authentic. Dentils are also seen below the eaves of the single storied section of the structure. A frieze and a cornice (*kat silmesi*) are seen below the eaves of the first floor. The slope of the rising roof is perceived.

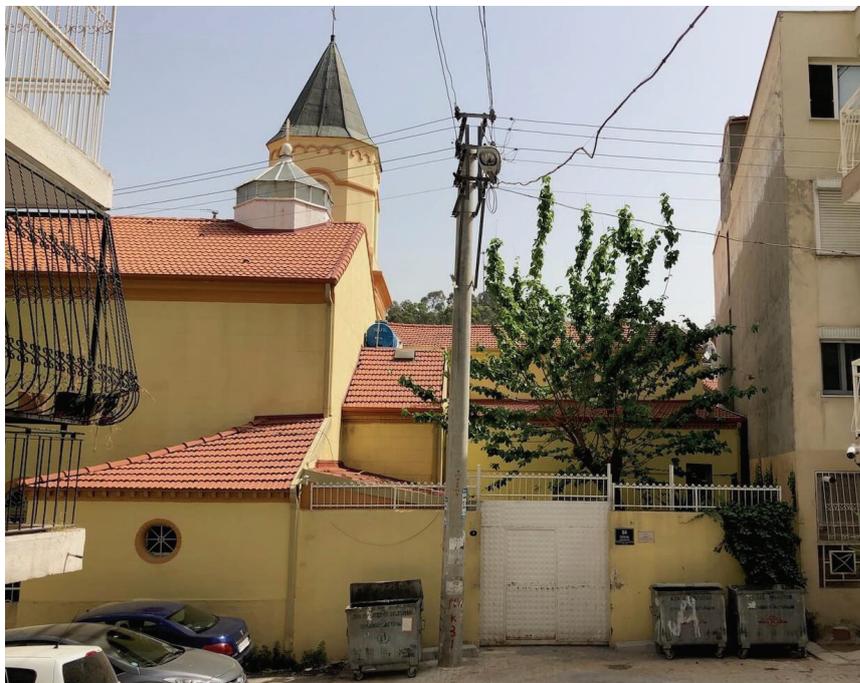
Figure 3.11. View from the street, the southwest facades of Notre Dame de Lourdes Church and the priest house, 2019

The southwest facade of the structure opens to the courtyard of the house (Figure 3.12). Plastered high walls define the zone of the small yard (Figure 3.11). An iron door is located on a partial section of the wall. The door provides a secondary entrance to the building. Courtyard can be barely observed from the street level due to the walls acting as a barrier. The mass recesses at the first-floor level and the separation of two different roofs are seen. At the ground floor, the facade has an irregular organization due to the alterations that had taken place in time. At the west of the facade, the traces of stone casings are visible. The traces are reflected as a niche to the interior space. Next to it, a door with rectangular stone casing is seen. The casing resembles the traces both in form and height. Another door opening is seen on the facade, which is much smaller in size, when compared to the other one. A small window opening is seen next to the small door and another one with the same alignment at the top. The casing traces around the windows suggest that the windows were diminished to a much smaller size. At the first floor, there is only a single small window opening with a pvc framed window. The slope of both roofs is visible from the exterior. An additional storage shed with a pvc framed door is located and seen on the west of the yard (Figure 3.11).

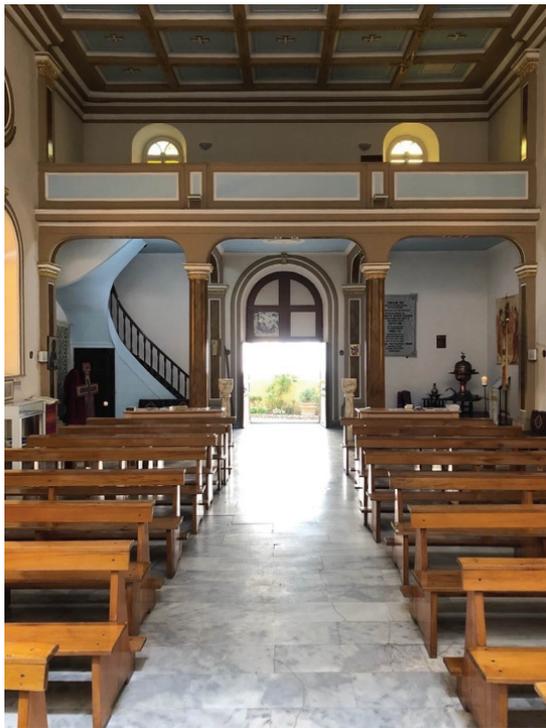
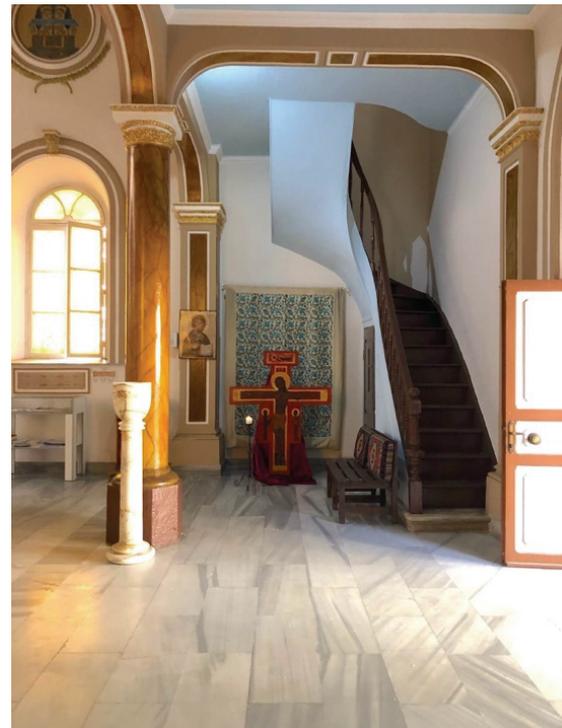
Figure 3.13 Gallery floor (a) and the narthex (b) of Notre Dame de Lourdes Church, 2019

The narthex (Figure 3.13) has a low, flat ceiling due to the gallery floor (Figure 3.13) above it. The ceiling is three parted and the middle one has a decorative center piece. Gallery floor is reached with a U planned wooden staircase at the northwest corner of the narthex. The columns and four pilasters carry the gallery floor. The columns are painted as marble imitations. Octagonal drum of the columns and all pilasters have floral motives and ornamented capitals. A baptistery section is seen on the northeast corner of the narthex. The area is lifted with a marble step. Baptism is made with the marble bowl placed on the marble surface.

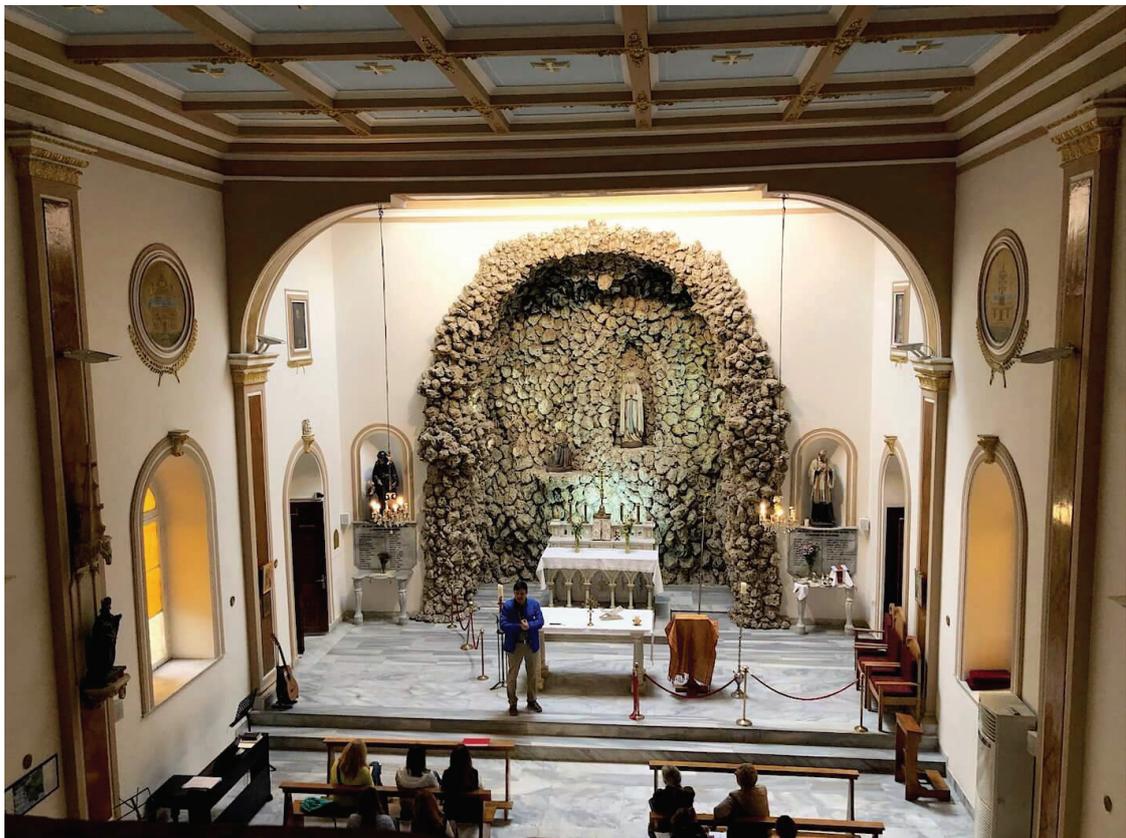
Figure 3.14. General interior view of Notre Dame de Lourdes Church, 2019

The bema (Figure 3.14) is located on the eastern side of the naos. The level difference between the naos and the bema, which was provided by two marble steps, defines a boundary among the adjacent spaces. Bema rises in front of the naos as a focal point. The ceiling starts to differ in the bema area. A cloister vault with an octagonal lantern (Figure 3.15) at the center are seen above the bema space. The lantern is covered with a pyramidal glass cone at the top. The two sides of the vault are ornamented as cassette forms with gypsum material. Four circular medallions are hanged at each face of the vault.

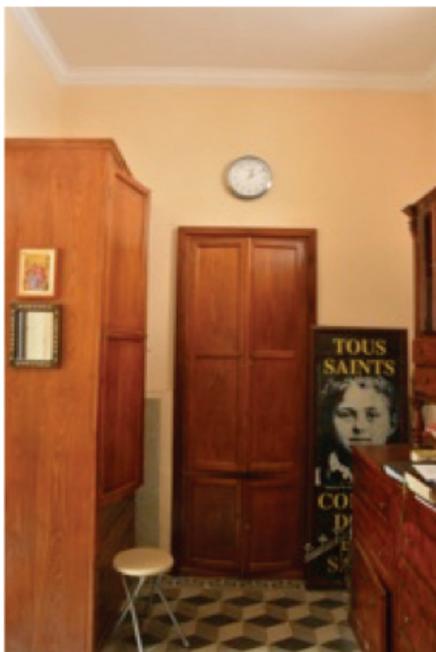
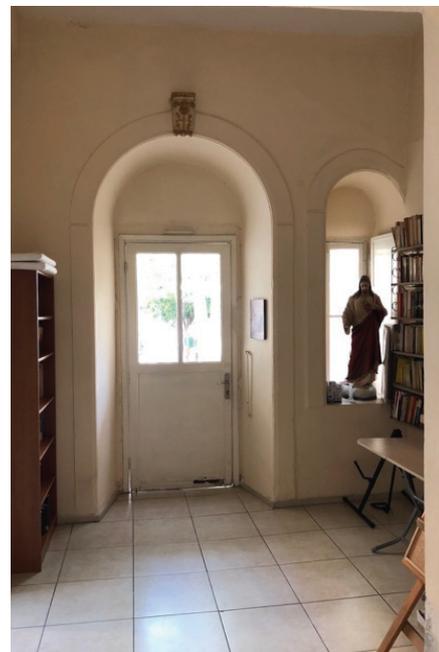
Figure 3.16. Diakonikon (a) and Prothesis (b) cells, Notre Dame de Lourdes Church

Pastaforium cells, which are formed as two small rectangular rooms, are attached to bema from both sides. The 'prothesis' cell is seen at the northeast part, while 'diakonikon' cell is seen at the southeast part. Diakonikon room (Figure 3.16), which is in a lower level than bema, is used for storing the belongings of the priest which can be used for the ceremonies. There are two door openings and a circular window opening on the walls of the diakonikon space. A center piece is located on the flat ceiling finished with plastering. A gypsum profile surrounds the edges of the ceiling. Prothesis cell provides connection between the church, the garden and the priest house. The space is used as a transition space between two structures and functions as a classroom for educational purposes. An arched niche provides an entrance to prothesis from the church. The space has a window opening on the exterior wall facing the garden, a niche which is located perpendicular to the window and three door openings leading to three different spaces. Concrete beams are visible on flat plastered ceiling of the prothesis space. Prothesis (Figure 3.16). is also in a lower level than bema. Although similar details are seen on the entrance to diakonikon space, ornaments of keystones differ from each other. Both of the entrance niches have rectangular door openings. Carved floral motives are seen on the wooden wings of the door. Rectangular formed panel is found above the door niches of the pastaforium cells. Saints are pictures on these panels. A bell tower rises above the prothesis space. Access to the bell tower is provided from the upper floor of the housing unit.

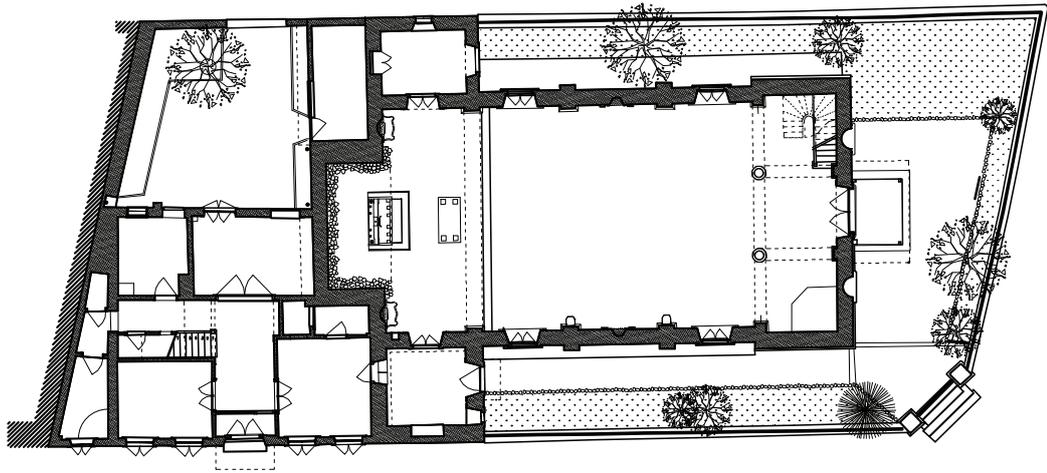
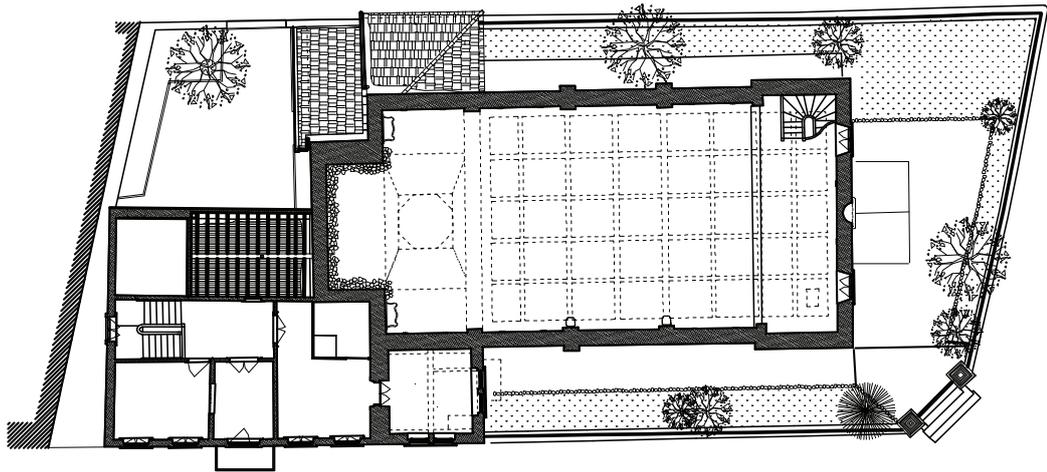
GROUND FLOOR PLAN

FIRST FLOOR PLAN

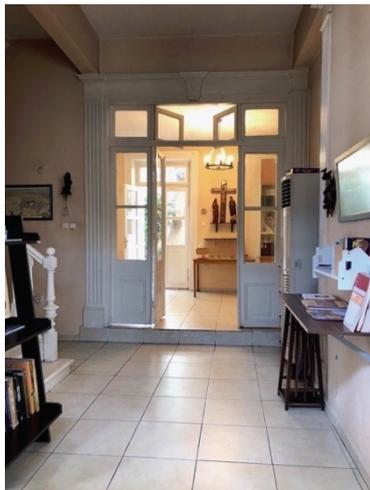
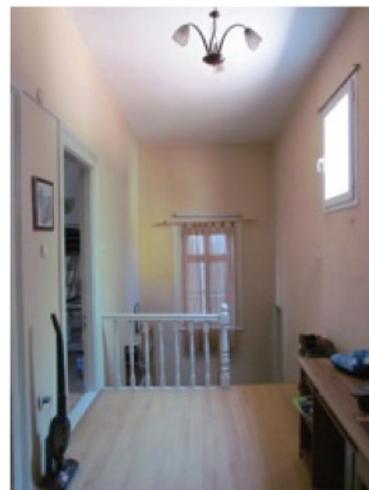
Figure 3.21. Ground floor hall and the first-floor hall of the priest house

A plan organization with a central hall is seen (Figure 3.20). On the ground floor, an entrance hall (Figure 3.21) is surrounded with three other rooms: the wooden staircase and the corridor leading to kitchen, storage and bathroom spaces. At the entrance of the building, there is an aluminum-framed entrance hall that acts as a wind screen. Two fluted wooden pilasters are located at the hall. One of them is located at the corner of the staircase and the other one is located across the first one.

The first floor has a smaller mass due to certain recessments. The central hall (Figure 3.21) of the first floor is surrounded by rooms, staircase and partially with the mezzanine level spaces. A roof attic above the meeting room can be accessed from the southwest side of the hall with a small wooden framed opening. The southwest wall at the attic was elevated with perforated brick bonding. An attic space was gained with the alteration of the roof. The traces of the authentic roof slope are visible on the northwest wall. Based to the traces on the northeast wall, the house was constructed adjacent to church without an additional wall between them and the construction was before the church facades were covered with plaster.

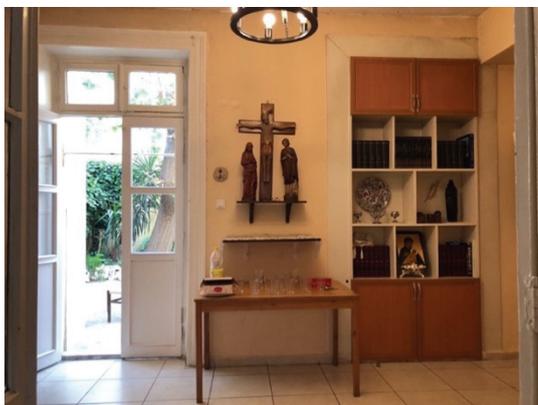
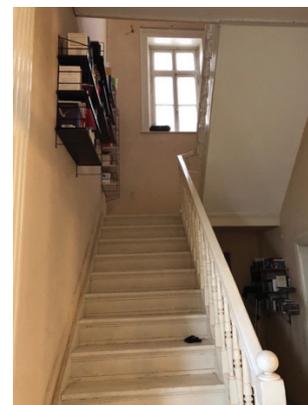
Figure 3.22. Meeting room (a) and the stairs of the priest house, 2019

and the service corridor. A rectangular timber framed window provides light to the staircase. Timber window sills are located underneath the double-leaf window. The window is conserved in its authentic state. The stairs (Figure 3.22) provide access to the first floor. The corridor space which acts as a secondary hall for the building connects the service spaces. Three doors open up to the service hall. The space underneath the stairs is utilized as a storage space. The kitchen is across the storage room. It opens up to the courtyard with a door and a window opening. There is an additional hall at the end of the secondary hall for separating the bathroom from the laundry area. The hall, bathroom and the laundry area create the single storied mass of the housing unit. The mass is a latter addition and in the form of the lot area which is a narrow trapezoid. A meeting room (Figure 3.22) is located directly across the entrance. There is a wide rectangular door opening with timber joinery and four foldable leaves. Fluted timber pilasters with profiled capitals are seen on the edges of the opening. The space opens up to the courtyard with another door. The traces of the casings at the exterior facade indicate to a second door opening which had converted into a cupboard. Pvc covering is seen on the ceiling together with concrete beams suggesting a previous alteration had been made through time. The office room at the northeast corner of the hall is accessed by an authentic double-leafed door with timber joinery. The room also has an opening to the prothesis space of the church, which provides transition between two masses. Two authentic sash windows with timber framed hung windows are seen on the entrance facade. A toilet space with a door and a window opening is located inside the office area. The wet space is thought to be added in time with its new architectural details and materials.

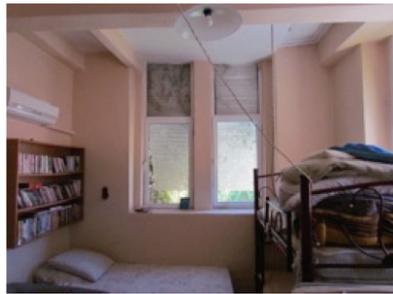
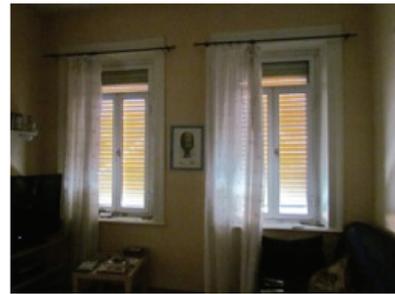
Figure 3.23. Bedroom (a) and the living room (b) of the priest house, 2014

A room, which functions as a living room (Figure 3.23) is located at the northern side of the rectangular hall. The room has two window openings at its front facade. A bathroom mass is seen at the southwest corner of the room. The bathroom space is incompatible with its both in location and material. This suggests that the bathroom is a latter addition to the building. Besides, the room provides a transition to the room above the prothesis space with a depressed arched opening. There are total of four windows located at the room (two on each exterior wall). The elongated arched windows of the northwest facade are partially seen under ceiling due to the alteration caused by the implementation of concrete frame system leading to a lower ceiling level to the room (Figure 3.23). Two bell chords are seen hanging from the ceiling as well as a gate at the ceiling for reaching the third floor of the bell tower. When the gateway to is tower is examined, the wooden circular stairs are seen. Two adjacent bedrooms, which are facing the front facade, are located next to the living room space. The smaller middle room provides access to the balcony door with pvc joinery. The balcony has iron balustrades with iron brackets underneath the floor. Single marble piece had been used for the flooring

of the balcony. The second bedroom has two windows with pvc joinery. The transition door between the rooms were sealed and turned into a cupboard. The rooms still have authentic timber casings around the window openings, even so the window leaves were altered with pvc ones. The wooden doors together with their wooden leaves, which provide access to the central hall, are authentic. The room at the southeast corner is single-leaf door, while the other two doors which are facing the hall are double-leaf doors.

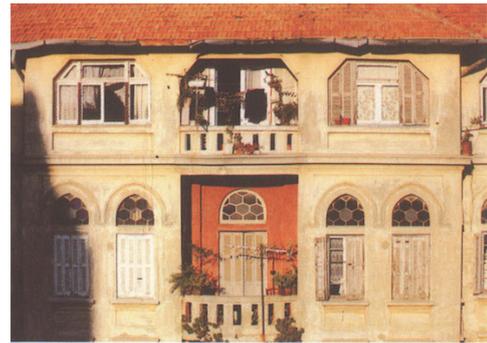
Figure 3.27. Northern (a) and western (b) facades of Anadolu Apartment Building before restoration

The first documentation of the building was done by Cengiz Kabaoğlu and his team in 1990 (Figure 3.27, Figure 3.28). The employer of the project was *Gökdemir İnşaat, Sanayi ve Ticaret Ltd.* The scope of the project involved the restoration of the cultural property and refunctioning the asset together with the adjacent new structure which would be designed further on (KABA Architects 2018). With the July 11th, 1991 decision of the Conservation Council, the measured drawings and documentation of the building were approved, while the demand of a new construction was rejected again. Another attempt for requesting permit for a new construction was made in 1996 (AOCC 1996).

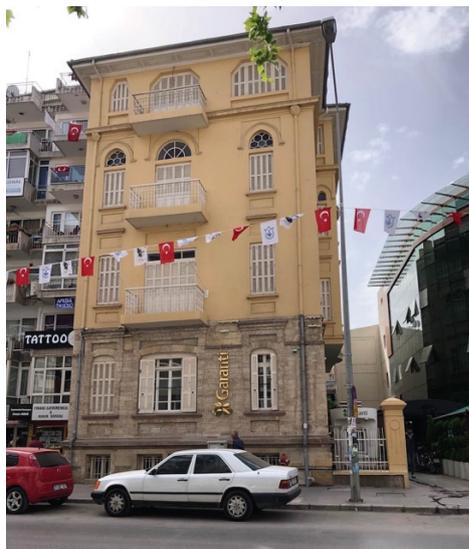
Figure 3.32. Northern facade of Anadolu Apartment Building, 2019

The northern facade is neighbored by Mithatpaşa Street (Figure 3.32). The facade is divided into horizontal sections with differences in materials and forms. Vertically three window axes are visible. The whole facade forms an asymmetrical organization together with the projections of the west facade and garden entrance.

Each floor differs from each other by the form of their windows. The partially seen basement floor has four equally rectangular window openings with timber framed windows and iron railings. A thick stone band moulding is seen between basement and ground floors. The ground floor is composed of three window openings with stone casings. The middle one is a larger opening, while the other two are smaller. Window openings have casings in depressed arched form. The casings are completed to a full rectangle with vertical and horizontal stone elements. Mouldings are seen on the top of each casing. All of the timber framed windows are covered with timber shutters from the exterior except the basement floor. The material of the facade changes from stone to plaster at the beginning of first floor level and continues through the eave. First, second and the third floor's facade organizations are similar excluding the form of the openings. Narrow balconies are seen in front of the larger middle openings, while two other narrower window openings are located at both sides of the balconies. The balconies, which have plain iron balustrades, can be accessed by the door openings with timber framed doors and shutters covering them. On the first floor, only rectangular form is seen in the openings. The openings on the second floor are in shorter rectangular form crowned with pointed arch openings with fixed colored glasses. The third floor differs from the others with its depressed height. Shorter openings are sharply beveled from the two top corners. A band moulding which is covered with plaster is seen between second and third floors.

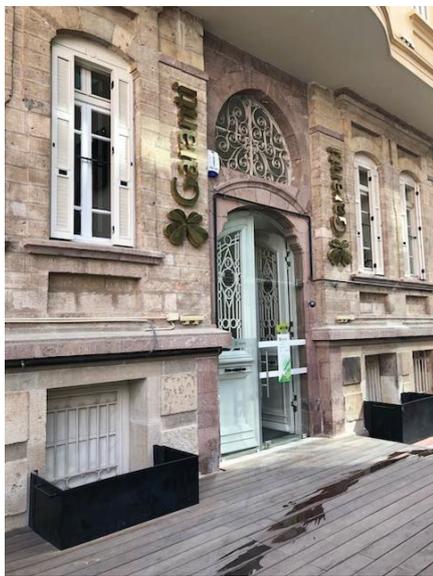
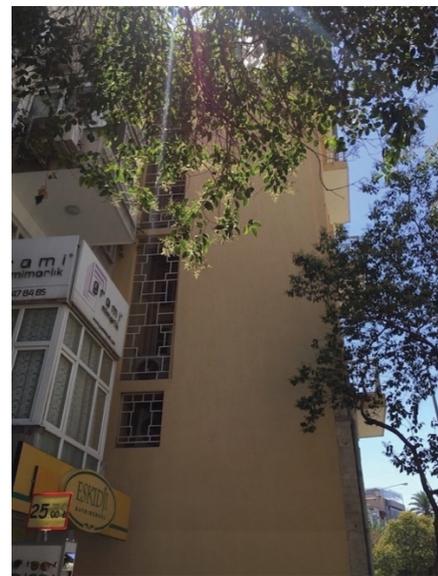
Figure 3.33. A block entrance on the western facade (a) and eastern facade (b) of Anadolu Apartment Building, 2019

Although the structure is on Mithatpaşa Street, the access to the building was designed from the narrow yard which is located in front of the western façade (Figure 3.33). The yard is formed as a narrow corridor due to the neighboring cultural center. On the western facade, there are two main entrances which serve the two twin blocks of the structure. The entrances can be accessed by two ascending steps.

The forms of the openings are in the same characteristics as the northern facade considering a vertical order. Differently, the horse shoe arches, which are above the entrance doors, reflect orientalist style (Kuyulu Ersoy 2001, 8). The cornices and the eave continue through the western facade, too. Windows above the basement floor are all covered with timber shutters. Basement floor can be partially observed from the facade. There are four door openings on the basement floor as well as the windows.

The partially seen surface of the east facade is placed perpendicular to the main street and is composed of basically a blind wall with service ventilation voids (Figure 3.33). The recession of service spaces shows an adjacent urbanization was considered. Today, an apartment building is located at the central area of the eastern facade of the building leaving two equal surfaces on two sides. The only window opening of the east facade can be observed on the top floor of the structure and from Mithatpaşa Street. The rectangular formed window opening is covered with timber shutters. A service shaft is seen on the east facade starting from the ground level. A metalwork with a rectangular mesh covers the vertical shaft. Basement floor level can be partially observed. The whole facade is covered with plaster and differs entirely from the other facades. The eave is seen till the connection to the apartment building.

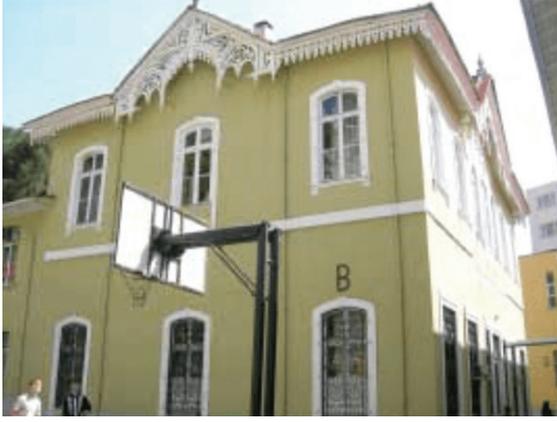
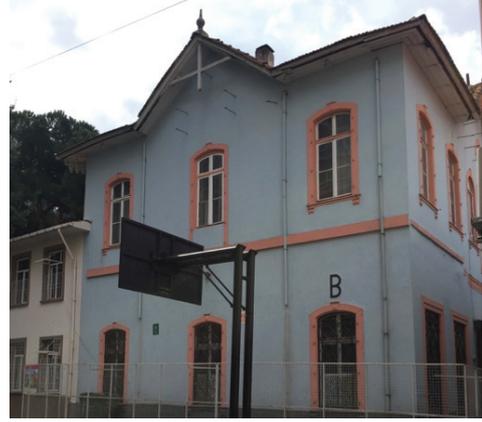
Figure 3.38. Arapyan Ispartalyan House in 2006 (a) and in 2018 (b)

A document dated December 6th, 2016 presented the danger caused by the historic structures physical condition and its insufficiency for accommodating students. On January 19th, 2017, a request for the restoration of the structure was made to the regional directorate of National Education. Thereafter, a document dated to 2017 states the same results as the document dated January 14th, 2015. Additionally, safety measures were continued against the rotted and deteriorated wooden elements of the eave. The removed pieces were stored inside the structure (AOCC 2015). At present, the building is still in poor structural condition and the risk of collapse is increasing each day (Figure 3.38).

Today, the historical building (B block) (Figure 3.38) of the school is evacuated due to safety measures. The exact time of the evacuation is unknown. However, when the

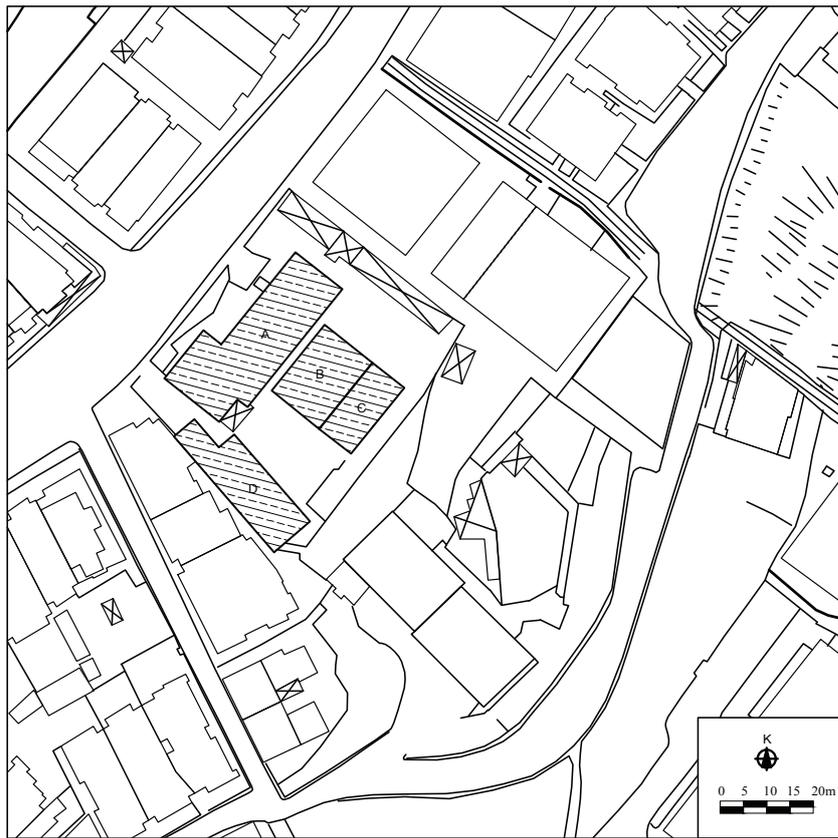
Figure 3.39. Site plan of *Hakimiyet-i Milliye Elementary School*, 2019
(Source: Adapted from İKM 2018)

Hakimiyet-i Milliye Elementary School is located on Mithatpaşa Street. The school is composed of several buildings which were built in time according to necessity of additional space. Placement of different blocks and their relations were not systematically designed. The union of different blocks had fulfilled the yard in time, forming narrow and limited open spaces (Figure 3.39, Figure 3.40). The garden was once filled with olive trees (AOCC 1983).

The school area can be accessed directly from Mithatpaşa Street. There are two entrances. One leads to Müge Uğurlu Art Gallery and one of the school yards, where the ceremonies take place, while the other entrance leads to the A block and indirectly to the second yard. There is another connection from the south of the school area to the upper level with a stairway leading to Misak-ı Milliye elementary School, whose lot primarily belonged to Hakimiyet-i Milliye School. Today, the school yard is shaped by four school blocks, an art gallery, a canteen and wet spaces (Figure 3.39, Figure 3.40).

The open space is divided into two different yards. One of them is located at the northeast side of the B block (the historical building), other, on its southwest side. The yard located at the southwest side has a fountain, probably belonging to the same period (beginning of the 20th century) with the historical building (Figure 3.41). The yard at the northeast of the historical building is bordered by a canteen and wet space units from the north side (Figure 3.41). The narrow yards are bordered by the many structures of the school and a high retaining wall located at the front of the Misak-ı Milliye School.

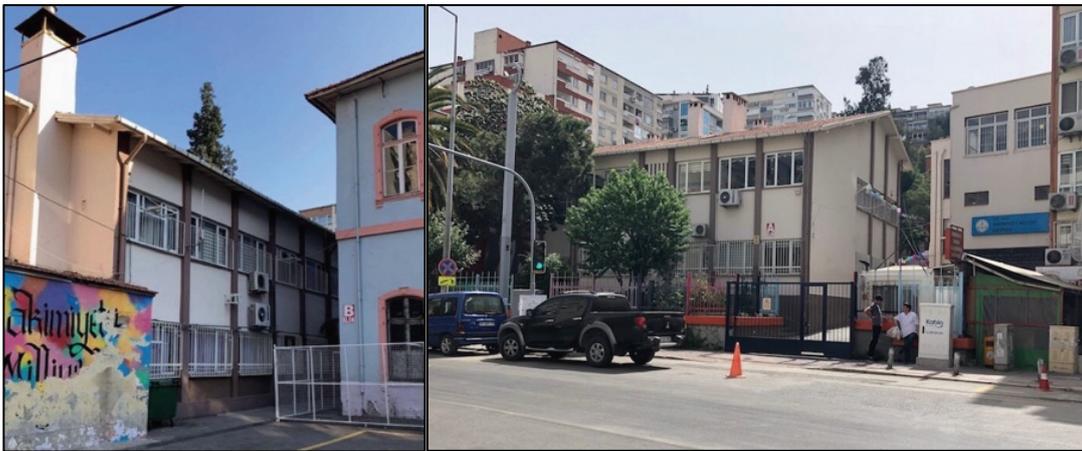
Figure 3.42. Facades of A Block, *Hakimiyet-i Milliye* Elementary School, 2018

The L shaped prismatic mass has its vertical load bearing elements apparent in all the facades. Also, the vertical grills express the wet space locations on the main facade. The structure has rhythmic rectangular window openings on both floors and a hipped roof (Figure 3.42). With these features the building reflects the characteristics of 1960s school structures (Avcı Özkaban and Akyol Altun 2013, 205).

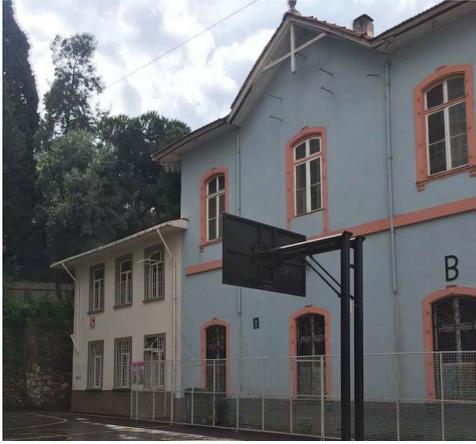
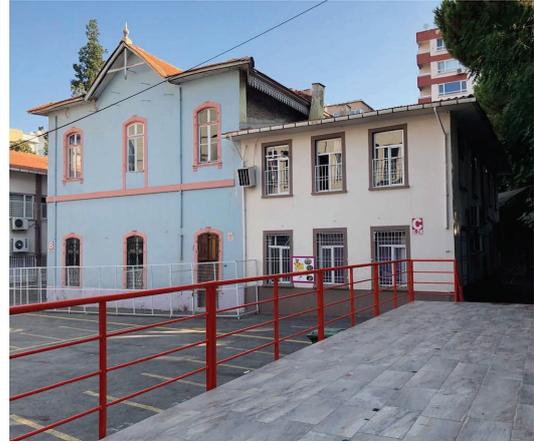
Figure 3.43. Eastern (a) and western (b) facades of B and C Blocks,
Hakimiyet-i Milliye Elementary School, 2018

symmetrical facade organizations (Figure 3.43). The symmetry of the western facade was affected by the alteration of a window. Southern facade is juxtaposed by C block building. No projections are seen among the facades of the building.

All of the openings of the prismatic mass have stone casings with depressed arches (Figure 3.44). The openings of the southern facade, which is juxtaposed by C block, did not reach the present day. All of the three facades except the southern facade are covered with plaster and paint. C block is a lower structure than the historical building; so, the fabric of stone brick bounding is visible from narrow top area of the southern facade. An intervention with cement is also observed at this area. Three of the facades except the southern facade have triangular wooden pediments. Lacelike timber panels surround the eave on all sides.

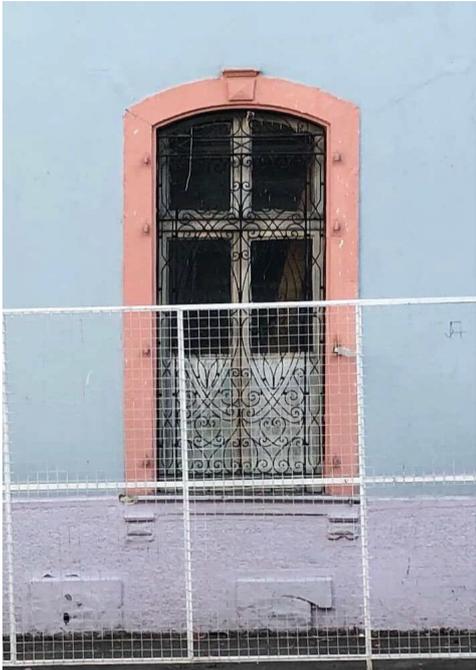
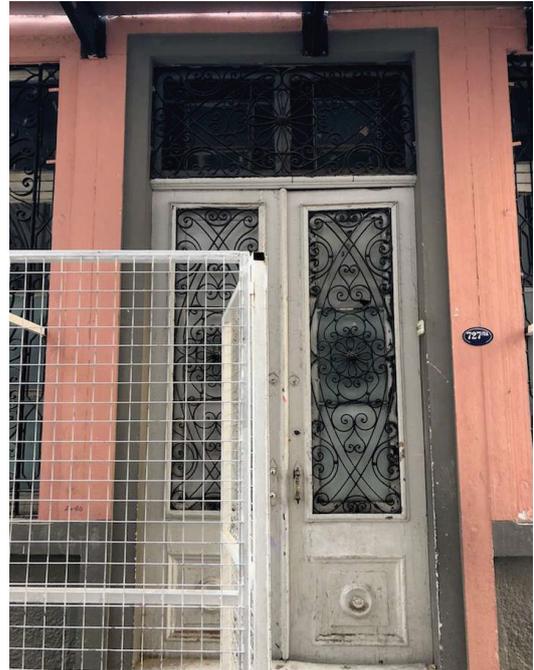
Figure 3.44. Window (a) and the main entrance door (b) of
Arapyan Ispartalyan House, 2018

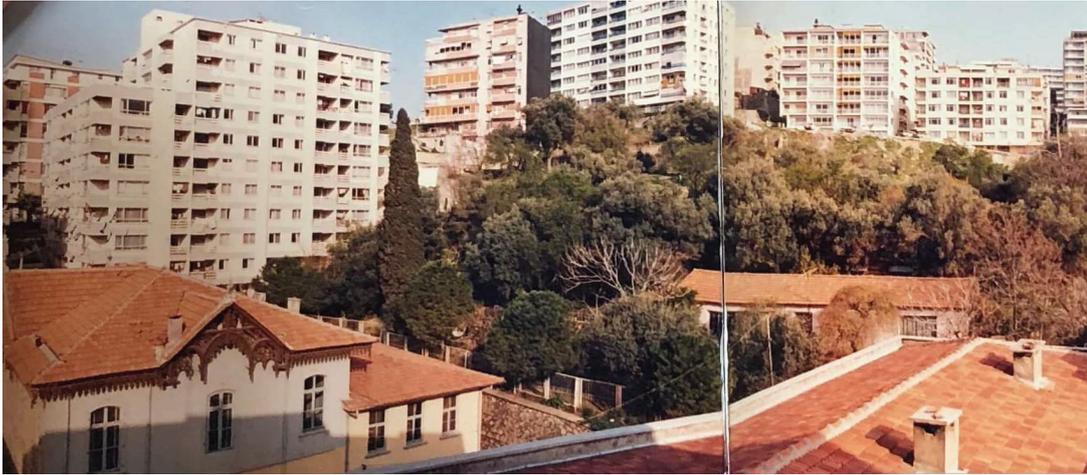
Figure 3.45. Roof of Arapyan Ispartalyan House
(Source: AOCC)

All of the buildings of the site except the historical building (B block) had been built in reinforced concrete frame system. The two storied historical building is brick and stone masonry. The hipped roof of the building has additional fractions above the wooden pediments. The roof is covered with Marseilles tiles (Figure 3.45).

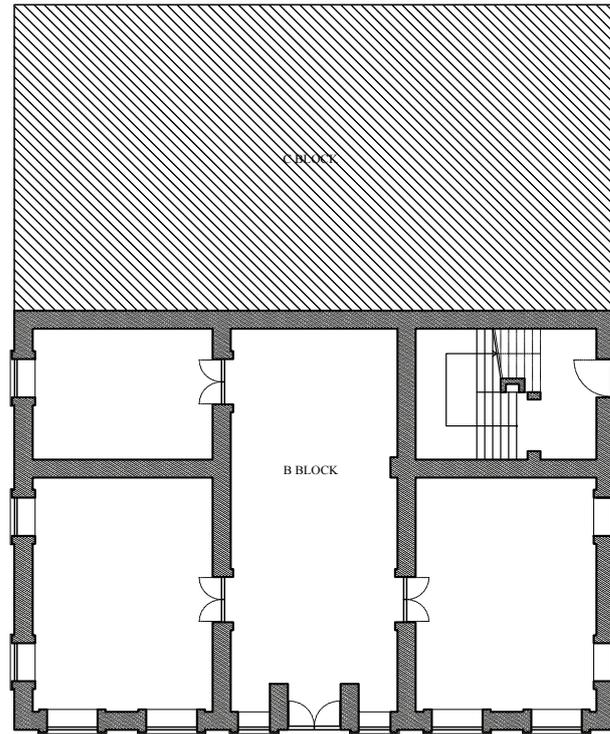
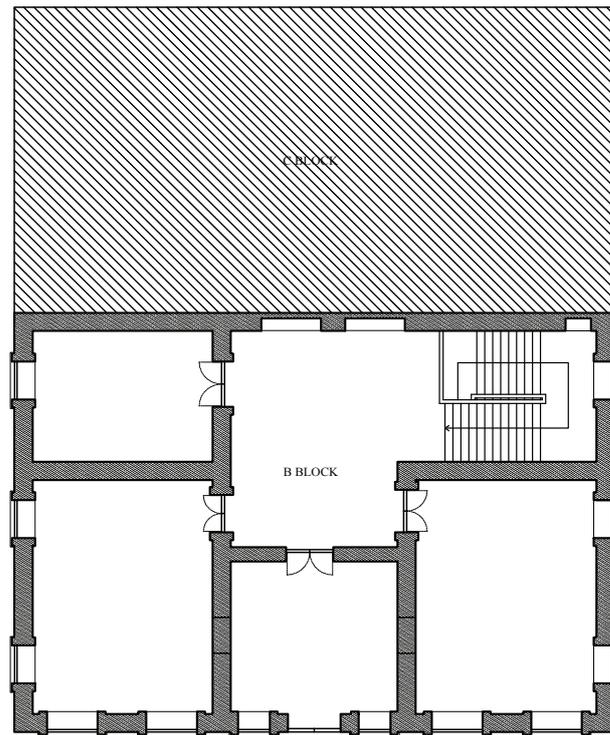
GROUND FLOOR PLAN

FIRST FLOOR PLAN
