Effect of urban transformation on the values of historic sites around mosques: Two cases in Manisa, Turkey

Abstract This study presents a framework for assessing the cultural asset values of historic sites around mosques. Case studies are selected from provinces of Manisa, Turkey, namely, Çarşı in Salihli with its new urban development and Pazaryeri in Gördes that is abandoned and currently considered as an archaeological site. Literature review, archive research, historical research, comparative study, and site survey are carried out to evaluate the urban development of site neighborhoods with a retrospective perspective. An approach presenting the effects of urban transformations on the cultural asset values of the historic neighborhood centers is proposed. The cases reveal that the urban aesthetic is nearly all lost today, but the holiness of each site preserves its authenticity while the historic land use is sustained. Their preservation problems are lack of maintenance and abandonment due to disasters, illegal interventions, inappropriate development plans, and unsuitable restoration approaches. The principles proposed for managing these historic environments consider their c

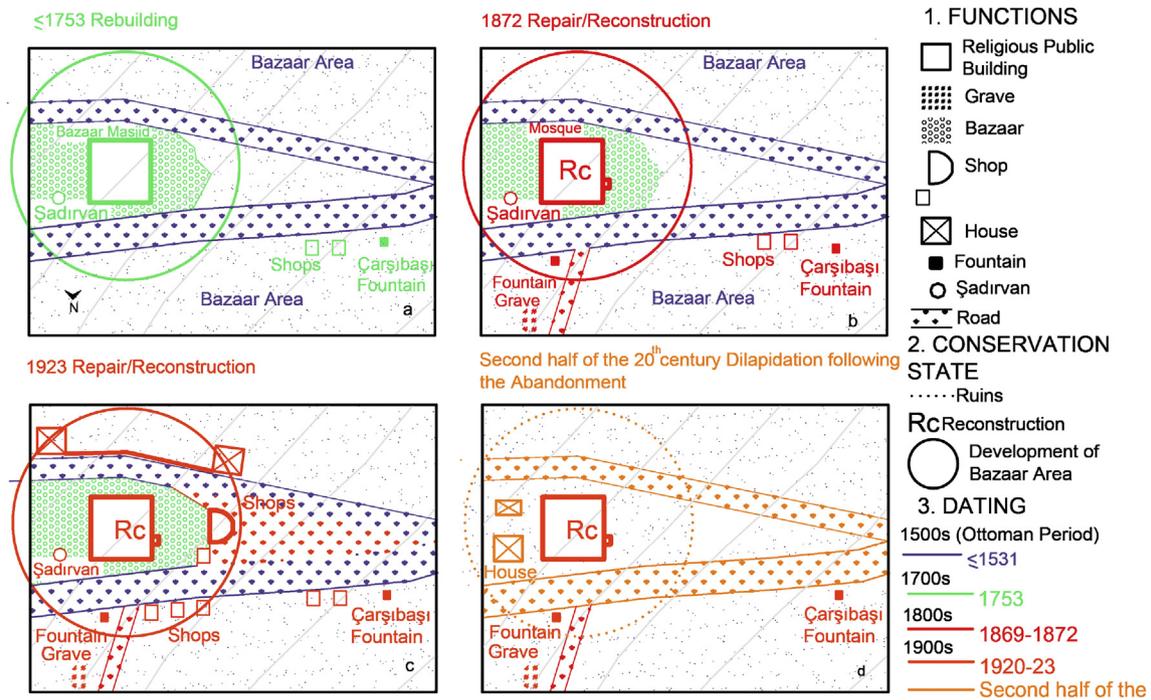
Fig. 1 Evolution of the Pazaryeri Mosque and its vicinity (site plans).

The old Gördes, which has been settled in since the Hittite Period (1450–1200 BC) (Tekdemir, 2016), is at the skirts of Kepez (Tekke) Mountain at the northeast of Manisa center. Bazaar Masjid was built in Bazaar Masjid (*Mescid-i Bazar*) Neighborhood in the 14th century. The modest monument was in harmony with its rural setting, and the traditional buildings in the vicinity were at the human scale in the 14th century (Fig. 5). The repetition of traditional design elements and construction technique provided a unity in the site (Fig. 3a). The neighborhood had weekly open bazaars and seasonal festivals, which contributed to the social welfare of the community. Pazaryeri Mosque is considered to have been constructed in the Nakıp Ağa Neighborhood in place of Bazaar Masjid built in Bazaar Masjid (the former name of the neighborhood) Neighborhood in the 14th century, before the Çarşıbaşı Fountain dated to 1753 (Figs. 1a and 5) (Adamaz, 2016).

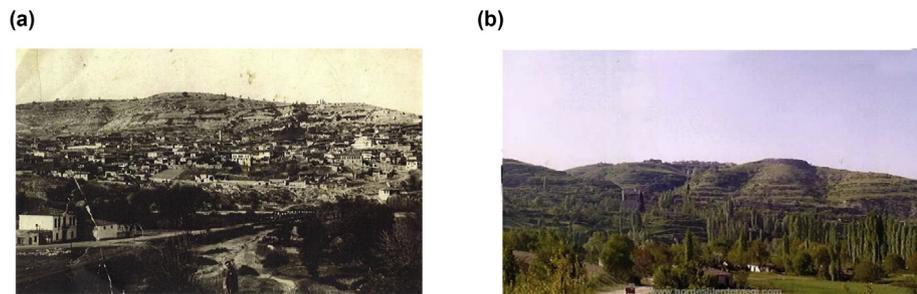
Fig. 2 Old Gördes: (a) Unknown date; (b) After abandonment.

migration of the entire community (Fig. 2a, b). Inhabitants moved to a new place identified by the government. The rapid dilapidation caused by weathering, lack of maintenance, and the removal of building elements by the former inhabitants moving to their new destinations triggered the loss of the urban fabric in their departure town (Fig. 3g). The mosque lost its community, resulting in the rapid transformation of the settlement of old Gördes into an archaeological site. The lack of maintenance led to partial collapse (Figs. 1d and 6), and the mosque lost its superstructure (roof and *külâh*) and portions of its walls. Its eastern and western passage entrances and shop windows. Only the old house located at the east of the mosque continued to be used at the abandoned site. In addition to the exterior elements, interior elements were exposed to weather conditions.

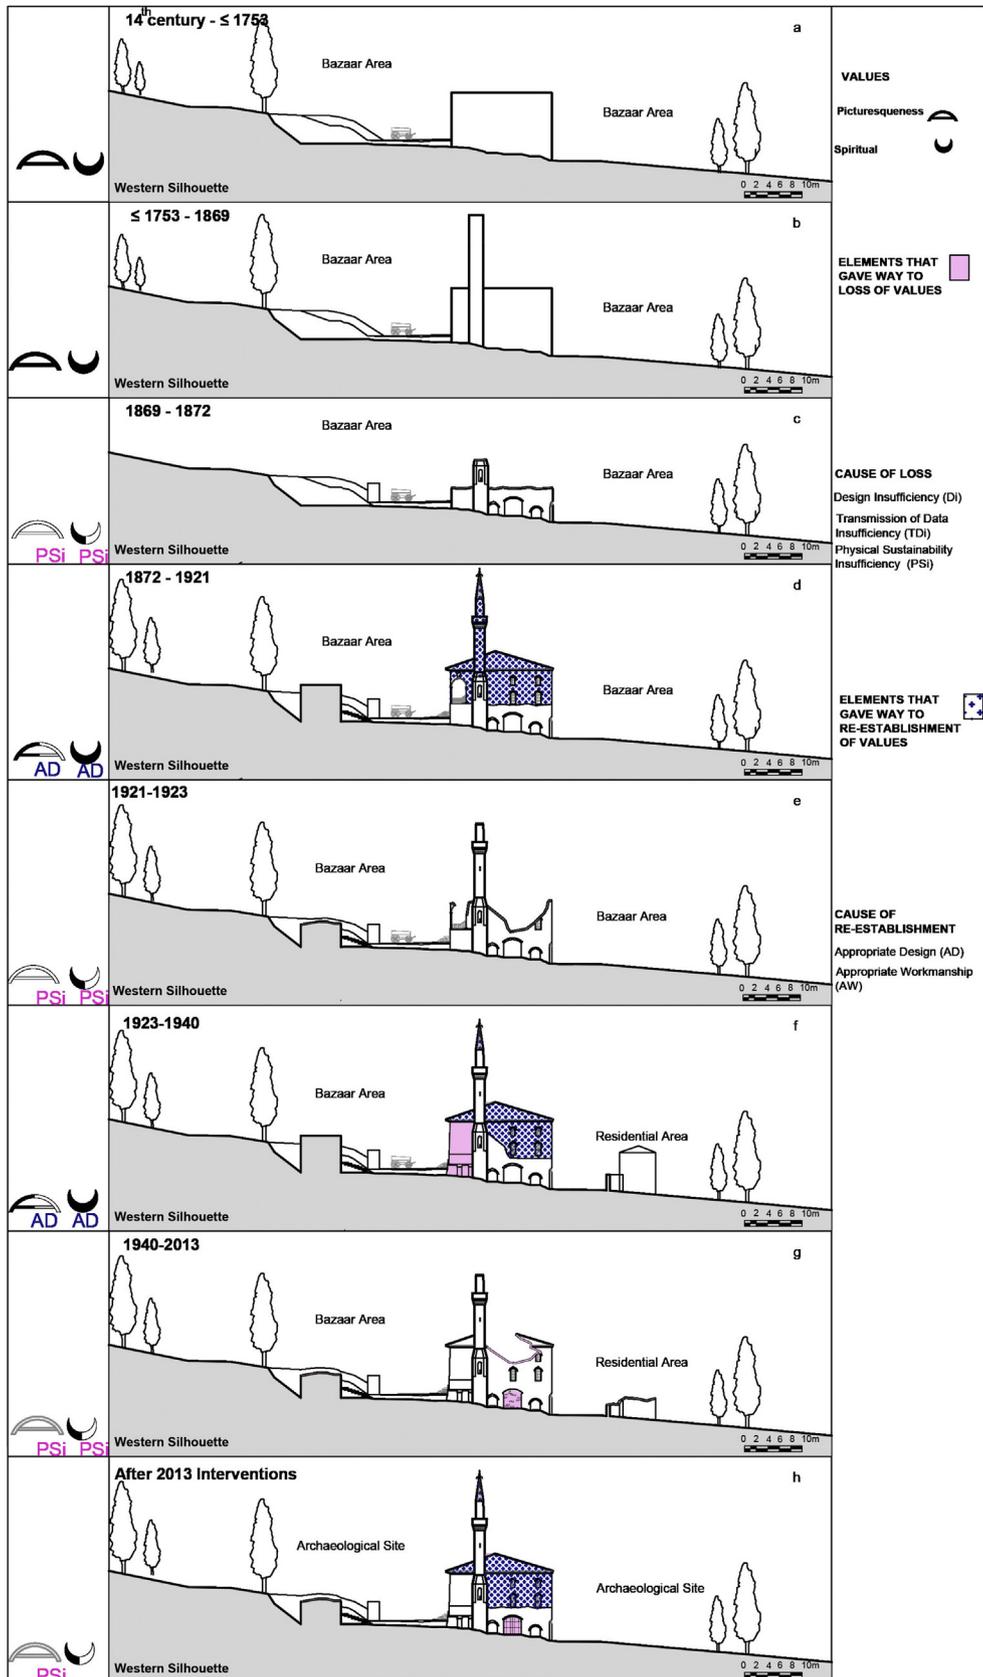
Fig. 3 Evolution of Pazaryeri Mosque and its vicinity (silhouette drawings).

its sides. The construction of the mosque in place of Bazaar Masjid sustained the spiritual significance of the site, similar to many other religious places where holiness has been sustained throughout history (Jokilehto, 1999). The building density in the site slightly increased but the human scale remained the same (Fig. 3b).

figure, and his burial in the vicinity of the mosque further reinforced the spiritual value of the site. The upper part of the building was rebuilt in accordance with the style of the time (Fig. 3d).

The 1921 fire set by Greeks ruined the mosque together with its surroundings. The site’s picturesque qualities were negatively affected (Fig. 3e). The shops and houses were not totally abandoned but repaired or reconstructed by the owners. The mosques were continually respected and immediately repaired in accordance with Waqf regulations (Madran, 1996). The buildings were rehabilitated in the early Republican years, and the number of shops at the bazaar area increased. The mosque’s repair was realized in 1923 (Acun, 2013) (Fig. 1c). A timber room mass was added to semi-open last comers’ hall, and its eastern and western façades were closed with stone masonry walls. Although these interventions were in line with the period’s legal framework (Madran, 1996), the quality of the historic environment decreased (Fig. 3f).

In old Gördes, only Pazaryeri Mosque was reintegrated. The monument was restored by RDPF in 2013 (Fig. 3h) and the partially collapsed building was reintegrated (Fig. 4). A

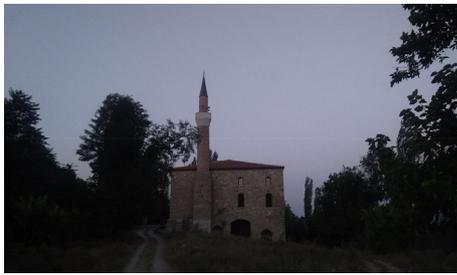
Fig. 4 Mosque mass, including its western entrance to a semi-open colonnaded space and its surrounding site.

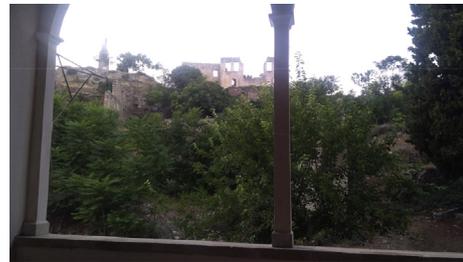
Fig. 6 Collapsed buildings at the north (view from the last comers' hall of Pazaryeri Mosque).

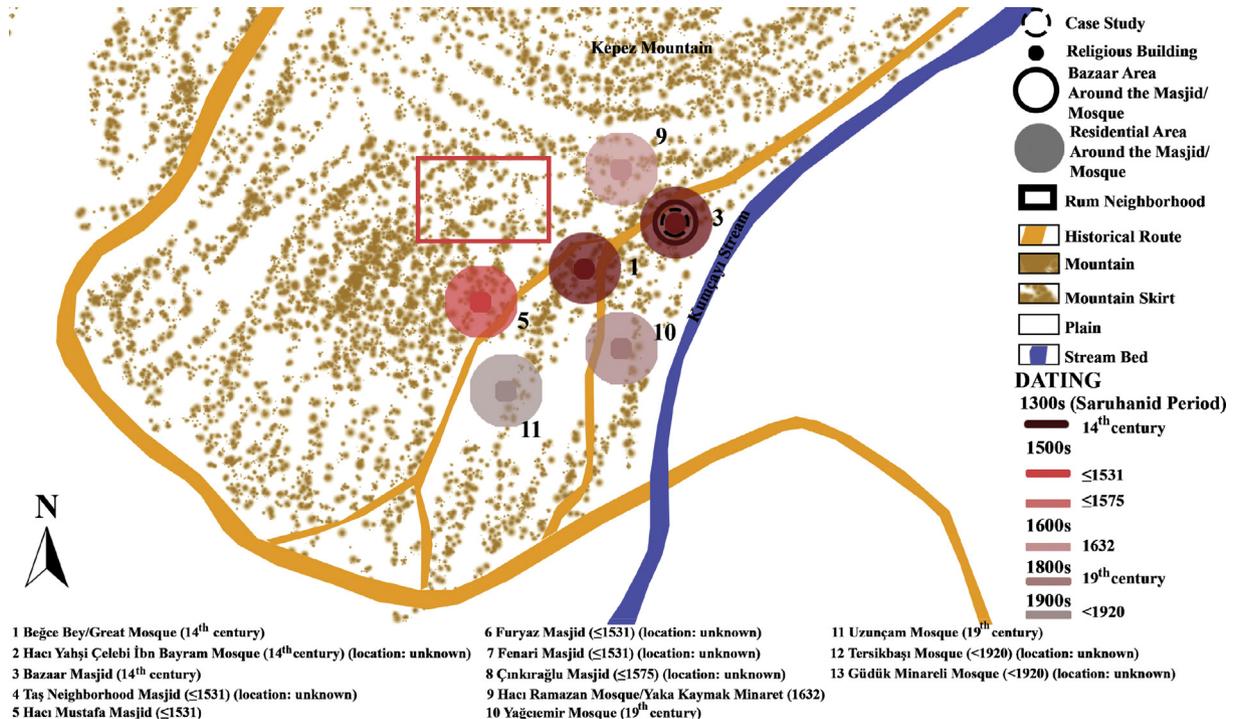
Fig. 5 Urban development around masjids/mosques in Gördes center.

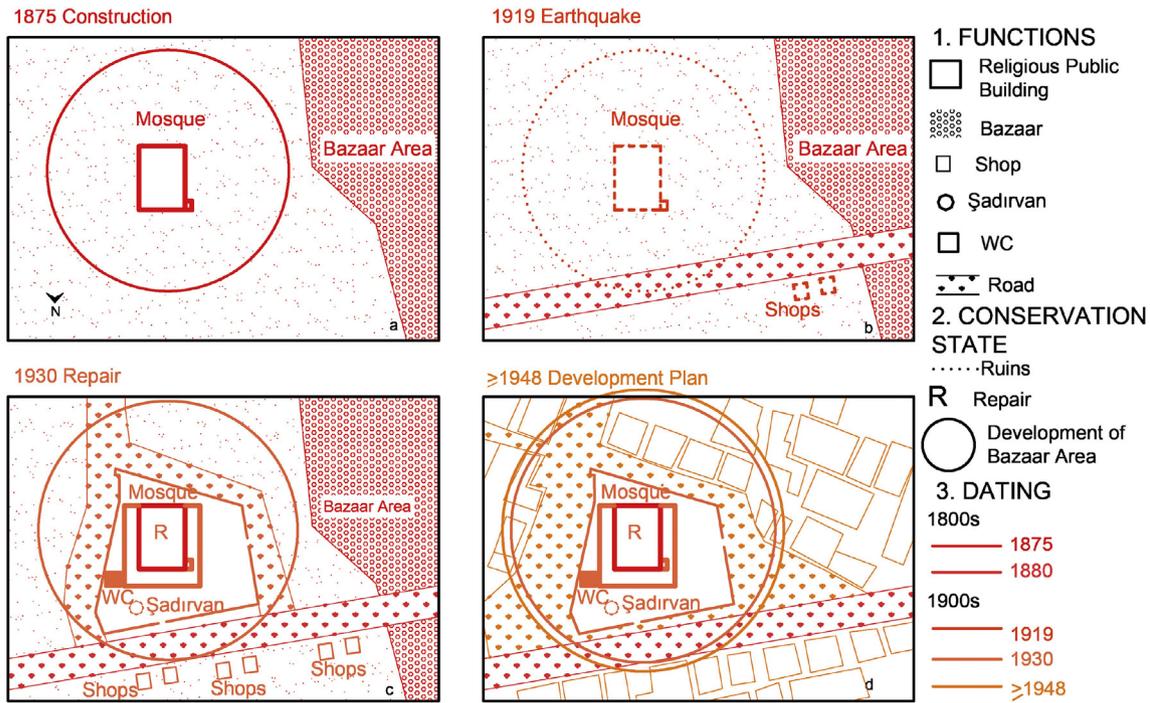
Fig. 7 Evolution of the Çarşı Mosque and its vicinity (site plans).

The Soma (a district of Manisa) earthquake in 1919 (Fig. 7b) (BUKOERIRETMC-Boğaziçi University Kandilli Observatory and Earthquake Research Institute Regional Earthquake-Tsunami Monitoring Centre, 2017) and the fire in 1922 (Uluçay and Gökçen, 1939) negatively affected the newly emerging commercial district. These incidents caused the collapse in the hipped roof, last comers' hall, and the minaret of the Çarşı Mosque (Fig. 7b). The site's picturesque qualities were negatively affected (Fig. 10b). The shops and houses were not totally abandoned but rather repaired or reconstructed by the owners. The mosque was continually respected and immediately repaired in accordance with Waqf regulations (Madran, 1996) in 1930. The restoration included the alteration of the last comers' hall with a reinforced concrete mass and its enlargement toward the north, reintegration of the main mass by altering its eastern and western façades for reaching the reinforced concrete masses added to these sides of the mosque, reintegration of minaret as a disproportional element with two *şerefes*, and the addition of an unqualified *şadırvan* to the courtyard (Fig. 7c). The interventions used modern building materials, and despite their alignment with the period's legal framework (Madran, 1996), the quality of the historic environment diminished. The reinforced concrete threatened not only the picturesque but also the spiritual values (Fig. 10c).

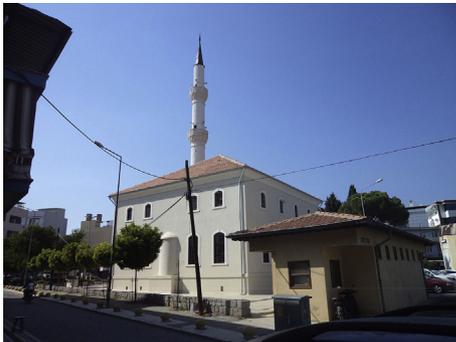
Fig. 8 Southeast view of Çarşı Mosque.

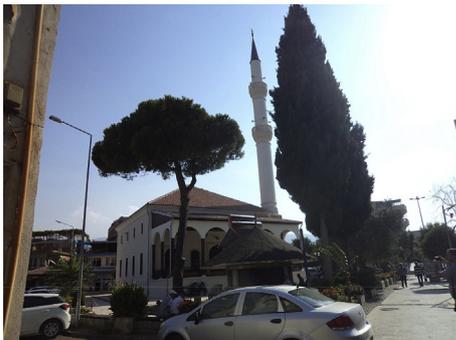
Fig. 9 Northeast view of Çarşı Mosque and its environs.

density in the environs of Çarşı Mosque. Multistory buildings began construction (Fig. 12). Human scale, traditional urban elements, and the balance of open–closed spaces in the neighborhood were lost (Fig. 10d). The grid urban layout in the vicinity involved two-to seven-story buildings, most of which were residential buildings with shops on their ground floors in accordance with the 1987 Development Plan (Baykal, 1990) (Fig. 7d). A parking area and a single-story toilet building were situated at the area adjacent to the mosque courtyard (Fig. 8). RDPF restored Çarşı Mosque in 2014. The courtyard encloses the mosque building (Fig. 9) from all sides, and can be accessed everywhere because of the low height (approximately 40 cm) of the courtyard wall and flower pots. The courtyard elements included an unqualified *şadırvan* repaired in 2011 at the north of the eastern corner, a *musalla* stone at the south-western corner, and trees at the boundaries (Fig. 9). The praying space is elevated over a storage space at the partial

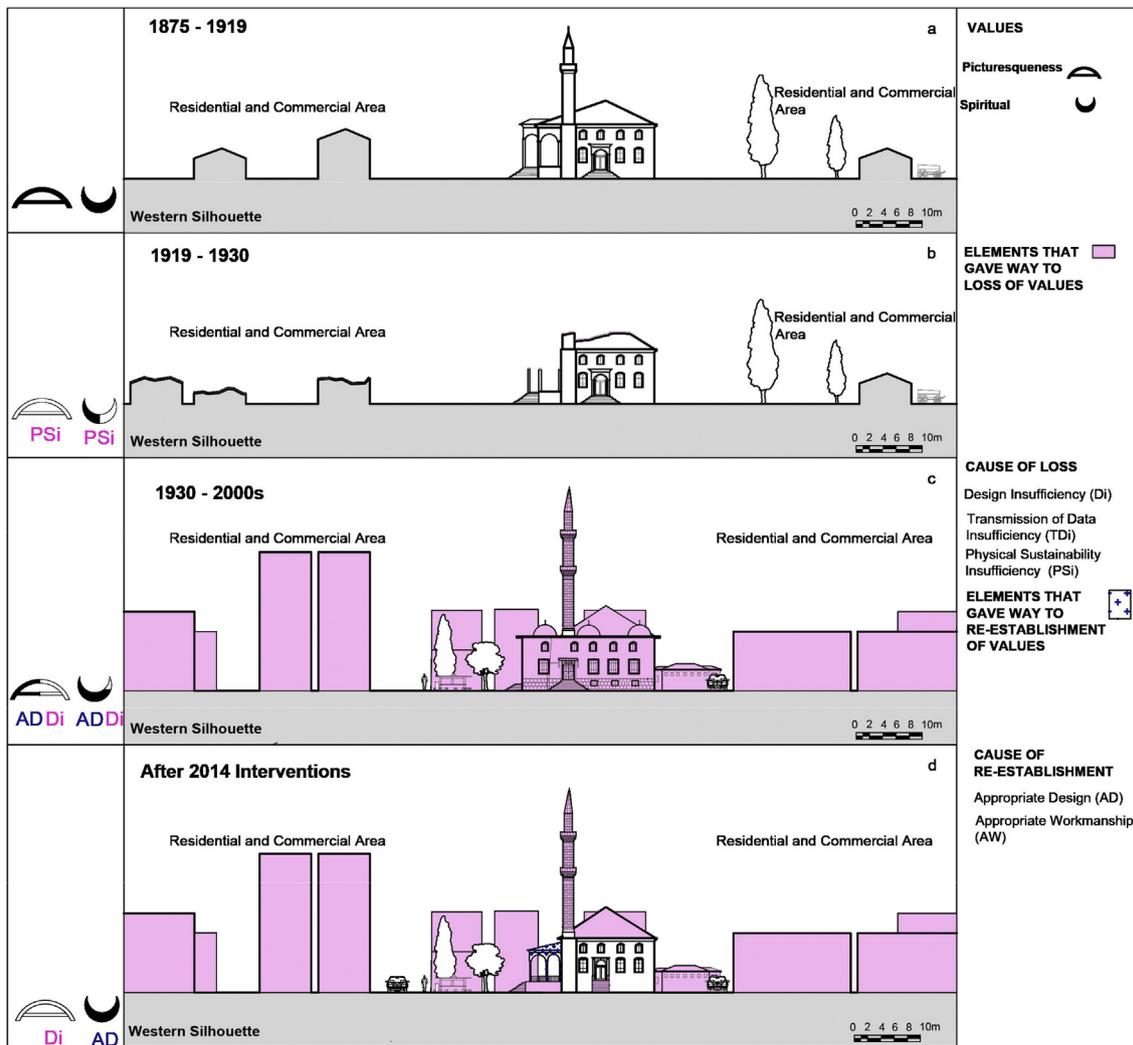
Fig. 10 Evolution of Çarşı Mosque and its vicinity (silhouette drawings).

have been proportional with its mass, as seismic vulnerability necessitates (Kuban, 2016). Human scale, balanced solid-void organization, and repetition of traditional building elements and construction technique led to a picturesque site (Fig. 10a) with a holy focal element.

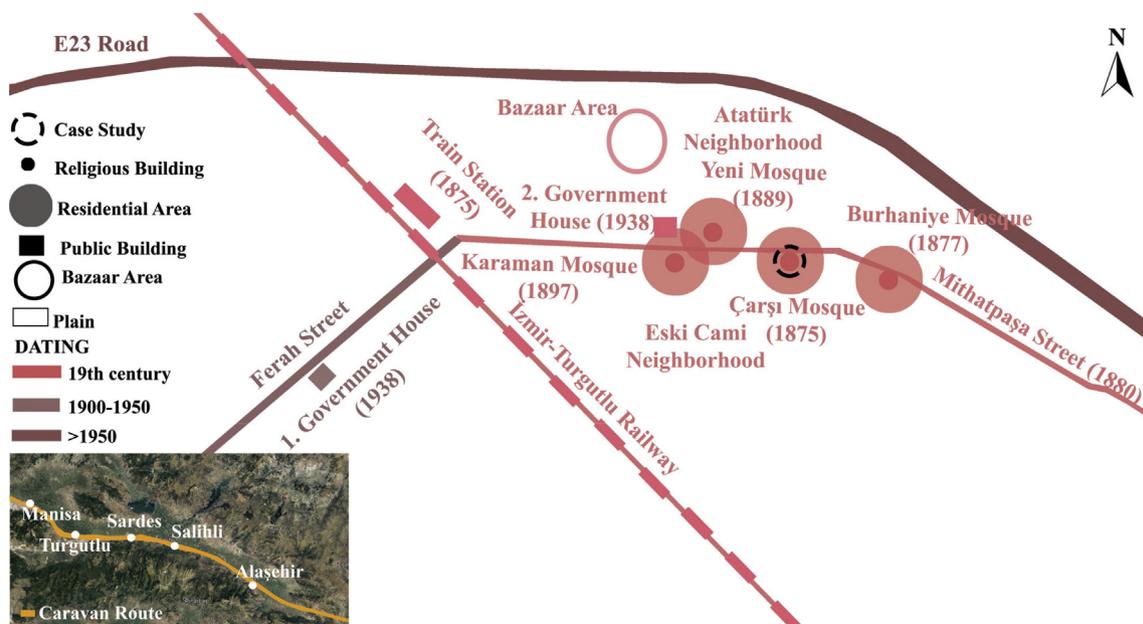
Fig. 11 Urban development around mosques at Salihli center.

Salihli is the neighbor of the ancient Sardes, the capital of Lydia (Fig. 11), and is located at the east of Manisa center. In place of the discussed settlement, rural lands of a former village were present (Baykal, 1990). In the second half of the 19th century, following the construction of a railway station at the site, Çarşı (Fig. 11) and the new commercial zone were implemented (Fig. 7a). Çarşı Mosque was placed on the Mithatpaşa Street in Eski Cami Neighborhood, Salihli District, Manisa. The neighborhood developed around Çarşı Mosque after its establishment in 1875 (Fig. 10a) during the Ottoman modernization period, when grid layout was a common design preference for settlements. The mosque had Neoclassical characteristics. Until its 1930 restoration,

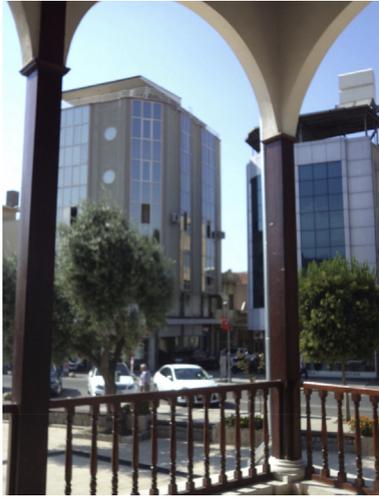
Fig. 12 Multistory buildings at the north (view from the last corner's hall of Çarşı Mosque).

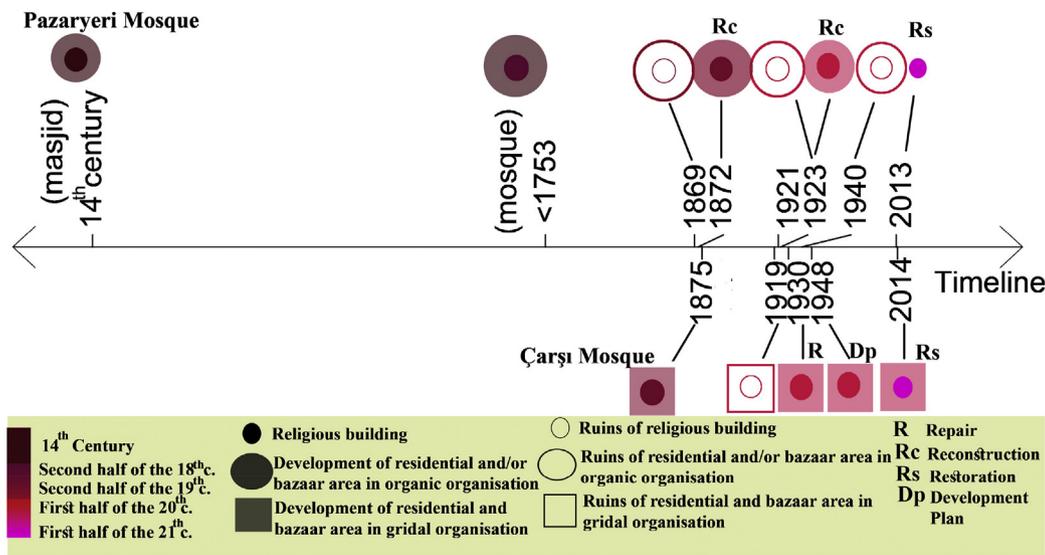
Fig. 13 Evolution of the case study sites.

Both of the case study sites have maintained their traditional physical characteristics until the 20th century (Fig. 13). Disaster such as a landslide (Pazaryeri) and dense urban development (Çarşı) have enabled the radical alteration of the site characteristics starting from the mid-20th century. The other historic sites around the mosques have also maintained their traditional qualities until the 20th century (sites around Sidna Ali Mosque, Masjed-e Jame, and Blue Mosque) (Section 1). The loss of traditional physical characteristics has started in 1948 at Sidna Ali, in 1925 at Masjed-e Jame, and in 1920 at Blue Mosque. The causes of these losses are the transformation and modernization of the city.
