# Retrofitting of Masonry Structures Considering the Architectural Perspective: A Case Study in Foca, Izmir

Ertugrul Turker Uzun <sup>1</sup>, Ilker Gucu <sup>1</sup>, Tolga Arslan <sup>2</sup>, Sevket Onur Kalkan <sup>2</sup>

**Abstract.** Masonry structures have been preferred for centuries in most of the countries across the world because they are easy to build and economical due to the use of local materials in their construction. As a result of high usage volume, masonry structures that created the architectural section of history and culture constitute an important part of the current building stock despite the developing and diversified construction techniques nowadays. The protection of these structures, which are important both in terms of their cultural values and their transfer to future generations, is of great importance in the architectural point of view. For this purpose, a masonry structure from Foca is selected. The material properties and architectural plan of the structure are determined in accordance with the original one. The structure is modelled by using a software program under seismic effects. Displacement and stress values for each acceleration record ar

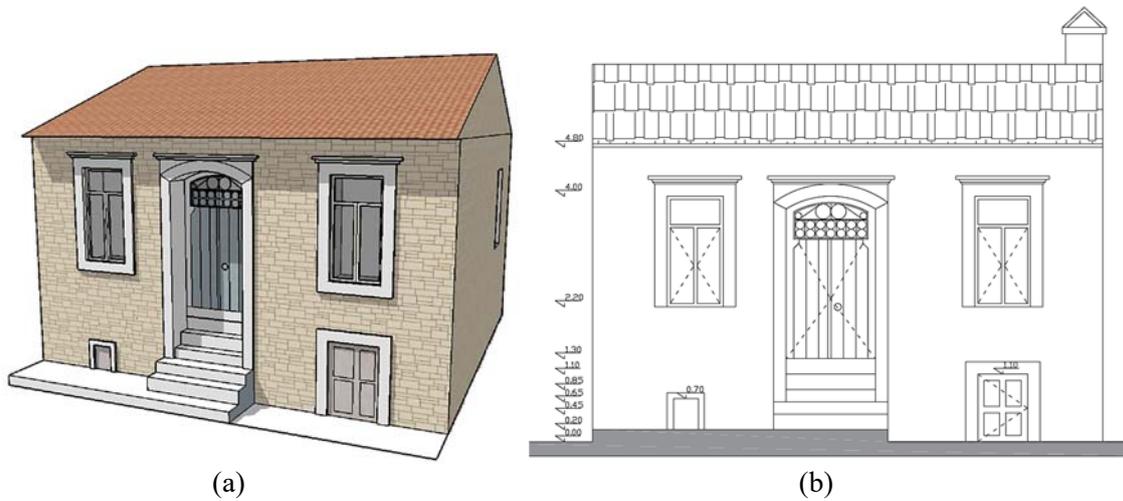
The examined structure is constructed by using stone material that is easily found in Foca region. The structure has two floors that can be described as basement and ground floor. The story heights are 1.3 m for the basement and 3.5 m for the ground floor. This is given in Figure 1 illustrating 3D and front view of the structure with dimensions.

**Figure 1.** (a) 3D and (b) front view of structure

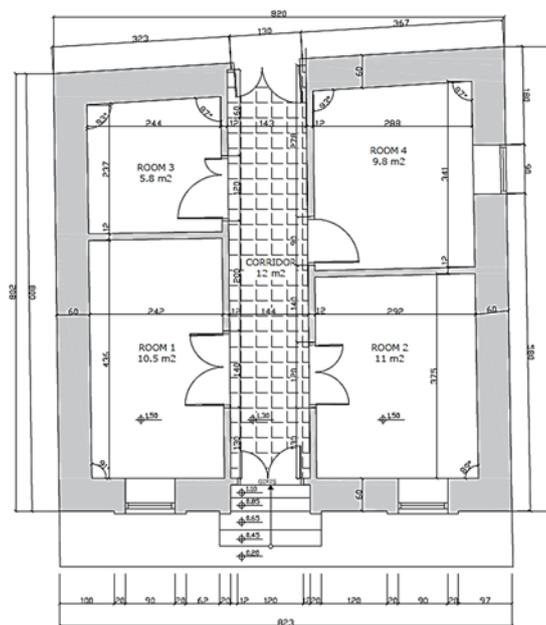
Moreover, the ground floor plan of the structure is given detailed in Figure 2. All dimensions are given as cm. The thickness of outer and inner walls are 60 cm and 12 cm respectively. The seating area of the structure is approximately 697000 cm<sup>2</sup>.

**Figure 2.** Ground floor plan of structure.

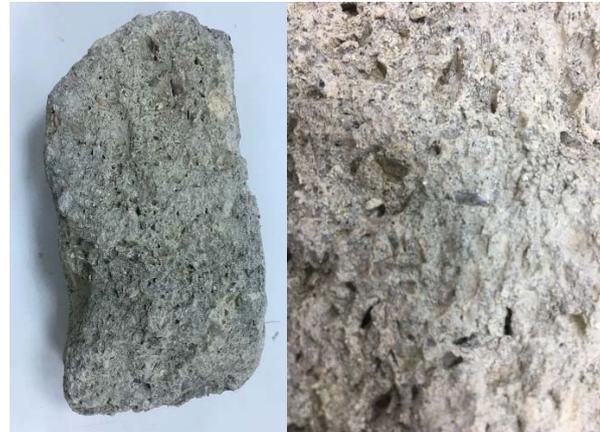
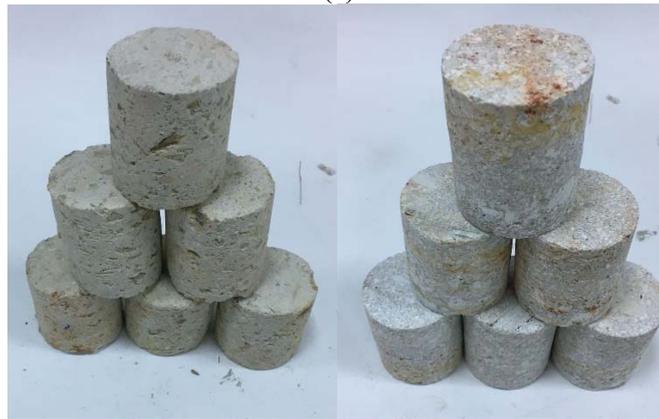
10 cored specimens are taken over the Foca-stone sample taken from the site and specimens are given in Figure 3. Due to the difficulty of taking the core in the uniaxial pressure resistance test made on the tuffs, some samples are subjected to the  $L = D$  rule and some correction formulas are used to determine the uniaxial compressive strength value.

**Figure 3** (a) Examined structure constructed material (b) test specimens

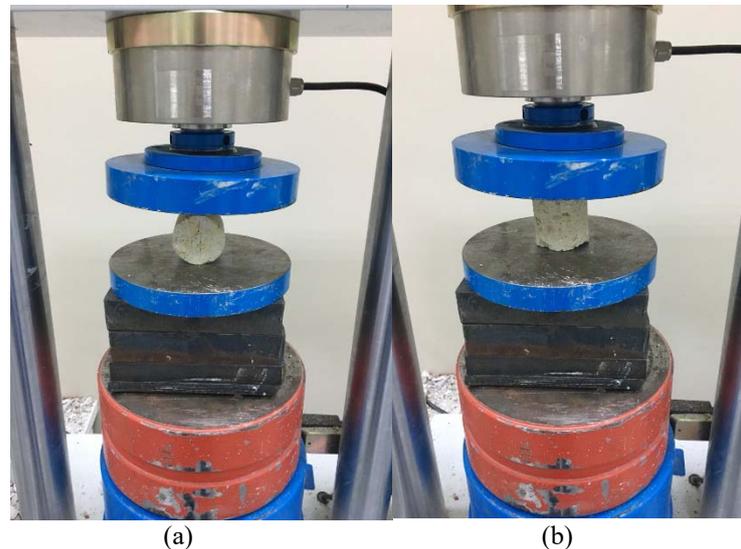
The ratio of mechanical stress to strain in a material when that material is being compressed; it is the modulus of elasticity applied to a material under compression: modulus of compression = compressive force per unit area/change in length per unit length. In Figure 4, analysed specimens are given as split tensile and uniaxial compressive tests respectively.

**Figure 4.** (a) Split tensile test (b) uniaxial compressive test

The general characteristics of the Foca Stone found in the area are given in Table 1. After the analyses, modulus of elasticity “E” is calculated as 9635 MPa or 9.6 GPa.

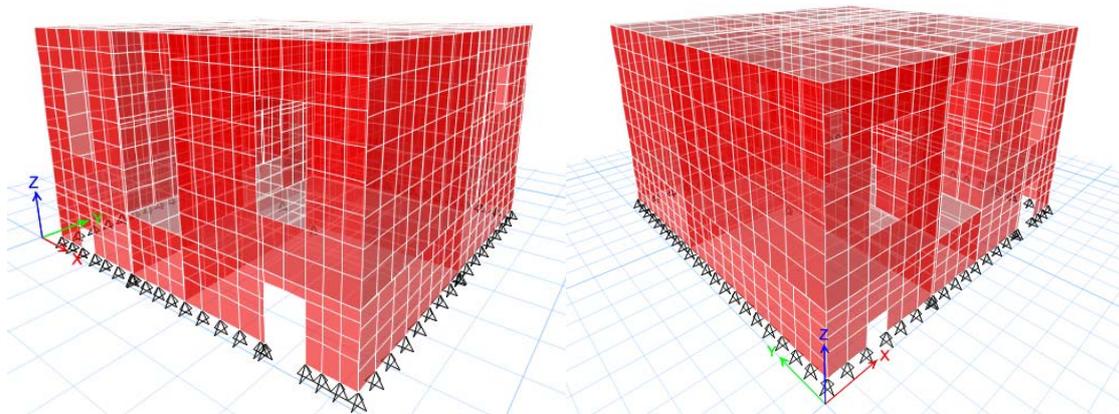
The 3D finite element model (FEM) is developed by using ETABS [12] and shown in Figure 5. The geometrical simulation is done by using shell elements and the discretization of the finite element mesh is assigned entirely flat quadrilateral and triangular elements. Material properties are defined by using experimental results. Then, the created model is used to analyse the structure.

**Figure 5.** 3D finite element model (FEM) of the stone masonry structure.

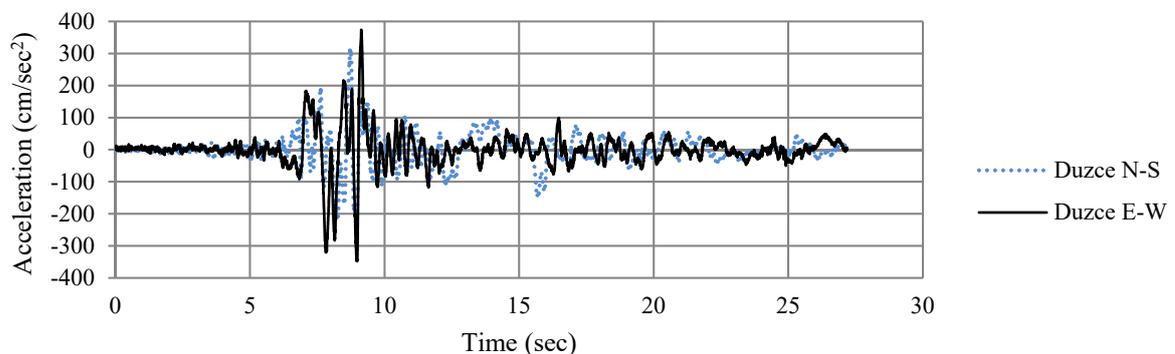
It is known that masonry structures are brittle properties and these structures are vulnerable to strong earthquake shaking. Therefore, it is important to determine and improve the seismic behaviour of the masonry structures. In order to investigate structure seismic performance, nonlinear response history analyses are conducted for each modelled. Since the examined stone masonry structure constructed in Izmir is located in the 1st seismic region, a strong ground motion is selected from Düzce recordings of Kocaeli Earthquake, which has the highest value of acceleration. In Figure 6, earthquake time-acceleration graph is given.

**Figure 6.** Strong ground motion from Düzce station

According to TSC 2007 [13], it is selected that the seismic zone is 1st seismic zone and soil class is Z4 type. In order to simulate the possible elastoplastic behaviour of the stone masonry structure, it is assumed that the seismic load reduction factor “R” for the structure is taken as 2. A 4 % damping ratio on the modal shapes are selected as suggested in the literature [14].

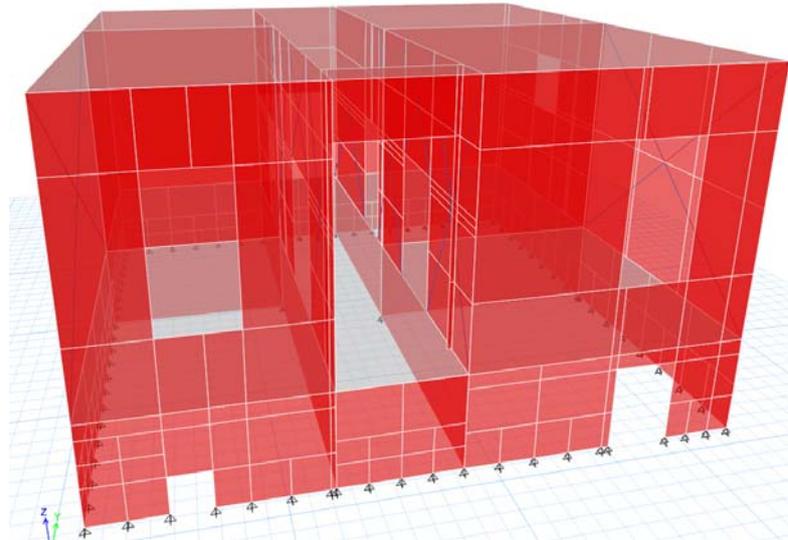
damages at critical points. Therefore, high strength steel material (modulus of elasticity “E” is 210 GPa, minimum yield stress “Fy” is 440 MPa, and minimum tensile strength “Fu” is 550 MPa) is selected to retrofitting process of the stone masonry structure adhering to Venetian Constitution [11] and TSC 2007 [13]. 200 mm steel rods are applied to the vulnerable parts of the structure and retrofitted structure is also examined the same method with the original structure. Applying points of the masonry structure for the retrofitting are selected after the nonlinear response spectrum analysis is realized. These points are also given in Figure 7.

**Figure 7.** Finite element (FE) model of the retrofitted stone masonry structure

Interior walls of the structure for the retrofitting are tried to select because of the considering architectural perspective. In this way, the structure has been tried to be strengthened by choosing the minimum number of elements that can be selected and the inner perspective is tried to be preserved. Also, outer appearance of the structure is protected.

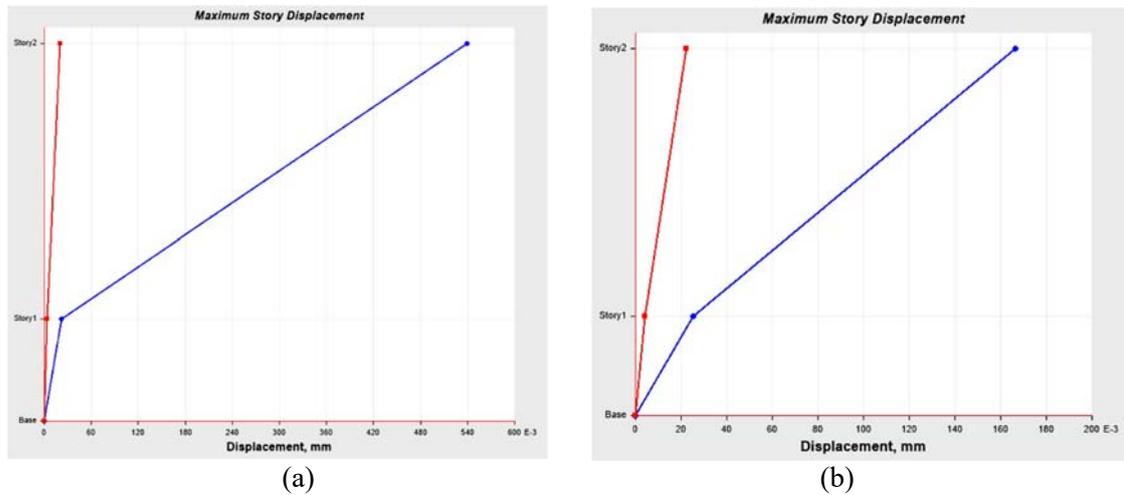
In this process, maximum story displacements of the structures are given in Figure 8 comparatively. Blue and red graphs represent x-direction and y-direction displacements in turn. With using proper and effective retrofitting, examined structure maximum story displacements for top point of the structure are decreased 68.5 % for x-direction. For y-direction, the original structure is analysed and any retrofitting processes in this direction are not applied because of the satisfying limit cases.

**Figure 8.** Maximum story displacements for (a) original structure (b) retrofitted structure.

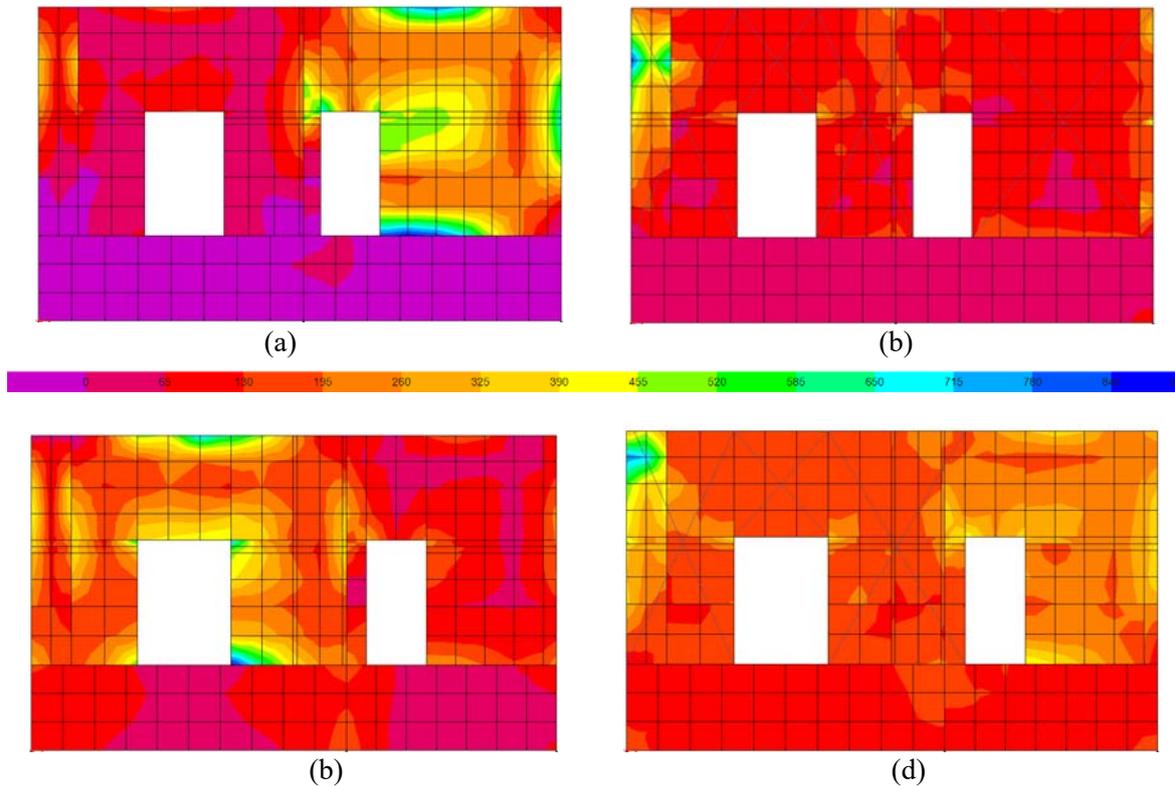
Moreover, occurred maximum shell stresses on the walls because of the ground motion are given in Figure 9. According to these results, vulnerable two different wall parts of the stone masonry structure are selected and retrofitted. After the retrofitting process, shell stress values in the wall are decreased considerably.

**Figure 9.** Maximum shell stress (a) (c) original structure (b) (d) retrofitted structure.
