**RESTORATION AND PRESENTATION OF  
BYZANTINE DEFENSE STRUCTURES IN CILICIA**

**A Thesis Submitted to  
the Graduate School of Engineering and Sciences of  
İzmir Institute of Technology  
in Partial Fulfillment of the Requirements for the Degree of**

**in Architectural Restoration**

The aim of this study is to evaluate current restorations and presentations of Byzantine defense structures in terms of sustaining and enhancement of the cultural heritage values and their success in solving conservation problems. So, better management of future interventions may be possible. Case study approach was undertaken: Three castle ruins in Cilicia, Turkey were focused on: Yılan and Feke castles and *Kızkalesi* in Korykos. The cases are located in the present-day rural areas. They are restored recently. The study consists of literature review, site survey, documentation and analysis of geographic characteristics, historic background, morphologic characteristics, construction technique and material usage and conservation activities of the case studies, identification of the cultural heritage values and conservation problems before and after interventions at the landscape, site and building s

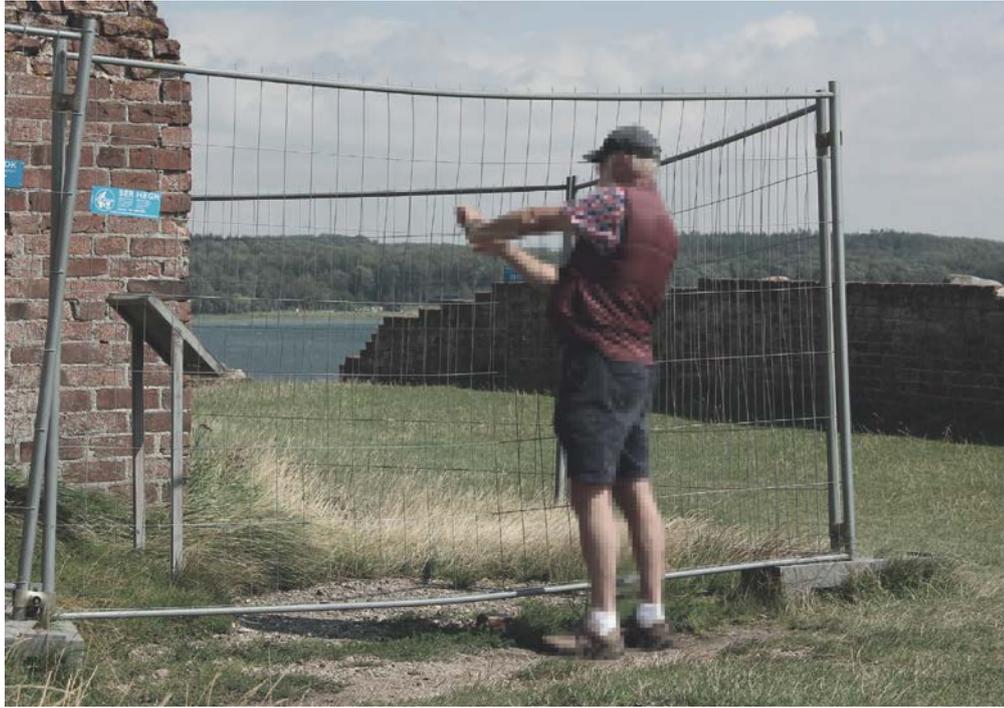
The tower ruin is presented fully with the help of the staircase. It provides visitors' access, and makes them perceive the archaeological layers and the beauty of the landscape. It is also a social platform that forces people to be communicate and interact. There is limited precaution for increasing security. The fenced area next to the tower provides a full secure zone against possible splits from the walls. But, it blocks access to a information board (Figure 2.6). Nevertheless, its design is unaesthetic.

Figure 2.6. An information board within the fenced area next to the tower  
(Source: Reese-Petersen, n.d.)

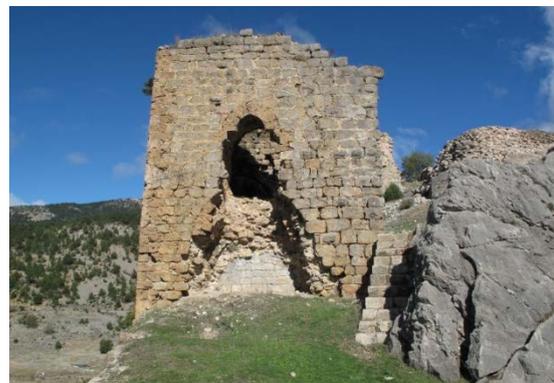
Figure 3.78. The inner gatehouse before the current interventions (Source: Buyruk, 2011, p. 520)

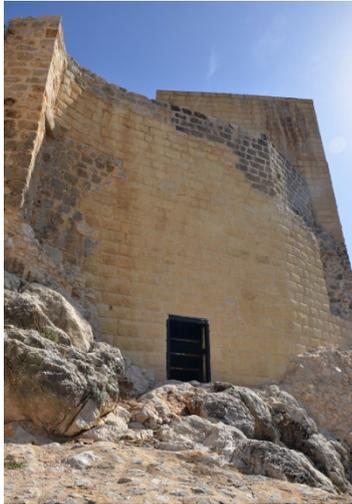
fortification wall; and the wall between the rooms J and K (Figure 3.79, 3.80 & Figure 3.84). Reintegration was carried out at the western facade of the tower D with the authentic large stone blocks together with small rubble stones (Figure 3.56).

Figure 3.79. West facade of the cistern C (2020, October 21<sup>st</sup>)

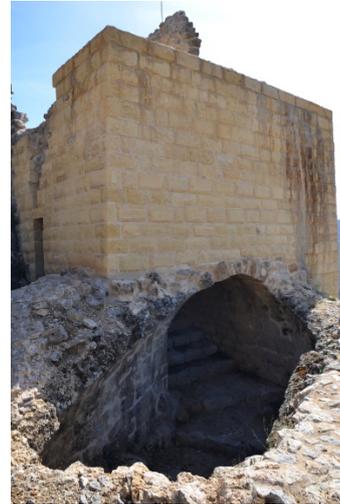
Figure 3.80. Upper level of the entrance passage (2020, October 21<sup>st</sup>)

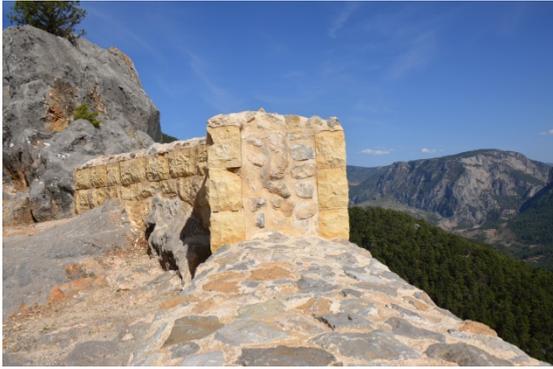
**Reconstruction** was carried out with the authentic construction technique, but with new stones in beige color that imitated authentic stones: at the eastern walls of the transition space (E), embrasures in the ground floor of the inner gatehouse, and vaults and the wall between the rooms J and K that was attached to the northwestern corner of the room K (Figure 3.81, 3.82, 3.83 & Figure 3.84).

Figure 3.81. Eastern wall of the transition space (E) (2020, October 21<sup>st</sup>)

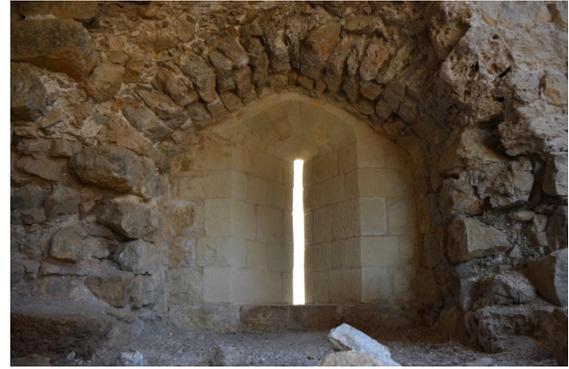
Figure 3.82. An embrasure of the inner gatehouse (2020, October 21<sup>st</sup>)

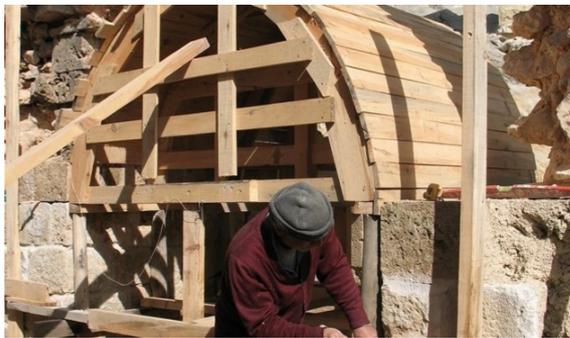
Figure 3.83. Reconstruction of a vault between the rooms J and K (Source: KMKD, n.d.)

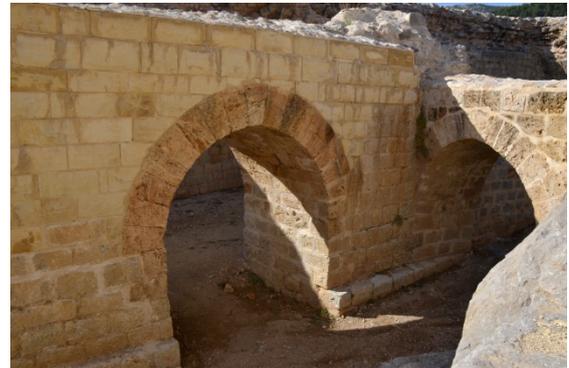
Figure 3.84. Vaulted openings on the walls between the rooms J and K (2020, October 21<sup>st</sup>)

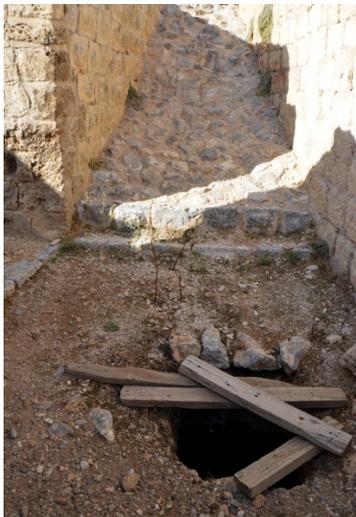
lime mortar was applied on the top of the walls and some of the vertical surfaces, e.g., at the entrance of the outer gatehouse, upper parts of the entrance passage and the wall remains between the rooms L and M. It was also applied on the partly unearthed stairs at the east of the room P to protect it until latter excavations (Figure 3.85) (Regional Council for Conservation, 2020).

**Cleaning** of vegetation in the castle courtyards and the plant colonization on the walls was carried out. However, graffiti, black crust and carbon deposit on the walls were not cleaned. Debris and earth were removed, and some elements were revealed: wall, vault, door opening, embrasure remains in the upper courtyard; stairs in the inner gatehouse that leads to the cistern H, the room N, between the rooms O and P, and in the eastern part of the room P; vaulted niches and toilets in the room P; and openings on the vaults of the rooms N, O and P (Figure 3.85 & Figure 3.87).

Figure 3.85. Unearthed stairs and an opening in room P (2020, October 21<sup>st</sup>)

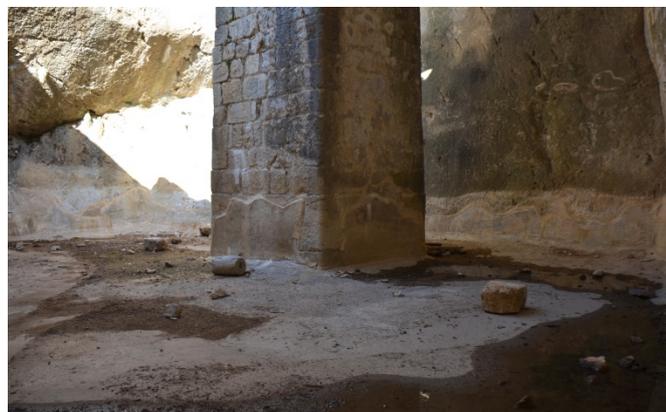
Figure 3.86. Consolidation of plasters in the cistern H (2020, October 21<sup>st</sup>)

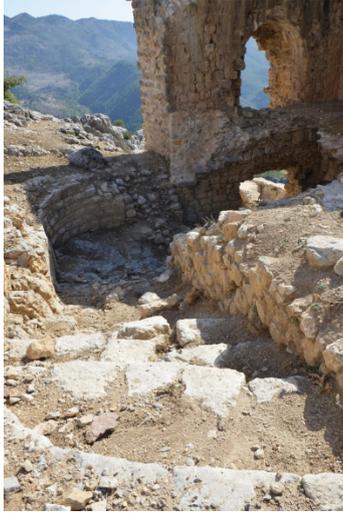
Figure 3.87. Unearthed stairs at the inner gatehouse (2020, October 21<sup>st</sup>)

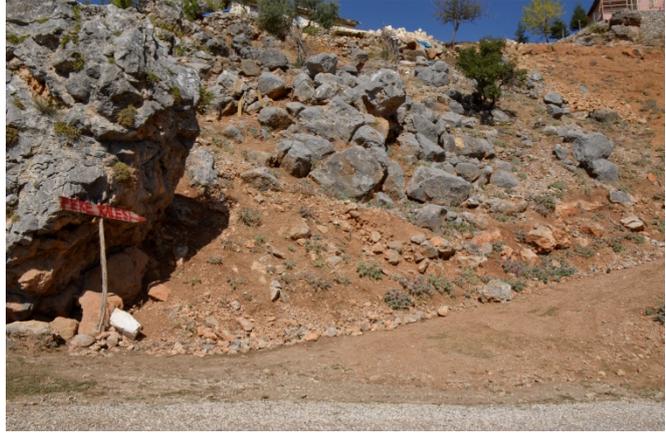
**Presentation:** The castle is functioned as an open-air museum, but there is no intervention to present the castle. The board pointing to the path leading to the castle is certainly provided by an amateur with good will (Figure 3.88).

Figure 3.88. The board that shows the path leads to the castle (2020, October 21<sup>st</sup>)

The castle site is functioned as an open-air museum. However, related managerial measures are insufficient. For example, regular maintenance is not carried out: the visitor path that leads to the entrance platform has been already filled with stone pieces falling from the hill. This becomes a risk for visitors' safety, in addition to the potential structural problems in the castle. Service facilities such as parking lot, security point, toilet and trash cans, and presentation facilities such as information boards and illumination elements are not provided (Figure 3.88).

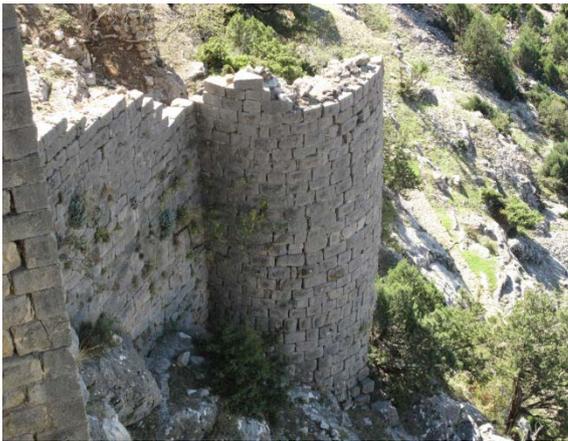
Figure 3.89. Tower T before the current restoration project  
(Source: Buyruk, 2011, p. 523)

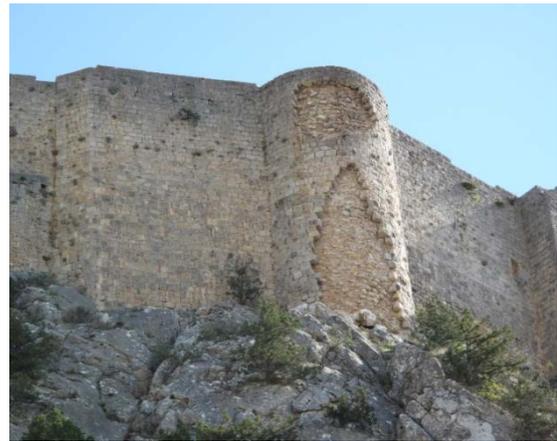
Feke Castle had accessibility and safety problems stemming from missing wall portions near the edges of the hill, unstable wall portions and covering with debris that gave way to slippery floors of the structures and courtyards (Figure 3.90). The castle had structural problems stemming from soil erosion and weathering: collapse or partial loss of some wall portions, out of plumbness and continuous vertical and diagonal cracks on the walls (Figure 3.89). There were also material deteriorations stemming from weathering, rising damp, rain penetration, the past implementations carried out with incompatible material such as cement, and vandalism<sup>26</sup>. The structures of the castle were covered partially or completely with debris, so the castle could not be completely conceived.

Figure 3.90. Tower S from the west, before the current restoration project  
(Source: Buyruk, 2011, p. 527)

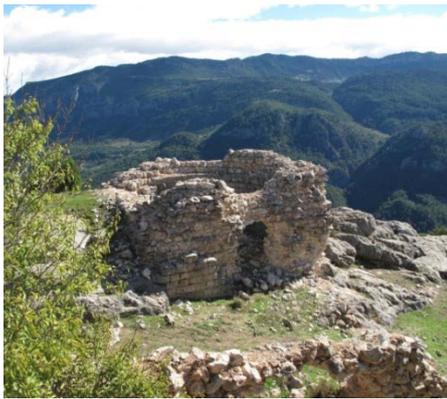
3.91 & Figure 3.92) (Buyruk, 2011, p. 259; Dunbar & Boal, 1964, p. 182; Regional Council for Conservation, 2020); and reconstruction using stone similar to the original at the some parts of the castle such as between the rooms J and K. Beside these interventions, most of the ruins that had lost their third dimension have been made legible by removing the earth and debris. The characteristics that possess the rarity value are sustained in the castle.

Figure 3.91. Room K before the current interventions  
(Source: Buyruk, 2011, p. 524)

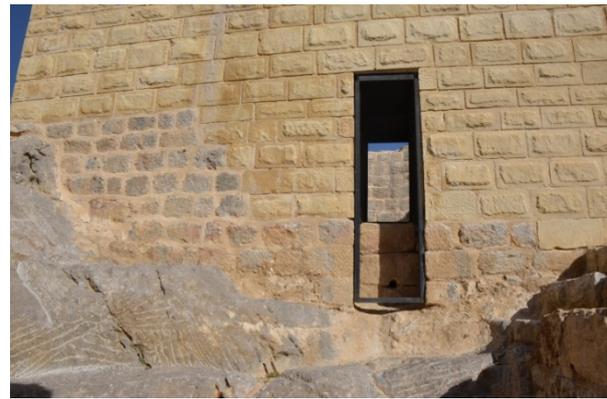
Figure 3.92. West facade of room K after the current interventions (2020, October 21<sup>st</sup>)

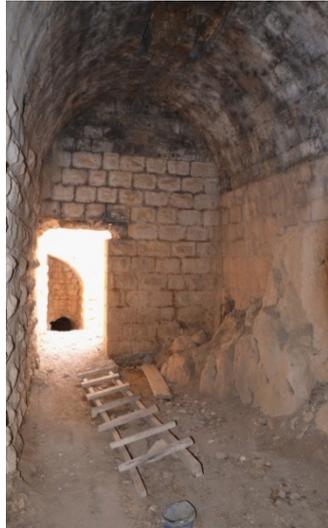
have partial loss of material, and cracks on the walls were consolidated with the injection material, and reintegrated with new materials. However, there is no intervention at some points where consolidation is required: e.g. the walls between the inner gatehouse and tower I. Hard capping was applied on the top of the walls, some of the vertical surfaces, and even on the partly revealed stairs in the room P. Instead of covering with hard capping, stairs could be preserved by reburying. Due to the partly or completely demolished ceilings, the buildings are exposed to weathering, rising damp and rain penetration. Some of the past interventions with cement were removed to prevent damage to the authentic stones, but this was not done systematically. Also, iron additions that were applied during the current restoration may damage the authentic stones (Figure 3.93). Vegetation in the courtyards and plant colonization were cleaned, but due to the lack of regular maintenance, plant colonization continues to give way to material deteriorations. There are no cleaning activities for encrustation, black crust and graffiti (Figure 3.95 & Figure 3.96). The wholeness of the architectural unit is presented with removal of debris, structural consolidation, reintegration and reconstruction of missing parts. But, revealed stone blocks are not presented, they are accumulated in some places of the courtyards and rooms, becoming obstacles for circulation (Figure 3.97). Still presence of the equipment in the castle that were used during the restoration give way to an aesthetic problem for the presentation of the castle (Figure 3.95 & Figure 3.98).

Figure 3.95. Interior view of room O (2020, October 21<sup>st</sup>)

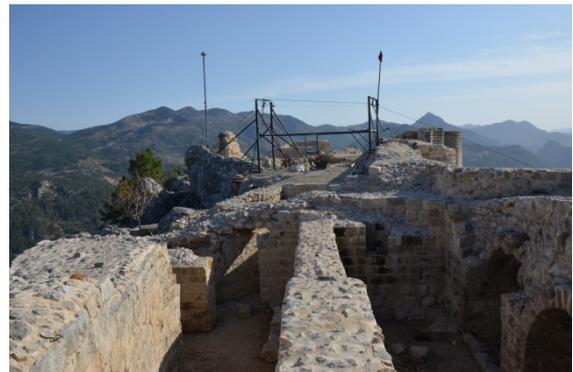
Figure 3.98. View from room P towards the south (2020, October 21<sup>st</sup>)

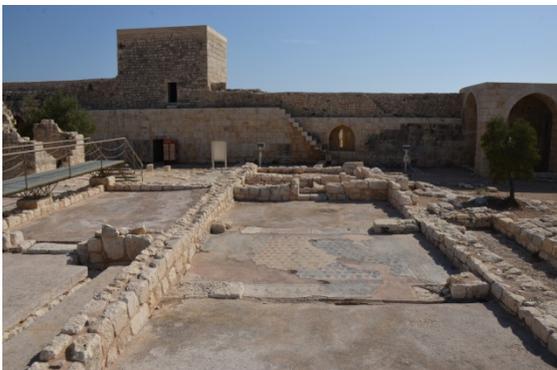
Figure 3.126. Southern walls between the tower D and portico from the building complex (2020, October 23<sup>rd</sup>)

**Reintegration** is observed in most of the structures and walls, especially in the southern and western part of the castle (Figure 3.126). It was generally carried out to complete cut stone facings with imitation stones that are cladding stones. Different construction technique and coursing were practiced in the walls (Figure 3.140). It is observed at the piers and arches of the portico, embrasures, windows, stone stairs attached to the southern wall, vault of the tower I, upper wall parts of the towers except the tower G and H, etc. Reintegration was also carried out to complete wall parts constructed with rubble stone and roughly rectangular stones: at the vaults of the portico

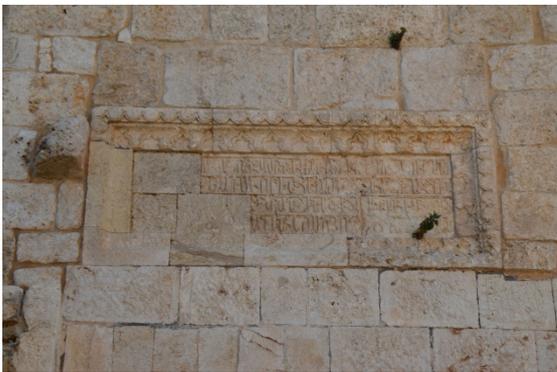
Figure 3.130. The inscription from 1206 on the northwest facade of the tower F (2020, October 23<sup>rd</sup>)

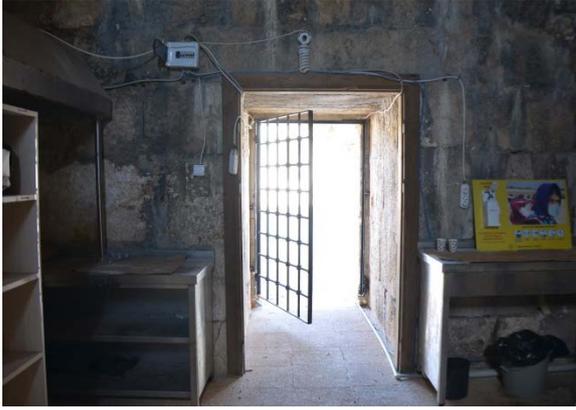
**Addition:** Mass, element and material additions are observed in the castle. Mass additions are the new building flanking the room E and used as toilet, and a transformer substation juxtaposing the tower J (Figure 3.134 & Figure 3.135). Element additions are iron grilles with iron profiles in the door and window openings of the castle; a modern timber door frame in the opening of the tower D (Figure 3.136); timber ceilings in the towers A, D, F and K (Figure 3.137); timber joists at the springing level of the vault in the tower F; an iron cover above the gap between the ground and first floor of the tower F to provide visitors safety; steel frame staircases with handrails at each facade of the portico where the remains of stairs are located, and at the entrance of the tower J with the stone landing (Figure 3.138); a lightning conductor on the top of the tower K; and a flag on the top of the tower I. Material additions are the steel mesh above the gap on the cistern B to provide visitors safety, and stone floor coverings on the ground floor of the tower D, I and on the second floor of the tower F<sup>42</sup> (Figure 3.139).

Figure 3.136. Inside of the ground floor of tower D (2020, October 23<sup>rd</sup>)

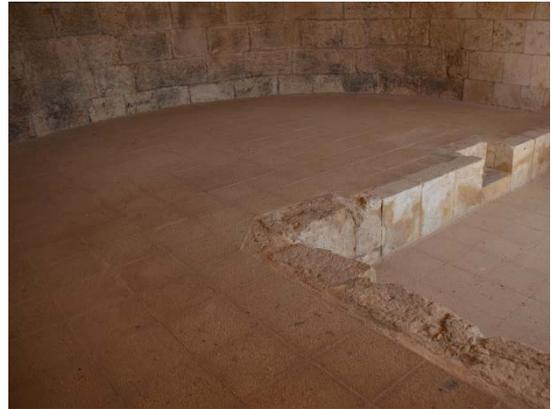
<sup>42</sup> The authenticity of the stone floor covering of the tower F is in doubt. Such floor covering is not observed in any other spaces in the castle. In addition, extensive reintegration was carried out in this floor of the tower F. However, it is neither as old as the tower nor as new as the current interventions. It was probably implemented before the current restoration.

Figure 3.139. Floor covering of tower I (2020, October 23<sup>rd</sup>)

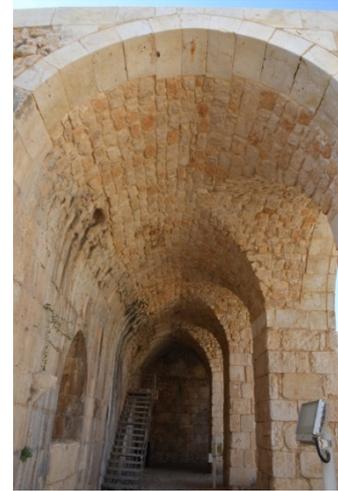
and the tower J (Figure 3.141). The mosaics were partially completed with the stones in the courtyard whose original positions were figured out (Küçük, 2012, pp. 25, 27).

Figure 3.141. Vault of the portico after the restoration (2020, October 23<sup>rd</sup>)

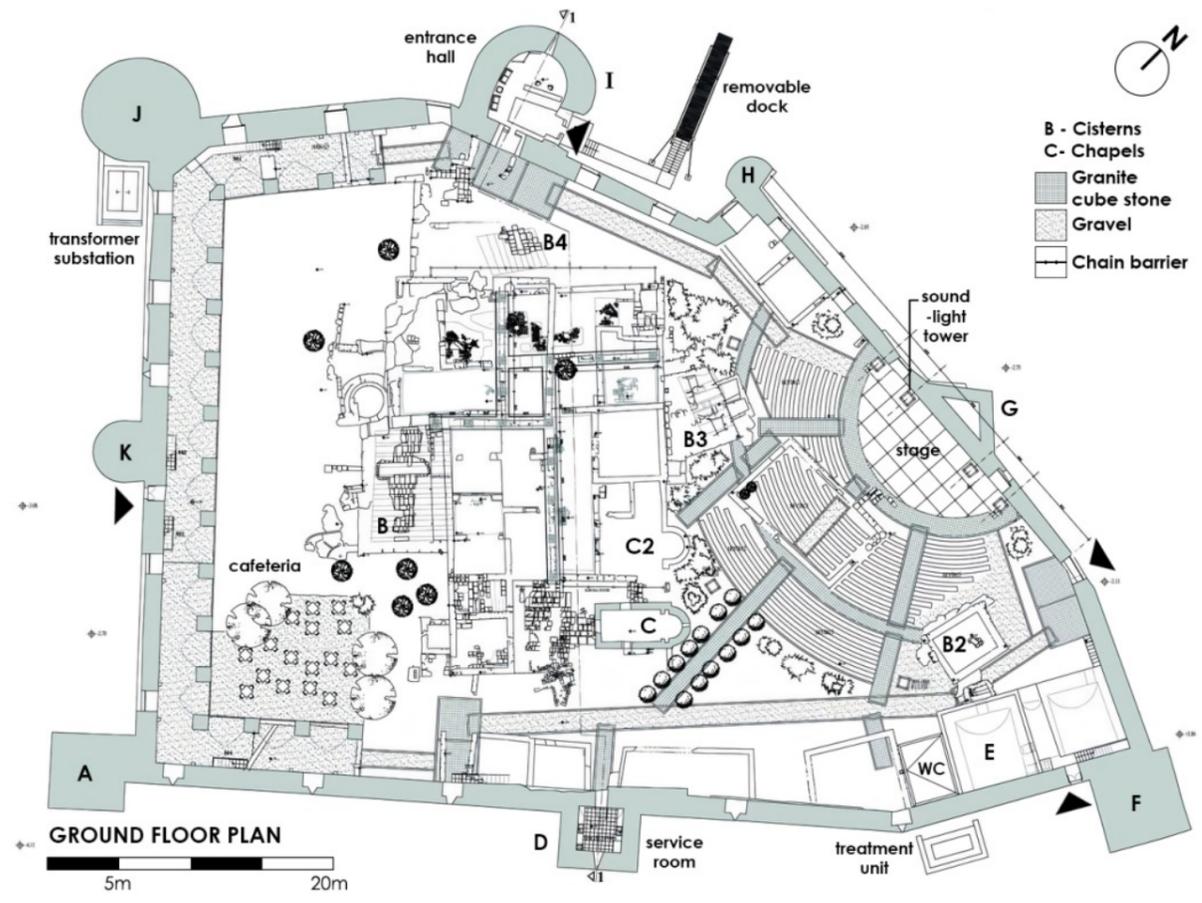
In the current restoration project, the sea castle is proposed to be used as a multi-space in which concerts, wedding ceremonies and special invitations are held. Within the scope of the restoration project, a stage with a capacity of 300-350 people at the east, a removable dock connected to the tower I, and a cafeteria at the southwestern corner of the portico were designed (Figure 3.147, 3.148 & Figure 3.149). While the ground floor of the tower I was re-functionalized as an entrance hall, the tower D was re-functionalized as a service room. In the courtyard, visitor paths whose floor coverings were constructed with granite cubes and gravel were designed. In addition, Kızkalesi is one of the sites presented and promoted by virtual tour project of Mersin Municipality named as VR Mersin (Mersin Municipality, n.d.).

Figure 3.147. Ground floor plan of the castle, restoration drawing (Source: Miyar Mimarlık Mühendislik, 2020)

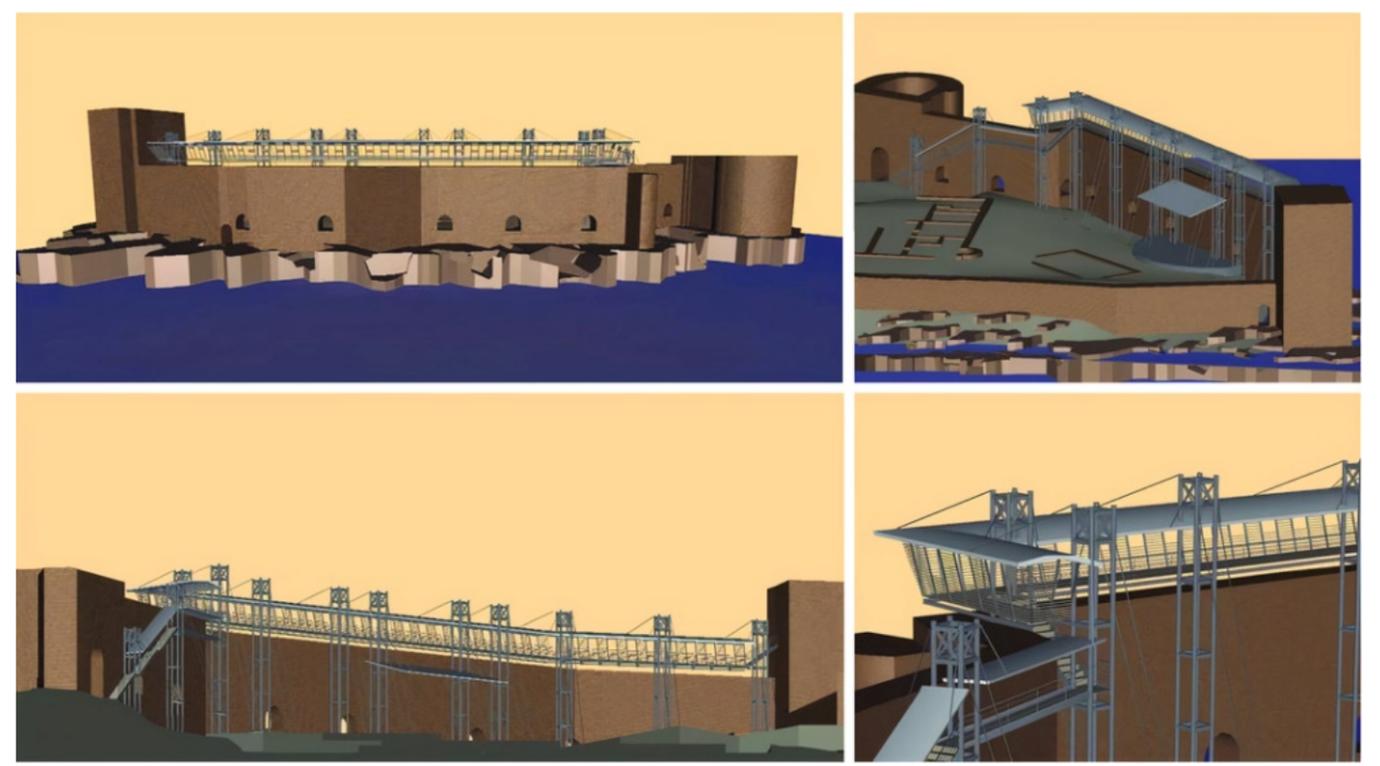
Figure 3.148. Images of the stage in the restoration project (Source: Miyar Mimarlık Mühendislik, 2020)
