**INVESTIGATION OF THE PRESERVATION
PROBLEMS OF THE MESCİD AND TÜRBE OF
AKŞEBE SULTAN IN ALANYA**

**MASTER OF SCIENCE
in Architectural Restoration**

**by
Fatma Selin ŞAHİN**

**June 2010
İZMİR**

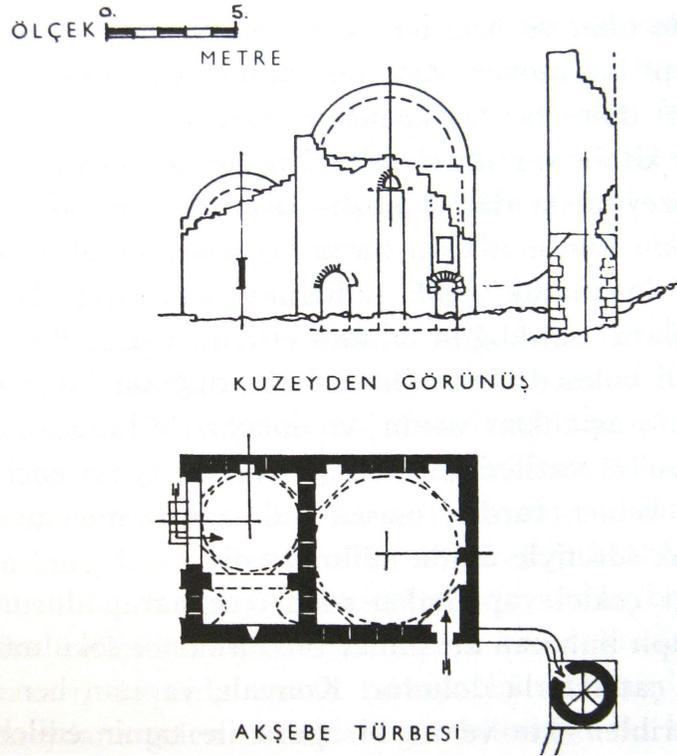
Following the visit of Konyalı, Seton Lloyd and David Storm Rice who examined the masjid in 1950's gave the plan and a simple drawing of the north façade. In this façade drawing, remarkable collapses on the upper parts of the additional front part and the upper levels of the northwestern corner of the masjid space are noticeable. A relatively narrow but extremely high door (closed at present) which is ends with a window with a pointed arched-opening above the lintel is seen on the axis of the masjid part on the same drawing (Figure 2.2). Although they based their views about the

functional features of the spaces on the definitions suggested by Konyalı, they noted that the building was in extremely bad condition. Without giving their exact positions, but they also noted the existence of a few serious cracks in the building (Lloyd and Rice 1989).

Figure 2.2. Schematic drawings of the north façade, the minaret and the plan of Akşebe Sultan around 1950's (Source: Lloyd and Rice 1989)

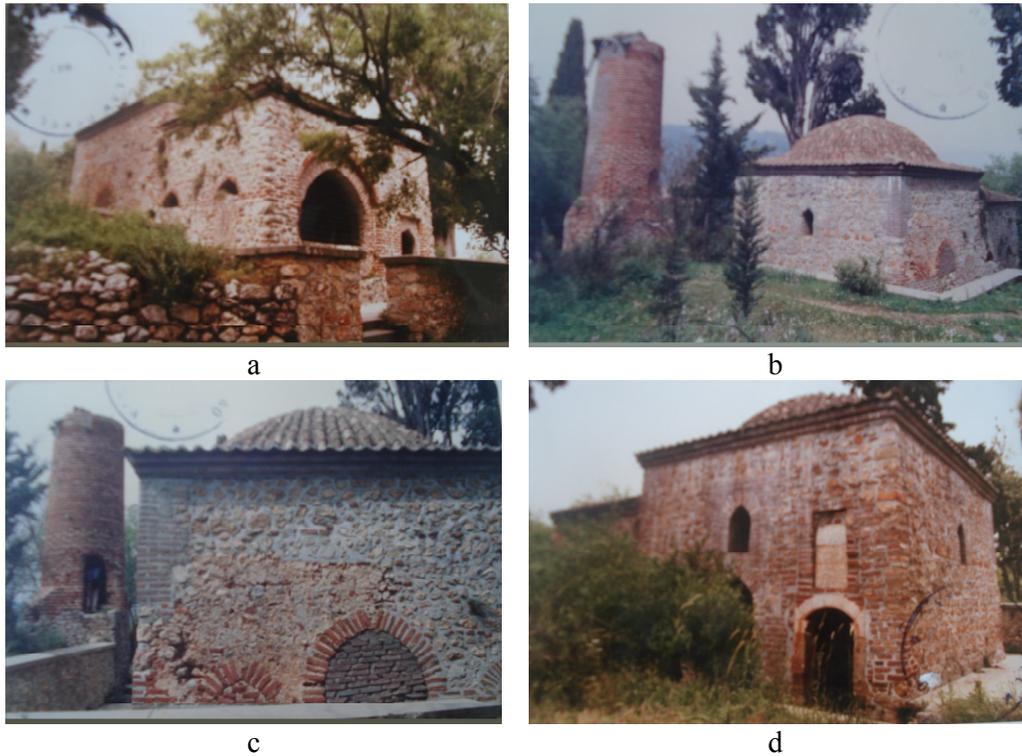
Figure 2.3. Exterior views from; a) the southeast, b) the southwest, c) south, and d) north
(Source: Archives of the Antalya Regional Board for the Conservation of Cultural and Natural Assets)

For the repair of the monument, General Directorate of Pious Endowments demanded permission from the Ministry of Culture and Tourism in 1997. In this application, the directorate proposes some interventions within the scope of ‘simple restoration,’ such as; the repair of the minaret, the removal of the cement mortars from the joints (although it is not known when they were applied) and replacement with lime mortar, renewal of the deteriorated stones in the masonry, the assembling of the windows and doors, the repair of the plasters and joint mortars, repair of the existing floor according to the original level and material, removal of plants on the roof and rehabilitation of the pavements around the monument. Showing the exterior and interior of the monument six photographs have also been attached to the application letter (Figures 2.3, 4).

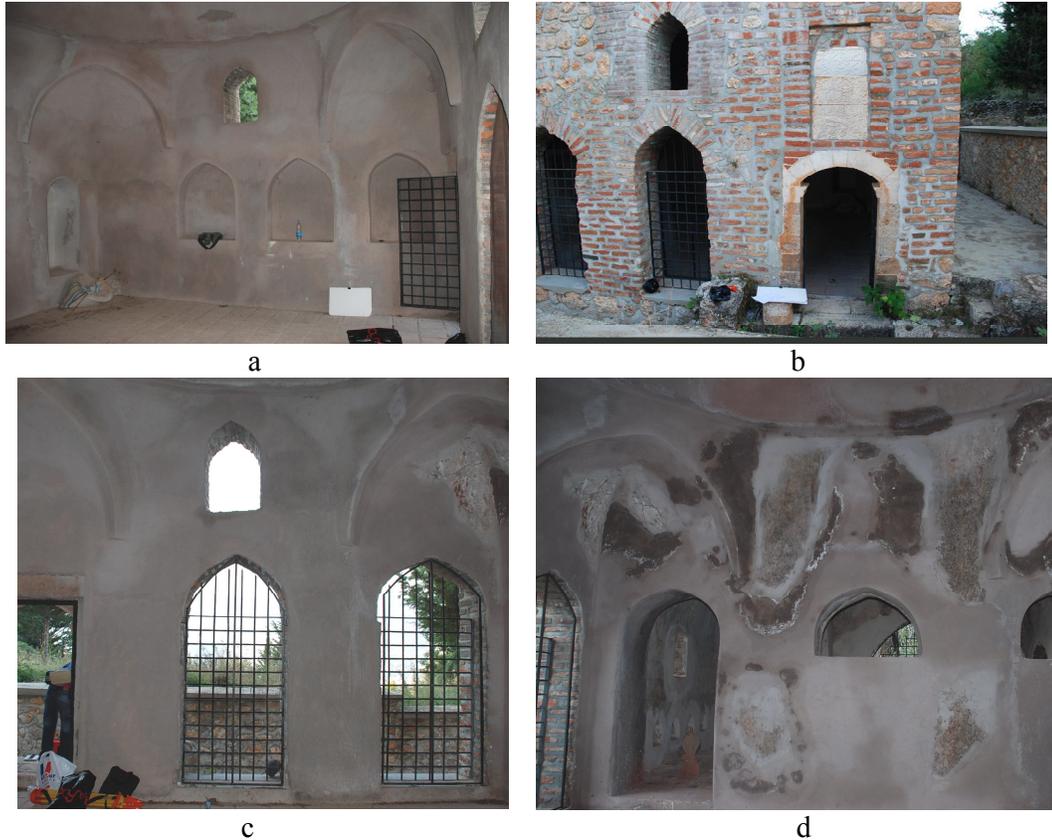
Z01 has a square shaped plan scheme. It is 5.56m at the north, 5.97 at the east, 5.42m at the south, and 5.93 at the west. Totally Z01 is 32.6m². The surfaces of the walls were plastered with gray colored plaster in 2005 (Figure 3.11 a).

The entrance of the Z01 took place in the west corner of the north wall by means of an opening with segmental arch (Figure 3.11b). The level of the threshold is 76cm higher than garden ground level. There are three reused stone steps leading to the prayer. There are two more openings to the east of the door and closed with iron grids and wire mesh fly screen (Figure 3.11.c, Figure B.1.7.).

this wall there is a door opening to provide transition between Z01 and Z02. Other two openings have similar form, and dimension and both of them filled with mortar till spring line (Figure 3.11.d, Figure B.1.8.).

Figure 3.11. a) Interior of the Z01 b) Entrance door c) North wall of Z01 d) East wall of Z01

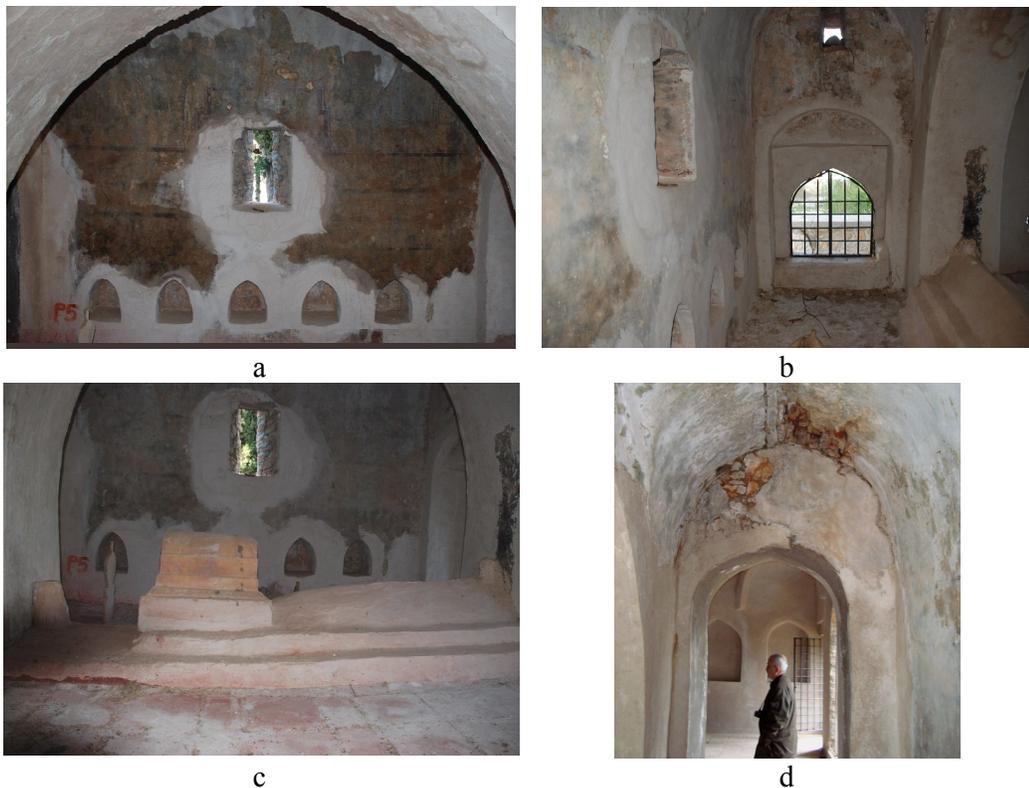
There are five niches on the north wall. They state 30cm higher than the ground level of Z02. The height of niches is 38cm, width is 32cm and depth is 30cm. there is a louver window above the niches (Figure 3.15.a, Figure B.1.11.). There is another opening spanned by a pointed arch on the east wall and closed with iron grids. There is one more louvered window upon this opening (Figure 3.15.b). The southern side of this space is spanned with a pointed arch. Below this arch there are two sarcophaguses. One of them is smaller than the other (Figure 3.15.c). There is an opening spanned by pointed arch on the west wall to provide connection between Z01 (Figure 3.15.d).

The west side of the ground is covered with imitation bricks recently applied. The east side of the ground is filled with soil. The middle of the covering is filled with soil and at the west side of this filling there is a wooden grave sign (Figure 3.15.e).

The vault of this space rests on the walls. There is some deterioration on the vault like loss of plaster and dampness. Original plaster is substantially reached today but there are some plaster additions look extremely white and fresh. All original ornamentations exist on the original plasters. There are red lines approximately 30cm above the intrados of the arched openings. Red lines proceed the spring lines of the vault on the east and west walls.

Figure 3.15. a) The northern wall of the space Z02, b) The eastern wall of the space Z02, c) The sarcophagus below the northern arch between the spaces Z02 and Z03, d) Access to the Z01 from Z02, e) Wood element representative of gravestone, f) Figures of ships drawn with fusains

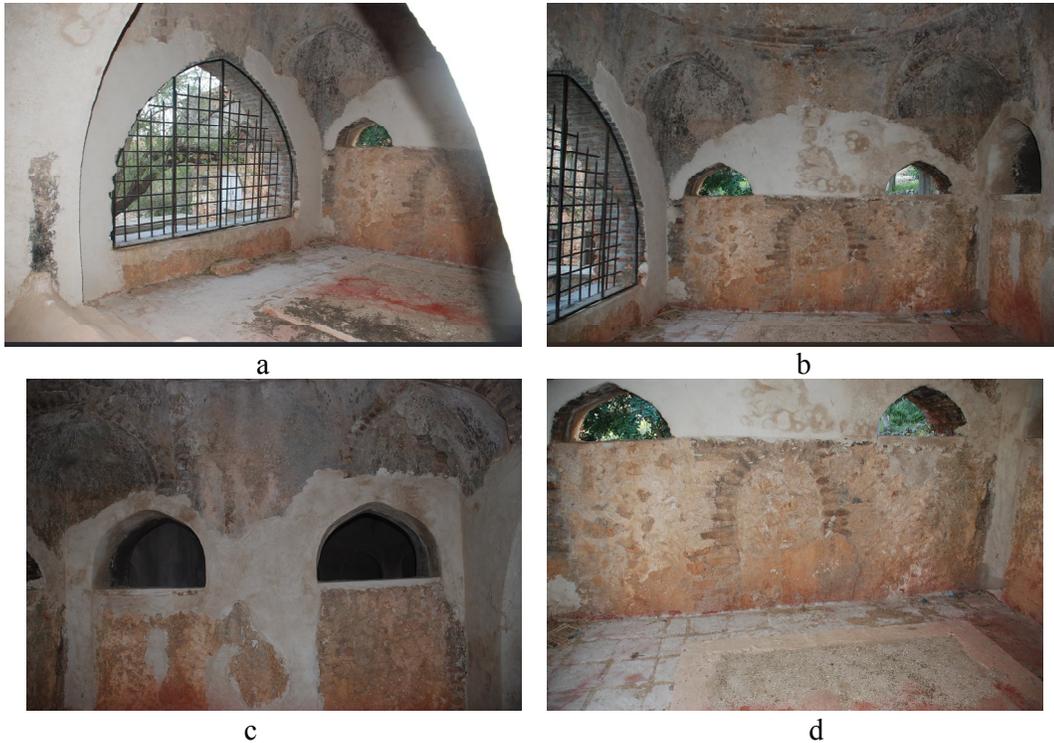
There is another large opening spanned by pointed arch on the east wall. The bottom of the opening is 35cm higher than the ground level. The width of this opening is 2.65m and the height is 2m. It was closed with iron grilles in 2005 (Figure B.1.10.). At the exterior there are four stone steps and inside there is one stone block in front of the opening (Figure 3.17.a).

There are two openings on the south wall. These openings are filled from ground to the spring lines of their pointed arches. A semicircular arch which is relatively shallower than the other two on both sides is located in the axis of the same wall (Figure 3.17.b, Figure B1.6.).

The western wall of this space contains two pointed arched openings that are infilled till their springing lines. The same ship figures on the north wall of Z02 are also found on these infilled parts (Figure 3.17.c).

Figure 3.17. a) The arched opening in the east and square platform in space Z03 b) The view of the southern wall c) The view of the western wall and d) A detailed view of the southern wall

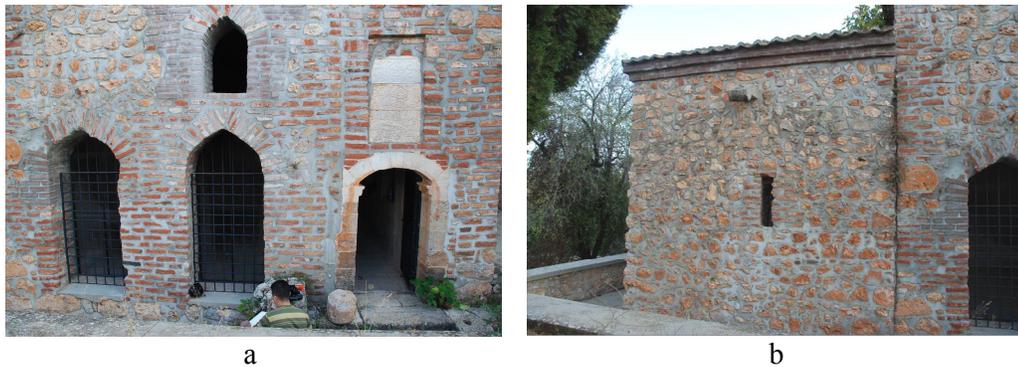
Figure 3.19. a) North façade compositions of the main mass and b) Additional mass in the east

The material of the arch of the door opening is travertine. Upon the door, there is a rectangular recess made enclosed with a brick frame in which the marble inscription panel, composed of three pieces took place (Figure 3.19.a).

A very narrow window (called as *mazgal*) exists at the western part which is separated from the main mass by a dilatation. A waterspout, made of stone, is located above this narrow window beneath the eaves (Figure 3.19.b).

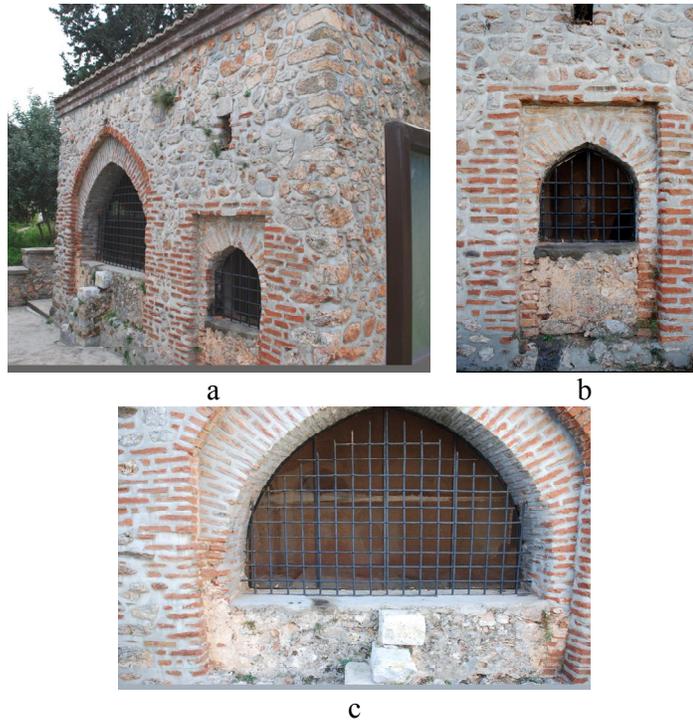
Figure 3.20. a) A general view of the eastern façade b) the infilled opening in the rectangular frame c) the arch of the space Z03

East façade has three openings. At the north side there is an opening set into a rectangular frame made of brick and a *mazgal* window above (Figure 3.20.a, b, Figure B.1.13.).

At the south side of the east façade, there is an opening spanned with a pointed arch which is placed in a recess with the same form both made of brick. There are five stone stairs in front of the opening. As well as the space Z02, the space Z03 is also protected with an iron grillage mounted in the opening. The lower parts of these two openings are filled with mortar. (Figure 3.20.b, c, Figure B.1.14.).

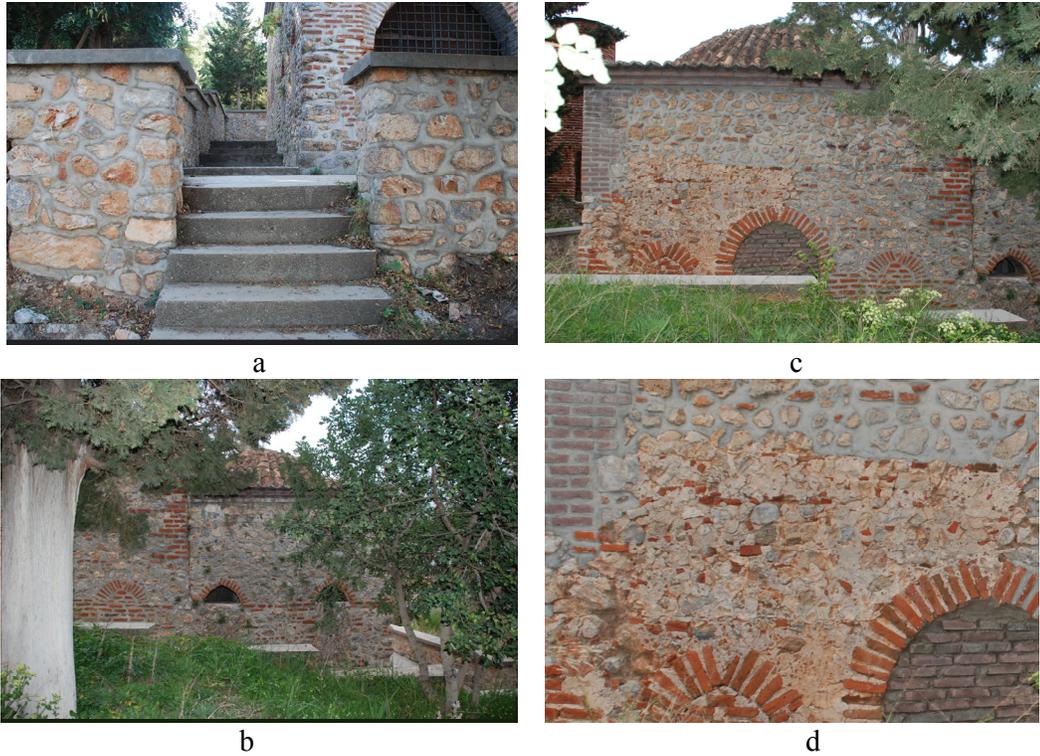
Figure 3.21. a) Concrete stairs leading to the garden b) far and c) close views from the southern façade, d) detail from the cement mortar application on the northwestern corner of the west façade

At the south side of the garden is leveled with lean concrete. The ground level rises from east to west with five concrete stairs (Figure 3.21.a).

There are three arches in the western part of the south façade. The one in the center is semicircular and filled new bricks and rubble stone. The other two on the either side of this arch two pointed arches are placed. These pointed arches correspond to the niches on the south wall of the space Z01 (Figure 3.21. b, c).

At the upper level of the west side of the façade there is a mortar layer and this mortar seems similar with the filling mortar under the pointed arched openings (Figure 3.19d). There are two openings formed with brick located at the eastern part of the south façade. They are infilled till their spring lines (Figure 3.21.b).

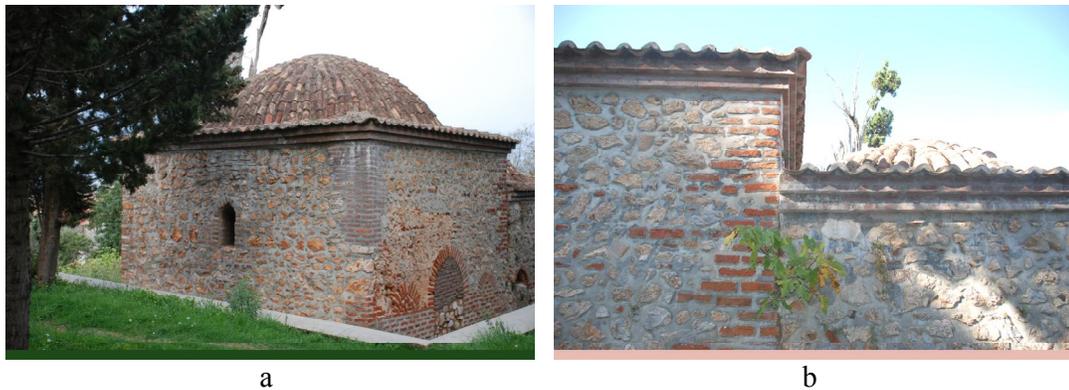
Figure 3.22. a) View from the southwest corner b) Level difference and the dilatation line at the south façade

At the west façade there is only a small opening at the centre of the wall. This opening is spanned by pointed arch and formed of brick (Figure 3.22.a, Figure B.1.15.). At the northwest, southwest and southeast corners of the building are formed with brick and stone but the northeast corner is formed with only stone. The level of the eaves of the main mass is 1.18m higher than the eaves of the mass in the east (Figure 3.22.b).

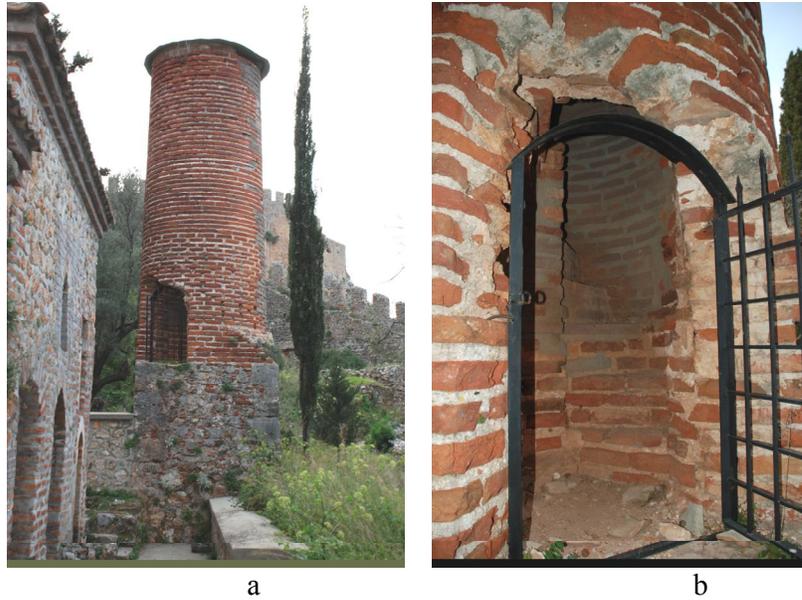
Figure 3.24. a) The view of the minaret from the east b) The entrance of the minaret

The entrance is at the southeast corner of the shaft. The considerable portion of the entrance arch is collapsed. This opening is closed with iron door in 2005 (Figure 3.24.b, Figure B.1.17.).

Although the reason is unknown, including the balcony (*şerefe*) and the spire the upper parts of the minaret is missing. In addition to the losses of the upper parts, a considerable part of the minaret entrance is collapsed. Only a small portion of the arch is visible at present (Figure 3.24.b, Figure B.3.11, 12.).

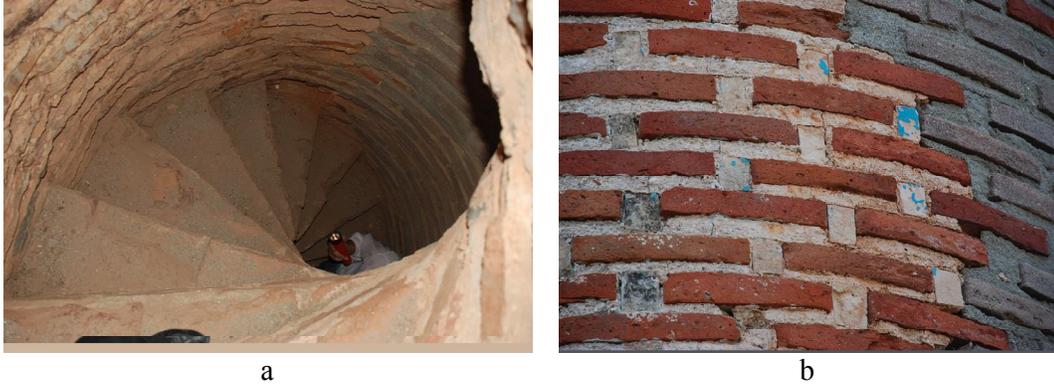
Figure 3.25. a) The spiral stairs without core, b) Difference between original and intervened portions

The minaret does not have a core. This is the only example in 12th and 13th century (Bakirer 1971). Brick stairs are supported by the shaft wall. The width of the stairs changes between 60cm to 75cm at the outer edge (Figure 3.25. a).

The construction material of base is rubble stone and cut stone. Pedestal and shaft are constructed with brick (30 x 30 x 6cm). The shaft above the pedestal rises as brick bond with single stretchers with glazed joint plugs in turquoise blue. After 2.5m above the brick bonds change to the half brick staggering with narrow rising and bed joints. The dimensions of plugs varied between 10 x 5, 10 x 7 and 10 x 10cm still exist in the brick bonds (Figure 3.25. b).

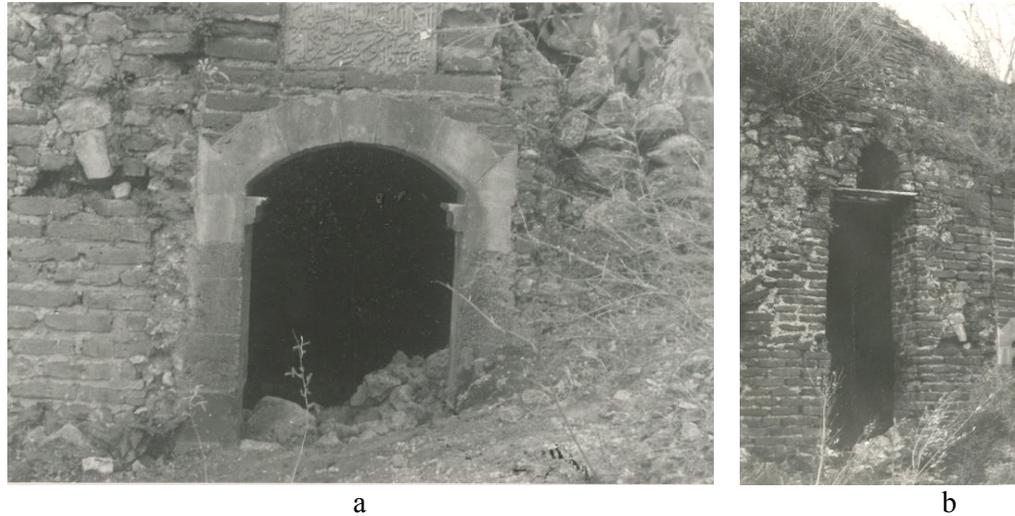
Figure 4.1. Views from; a) the masjid entrance, b) the opening on the axis of the northern wall of the masjid (Source: Archives of the General Directorate of Pious Endowments).

As seen in the photographs the site looks that it was abandoned for a long time and filled with earth. The earth covered the entrance of the masjid part to half of its total height (Figure A.2.3.a, Figure 4.1.a). Due to the inclination of the slope from west to the east, the level of the earth seen at the northern façade slumped down to the level of the ground at the east end (Figure A.2.3.b, Figure 4.1.b).

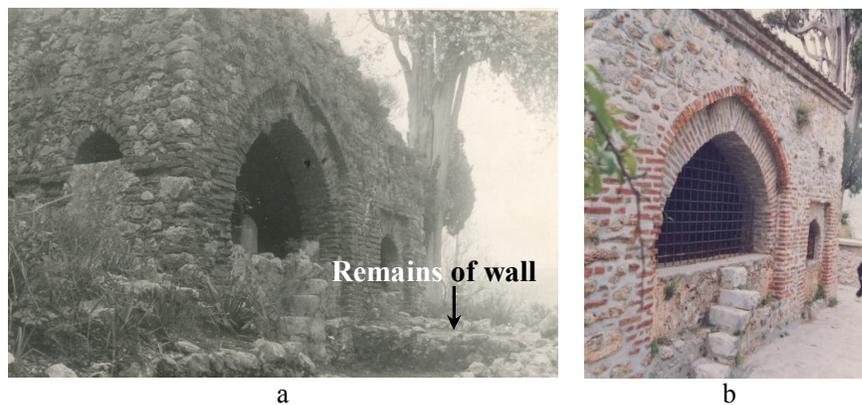
Figure 4.2. Views from the east façade of the masjid a) before and b) after interventions (Source: Archives of the General Directorate of Pious Endowments)

In the old photographs, the old ground level of the eastern part of the garden looks same as the level at present, but the original floor cover cannot be determined since it was missing (Figure A.2.4.a, b, Figure 4.2.a, b). However, in figure 4.2.a, a wall-like mass leaning to the east façade may be indicative of a former platform corresponding approximately to -0.16, the level of infilled-arched opening of the space Z03 (Figure 4.2.a, Drawing of East Façade). In this case, the stone steps exist today and look as if they were put randomly in front of the opening are not original.

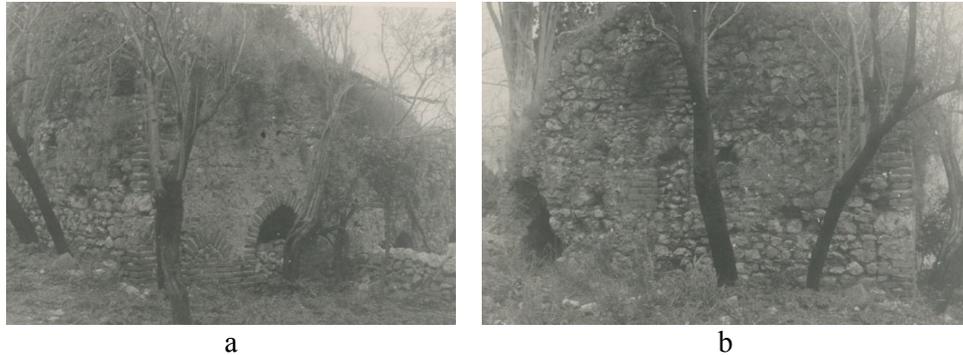
Figure 4.3. a) Views from the southwestern corner b) earth fill at the north façade
(Source: Archives of the General Directorate of Pious Endowments)

The western part of the south façade is also filled with earth to the level approximately 75cm below the arch with semi-circled profile (Figure A.2.5 a, Figure 4.3.a), the inclination of the earth continued to the east from here. The level of the filled earth at the west is approximately 1.5m above the ground (Figure A.2.5.b, Figure 4.3.b).

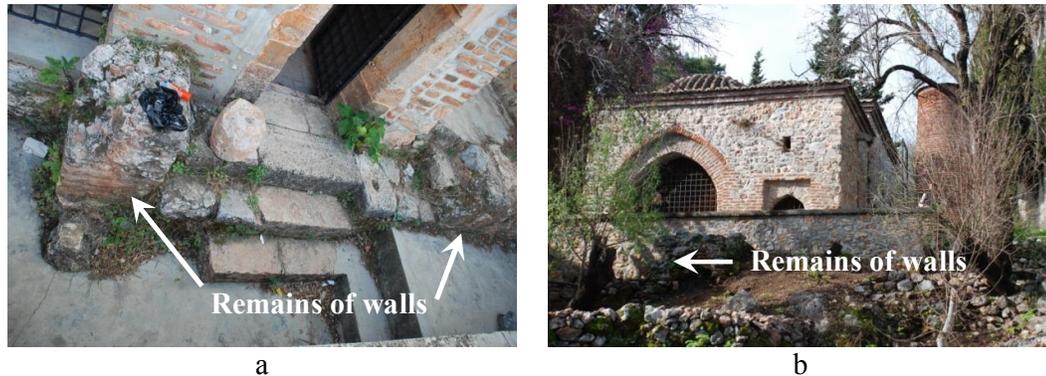
Figure 4.4. a) Views from the remaining walls (at the east and western edges of the *masjid* stairs and b) their extension above ground in the east

steps on the remaining walls starting from the eastern edge of the stairs leading to the masjid space, and ends at the alignment of the eastern face of the minaret base. As well as those at the western edge, similar wall remains also found at the eastern edge of the masjid stairs (Figures 4.4.a). The extension of this wall emerged above the ground after the newly constructed retaining wall at present (Figures 4.4.b).

These remaining walls are the evidences of a former building likely from Byzantine Period once existed on the site and demolished before the construction of *Akşebe Sultan*.

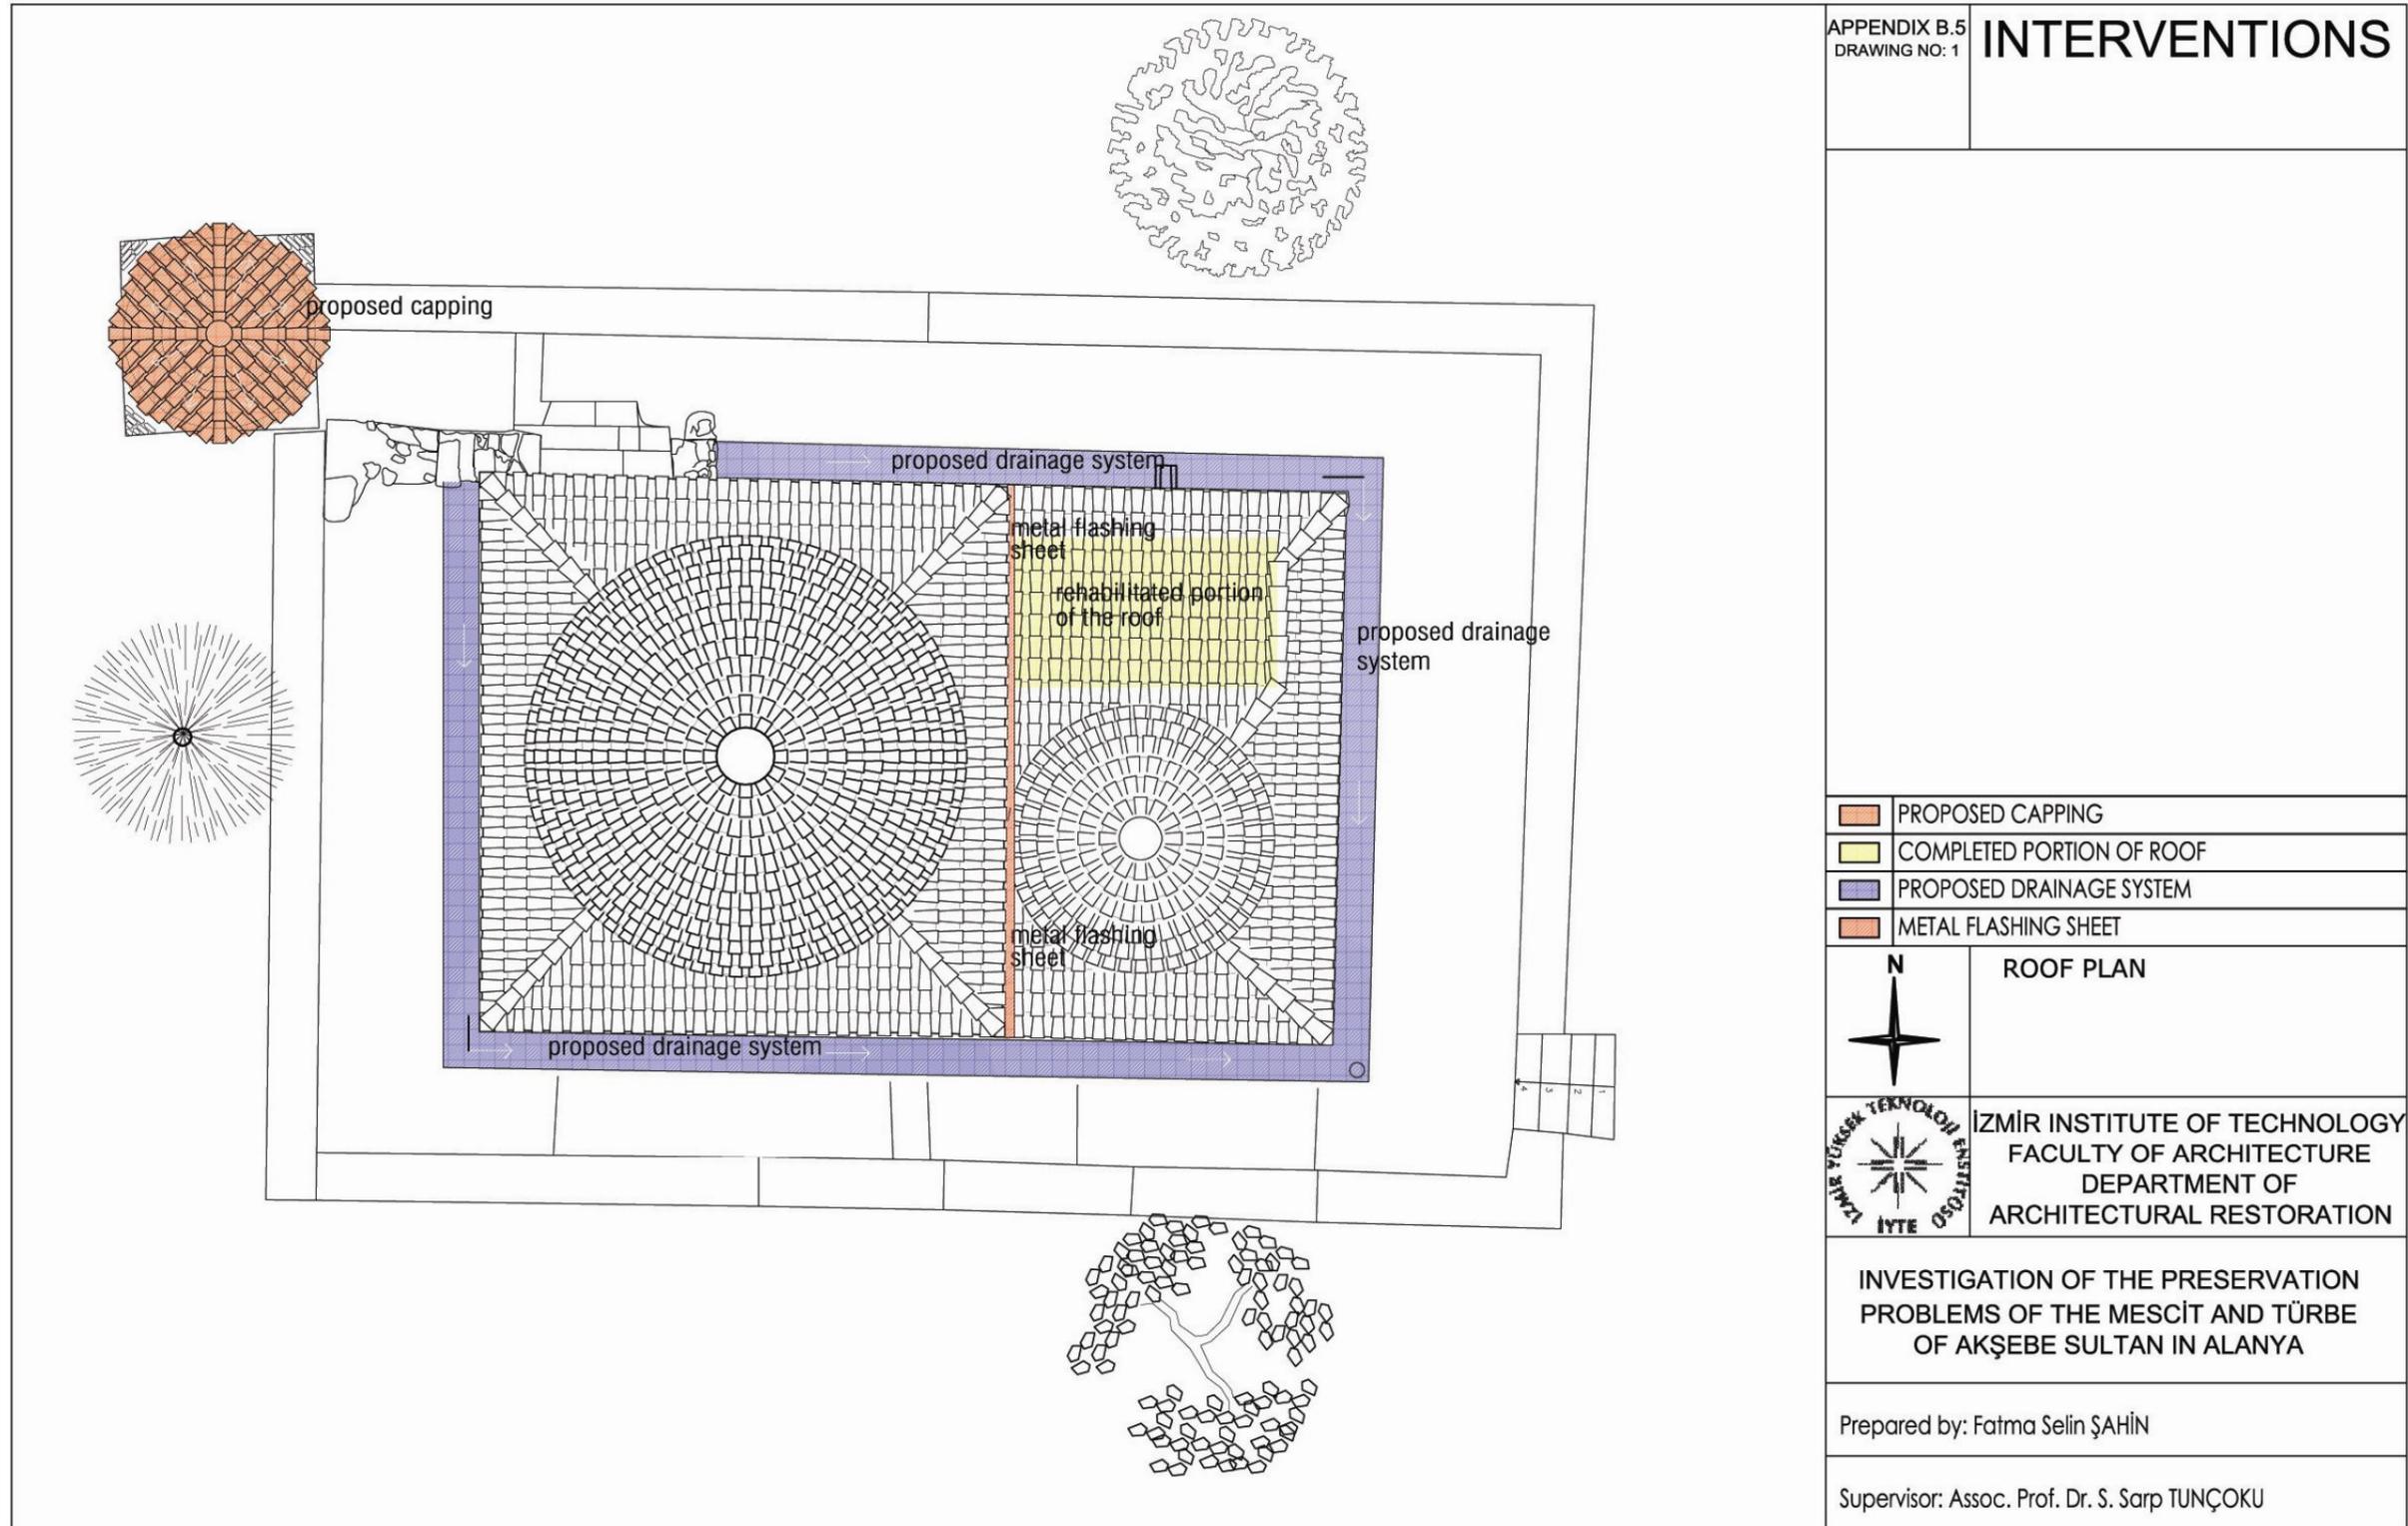
Figure B.5.1. Roof Plan

3. The most urgent problem is the rainwater penetration through the dilatation line where the two masses of the building leaned on each other. Such a continuous water penetration will cause the loosening of mortar in the masonry joints and weakening the adhesion of the plaster together with the layer of ornamentations behind. When the limited conditions of ventilation, especially in the space Z01 is considered, this water penetration will also cause permanent dampness problem in the building. Therefore, an important intervention to be carried out is the prevention of this penetration from the roof by the rehabilitation of the roof cover composed of Turkish tiles. In addition, a metal sheet to be fixed at the edge of the additional part where it leaned to the east wall of the prayer hall will be helpful to prevent water penetration from this edge (Figure B.5.1.). The prevention of water penetration, and hence, the prevention of permanent dampness will be helpful for preventing the further movements and successive cycles of crystallizations of soluble salts introduced in great amounts by the application of cement based materials.

4. Although not observed during the field survey period, another potential danger is the rising dampness which can be due to the possible rise in ground water table in rainy seasons. At first, rising dampness should be checked and followed by nondestructive test techniques such as infrared thermography. If such a problem exists, a drainage system surrounding the building at the

approximate level of foundation footings should be applied. The application of such a system is also useful to collect splash water from the eaves of the building (Figure B.5.1.).
