**EVALUATION OF ALTERATIONS IN OTTOMAN
HANS IN TIRE FOR THEIR RESTITUTION**

**A Thesis Submitted to
the Graduate School of Engineering and Sciences of
İzmir Institute of Technology
in Partial Fulfillment of the Requirements for the Degree**

in Architectural Restoration

**by
Sevinç ÇULCU**

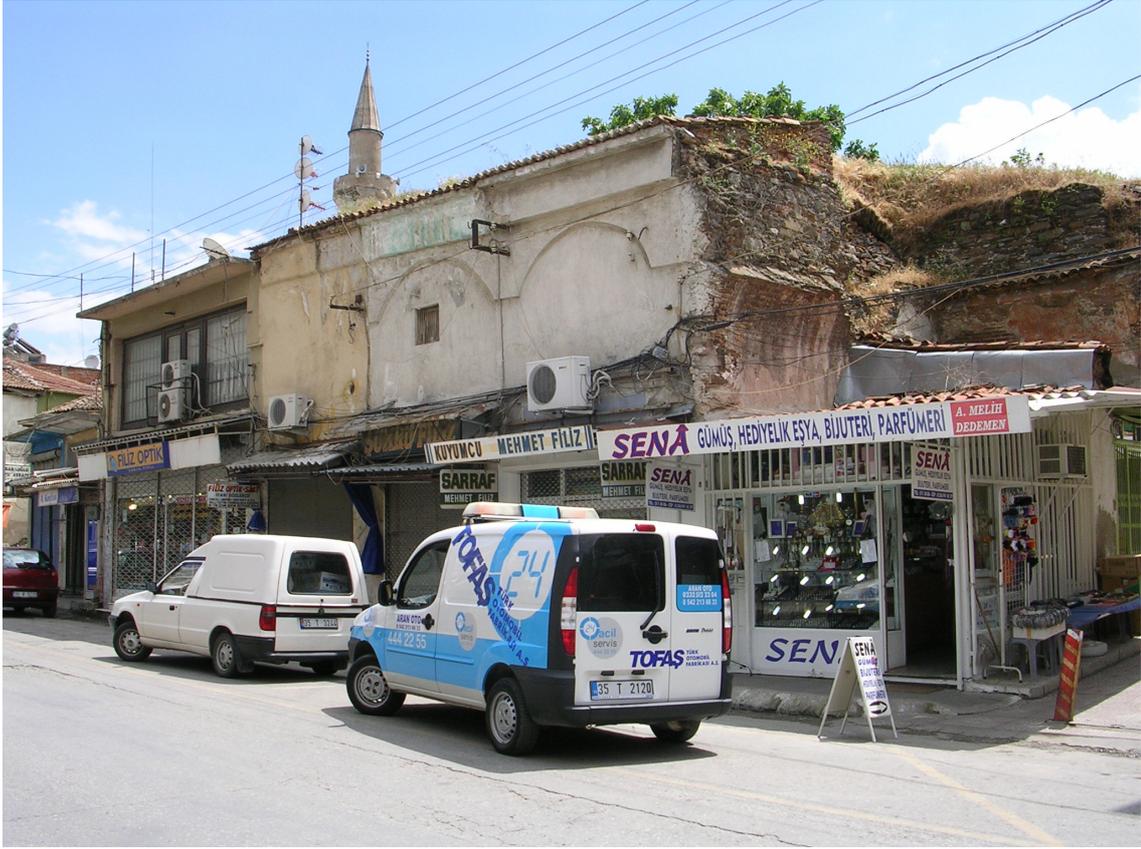
Figure 4.3. The North Façade of Çöplüce Han.

later. And next to this structure is a section which is thought to have been a shop when the han was first built (Figure 4.3).

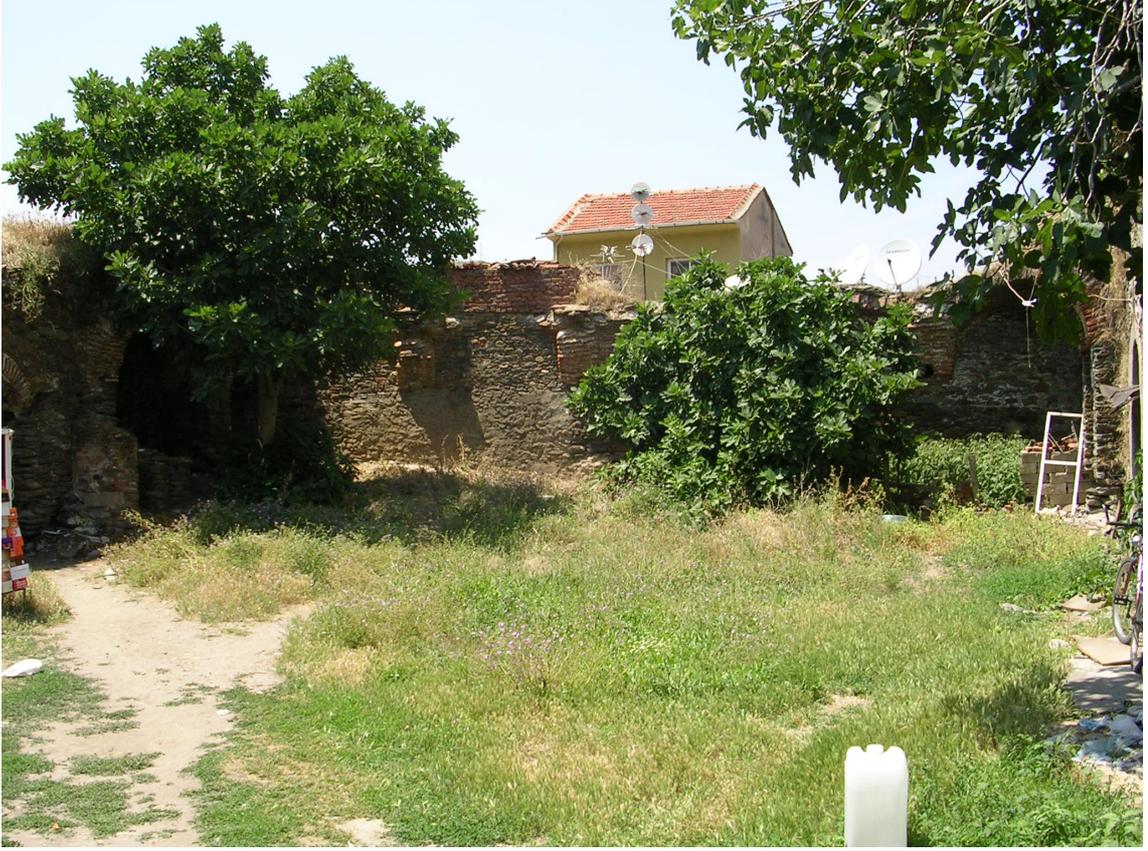
Figure 4.9. Çöplüce Han, Courtyard Side of the North Wing.

Stable space was placed in the courtyard side of the north wing (Figure 4.9). Of the stable space, nearly the whole of which is ruined today, only a small part to the northwest is still standing. This standing part was composed of two spaces that were connected to each other by a four-centered arch supported by a cross-planned pier in the middle, and they were covered with cross vaults. The northeast corner of the stable space there is a half cross vault. In addition, on the north and east wall, there are traces of vaults (Figure 4.10).

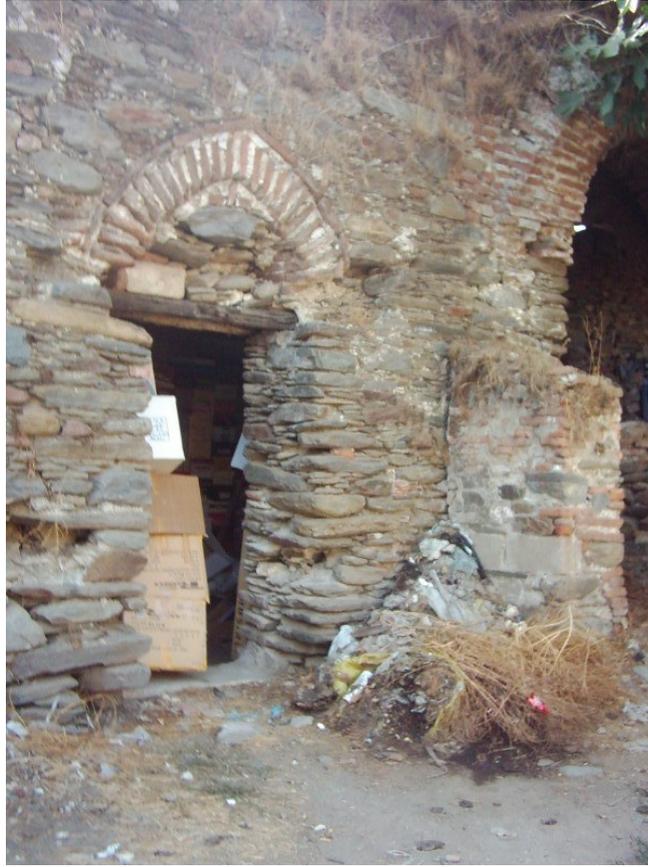
Figure 4.11. Çöplüce Han, The Walls of West Wing.

The walls were constructed with rubble stone, slatestone and brick in composite order masonry system (Figure 4.11). They are approximately 80 cm. thick. The walls in the entrance space were plastered and whitewashed. The wall, which was added to the west to obtain a new space, was built of brick. The east and west walls of the courtyard are original. In the west side, 8x12x150 cm. Wooden lintels were laid over the door openings of the rooms. Door openings are approximately 1.10x1.50 m. in dimension. Rubble stone, slatestone and brick were used between the four-centered arched pediments and the lintels over the doors. The wooden lintels were not placed in door openings in the east wing. The door openings in this wing are 1.10x3.20 m. in dimension. In the north wing, however, there is a plastered surface to the west and a repaired section to the east. Rubble stone and slatestone were used for the repair.

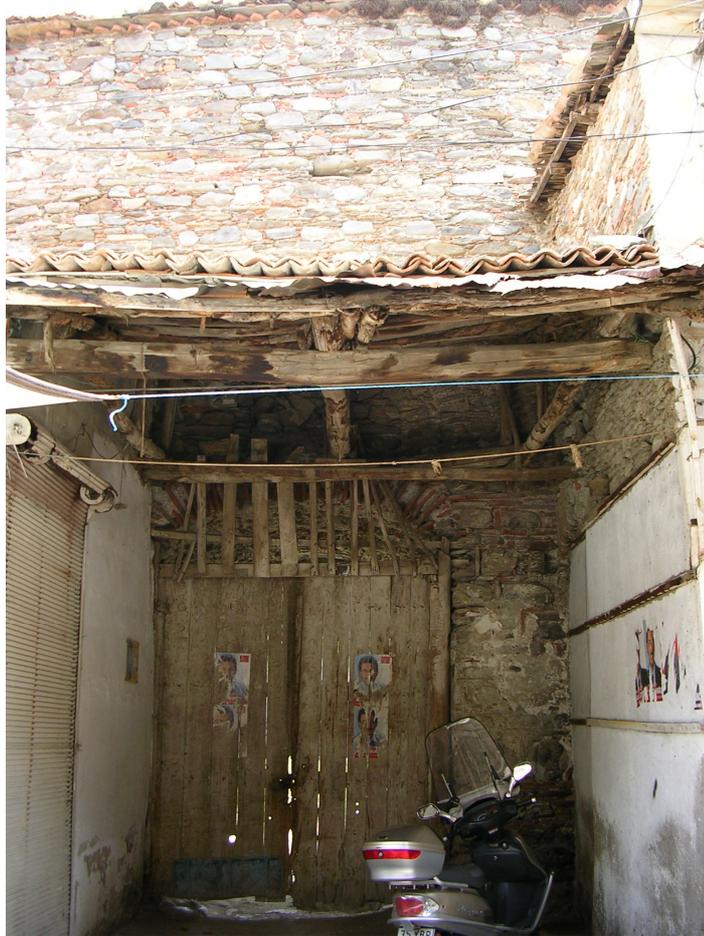
Figure 4.21. The Entrance of the Kutu Han.

Access to the han is provided through a semicircular arched door facing Tahtakale Street in the west wing (Figure 4.21). The entrance is composed of two sections. First section is 3.20x3.50 m. in dimension and was covered with a wooden shed. It is understood from the traces on the wall that it was originally covered with a cross vault. A wall was built later to the north of this section in order to obtain a new space, 0.98x3.70 m. in dimension which is used as a shop. A four-centered arched door, which is in a very bad state now, gives way to the second entrance section which is 2.90x3.70 m. in dimension and was covered with a barrel vault in the east-west direction. There are two spaces to the north and south of this space. These spaces which are rectangular planned and covered with barrel vault open into the second entrance section through a door each. In the north space, the door, which was opened out to the courtyard in the original plan, was converted to a window. Also there is a staircase in the south of the second section that leads to the second floor.

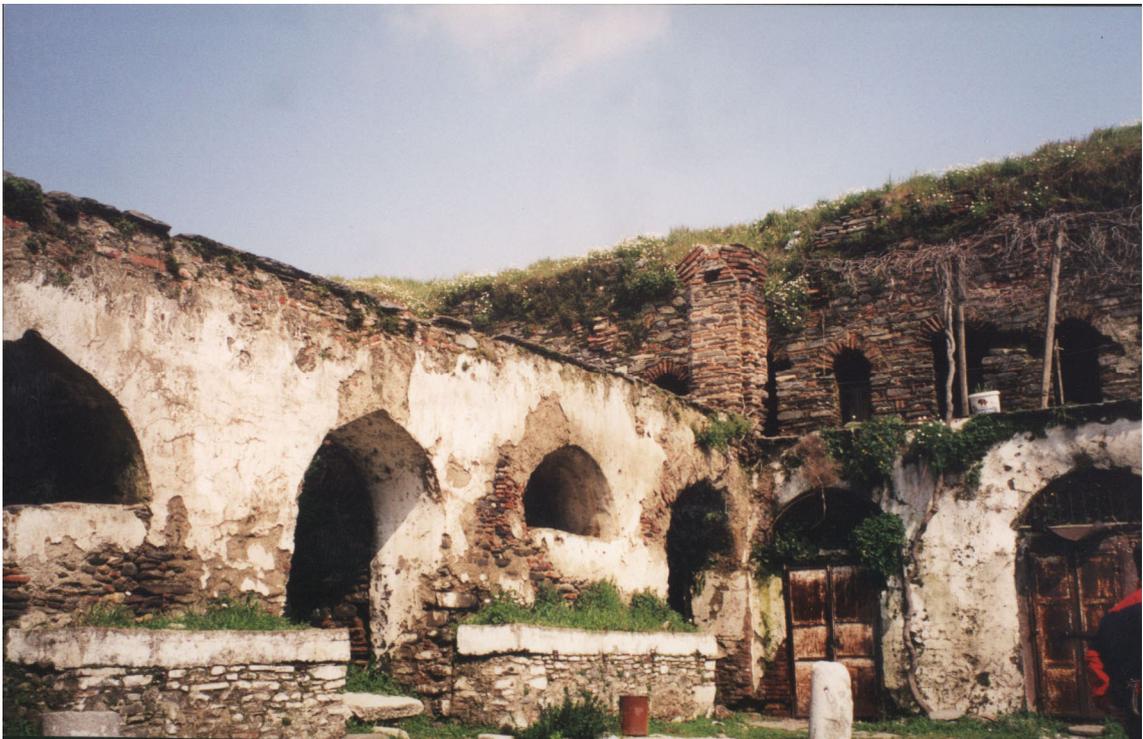
Figure 4.22. Kutu Han, Courtyard Side of the North Wing.

The entrance unit of the han gives way to the courtyard which is 15.00x17.00 m. in dimension. To the north of the courtyard, there is a stable space 11.20x22.70 m. in dimension. The stable was covered with cross vaults and these vaults were supported by cross-planned piers. Only the section of the stable at the northwest was covered with a barrel vault. The stable section of the han survived up till now with small changes. The stable opens into the courtyard through four four-centered arched openings. The stable used to open into the courtyard through five arches originally but today one of them was filled in to build a wall. In addition, in the middle of the stable there is a stair which is used from the courtyard (Figure 4.22).

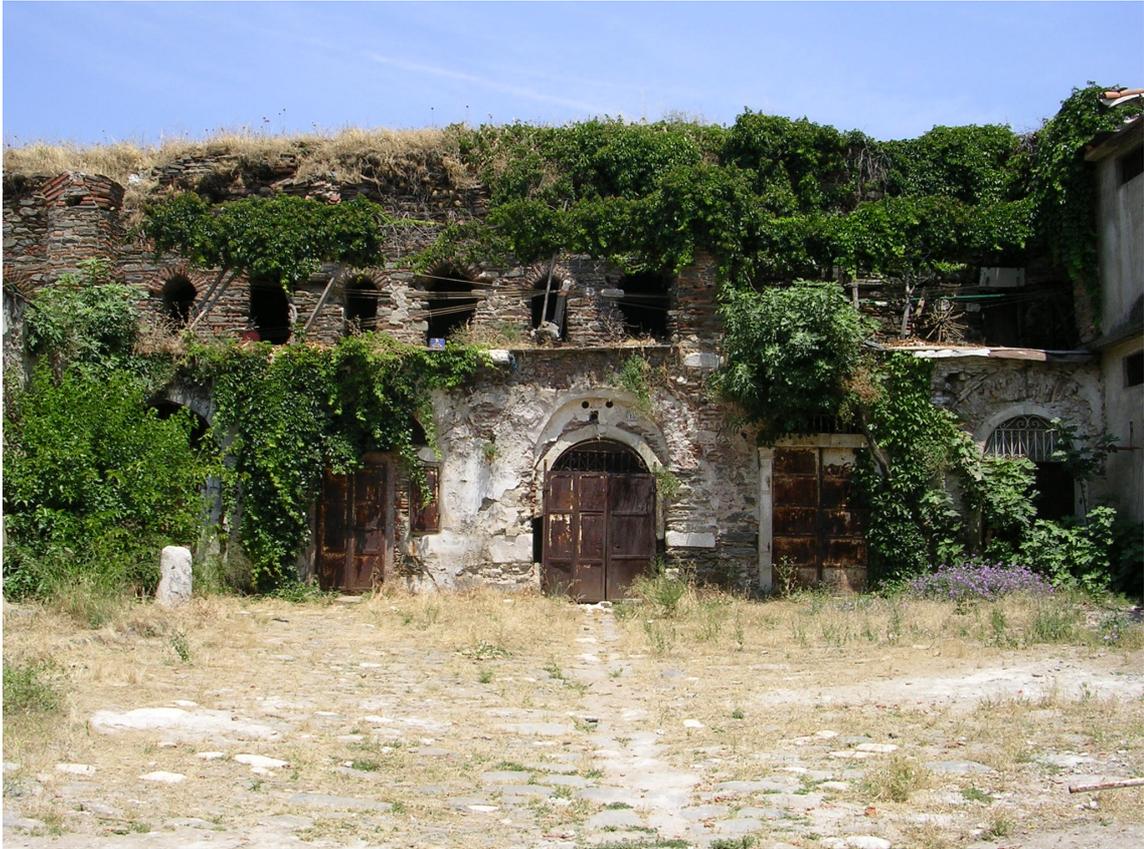
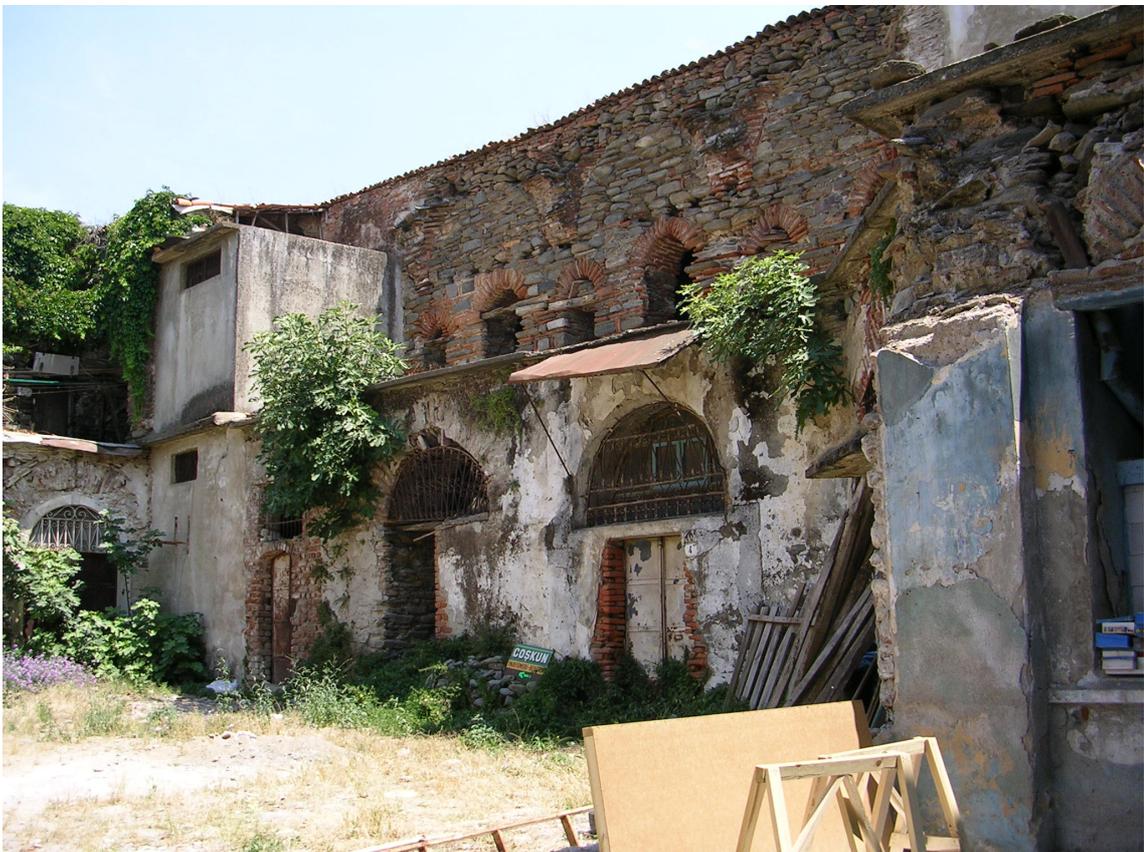
In the south wing of the courtyard, there are four rooms 2.20x2.40 m. in dimension and also a room 2.40x4.00 m. in dimension, and in the east part, there are six rooms, 1.90x2.10 m. in dimension. Today there is one more space in front of each of these rooms. These spaces were formed by filling the arch openings of the arcade in front of the rooms, and there are arcade arches on the facades of these rooms facing the courtyard. These rooms and the spaces in front of them were covered with cross vaults. Being different than the other spaces, the arcade which is in the east wing and just opposite the entrance and the room behind it are covered with barrel vaults in east-west direction (Figure 4.23, Figure 4.24).

Figure 4.23. Kutu Han, Courtyard Side of the East Wing.

Figure 4.24. Kutu Han, Courtyard Side of the South Wing.

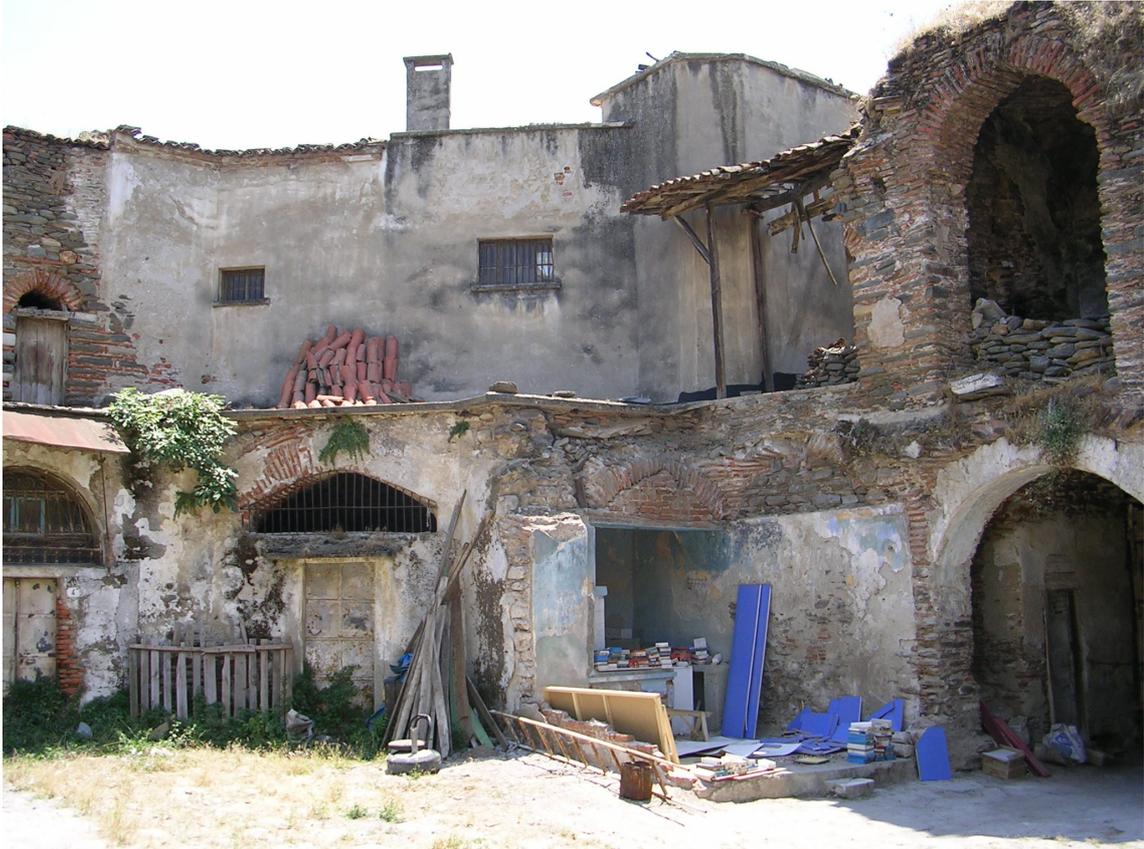
Figure 4.25. Kutu Han, The Southwest Corner.

On the facade facing the courtyard of the west wing part where the entrance exists, there is a simple, one story mass to the south of the entrance, 2.20x3.00 m. in dimension. In the southwest corner of the building, there exists a concrete section. Here rooms and arcade were removed and the shops already present were broadened. At the southwest corner and at the west end of the south wing, the connections of the 1st and 3rd rooms to the courtyard were cut off and they were merged with the adjacent shops (Figure 4.25).

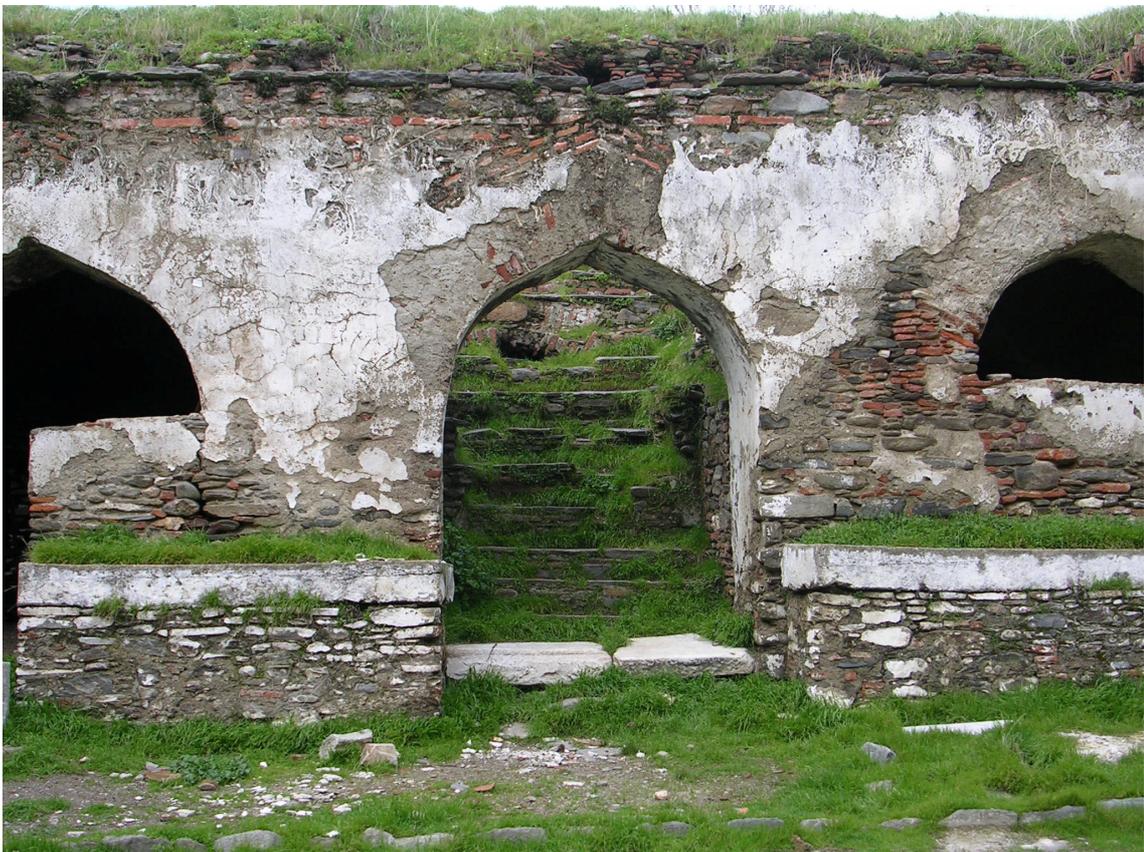
Figure 4.26. Kutu Han, Stair in the Middle of the North Wing.

Access to the second floor is provided by two staircases of which one is in the south of the entrance and the other is in the middle of the north wing of the courtyard (Figure 4.26). The staircase in the entrance is covered with a barrel vault measuring 0.70x3.00 m. The one in the courtyard is large in dimension and it was not covered.

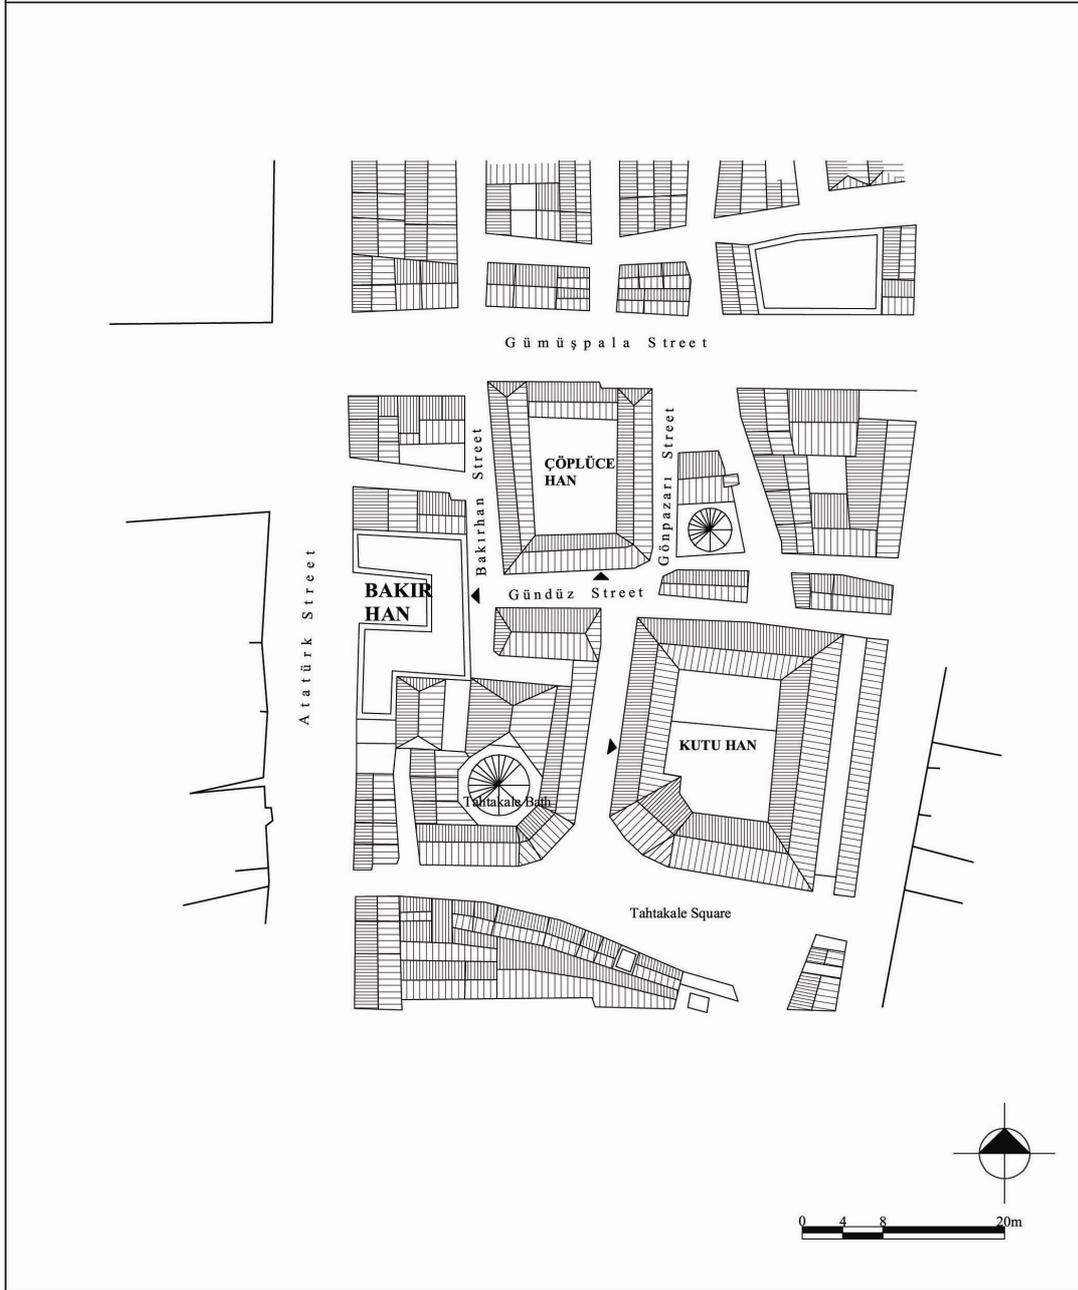
Figure 4.29. Site Plan of the Bakır Han.

adjacent structure to the south, and Çöplüce Han to the northeast. While historical texture, which is composed of Ottoman period shops and hans are observed to the east, there are buildings recently constructed to the west (Figure 4.29, Figure 4.30, Figure 4.31).

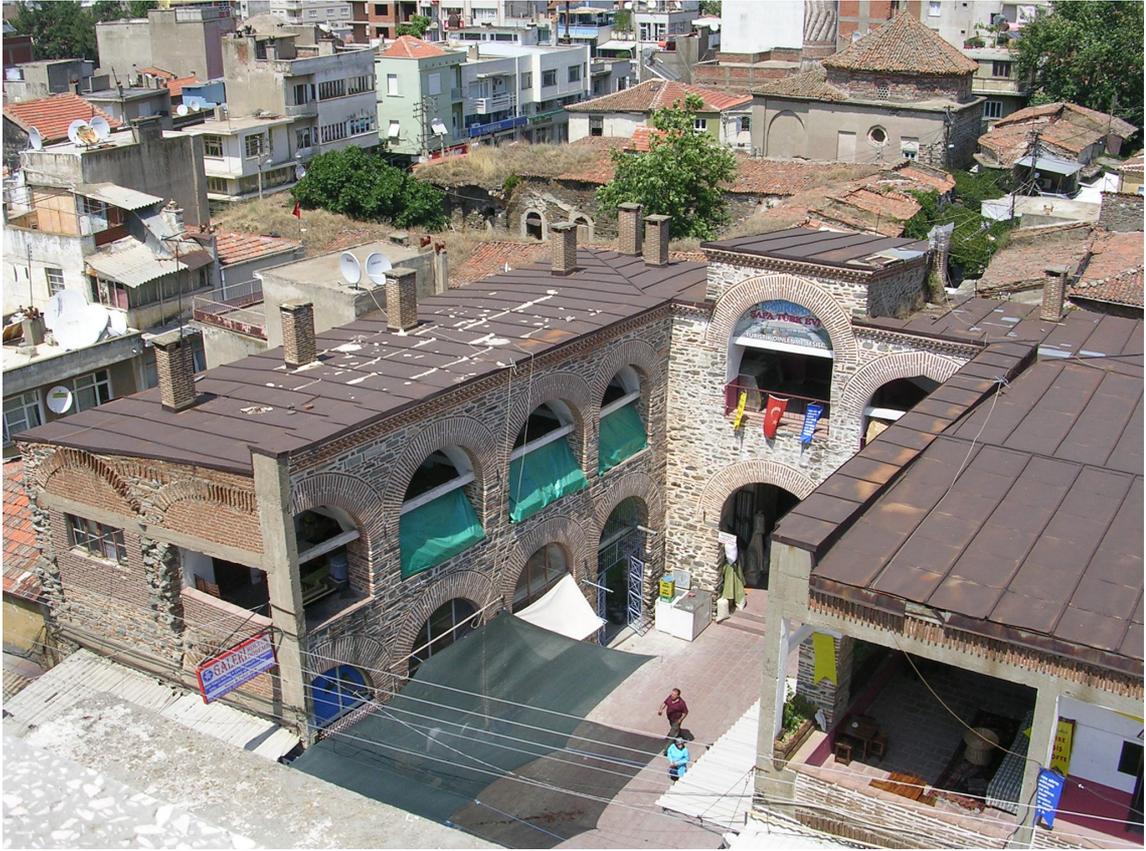
Figure 4.30. Bakır Han, General View of West Side.

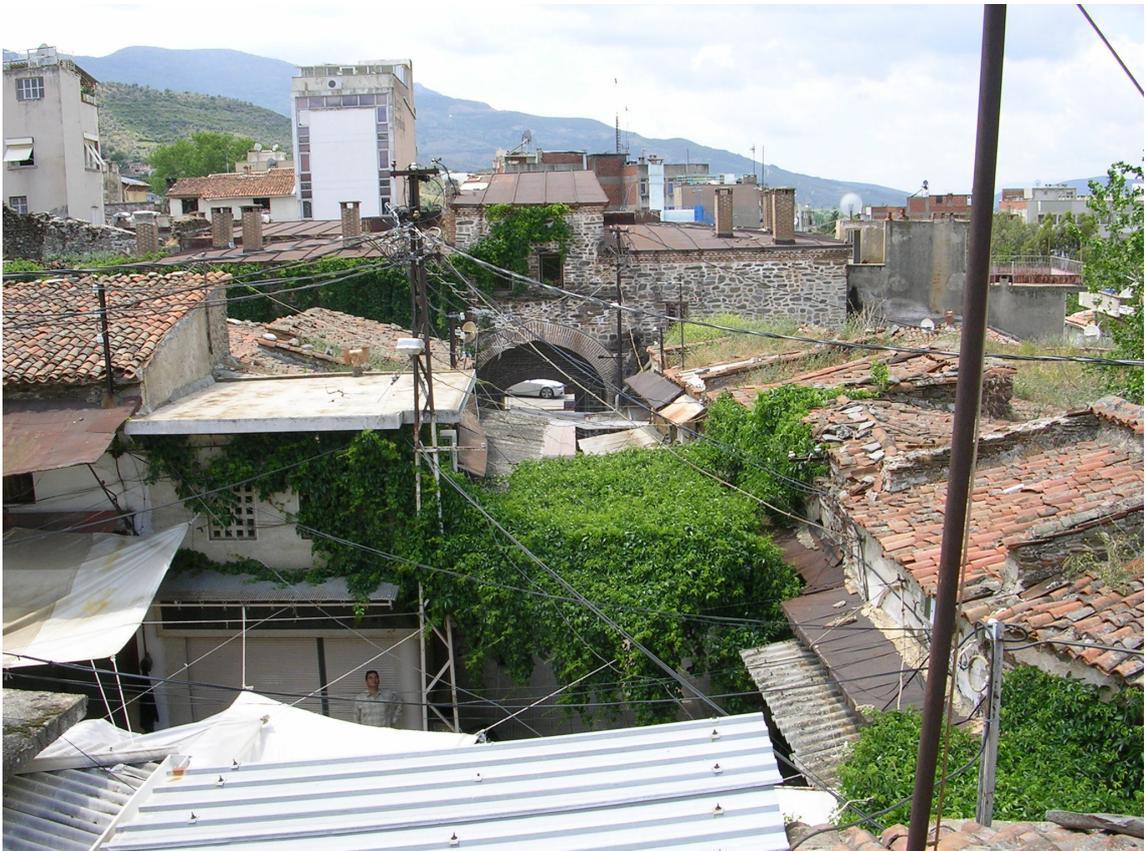
Figure 4.31. Bakır Han, General View of East Side.

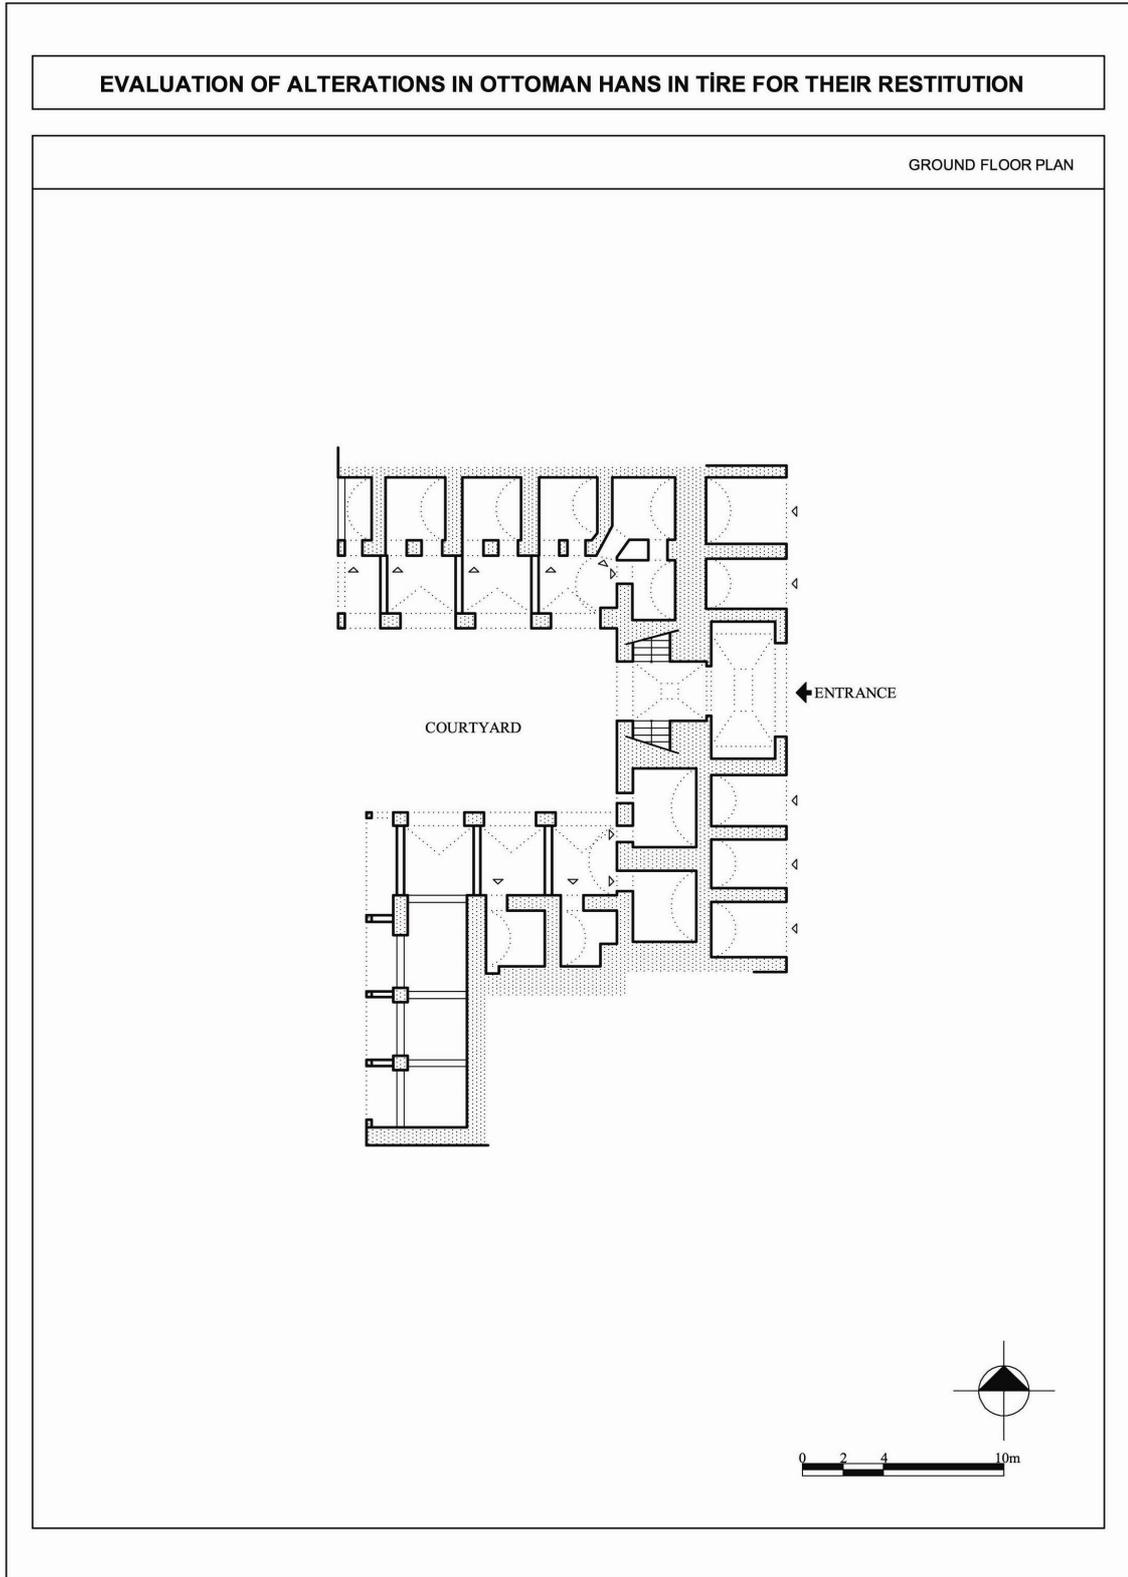
Figure 4.32. Ground Floor of Bakır Han (Redrawn from Gürboğa, F., 1985. "*Tire'de Türk İslam Anıtları*", Unpublished Undergraduate Thesis, Ege University, İzmir).

The building has a rectangular plan almost square, two stories, and a courtyard. It is situated on a plot of 42.40x38.20 m. The west of the original courtyard was demolished and converted to a “U” shape because of the construction of a road (Figure 4.32, Figure 4.33).

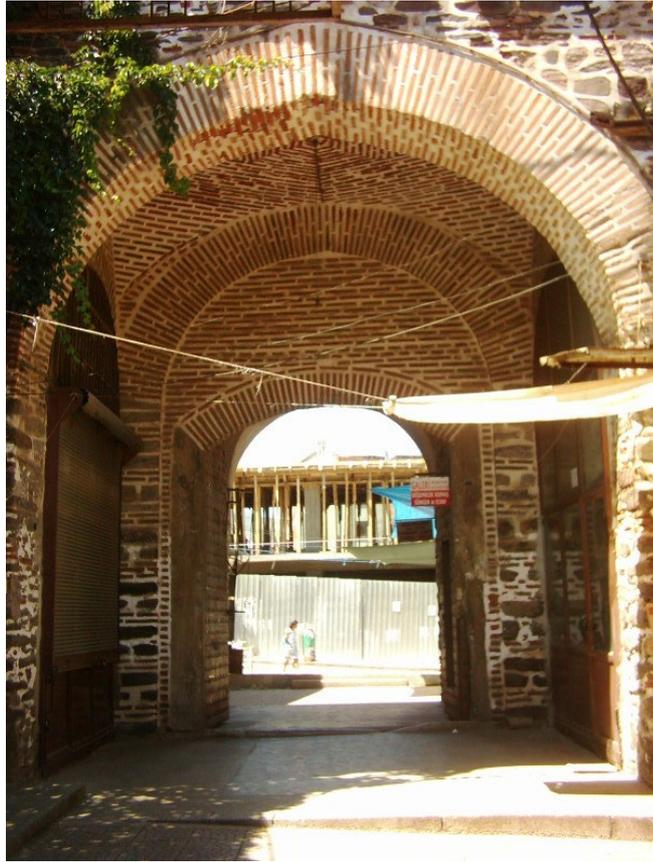
Figure 4.34. The Entrance of Bakır Han.

The entrance of the building is in the east wing and is composed of two sections (Figure 4.34). Access to the first section, which was covered with a cross vault, is provided through a four-centered arched opening. On both sides of this space, which is 7.80x3.60 m. in dimension, there are arched niches. These recesses are closed with glass partitions and are used as shops. It is observed that there is a depressed arch opening made of brick between the two entrance sections. Access to the courtyard was provided through a depressed arched opening from the second section, which was covered with a cross vault, like the first section. On both sides of the second section, which is 3.40x4.20 m. in dimension, there are staircases leading upstairs. The entrance section is elevated about 1.50 m. from the level of the courtyard.

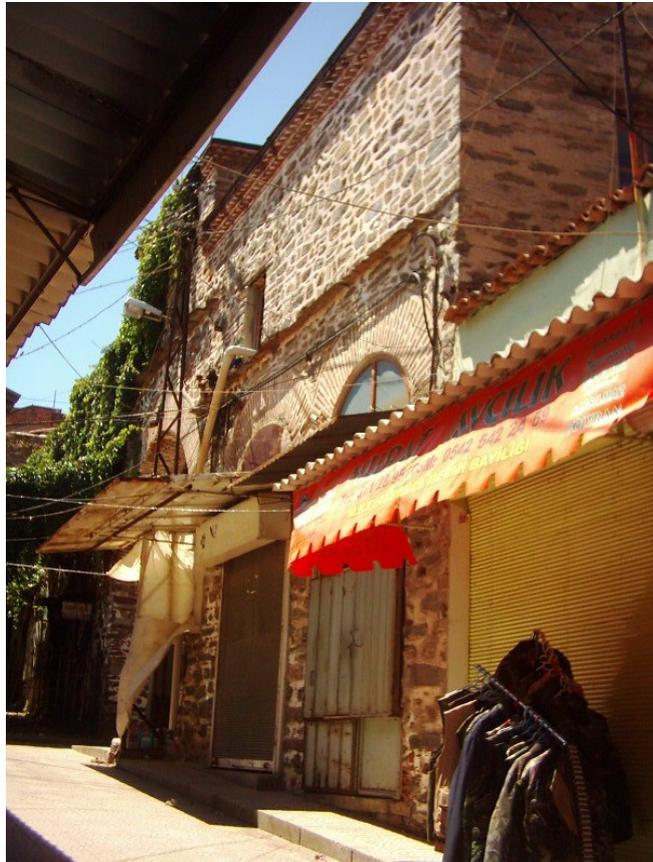
Figure 4.35. The West Facade of Bakır Han.

There are shops on the east wing where the entrance is facing the street between the Bakır Han and Çöplüce Han (Figure 4.35). There are three shops, approximately 4.30x3.00 m. in dimension, to the north of the entrance and two others to the south of the entrance. These shops were covered with barrel vaults in east-west direction which span 2.50 m. on average. On the courtyard side of the east wing to the north of the entrance, there are two rooms, 3.50x4.50 m., and there are another two rooms to the south 4.50x3.60 m. in dimension. Access to these rooms, which are used as depots, is provided through the ground floor arcade.
