**STRUCTURAL CONSERVATION OF CEVHER
PAŐA BATH IN KALE, DENİZLİ**

**A Thesis Submitted to
the Graduate School of Engineering and Sciences of
İzmir Institute of Technology
in Partial Fulfilment of the Requirements for the Degree of**

**by
Feyza DURMUŐLAR**

**December 2018
İZMİR**

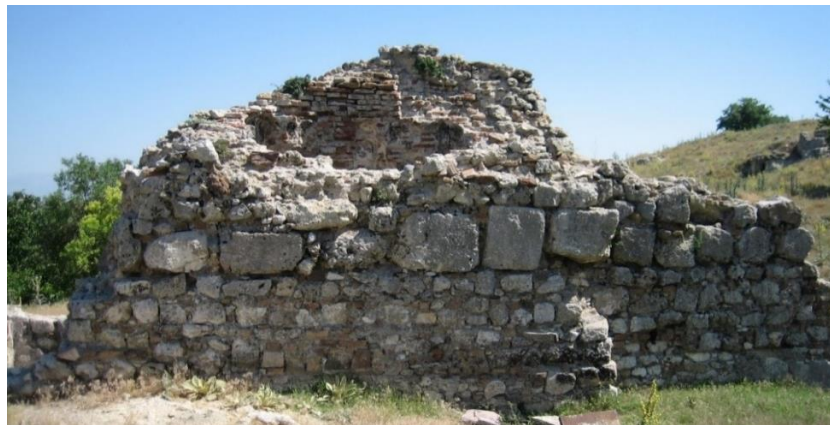
Figure 3.8. Southwestern façade

This is the entrance façade and its totally blind (Appendix A, Fig A.5). The height (h) of the wall ranges between 2.5 m to 1.35 m. The l of the façade is 21.74 m. There is a step remain belonging to space 1. There is a bulge at the central portion of the wall. The corners of the wall are the most damaged parts. The material is rough-cut stone at outer shells, rubble stone and lime mortar in between.

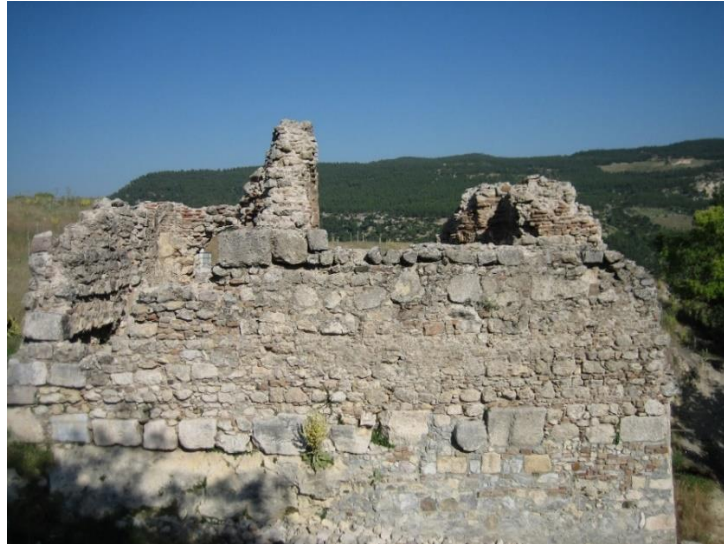
Figure 3.9. Southeastern façade

This façade is the valley side (Appendix A, Fig A.3). Therefore, there is a retaining wall supporting it at its bottom portion. The façade is totally blind. The h of the bath wall changes between 1.45 to 3.54 m. The l of the façade is 13.75 m. Beneath this wall, there is a retaining wall whose h ranges between 0.2 m to 2.23 m. The material of upper portion is rough-cut stone at outer shells, rubble stone and lime mortar in between. The material of bottom portions of the façade is rough-cut stone with cement mortar. There are some spolia in this façade.

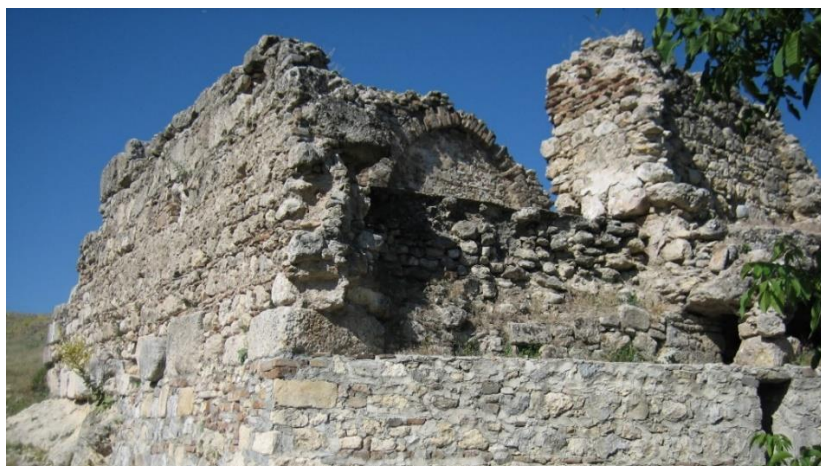
Figure 3.10. Northeastern façade

Northeastern façade faces the valley (Appendix A, Fig A.2). It is totally blind. The wall of the façade consists of two parts similar with southeastern façade. The material of the upper part is rough-cut stone at outer shells, rubble stone and lime mortar in between. The material of bottom portion, which is the retaining wall of the façade, is rough-cut stone with cement mortar. The h of upper part changes between 1.62 m to 4.30 m. The h of the bottom part ranges between 0.48 m to 2.22 m. The l of the façade is 12.05 m. Space 9 and space 11's ruins are perceivable at the rear of this façade. There is also a water channel remain at the bottom portion. Water still runs through the channel.

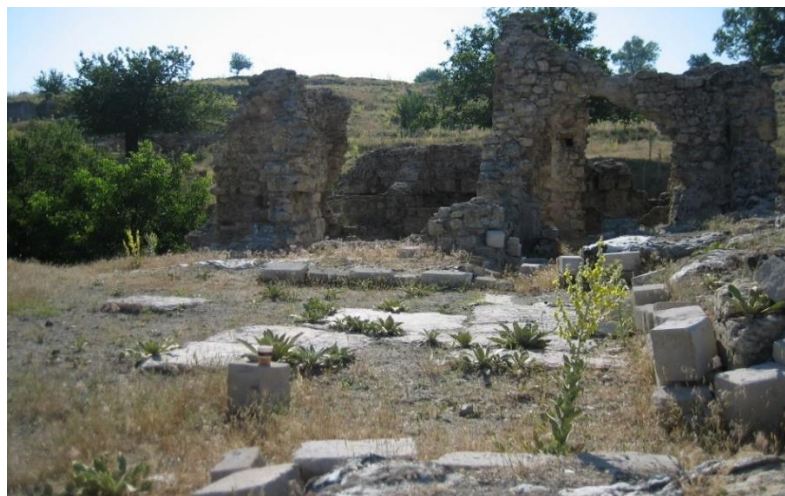
Figure 3.11. View of space 1 from the west

Space 1 (8.8 m x 11 m) is located at the western part of the building. The northern and eastern walls of the space have collapsed. The southern and western walls are in ruin. The highest wall in eastern part is 0.57 m in height. In the southern wall, there are some portions covered with earth. There are some remains of authentic stone floor covering (Fig 3.11). There is no superstructure of this space. The space had lost its third dimension. There are few steps at the southern part. There is an opening (1.35 m x 2.42 m) in between space 1 and space 2.

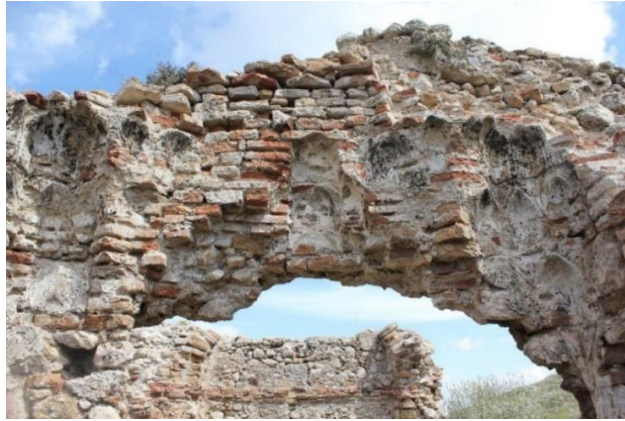
Figure 3.24. Dome Remain as viewed from south

There is a dome remain over space 4 at its northern portion. It was constructed with brick (0,5 m x 0,17 m) at outer shells and rubble stone and lime mortar in between (Fig 3.24).

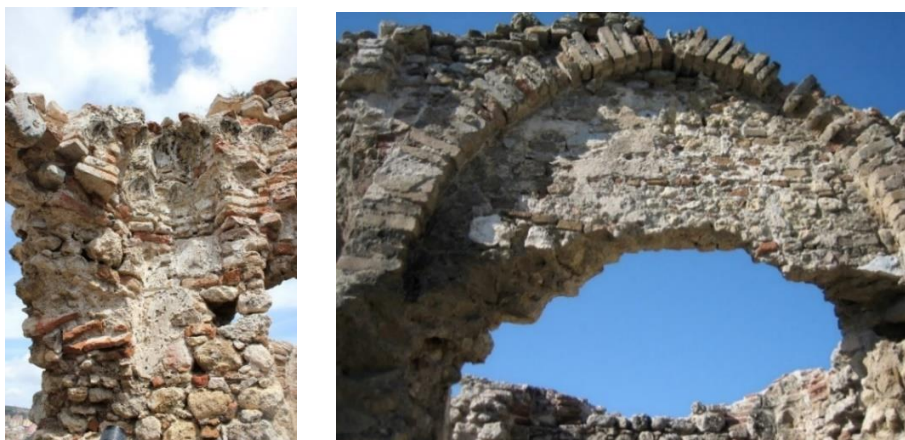
Figure 3.25. Squinch remain as viewed from southeast (left), arch remain as viewed from north (right)

There are three arch remains existing in the building. Two of these arches are on the northern and southern walls of space 6 with 3,8 m and 3,7 m spanning distance and 4,00 m and 5,04 m h, respectively. Third one is on the chamfered wall in between space 6 and space 9. Its spanning distance is 1,44 m and h are 3 m. All arches were constructed with brick (0,8 m x 0,28 m) at their shells, rubble stone and lime mortar in their core.

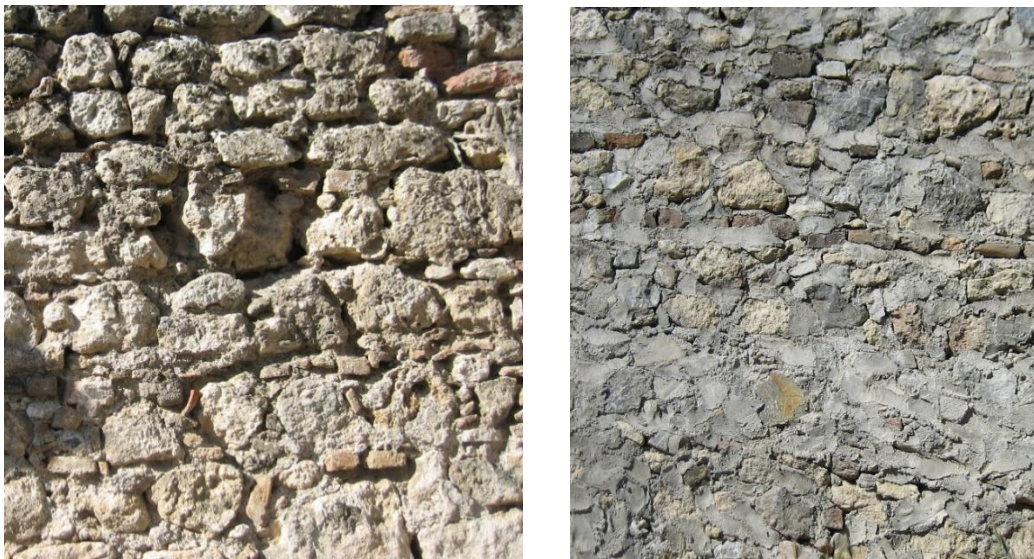
Figure 3.26. Load bearing walls: First group (left), Second group (right)

Load bearing walls are classified in two groups as rough-cut stone at outer shells, rubble stone and lime mortar in between, and rough-cut stone with cement mortar. The first group is seen at all exterior walls except the retaining walls at the bottom portions of northeastern and southeastern façades. The thickness of these walls ranges between 60 cm to 82 cm. So, the second group (approximately h 2.20 m) includes the intervened portions (Fig 3.26).

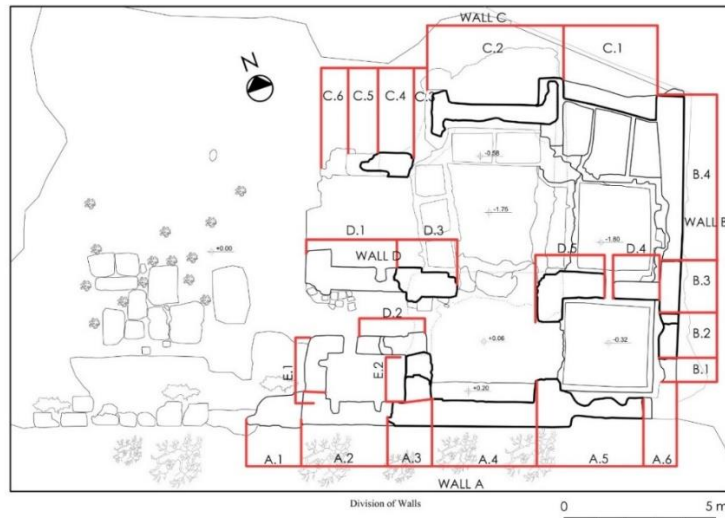
Figure 3.28. Portions of walls defined according to their heights

A table of the safety factors are listed in which found by above simple approach, which gives an idea on the safety and relative urgency of retrofit among the walls. At the northeastern corner B4-C1 of the building, (Fig 3.28) safety factor is low due to long unsupported span of the wall B4 and free (unsupported) end at the C1 corner. Moreover, intuitively long walls would not behave as single block out of plane direction but shows bulging behavior. Therefore, there should be a consolidation at this wall close to the corner side. This wall can be examined in more detail by civil engineers. If necessary, consolidation proposed in this study can be revised according to the results of the detailed analysis. There are some arch remains as mentioned above (Chapter 3.7). These arches are in almost collapsed state. Therefore, they need structural consolidation.

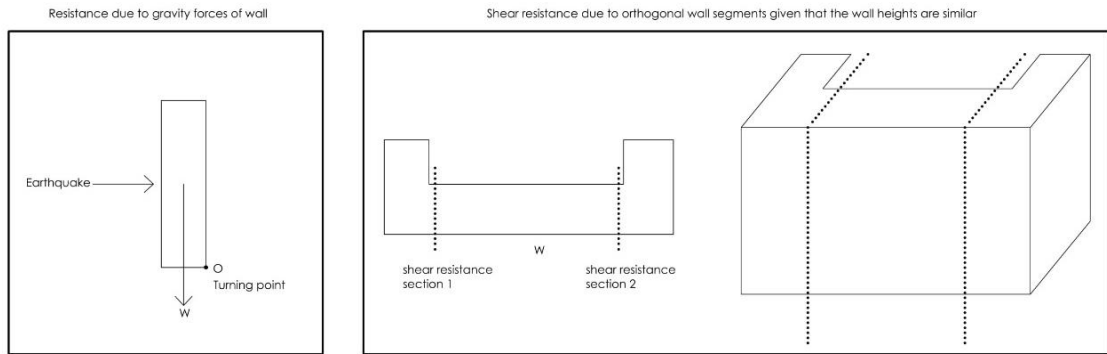
Figure 3.31. Calculation of overturning resistance

Overturning or in the specific case out of plane failure, which is likely to occur partially at upper parts of wall, is checked by assuming the wall doesn't show any flexural behavior. Orthogonally joining walls are assumed to be rigid their inplane direction and forms support points in out of plane direction of the wall (Fig. 3.31). Thus, for the wall to collapse out of plain the shear strength at the support ends need to be exceeded. The resisting resultant vector of the shear is assumed to be acting the the mid-height of the

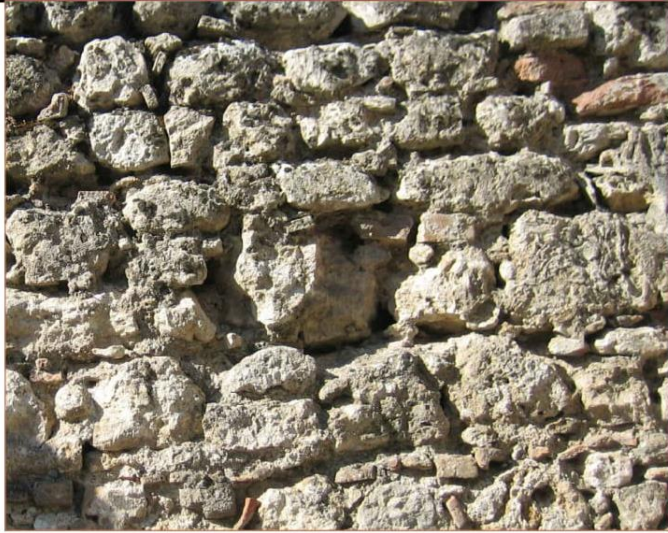
a. Load bearing wall: Rough cut stone at both surfaces, rubble stone and lime mortar in between

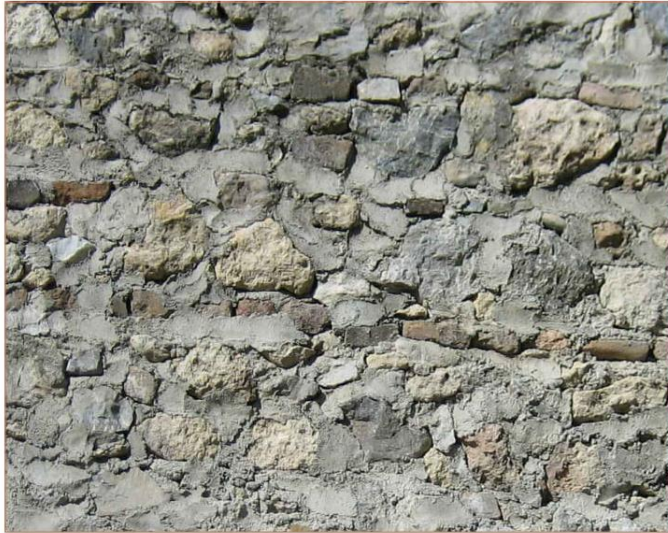
b. Load bearing wall: Rough cut stone with cement mortar

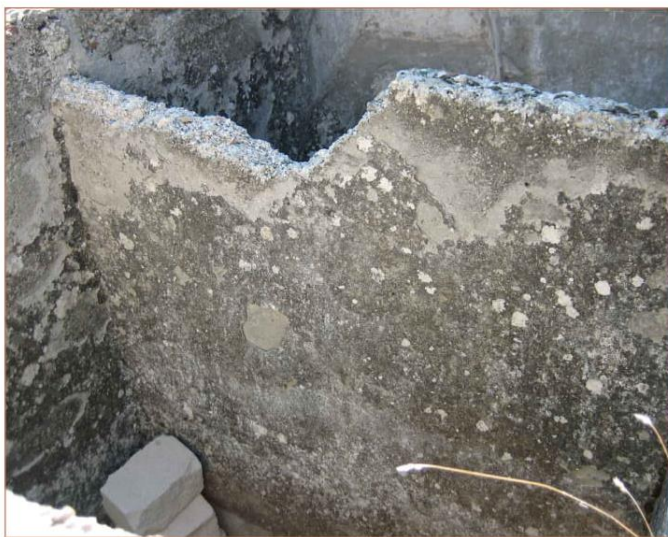
c. Non-load bearing walls: Cement interventions
