**INVESTIGATION AND EVALUATION OF
TECHNICAL, ADMINISTRATIVE AND LEGAL
DECISIONS DURING THE RESTORATION
PROCESS OF AKMUR HOUSES**

**A Thesis Submitted to
the Graduate School of Engineering and Sciences of
İzmir Institute of Technology
in Partial Fulfilment of the Requirements for the Degree of**

in Architectural Restoration

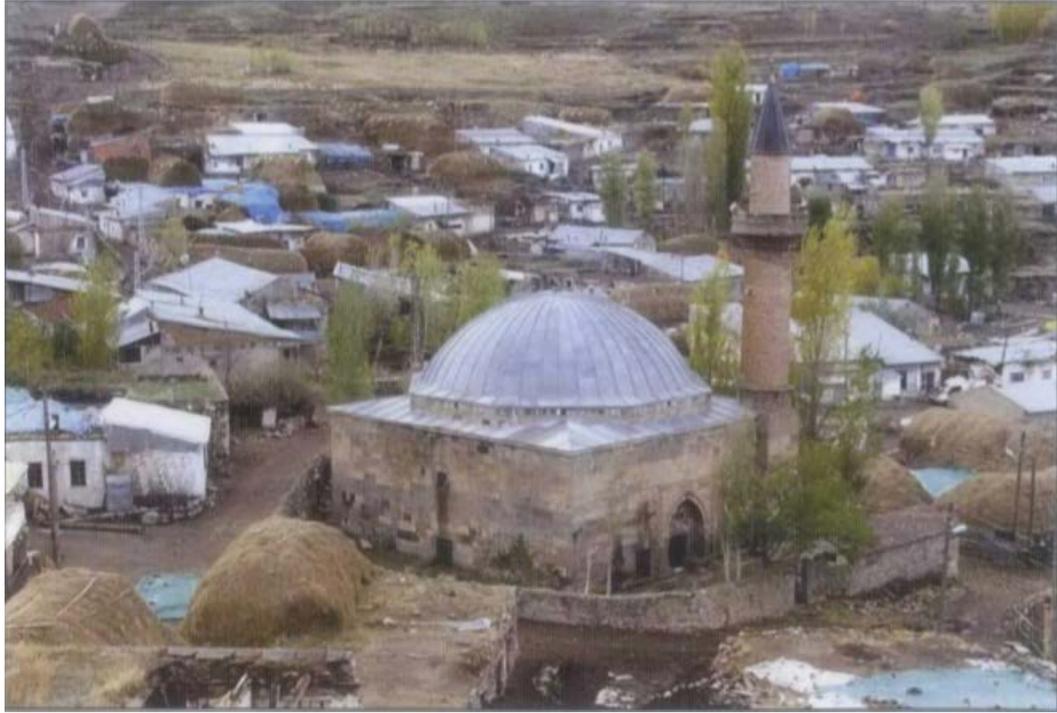
Figure 2.6. The view of Bardız Mosque from the northeast, 2007 (Source: Yıldız Technical University Faculty of Architecture of Restoration Project Group, 2007).

In 1647, while Evliya Çelebi was traveling from Erzurum to Revan, he related reaching to Bardız Castle in Kars Province and described that there were a small bath, a mosque and prayer rooms (Evliya Çelebi 1846/2005, 383)⁴. Only the castle from these structures has survived to today. The only public structure that survived from the Ottoman period is the Bardız Mosque, dated 1728, in the northeast of the village square (Figure 2. 6 and Figure 2. 7) (Konyalı 1960, 527).

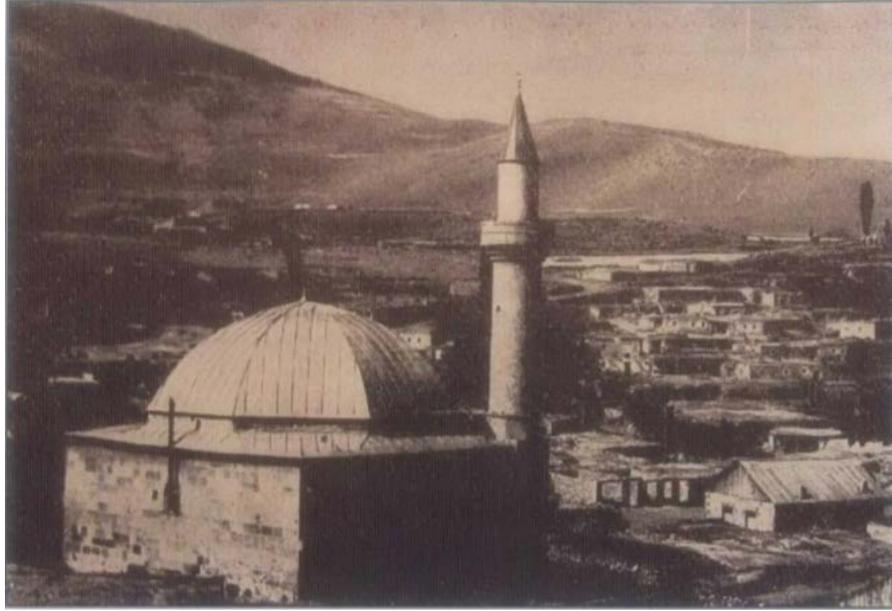
Figure 2.7. The view of Bardız Mosque from the northeast, 1960.
(Source: Konyalı 1960, 526)

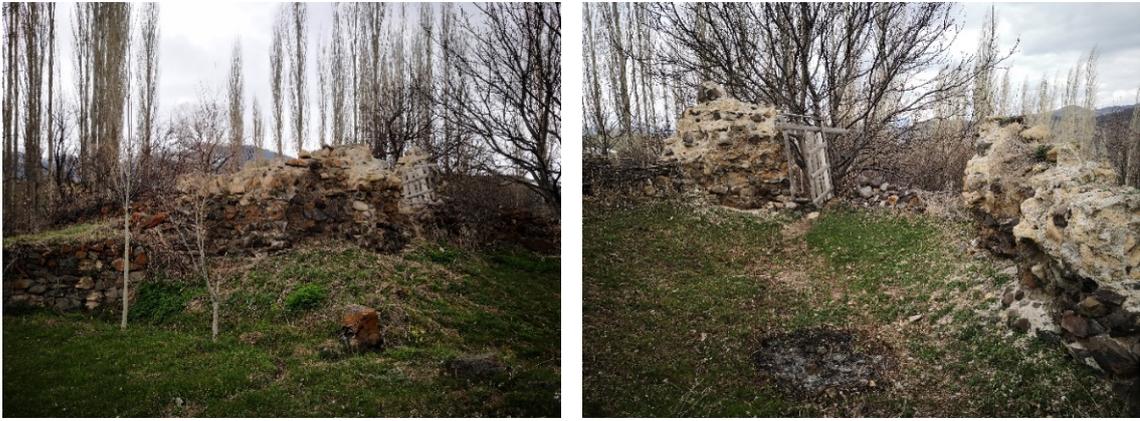
Figure 2.8. View of the ruins of the church from southeast and southwest, respectively (Photograph: Author, 2018).

Between 1878 and 1917 (Bolshevik Revolution), churches, police stations and primary school buildings were built in Bardız. The construction date of the church, the ruins of which have survived to date, is unknown (Figure 2. 8). However, it is reported that churches of four villages, includes Bardız, were looted in the Turkish Attacks that occurred on May 25-26, 1914 in the newspaper Kavkaz published in Tbilisi (Badem 2018, 436).

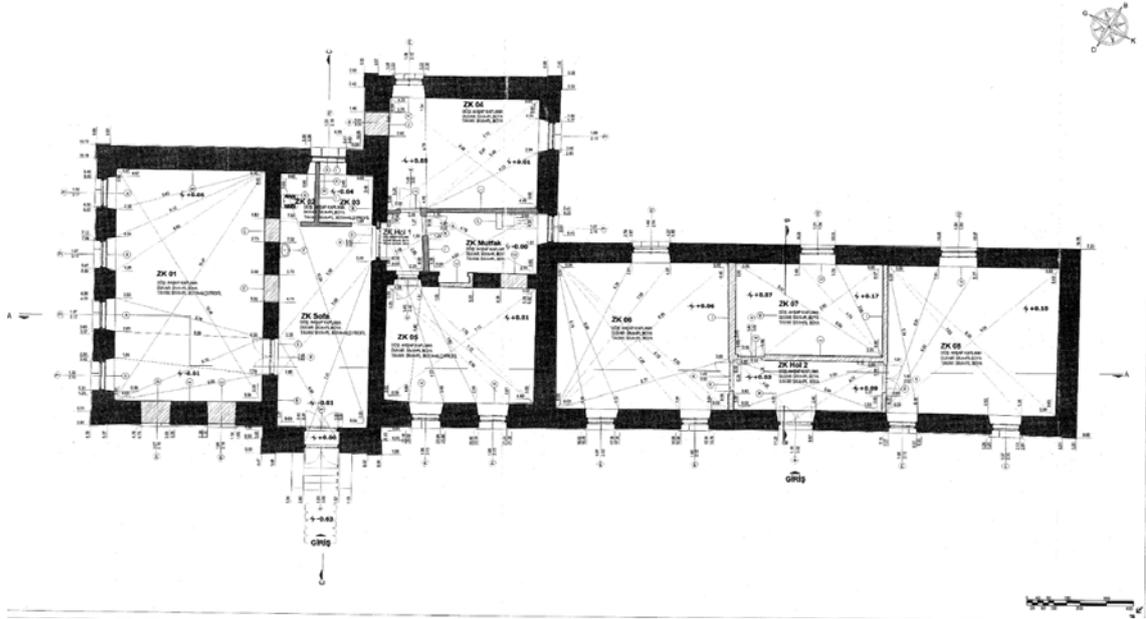
Figure 2.9. Building survey plan of Bardız Primary School.(Source: Yıldız Technical University Faculty of Architecture Restoration Project Group, 2007)

In 1886, the settlers of the villages of Bardız, Merines, Ersinek and Posik in Oltu District built a school. Bardız, one of these villages, was found suitable for school construction due to being large and rich village although it is close to Ottoman border (Badem 2018, 382). The school was opened in 1898 and had 60 Orthodox students in 1899 (Badem 2018, 411). In the advancing years, it is known that Turks also studied Russian at Bardız Primary School (Figure 2. 9 and Figure 2. 10). After the proclamation of the Republic, the primary school was named after teacher Nesimi Akın (Yıldız

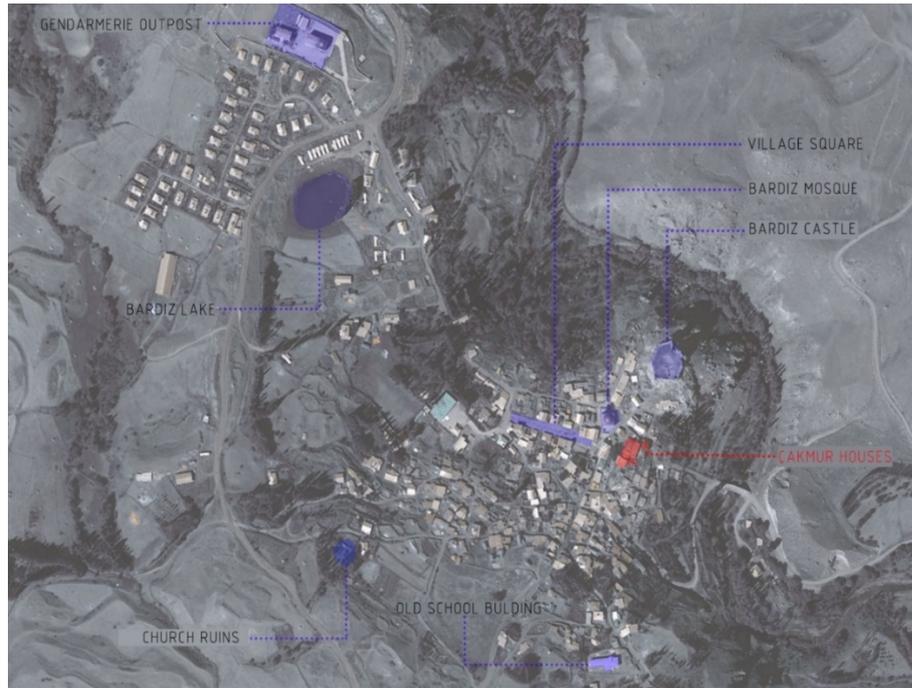
Figure 2.13. Map showing the settlement of Gaziler Village.
(Drawer: Author, 2019)

Today there is a 3-centered settlement in the Gaziler (Bardız) Neighbourhood. These centres; Old Village, Container Campus and Earthquake Houses in chronological order. The Old Village is located in the southwest. In the northwest 300 m away from the old village is the Container Campus which essentially abandoned. This campus is bordered by Horasan-Şenkaya Highway from the north and east sides. Earthquake Houses are located to the northwest of the highway (Figure 2.13).

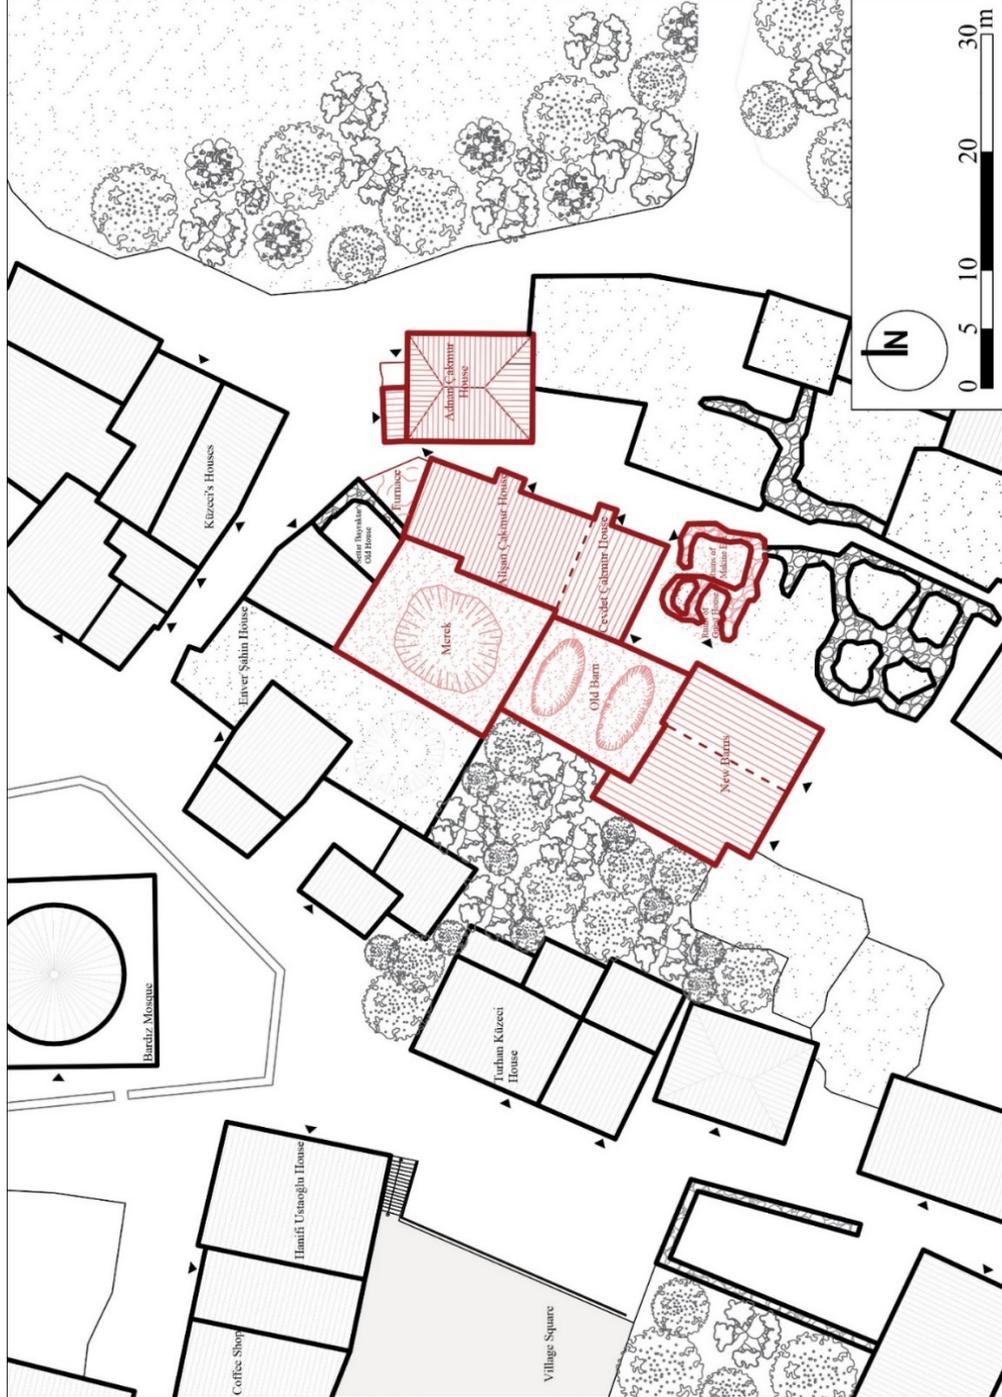
Figure 3.3. Site plan showing the location of Çakmur Houses (Source: Prepared by Tuncer Çağrı Çakmur, 2019).

Çakmur Houses in Gaziler Neighbourhood of Şenkaya District of Erzurum Province; consists of the structure ruins belonging to machine house (milk house) and Guest House and Alişan Çakmur House, Adnan Çakmur House, Cevdet Çakmur House, *merek* (sheepfold) and three barns (two new barns and one old barn) (Figure 3.3). After the earthquake with 5.4 magnitude on 3 December 1999, the machine house and guest house and roof of the furnace of Alişan Çakmur House and the southern wall of Cevdet Çakmur House were destroyed. Other parts of the structure group were also damaged.

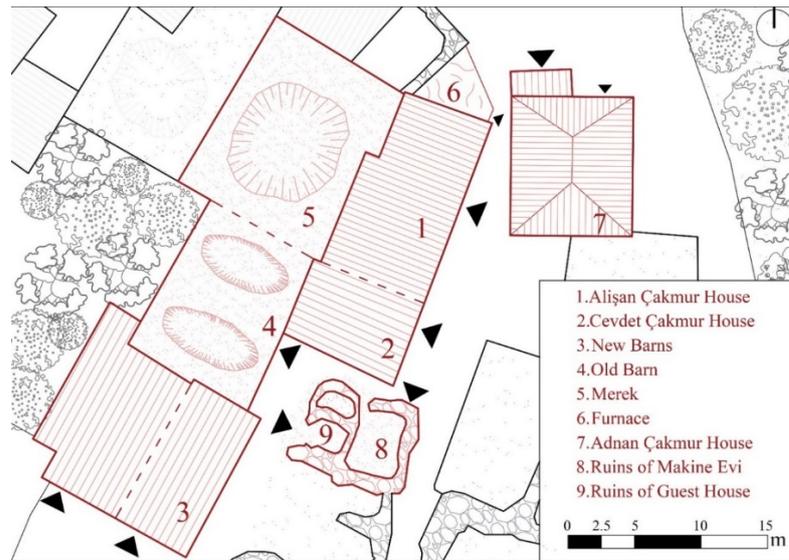
Figure 3.6. The site plan showing Çakmur Houses and surroundings
(Prepared by Author, 2019).

The unit, which was built adjacent to the western wall of the Alişan Çakmur House, is known as *merek* (sheepfold). The structure of *merek* is adjacent to the kitchen of Enver Şahin's house in the west and Settar Bayraktar's old house in the east (Figure 3.6).

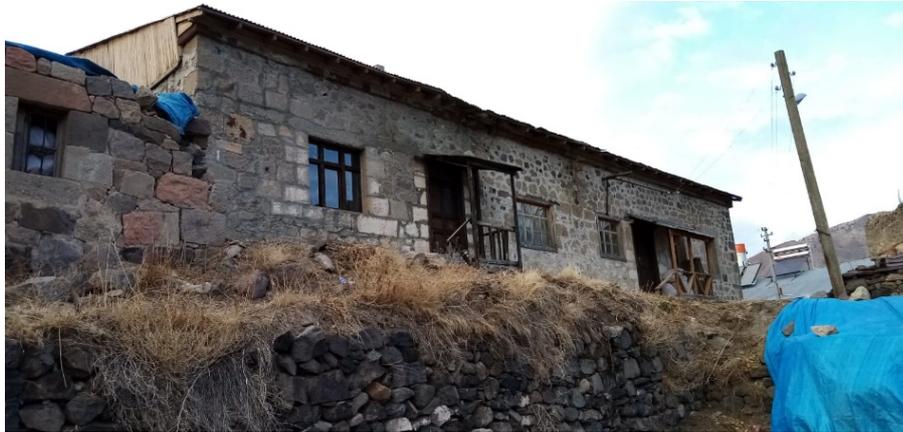
Figure 3.7. The view of Alişan Çakmur House and Cevdet Çakmur House from the southeast (Source: Bahadır Küzeci, 2019).

Alişan Çakmur House has two floors and consists of six rooms. On the ground floor there is a hall, a daily room, a bedroom and a bathroom. Below the bedroom in the north is the warehouse. In the north of the warehouse is a trapezoidal planned furnace adjacent to the structure. The furnace and warehouse are below the basement level of the structure (Figure 3.7).

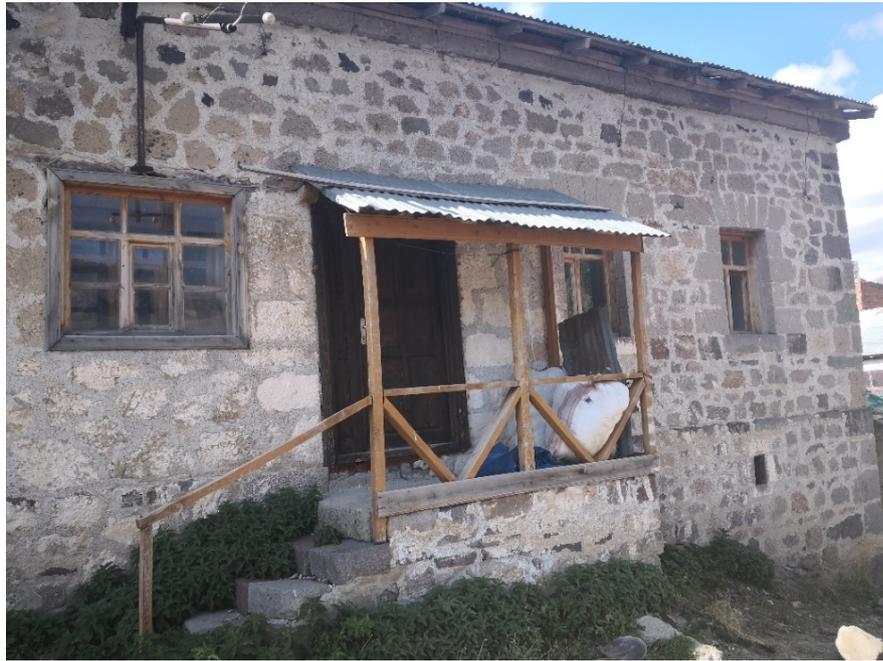
Figure 3.8. The view of the entrance landing from the southeast.
(Photograph: Author, 2019)

The entrance to the house is provided by the landing of 1.50x1.50 m on the east side of the house and reached by three stone steps. Both sides of the stone steps and the landing are surrounded by wooden railings. The upper surface of the landing is covered with later production sheet material (Figure 3.8).

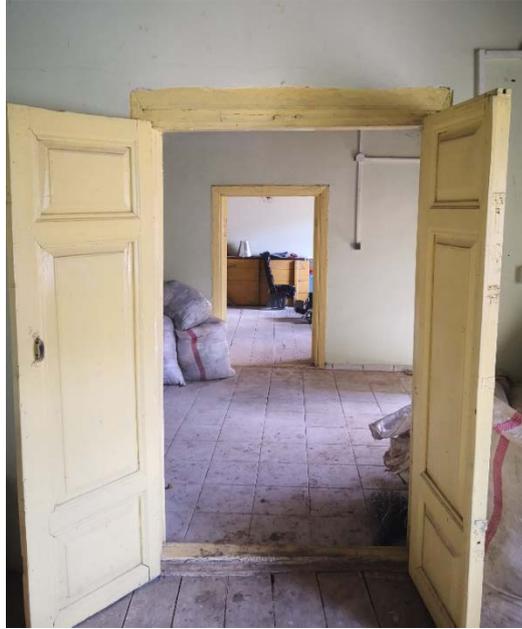
Figure 3.10. The view from the daily room to the hall and bedroom.
(Photograph: Author, 2019)

There are wooden, double-leaf doors, understood to be original, on the north and south walls in the lower level of the *sofa*. These doors open to the bedroom in the north and the daily room in the south (Figure 3.10).

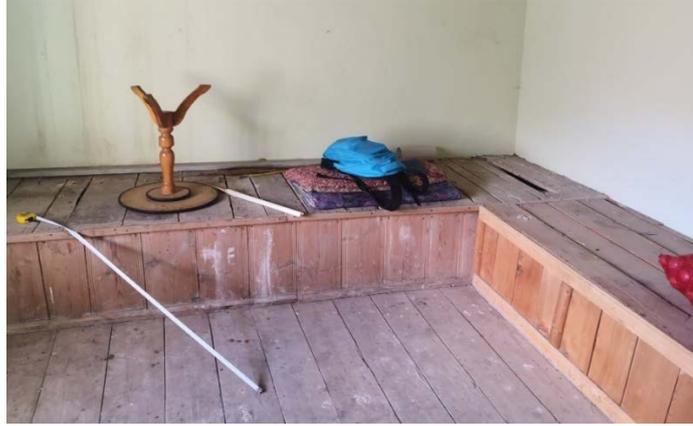
The space in the south of the *sofa* is the daily room (4.81x4.02 m). On the south wall of the room there is an old *sedir*, which is 94 cm wide and 49 cm high. During the repair, a new *sedir*, 60 cm wide and 49 cm high along the western wall of the room was added (Figure 3.11). The window on the eastern wall of the room measures 1.48x1.11 m.

Figure 3.11. Old and new *sedir*.
(Photograph: Author, 2019)

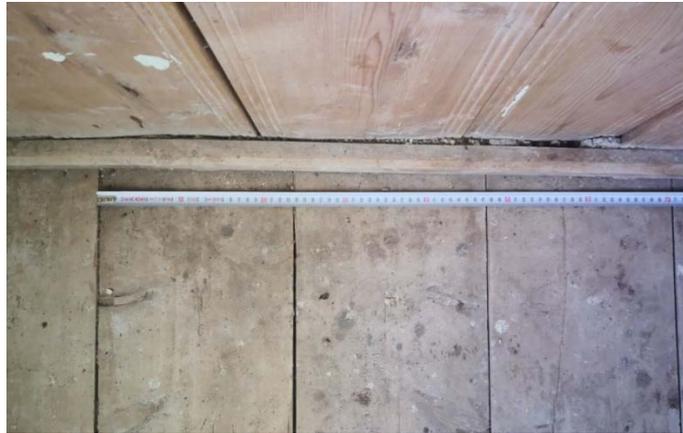
The wooden window has three sashes, one of which is openable. The floor of the daily room, which is understood to be original, is covered with wooden covering boards of 24 cm wide extending in the north-south direction (Figure 3.12).

Figure 3.12. Daily room floor.
(Photograph: Tuncer Çağrı Çakmur)

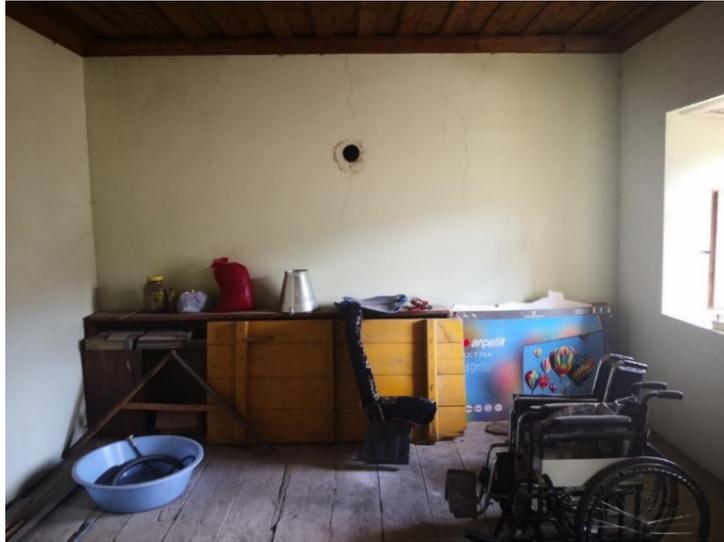
To the north of the *sofa* is a bedroom measuring 4.94x4.24 m (Figure 3.13). Two 90x129 cm single-sashed wooden windows that light the room are located on the east wall. The floor of the bedroom is covered with about 24 cm wide wainscoting woods extending in the north-south direction.

Figure 3.13. The view of the bedroom from the door.
(Photograph: Author, 2019)

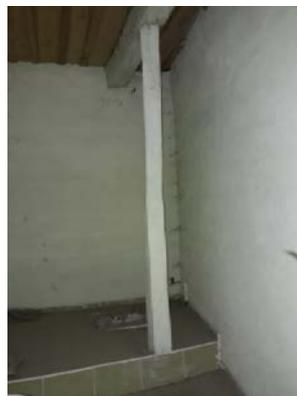
In the south of the 6 cm high western part of the *sofa*, there is a toilet and a bathroom (Figure 3.14). The wet area floor, covered with ceramic, is 24 cm higher than the western part of the *sofa* and has two elevations in itself. There is a stud measuring 20x20 cm in the 2.27 m south starting from the door inside this space of 397x114 cm. The floor in the south of the stud is 16 cm higher and has pan closet on it. The stud carries a joist that is made of wooden material, which is understood to be original and extends between the southern wall and the door belonging to the space. There is a 40x60 cm space on the timber joist that provides access to the attic (Figure 3.15).

Figure 3.14. The view of the bathroom from the door.
(Photograph: Author, 2019)

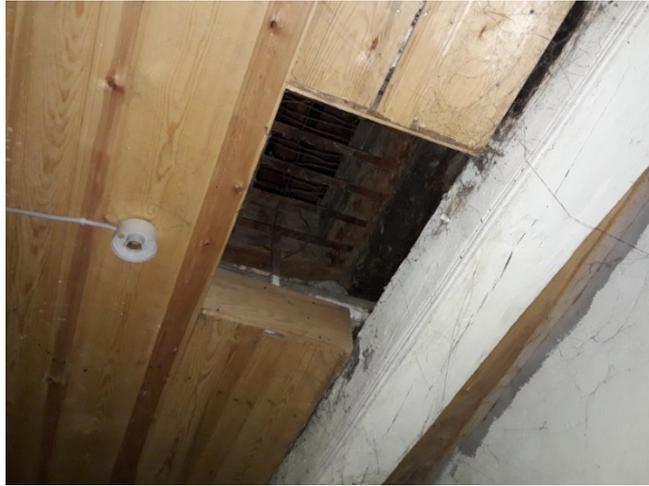
Figure 3.15. The area that provides access to the attic.
(Photograph: Author, 2019)

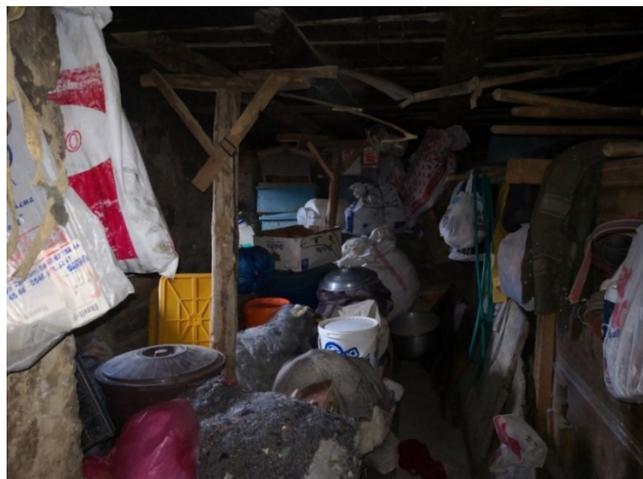
Figure 3.16. The view of warehouse from the furnace.
(Photograph: Author, 2019)

The warehouse below the bedroom is used as cereal storage. This room is accessed from a single-sashed wooden door in the south of the furnace built adjacent to the structure. There are two embrasures that narrow towards the front on the east wall of the warehouse. The ceiling of the warehouse with soil ground is wooden joisting. Rubble stone is observed on the plastered walls (Figure 3.16).

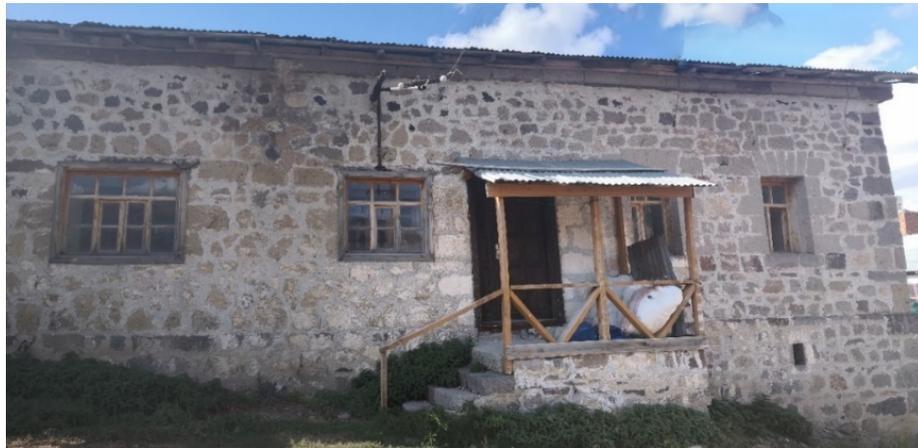
The main entrance to house is on the eastern side. The facade is bordered by Cevdet Çakmur House in the south and by furnace in the north. The door that provides entrance to the hall of the house is on this facade. In the south of the entrance door, there are two windows, one belonging to the hall and one to the daily room. In the north of the door have two windows of the bedroom and two embrasures of the warehouse on the lower floor of the bedroom (Figure 3.17).

Figure 3.17. The east facade of Alişan Çakmur House.
(Photograph: Author, 2019)

The part from the floor up to the threshold level of the entrance door is the subbasement line and this part protrudes 2 cm from the facade surface. There are cornices made of cut stone at the upper level of the facade, under the soffit. Jointings are cement mortar on the facade where there are different stone wall bondings.

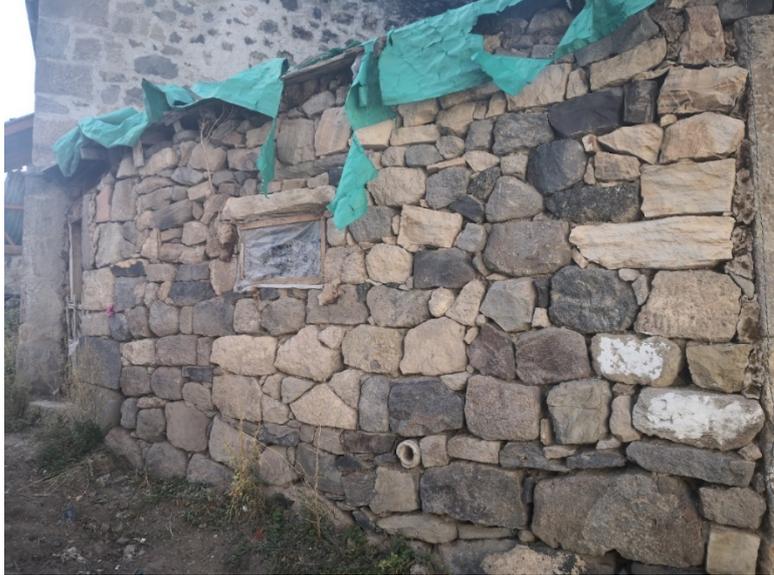
The north-eastern facade of the structure formed the entrance facade of the furnace area built adjacent to the structure. There is a single-sashed wooden entrance door with a width of 124 cm and a height of 197 cm in the northeast-facing front of the furnace. There is a lattice element 60 cm high on the exterior side of the wooden door ¹¹. The northeast facade of the furnace was built with pitch-faced rubble stones (Figure 3.18). There is a lintel made of one-piece cut stone on the 22x36 cm aperture on the northeast facade.

Figure 3.18. The northeast view of the furnace area.
(Photo: Author, 2019)

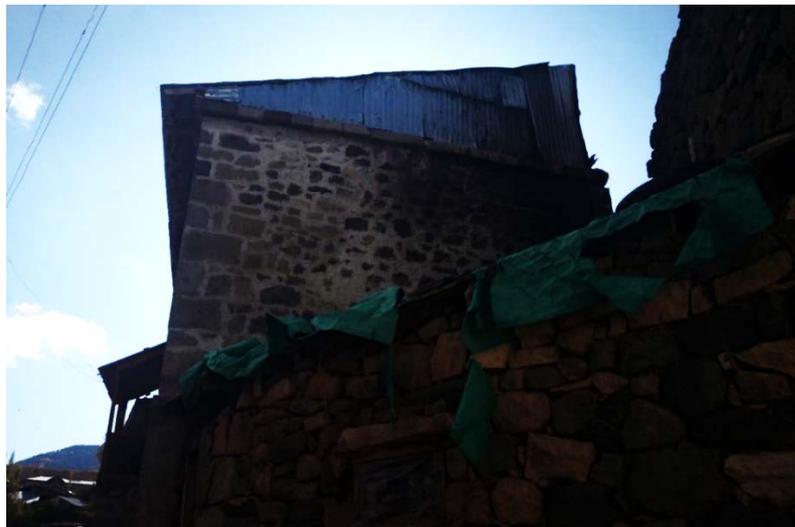
towards one direction, with wooden base and plating, is covered with plate material on the north side (Figure 3.19).

Figure 3.19. The east facade of Alişan Çakmur House.
(Photograph: Author, 2019)

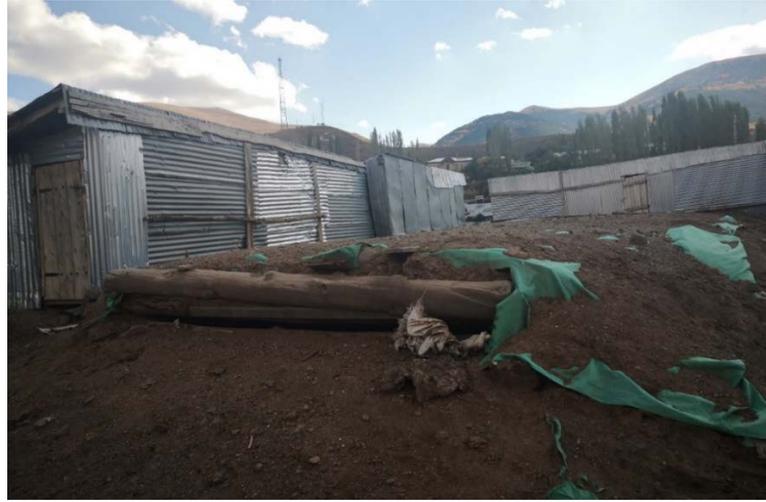
The west facade of the house can be seen from the roof of the *merek* and the old barn. This facade is adjacent to the west facade of Cevdet Çakmur House in the south. The west facade of the Alişan Çakmur House forms the back surface of the roof inclined towards one direction, rising from the east to the west and is completely covered with plate metal roofing material. The west wall of the bedroom is recessed to the east by 107 cm and forms a recession on the facade. There is a wooden door on this recessed part allowing access to the roof above *merek* through the attic (Figure 3.20).

Figure 3.20. The west facade of Alişan Çakmur House and Cevdet Çakmur House.
(Photograph: Author, 2019)

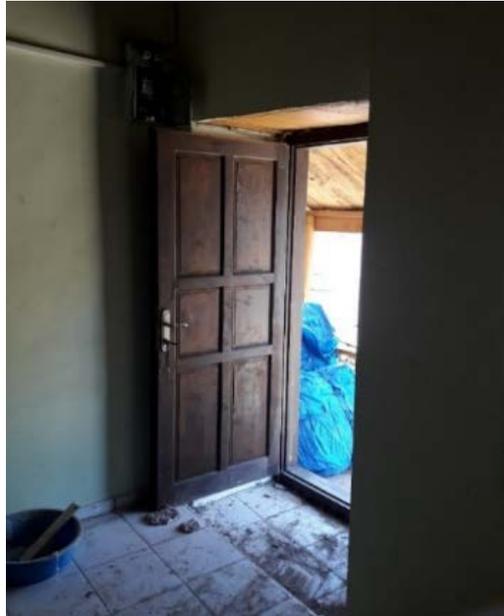
Entrance Door: Single leaf entrance door with 1.00x2.00 m measurements and its frame made of wood. The ceiling of the door opening is covered with wood (Figure 3.21).

Figure 3.21. Renewed entrance door during repair.
(Photograph: Author, 2019)

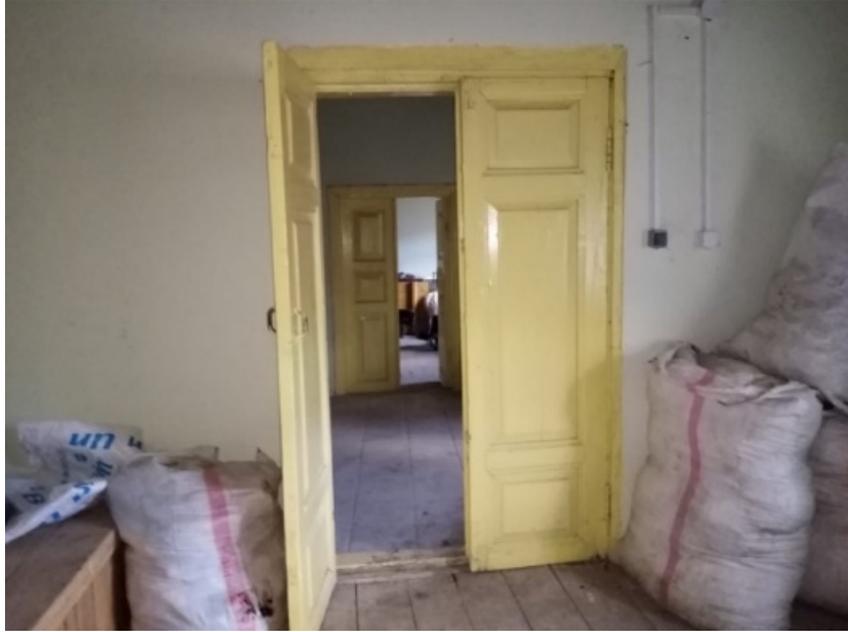
Daily Room Door: The door, which is known to be original, has an opening of 1.21x2.08 m and is biparting door (Figure 3.22). The wooden leaves open toward the lounge/daily room and are pieced to the frame by three hinges. In the hall front of the door has a wooden frame with the width of 14 cm and diagonal corner pieces. The doorframe on the facade of daily room is 8 cm wide. The door, which is 24 cm thick, has a wooden threshold of 12 cm wide and 7 cm high.

Figure 3.22. The view of the daily room door from the daily room.
(Source: Bahadır Küzeci, 2019)

There is no door handle on the eastern door leaf, which is 60.5 cm wide. This leaf has only the upper bolt. Mark of the lower bolt can be seen. In addition, there are marks of hinges on the surface where the leaf merges with the other leaf. It is understood that this leaf was reassembled by turning it upside down. The whole wooden door is painted with oil paint.

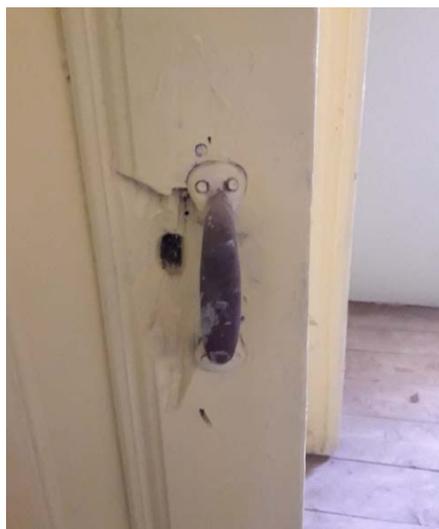
On the both sides of the 60.5 cm wide west leaf have a door handle one each made of cast iron (Figure 3.23). The keyhole is seen next to the door handles. There is a metal bolt used to stick the frame on the top of the leaf (Figure 3.24). The mark of underside bolt is seen.

Figure 3.23. Metal door handle of daily room door.
(Photograph: Author, 2019)

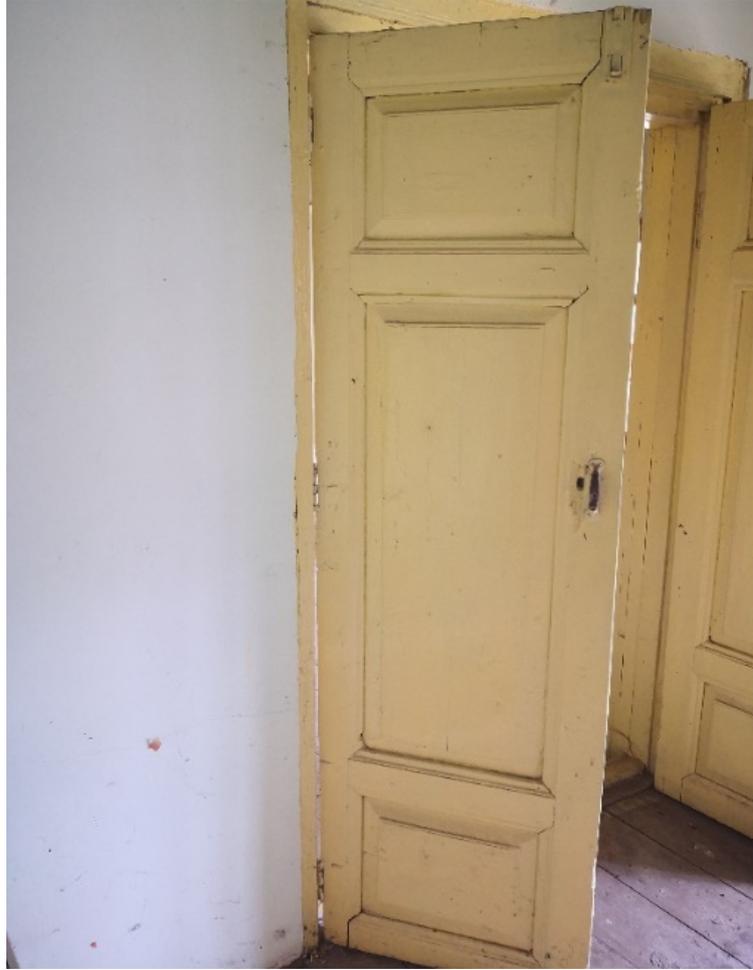
Figure 3.24. The metal bolt of the daily room door.
(Source: Bahadır Küzeci, 2019)

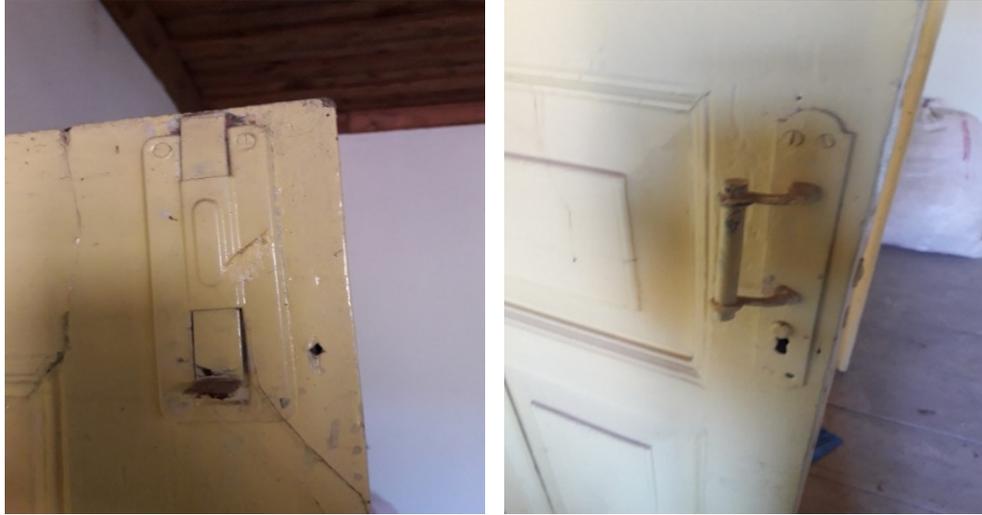
Bedroom Door: The wooden door, which is known to be original, has an opening of 1.03x 2.00 m and a depth of 22 cm, has double leafs and has 7 cm wide doorframe on both sides. The wooden doorframe is 18 cm wide and 5 cm high. On the inside and outside of 52 cm wide eastern door leaf has decorative metal door handles. The west leaf is 54 cm wide and has a 2 cm wide tread on which the other leaf can settle. On both leafs, there is one metal bolt that sticks the leafs to the doorframe (Figure 3.25).

Figure 3.25. Metal bolt and door handle
(Photograph: Author, 2019)

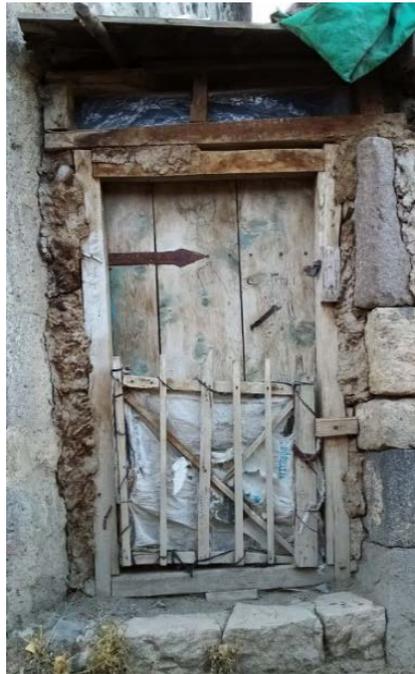
Figure 3.26. The *tirhiş* element.
(Source: Bahadır Küzeci, 2019)

Tirhiş: The wooden lattice on the outside of the door that provides access to the f area is 60x124 cm and is made by the users after the repair. It is closed when the entrance door is open to prevent animals from entering the interior. (Figure 3.26).

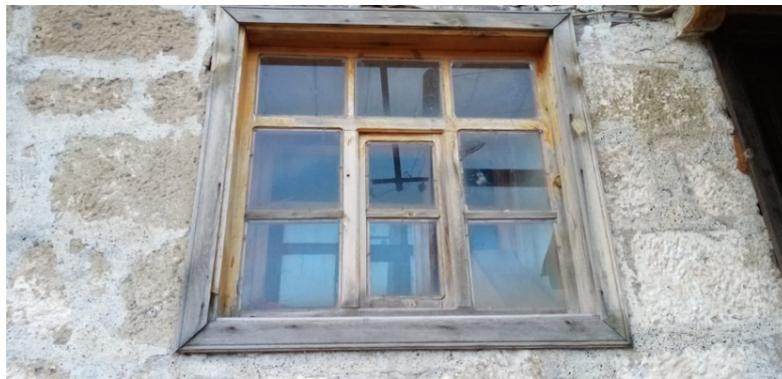
***Sofa* window:** There is a 127 cm wide, 126 cm high and 90 cm deep original window aperture on the east side of the *sofa*. There are windows one each on the interior and exterior surfaces of the window aperture. Wooden doorframes are seen on both facade and surfaces of interior area (Figure 3.27).

Figure 3.27. The view of *sofa* window from the east.
(Source: Bahadır Küzeci, 2019).

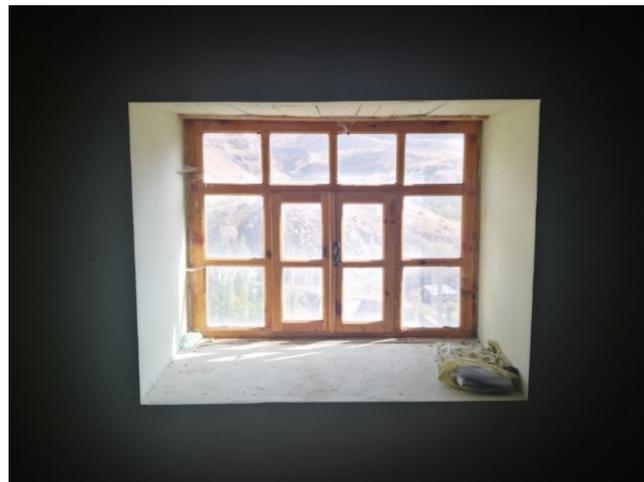
Figure 3.28. The view of daily room window from interior area.
(Photograph: Author, 2019)

Daily room window: It is a 138x111 cm window on the eastern facade of the daily room. Window opening is 148x111 cm in the interior and 138x111 cm on the exterior. In the narrowing part towards the exterior of the wall of 88 cm thickness, the wooden window that has been renewed within the scope of the repair has wooden doorframe on its facade surface. The bottom and side walls of the window opening are plastered and painted with plastic. The ceiling of the opening is covered with wood (Figure 3.28).

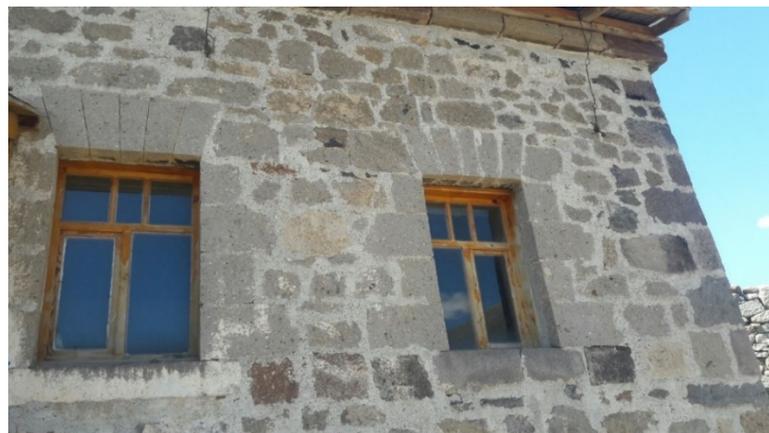
Bedroom windows: There are two windows on the eastern wall of the bedroom. There is a distance of 104 cm between the windows. Windows that have same size, narrow towards the exterior. The window openings are 120 cm interior and 90 cm wide exterior. Towards the exterior, the window frames are settled in the parts where the window opening is flattened.

The upper surface of window openings is each a jack arch made of stones by five. The jack arch stones are wedge-shaped. Four cut stones were used as one long and one short towards down from up on the sides of the window. Trapezoid shaped stones cut according to the angle of the arch stone were used in the mergence of the outer arch stones and the blocks on the windowsill. There are stone windowsills under the windows. A crack is seen on the windowsill of the northern window (Figure 3.29).

Figure 3.29. The view from the east of the bedroom windows.
(Photograph: Author, 2019)

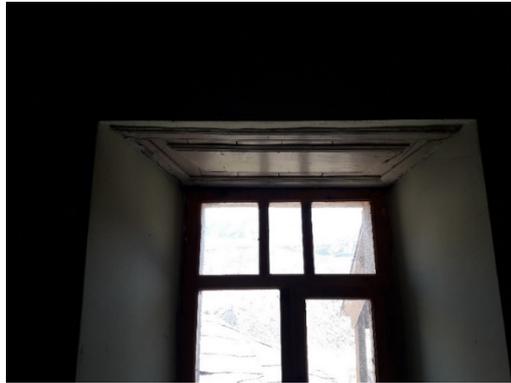
The window joinery, which are completely renewed during the repair, are divided into two by a transverse muntin close to the upper part. The three niches, which are at the

top of the muntin, the equal size in next two and the narrower in the middle, are stable. Under the middle frame there are two sashes one of which is openable. The ceiling parts of the window openings are covered with wood (Figure 3.30).

Figure 3.30. The view of bedroom north window after repair.
(Photograph: Author, 2019)

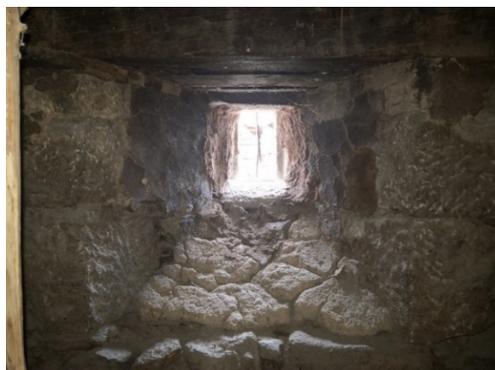
Warehouse windows: On the eastern wall of the warehouse, there are two embrasure windows opening equally sized, enlarging towards exterior. The windows have an opening of 68x 62 cm on the interior and 15x27 cm on the facade. The window openings are flattened starting from 12 cm behind the facade surface. The bonding timber pass through the windows indoors. The ceilings of the window openings are covered with wood. Window openings are unplastered, but soil plaster ruins are seen on the opening grounds (Figure 3.31).

Figure 3.31. The view from indoors of the north window of the warehouse.
(Photograph: Author, 2019)

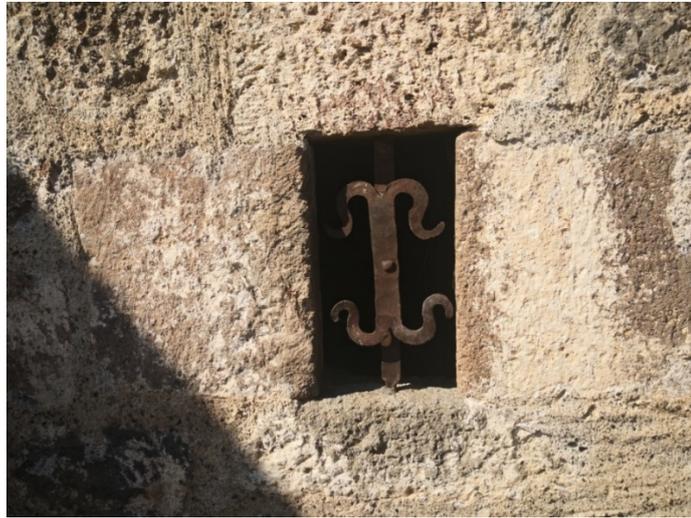
There is no woodwork in the windows. There is an ornamented cast iron bar on the north window. It is understood that this element was made to prevent the entrance of animals to the area used as grain storage (Figure 3.32 and Figure 3.33).

Figure 3.32. Warehouse north window and metal bar element.
(Photograph: Author, 2019)

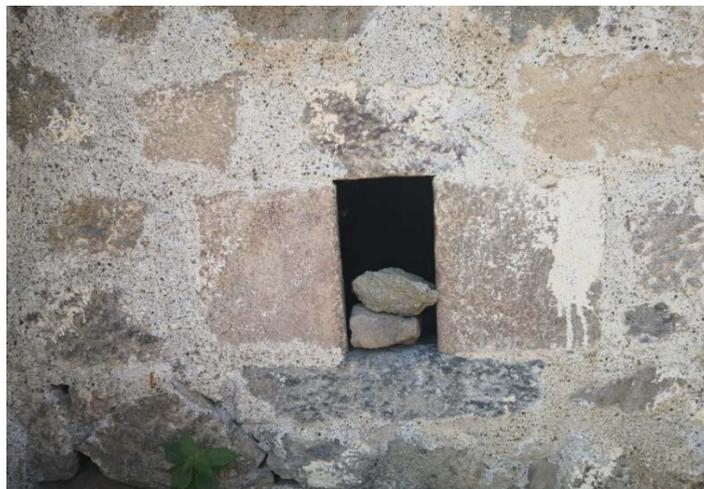
Figure 3.33. Warehouse south window.
(Photograph: Author, 2019)

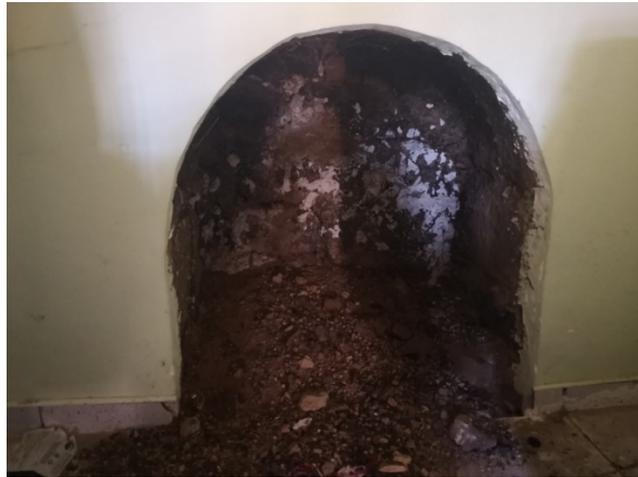
Sofa Fireplace and Its Niche: On the western wall of the *sofa*, there is semi-circle arched fireplace which have a 70 cm opening and 71 cm height. In the north of the fireplace is a niche measuring 18x20 cm on the south side of the bedroom wall (Figure 3.34 and Figure 3.35).

Figure 3.34. *Sofa* fireplace.
(Photograph: Author, 2019)

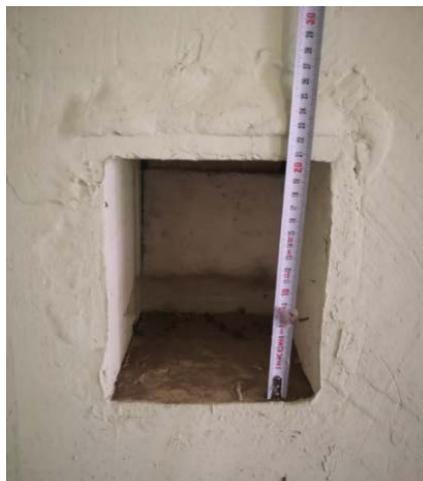
Figure 3.35. *Sofa* fireplace niche.
(Photograph: Author, 2019)

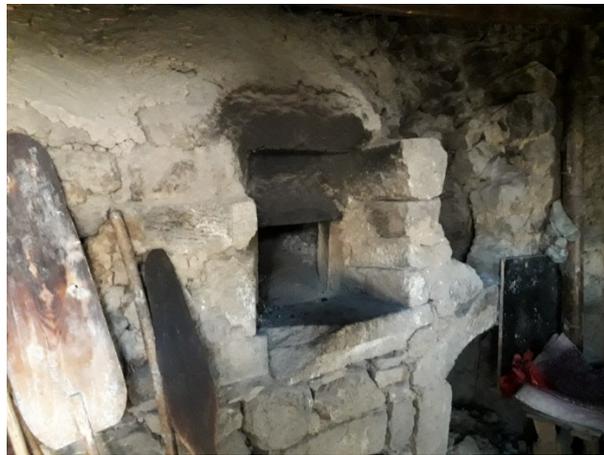
Fireplaces in Furnace: There are two fireplaces, one is one-chambered and other is two on the western wall of the furnace. Today these fireplaces are used in the south. The fireplace with damaged cover is 68 cm wide. There is a 39x32 cm chamber under this fireplace. The northern fireplace is 68 cm wide and 115 cm high. The arch of the fireplace at the ground level is in good condition. However, it is not used because its flue is damaged.

The fireplaces have dome-like covers. The soil plaster ruins on the surfaces of the covers are seen. The fireplaces, which were largely destroyed during the earthquake, were partially repaired by the users (Figure 3.36).

Figure 3.36. Fireplaces in the furnace.
(Photograph: Author, 2019)

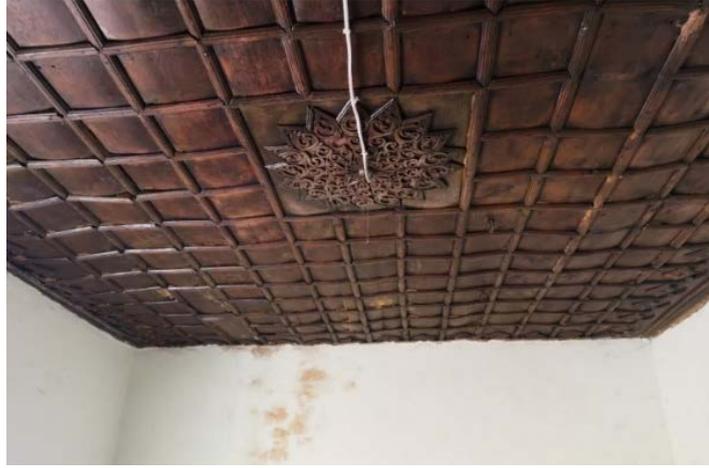
Daily Room Ceiling: The original ornamented wooden ceiling belonging to daily room has survived to today. The ceiling, which its profile is surrounded by a lath, is divided into 16x16 cm squares with 3.5 cm wide profiled wooden laths (Figure 3.37). The square surfaces where the ceiling merges the walls are enriched with floral motifs. Among the floral motifs, a motif consisting of interwoven squares is repeated (Figure 3.38).

Figure 5.37. The ceiling of the daily room.
(Photograph: Author, 2019)

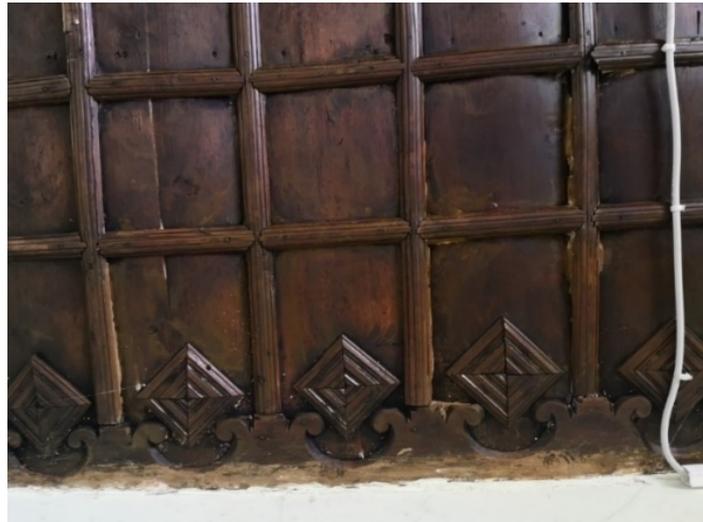
Figure 3.38. Detail of the mergence of daily room ceiling with the wall.
(Photograph: Author, 2019)

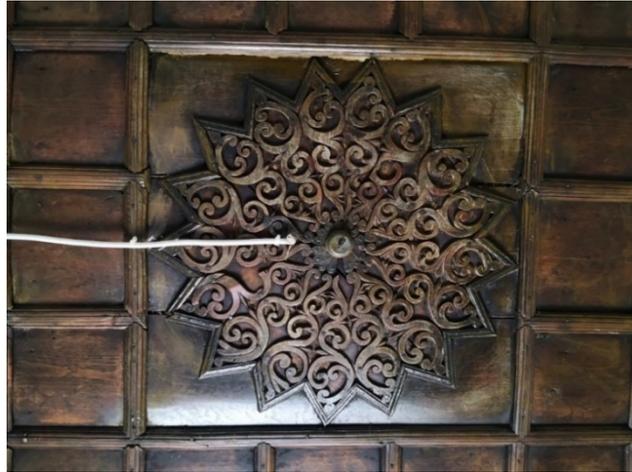
The ceiling rose is located 9-square-part in the middle ceiling. The rose is in the form of a 17-angled star. There are spiral plant motifs on the ceiling rose extend decreasing from the corners to the center. From oral sources¹² it was learned that this detail was designed by Emin Usta and that it was put on the ceiling after engraved into wood by Molla Mehmet (Figure 3.39).

Figure 3.39. The rose detail of daily room ceiling.
(Photograph: Author, 2019)

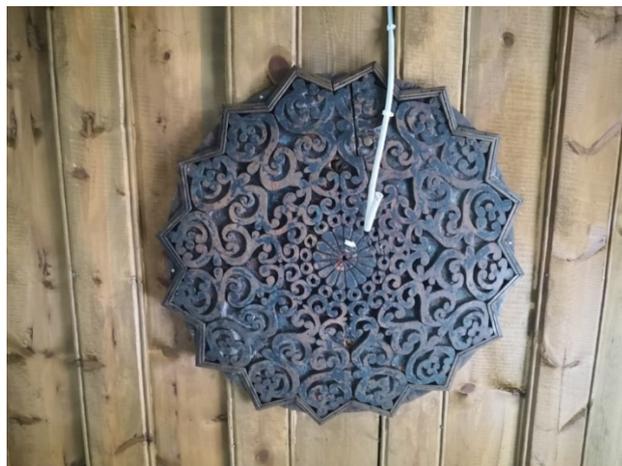
The original ceiling rose was cut and placed on the original reconstructed ceiling during the repair. The rose consists of a 16-angled star, placed on a 110-centimeter circle. The element known to be made by Greek users consists of floral motifs narrowing towards the centre, similar to the ceiling rose in the daily room (Figure 3.40).

Figure 3.40. The detail of bedroom ceiling rose.
(Photograph: Author, 2019)

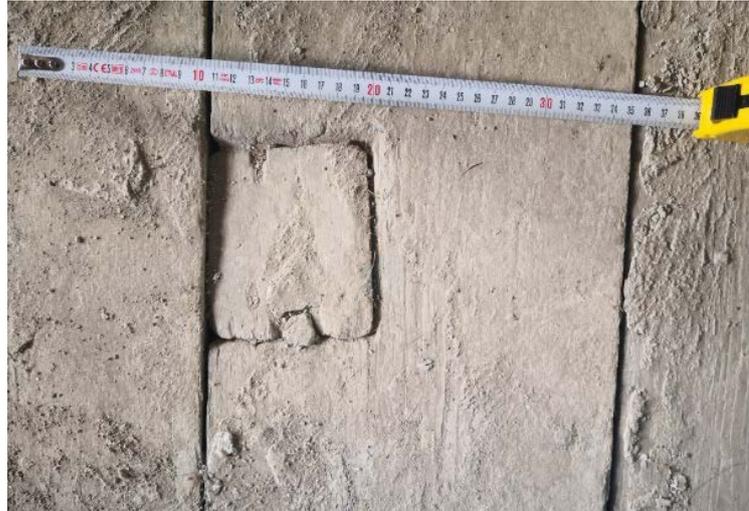
There are 3 chocks measuring 10x12 cm on the wooden ground of the bedroom. It is understood that these chocks close the holes the warehouse used for storage to spread grain and which is located below the bedroom (Figure 3.41).

Figure 3.41. The wedge on the bedroom ground.
(Photograph: Author, 2019)

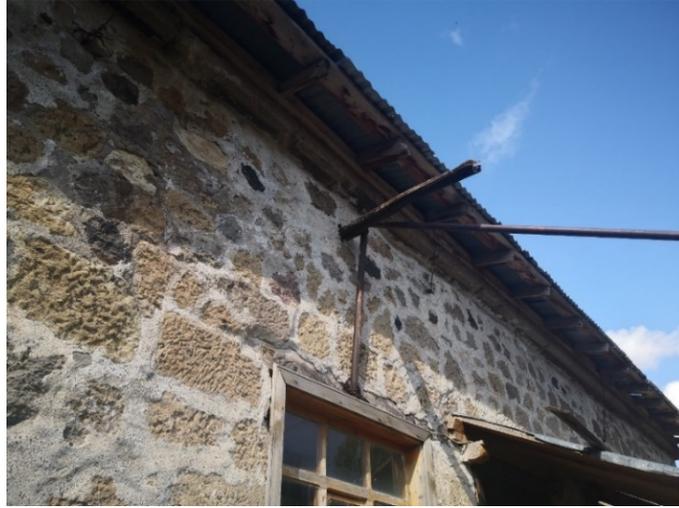
There is a wooden element protruding 80 cm from the surface of the facade 110 cm above the *sofa* window of Alişan Çakmur House (Figure 3.42). It is believed that this element was used to carry material with rope to the roof, which was originally soil.

Figure 3.42. Wooden element on the east façade.
(Photograph: Author, 2019)

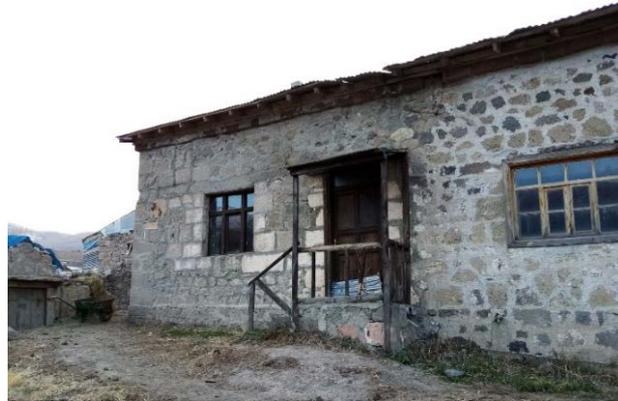
Cevdet Çakmur House is one-storey and it consists of three areas. These areas are hall, daily room and bedroom (Figure 3.43).

Figure 3.43. The view of the Cevdet Çakmur House from the northeast.
(Source: Bahadır Küzeci, 2019)
