**INVESTIGATION AND EVALUATION OF
TECHNICAL, ADMINISTRATIVE AND LEGAL
DECISIONS DURING THE RESTORATION
PROCESS OF AKMUR HOUSES**

**A Thesis Submitted to
the Graduate School of Engineering and Sciences of
İzmir Institute of Technology
in Partial Fulfilment of the Requirements for the Degree of**

in Architectural Restoration

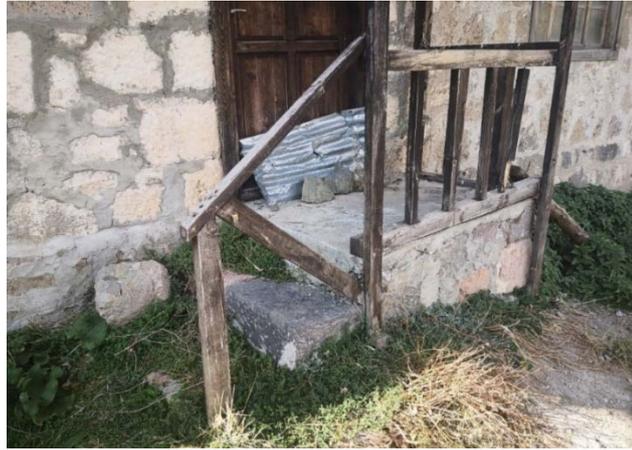
The house is accessed from the entrance landing measuring 1.50x1.16 m which is on the east facade of the house and reached by two stone steps. The stone steps and landing are surrounded by wood railings. The upper surface of the landing is covered with sheet metal material inclined single direction (Figure 3.44).

Figure 3.44. Entrance landing of Cevdet Çakmur House.
(Photograph: Author, 2019)

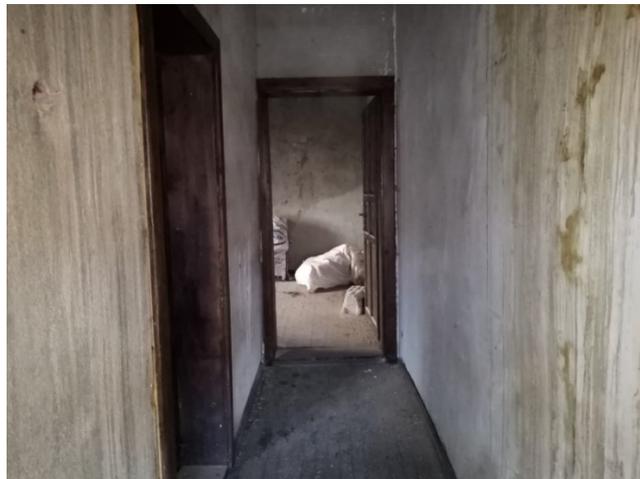
The hall is entered through a wooden door with a top window, single wing, measuring 104x240 cm, on the east side of the house. In the west of hall measuring 1.01x4.14 m has a daily room and a bedroom in its south (Figure 3.45).

Figure 3.45. The view of the hall from the entrance door.
(Source: Bahadır Küzeci, 2019)

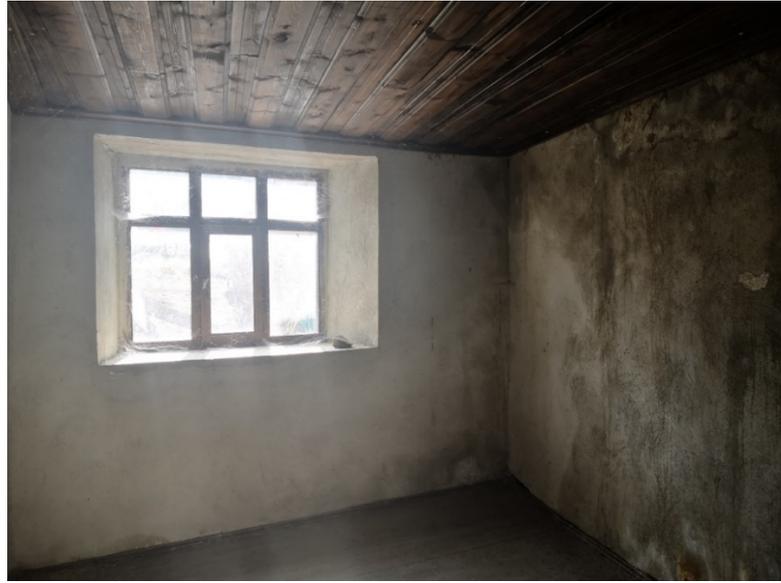
The daily room in west of the hall is accessed by a single-sashed wooden door measuring 116x171 cm. There is a window measuring 142x142 cm on the south wall of the 15.5 m² sized daily room and the original fireplace on the north wall (Figure 3.46 and Figure 3.47).

Figure 3.46. The view of daily room in Cevdet Çakmur House.
(Photograph: Author, 2019)

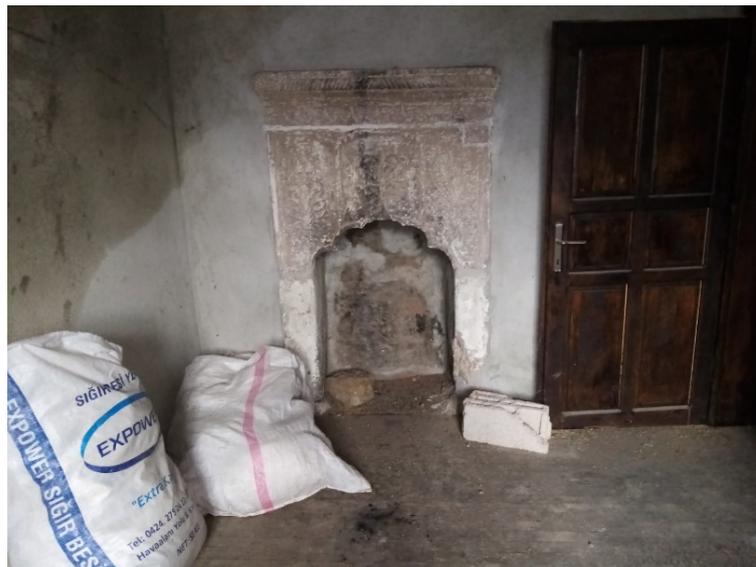
Figure 3.47. The view of daily room fireplace from the south.
(Source: Bahadır Küzeci, 2019)

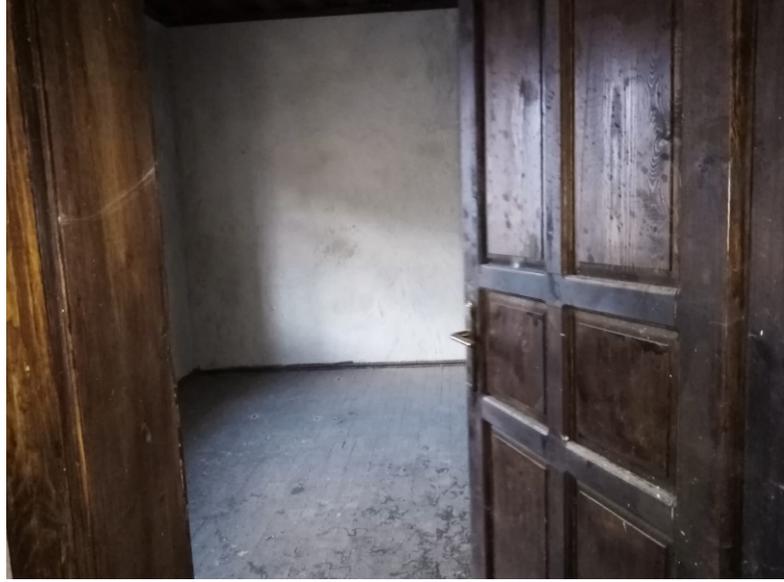
The bedroom is accessed from a single-sashed wooden door measuring 119x186 cm on the south wall of the hall. This room is in 4.02x2.85 m and covers 142x142 cm on the eastern wall (Figure 3.48).

Figure 3.48. The view of the bedroom from the hall.
(Source: Bahadır Küzeci, 2019)

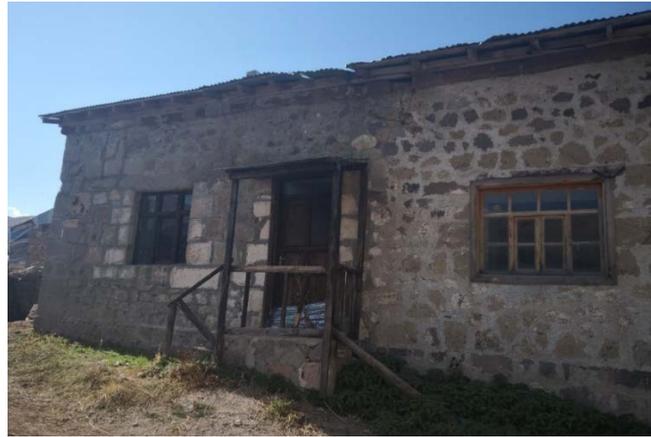
In the mergence of the east and south facade, obfuscatory cut stones arranged from subbasement line up to the reinforced concrete beam were used. The same stone masonry is seen at the ledges of the window and door openings on the facade. The subbasement part, which protrudes 2 cm from the surface of the facade, is built with pitch-faced stone. In the part between the sub-basement line and the windowsill, serial rubble stones were used. The ledges of the windows between the reinforced concrete beam and the windowsills made of cut stones were built with cut stones. Between the reinforced concrete beam and the cornice, both rubble and cut stone bonding are seen (Figure 3.49).

Figure 3.49. The east facade of Cevdet Çakmur House.
(Photograph: Author, 2019)

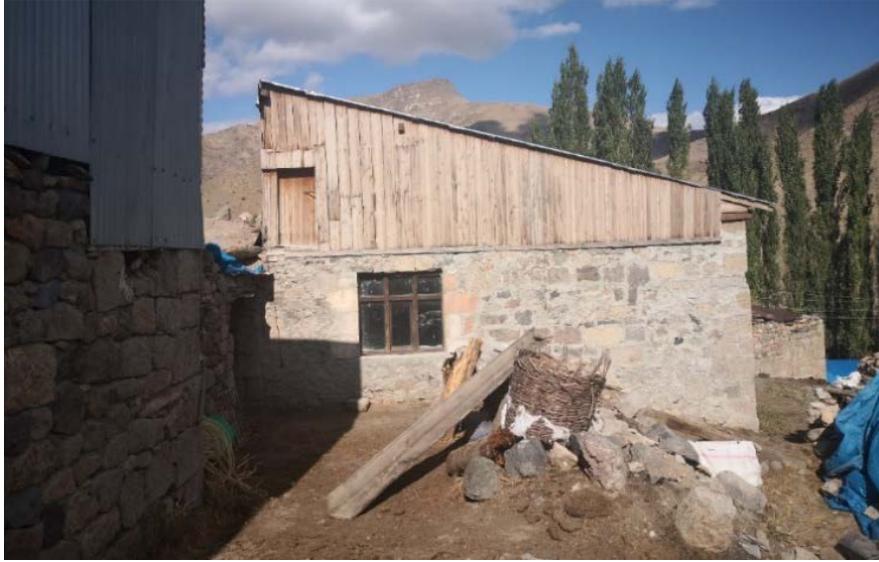
The south facade of the building merges precipitously to the eastern wall of the old barn. The facade consists of the south wall of the daily room and the triangular wooden surface formed by the roof slope. On the facade, there is a daily room window and a wooden door on the side surface of the roof. Cut stones were used in the corner of the facade and on the ledges of the daily room window. The triangular wooden surface formed by the slope of the roof and the wall of daily room; 6 cm wide wooden moulding passes over 22 cm of the window (Figure 3.50).

Figure 3.50. The east facade of Cevdet Çakmur House.
(Photograph: Author, 2019)

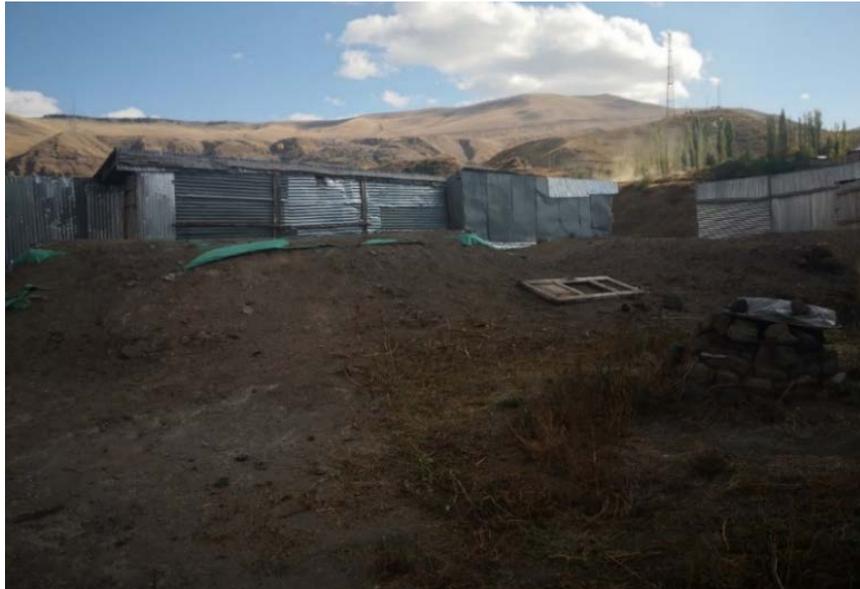
The west facade can be seen over the old barn. The facade, which consists of the back surface of the roof space, is metal covered with metal sheet (Figure 3.51).

Figure 3.51. The west facade of Alişan Çakmur House and Cevdet Çakmur House.
(Photograph: Author, 2019)

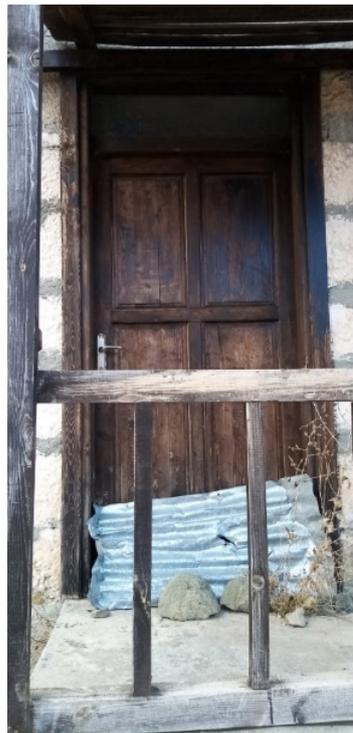
Entrance Door: The entrance door on the east side of the house is 104x240 cm. Single-leaf door and doorframes and sill are wooden. The abat-jour window on the entrance door provides lighting of the hall area (Figure 3.52).

Figure 3.52. The view of the entrance door from the east.
(Source: Bahadır Küzeci, 2019)

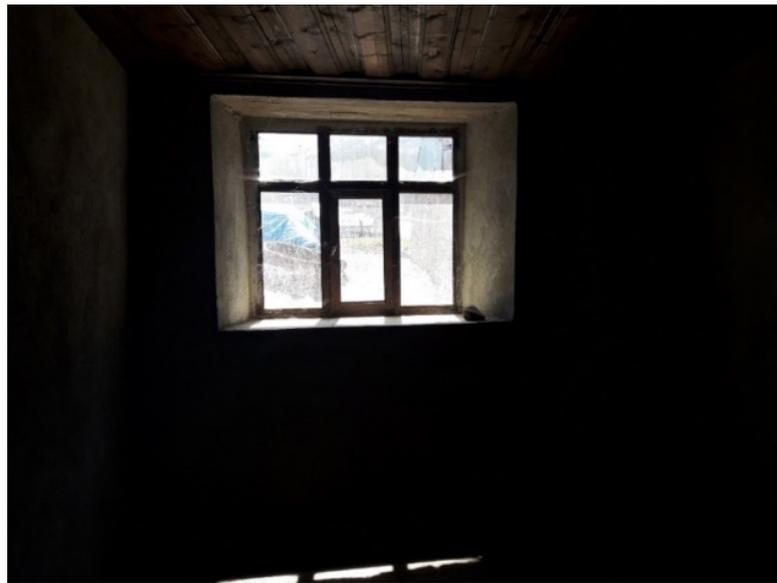
Daily Room Window: Daily room window is on the south facade and is wood. The window opening that extends from the interior area to the outside is 163 cm indoors; 142 cm wide on the facade. The depth of the window opening is 84 cm. The window frame measures 142x142 cm. The upper part of the window, which is divided into three vertically, is stable. In the lower part, there are three stable sashes on the two sides and the opening in the middle.

On the exterior, both sides of the window are bordered by one short and one long four cut stones (Figure 3.53).

Figure 3.53. Cevdet Çakmur House, daily room window.
(Photograph: Author, 2019)

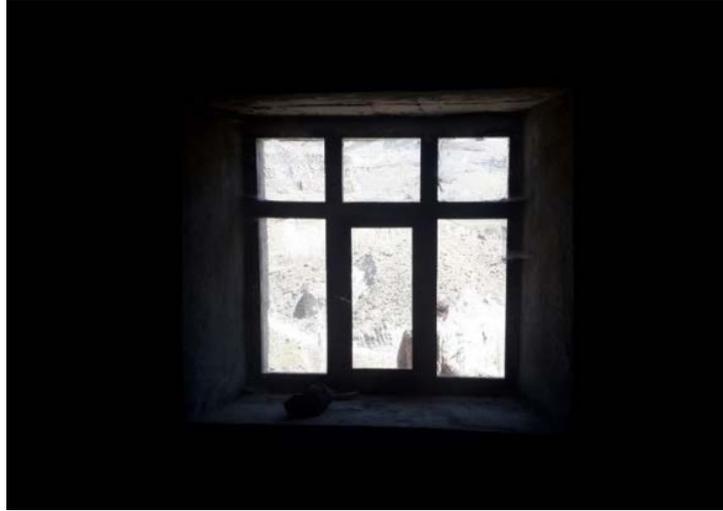
Bedroom Window: The bedroom window is located on the east facade and is made of wood. The window aperture that extends from the interior area to the exterior is 163 cm indoors; 142 cm wide on the facade. The depth of the opening of the window is 52 cm. The window frame and its joineries are similar to the daily room windows (Figure 3.54).

Figure 3.54. The bedroom window of Cevdet Çakmur House.
(Photograph: Author, 2019)

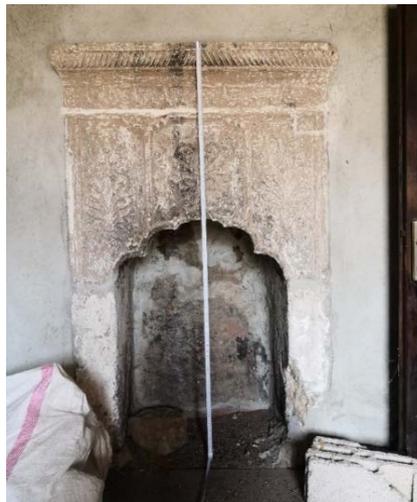
The fireplace of the house is on the northern wall of the daily room and 75 cm away from the western wall of the room. The fireplace measuring 109x168 cm has a depth of 85 cm. The face of the fireplace, which opens into the room, is arranged with an ornamental stone facing, cusped arches. There are geometric and floral motif reliefs on the furnace which has symmetrical ornament (Figure 3.55 and Figure 3.56).

Figure 3.55. Cevdet Çakmur House, the fireplace in the daily room.
(Photograph: Author, 2019)

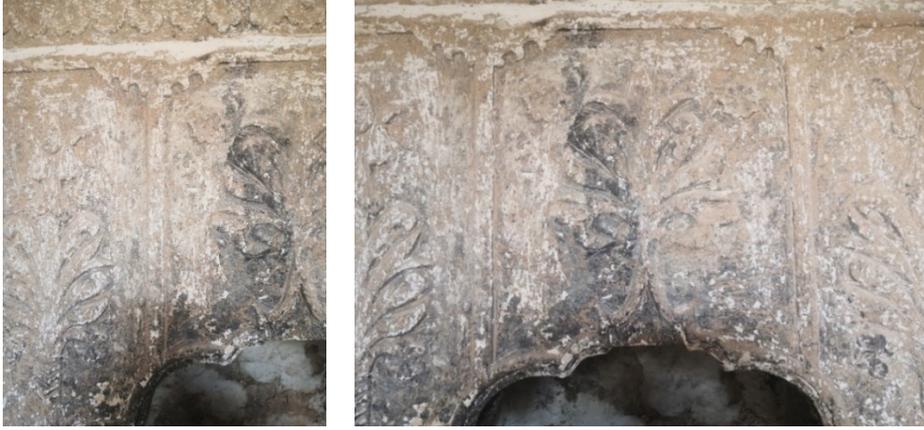
Figure 3.56. Reliefs on fireplace.
(Photograph: Author, 2019)

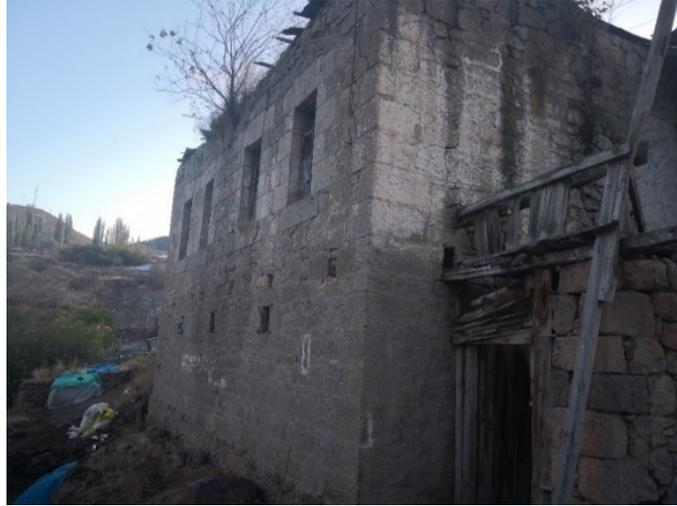
The basement of the building is reached by a wooden frame door opening on the eastern wall of the entrance landing (Figure 3.57). There is a single-leaf wooden door which provides access to the cellar on the south wall of the middle area is in ruins. There are 8 studs with circular sections that carry the ceiling, the cellar measures 8.90x6.65 m (Figure 3.58). The area is lighted by three embrasures on the east wall and one embrasure on the south wall.

Figure 3.57. Door under the landing providing access to the basement of the building
(Photograph: Author, 2019).

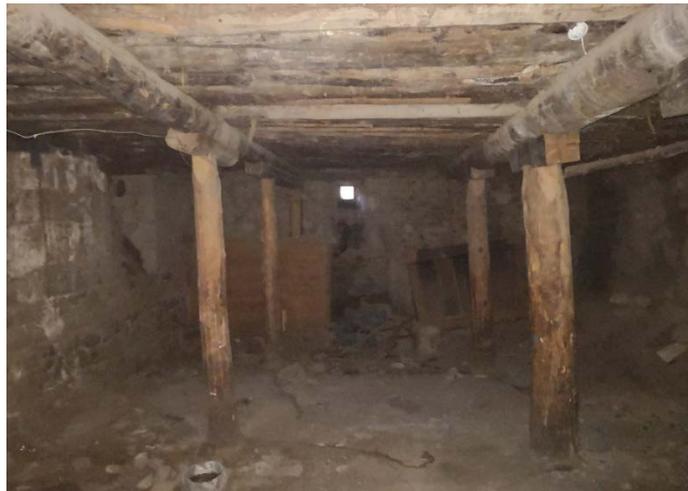
Figure 3.58. The view of the cellar from the entrance door.
(Photograph: Author, 2019)

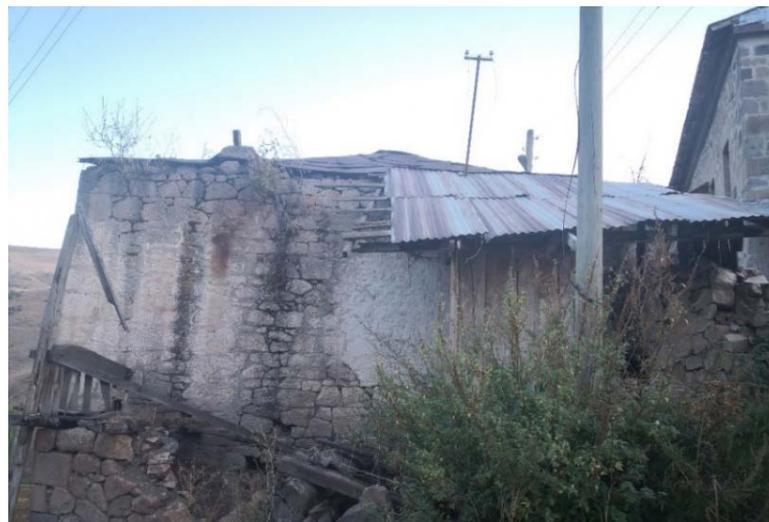
The retaining wall to the west of the facade and the landing extending along the facade were largely demolished. In the coursed rubble stone facing walls, material loss, vegetation and colour changes are seen (Figure 3.59).

Figure 3.59. The north facade of Adnan Çakmur House.
(Photograph: Author, 2019)

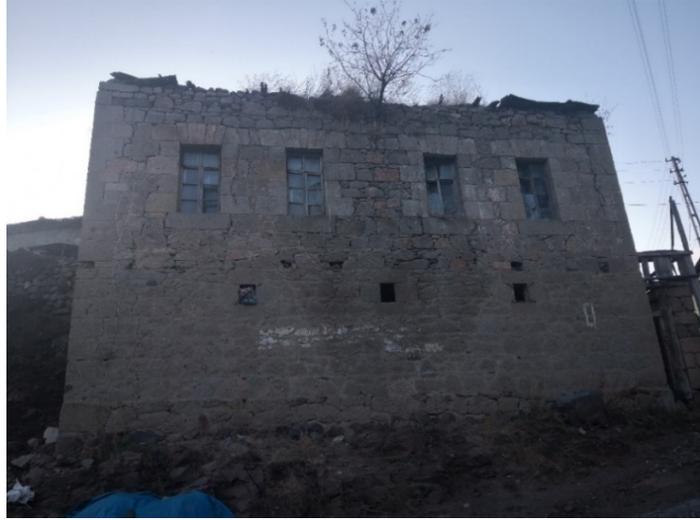
East Facade: The east facade of the building is formed by the eastern walls of the entrance landing, bedrooms and cellar. To the north of the facade, there is a single-storey entrance landing built adjacent to the building. On the eastern wall of the landing there is a wooden frame door opening which have heavily destroyed (Figure 3.60 and Figure 3.61).

On the surface of the facade, there are four vertical rectangular bedroom windows and three embrasures of the cellar. Between the embrasures and the bedroom windows there are wooden arranged slots along the facade.

There are cut stones around the window openings and in the corners of the facade, and the remaining surfaces are coursed rubble stone bonding.

Figure 3.60. The east facade of Adnan Çakmur House.
(Photograph: Author, 2019)

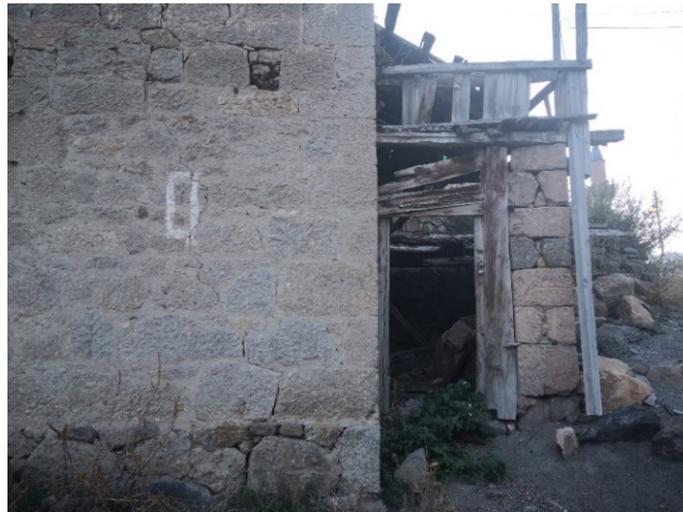
Figure 3.61. Door opening on the eastern wall of the entrance landing.
(Photograph: Author, 2019)

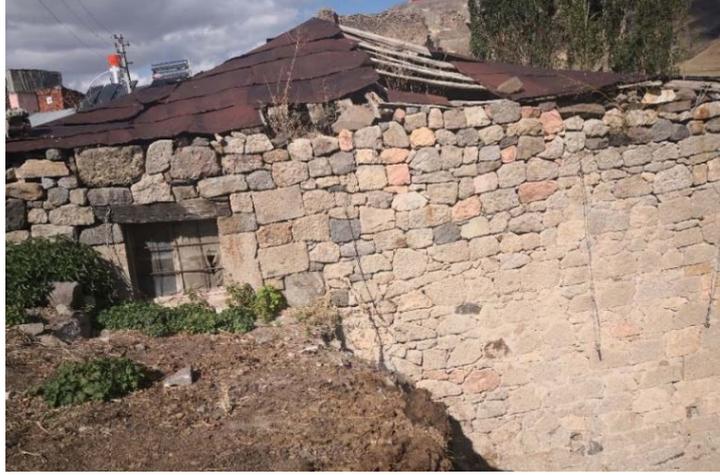
South Facade: The south facade of the building consists of the southern part of the *sofa* on the ground floor, the southern bedroom and the south facade of the cellar on the basement floor. Due to the slop of the land, the western part of the cellar facade is underground (Figure 3.62).

Figure 3.62. The south facade of Adnan Çakmur House.
(Photograph: Author, 2019)

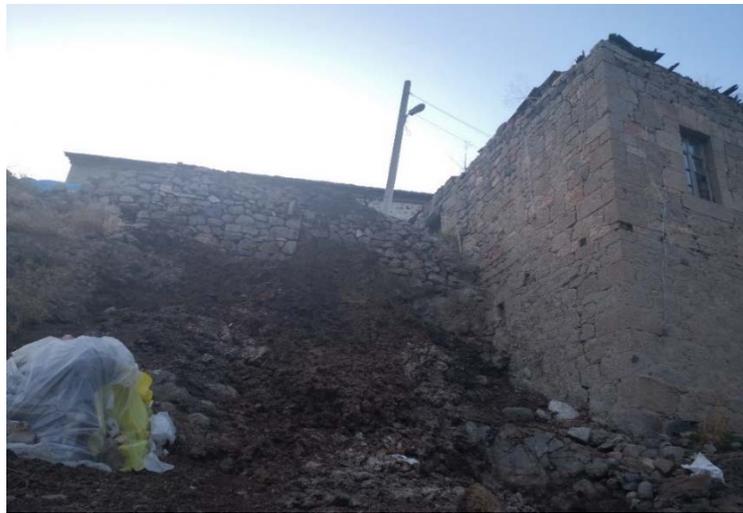
On the facade, there is a wooden lintel *sofa* window on the ground floor and an embrasure of the cellar on the basement floor. In the eastern corner of the facade, there

are cut stones, and on the other surfaces there are coursed rubble stone bonding (Figure 3.63).

Figure 3.63. The view of the south facade from the southeast.
(Photograph: Author, 2019)

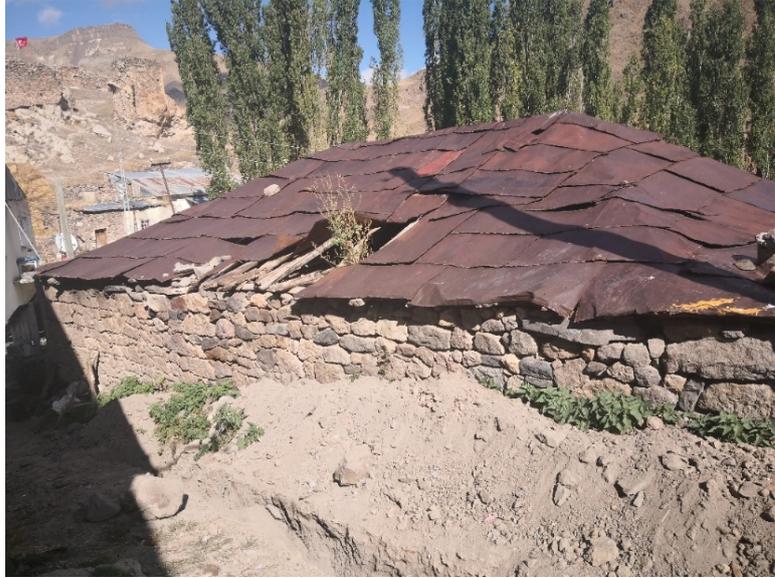
West Facade: Due to the slop of the land rising from east to west, the west facade of Adnan Çakmur House can be partially seen. There is no opening on the facade which was built with the coursed rubble stone bonding (Figure 3.64).

Figure 3.64. The view of the west facade from Alişan Çakmur House (Photograph: Author, 2019).

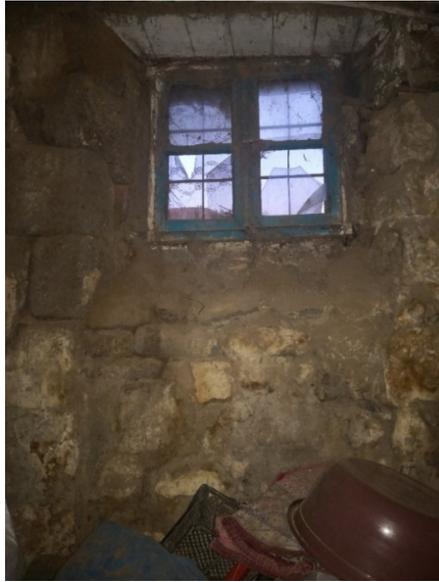
Sofa window: *Sofa* window is on southern wall of the *sofa* and the opening is adjacent to the ceiling. The window opening is 96x112 cm indoors and 86x92 cm on the exterior. The walls of the aperture are unplastered, and its ceiling is timber cover. Wooden window frame and metal railings are placed in the part where the window aperture is flattened towards the exterior.

There is a wooden lintel on the exterior on the window opening. The right and left side of the opening and windowsill is cut stone (Figure 3.65 and Figure 3.66).

Figure 3.65. The view of *sofa* window from interior.
(Photograph: Author, 2019).

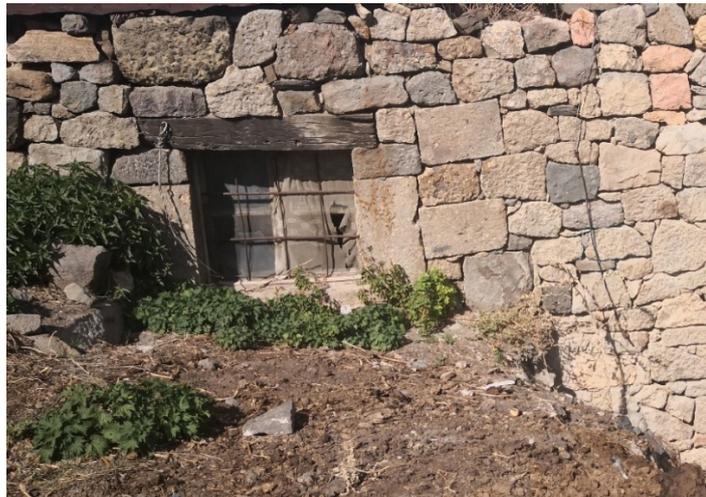
Figure 3.66. The view of *sofa* window from the south.
(Photograph: Author, 2019)

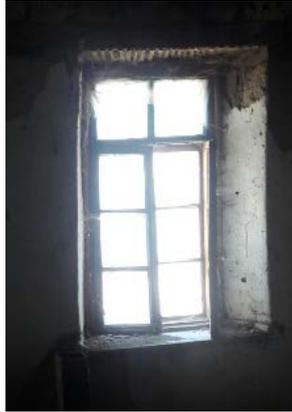
Windows in bedrooms: There are found equal window openings on the east wall of the bedrooms. The window opening narrows towards the exterior. The openings are 106 cm wide interior and 90 cm wide exterior. In the parts where the window opening is flattened towards the exterior, woodwork windows are placed in two vertically and four horizontally (Figure 3.67).

Figure 3.67. The south window of the south bedroom.
(Photograph: Author, 2019)

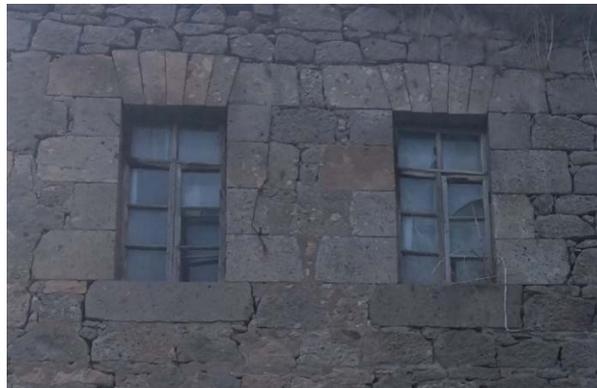
The upper surface of window openings is flat arched each made of five stones. The flat arched stones are wedge-shaped. The four cut stones were used as one long and one short from down to up on the ledges of the window. There are stone windowsills under the windows (Figure 3.68).

Figure 3.68. The windows of south bedroom.
(Photograph: Author, 2019)

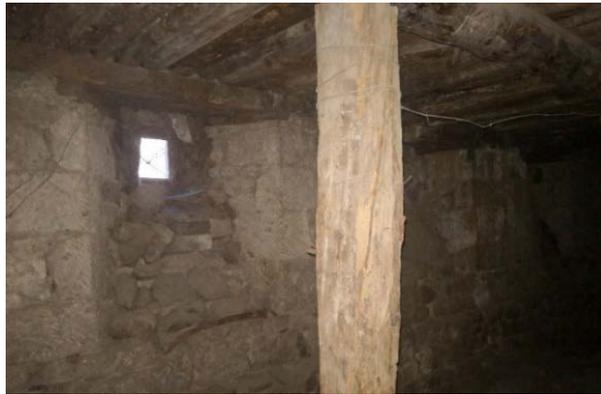
Cellar windows: There are three embrasures on the eastern wall of the cellar and one embrasure on its south wall. The openings narrow from the interior to the facade. Equally sized windows have an opening of 116x130 cm on the interior and 18x27 cm on the exterior. The window openings are flattened starting from 14 cm behind the facade

surface. The timber beam pass over the windows at the interior. Cut stone on the right and left of the unplastered window openings and rubble stone bonding on the floor are seen. The ceiling of the openings is covered with wood. The embrasures are formed with cut stones on the facade (Figure 3.69 and Figure 3.70).

Figure 3.69. The view of the embrasure on the east facade from interior.
(Photograph: Author, 2019)

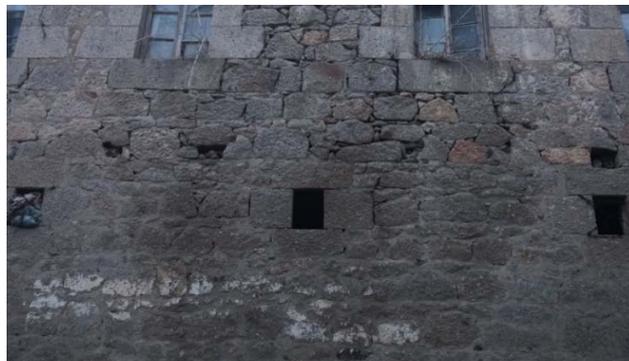
Figure 3.70. Embrasures on the east façade.
(Photograph: Author, 2019)

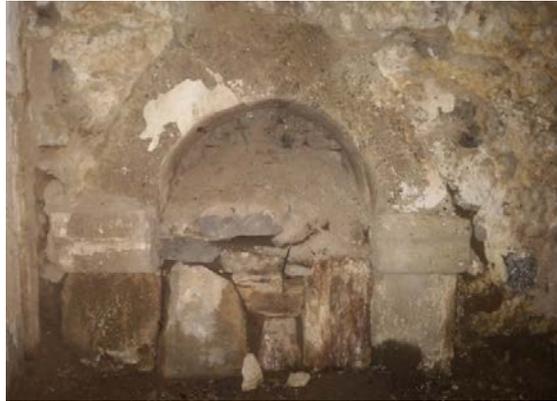
It is seen arch bases which is profiled stone on cut stone curbs. There is a semi-circular arch consisting of three cut stones on the bases (Figure 3.71).

Figure 3.71. *Sofa* fireplace.
(Photograph: Author, 2019)

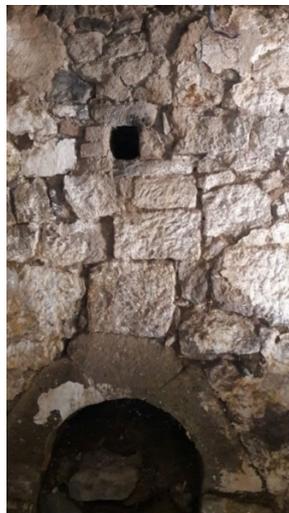
There is a 12x12 cm niche 60 cm above fireplace not used today (Figure 3.72).

Figure 3.72. Niche above the *sofa* fireplace.
(Photograph: Author, 2019)

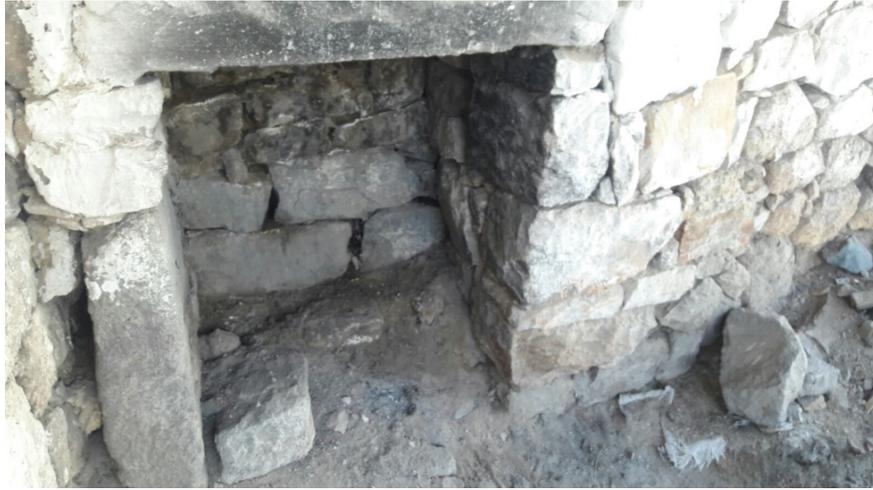
Entrance landing fireplace: There is a fireplace 60x76 cm with rectangular opening on the retaining wall to the west of the entrance landing (Figure 3.73).

Figure 3.73. Entrance landing fireplace.
(Photograph: Author, 2019)

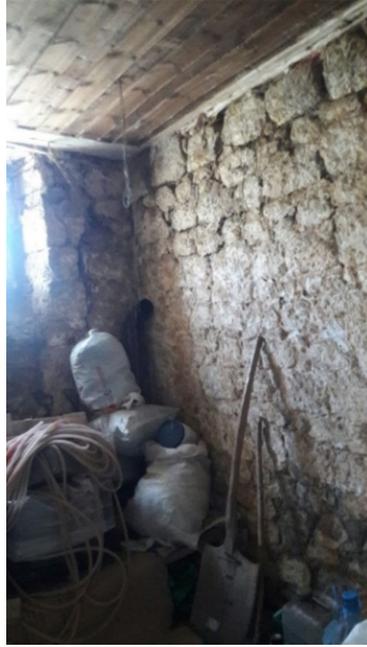
The destroyed ceilings of the *sofa* and bedrooms are wooden ceilings with batten cleat. The ceiling of the cellar is wooden joisting (Figure 3.74).

Figure 3.74. The mergence of southern and western wall and ceiling of the *sofa*.
(Photograph: Author, 2019)

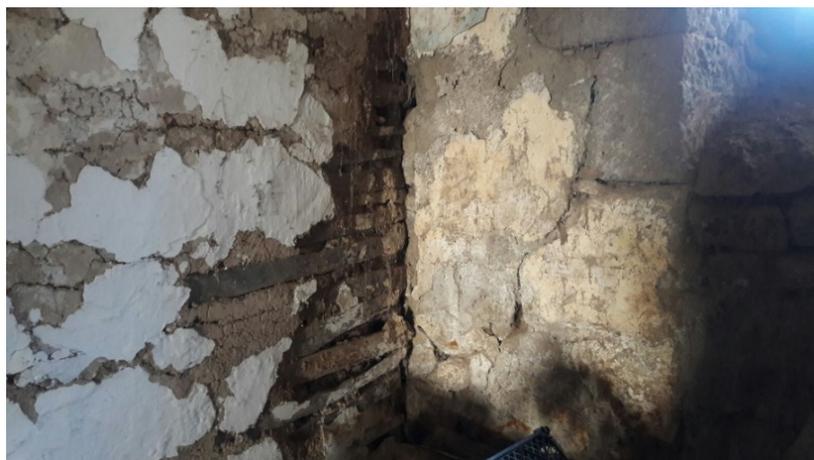
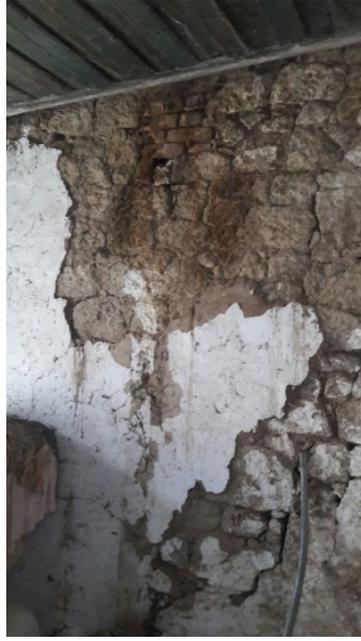
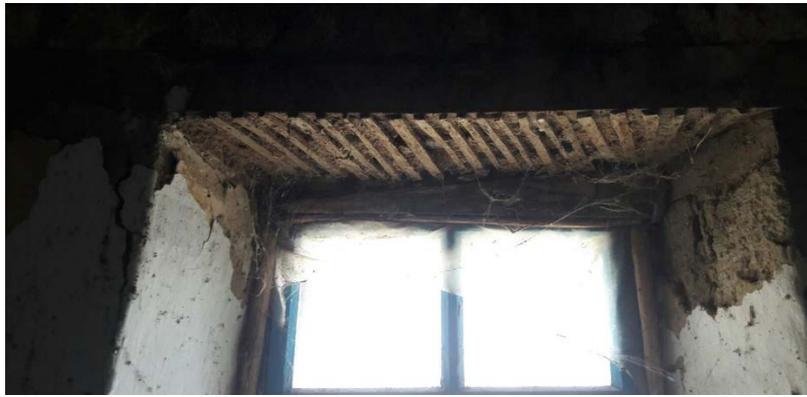
The exterior walls of the building and the interior walls of the cellar are unplastered. Plaster in powder form, which is largely damaged is seen on the load-bearing walls of the ground floor. On the baffle walls, there is plaster made by lath and plaster technique (Figure 3.75, Figure 3.76 and Figure 3.77).

Figure 3.75. The mergence of the south bedroom and the south wall of the building.
(Photograph: Author, 2019)

Figure 3.76. The west wall of the building.
(Photograph: Author, 2019)

Figure 3.77. The north window of the south bedroom.
(Photograph: Author, 2019)

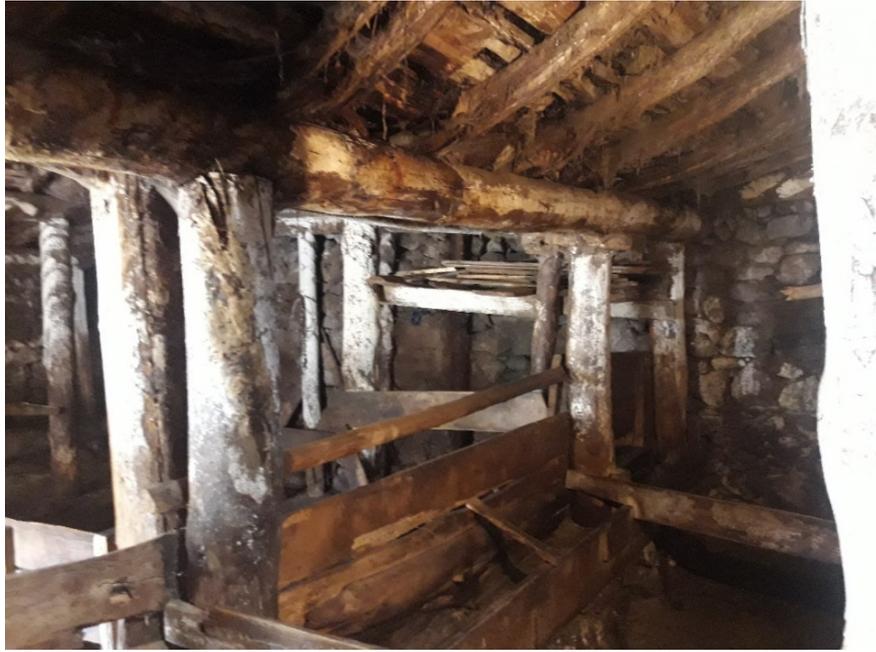
The old barn is one-storey and consists of two parts as the north and the south. The northern and southern parts are divided by the circular wooden posts and wooden screens (Figure 3.79).

Figure 3.79. Serial of wooden posts separating the northern and southern parts.
(Photograph: Author, 2019)

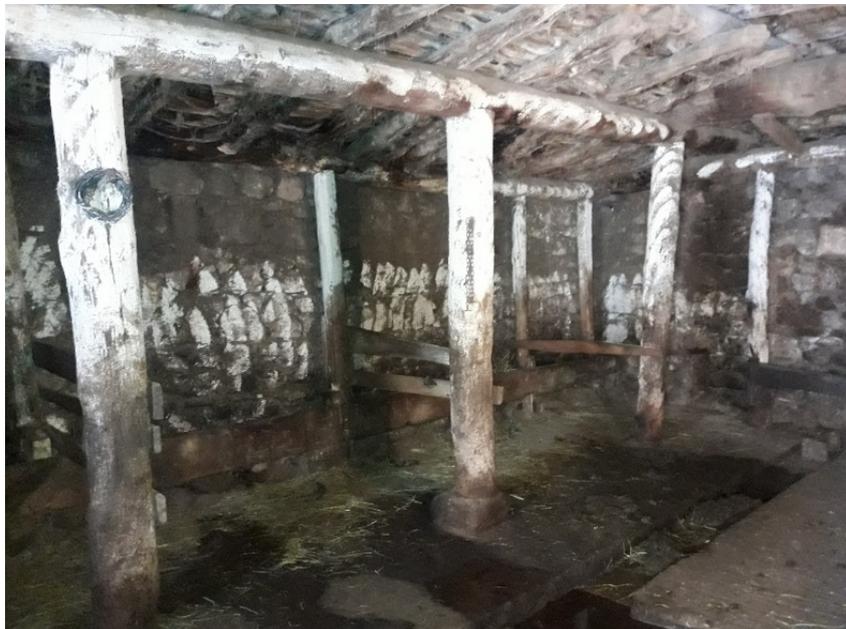
The building is entered by a single-leaf wooden door measuring 120x185 cm on the east wall of the southern part. The southern part measures 9.75x12.20 m and is supported by 19 circular cross wooden studs of various sizes (Figure 3.80). The area is lighted with a window aperture of 55x66 cm on the eastern wall.

Figure 3.80. The view of the southern part from the entrance door. The wall on the left separates the old barn and new barns (Photograph: Author, 2019).

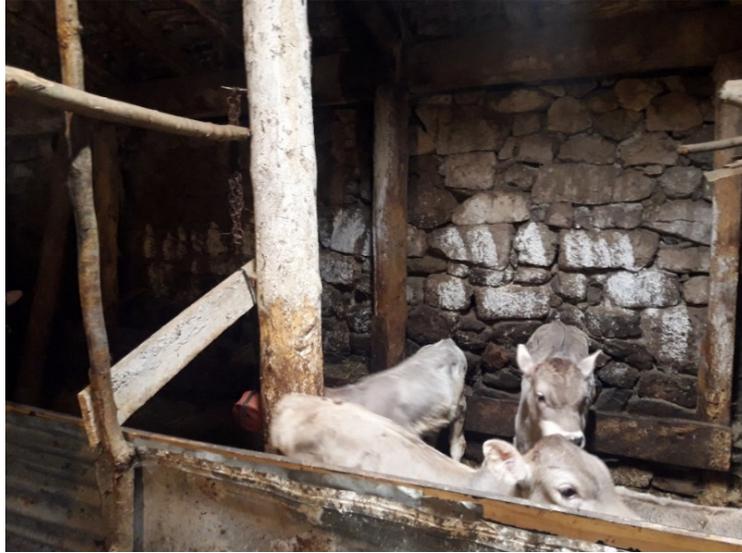
The northern part is reached from the 2.65 m wide opening in the north of the southern part. There is a wooden door providing entrance to *merék* area on the north wall of the southern part measuring 7.90x11.70 m (Figure 3.81). The area is lighted by an abat-jour in the east and west of the corbelled ceiling.

Figure 3.81. The view of the wall between the northern part and the *merék* from the south (Photograph: Author, 2019).

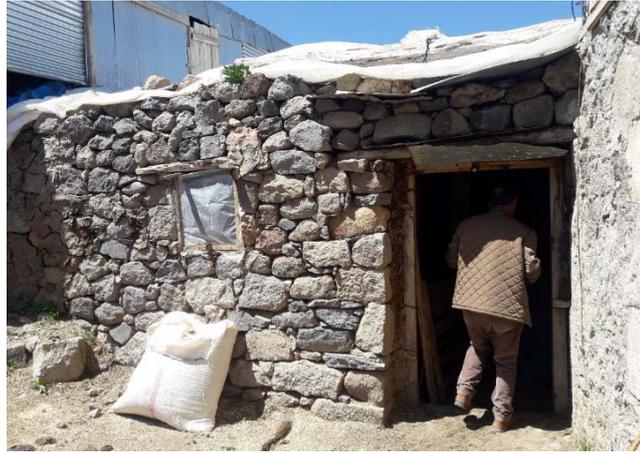
East Facade: The east facade has a width of 8.06 m and is adjacent to Cevdet Çakmur House in the north and new barns in the south. There are 2 apertures on the facade. In the north of the facade, there is an entrance door adjacent to the southern wall of Cevdet Çakmur House. Door opening has wooden lintel, frame and leaf. There is a window opening with wooden lintel and wooden frame in the 1.15 m south of the door opening. The facade wall is made of rubble stone (Figure 3.82).

Figure 3.82. The east facade of the old barn.
(Photograph: Author, 2019)

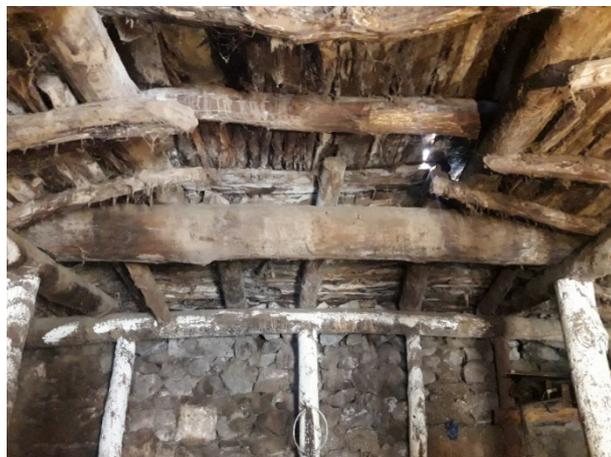
The upper surface of the northern and southern parts is covered corbelled ceiling. The corbelled ceilings are supported by circular wooden posts. The exterior surface of the ceiling is covered with soil. There are 2 skylights in the east and west of the northern part (Figure 3.83).

Figure 3.83. The west wall and corbelled ceiling of the southern part.
(Photograph: Author, 2019)

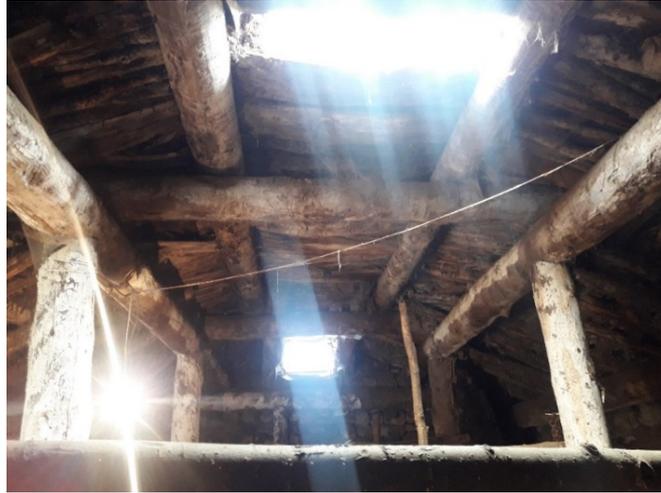
Levelling concrete was poured by the users of the building on the floor of the old barn. The decomposed wooden posts in front of the walls were replaced with wooden posts of different sizes (Figure 3.84).

Figure 3.84. Corbelled ceiling and skylight of the northern part.
(Photograph: Author, 2019)

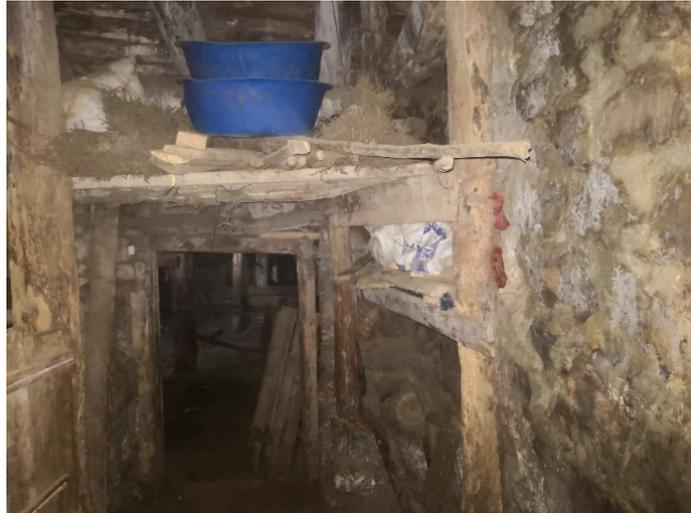
The single storey *merek* area consists of a single volume. *Merek* is accessed from a single leaf wooden door measuring 120x183 cm on the northern wall of the old barn (Figure 3.85). The *merek* area, almost rectangular planned, protrudes to east 91 cm along the western wall of the bedroom of Alişan Çakmur House.

Figure 3.85. The door providing passage from the old barn to the *merék*.
(Photograph: Author, 2019)

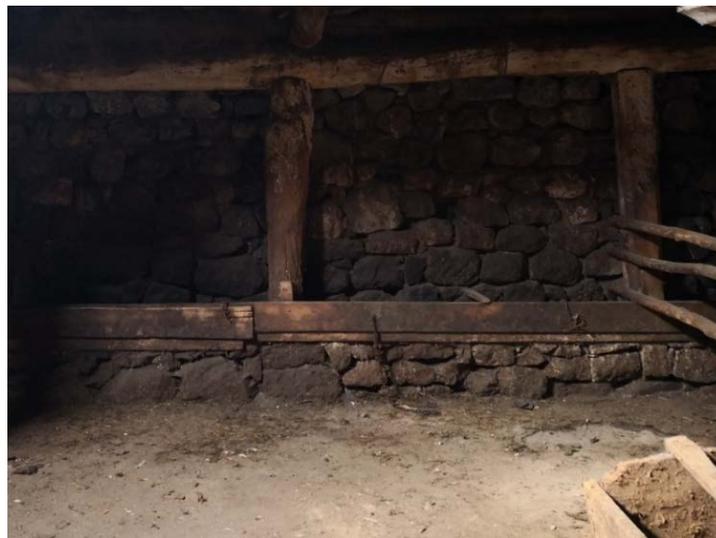
In front of the rubble stone walls surrounding the area, wooden posts of different sizes are arranged. The average of 45 cm wide floor, where the posts are arranged, is raised about 50 cm with rubble stone bonding and between the posts a manger was designed by covering with wood in front of its¹⁵ (Figure 3. 86).

Figure 3.86. The manger on the western wall.
(Photograph: Author, 2019)

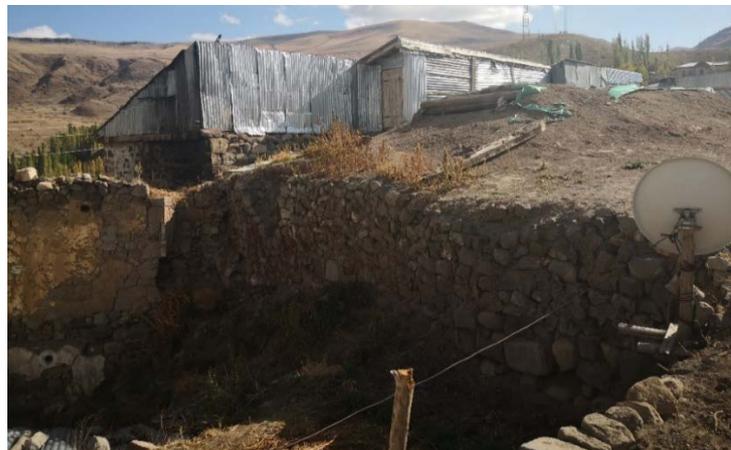
North Facade: The north facade consists of a masonry wall without opening made of rubble stones of various sizes (Figure 3.87).

Figure 3.87. The north facade of the *merék* building.
(Photograph: Author, 2019)

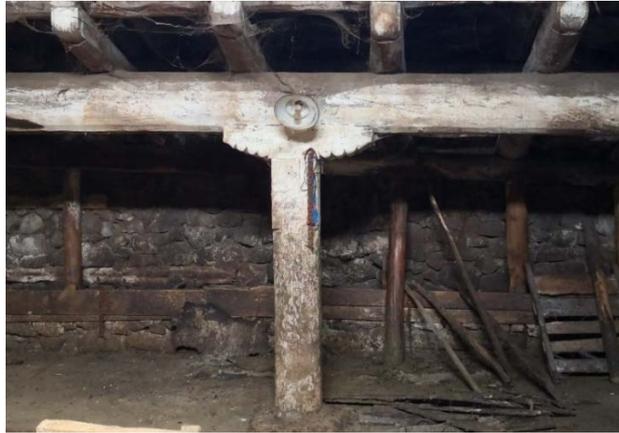
of the area measuring 8.20x5.45 m in the center of the *merek* area. The wooden posts supporting the corbelled ceiling have an average cross-section of 25x25 cm and consist of 3 sections: base, shaft and capital (Figure 3.88).

Figure 3.88. The wooden carrier in the north of *merek* center.
(Photograph: Author, 2019)

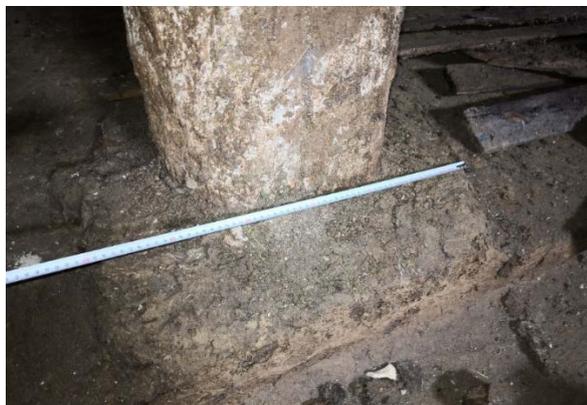
The base sections are made of cut stone. The 60x60 cm bases have a height of 6 cm (Figure 3.89). Square cross-section posts are placed on the bases. The posts on the east and west of the center are approximately 2 m; the posts on the north and south have an average height of 1.5 m. The corners of the posts were cut above the 145 cm base level (Figure 3.90).

Figure 3.89. Cut stone base.
(Photograph: Author, 2019)

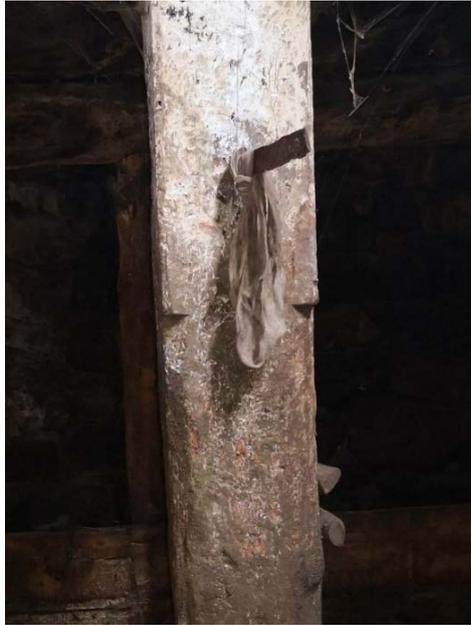
Figure 3.90. Notches on the post.
(Photograph: Author, 2019).

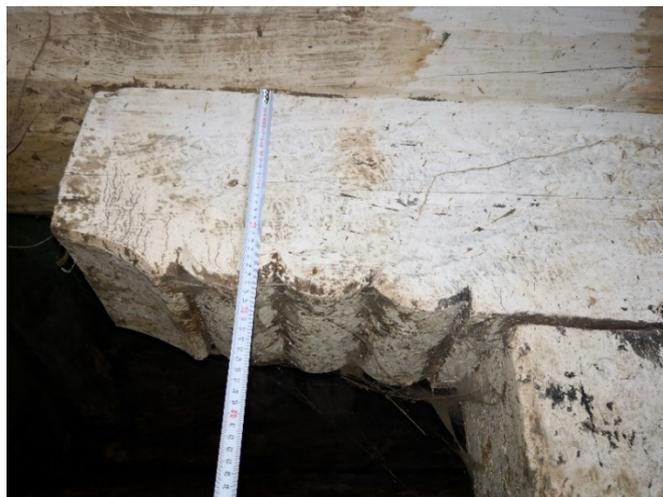
On the posts, there are wooden capitals with an average length of 110 cm and a height of 25 cm (Figure 3. 91). The capitals, where lower surfaces were sharpened as 3 convex and 1 concave, have symmetric regularity. The timber joists with circular cross-sections, which support the corbelled ceiling, were placed to upper surface of capitals (Figure 3.92).

Figure 3.91. Wooden capital.
(Photograph: Author, 2019)

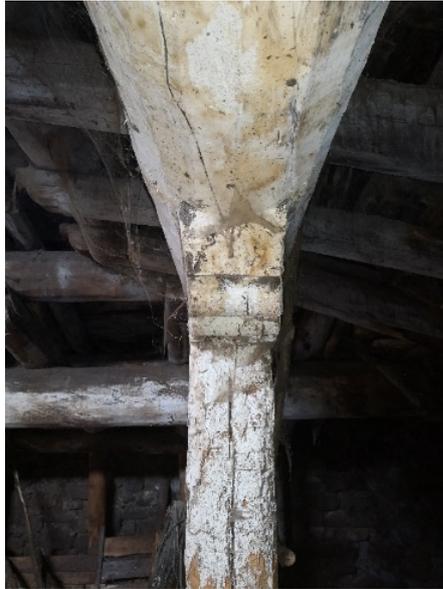
Figure 3.92. The merge of wooden capital and ceiling joist.
(Photograph: Author, 2019)

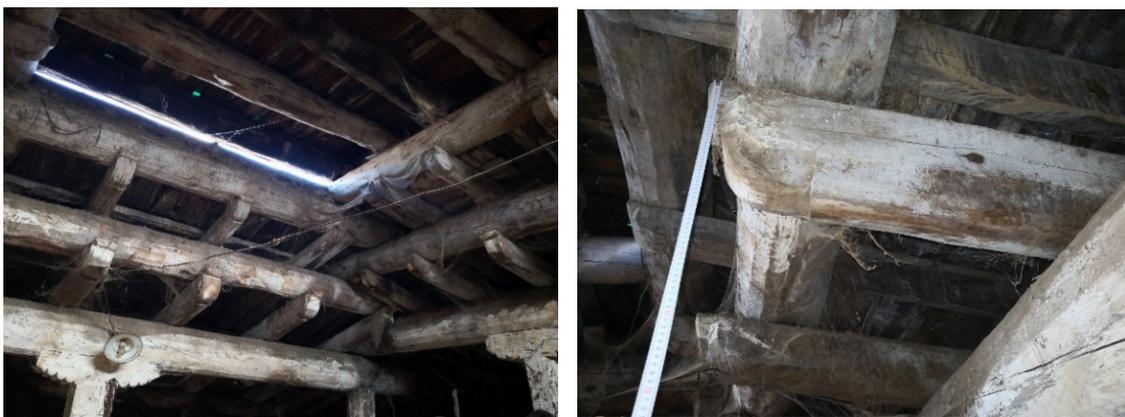
Corbelled Ceiling: The upper surface of area measuring 8.20x5.45 m in the center of the building is covered by a corbelled ceiling with skylight. Ceiling is supported by a series of 3 series of wooden joist, which its end is sharpened in the form of hammerhead, rising towards the center of the area. There are skylights in the north and south of the corbelled ceiling (Figure 3.93).

Figure 3.93. Corbelled ceiling and skylight and wooden joist sharpened in the form of hammerhead its ends (Photograph: Author, 2019).

According to the information received from oral sources; the corbelled ceiling covering the *merek* place was changed in the 1970s repairs. The height of the ceiling was reduced by removing the last rows of beams on the corbelled ceiling.

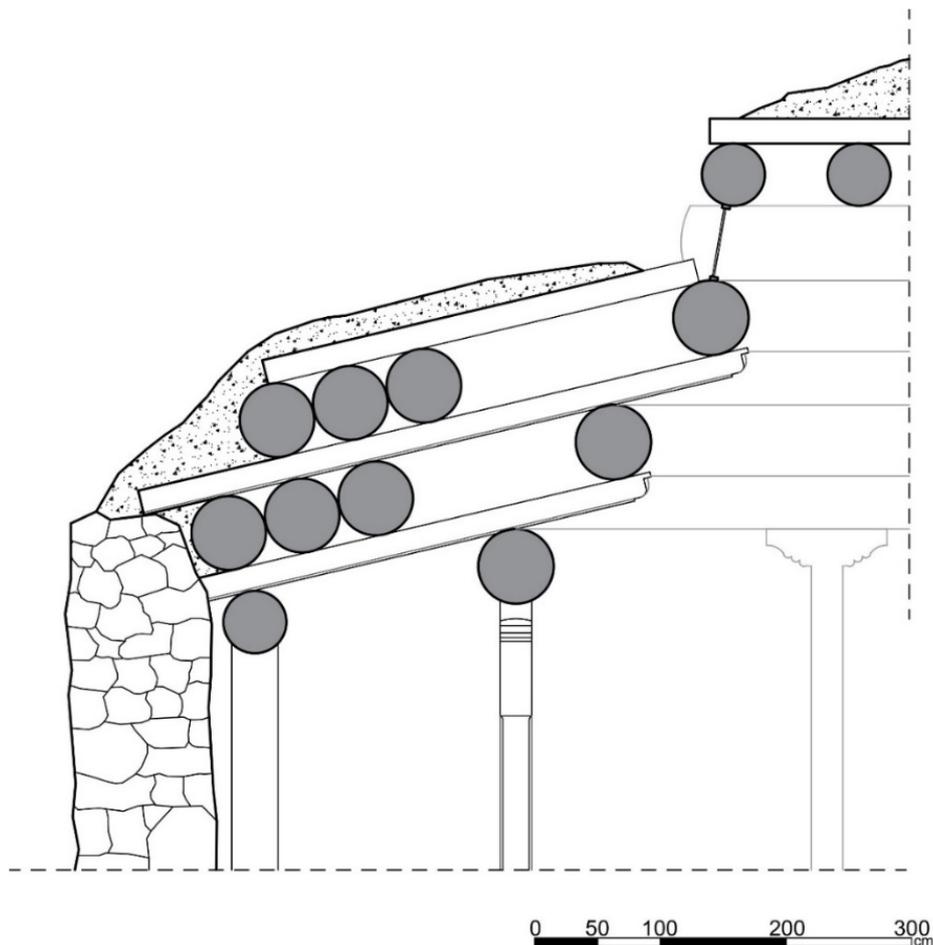
The building has masonry rubble stone walls. Soil mortar is seen between the stones. The wooden studs arranged in front of the wall and around the center supported joists with a circular cross-section approximately 60 cm diameter. Above circular cross-section joists there are wooden joists, sharpened in the form of hammerhead, descending towards the exterior and enter into the rubble stone wall (Figure 3.94). The hammerhead joists supported another circular cross-section joist beam by protruding 100 cm from its under joist towards the center. The system is repeated 3 series vertically ends with skylight. The area is covered with soil (Figure 3.95).

Figure 3.94. Schematic section drawing of merk's east wall.
(Prepared by Author, 2019)
