**INVESTIGATION AND EVALUATION OF
TECHNICAL, ADMINISTRATIVE AND LEGAL
DECISIONS DURING THE RESTORATION
PROCESS OF AKMUR HOUSES**

**A Thesis Submitted to
the Graduate School of Engineering and Sciences of
İzmir Institute of Technology
in Partial Fulfilment of the Requirements for the Degree of**

in Architectural Restoration

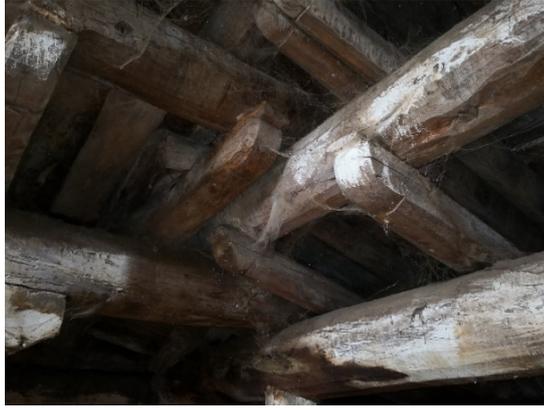
The building has masonry rubble stone walls. Soil mortar is seen between the stones. The wooden studs arranged in front of the wall and around the center supported joists with a circular cross-section approximately 60 cm diameter. Above circular cross-section joists there are wooden joists, sharpened in the form of hammerhead, descending towards the exterior and enter into the rubble stone wall (Figure 3.94). The hammerhead joists supported another circular cross-section joist beam by protruding 100 cm from its under joist towards the center. The system is repeated 3 series vertically ends with skylight. The area is covered with soil (Figure 3.95).

Figure 3.95. The corner merge of hammerhead joists.
(Photograph: Author, 2019)

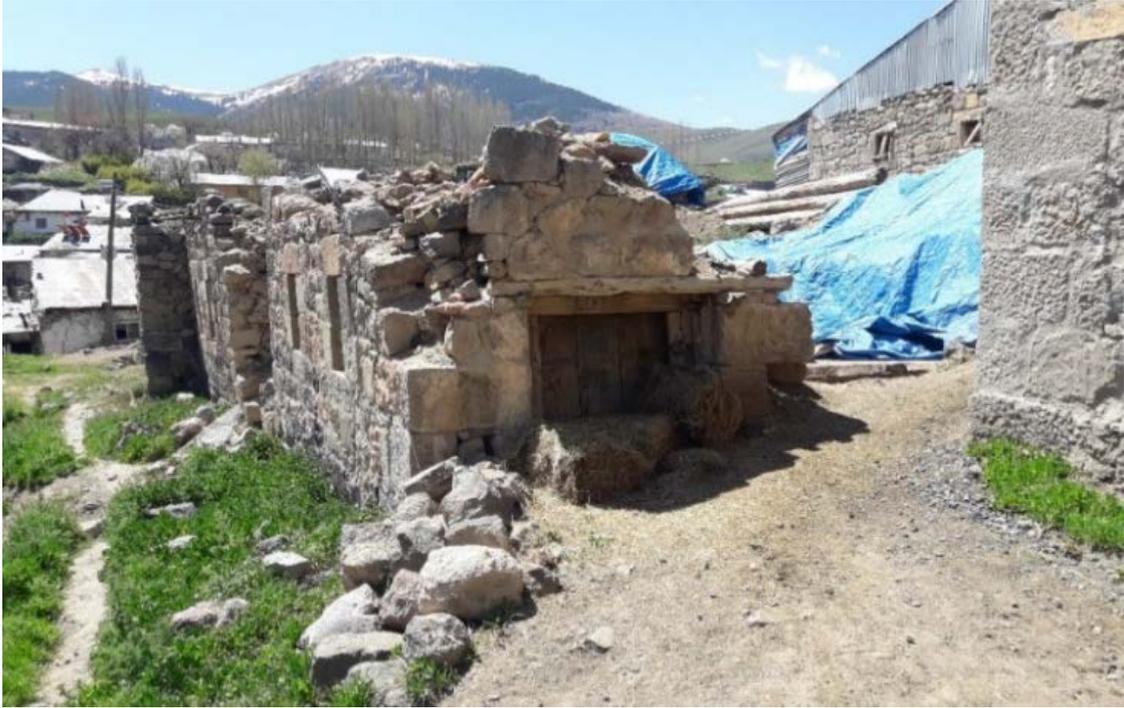
The machine house is entered by a wooden door with single-leaf, wooden lintel and frame on the north wall. The area is about 25 m² and built with rubble stone bonding by masonry technique. Cut stones were used at the opening corners and ledges of the building. Soil mortar is observed inside the walls. The exterior is unplastered. Interior surface the walls, there are ruins of soil plaster and whitewash (Figure 3.97).

Figure 3.97. The view of the machine house from the north.
(Photograph: Author, 2019)

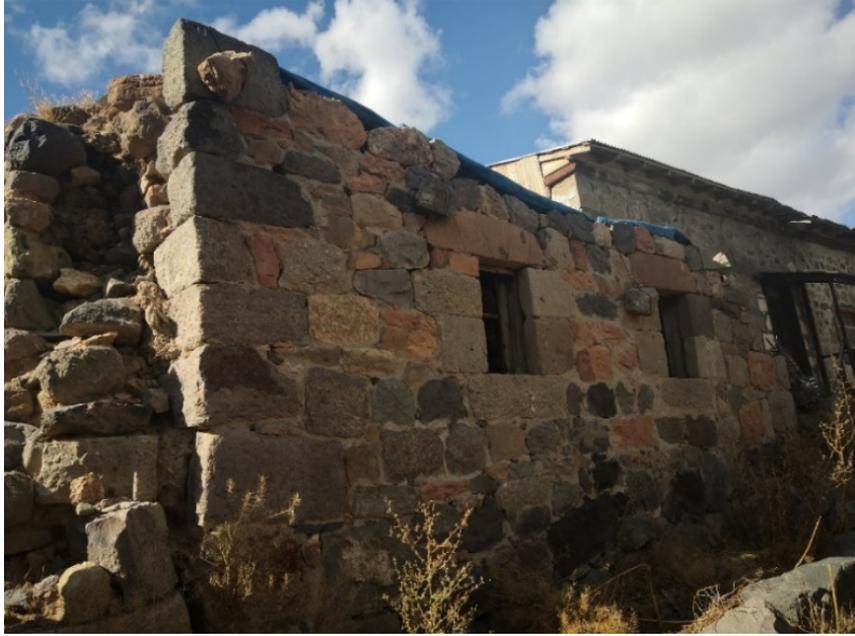
On the eastern wall, there are 2 window openings with wooden frames enlarging from the interior to the exterior (Figure 3.98). The upper surface of the window openings, there is wood in the interior and stone lintel on the exterior (Figure 3.99). The stone lintel of the southern window was sharpened like the flat arches above the window openings of the bedroom of Alişan Çakmur House. Ruins of a fireplace are seen on the southern wall adjacent to the ruins of another building (Figure 3.100).

Figure 3.98. East facade of the machine house.
(Photograph: Author, 2019)

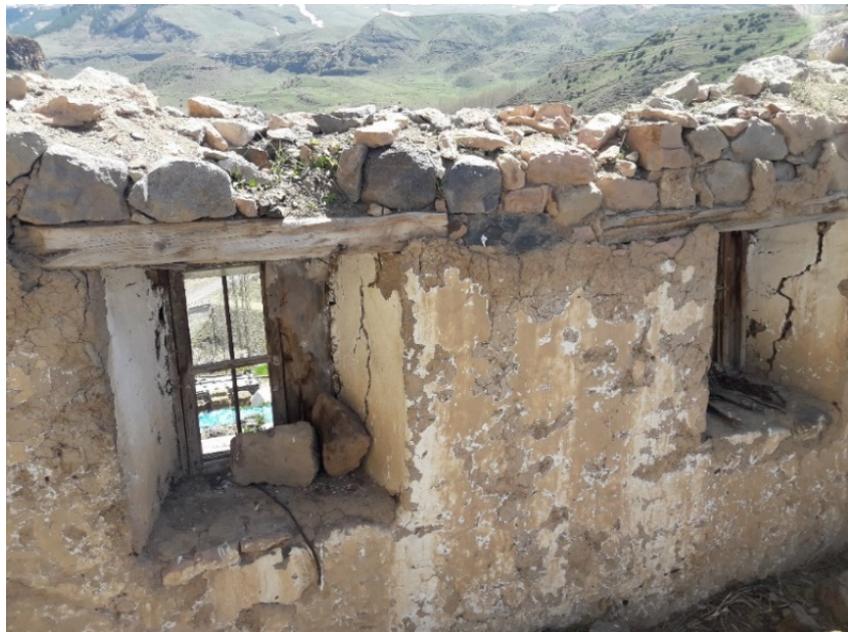
Figure 3.99. The windows on the east wall of the machine house.
(Photograph: Author, 2019)

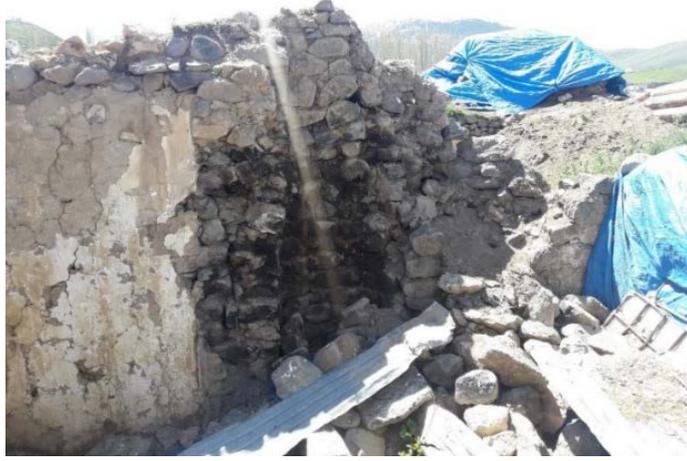
Figure 3.100. The ruins of the fireplace on the south wall of the machine house. (Photograph: Author, 2019).

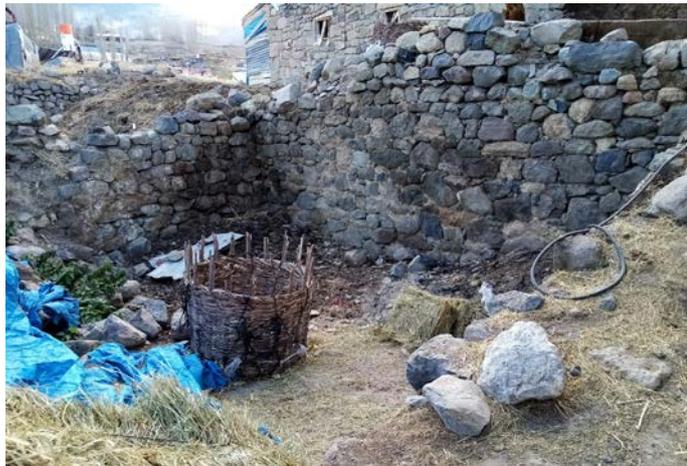
The guest house is located to the west of the machine house and on its upper level. The ground floor of the building, according to oral sources¹⁶, covers on the machine house by extending to the east. The entrance to the building is from the west. The ruins of the building indicate that there were two rooms in the western part of the building. In the masonry walls, rubble stone bonding with soil mortar is seen (Figure 3.101).

Figure 3.101. The view of the guest house from the northeast. (Photograph: Author, 2019)

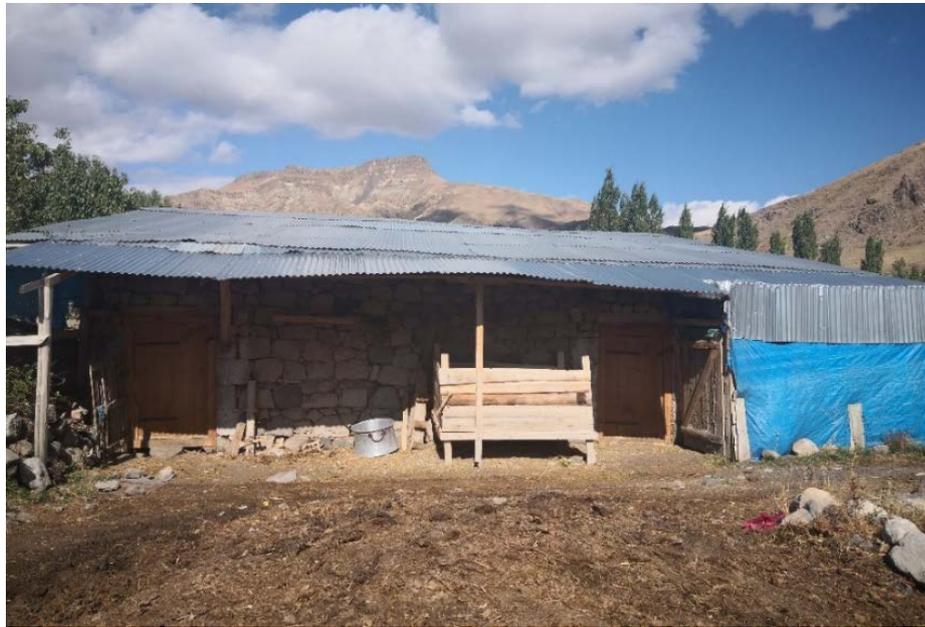
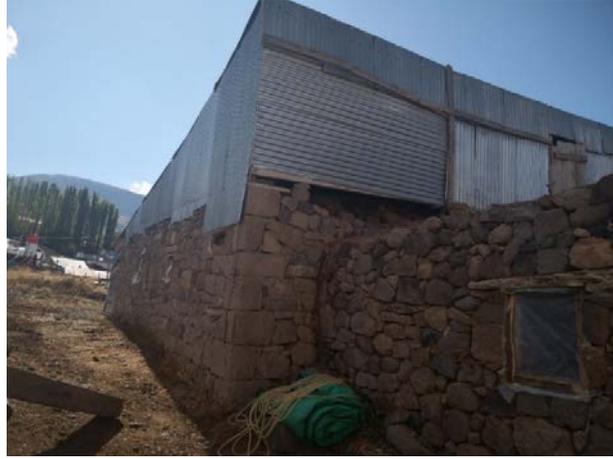
New barns are located to the southwest of the machine house and guest house. The building group consists of two barns and were built with rubble stone bonding by masonry technique. Cut stones were used at the opening corners and ledges of the building. There are 2 entrance doors on the south facade and two windows each on the east and west facades. Window and door lintels are wooden. The upper surface of the building group consists of the lean-to roof with sheet metal-cover, wooden base and inclined in single direction, descending to the south starting from the north and forming eaves along the south facade (Figure 3.102 and Figure 3.103).

Figure 3.102. The south facade of the new barns.
(Photograph: Author, 2019)

Figure 3.103. The view of the new barns from the northeast.
(Photograph: Author, 2019)

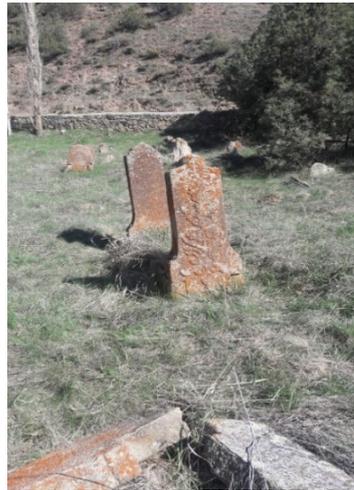
Figure 2.12. The grave of Abdullah Hoca from Mollamehmetoğulları in İçmesu Village of Şenkaya (Photograph: Author, 2019).

The oldest known ancestor belonging to the Çakmur family is Abdullah Hoca, one of the Mollamehmetoğulları. According to historical inferences; Between 1820 and 1830, Abdullah Hoca, with Mustafa (known as Çakmur Ağa), Mehmet (Molla Mehmet) and Sallı, who were his wife and children were subjected to forced migration from Ahıska region in the Caucasus and settled today in Aydınköy which is under the rule of Ardanuç District of Artvin (formerly known as Danzot). The family (5 people) emigrated to Bardız as a result of a disagreement experienced in Aydınköy (Danzot) on an unspecified date (Figure 2.12).

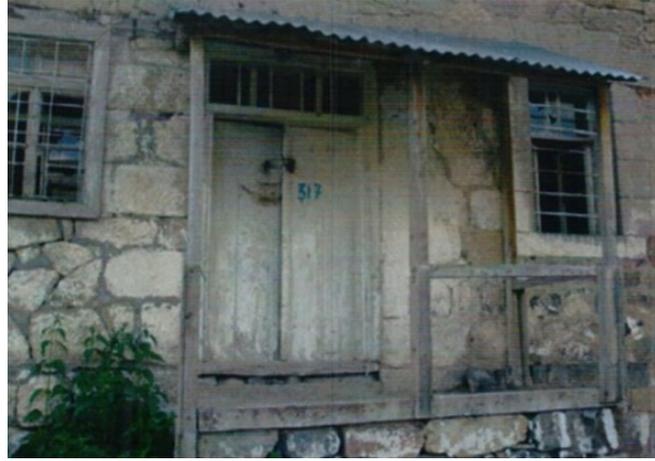
Figure 4.1. Condition of the entrance landing before restoration (Source: Erzurum Regional Conservation Council of Immovable Cultural Assets Archive. Access Date: 19 July, 2019).

Entrance Landing: The stairs of the entrance landing, which were destroyed during the earthquake, were repaired with their original materials. The wooden railing and porch surrounding the landing were renewed with wooden material and the roof of the porch was covered with sheet metal roofing material (Figure 4.1).

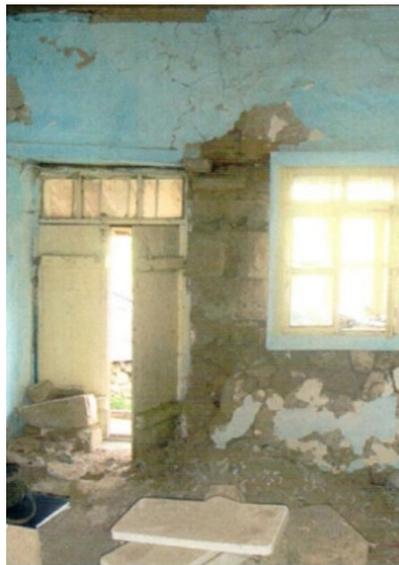
Figure 4.2. The view of the entrance door and *sofa* window from the interior before the restoration (Source: Erzurum Regional Conservation Council of Immovable Cultural Assets Archive. Access Date: 19 July, 2019).

It is known that the single-leaf wooden entrance door used today had a double-leaf and wooden sliding entrance door with a top window before the earthquake. According to the survey drawings made by Sırmacı Architecture, the original door measures 1.25x 2.00 m. (Figure 4.2).

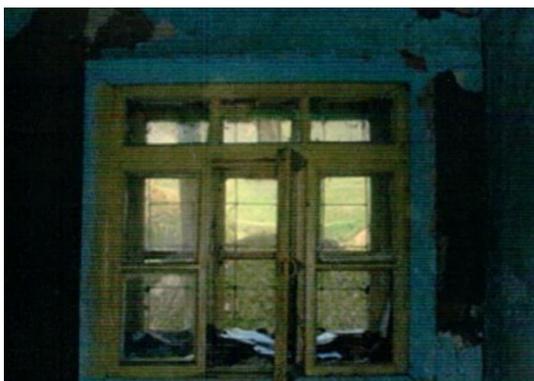
Figure 4.3. Condition of the *sofa* window before restoration (Source: Erzurum Regional Conservation Council of Immovable Cultural Assets Archive. Access Date: 19 July, 2019).

The *sofa* window was renewed with wooden material so that the joinery dimensions remained the same during repair, and the metal bars on the facade were removed (Figure 4.3).

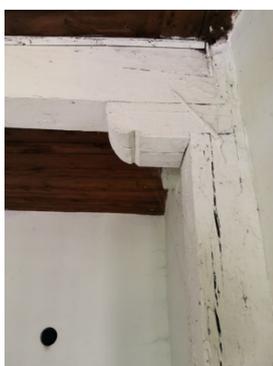
Figure 4.4. Wooden post and beam on the north wall of the *sofa*.
(Photograph: Author, 2019)

The arch of the fireplace on the east wall of the *sofa* was covered with plaster and plastic paint. Wooden posts on the north and south walls of the *sofa* and 30x20 cm wooden beam carried by the posts were painted with oil paint (Figure 4.4 and Figure 4.5).

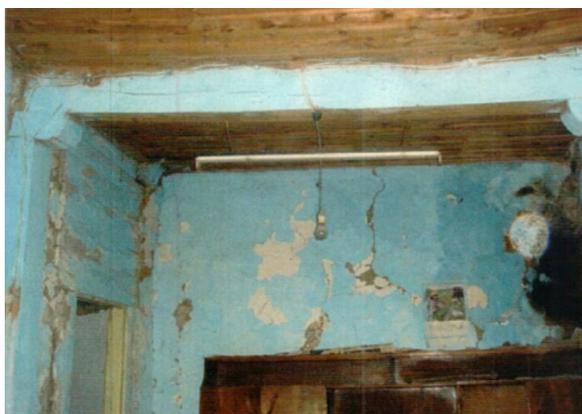
Figure 4.5. The east view of the west part of *sofa* (Source: Erzurum Regional Conservation Council of Immovable Cultural Assets Archive. Access Date: 19 July, 2019).

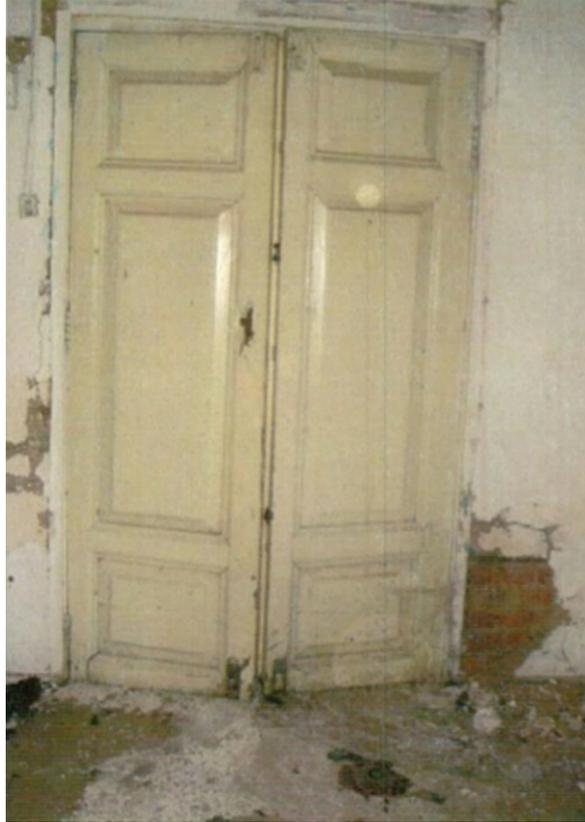
Figure 4.6. Inside view of the door after the earthquake (Source: Erzurum Regional Conservation Council of Immovable Cultural Assets Archive. Access Date: 19 July, 2019).

Original daily room door was cleaned and protected (Figure 4.6). The dimensions of the window space have been preserved and the wooden floor of the window's metal rail and the window aperture have been removed. In addition, the joinery details have changed and wider top windows were used (Figure 4.7). The old *sedir* on the south wall of daily room was repaired and a new wooden *sedir* was added on the western wall (Figure 4.8).

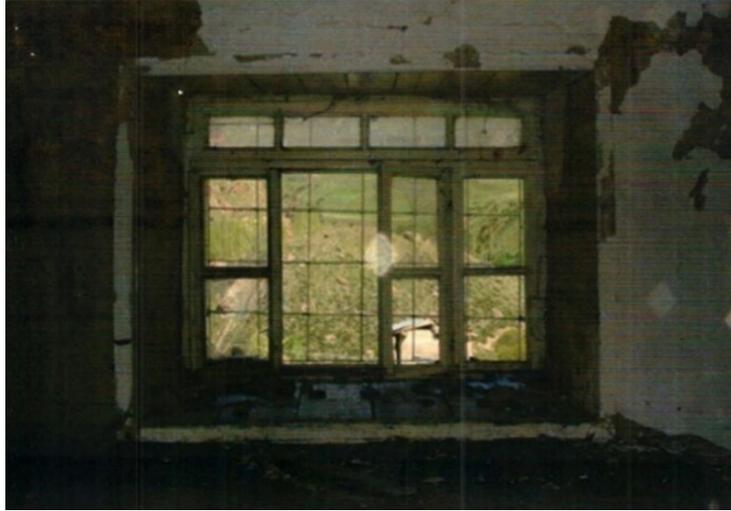
Figure 4.7. The condition of daily room window before restoration (Source: Erzurum Regional Conservation Council of Immovable Cultural Assets Archive. Access Date: 19 July, 2019).

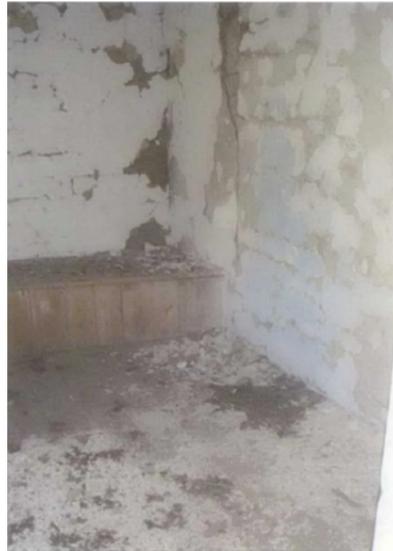
Figure 4.8. View of *sedir* before the restoration (Source: Erzurum Regional Conservation Council of Immovable Cultural Assets Archive. Access Date: 19 July, 2019).

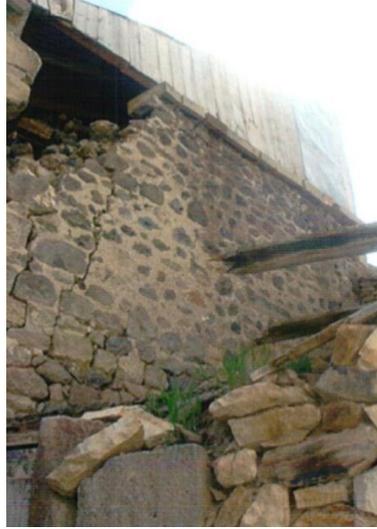
Figure 4.9. The northern wall of the bedroom that was destroyed during the earthquake (Source: Erzurum Regional Conservation Council of Immovable Cultural Assets Archive. Access Date: 19 July, 2019).

Bedroom: As part of the restoration works, the destroyed parts of the north wall were rebuilt with stone material and cement mortar (Figure 4.9). Gypsum plaster and plastic paint were applied to all interior walls of the bedroom, and the original floor was cleaned and preserved. The wooden ceiling was completely renewed, but the original ceiling core was cut and placed on the new ceiling.

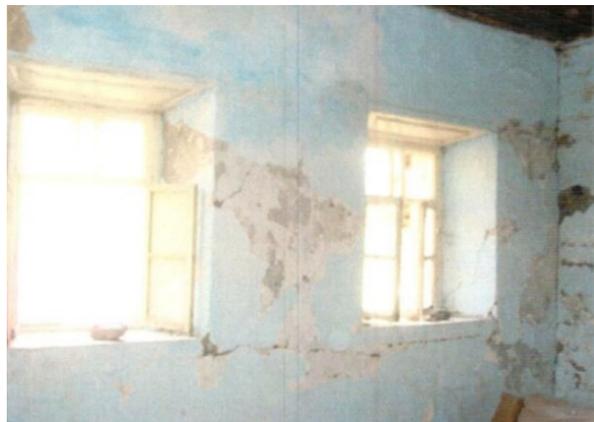
Figure 4.10. The view of the bedroom windows from the interior before the restoration (Source: Erzurum Regional Conservation Council of Immovable Cultural Assets Archive. Access Date: 19 July, 2019).

The original door of the bedroom was cleaned and preserved. The size of the window openings was not changed, but the joinery was renewed with wooden material. In the pre-repair photos, it is understood that the middle part remaining above the intermediate mullion in the previous windows is narrower and the two wings below can be opened. The detail of the ceiling of window opening is the same as before repair. The metal bars seen in the photos before the repair do not exist today (Figure 4.10 and Figure 4.11).

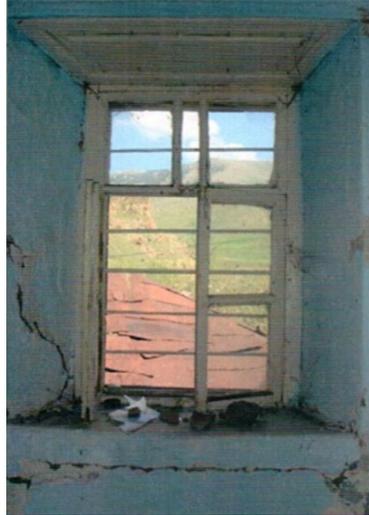
Figure 4.11. The view of northern window of bedroom before restoration (Source: Erzurum Regional Conservation Council of Immovable Cultural Assets Archive. Access Date: 19 July, 2019).

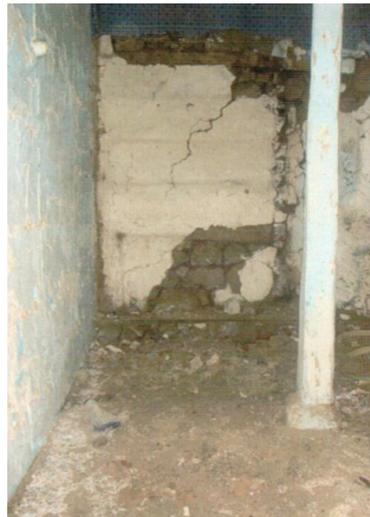
Figure 4.12. Cellar view from the door before the restoration (Source: Erzurum Regional Conservation Council of Immovable Cultural Assets Archive. Access Date: 19 July, 2019).

Bathroom: This space, which was originally used as a cellar, was converted into wet space during restoration. Levelling concrete was used on the floor, which was soil before restoration, and covered with tiles measuring 30x30 cm. The ceiling of bathroom has been renewed with wood material, gypsum plaster and plastic paint has been applied to all interior walls. A wooden door was placed in the 76 cm wide entrance opening (Figure 4.12).

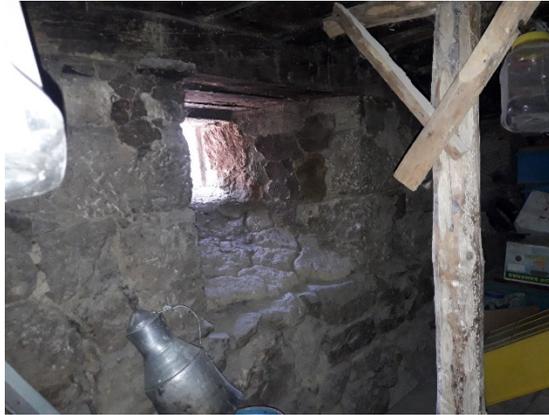
Figure 4.13. Wooden posts supporting the warehouse roof.
(Photograph: Author, 2019)

Warehouse: The space used as a grain storage was repaired by the users of the building after the earthquake. Wooden beam ceiling is supported by wooden posts (Figure 4.13).

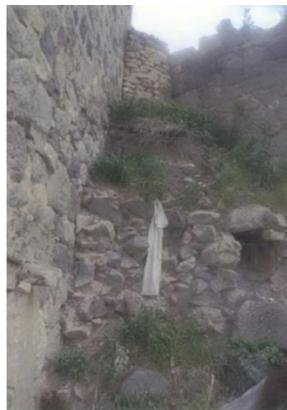
Figure 4.14. The view of furnace damaged during earthquake from the northeast
(Source: Erzurum Regional Conservation Council of Immovable Cultural Assets Archive. Access Date: 19 July, 2019).

Furnace: During the earthquake, the roof of the furnace was completely collapsed, the northeast wall was partially destroyed, and the fireplaces were destroyed. The northeast wall of the building was restored with rubble stone; the destroyed fireplaces were partially restored. The roof was formed by covering the wooden beams on the wall with a nylon canvas (Figure 4.14).

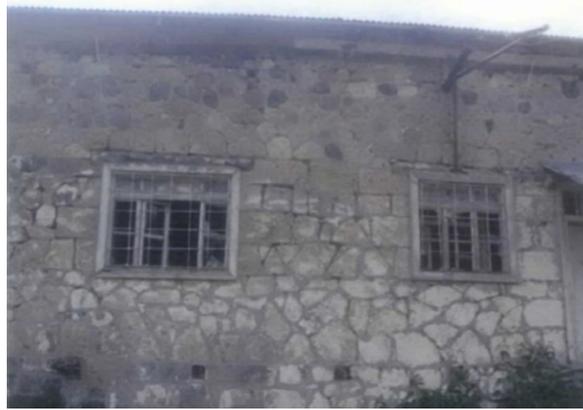
Figure 4.15. The view of Alişan Çakmur from the east before the restoration (Source: Erzurum Regional Conservation Council of Immovable Cultural Assets Archive. Access Date: 19 July, 2019).

Facades: During the restoration, cement joints were made between the stones on the east and north facades. Scaffolding holes on the basement wall were filled with cement mortar. Metal window bars are removed (Figure 4.15).

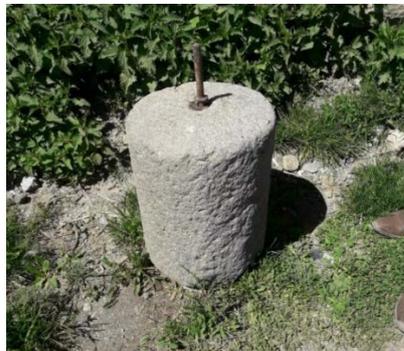
Figure 4.16. The stone roller in the attic.
(Photograph: Author, 2019)

Nowadays, the wooden roof coated with sheet metal inclined in one direction, covers the structure. The stone roller, which came out of the roof during the restoration applications in 2010, indicates that the original roof was a flat roof covered with soil. According to oral sources, during the repairs made in the 1970s, the house was covered with a wooden roof coated with sheet metal.

Roof: The original roof appears to have been soil. The stone roller found under the roof during the restoration supports this opinion. Nowadays, no traces of gutters or waterspouts were found. However, according to the information obtained from the users, there were wooden gutters that provide water discharge from the roof until about 30 years ago (Figure 4.16).

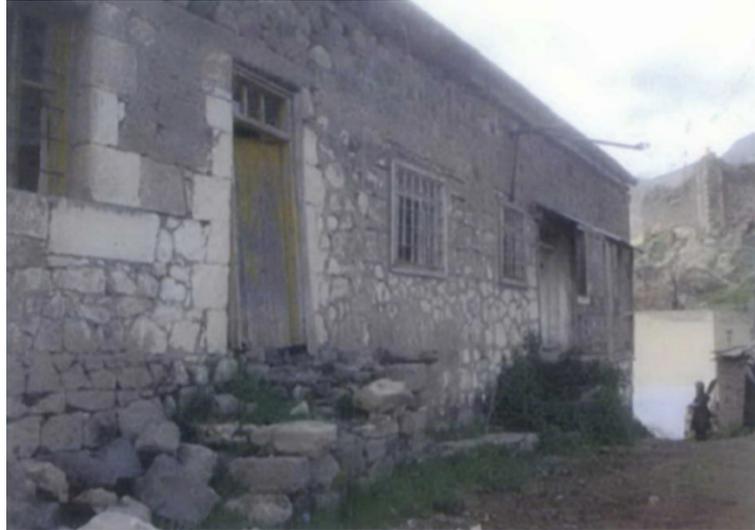
Figure 4.17. View of the entrance landing from the southeast before restoration (Source: Erzurum Regional Conservation Council of Immovable Cultural Assets Archive. Access Date: 19 July, 2019).

Entrance Landing: The entrance landing and steps that were destroyed during the earthquake were restored with their original material. The landing is covered with levelling concrete. Wooden railing was built around the steps and the entrance landing. The landing was covered with a wooden porch covered with metal sheet (Figure 4.17).

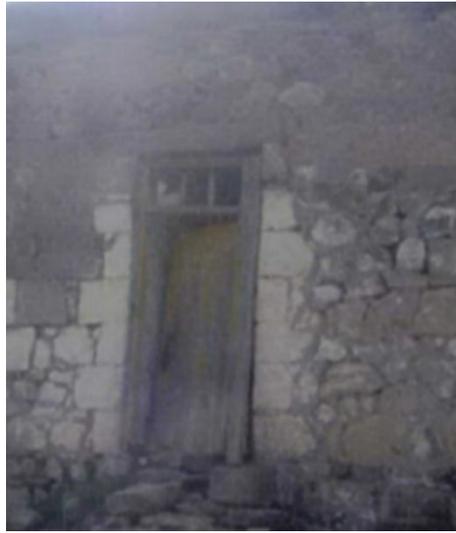
Figure 4.18. East view of the entrance door of Cevdet Çakmur House before the restoration (Source: Erzurum Regional Conservation Council of Immovable Cultural Assets Archive. Access Date: 19 July, 2019).

The wooden entrance door of the residence was replaced by a wooden door with different details. A top window with wooden frame and no partition was placed instead of the top window belonging to the entrance door with wooden frame and divided into three vertically (Figure 4.18).

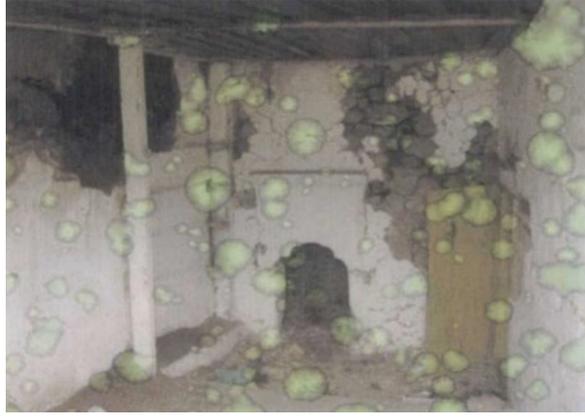
Figure 4.19. The view of the dally room from the south before the restoration (Source: Erzurum Regional Conservation Council of Immovable Cultural Assets Archive. Access Date: 19 July, 2019).

Before the restoration application, the surface of the fireplace, which was covered with whitewash, was cleaned and reliefs were revealed (Figure 4.19).

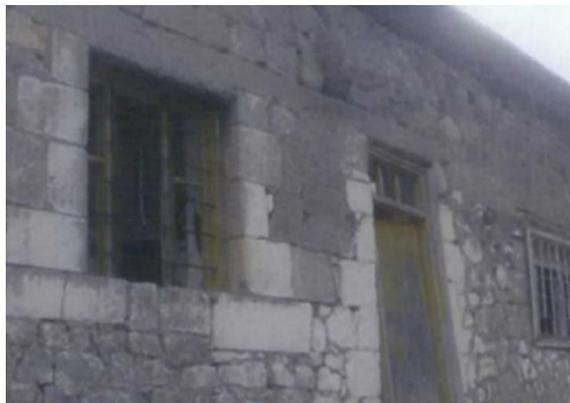
Figure 4.20. View of the bedroom window from the southeast before restoration (Source: Erzurum Regional Conservation Council of Immovable Cultural Assets Archive. Access Date: 19 July, 2019).

The wood window joinery on the east facade was renewed with wood; the metal bars in front of the window were removed (Figure 4.20).

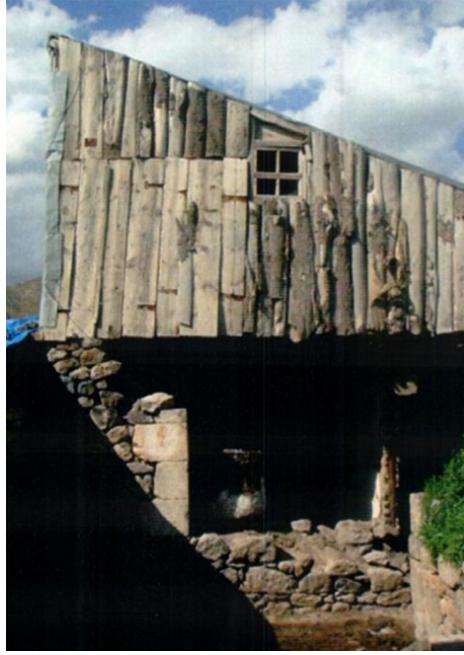
Figure 4.21. The south facade of Cevdet Çakmur House before the restoration (Source: Erzurum Regional Conservation Council of Immovable Cultural Assets Archive. Access Date: 19 July, 2019).

Facades: The destroyed south wall of the building was rebuilt using cement mortar and original stones (Figure 4.21). Cement joints were made between the stones on the east facade, and the window bars were removed (Figure 4.22).

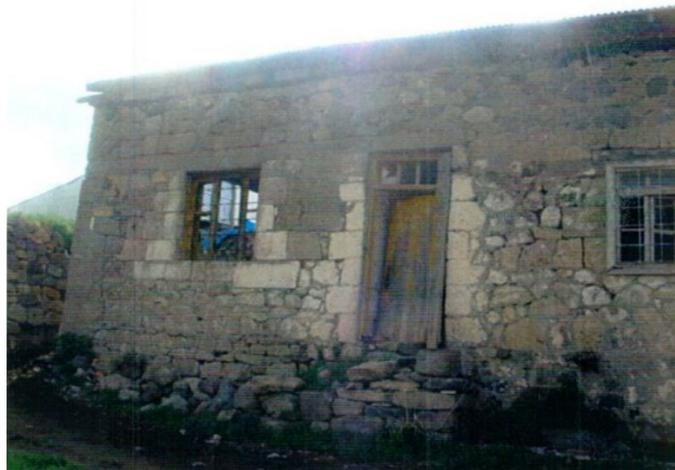
Figure 4.22. The south facade of Cevdet Çakmur House before the restoration (Source: Erzurum Regional Conservation Council of Immovable Cultural Assets Archive. Access Date: 19 July, 2019).

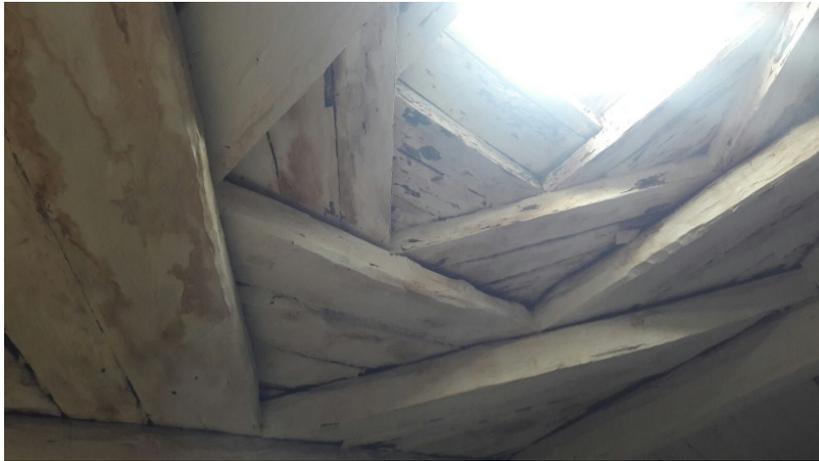
Figure 4.23. *Kırlangi* (corbelled) ceiling of Enver řahin House's *ařhane*. (Photograph: Author, 2018).

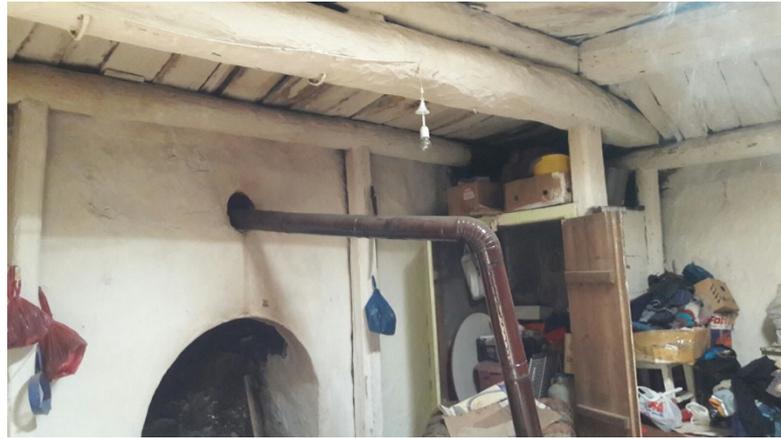
Figure 4.24. *Terek* (shelf) of Enver Şahin House's aşhane.
(Photograph: Author, 2018).

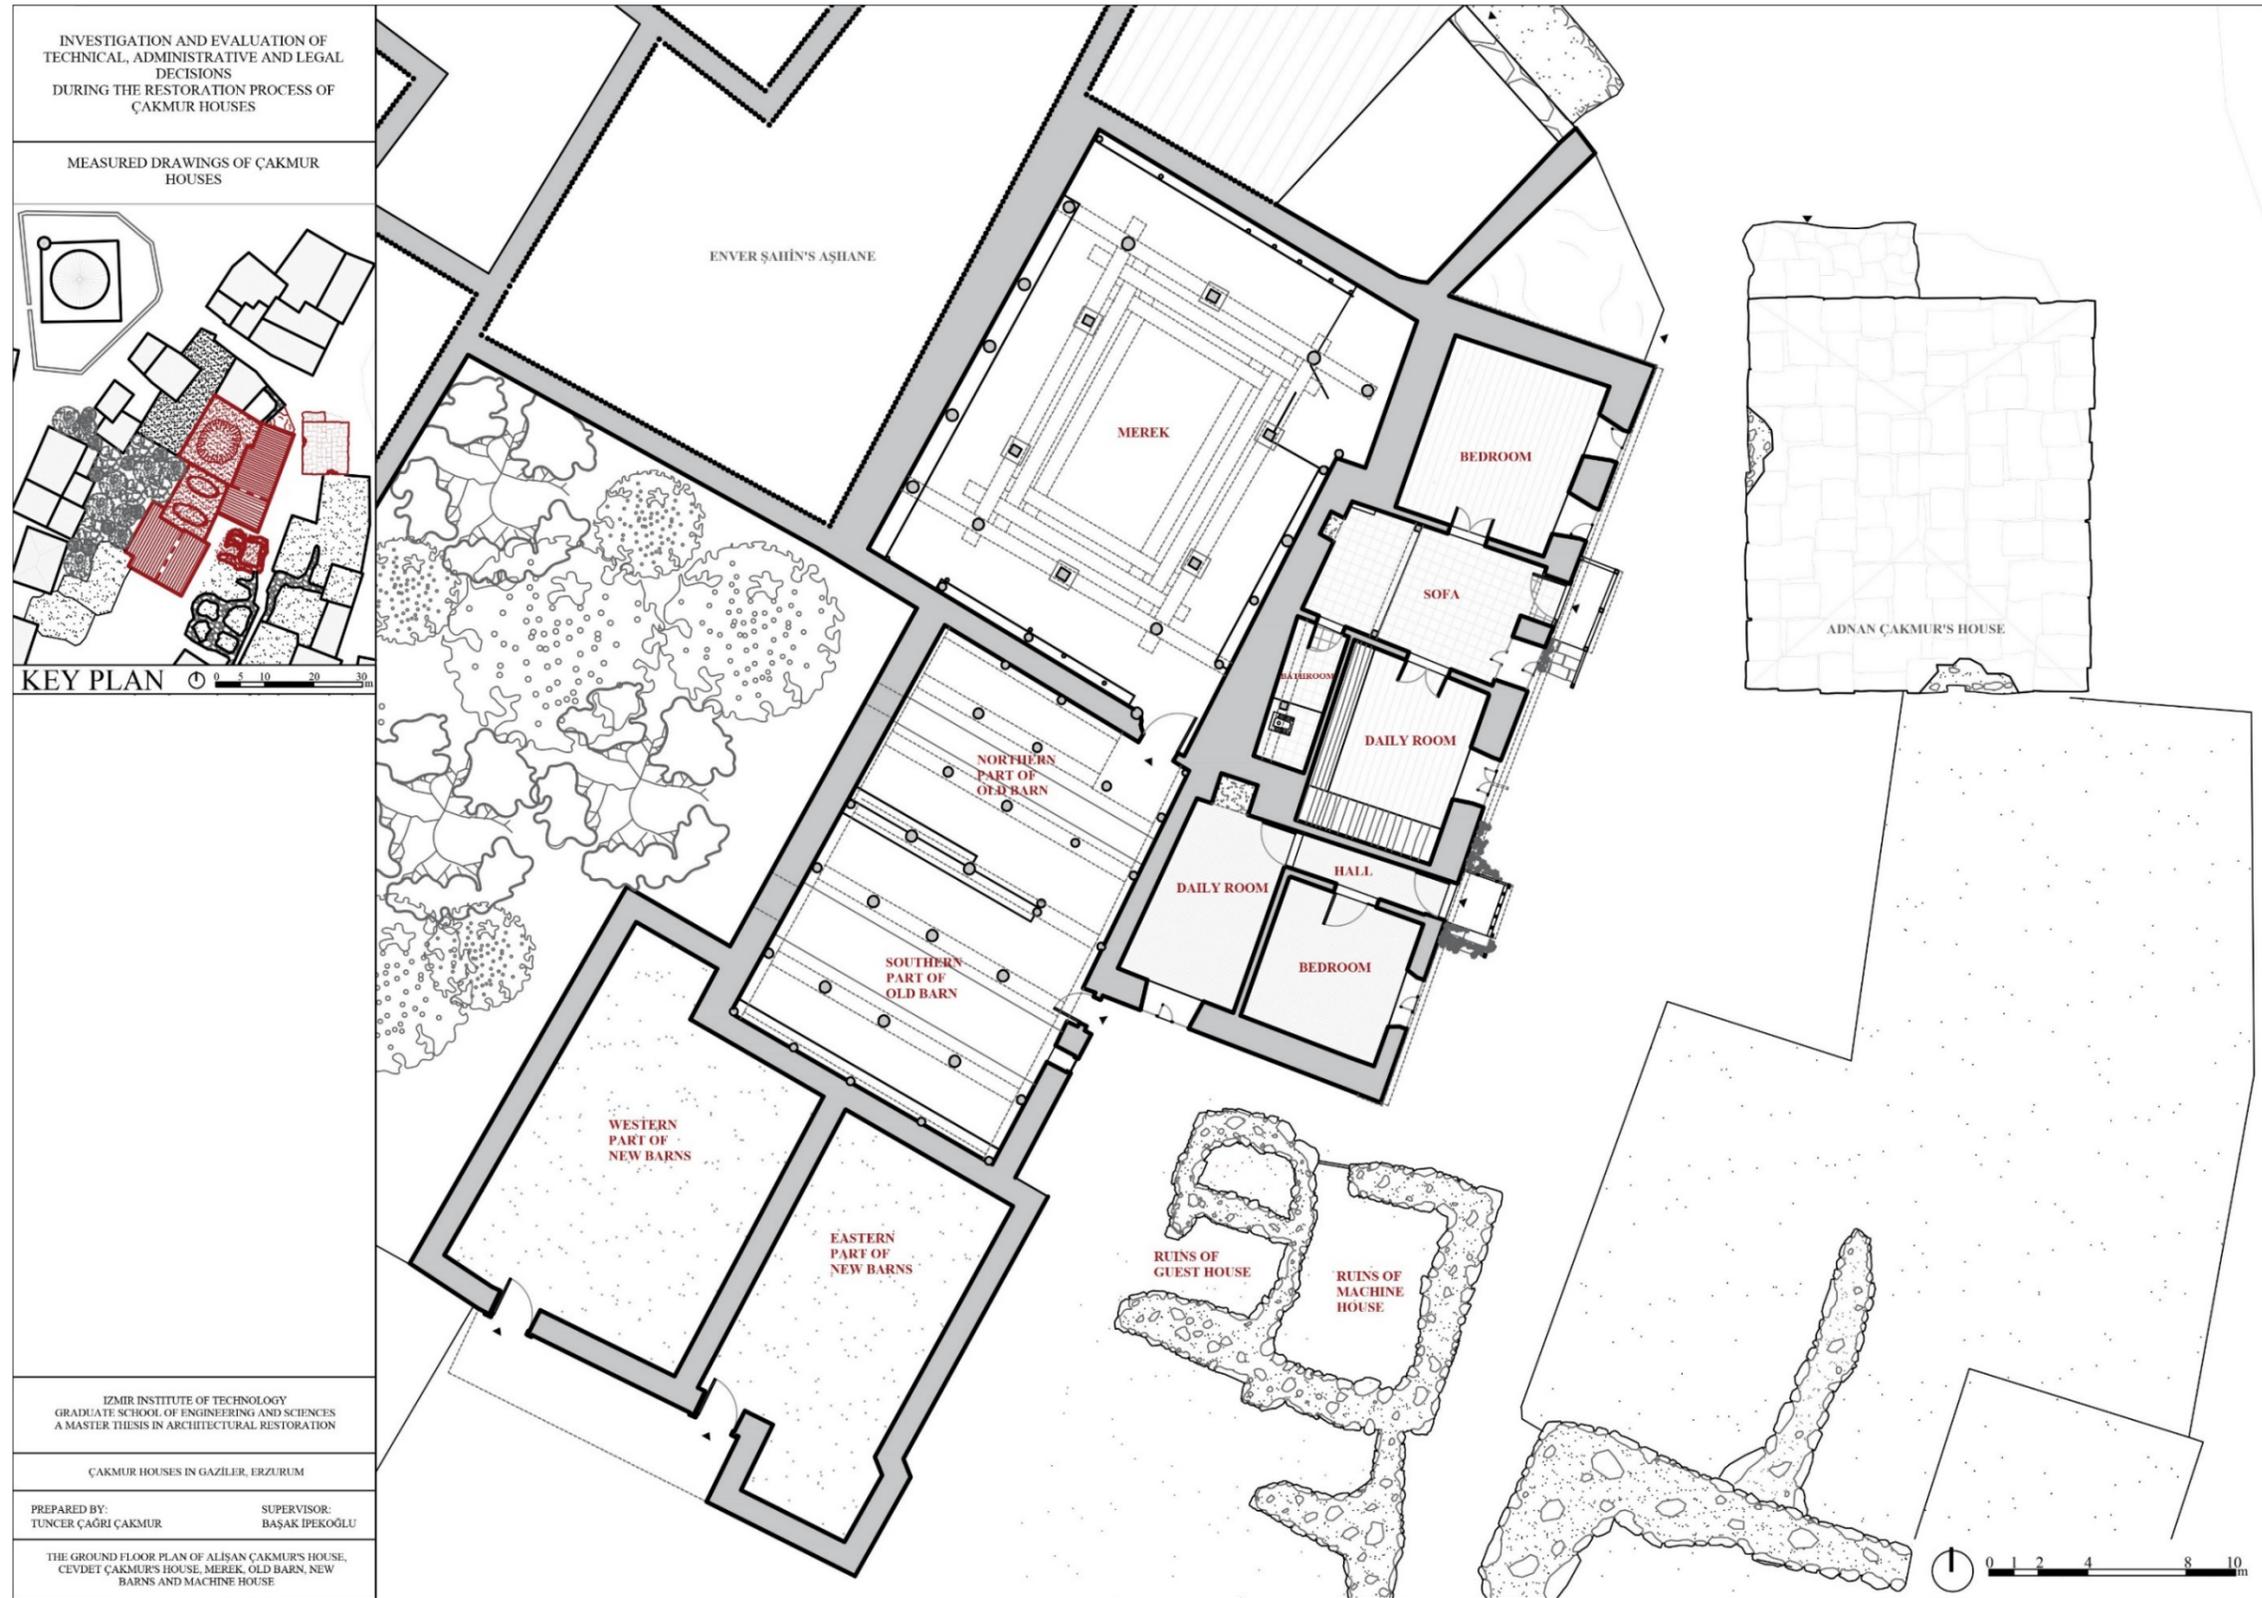
Figure A.1. Measured drawing plan redrawn from Sirmacı Architecture (Prepared by Author, 2019).

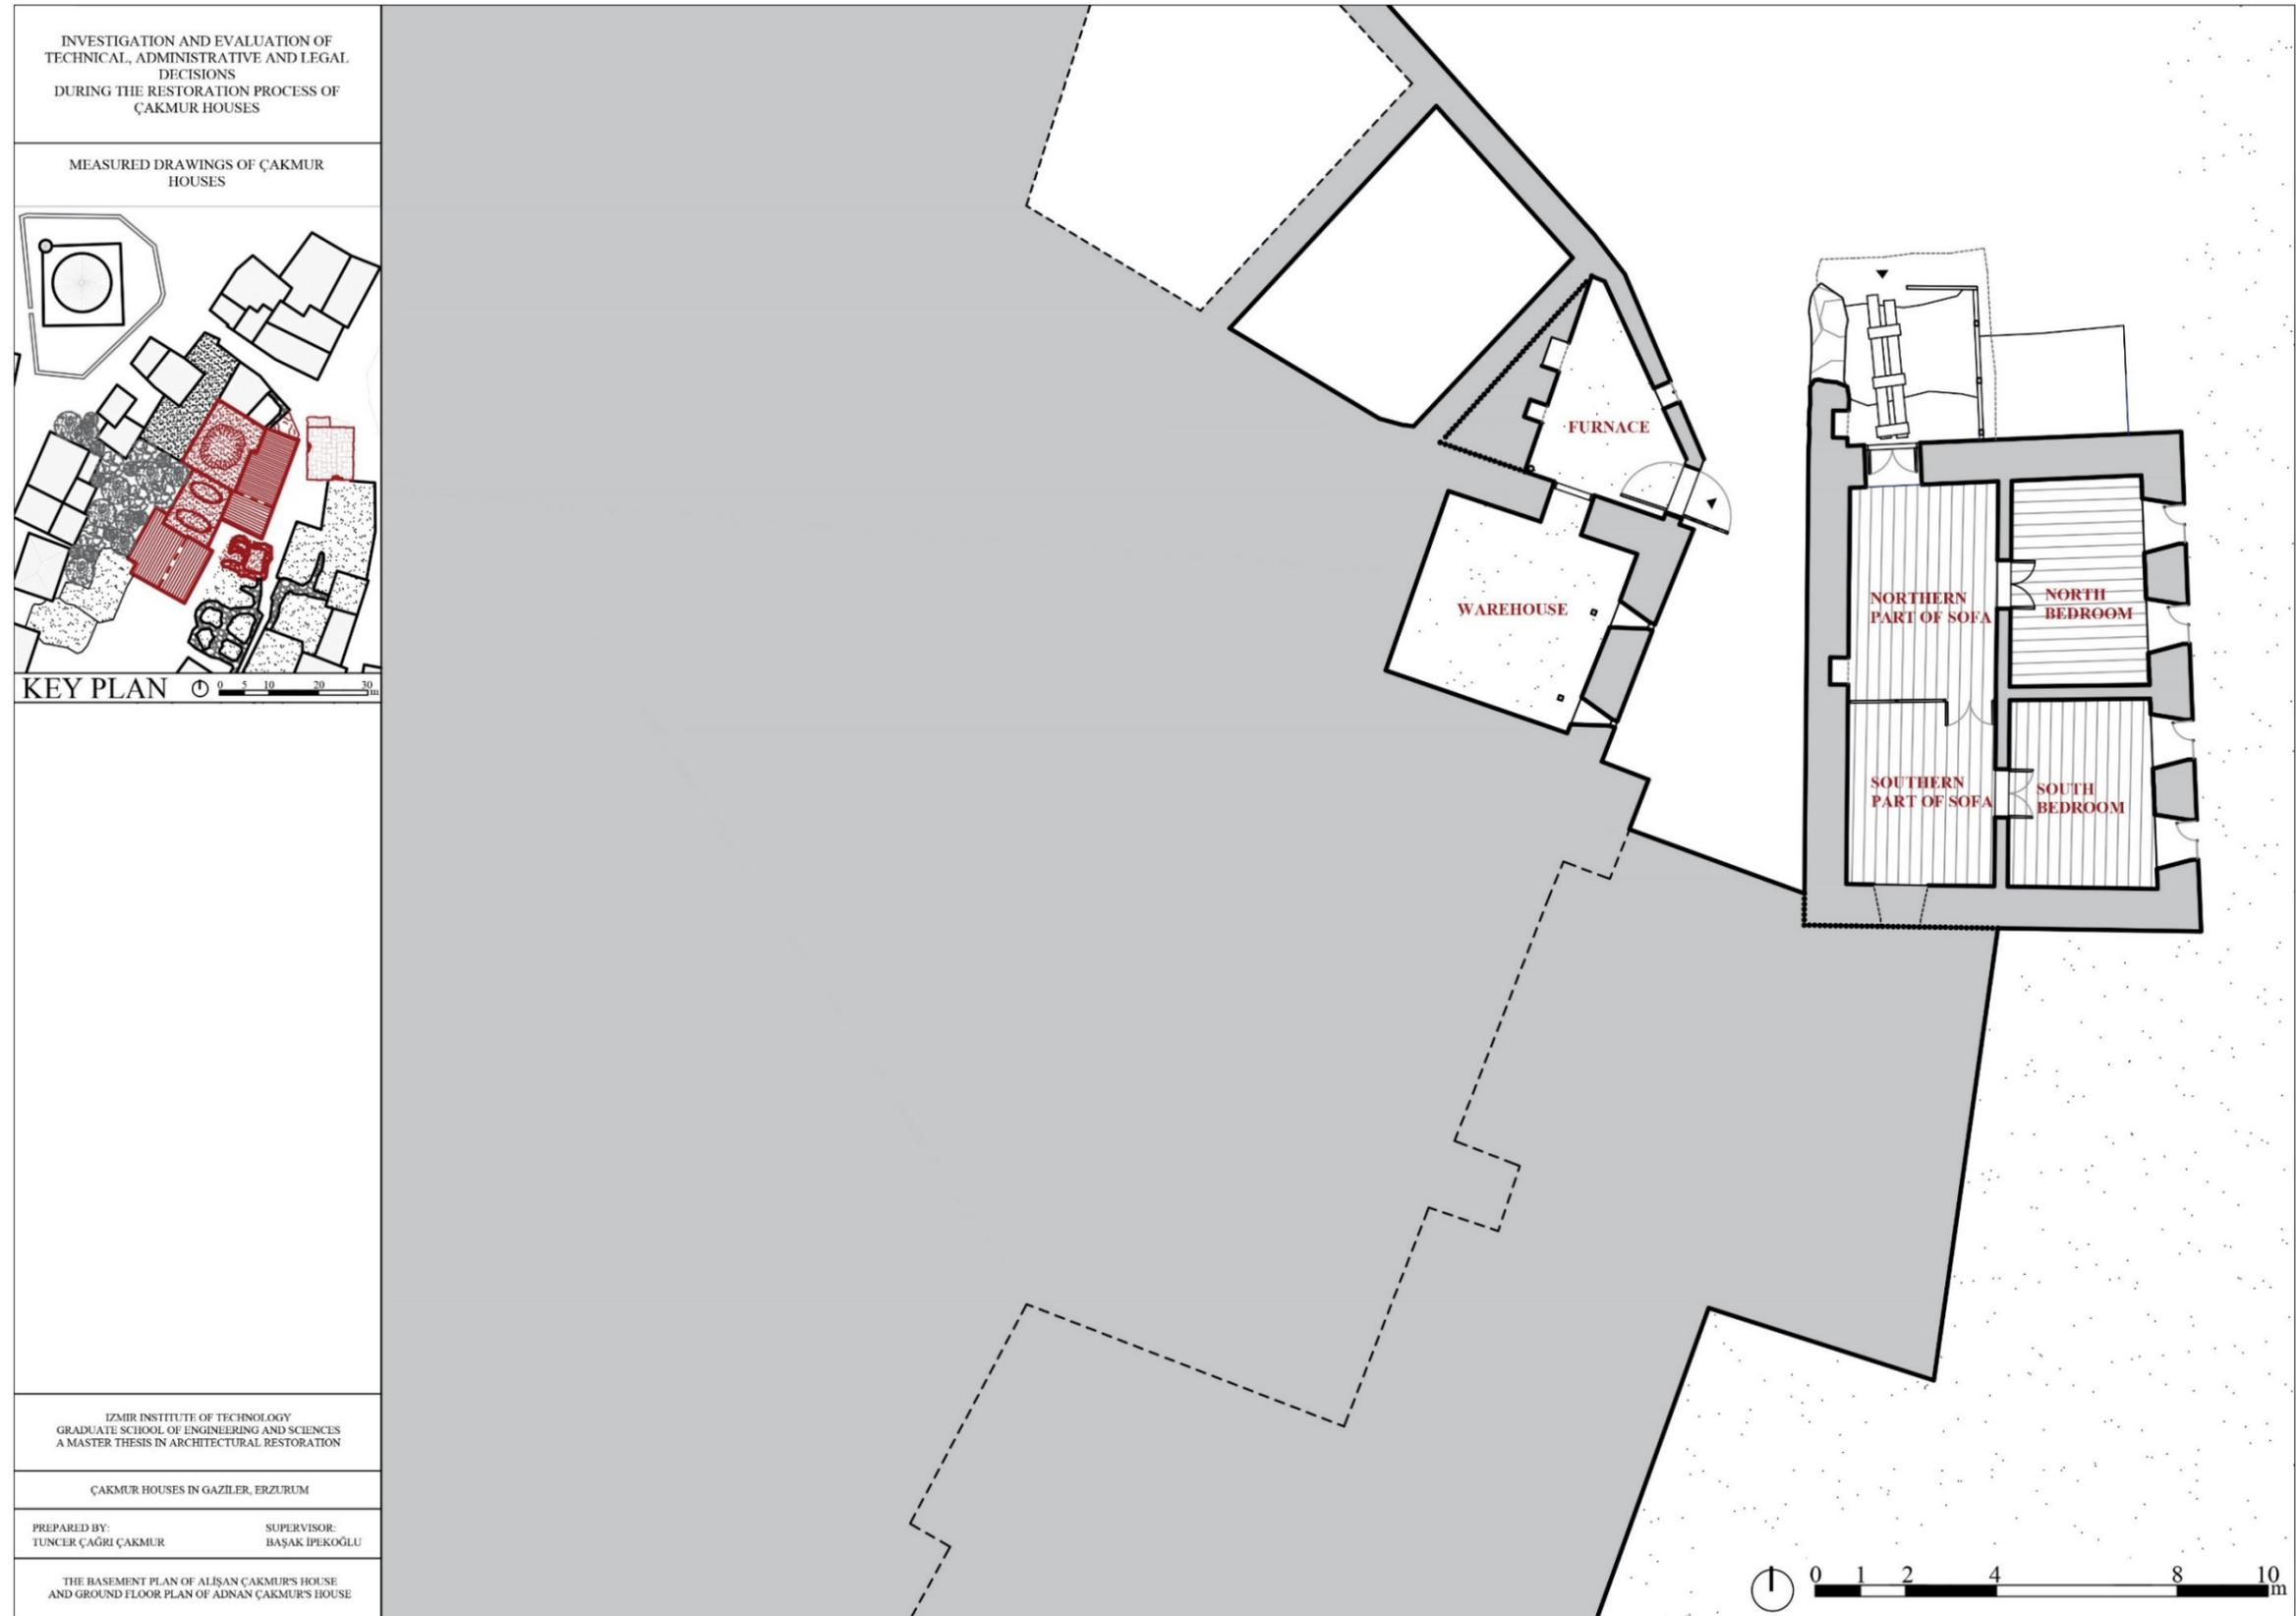
Figure A.2. Measured drawing plan redrawn from Sirmacı Architecture.
(Prepared by Author, 2019)
