**INVESTIGATION AND EVALUATION OF
TECHNICAL, ADMINISTRATIVE AND LEGAL
DECISIONS DURING THE RESTORATION
PROCESS OF AKMUR HOUSES**

**A Thesis Submitted to
the Graduate School of Engineering and Sciences of
İzmir Institute of Technology
in Partial Fulfilment of the Requirements for the Degree of**

in Architectural Restoration

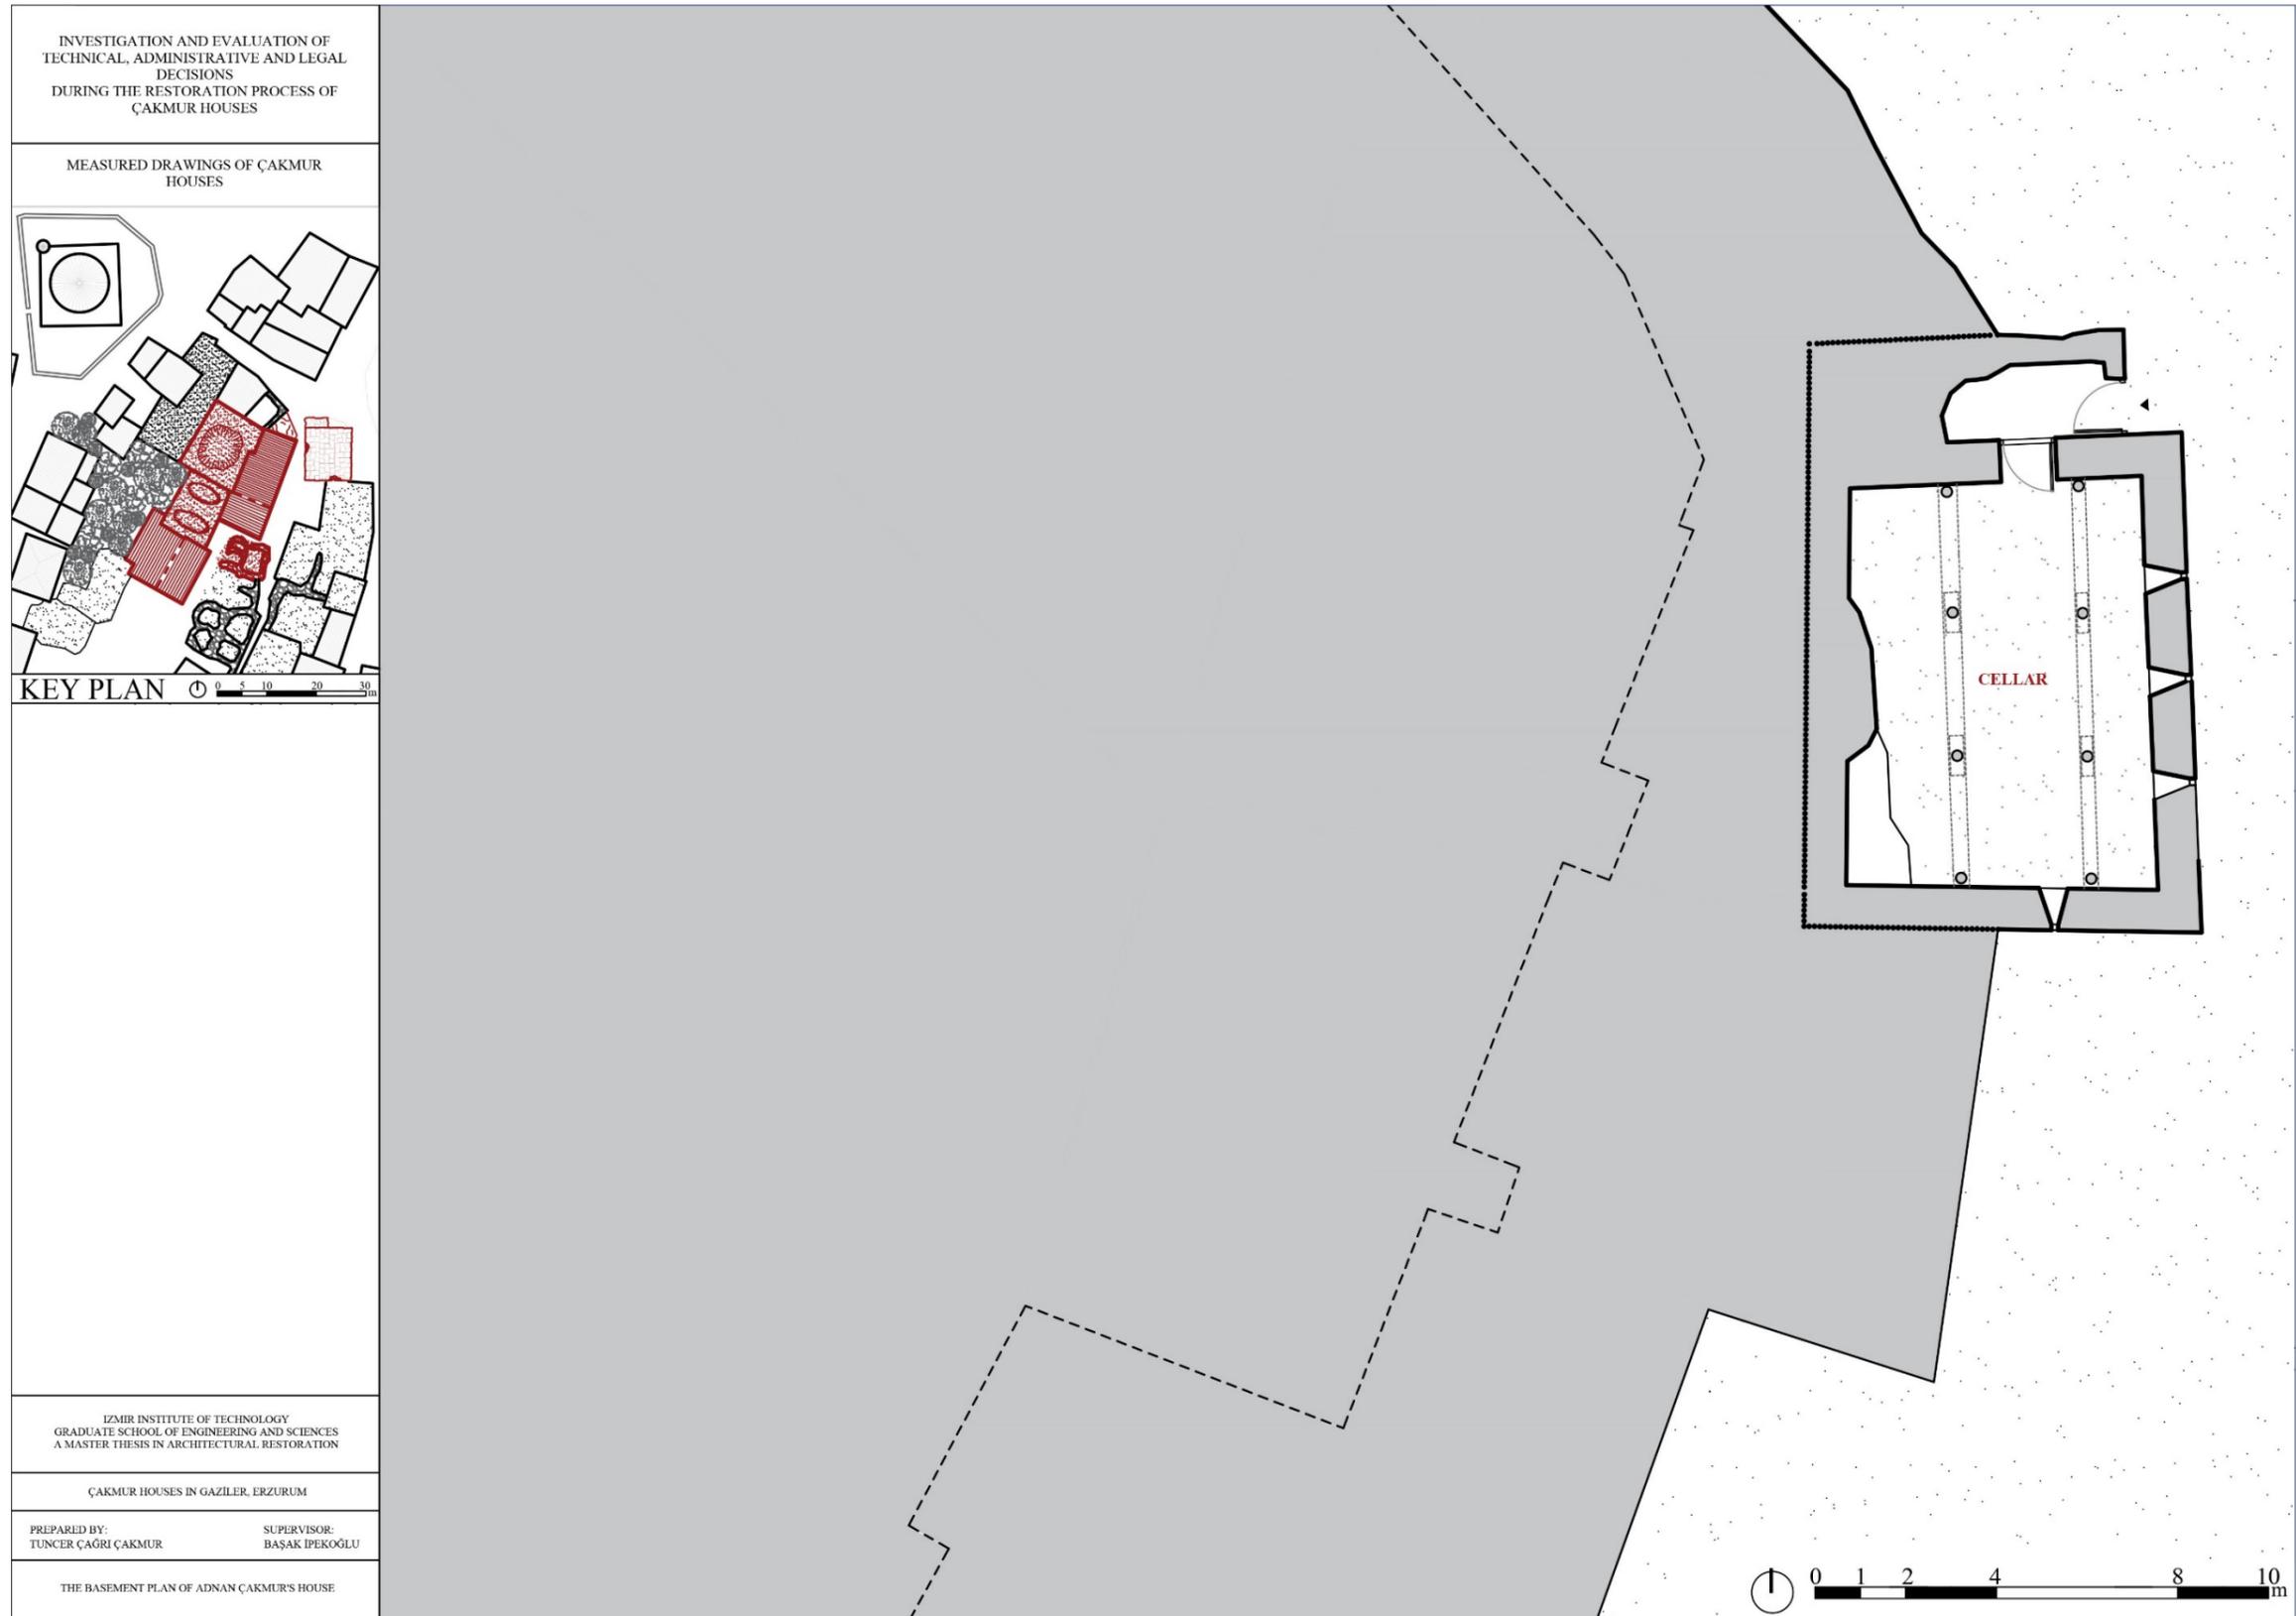
Figure A.3. Measured drawing plan redrawn from Sırmacı Architecture.
(Prepared by Author, 2019)

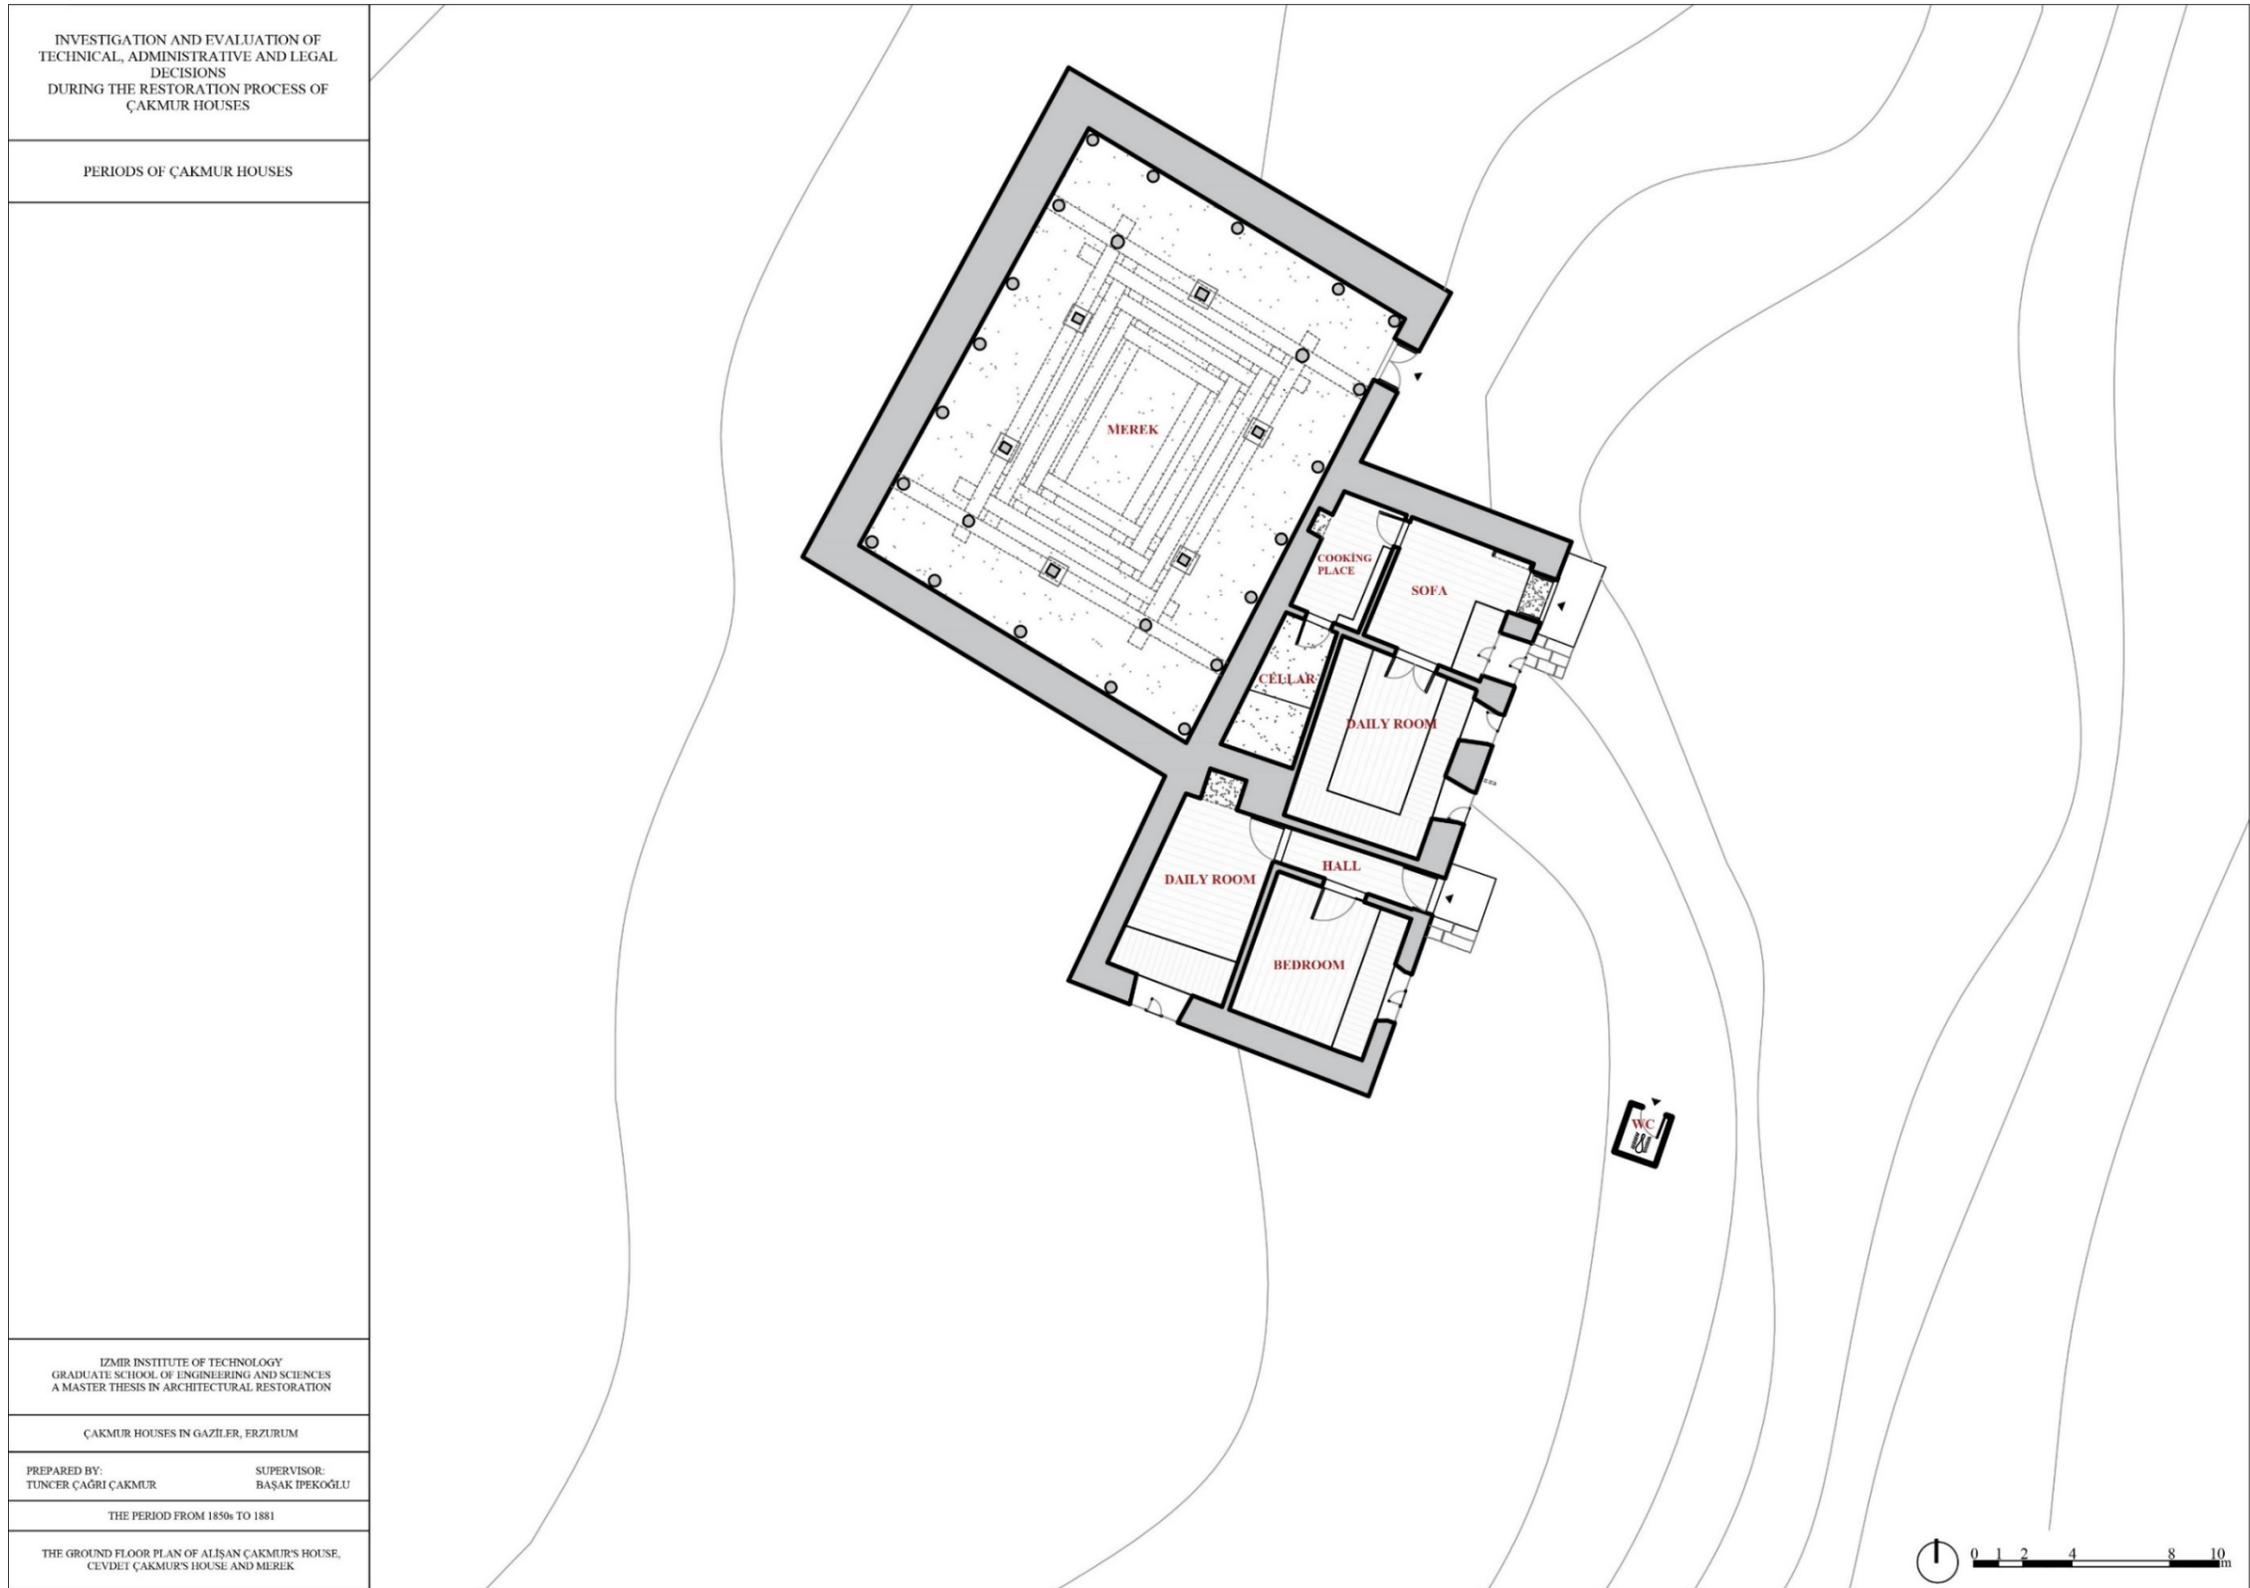
Figure C.1. Restitution drawing of the period from 1850s to 1881.
 (Prepared by Author, 2019)

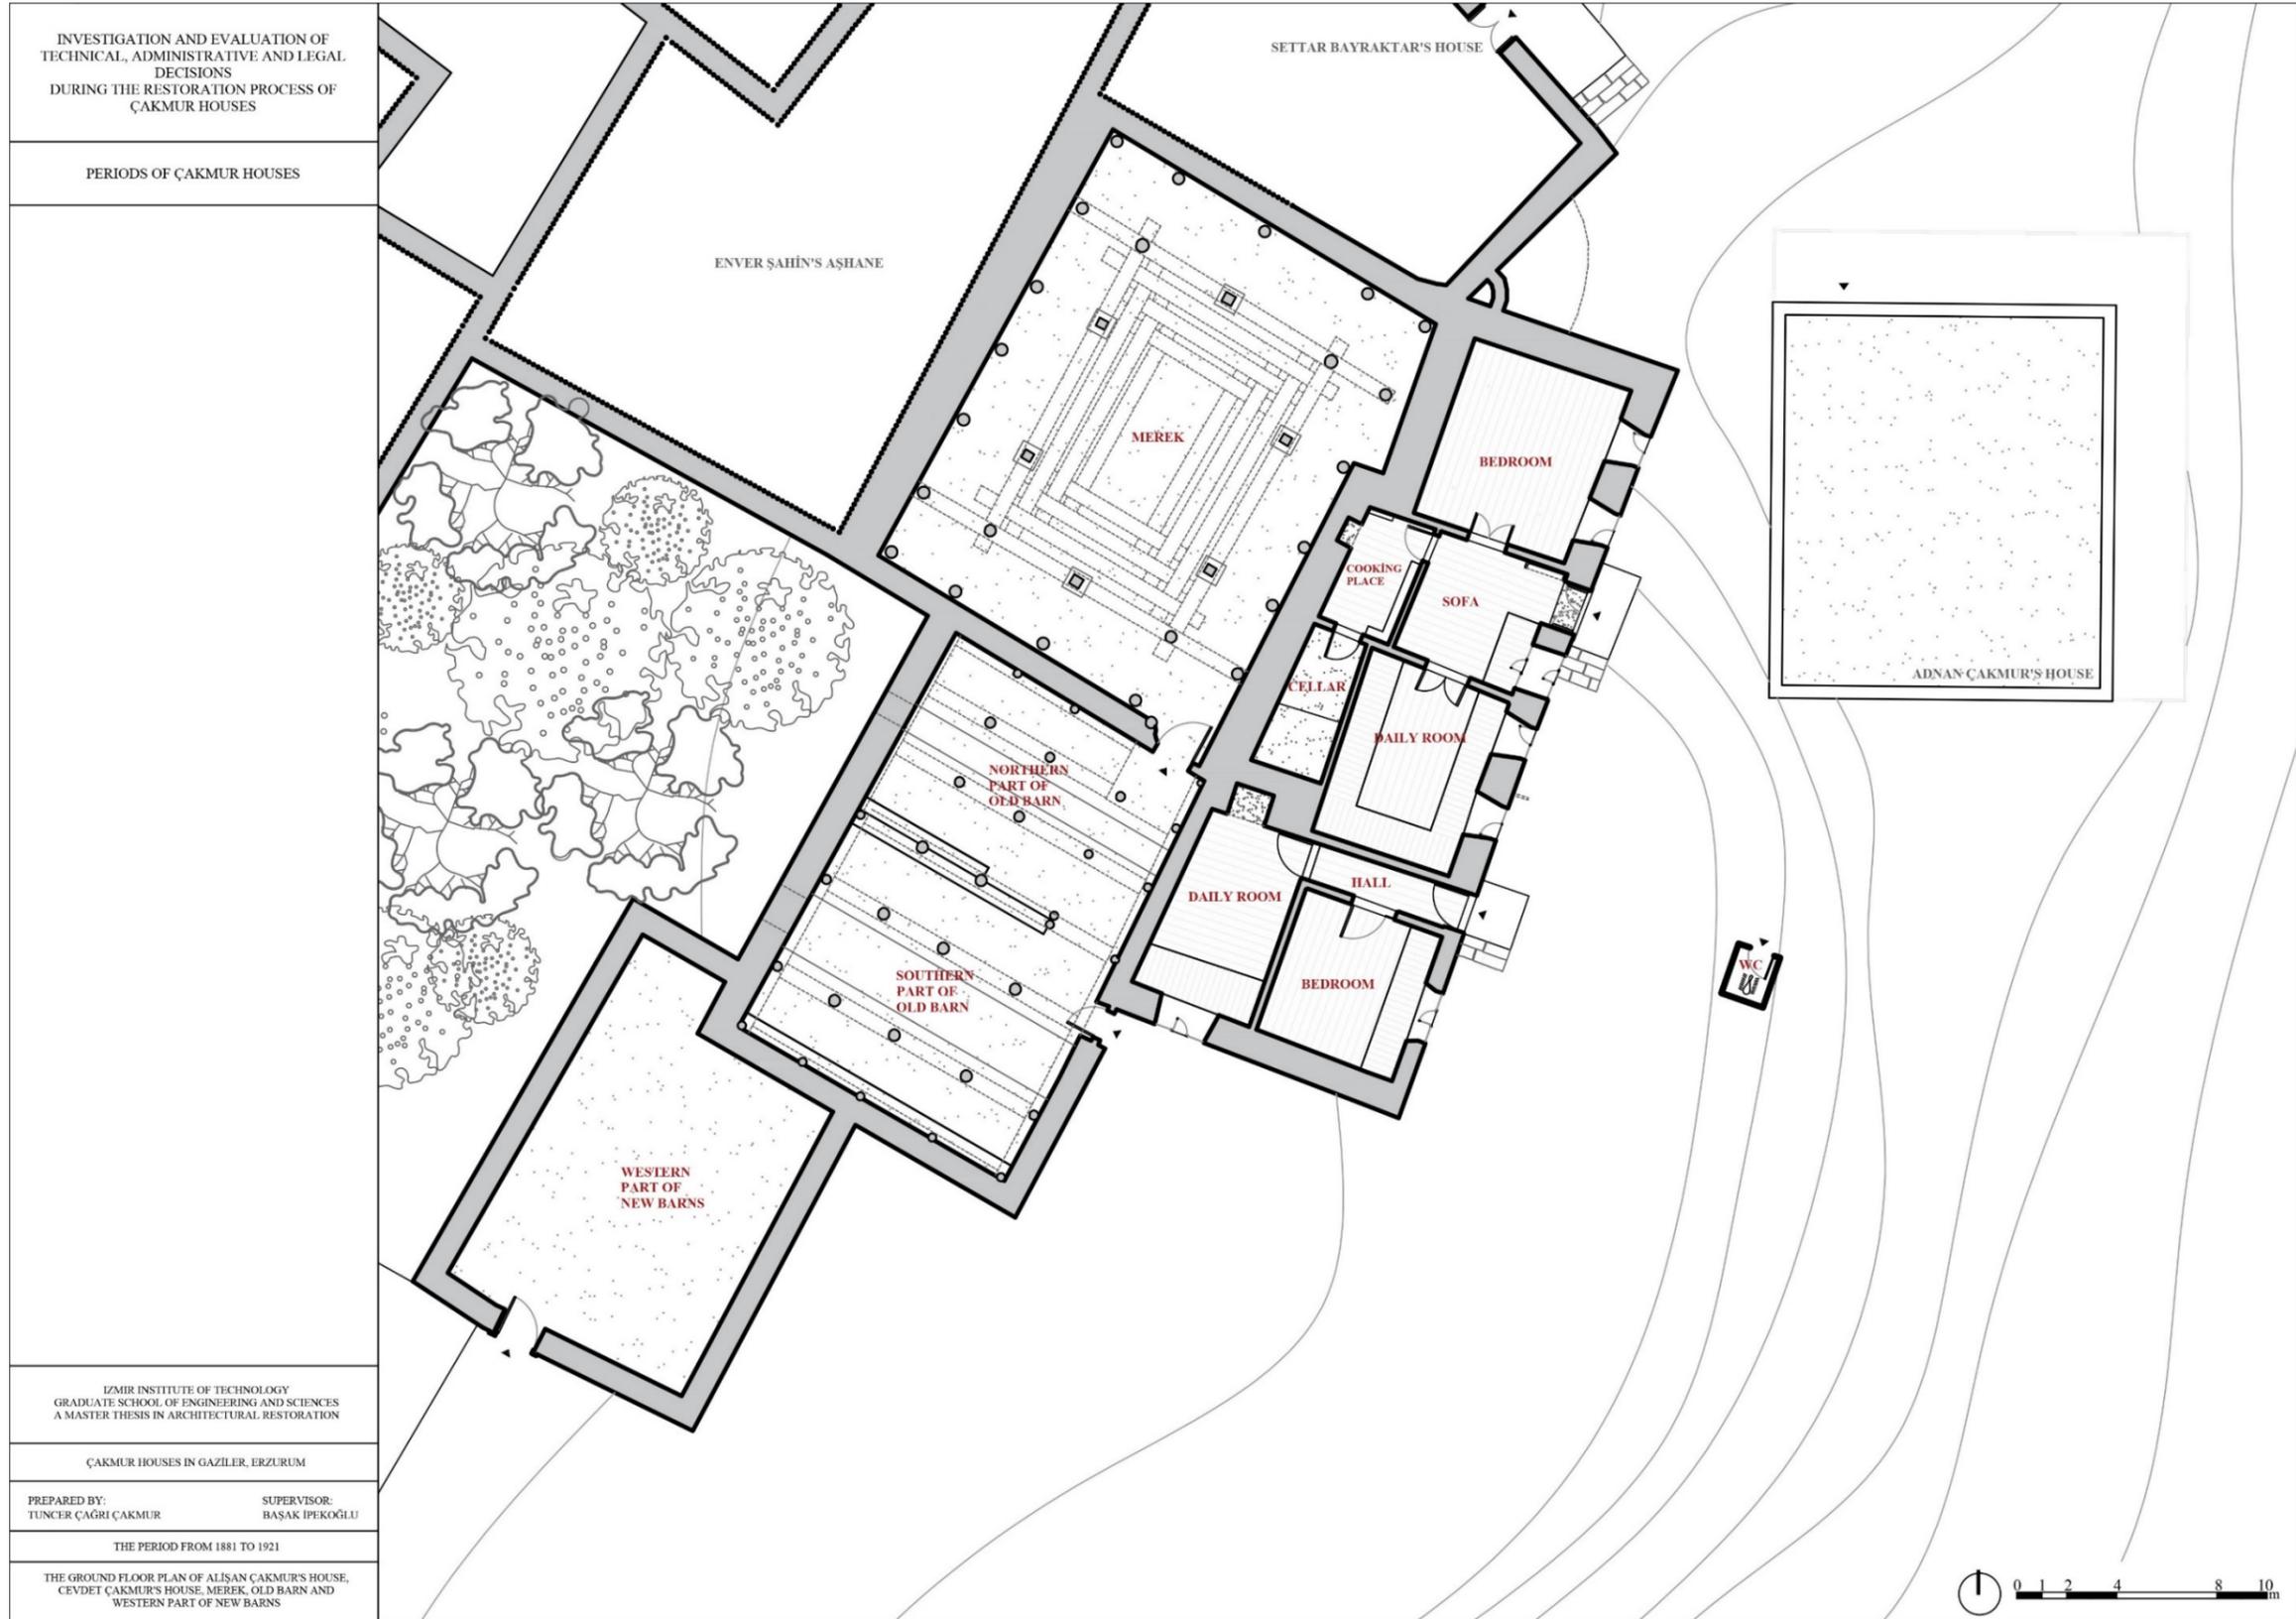
Figure C.2. Restitution drawing of the period from 1881 to 1921.
 (Prepared by Author, 2019).

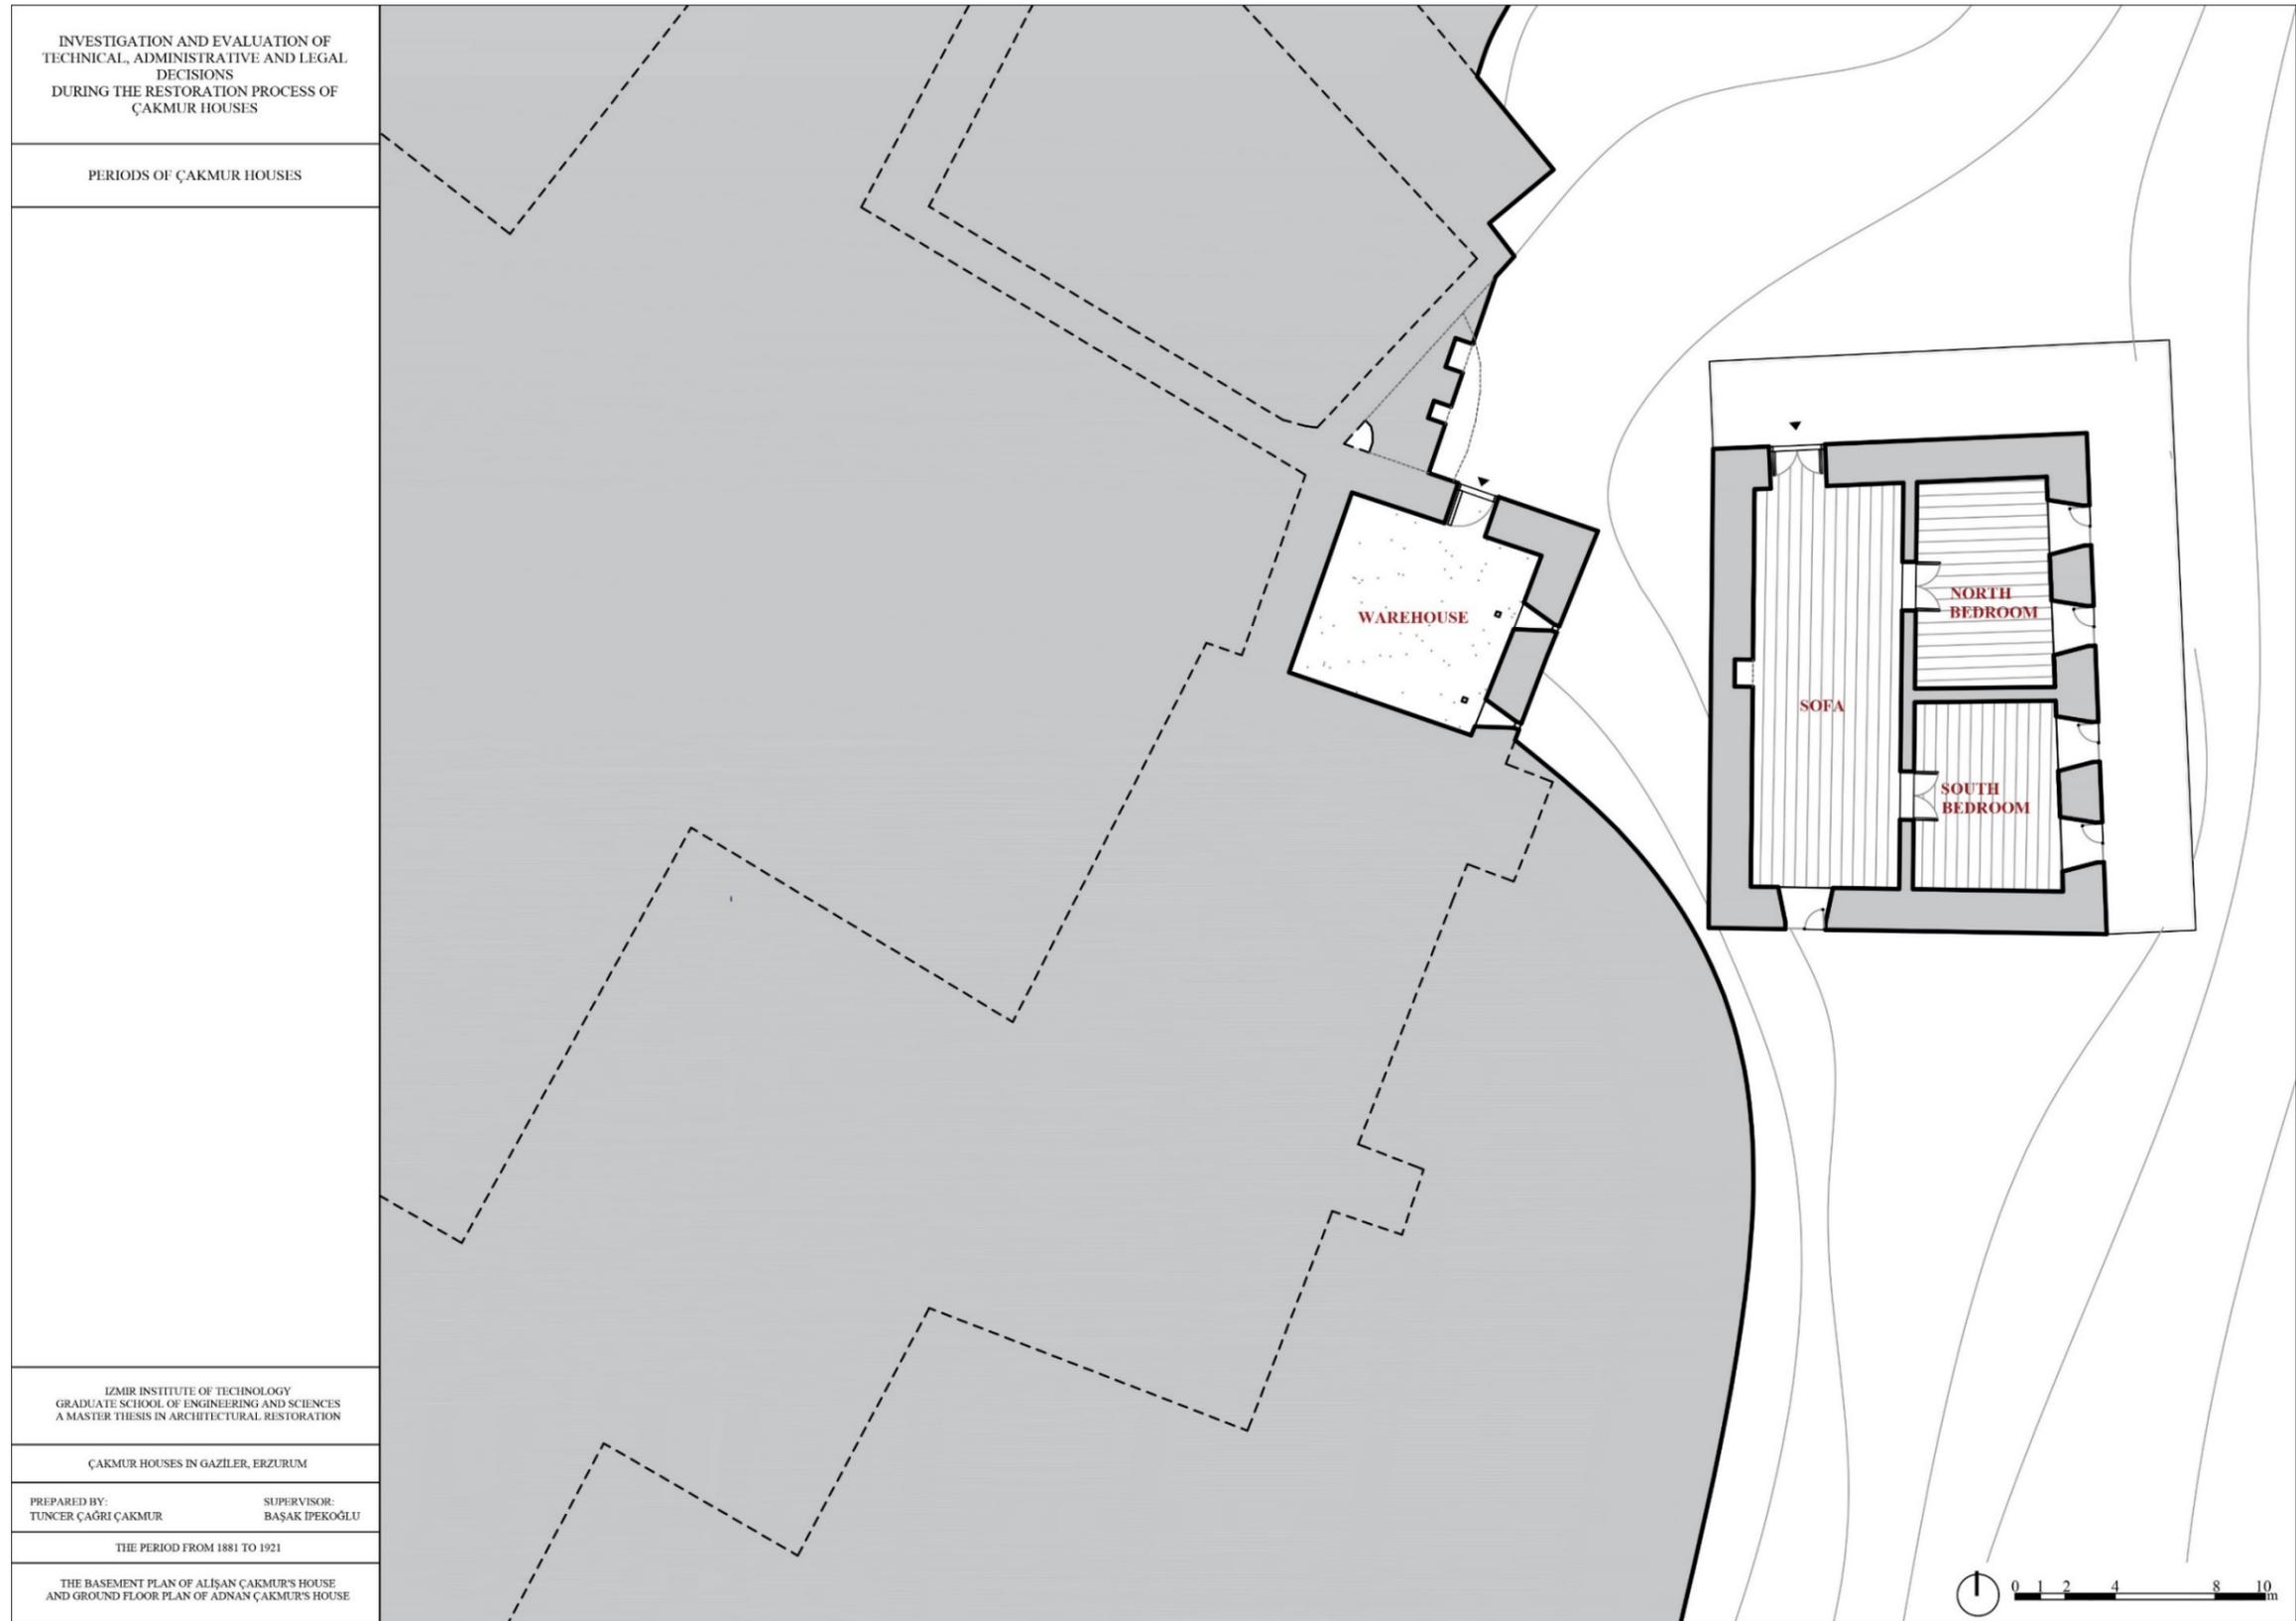
Figure C.3. Restitution drawing of the period from 1881 to 1921.
 (Prepared by Author, 2019)

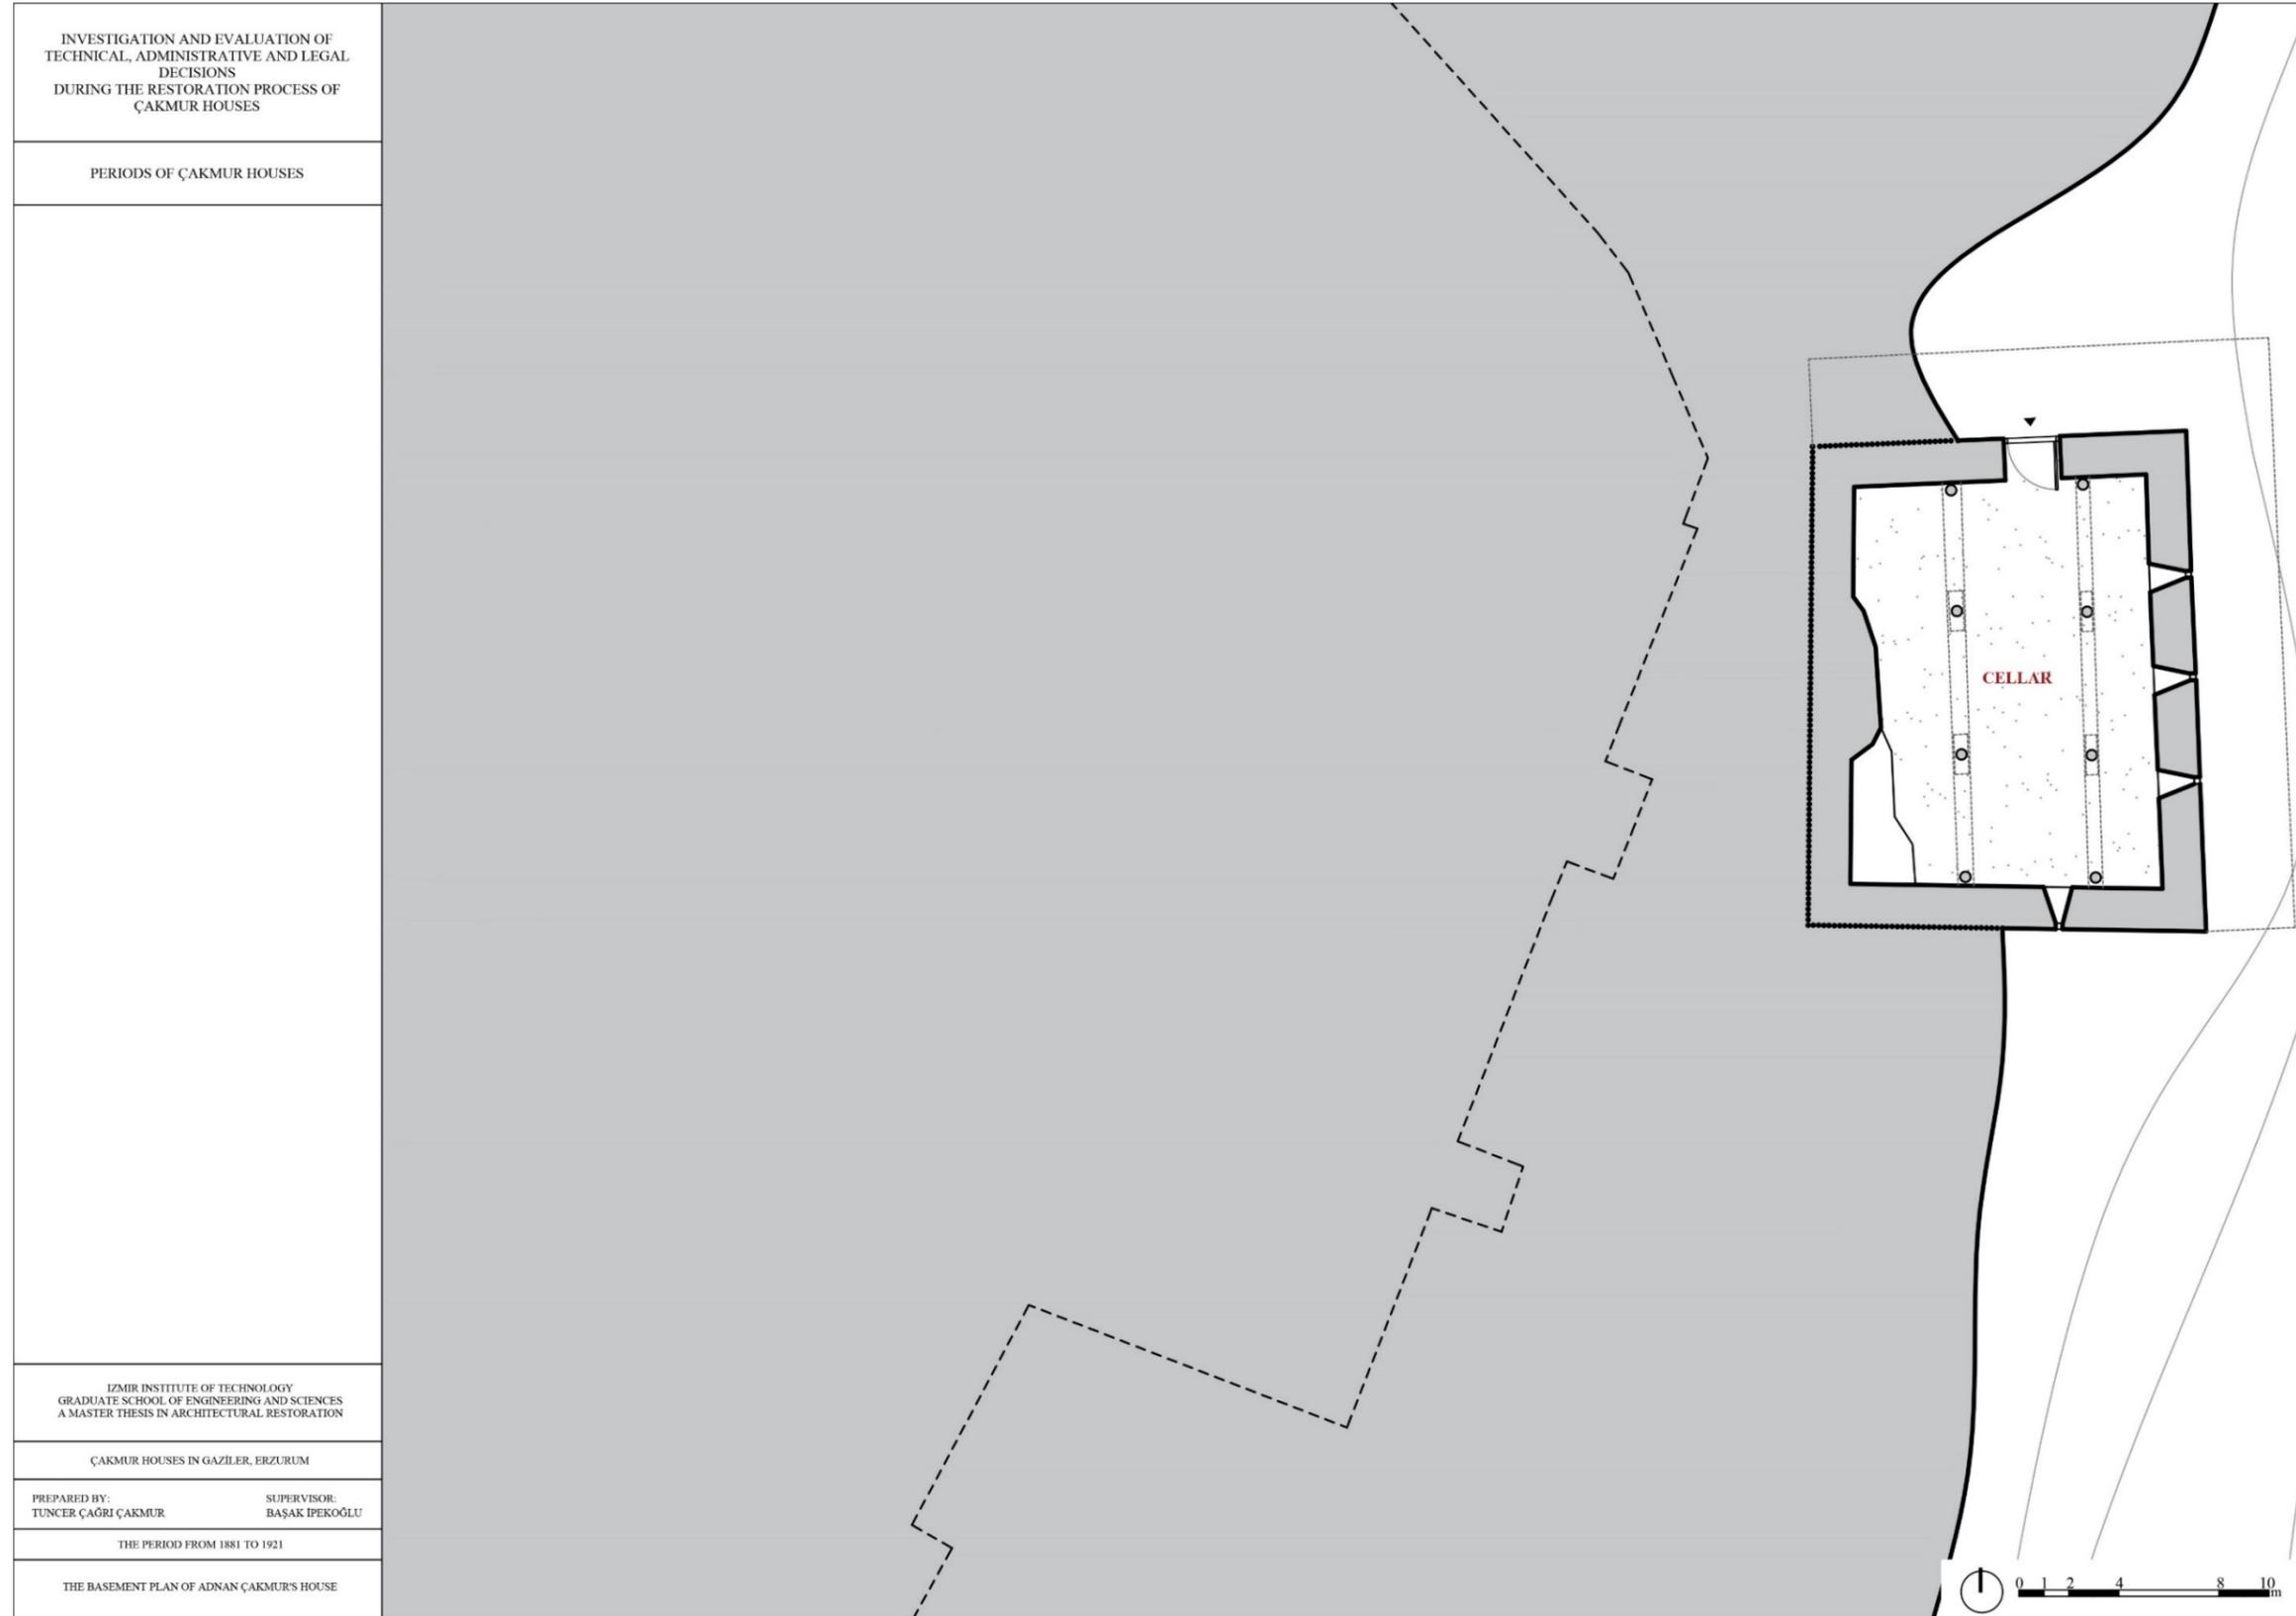
Figure C.4. Restitution drawing of the period from 1881 to 1921.
 (Prepared by Author, 2019)

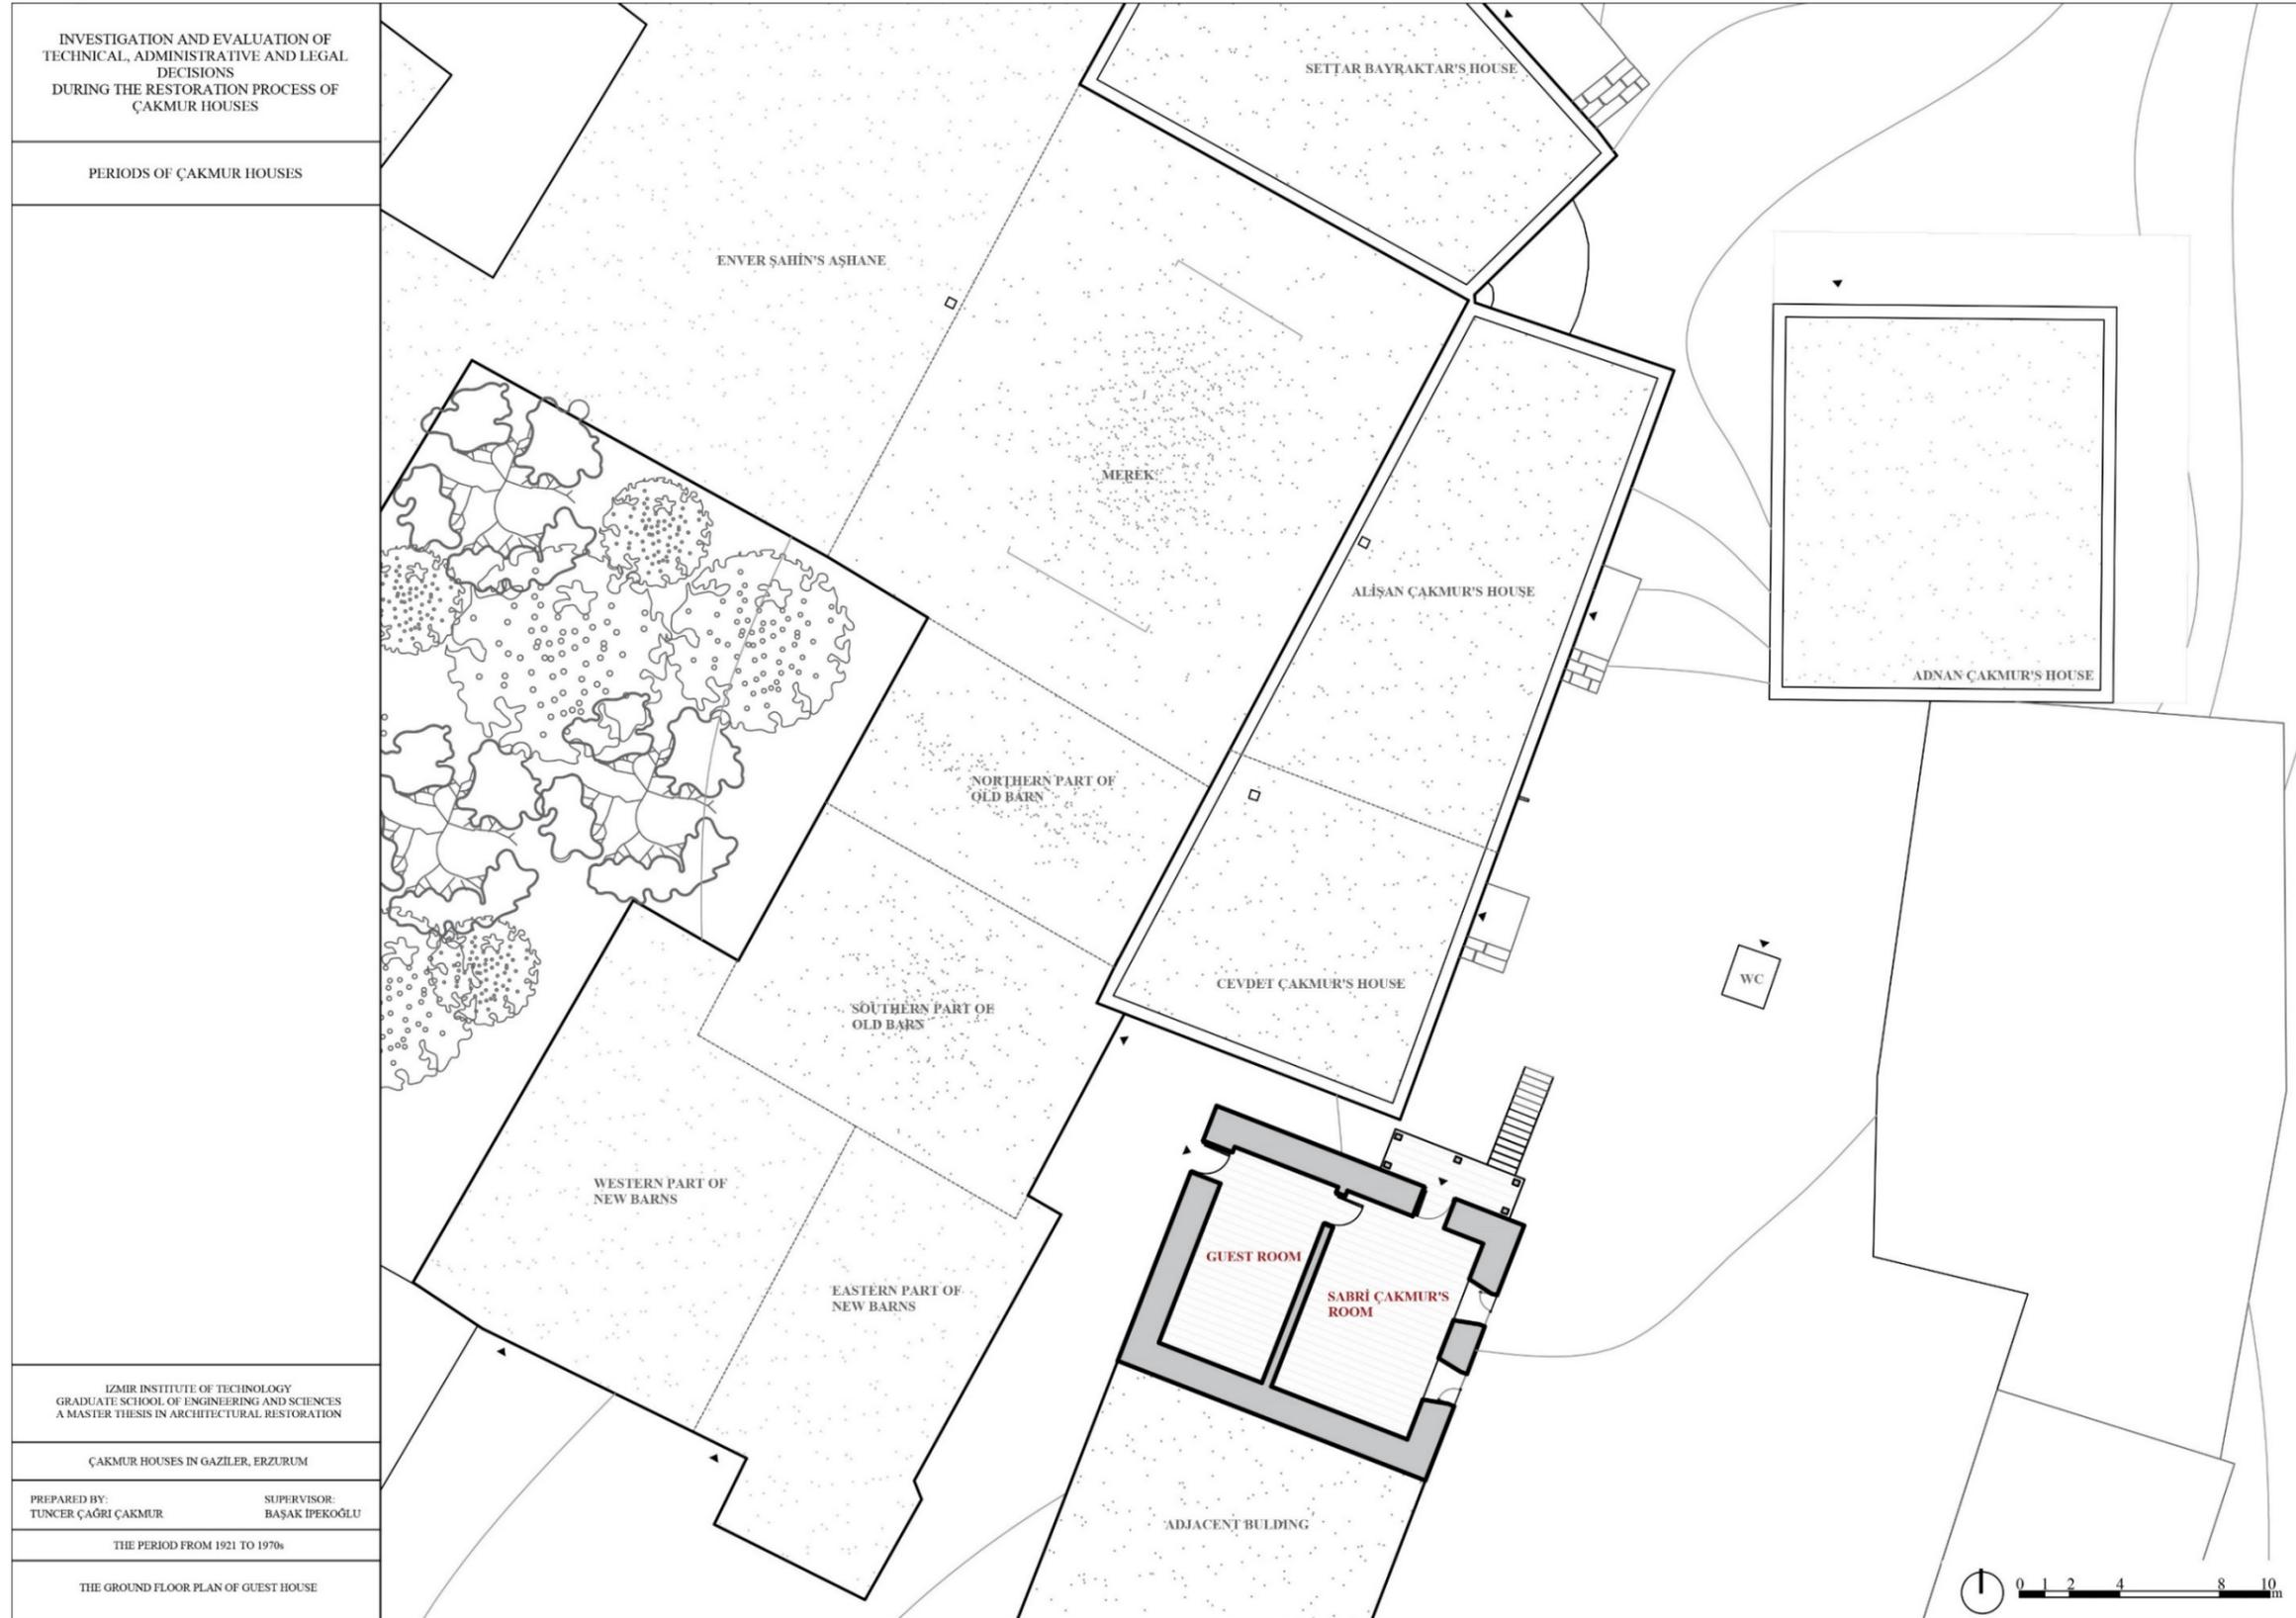
Figure C.5. Restitution drawing of the period from 1921 to 1970s.
 (Prepared by Author, 2019)
