**INVESTIGATION AND EVALUATION OF
TECHNICAL, ADMINISTRATIVE AND LEGAL
DECISIONS DURING THE RESTORATION
PROCESS OF AKMUR HOUSES**

**A Thesis Submitted to
the Graduate School of Engineering and Sciences of
İzmir Institute of Technology
in Partial Fulfilment of the Requirements for the Degree of**

in Architectural Restoration

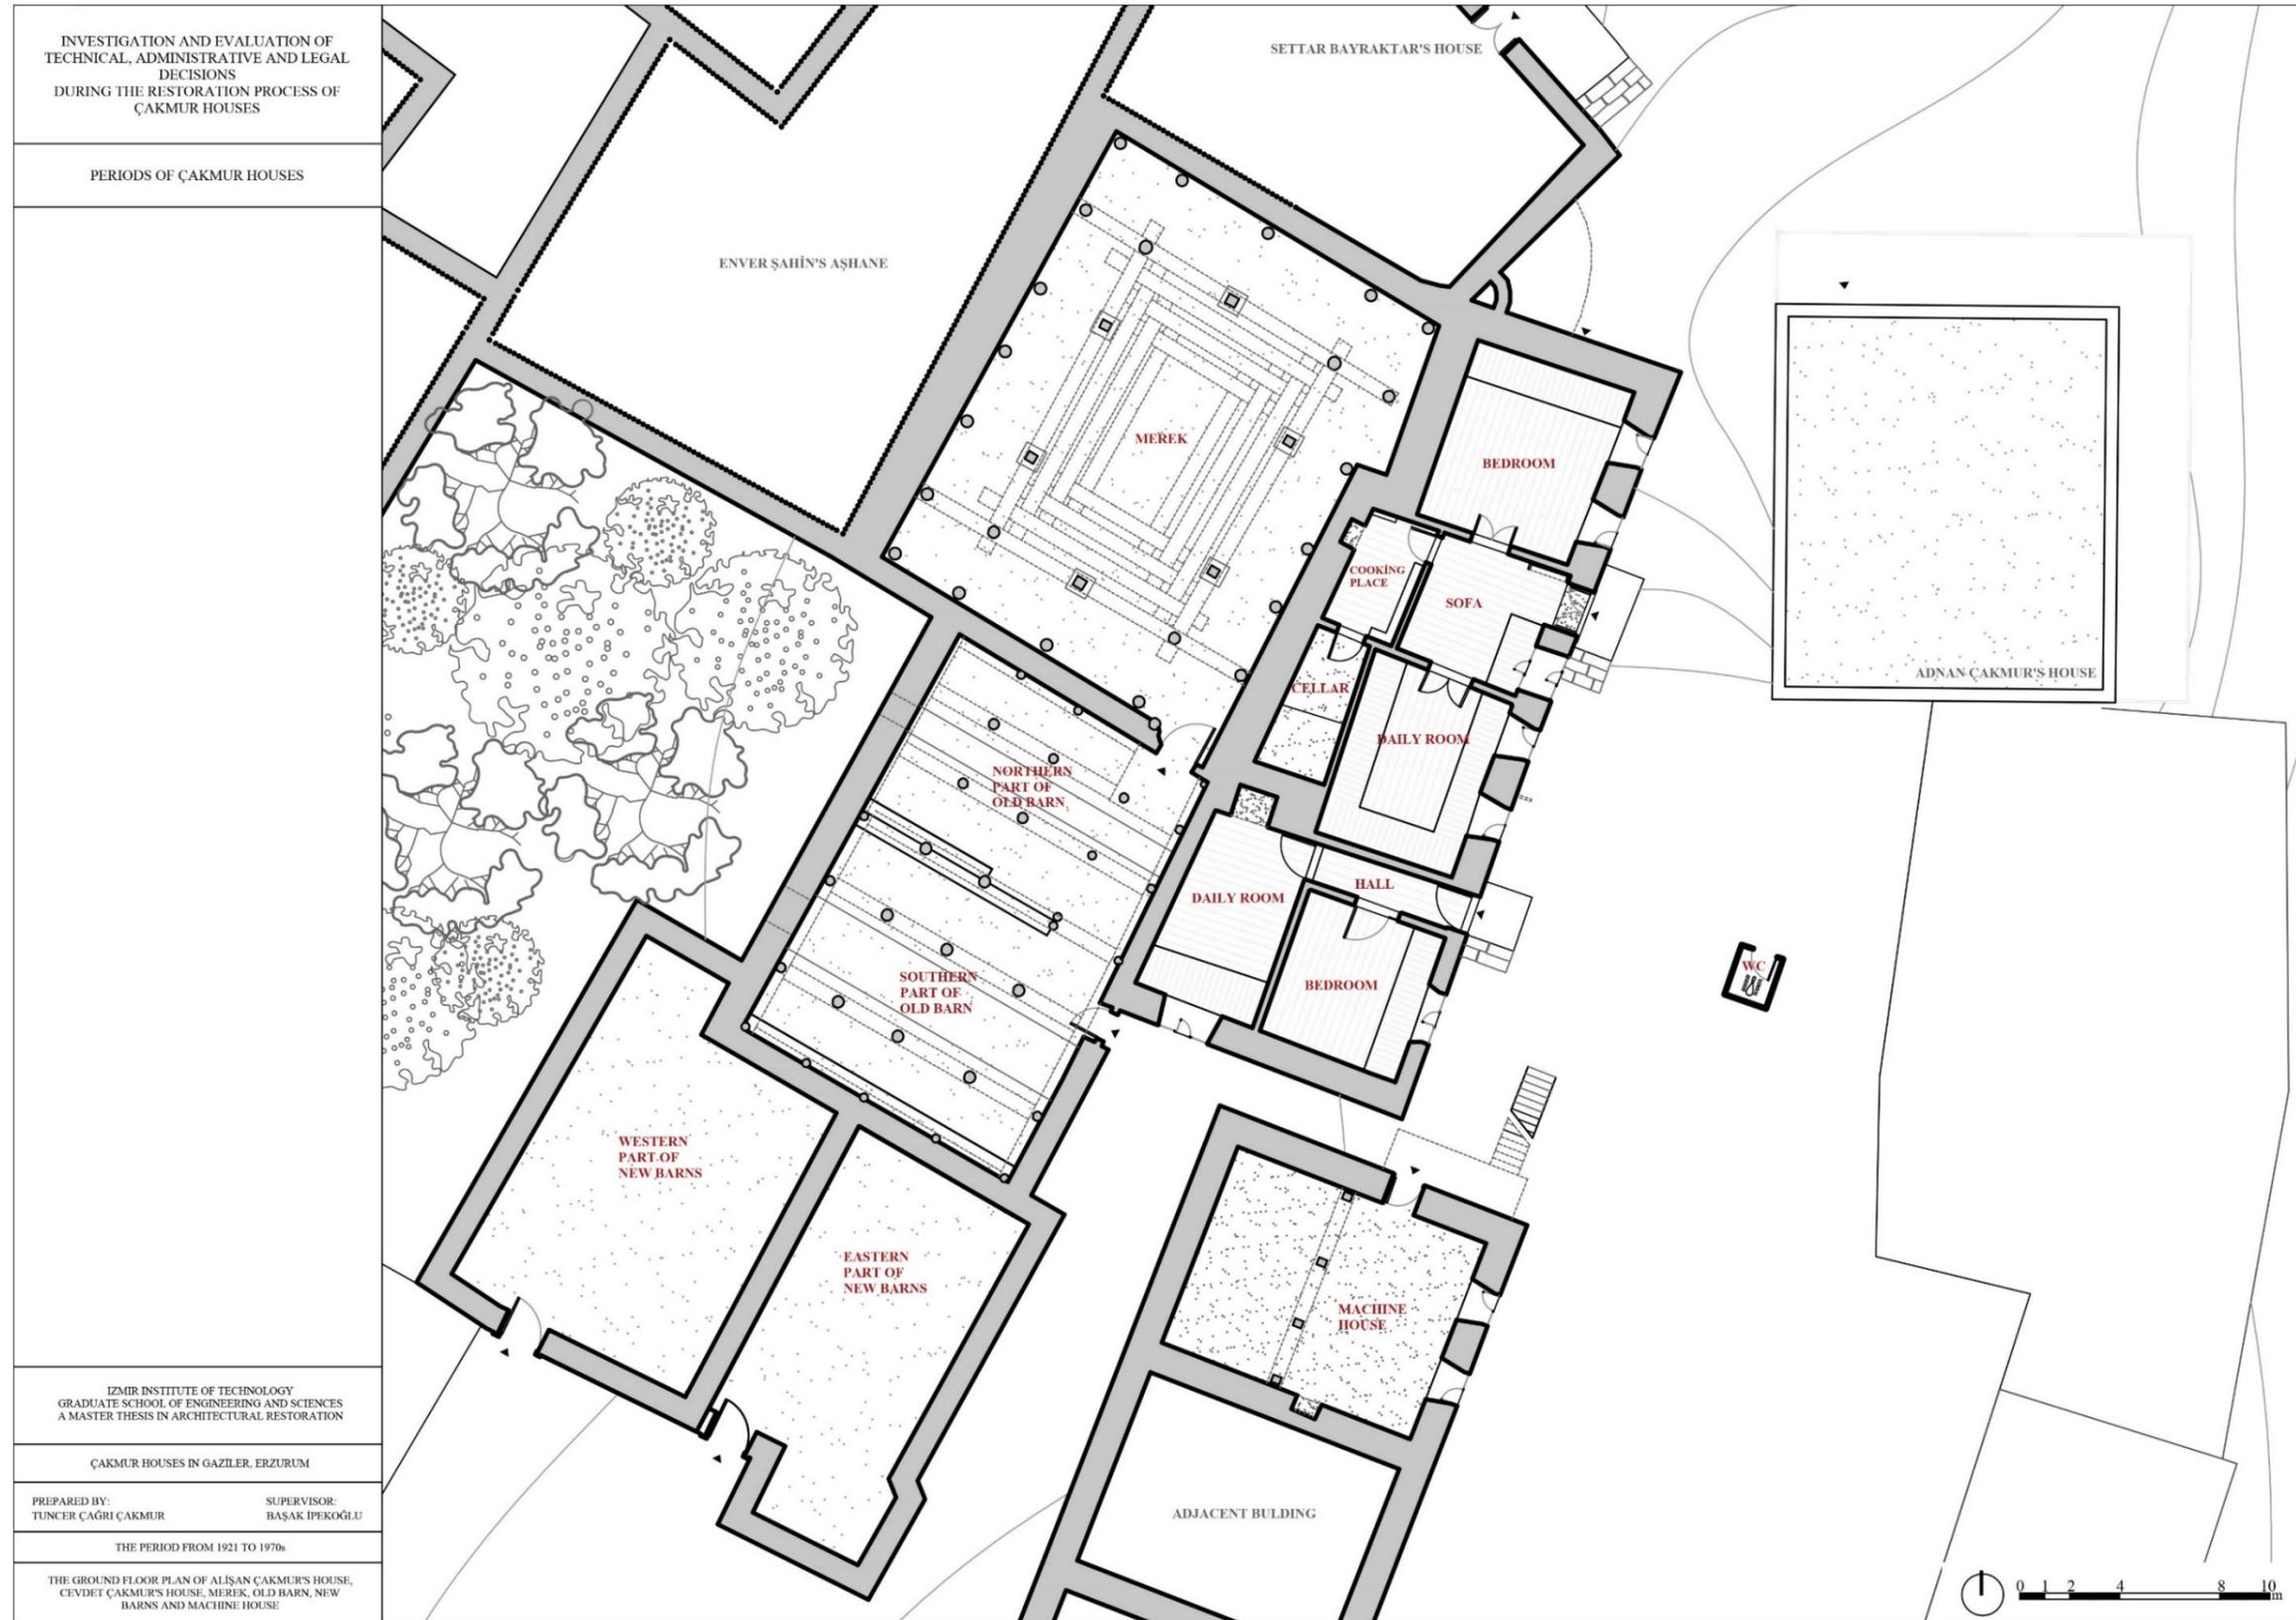
Figure C.6. Restitution drawing of the period from 1921 to 1970s.
 (Prepared by Author, 2019)

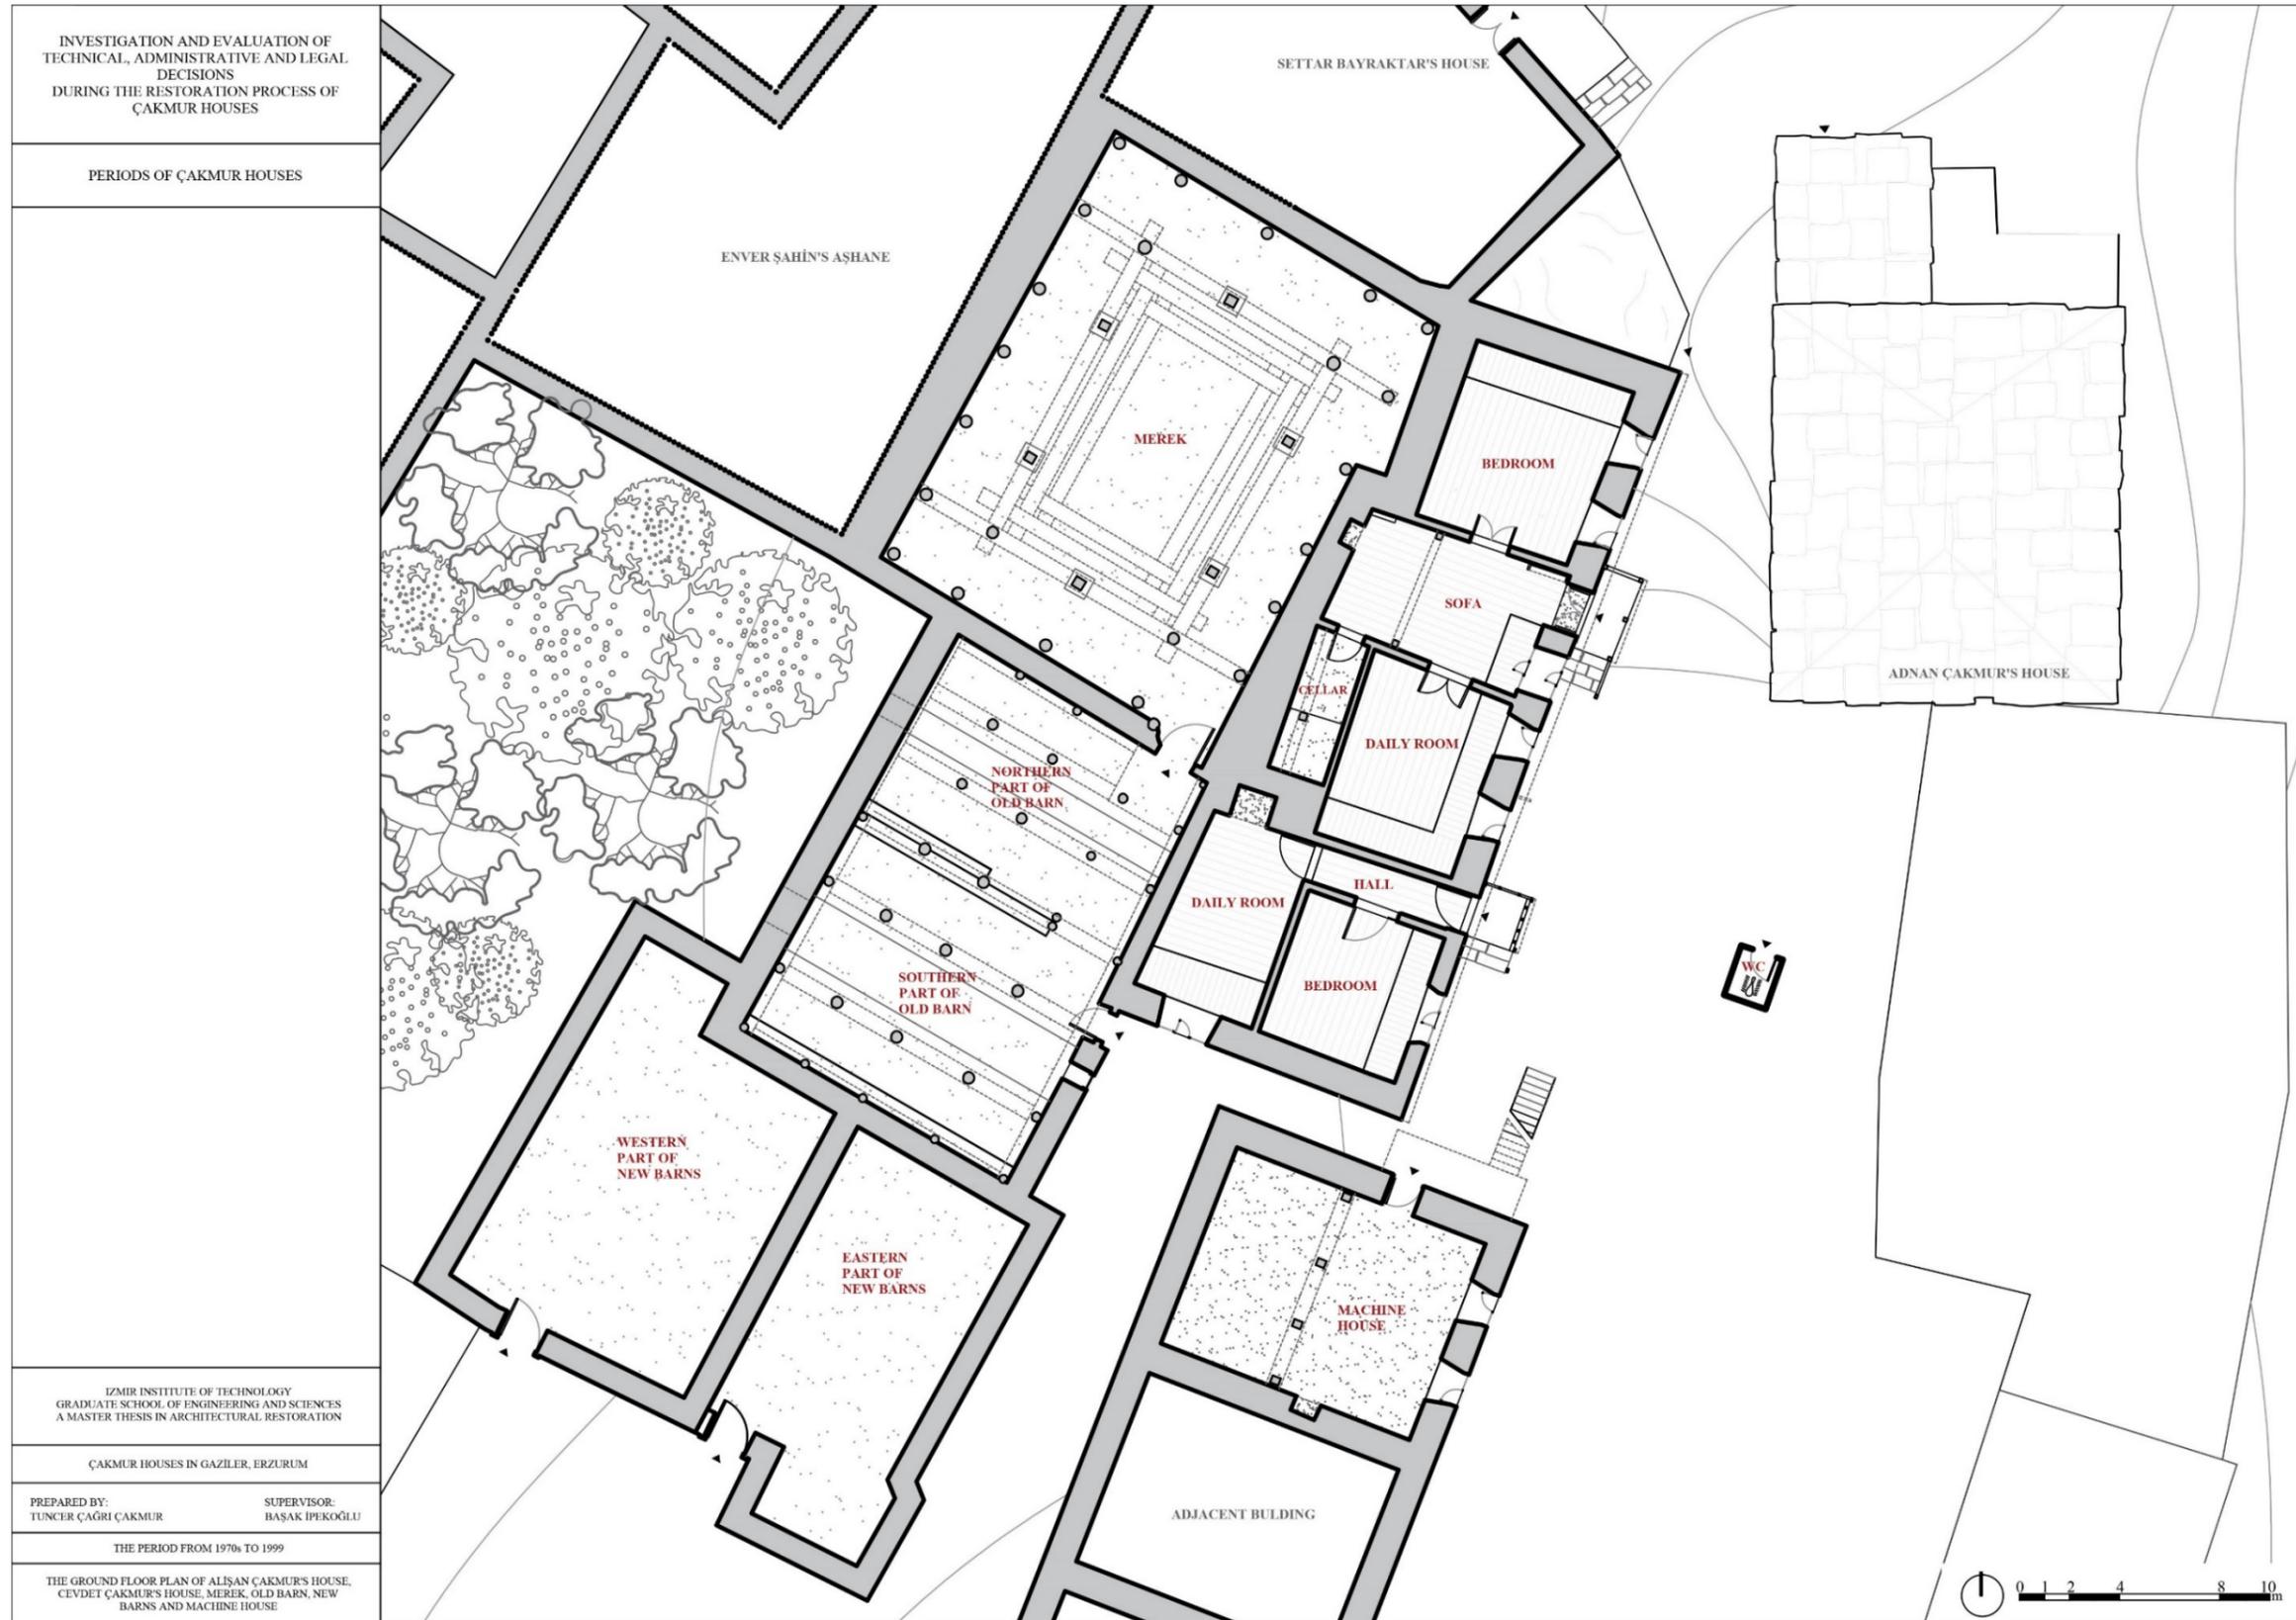
Figure C.7. Restitution drawing of the period from 1970s to 1999.
 (Prepared by Author, 2019)

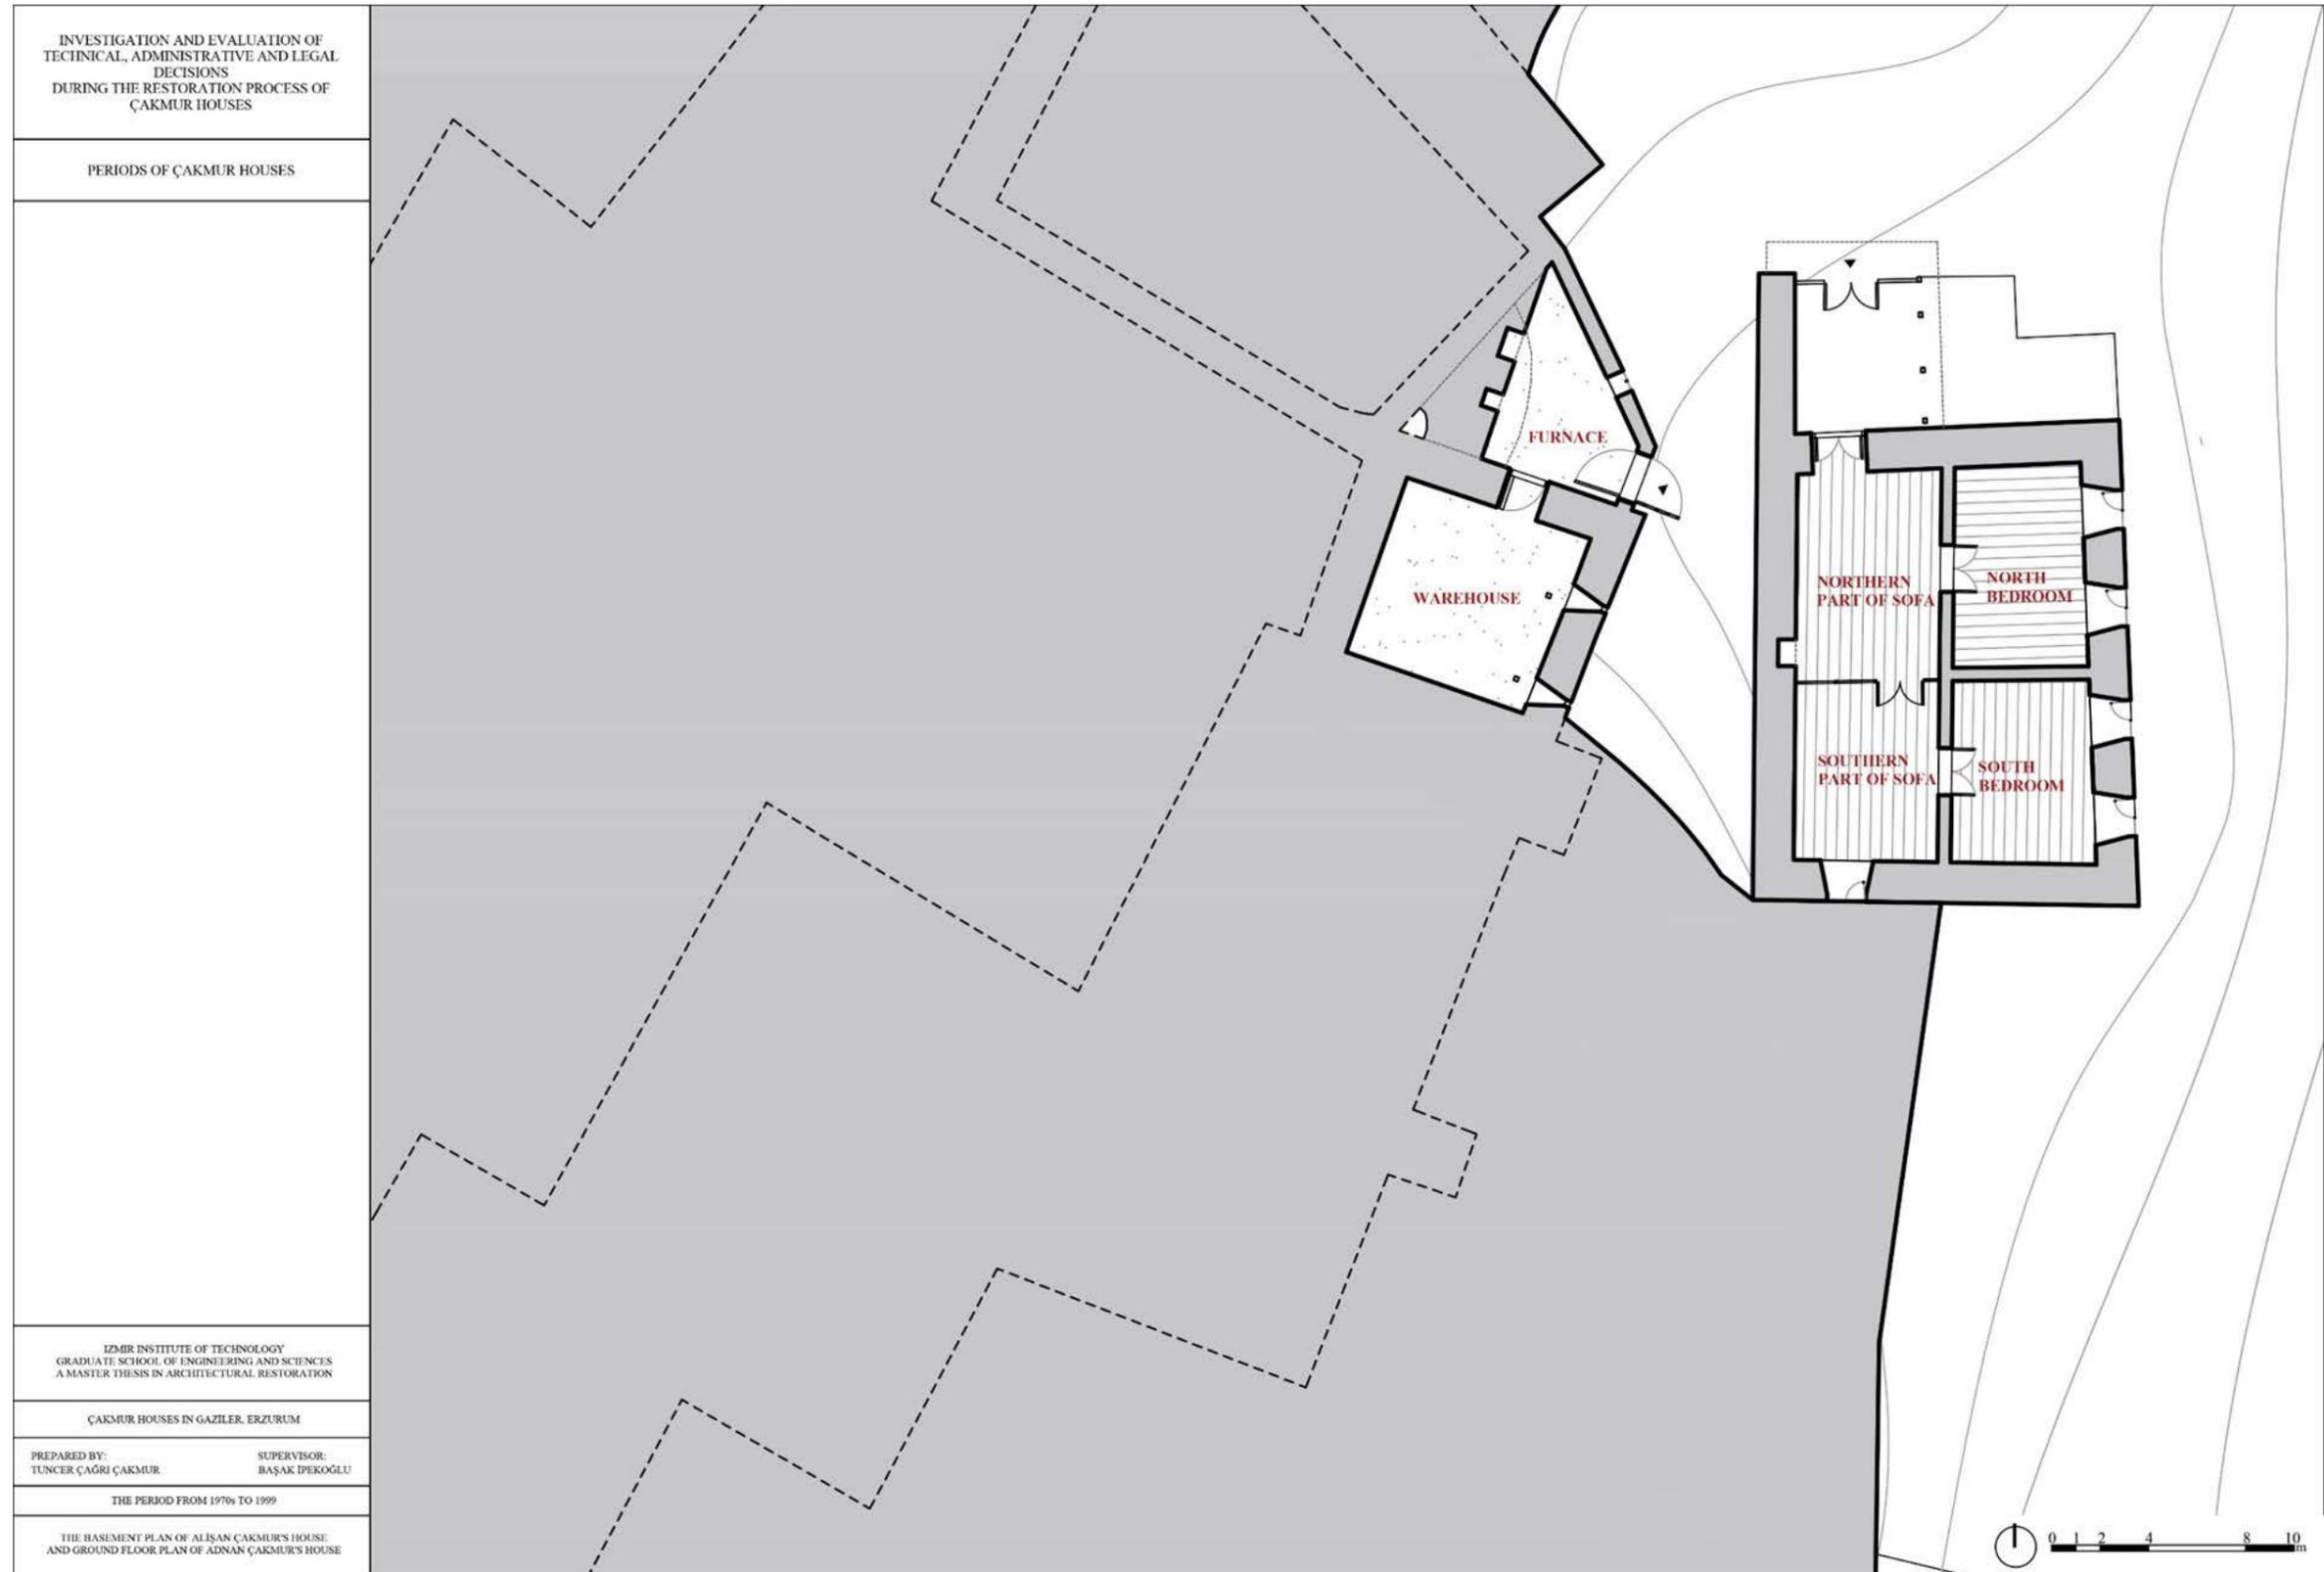
Figure C.8. Restituted drawing of the period from 1970s to 1999.
(Prepared by Author, 2019)

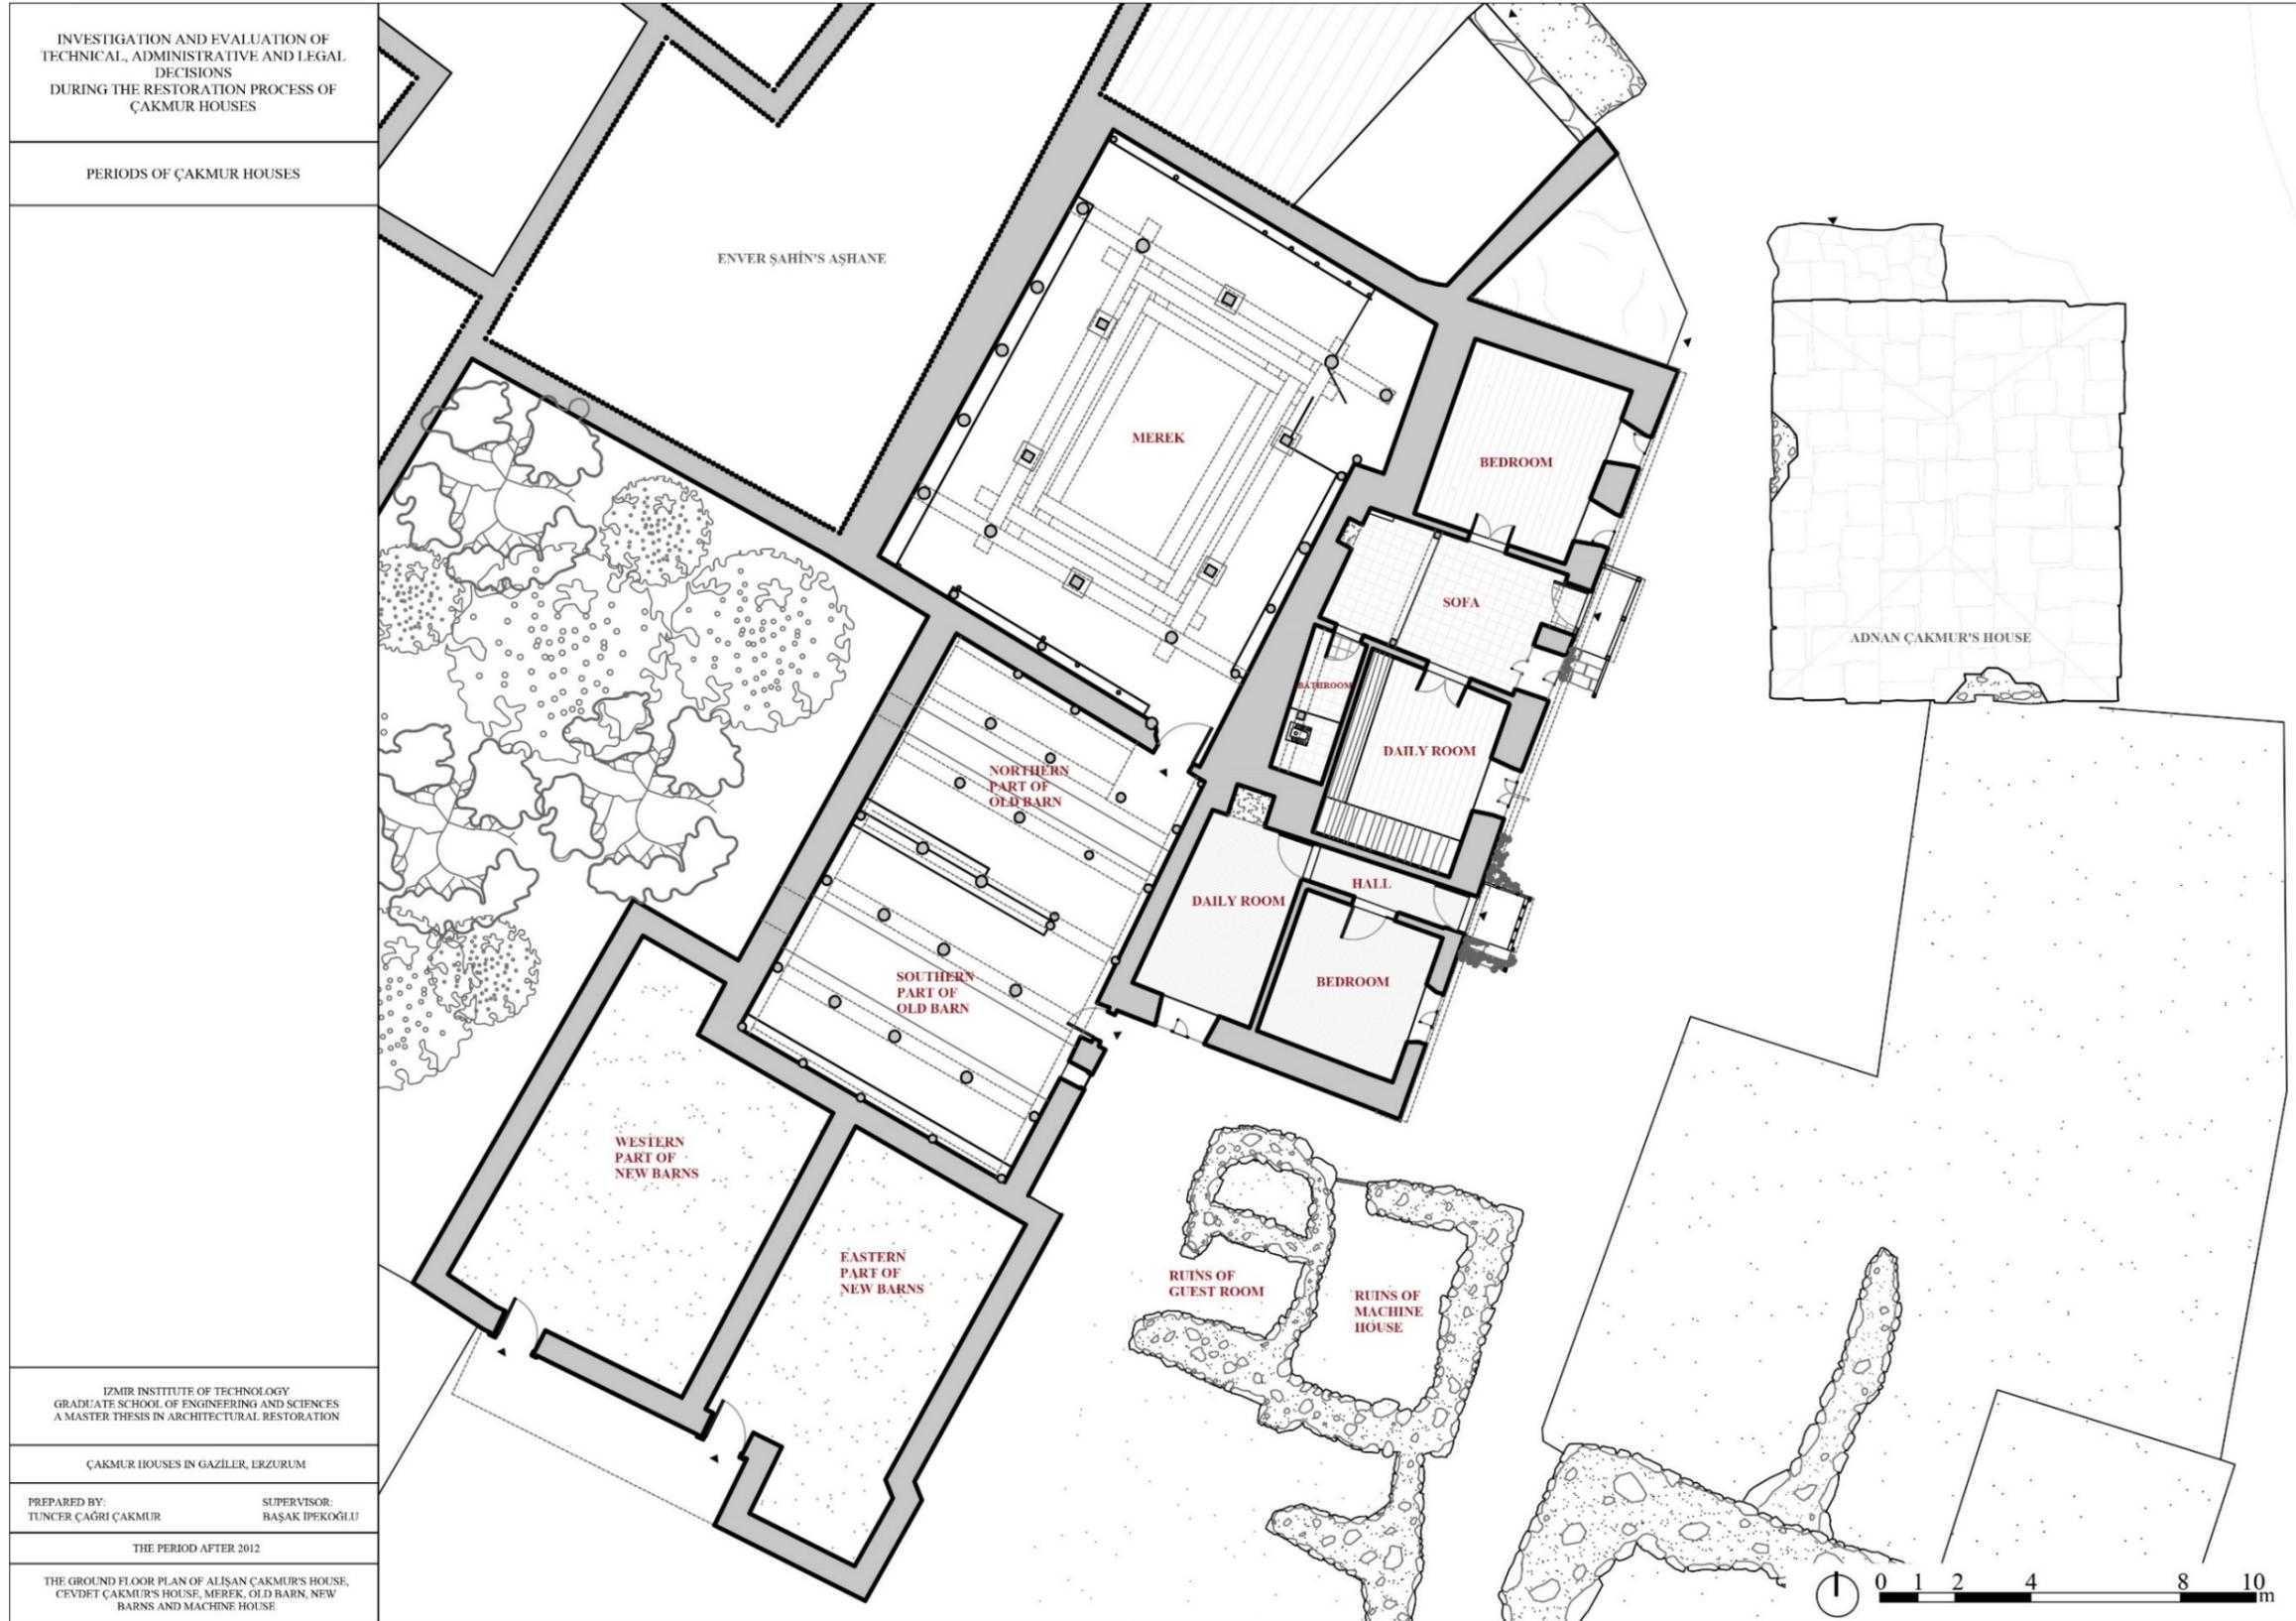
Figure C.9. Restitution drawing of the period after 2012.
 (Prepared by Author, 2019)

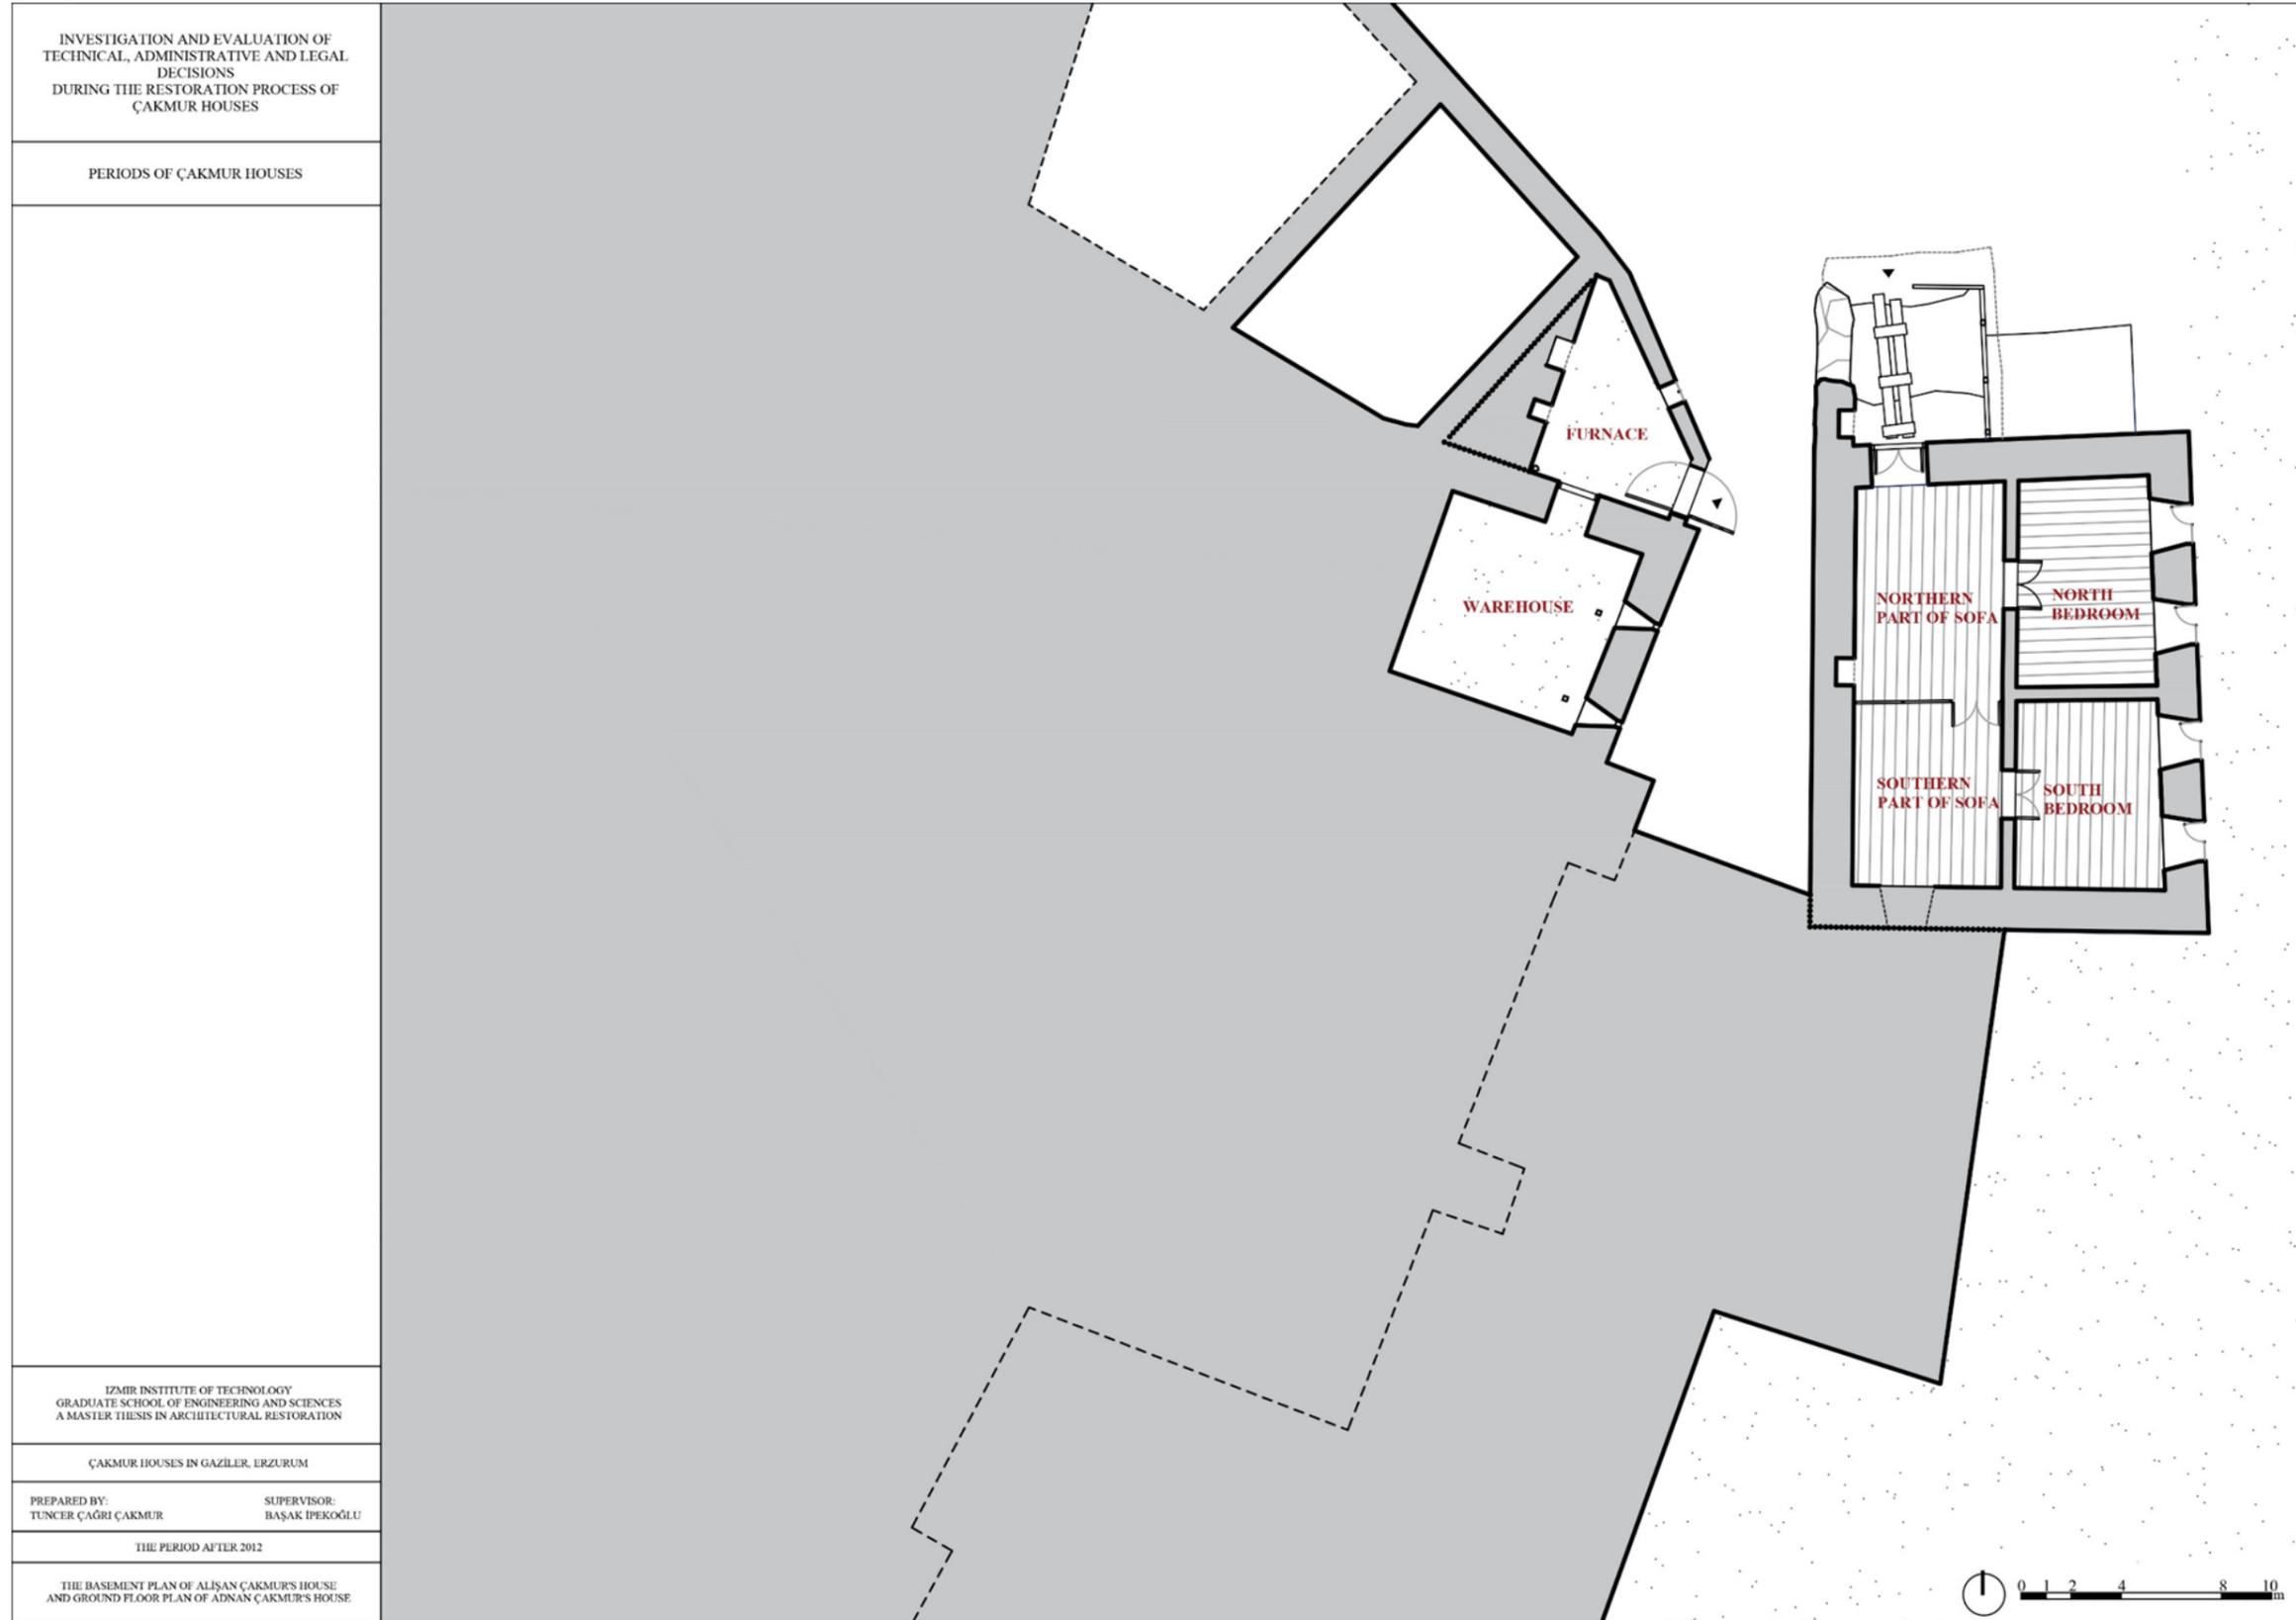
Figure C.10. Restitution drawing of the period after 2012.
 (Prepared by Author, 2019)

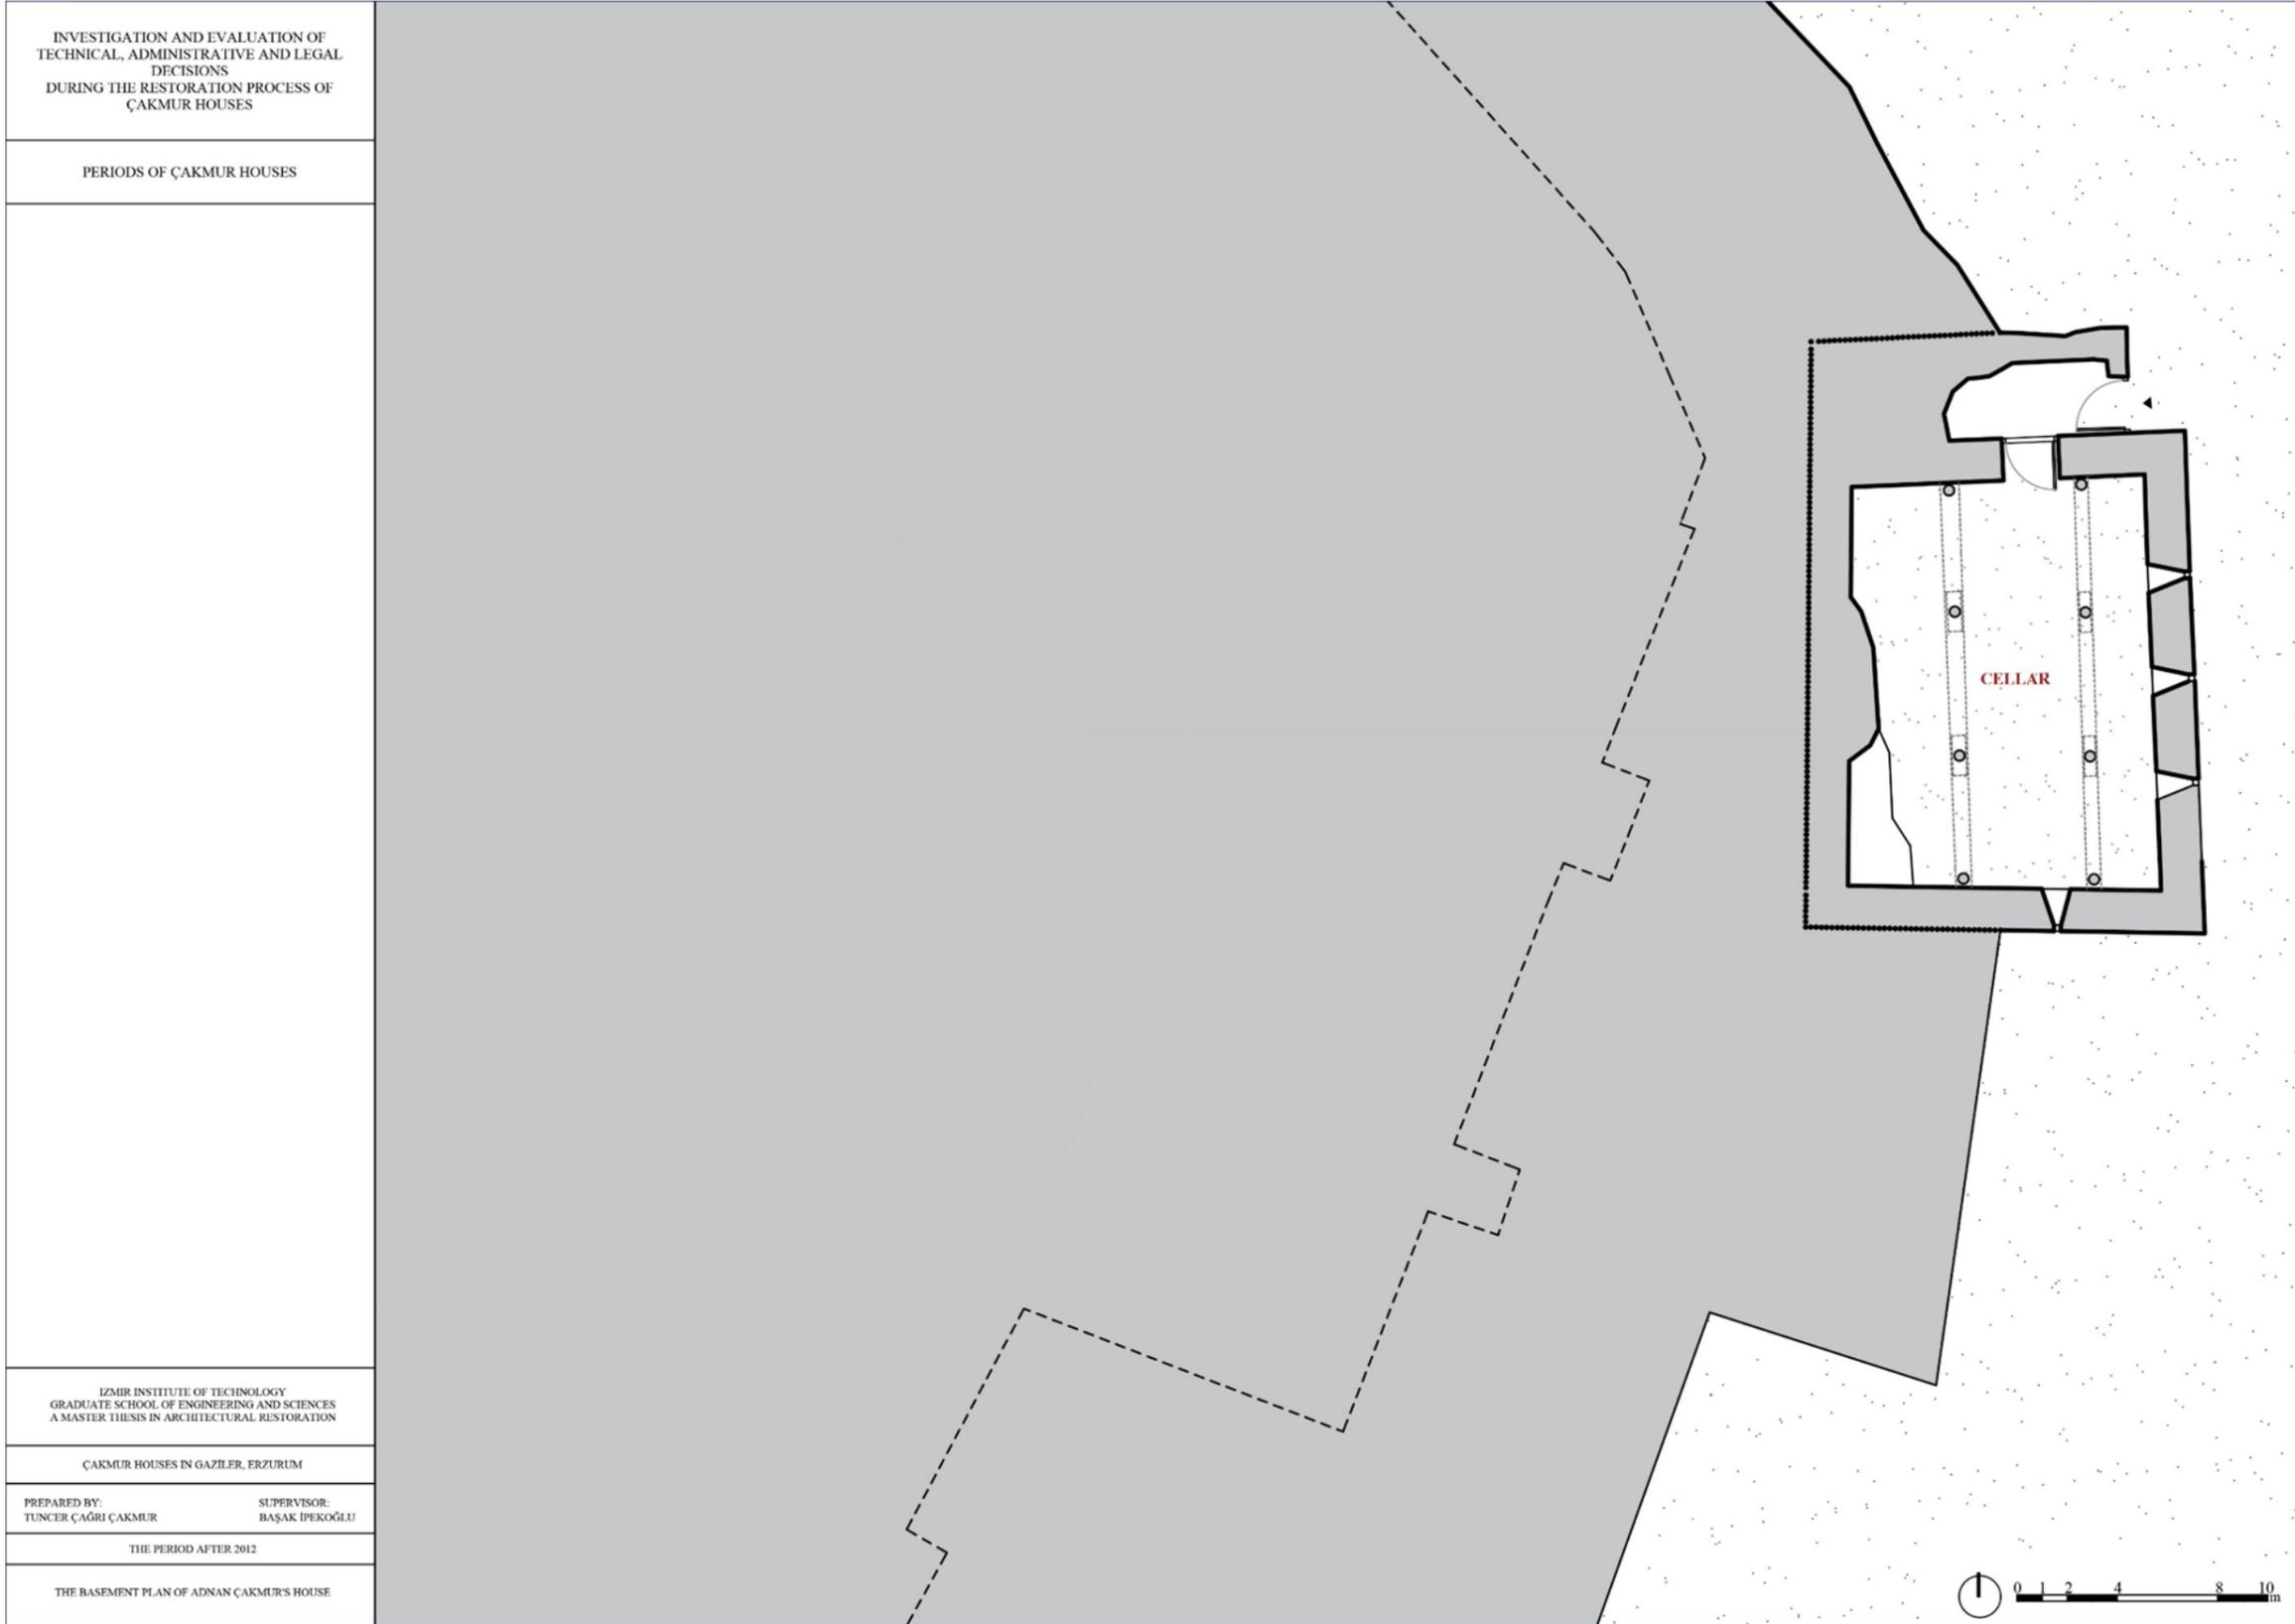
Figure C.11. Restitution drawing of the period after 2012.
(Prepared by Author, 2019)
