**INVESTIGATION AND EVALUATION OF
TECHNICAL, ADMINISTRATIVE AND LEGAL
DECISIONS DURING THE RESTORATION
PROCESS OF AKMUR HOUSES**

**A Thesis Submitted to
the Graduate School of Engineering and Sciences of
İzmir Institute of Technology
in Partial Fulfilment of the Requirements for the Degree of**

in Architectural Restoration

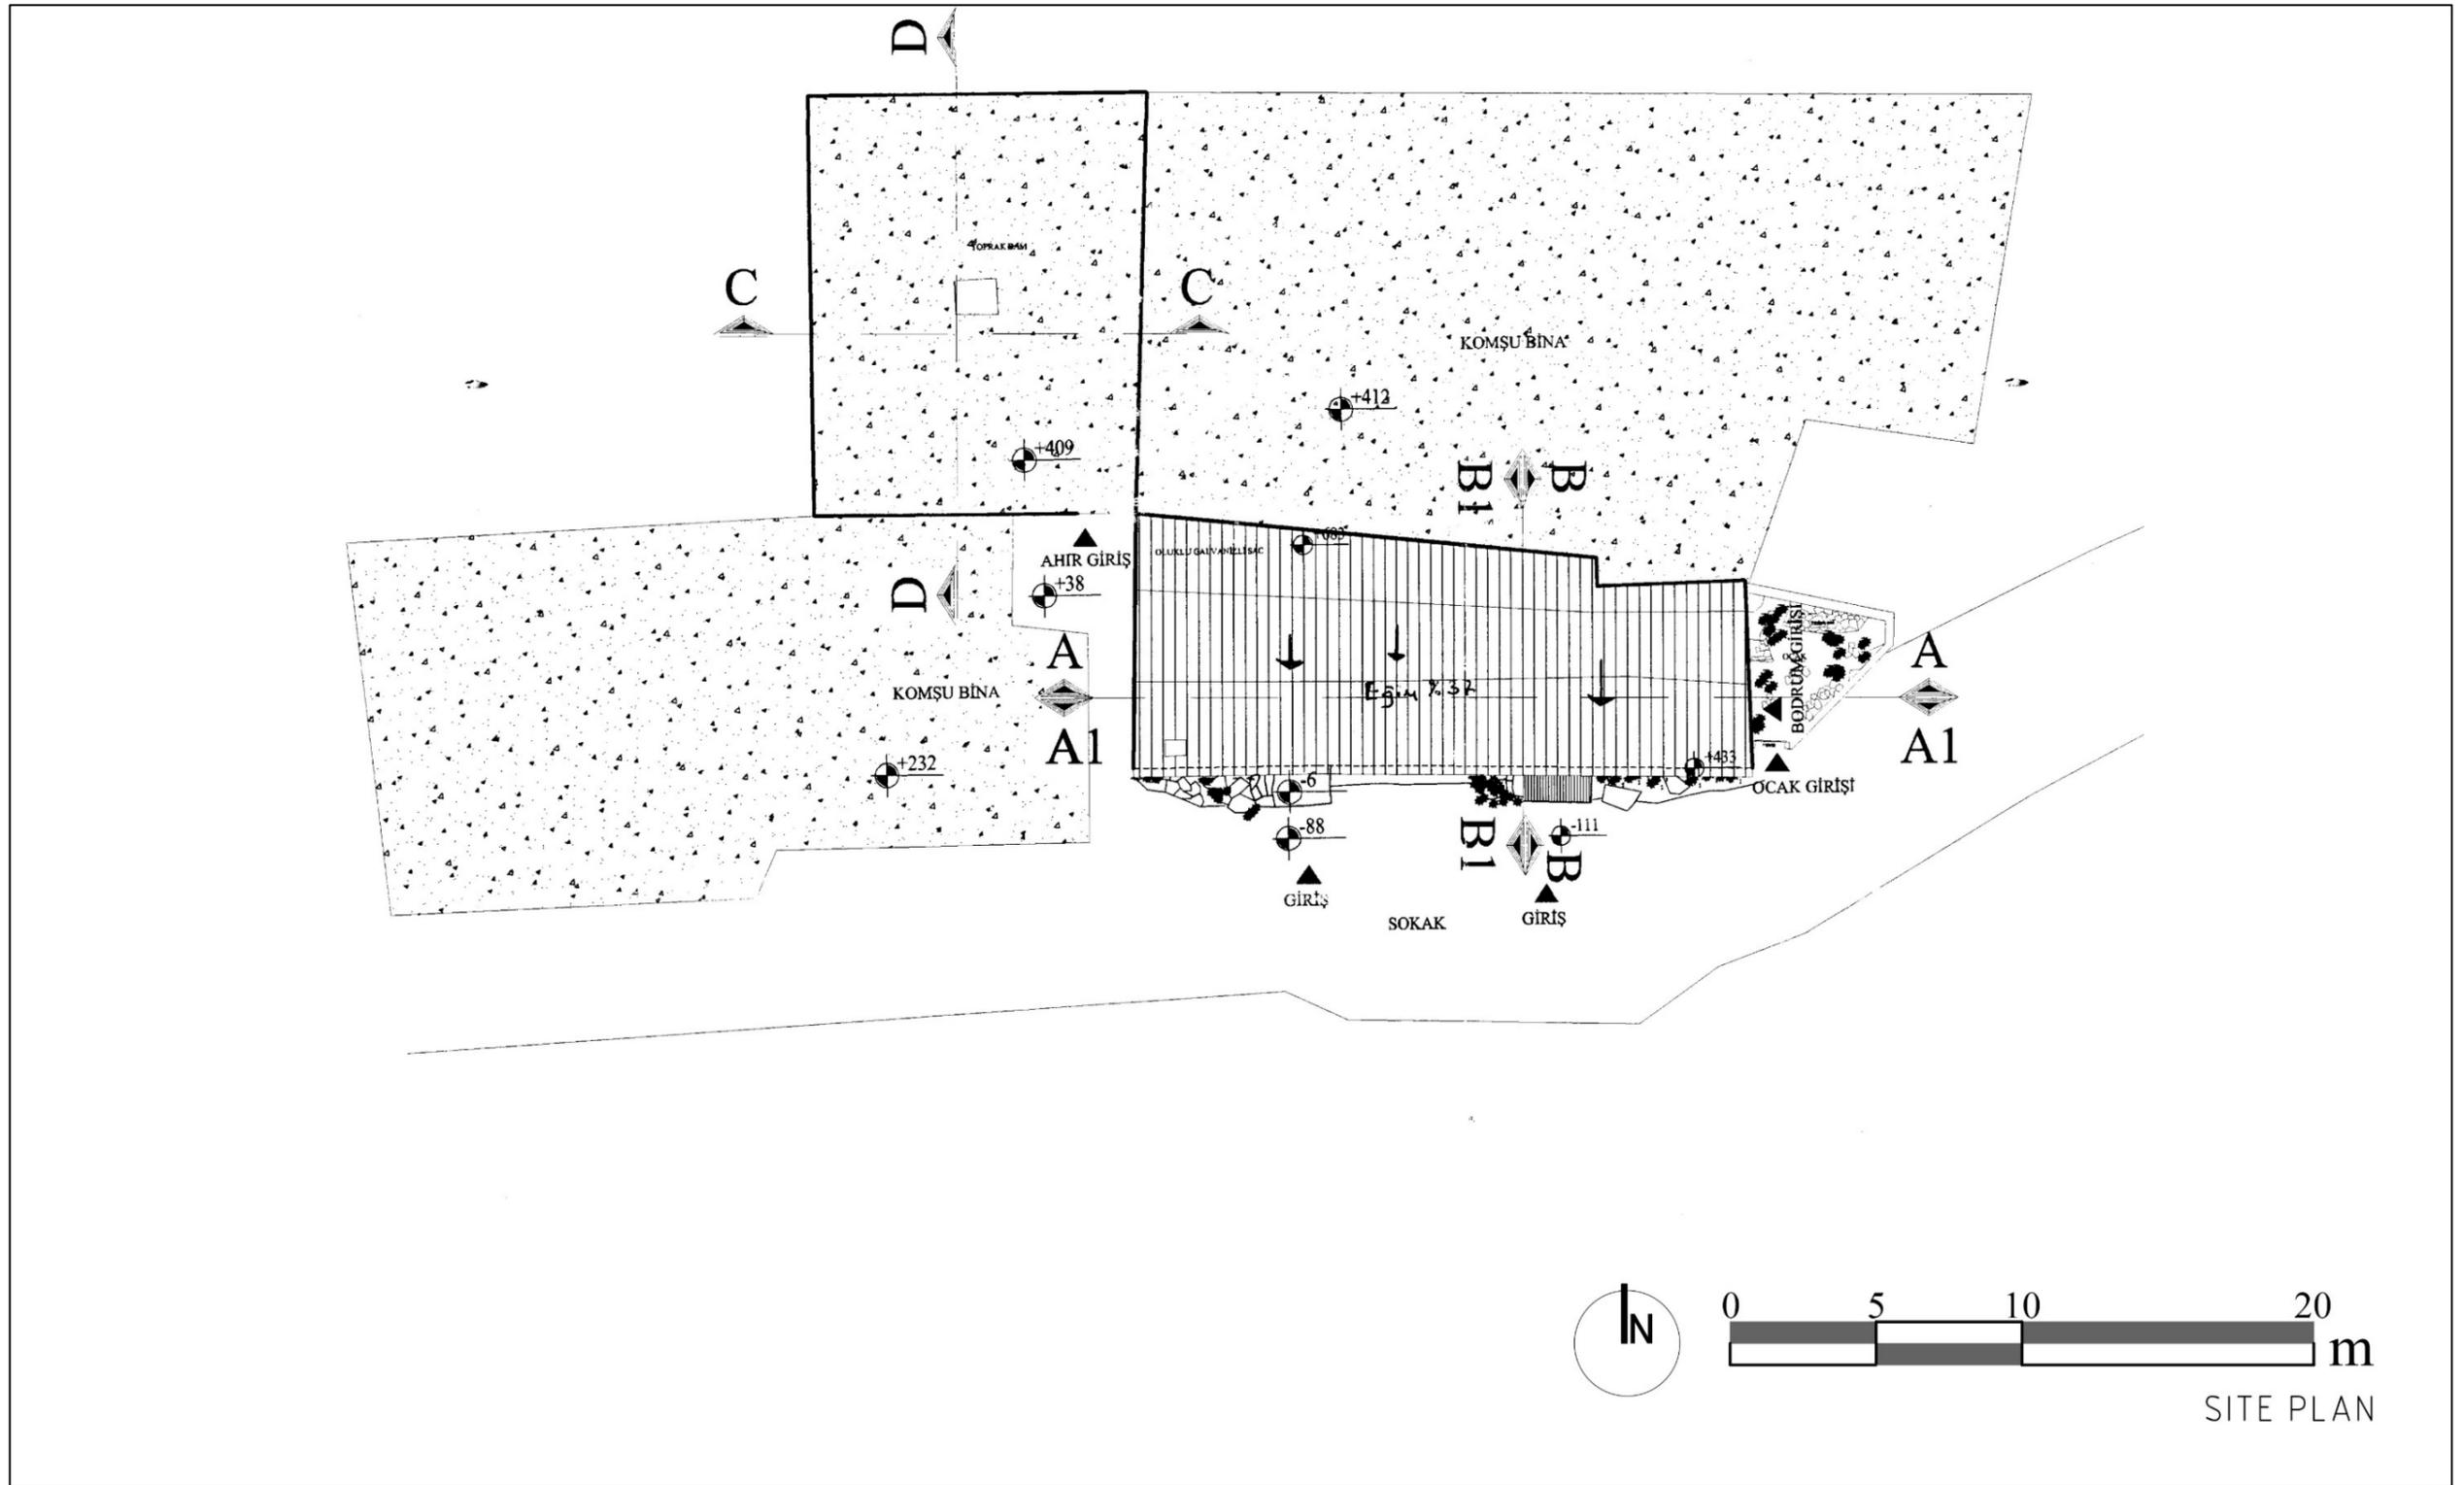
Figure D.1. Measured drawings, 2010.
 (Source: Erzurum Regional Conservation Council of Immovable Cultural Assets Archive, Access: 2019)

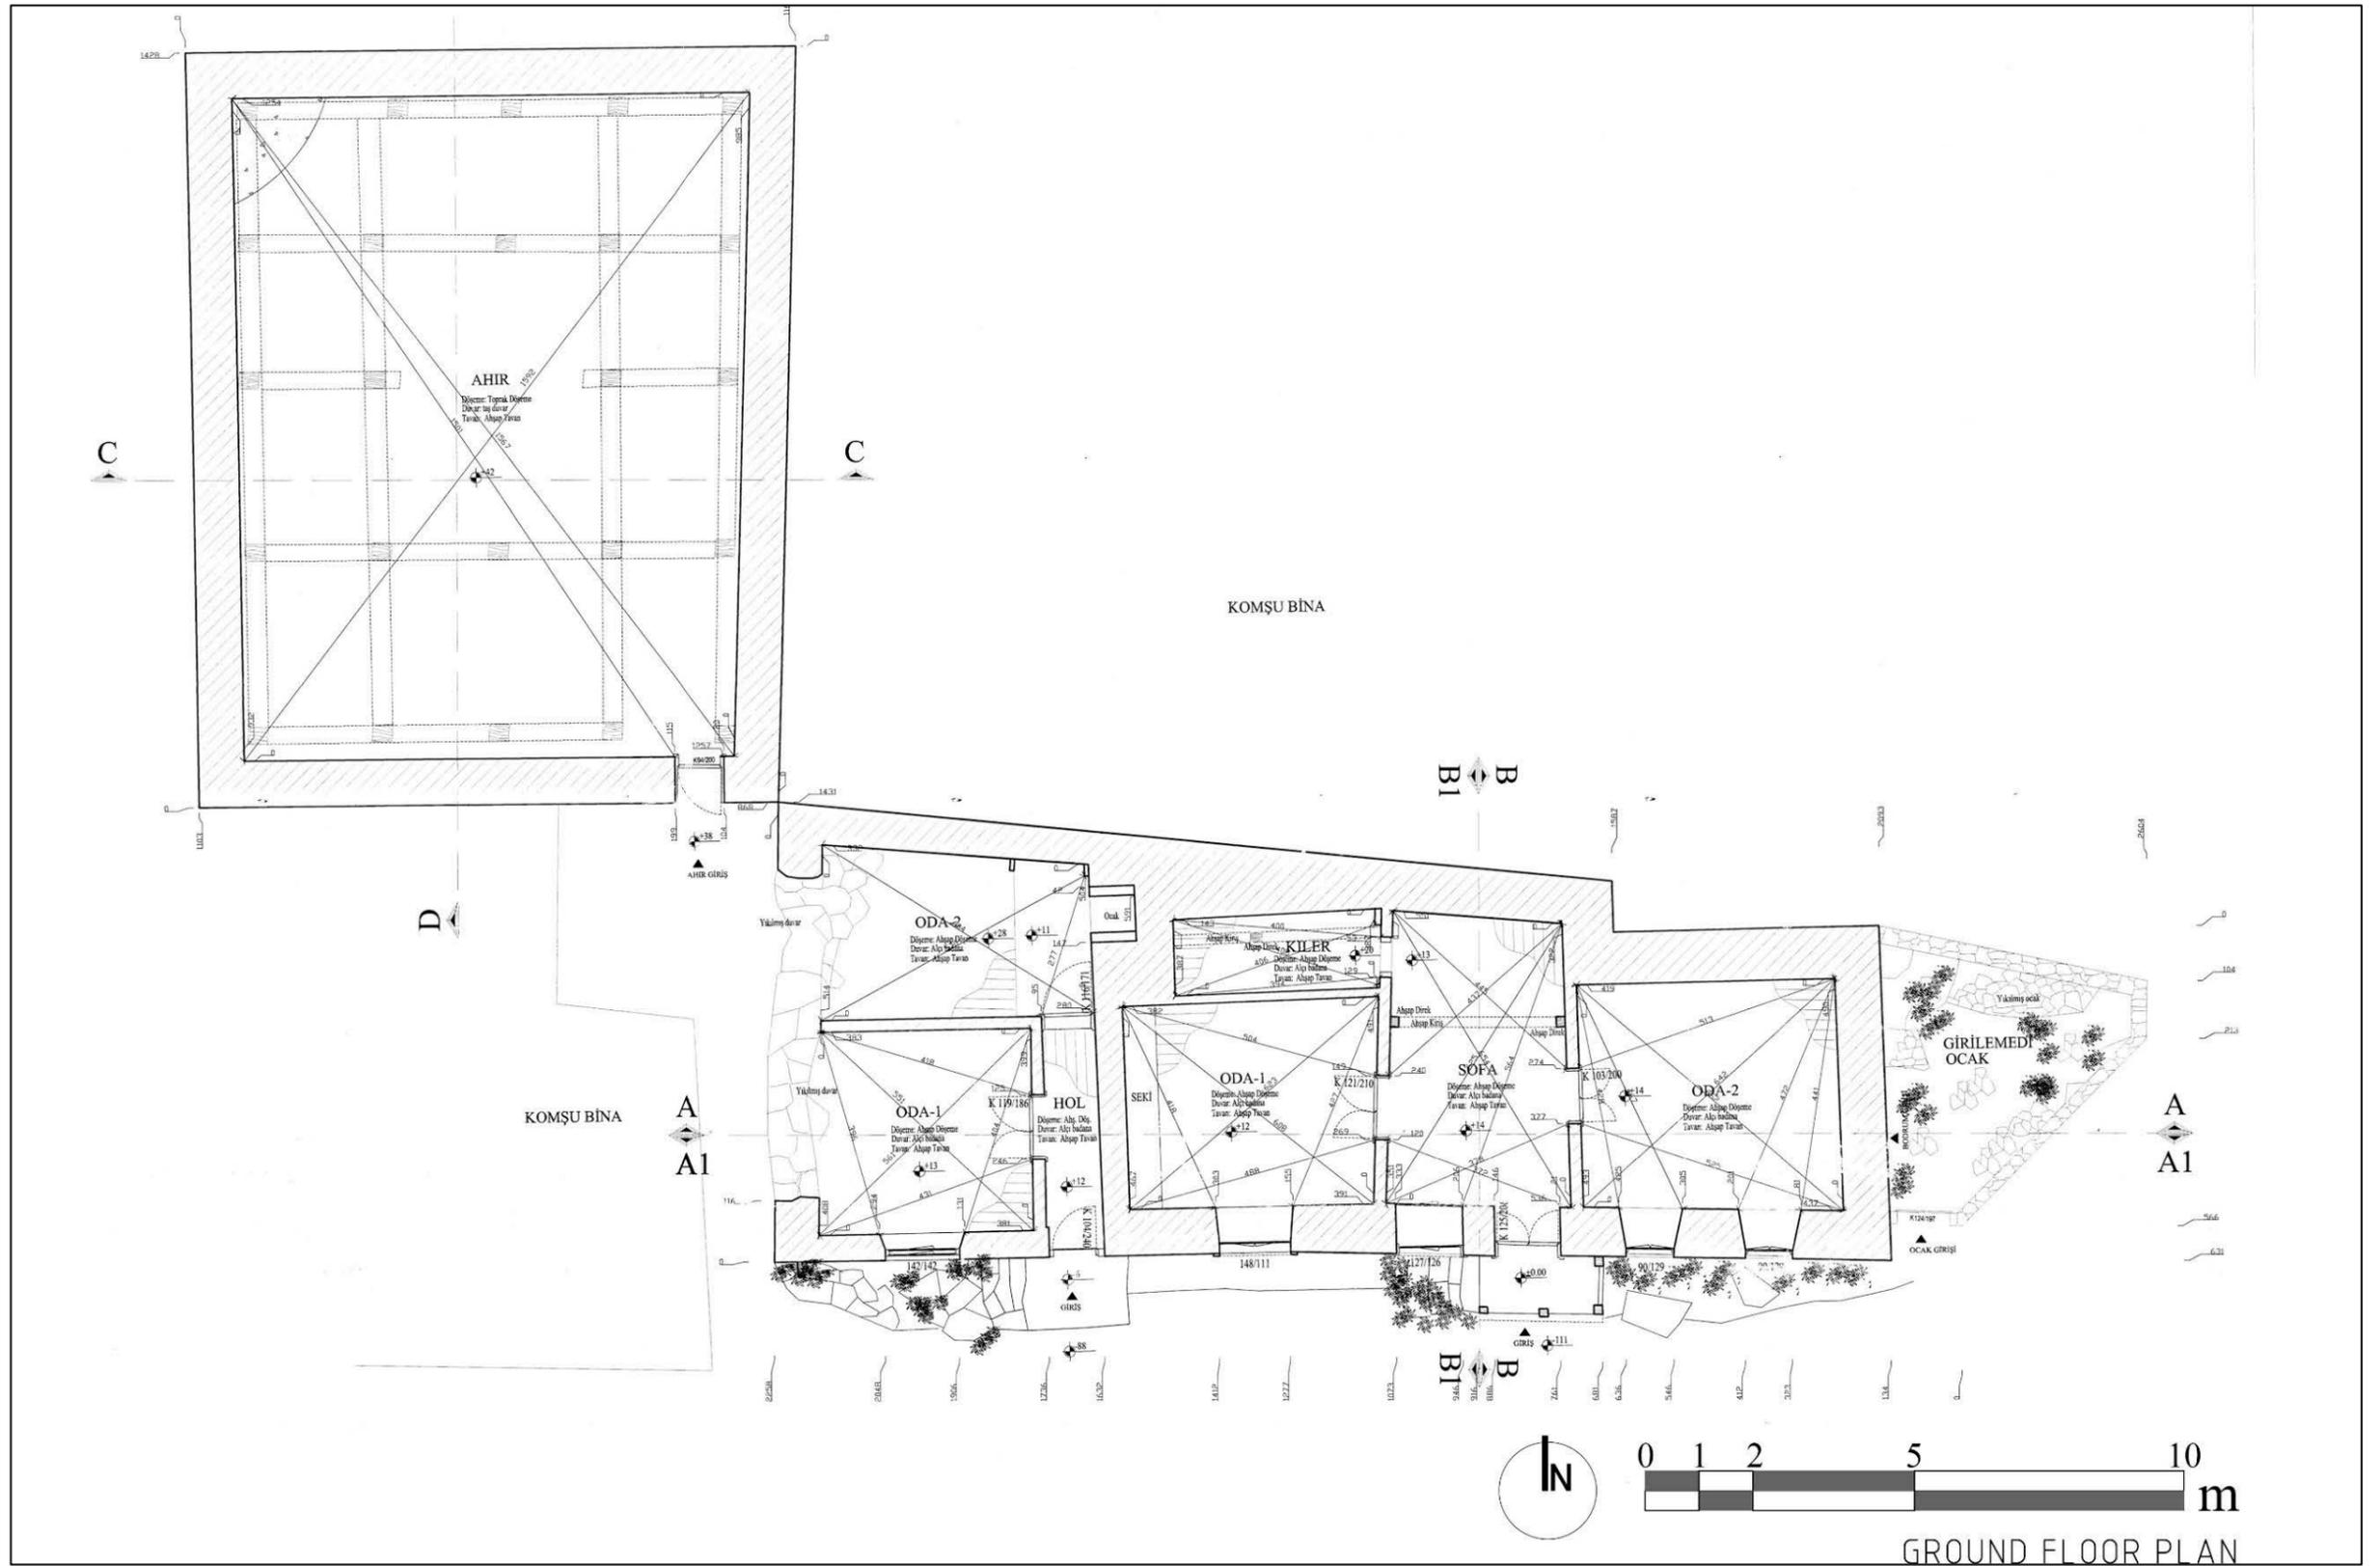
Figure D.2. Measured drawings, 2010.
 (Source: Erzurum Regional Conservation Council of Immovable Cultural Assets Archive, Access: 2019)

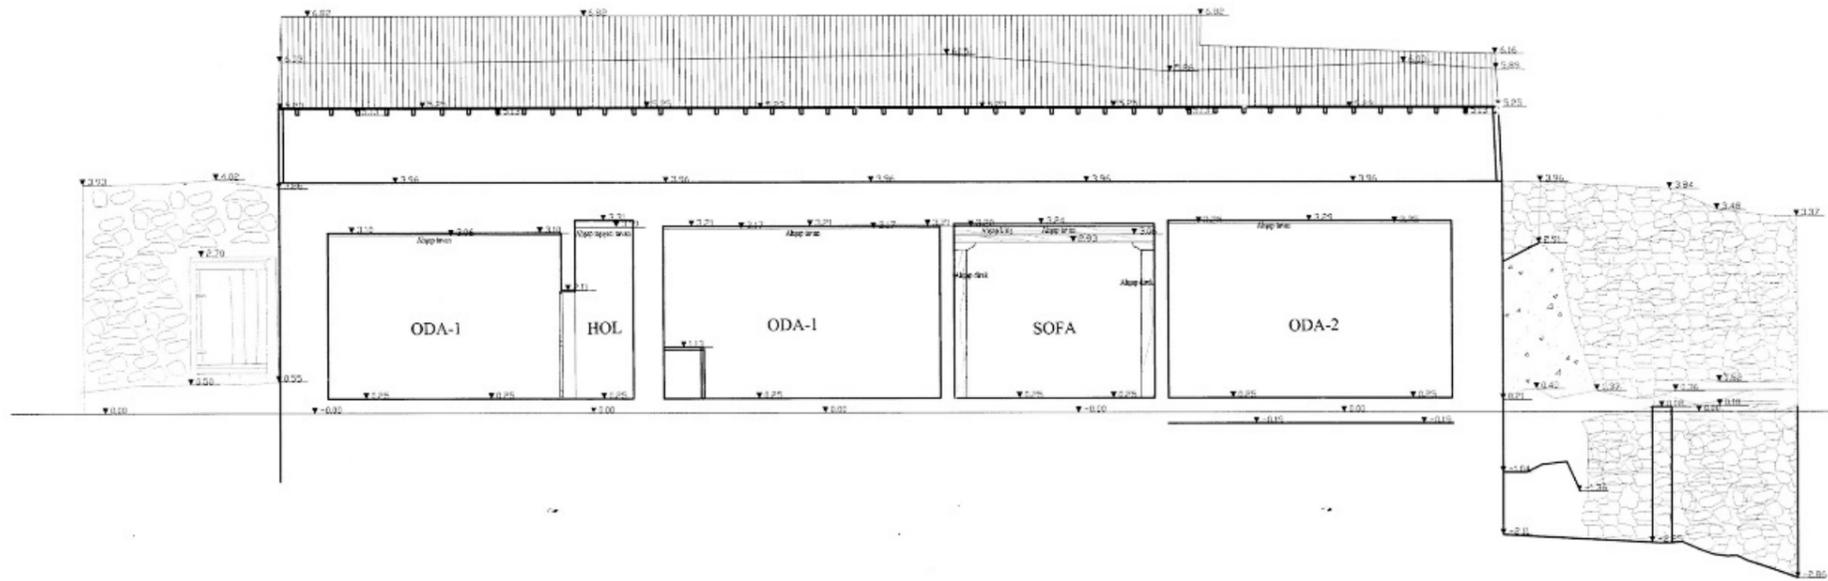
A - A SECTION

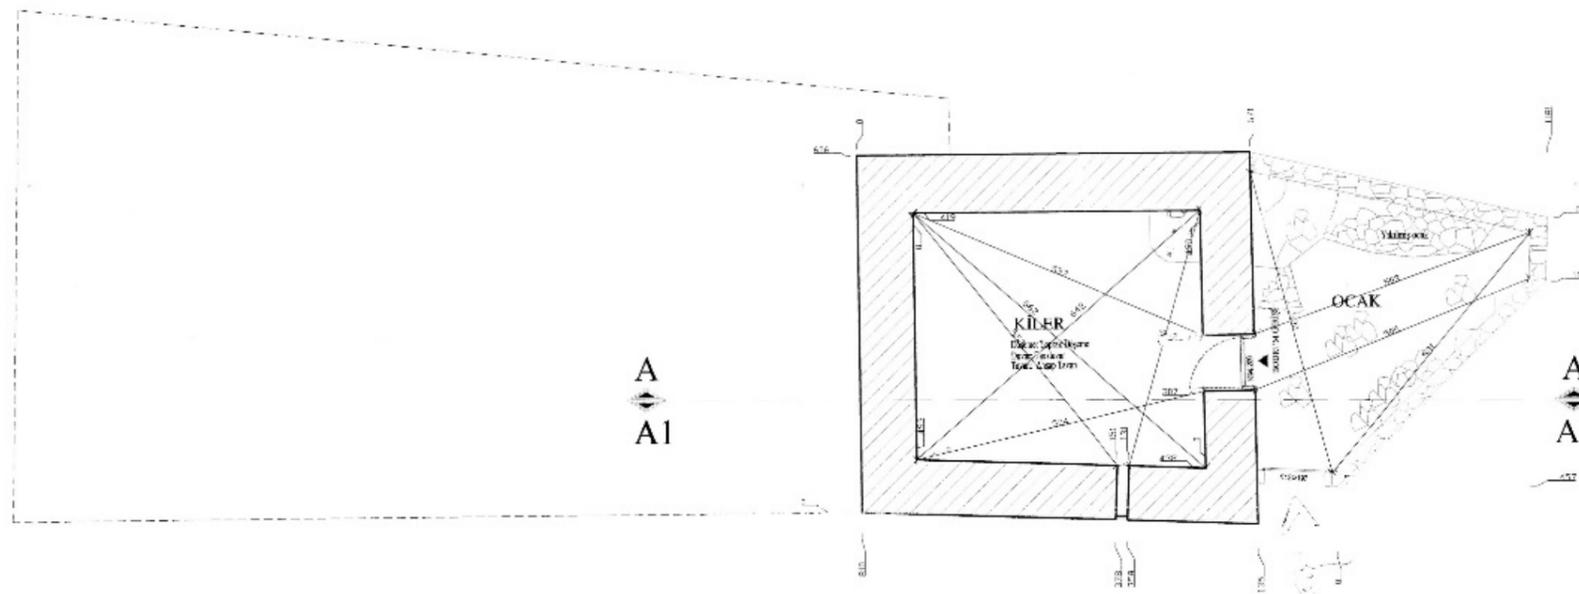
BASEMENT FLOOR PLAN

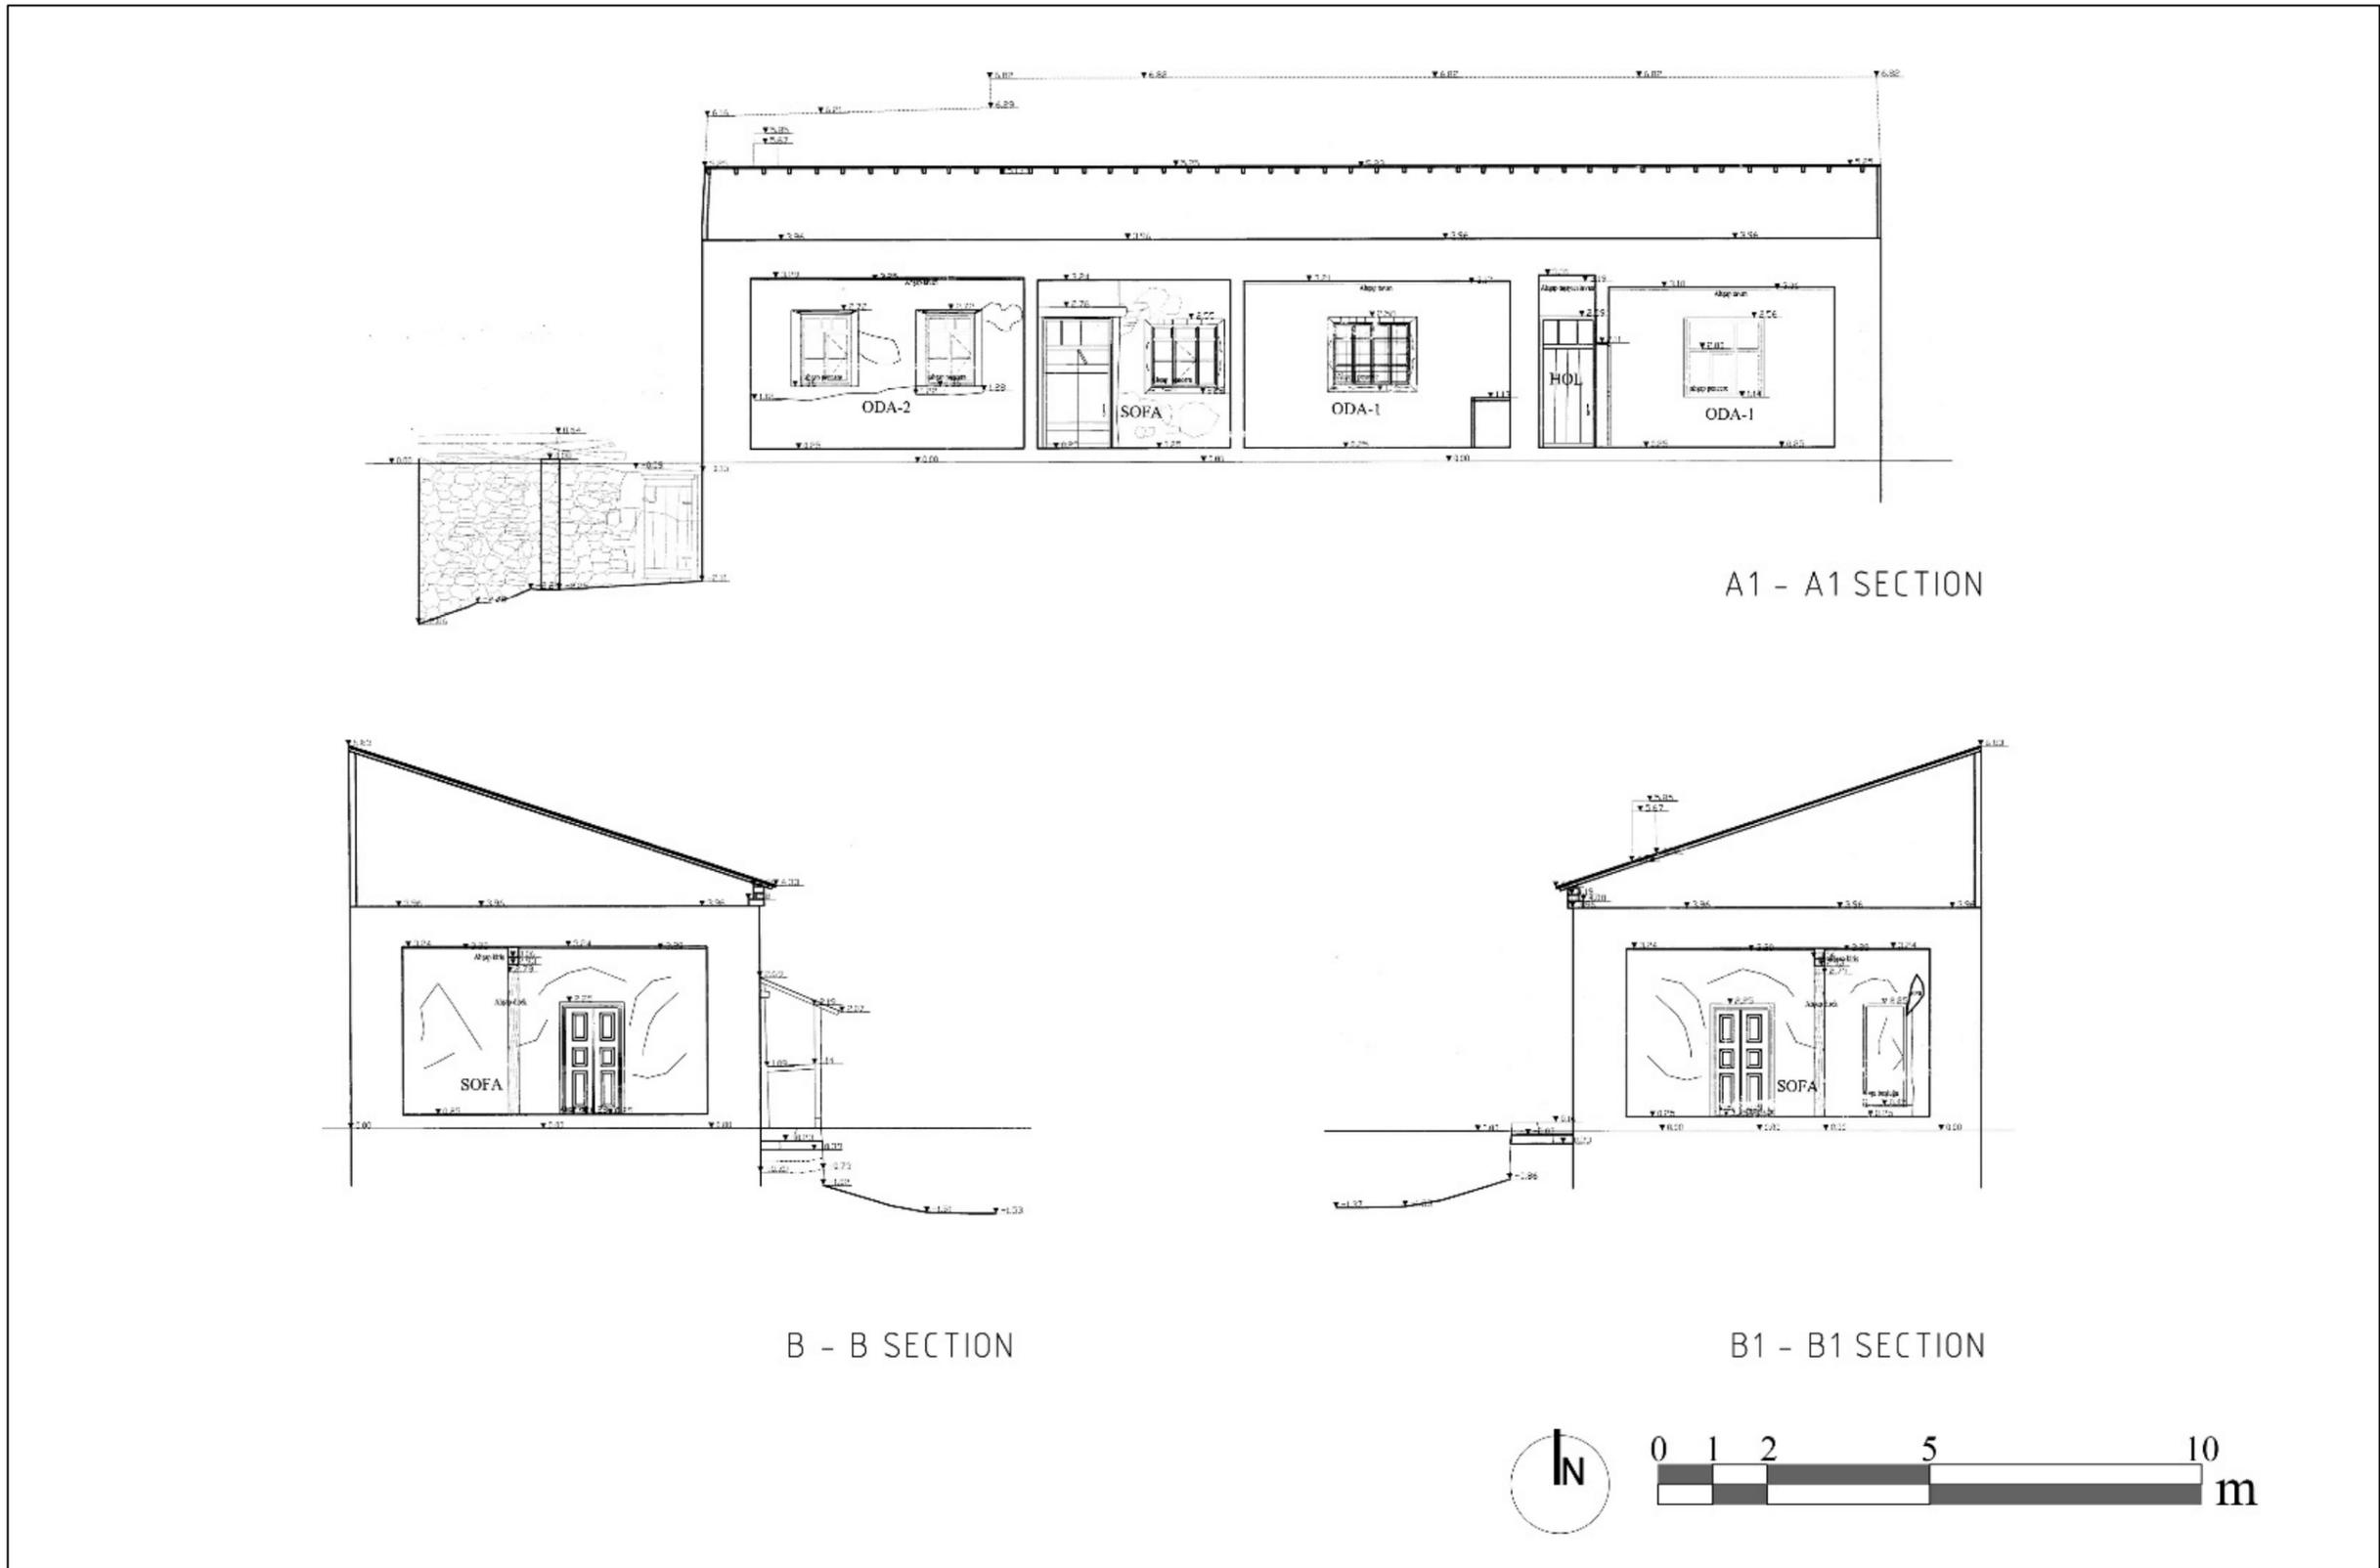
Figure D.4. Measured drawings, 2010.
 (Source: Erzurum Regional Conservation Council of Immovable Cultural Assets Archive, Access: 2019)

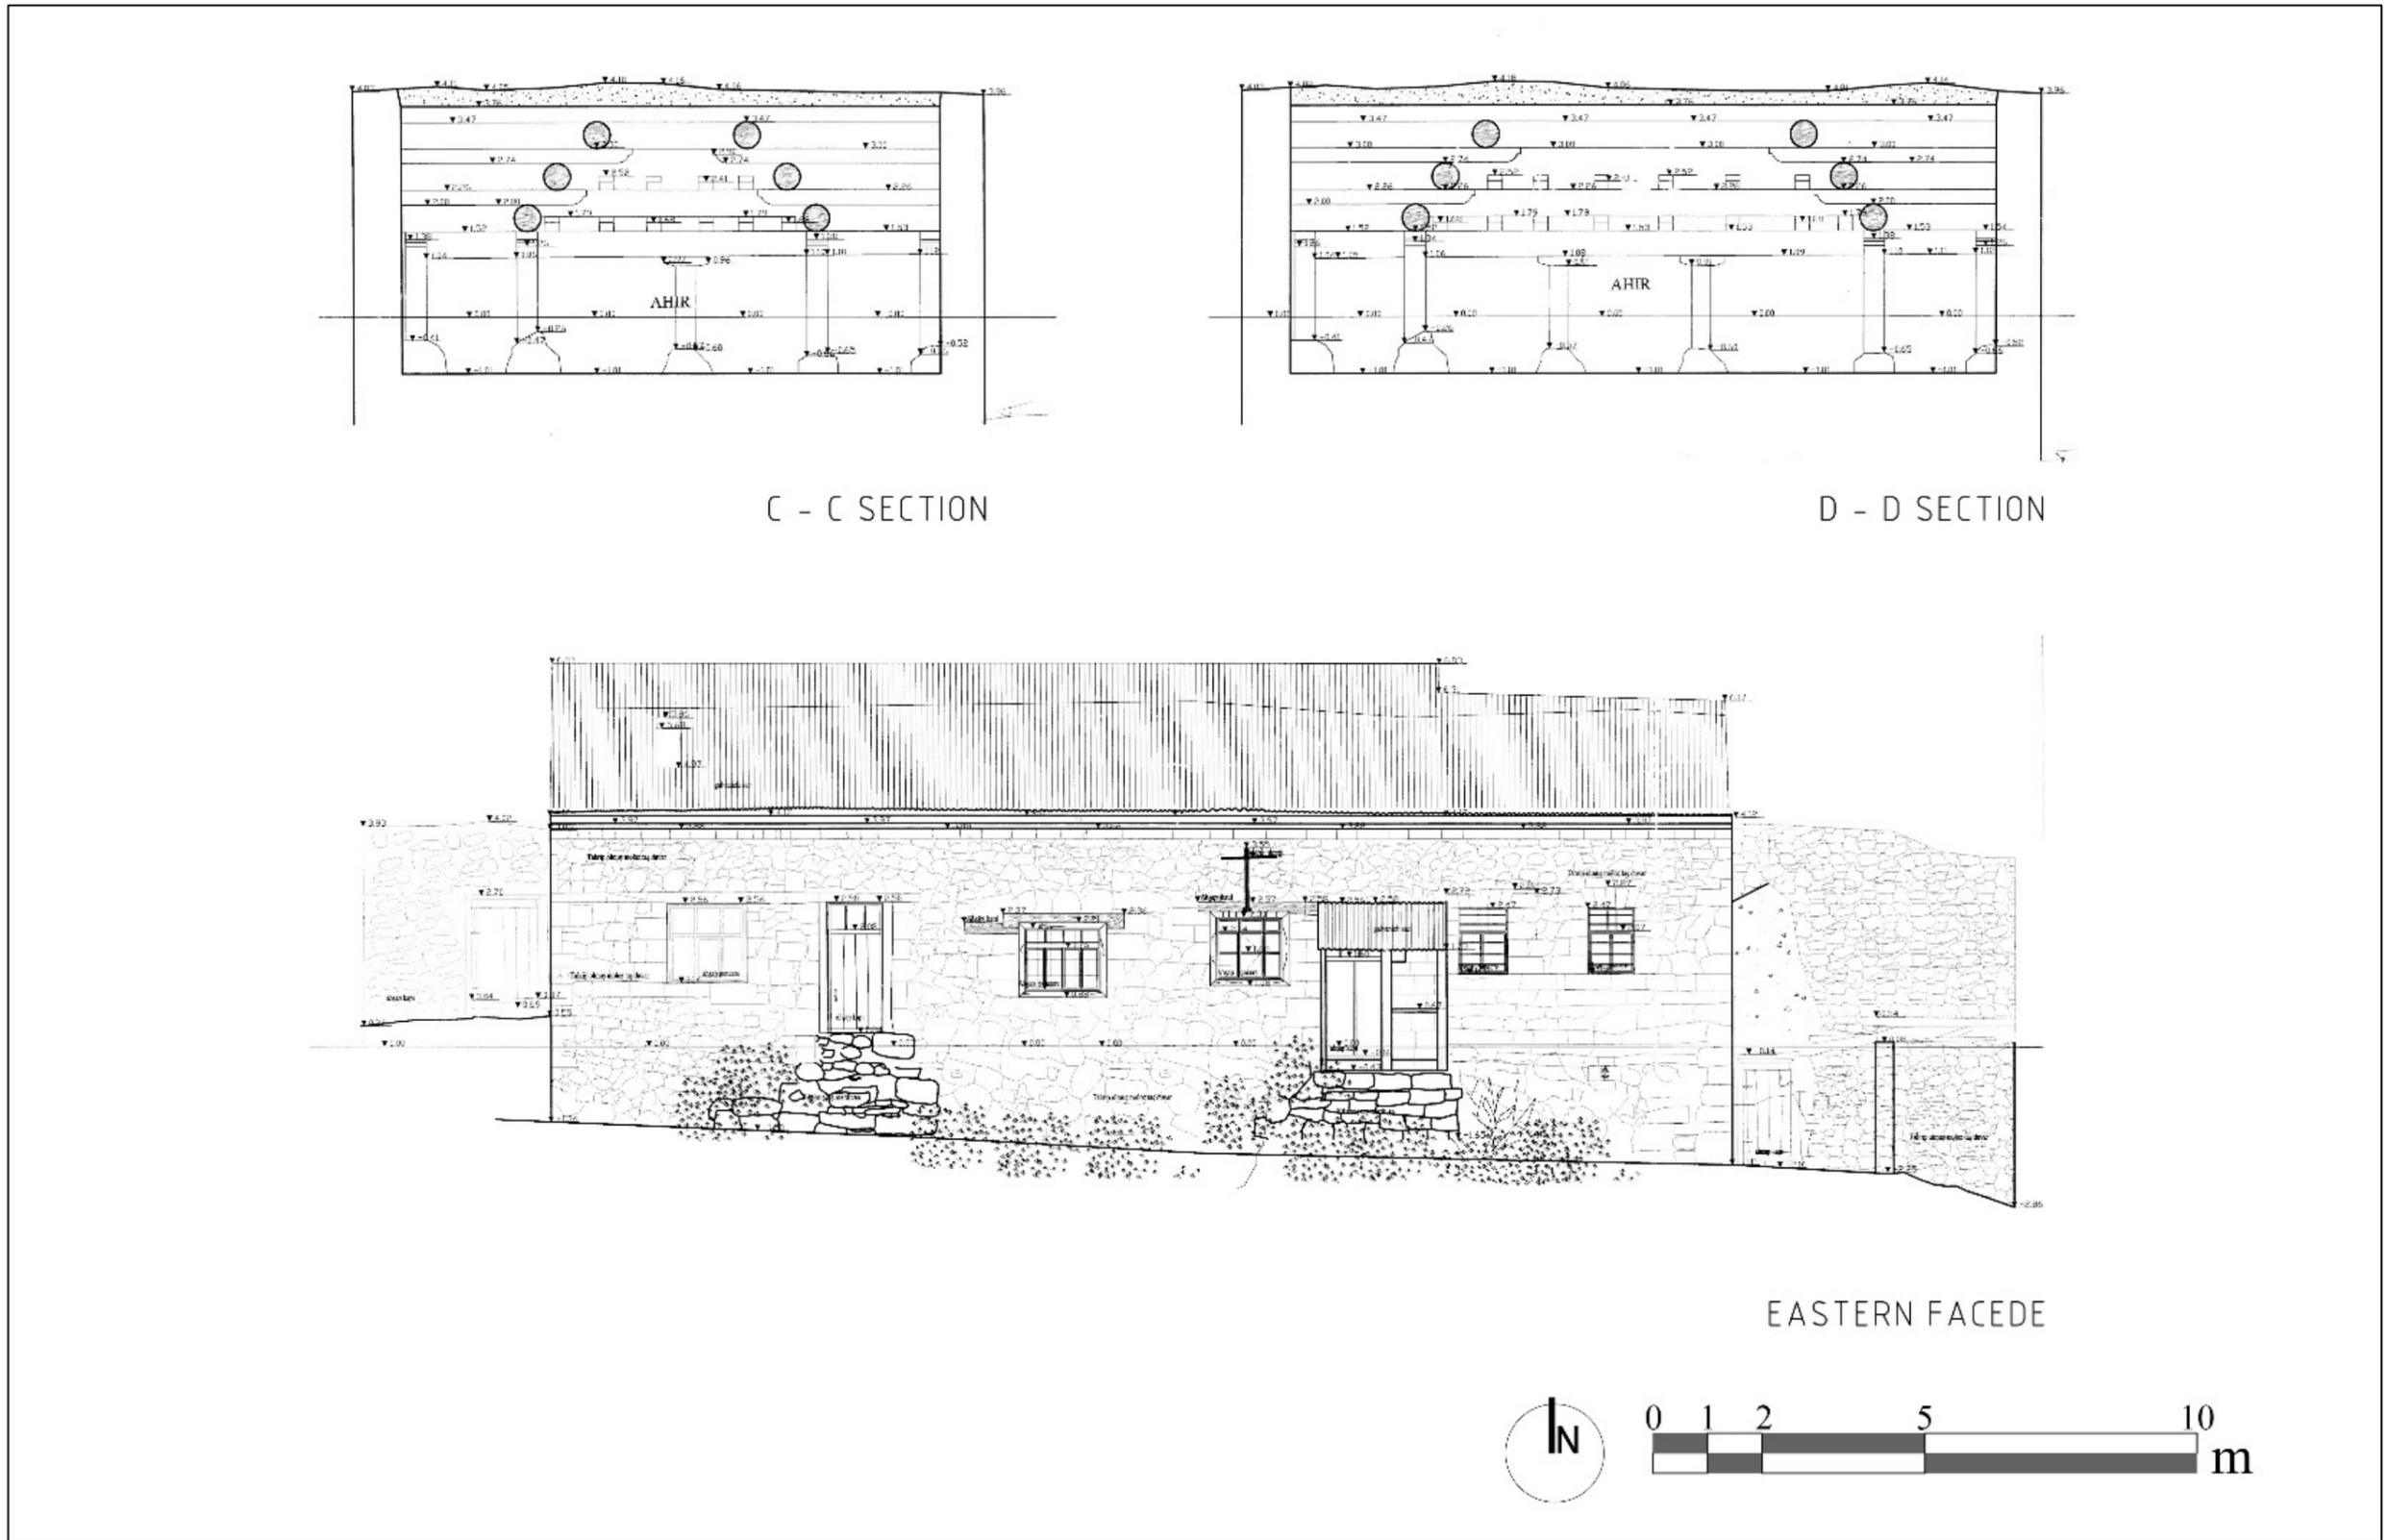
Figure D.5. Measured drawings, 2010.
 (Source: Erzurum Regional Conservation Council of Immovable Cultural Assets Archive, Access: 2019)

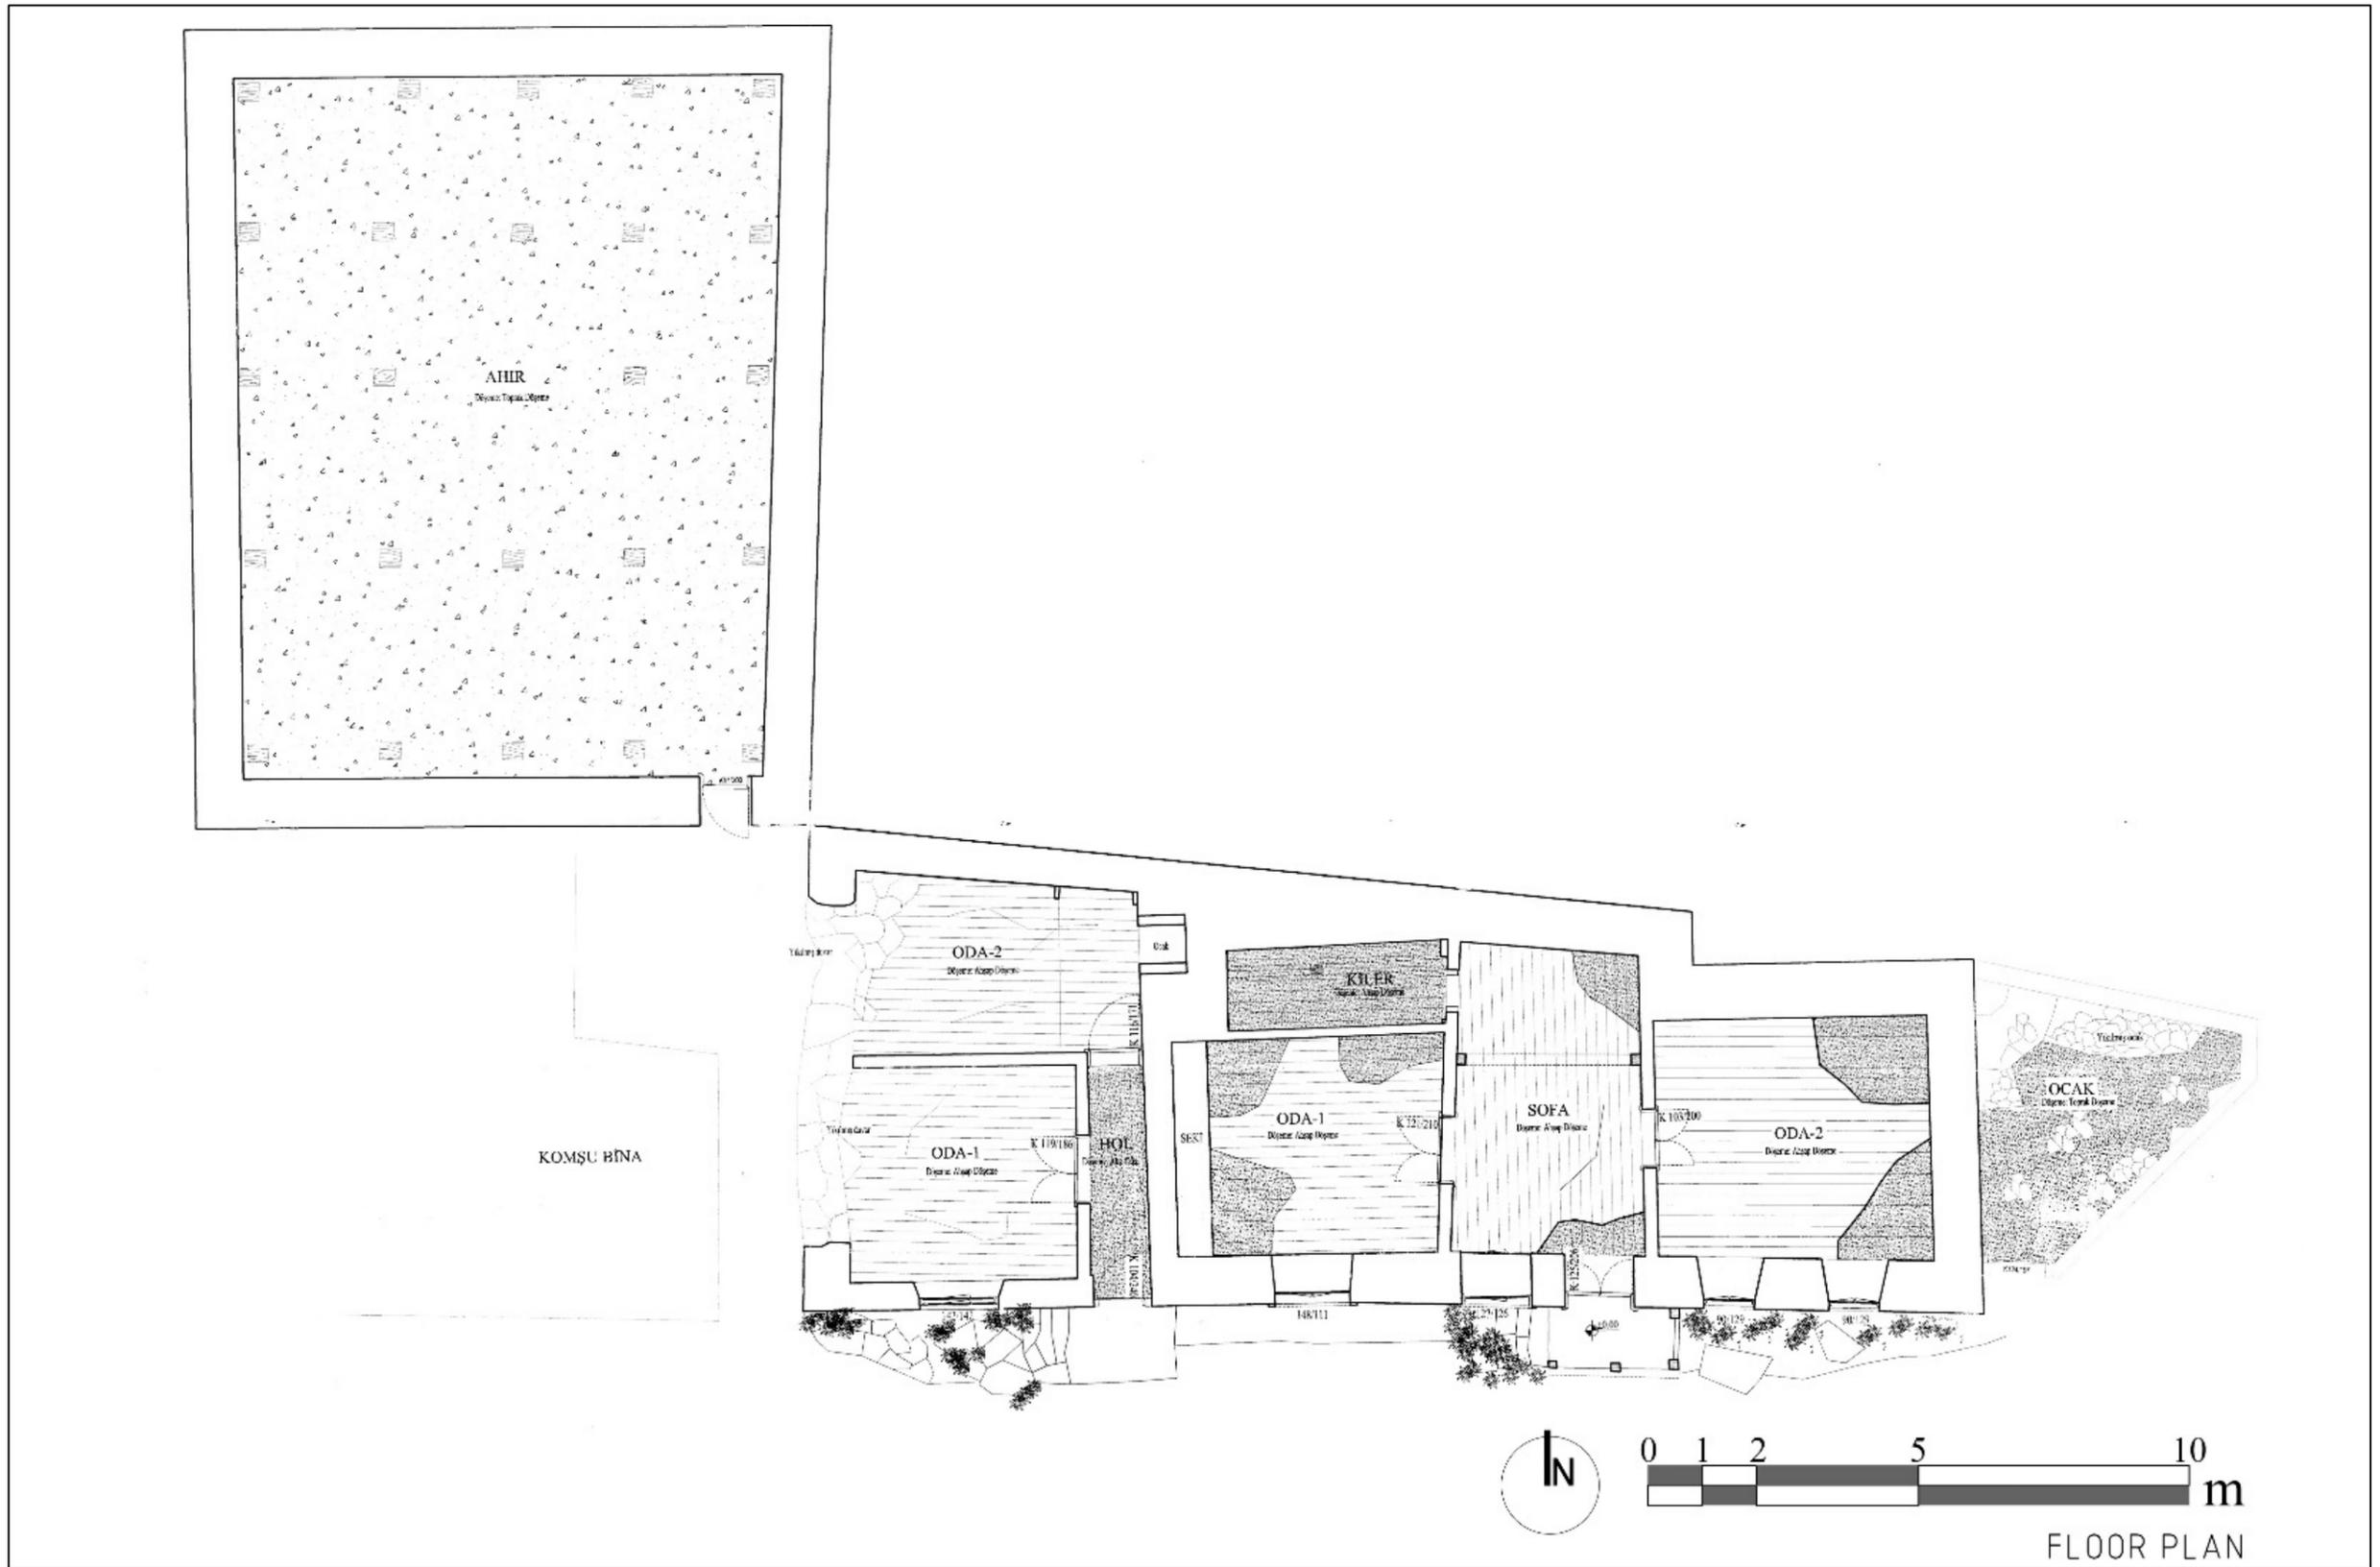
Figure D.6. Measured drawings, 2010.
 (Source: Erzurum Regional Conservation Council of Immovable Cultural Assets Archive, Access: 2019).
