**INVESTIGATION AND EVALUATION OF
TECHNICAL, ADMINISTRATIVE AND LEGAL
DECISIONS DURING THE RESTORATION
PROCESS OF AKMUR HOUSES**

**A Thesis Submitted to
the Graduate School of Engineering and Sciences of
İzmir Institute of Technology
in Partial Fulfilment of the Requirements for the Degree of**

in Architectural Restoration

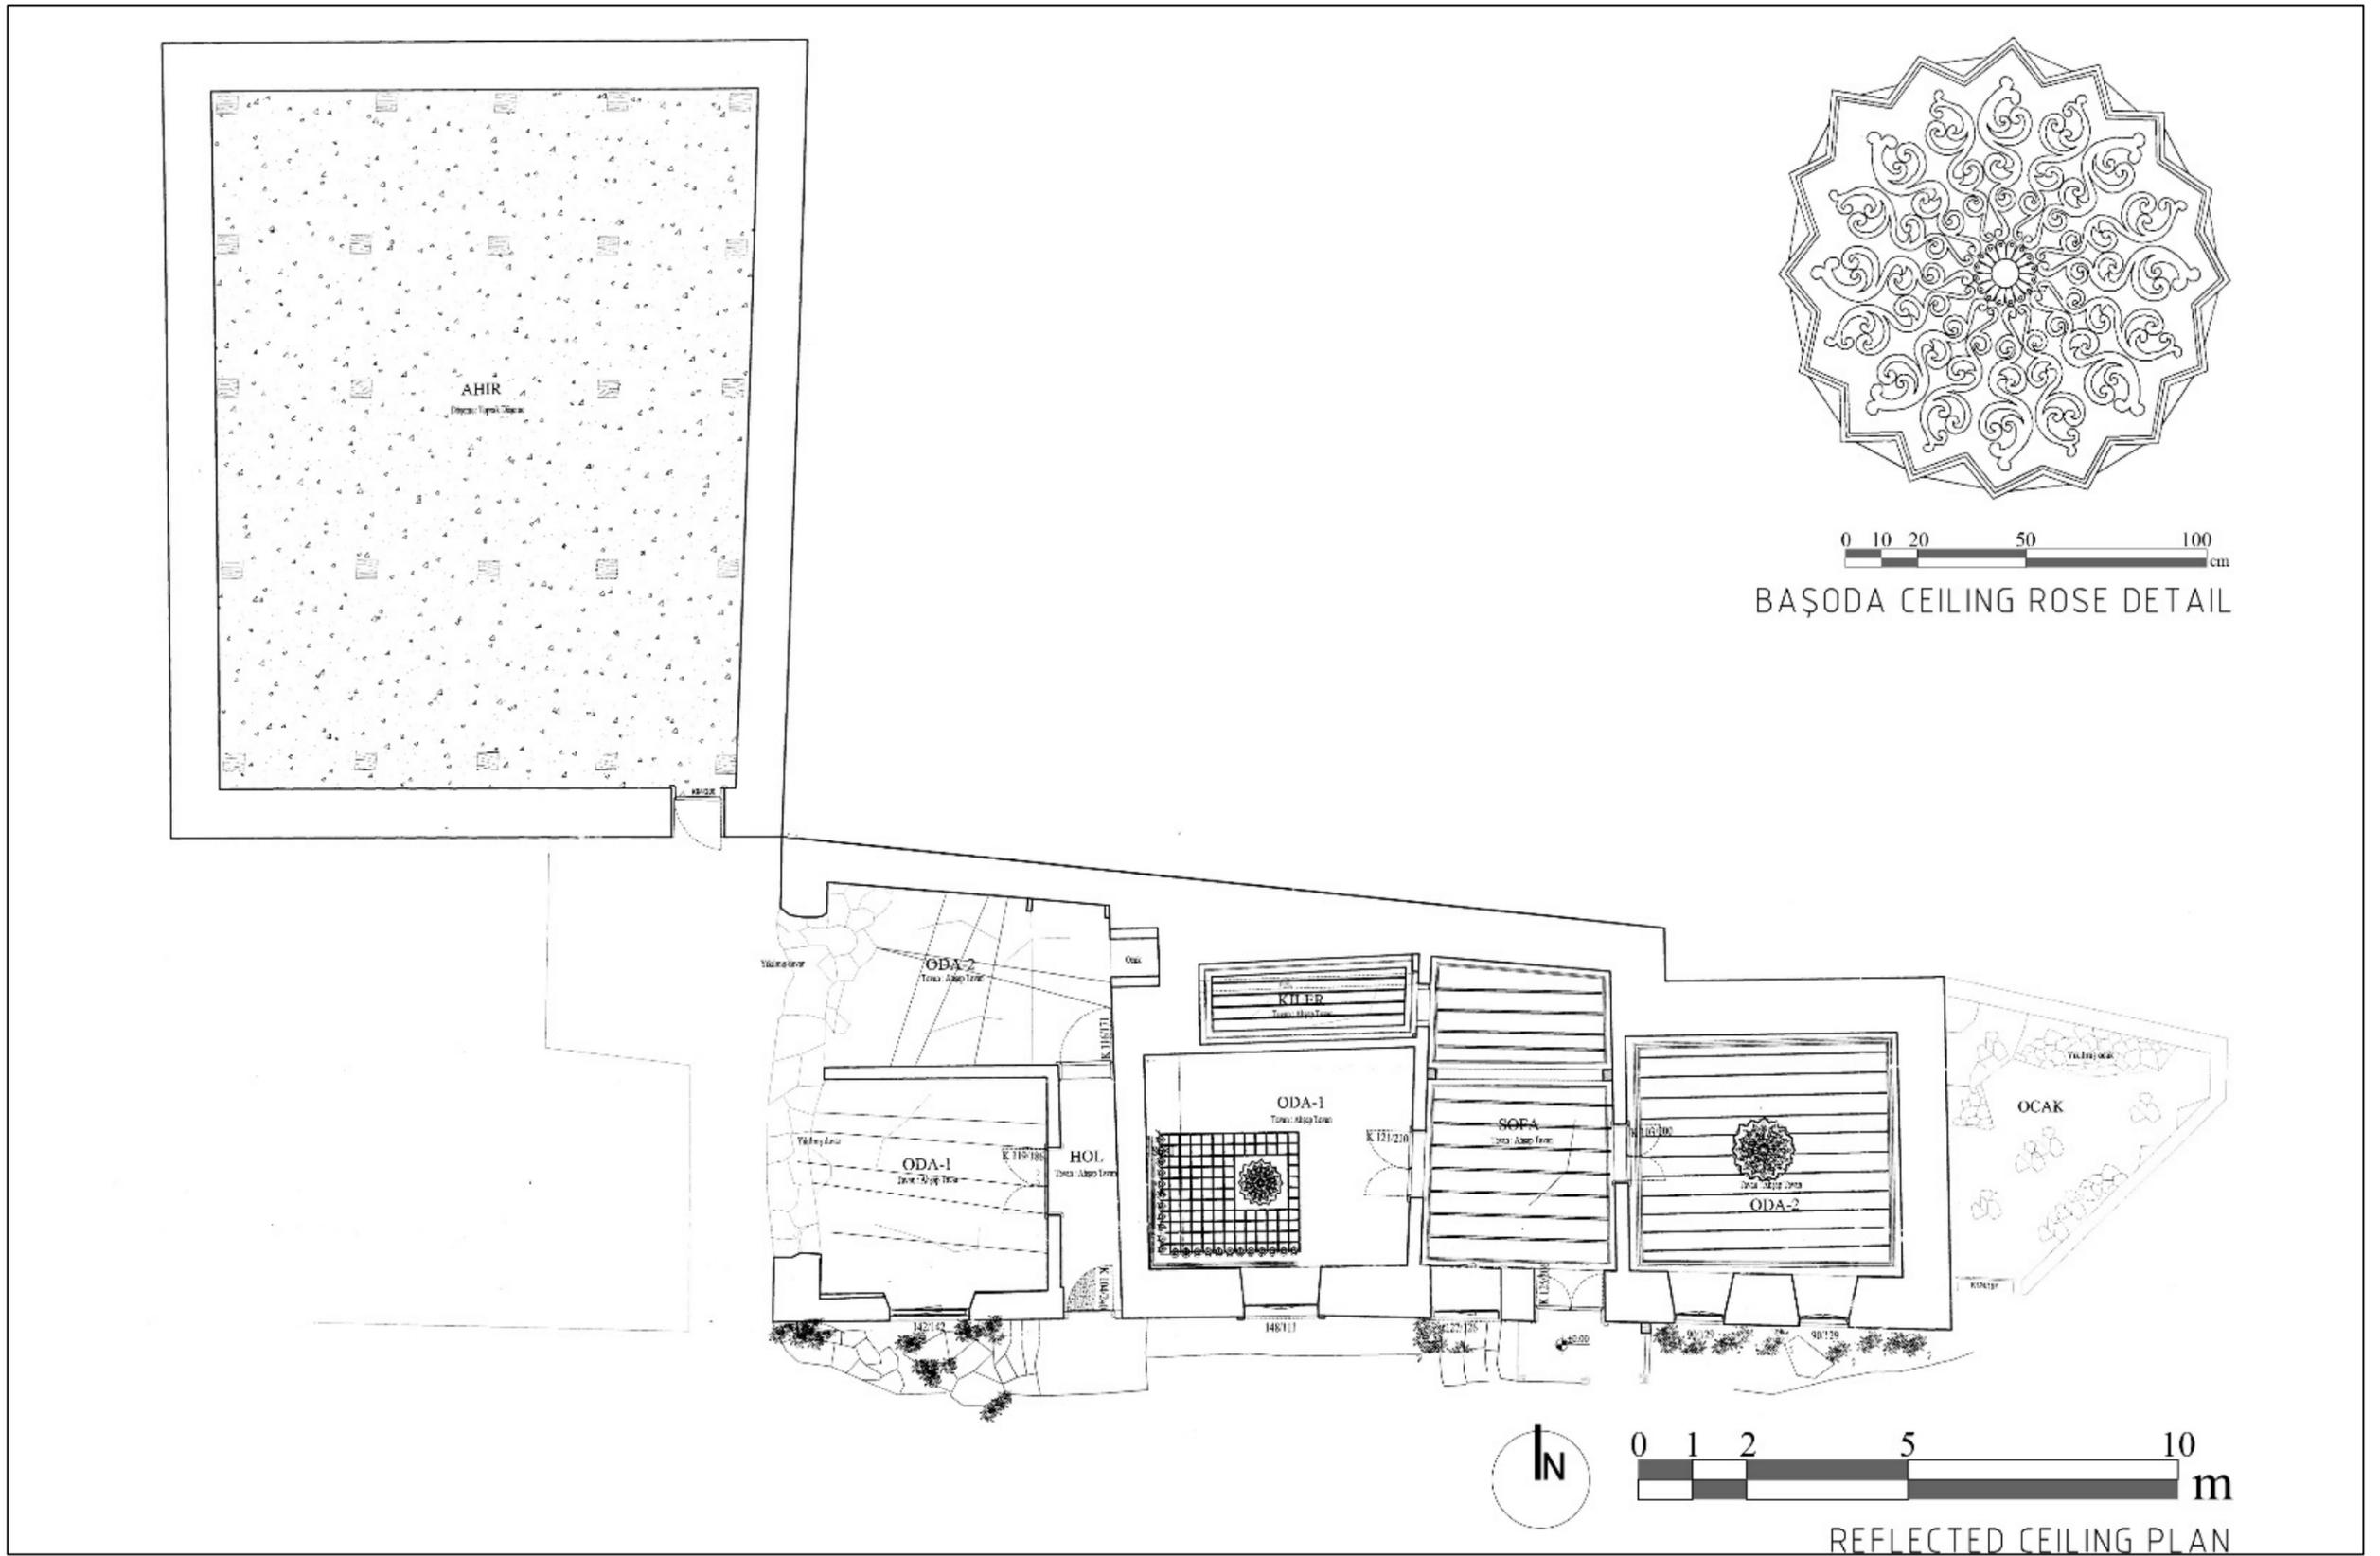
Figure D.7. Measured drawings, 2010.
 (Source: Erzurum Regional Conservation Council of Immovable Cultural Assets Archive, Access: 2019)

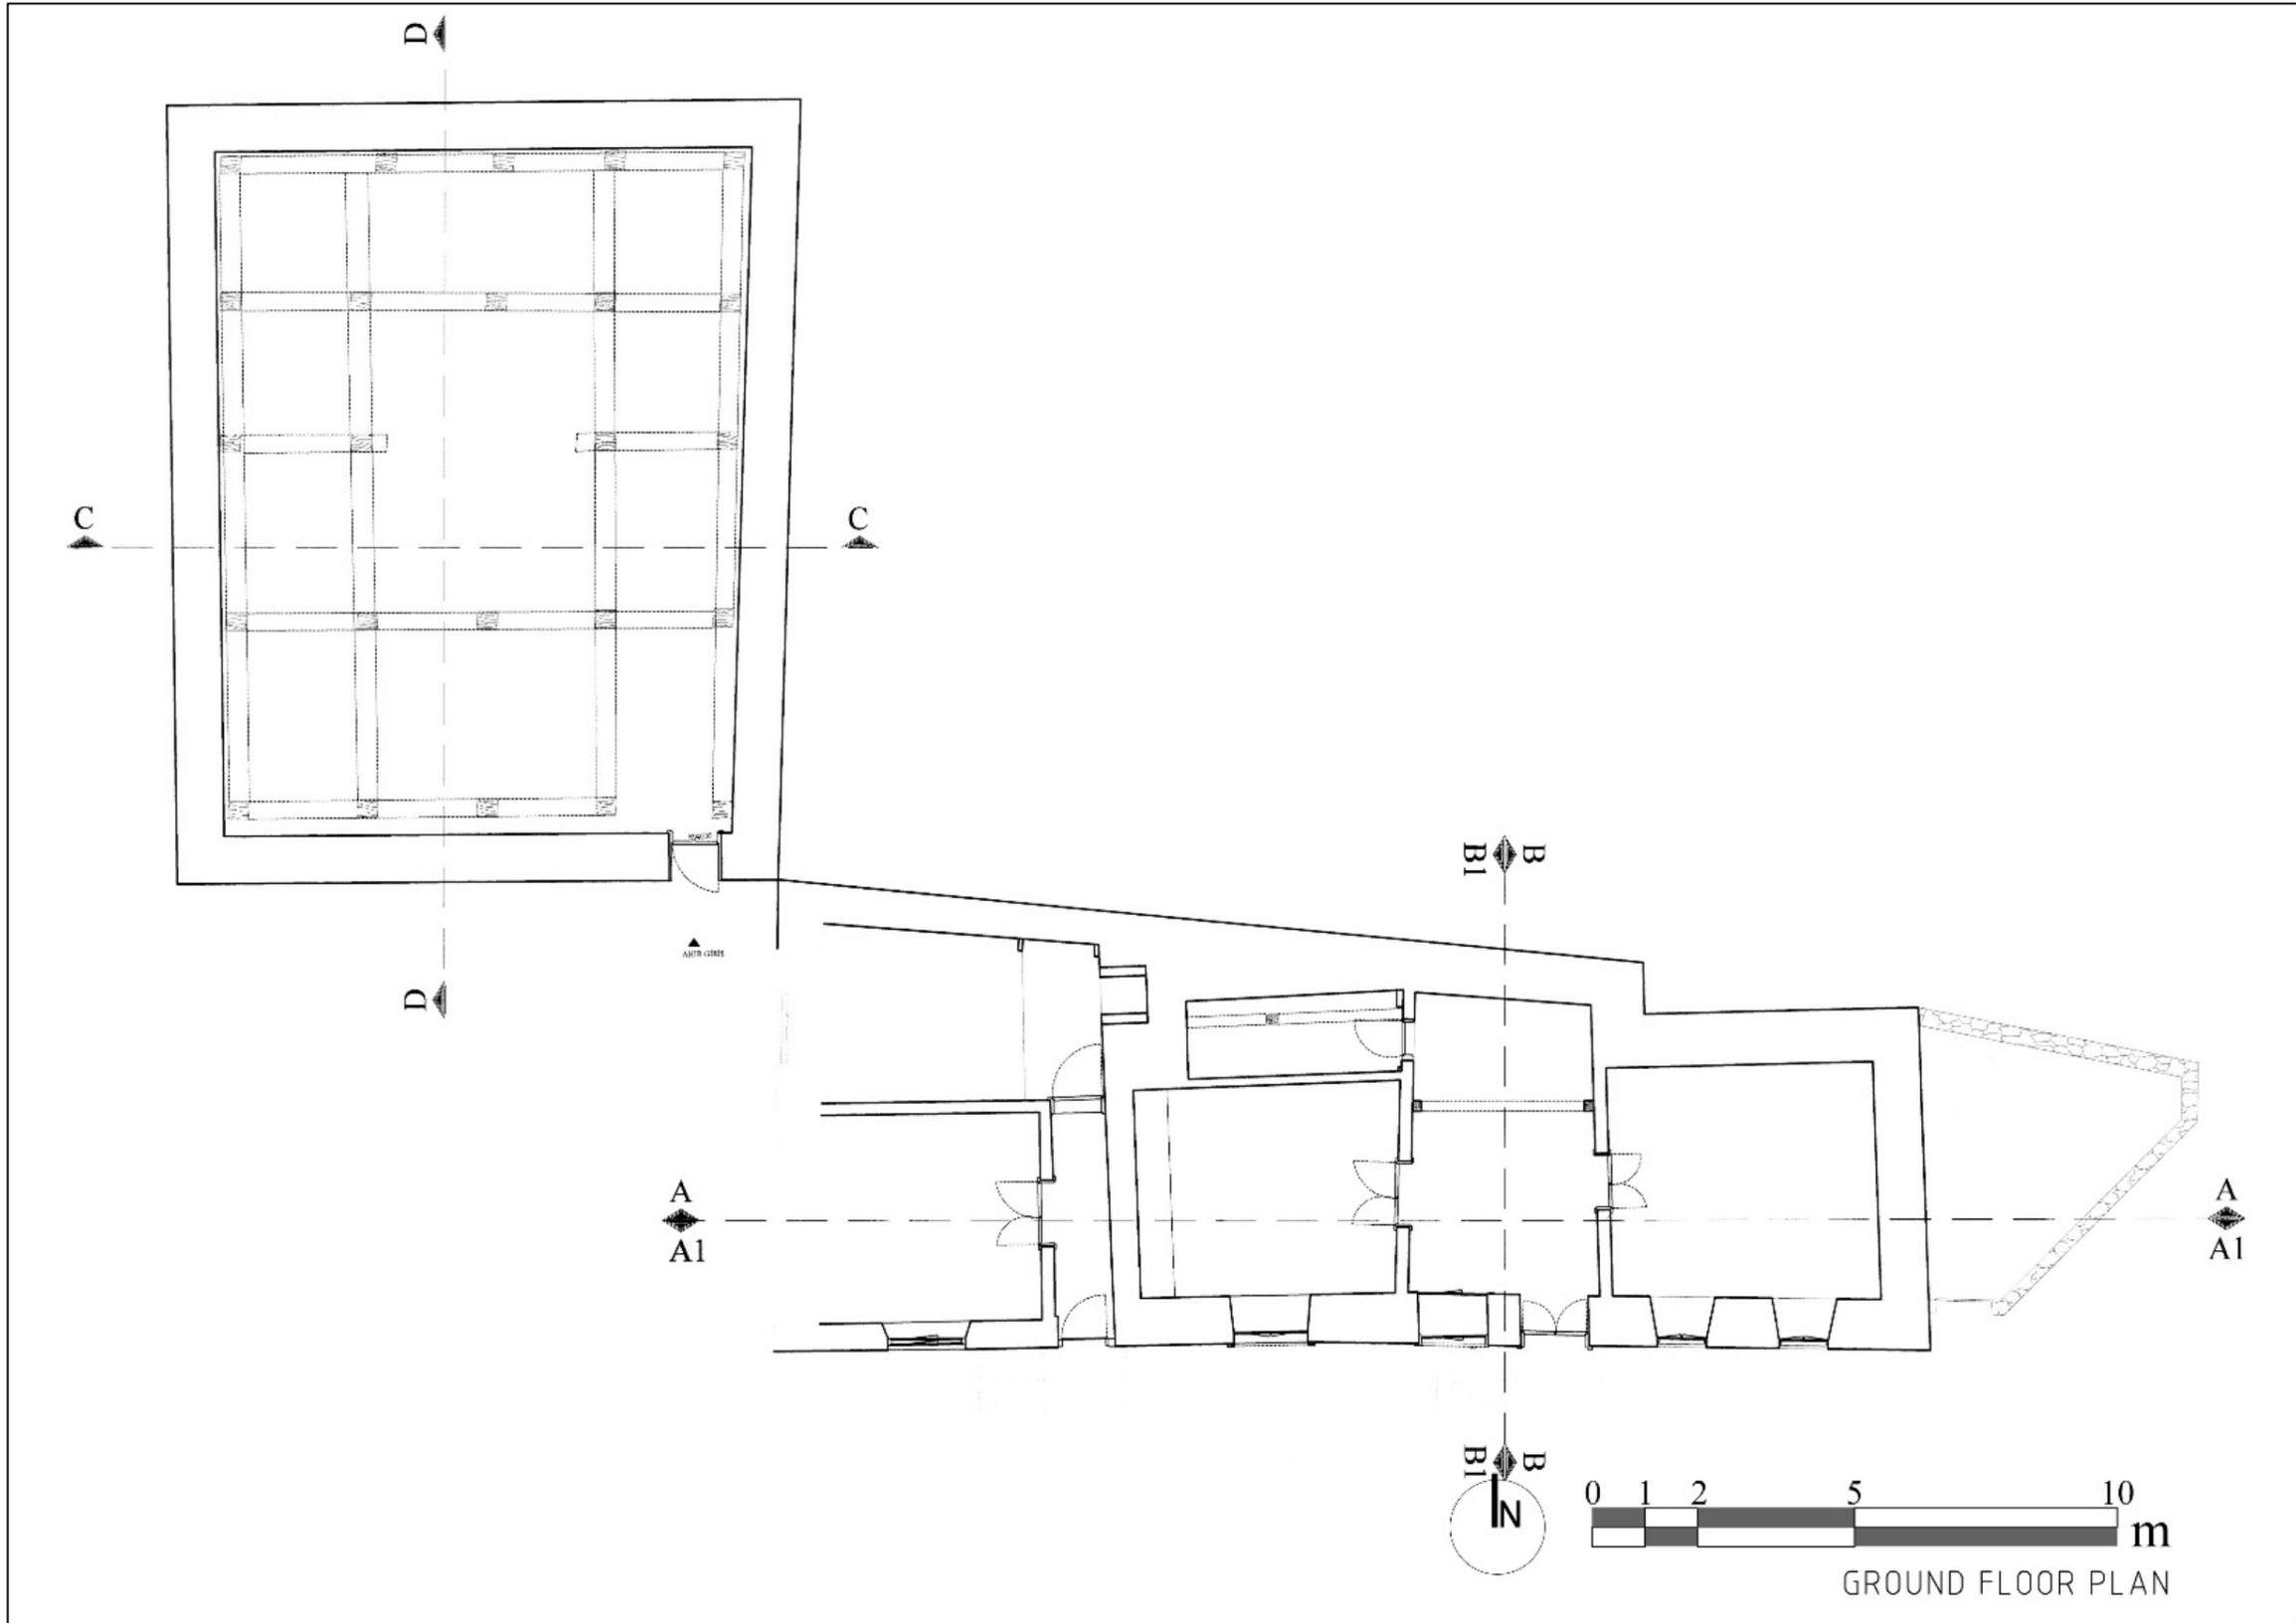
Figure D.8. Restitution drawings, 2010.
 (Source: Erzurum Regional Conservation Council of Immovable Cultural Assets Archive, Access: 2019)

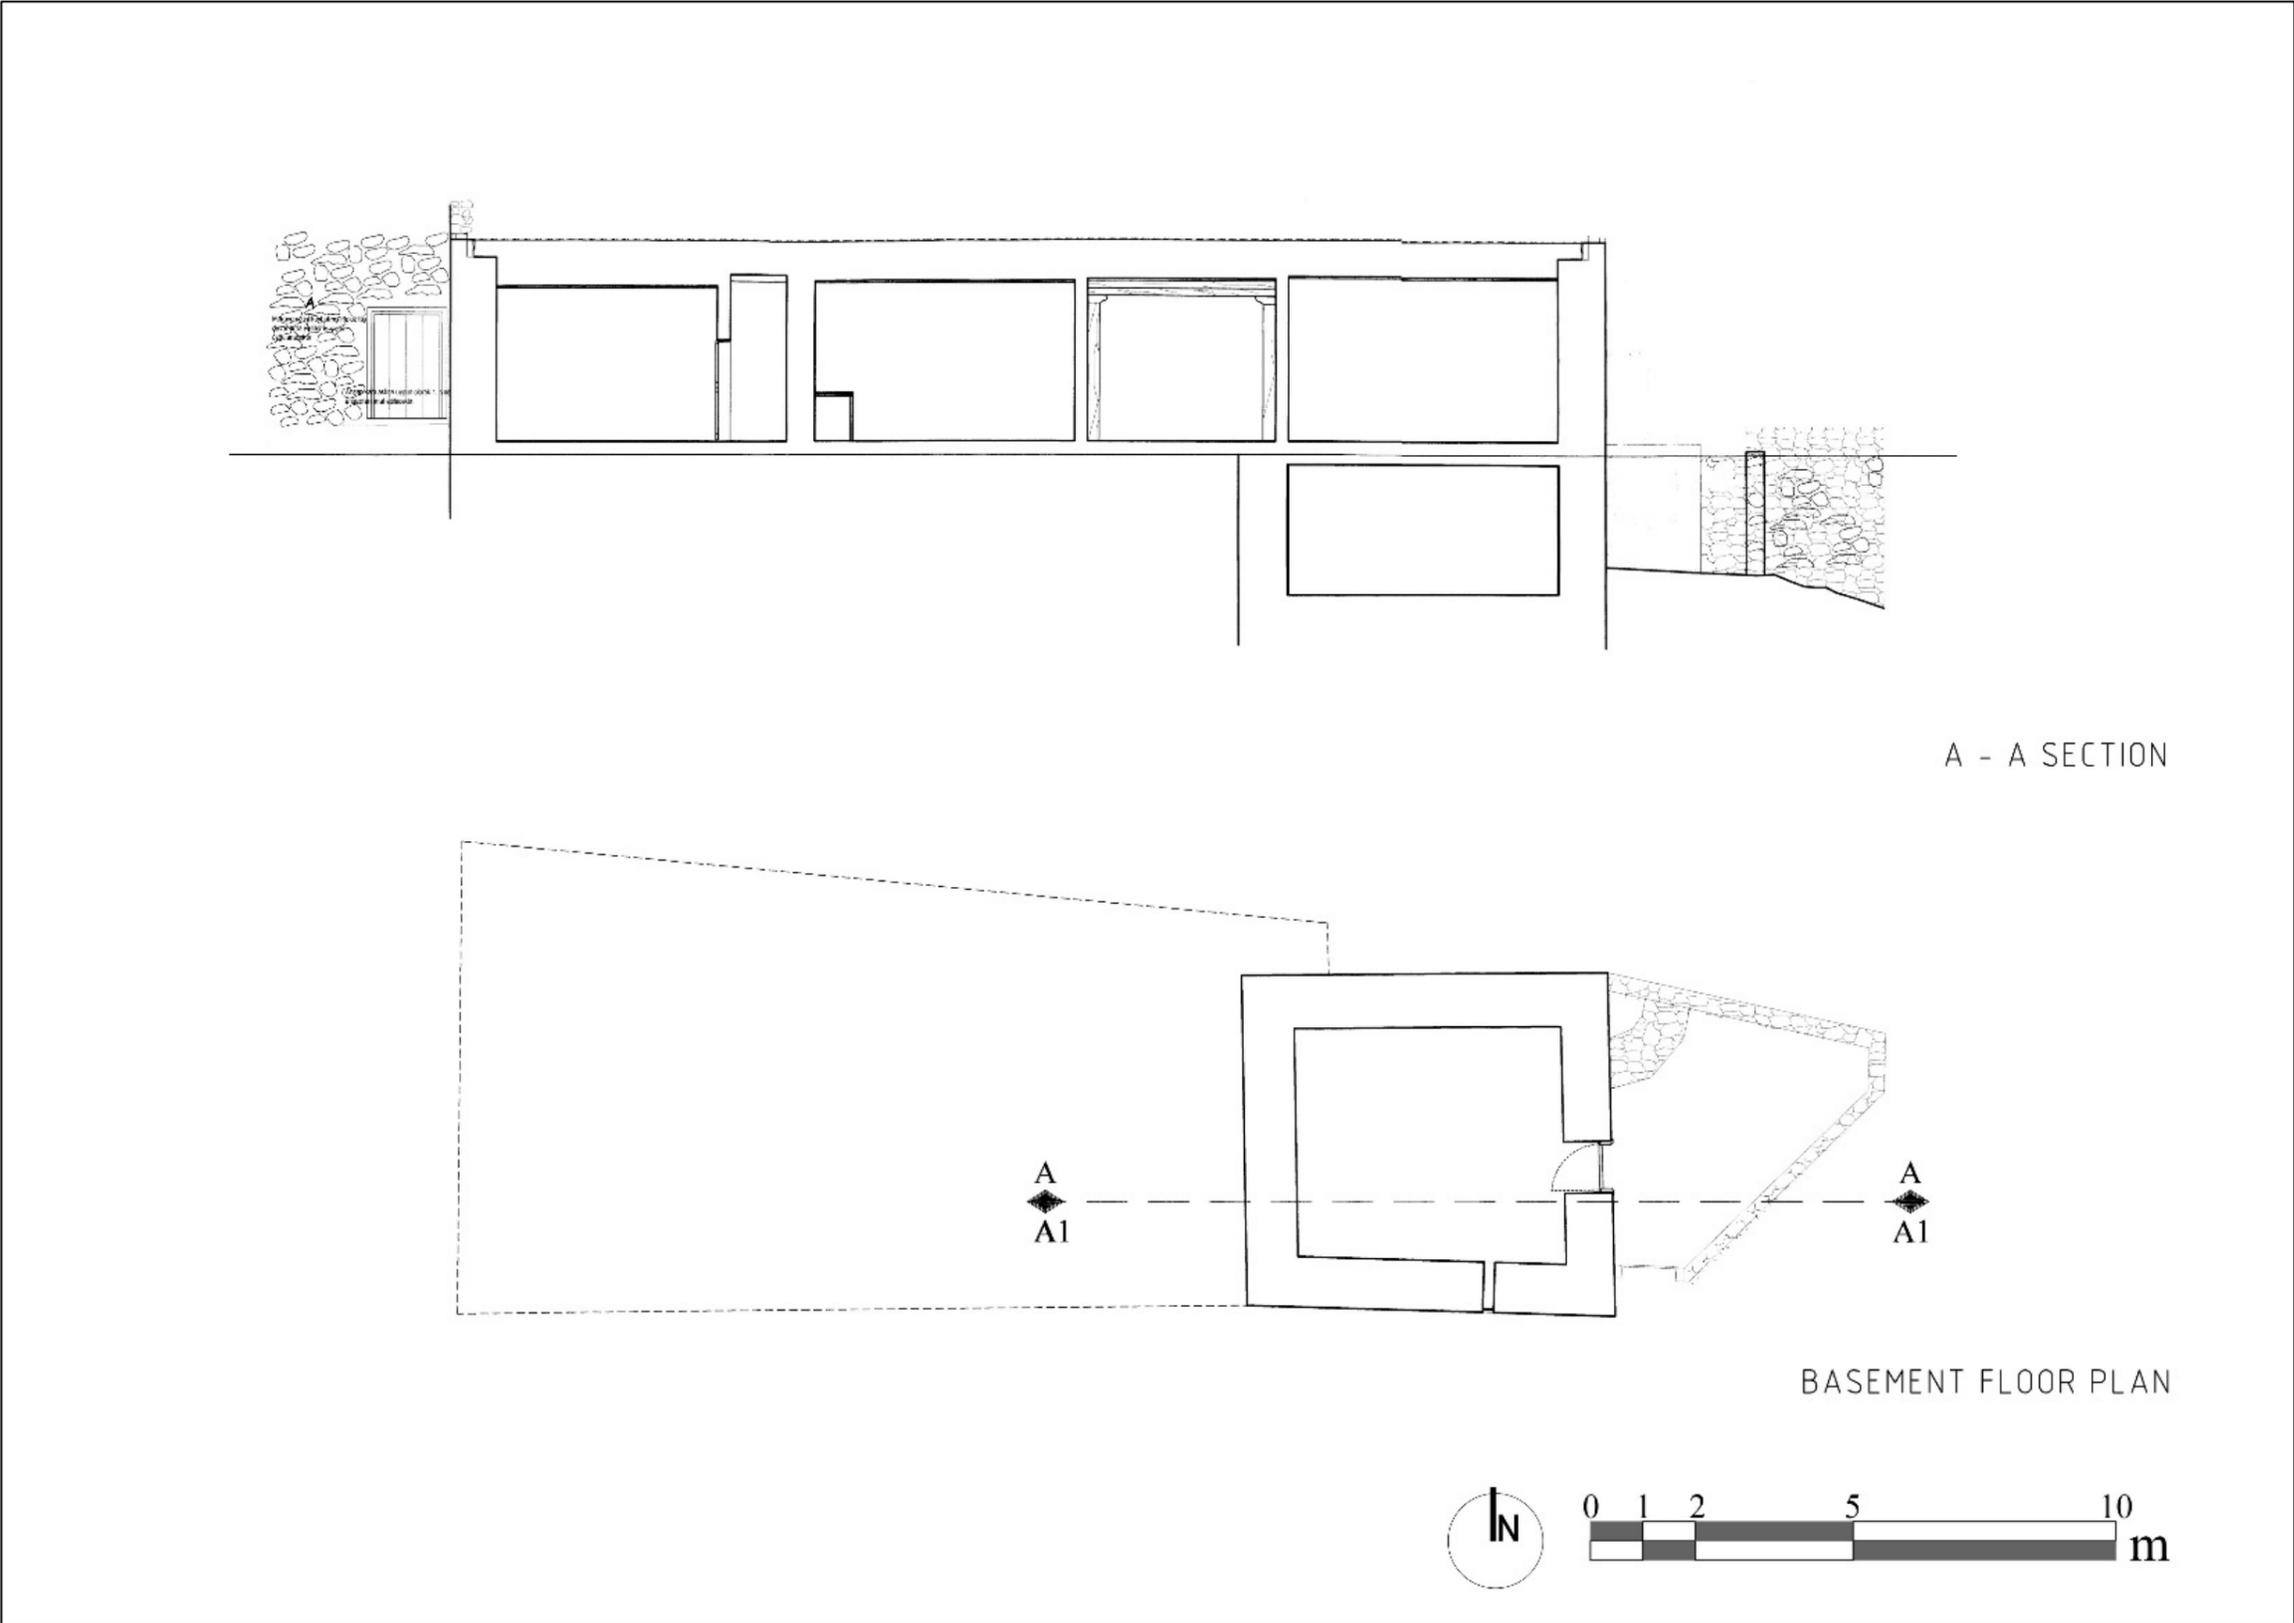
Figure D.9. Restitution drawings, 2010.
 (Source: Erzurum Regional Conservation Council of Immovable Cultural Assets Archive, Access: 2019)

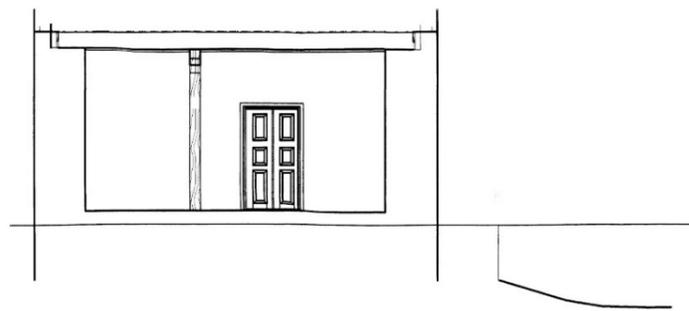
B - B SECTION

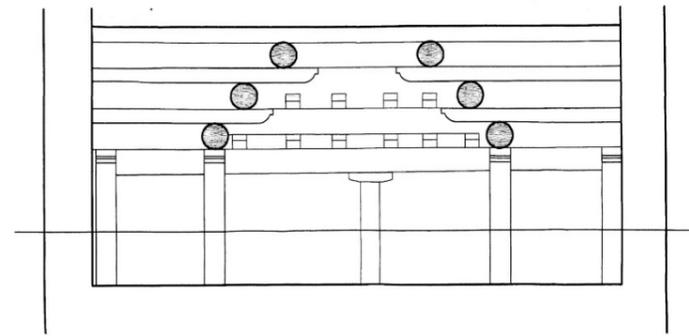
C - C SECTION

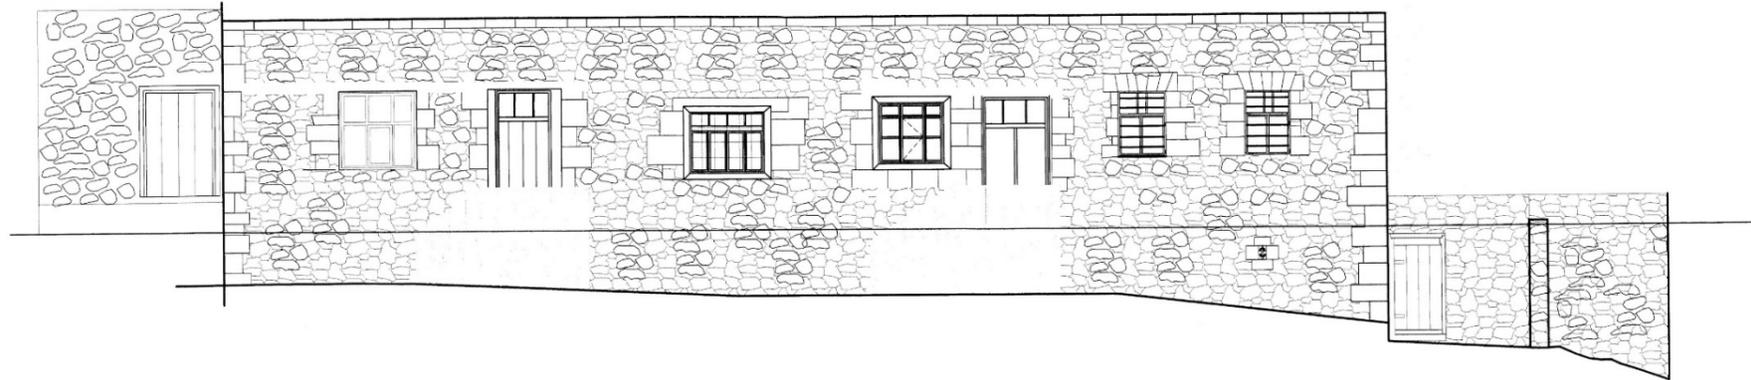
EASTERN FACADE
